## Housing Rehab Program

**PROJECT:** Reconstruction of a single-family housing unit located at: 317 Mesquite St Donna Texas

# INITIAL INSPECTION

317 Mesquite St., Donna TX

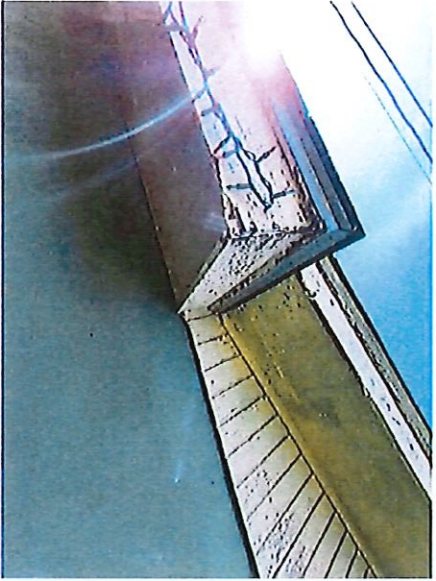
Notes: The overhang is in good shape but needs to be repainted.

Soffit and Fascia

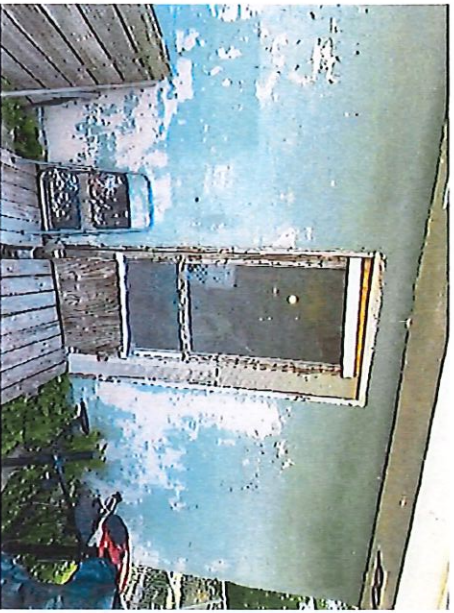
Notes: The back porch has a pallet for a step causing a tripping /fall hazard.

Pallet as a back porch deck

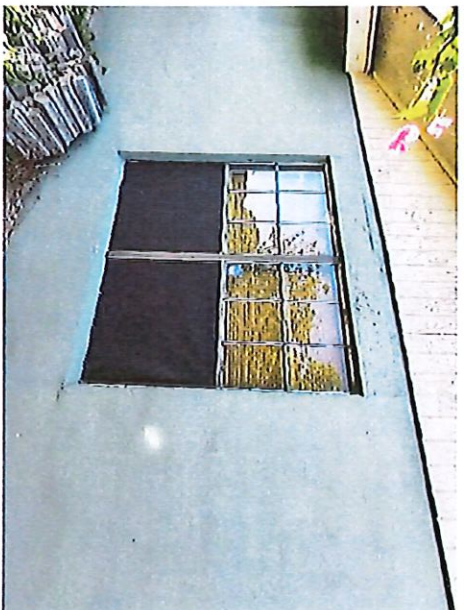
new windows throughout the house

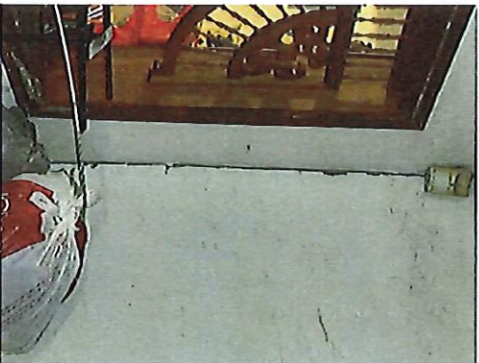
Notes: The wall coverings and trim are in need of repair. There are holes in walls and cracks due to foundation movement. Door frames and trims are broken and do not close properly.

interior walls cracked and separated

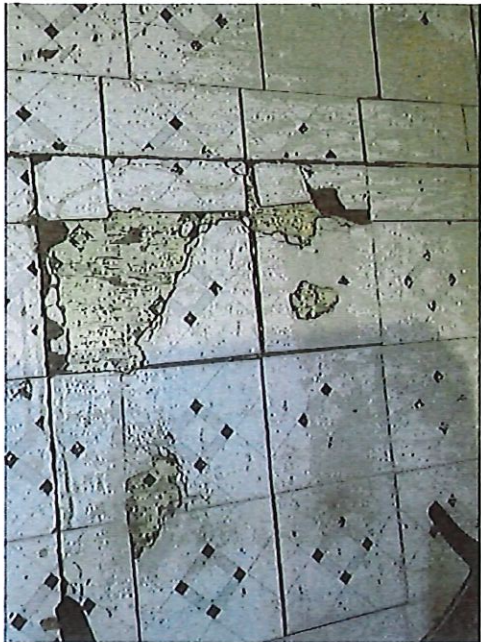
The flooring for the entire house needs to be replaced. In several areas in the house the VCT has come unglued and or worn down to the subfloor.

Worn out vinyl flooring

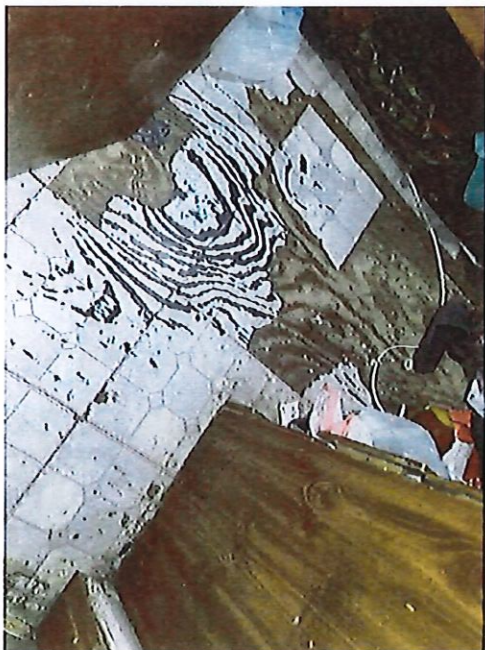
Subfloor exposed through flooring material

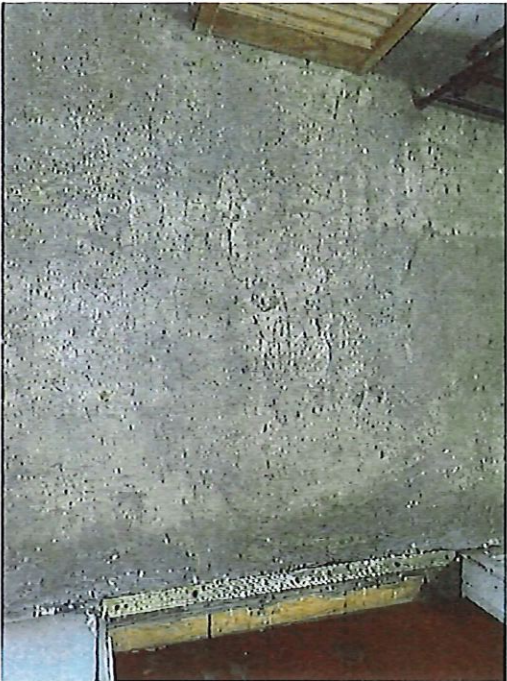
No Flooring Material

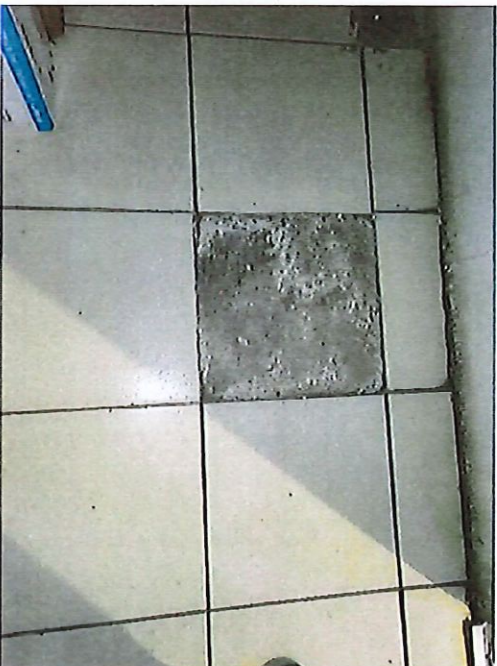
Missing & broken tiles

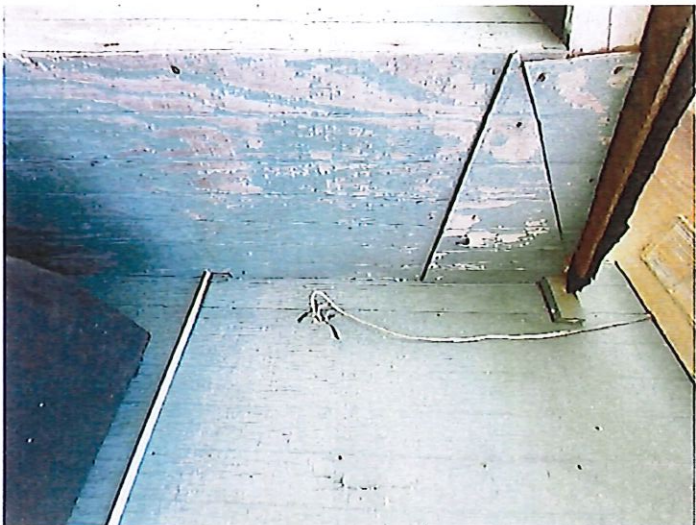
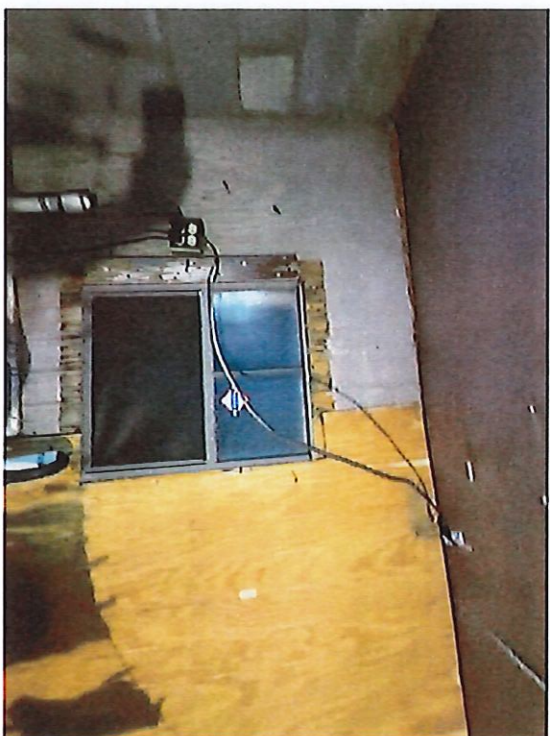
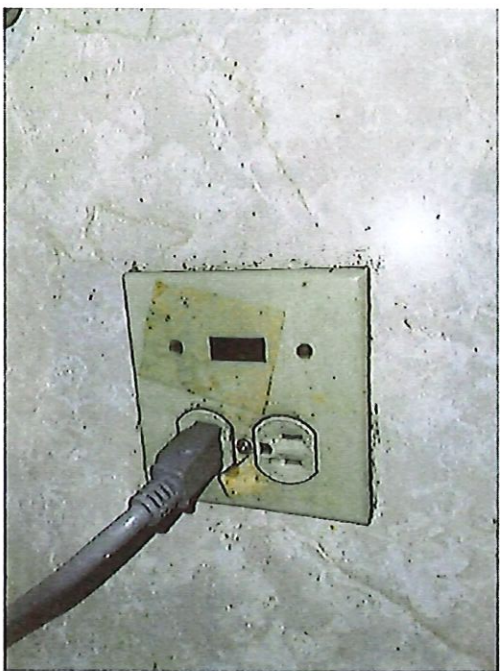
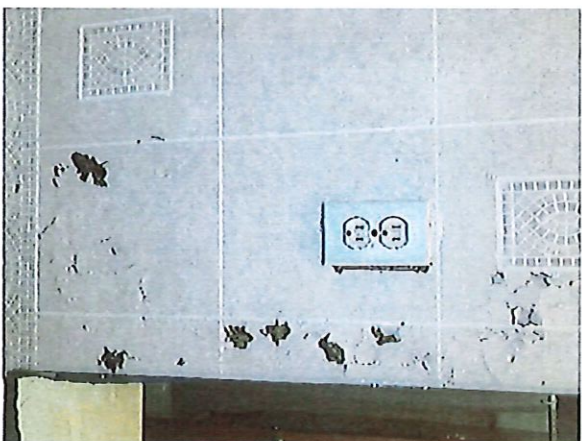
Location(s): Electrical meter riser in not up to code. Electrical wires without proper conduit alongside of the house.

Notes: There were several plugs throughout the house that were not working. Several ceiling light fixtures in the house were also not working. Electrical needs to be inspected for electrical shorts.

Electrical Deficiencies

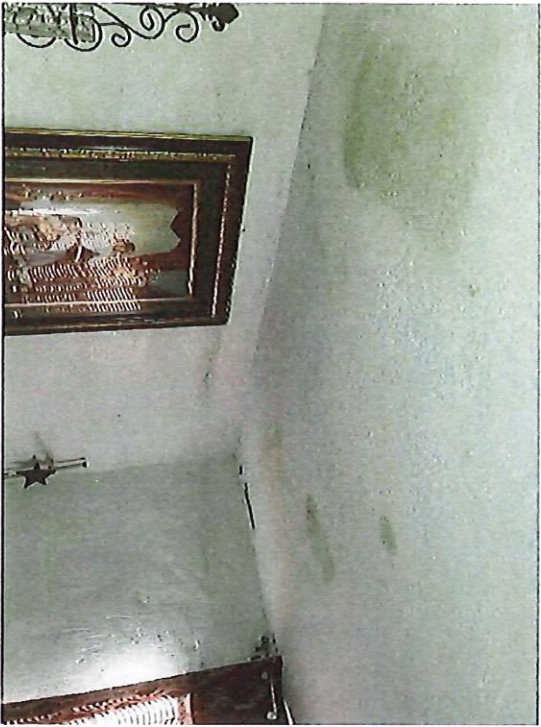
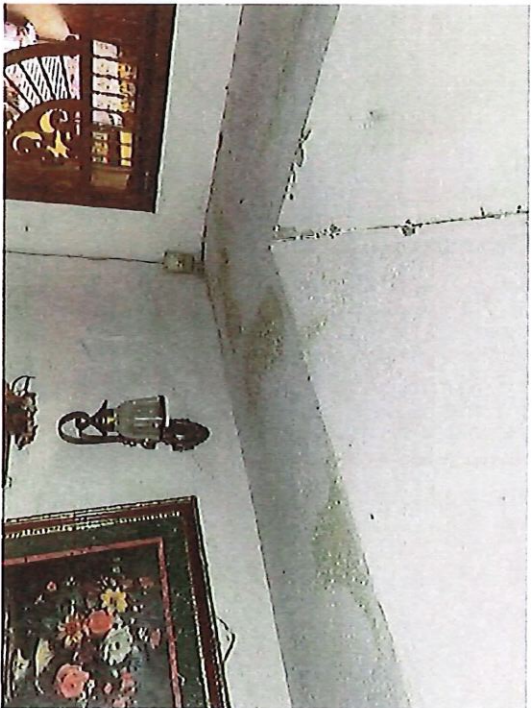
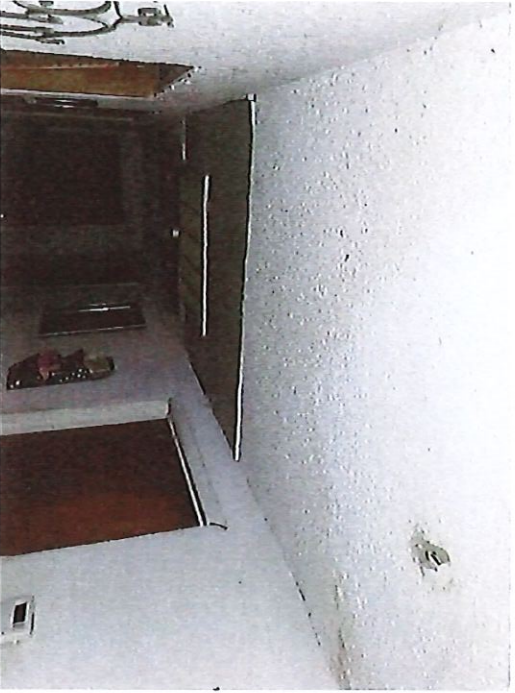
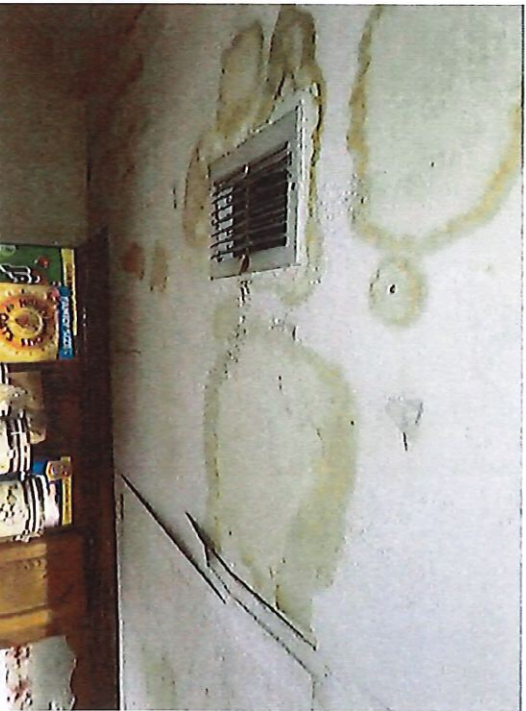
Notes: The ceiling coverings have cracks around the perimeter walls due to foundation movement. There are several areas where water damage has stained the ceiling. There are also signs of termites and rodent infestation.

Ceiling Deficiencies
