Housing Rehab Program

ENTITY: City of San Juan

PROJECT: Reconstruction of a single-family housing unit located at: 1505 Pullin St. San Juan Texas

INITIAL INSPECTION

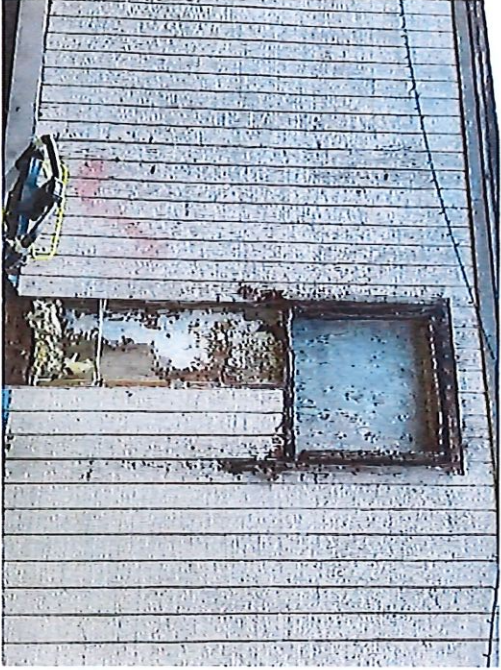
Notes: The exterior wall siding is in bad shape. There are many areas where the wood siding has deteriorated due to moisture or termites. Wood siding needs to be replaced and sealed to prevent future deterioration.

Exterior siding weather damaged and missing in some areas

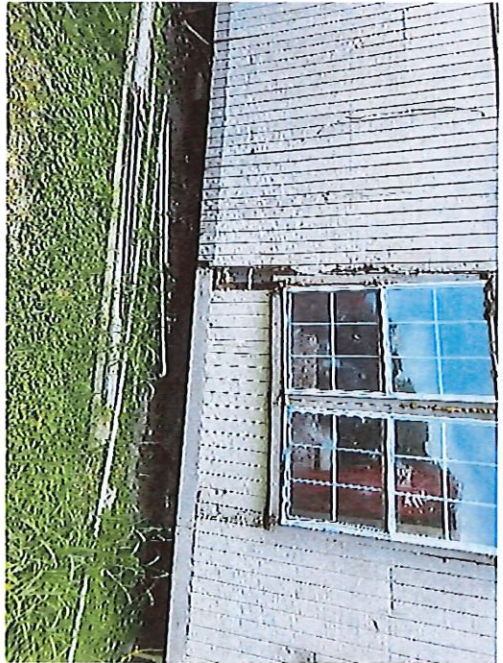
Notes: The windows are not in good working order and need to be replaced. Windows are aluminum and many are cracked and do not open.

weather damaged Siding and inoperable windows

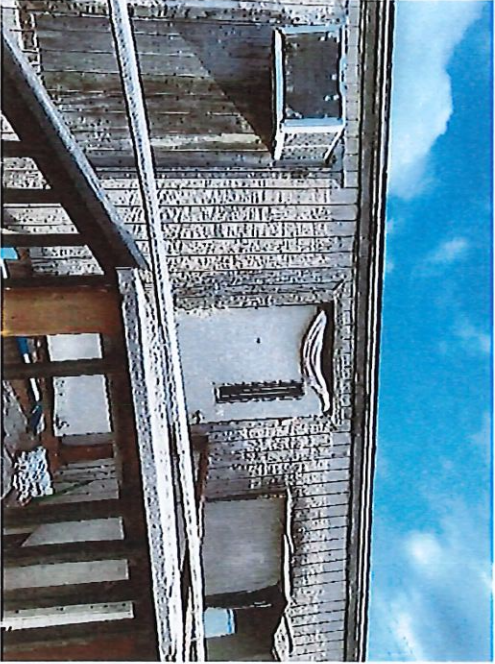
Notes: The front and rear exterior doors need to be replaced. The door frames is damaged and cracked due to weather deterioration.

Back door inoperable and has big gaps

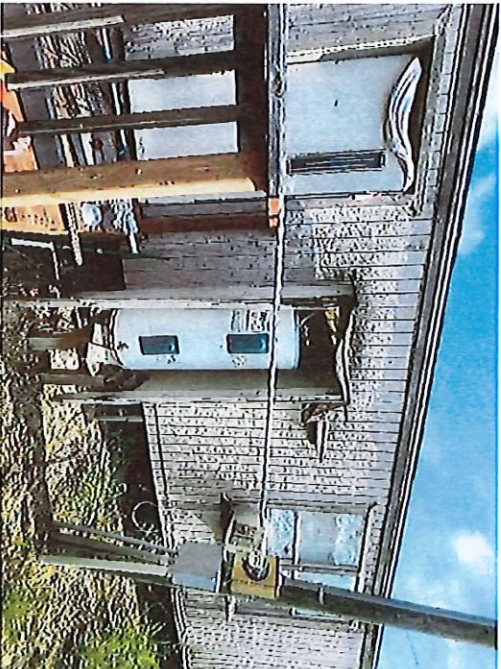
Notes: The water heater is located outside and is exposed to the elements, exposed wires and rust and needs to be replaced.

Water heater rusted and closet needs to be replaced

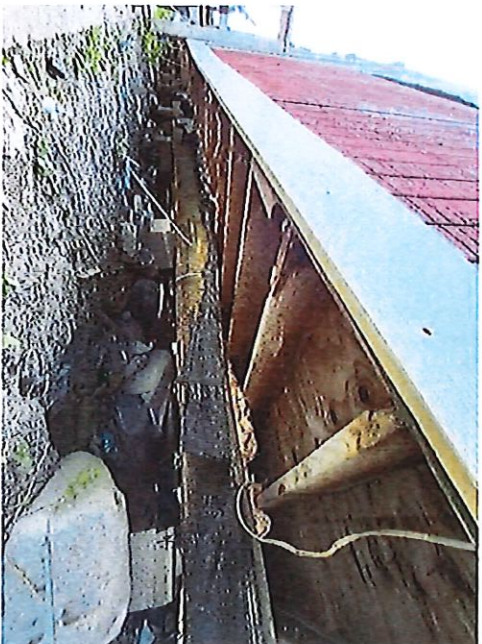
No Insulation or Pinning

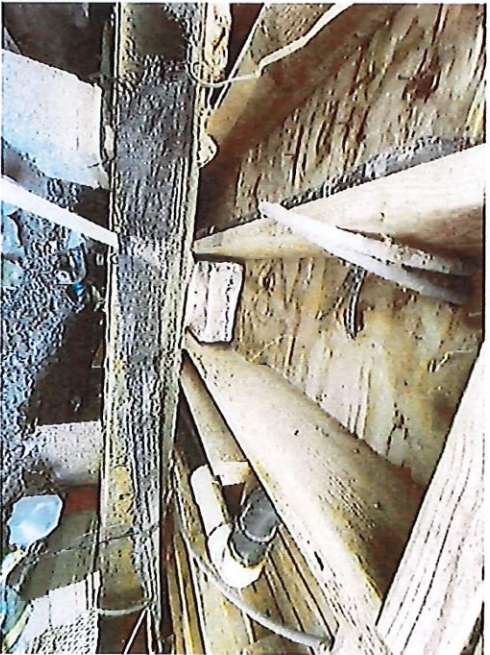
12. **Other observations about all Exterior Plumbing/Drain/Sewer:**
Plumbing is exposed throughout the entire home; vent pipes not above roof line, water lines leaking.

sewer lines not properly supported

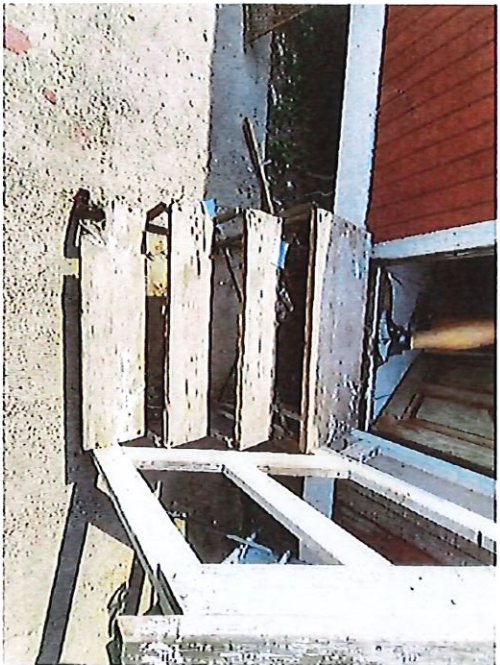
Notes: The front steps and back steps not to code and has no rails, the side door steps are old and broken causing a tripping /fall hazard.

Stairs need to be replaced

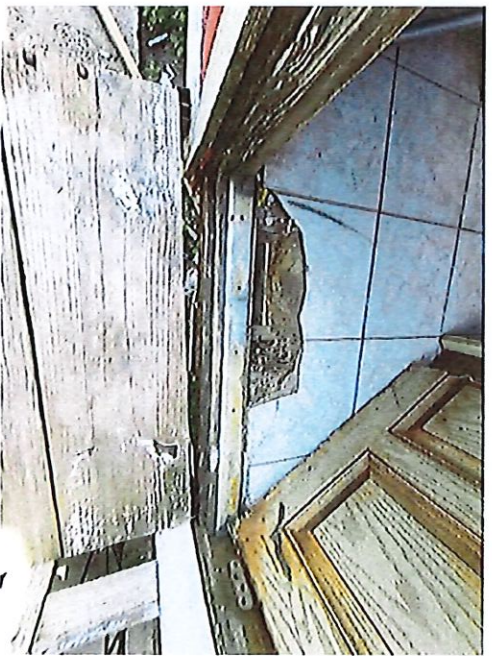
The flooring for the entire house needs to be replaced. In several areas in the house the VCT has come unglued and or worn .The subfloor has major holes exposing the entire house to the elements.

tile broken and holes through the sub-floor

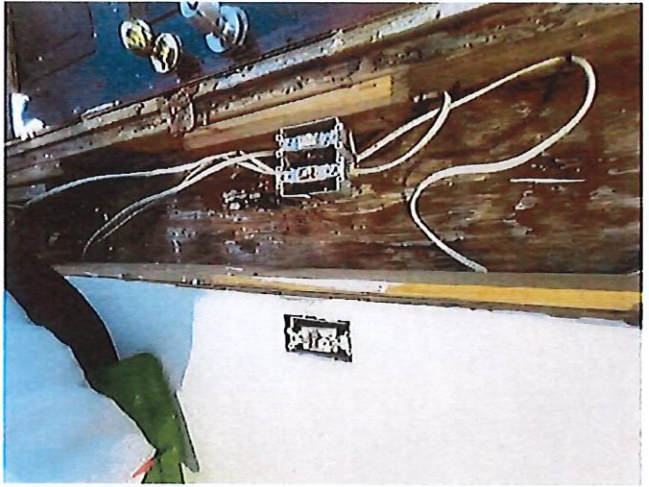
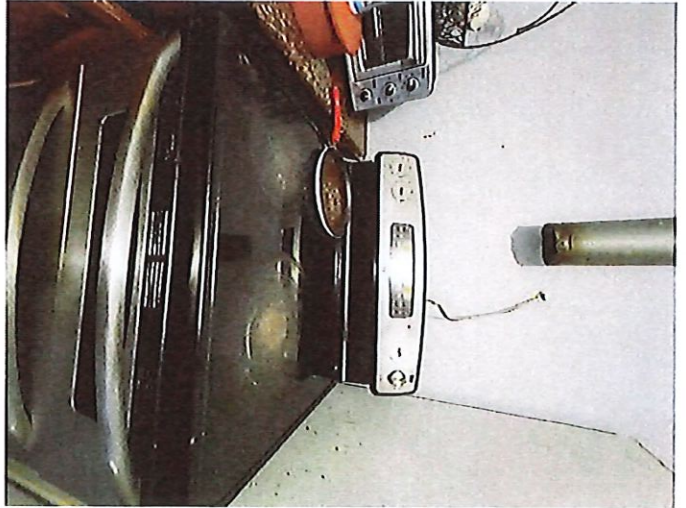
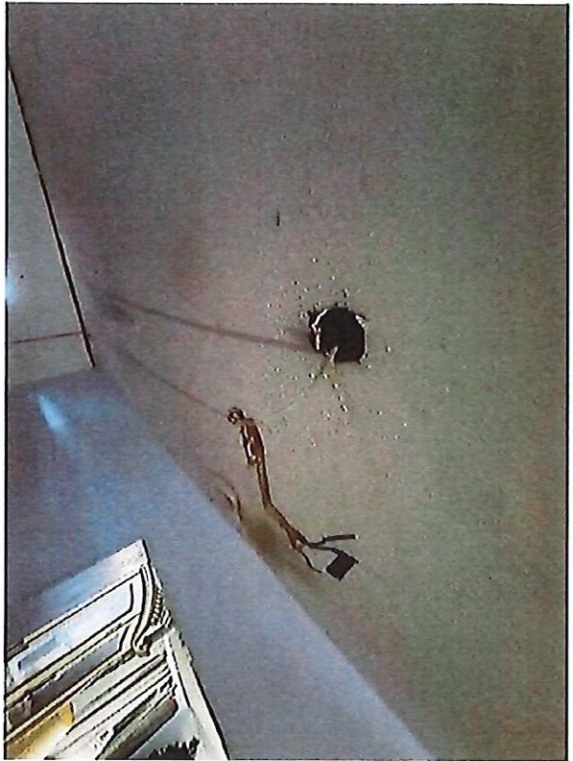
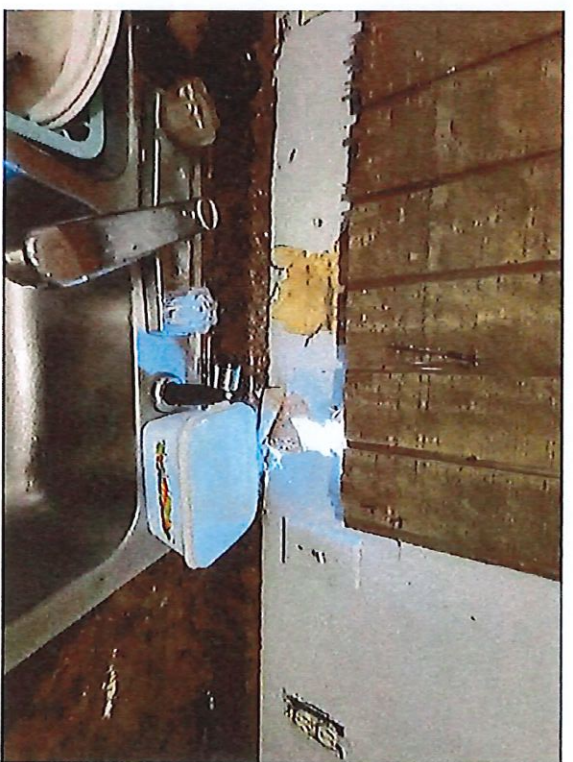
Notes: There were several plugs throughout the house that were not working. Several ceiling light fixtures in the house were also not working, exposed electrical wires. Electrical needs to be inspected for electrical shorts.

Electrical Deficiencies

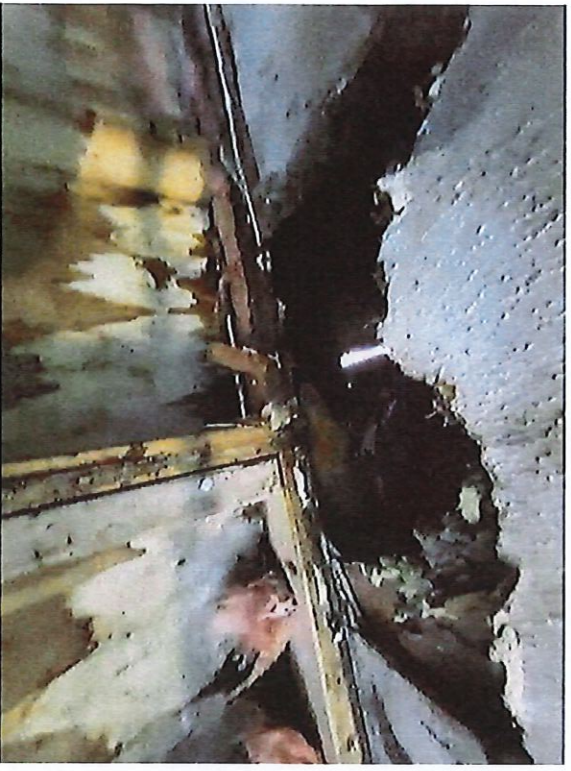
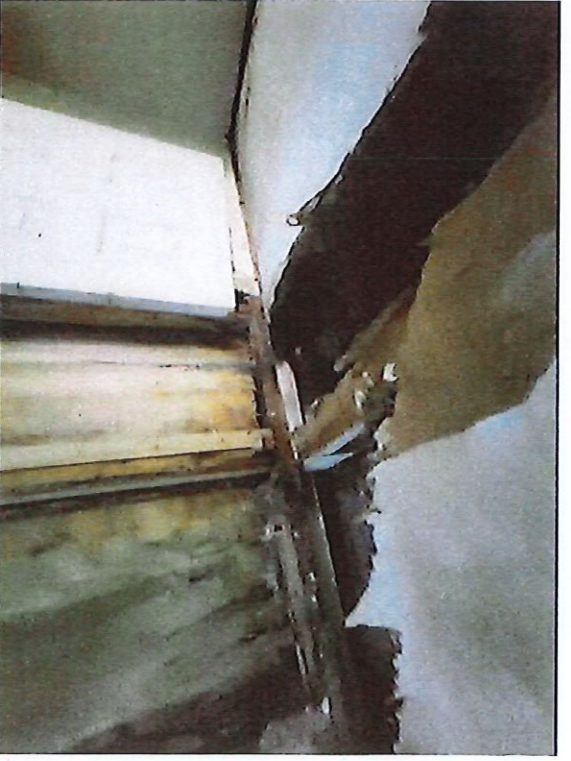
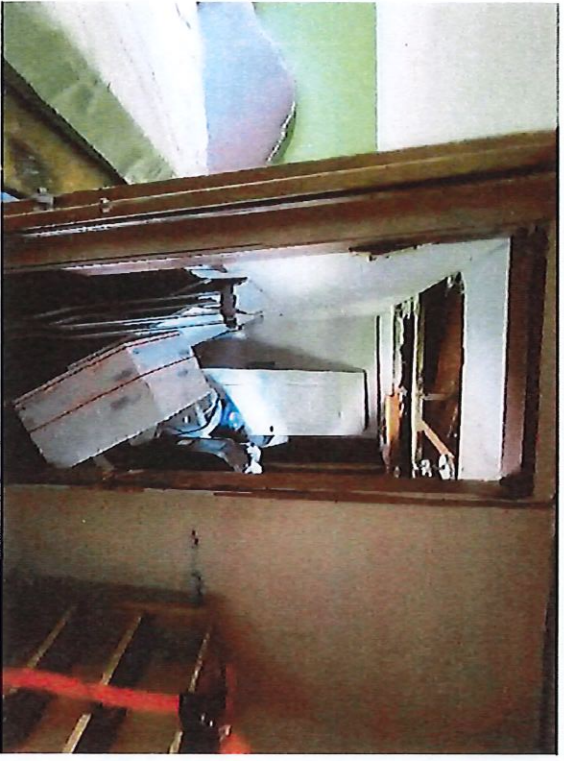
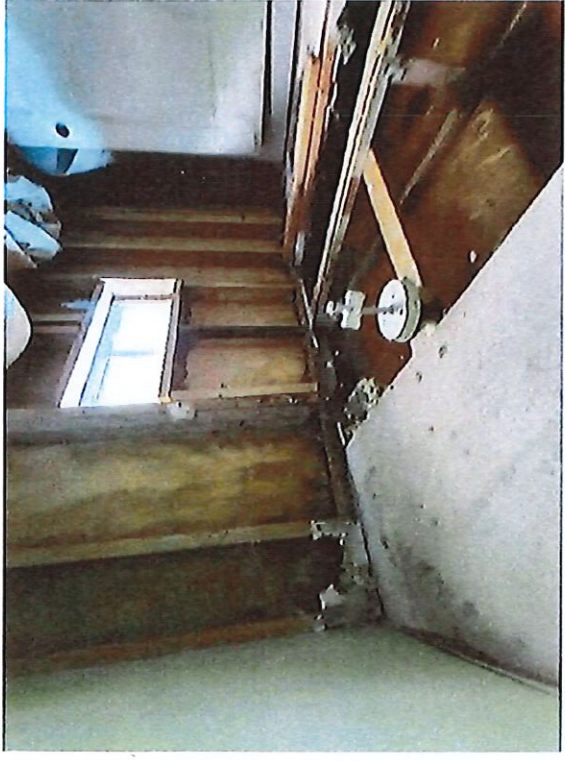
Notes: There are several major holes where water damage has caved in the ceiling. There are also signs of termites and rodent infestation.

Ceiling Deficiencies
