**RE: Contract # C-23-0417-10-31
 Pct. 2 McAllen Health Clinic
 Work Authorization #2 ~ CMT**

McAllen Health Center | ARPA-24-340-352
P.O. 26200744 / 902385
Acct. # 1290-41-115-000-0000-507300

Project Info:
McAllen Health Clinic Improvement Project
Contract # C-24-0150-05-28
Work Authorization #2 - CMT
PO # 902385
B2Z JOB: 2324

2324B
WA#2 McAllen Health Clinic Improvement
Project
Various
McAllen, TX

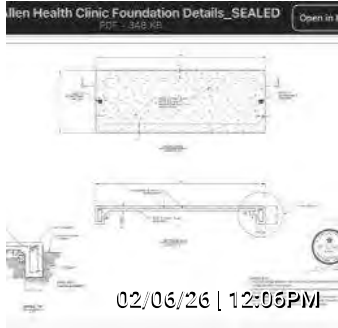
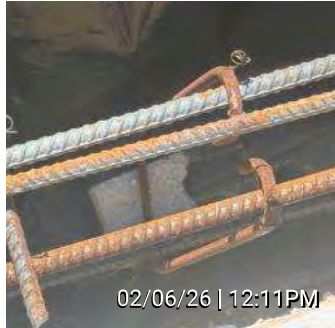
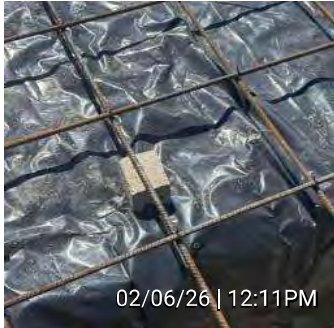
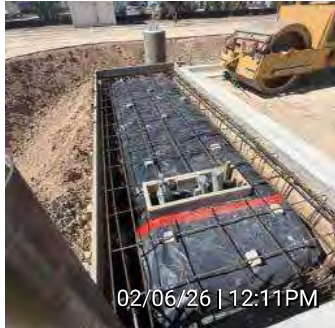
*Missing vapor barrier THROUGH beam

All deficiencies fixed on site

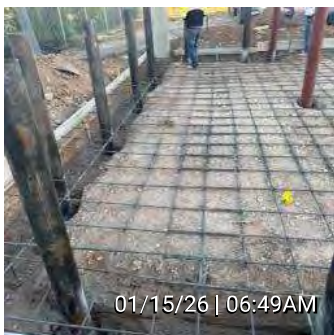
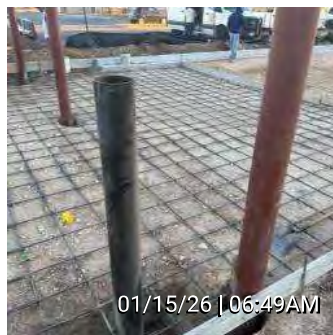
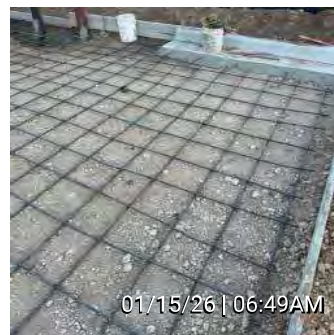
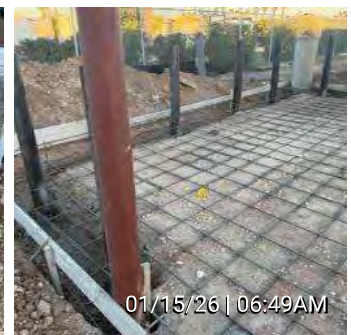
*missing a few ties

*vertical reinforcement missing (will be embedded when poured)

All deficiencies fixed on site
