Housing Rehab Program

PROJECT: Reconstruction of a single-family housing unit located at: 416 S. 7th St Donna, Texas

INITIAL INSPECTION

416 S. 7th St. Donna TX

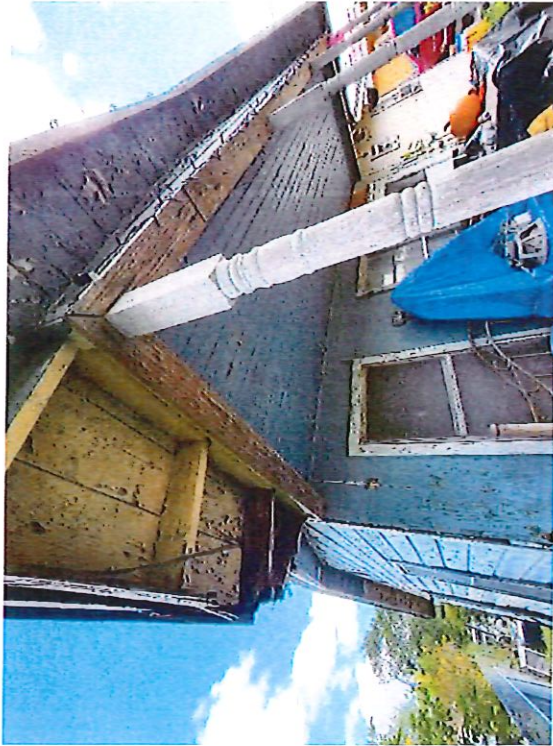
Soffit and Fascia

Notes: The overhang is in bad shape. There are many areas where the overhang has deteriorated due to moisture or termites. Overhang needs to be replaced and sealed to prevent future deterioration. The trim needs to be replaced due to deterioration.

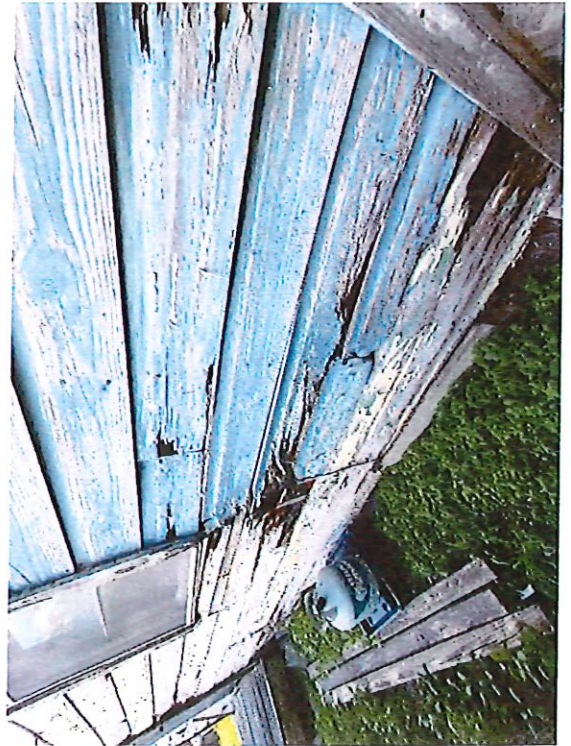
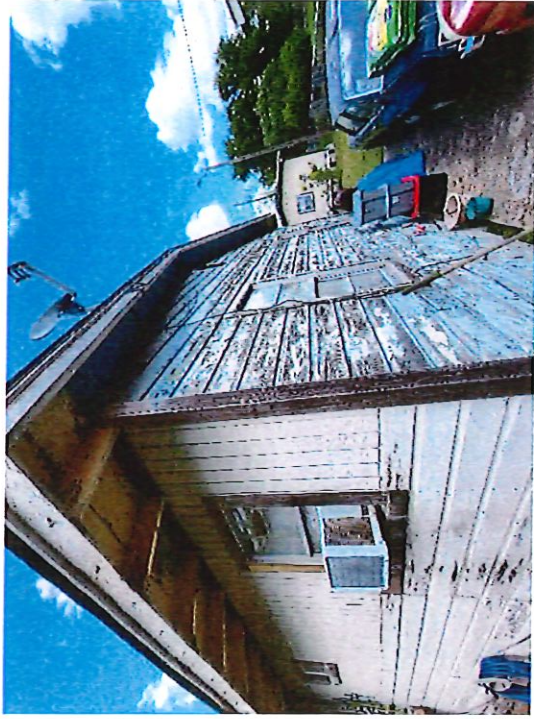
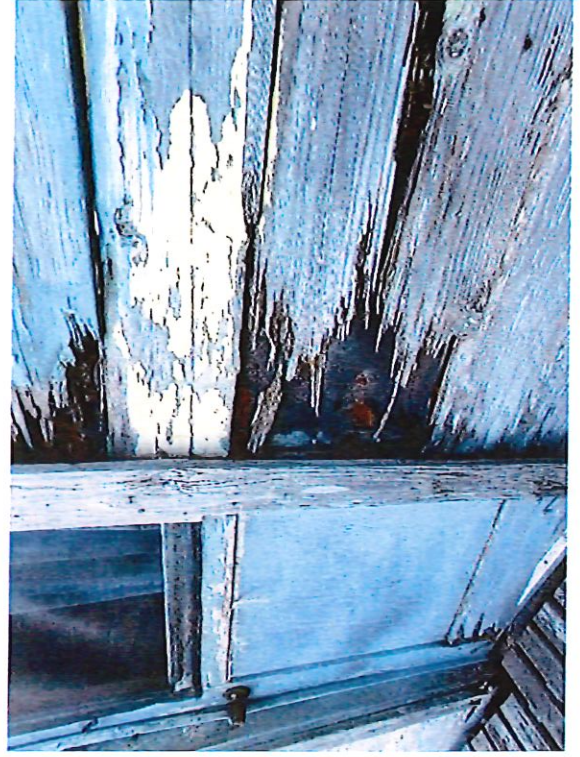
Exterior Siding

Notes: The exterior wall siding is in bad shape. There are many areas where the wood siding has deteriorated due to moisture or termites. Wood siding needs to be replaced and sealed to prevent future deterioration.

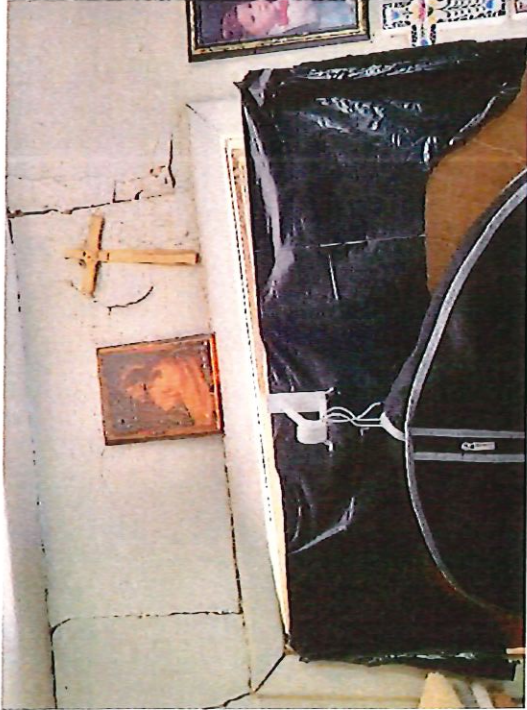
Notes: The front and rear exterior doors need to be replaced. The door frames is damaged and cracked due to the shifting of the house.

Exterior doors do not close properly.

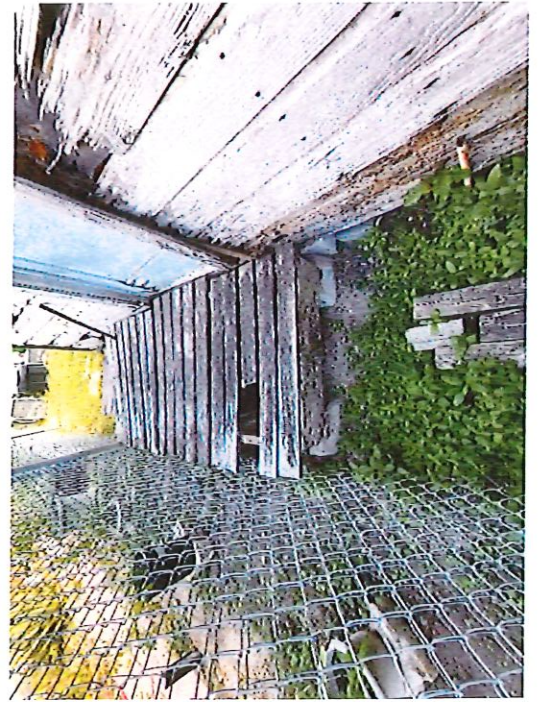
Notes: The Side porch and steps need to be replaced.

Steps need to be repaired

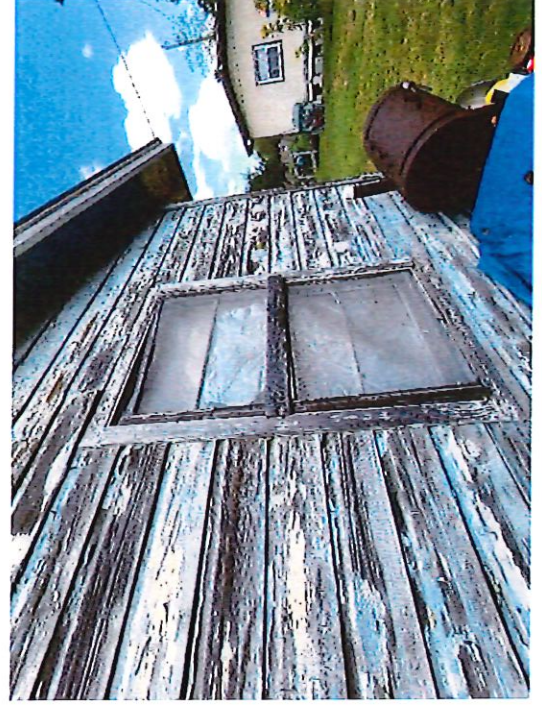
Broken windows

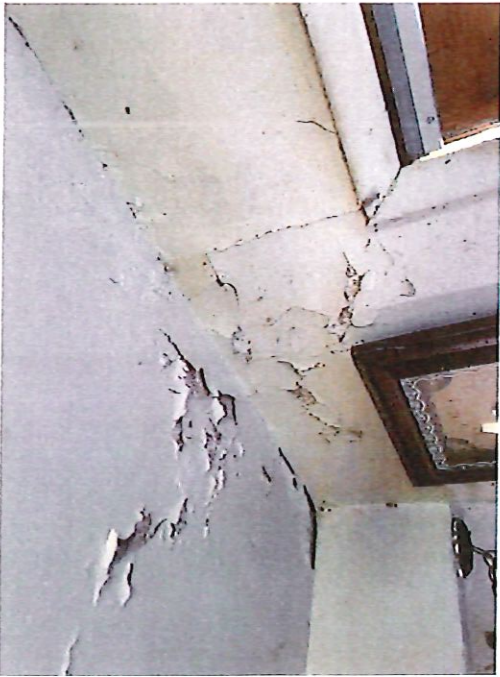
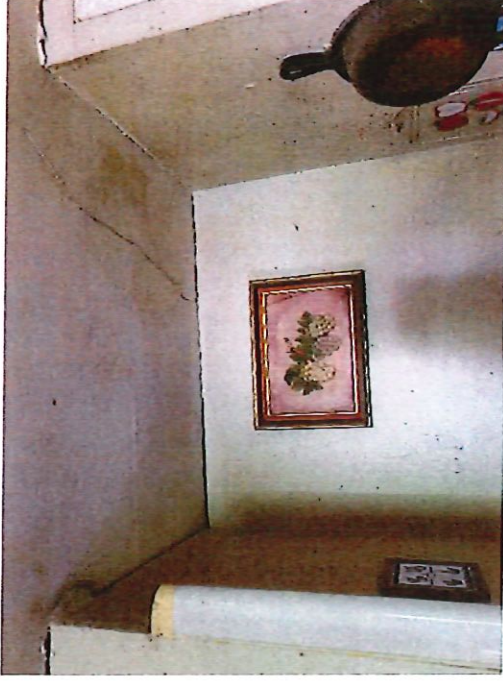
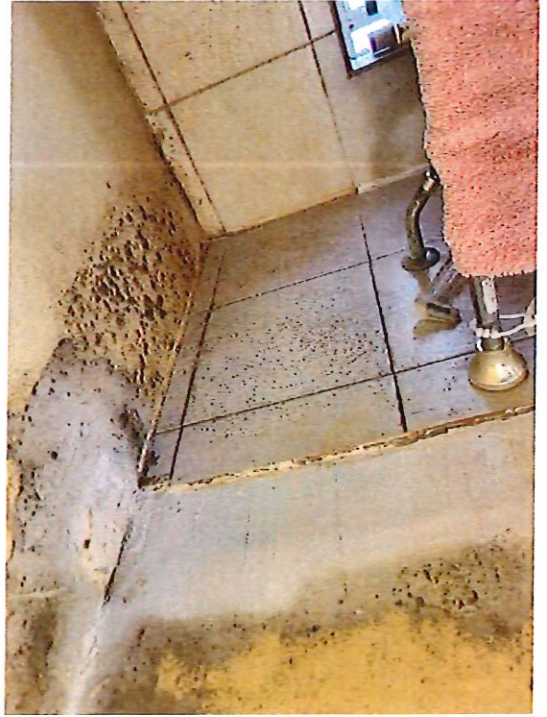
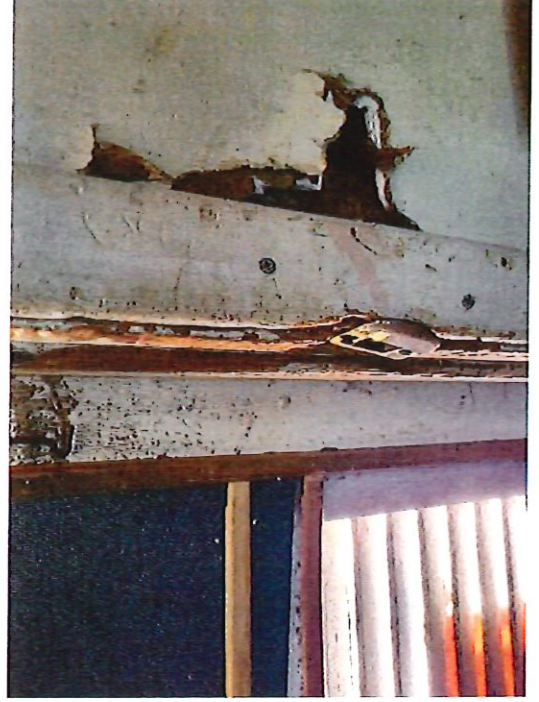
Notes: The ceiling coverings have cracks around the perimeter walls due to foundation movement. There are several areas where water damage has stained the ceiling. There are also signs of termites and rodent infestation. Mold is present in several areas of the house.

Notes: The wall coverings and trim are in need of repair. There are holes in walls and cracks due to foundation movement. Door frames and trims are broken and do not close properly. There are also signs of termites and rodent infestation.

Interior walls & Ceiling Deficiencies
