## Housing Rehab Program

**ENTITY:** City of Elsa  
**PROJECT:** Reconstruction of a single-family housing unit located at: 517 W. 5<sup>th</sup> St., Elsa Texas  
**FUNDING YEAR:** HOME 2025

# INITIAL INSPECTION

517 Arcadillo Padilla Sr., Elsa TX

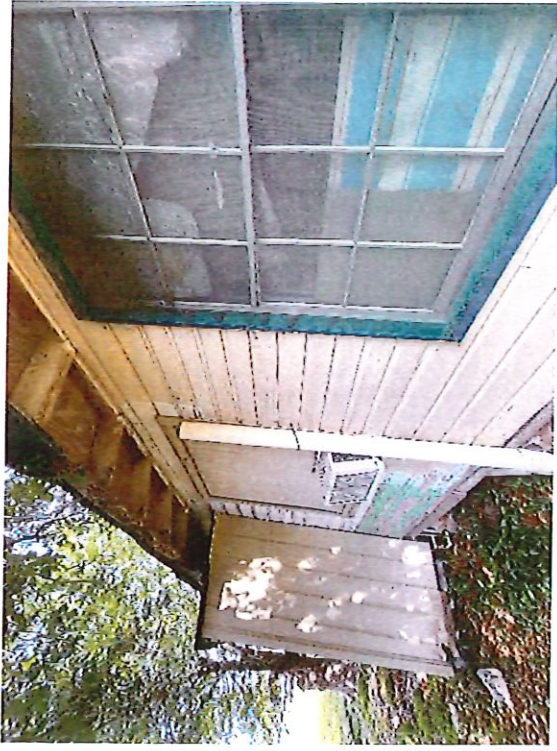
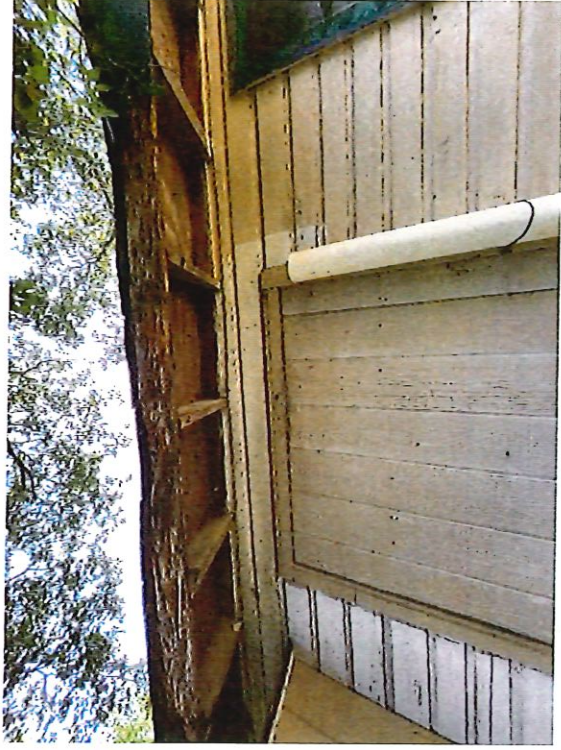
Soffit and Fascia

Notes: The overhang is in bad shape. There are many areas where the overhang has deteriorated due to moisture or termites. Overhang needs to be replaced and sealed to prevent future deterioration. The trim needs to be replaced due to deterioration.

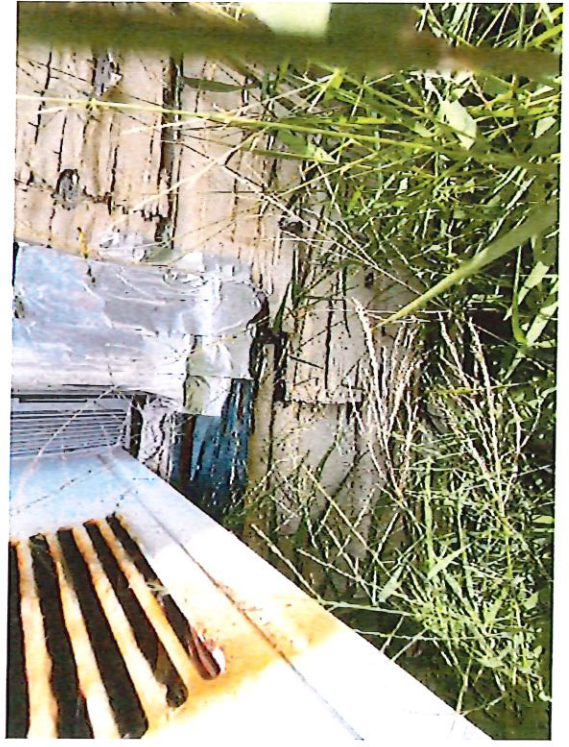
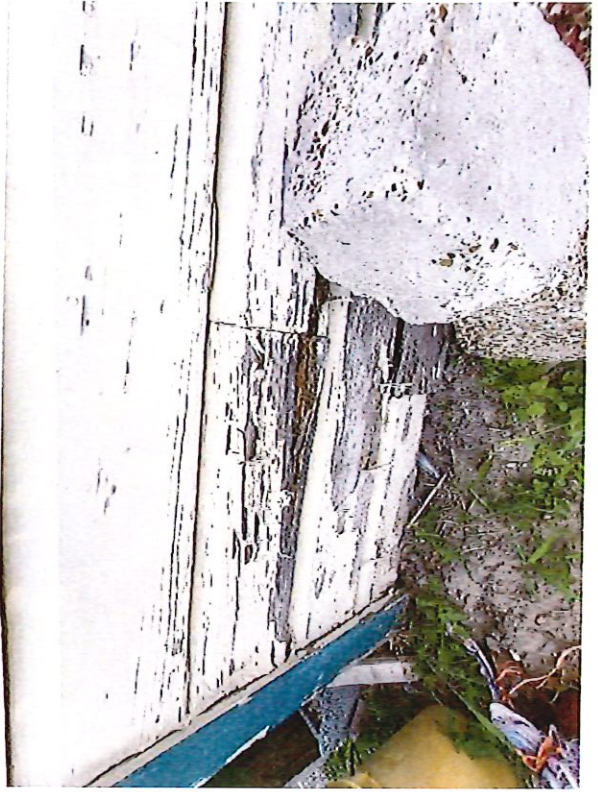
Exterior Siding

Notes: The exterior wall siding is in bad shape. There are many areas where the wood siding has deteriorated due to moisture or termites. Wood siding needs to be replaced and sealed to prevent future deterioration.

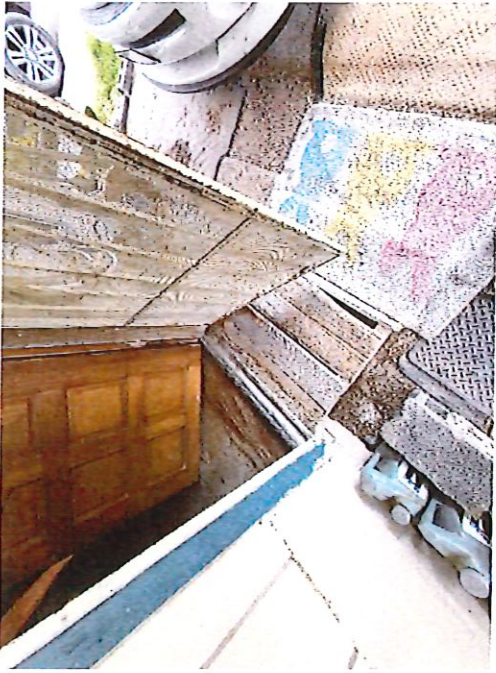
Notes: The front and rear exterior doors need to be replaced. The door frames is damaged and cracked due to the shifting of the house.

Exterior doors do not close properly.

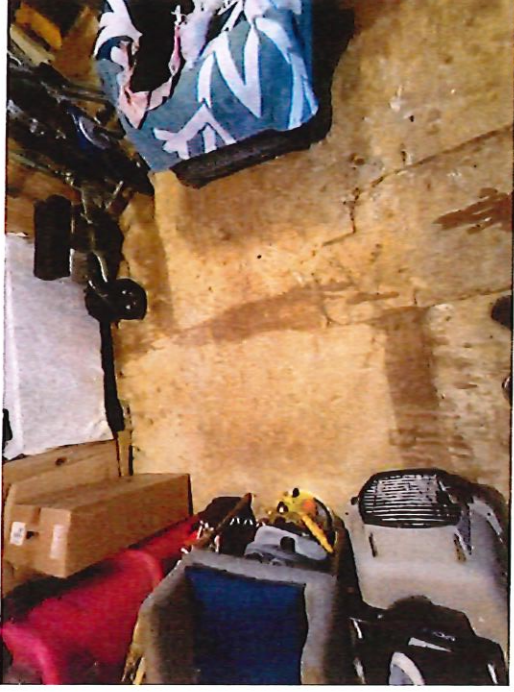
The flooring for the entire house needs to be replaced. In several areas in the house the VCT has come unglued and or worn done to the subfloor.

Subfloor exposed in 75% of the home

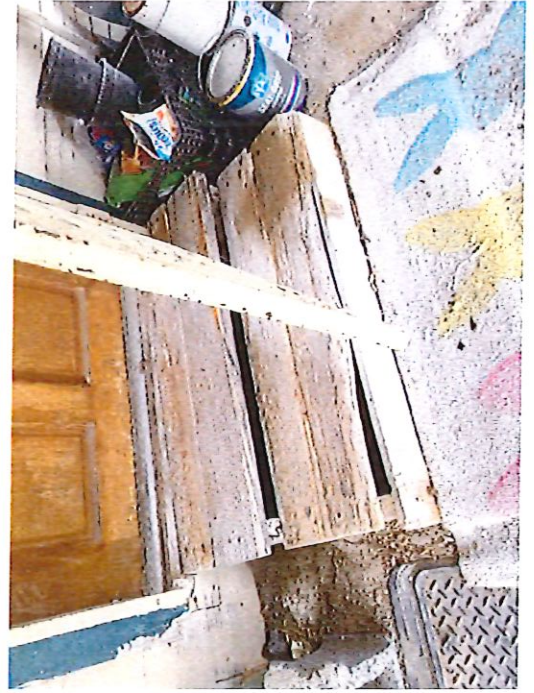
Notes: The front porch steps need to be replaced.

Steps need to be repaired

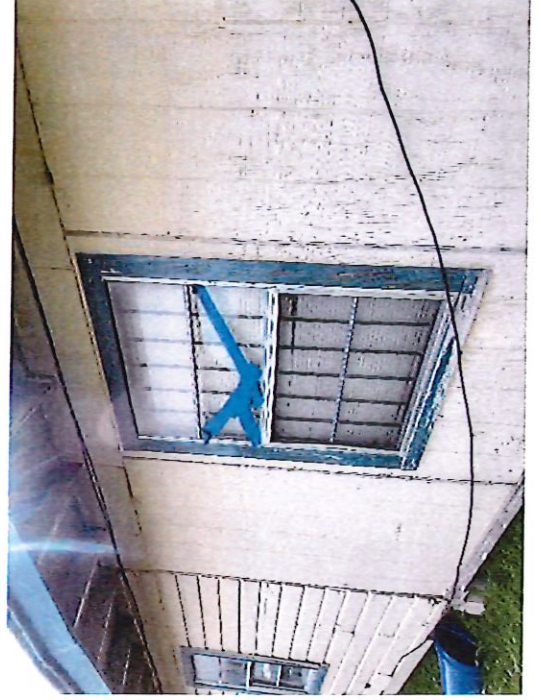
Broken windows

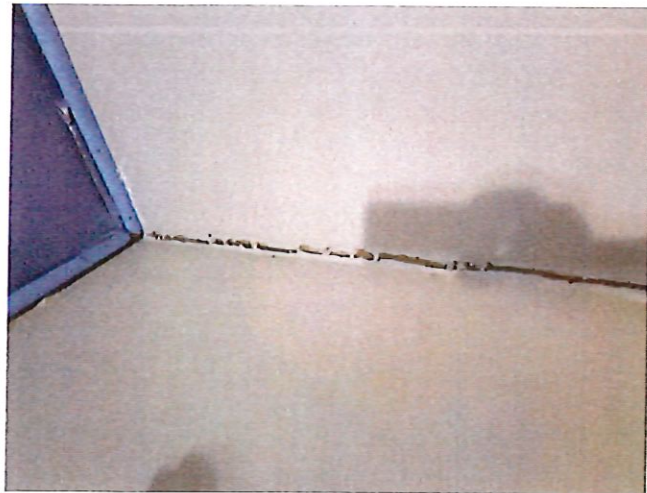
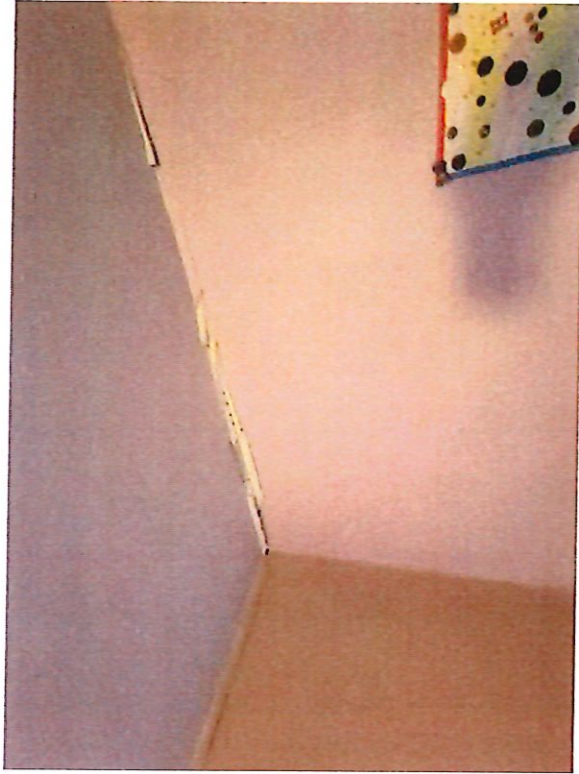
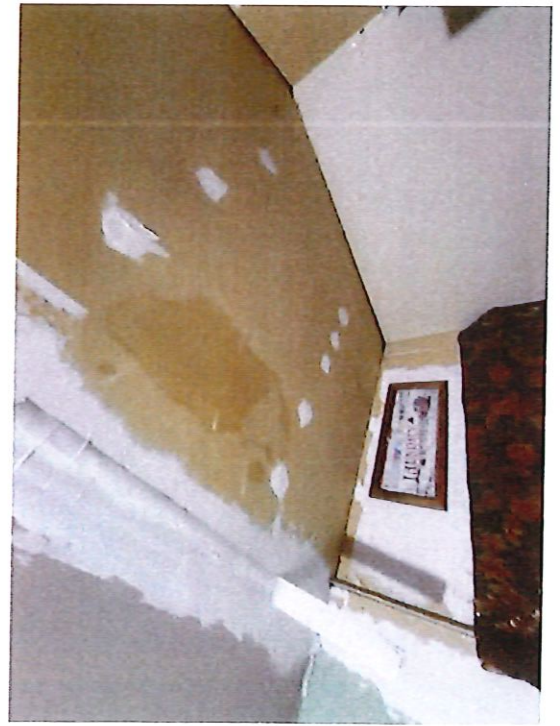
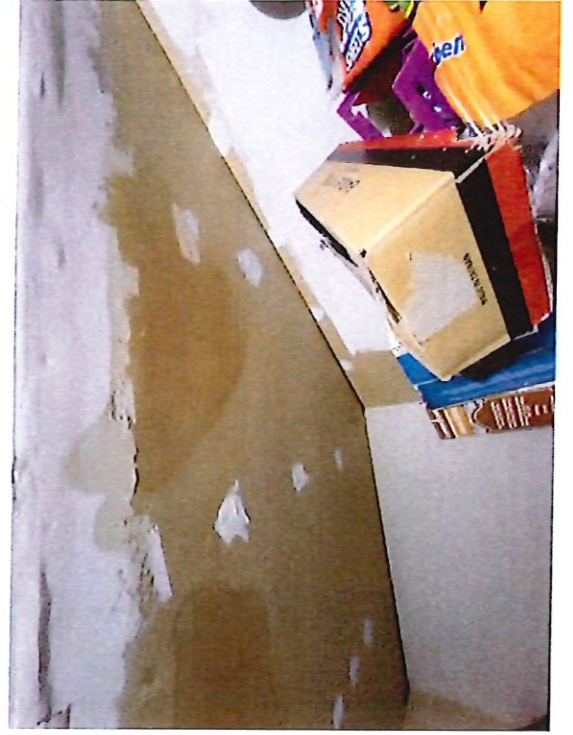
Notes: The ceiling coverings have cracks around the perimeter walls due to foundation movement. There are several areas where water damage has stained the ceiling. There are also signs of termites and rodent infestation.

Notes: The wall coverings and trim are in need of repair. There are holes in walls and cracks due to foundation movement. Door frames and trims are broken and do not close properly. There are also signs of termites and rodent infestation.

Interior walls & Ceiling Deficiencies

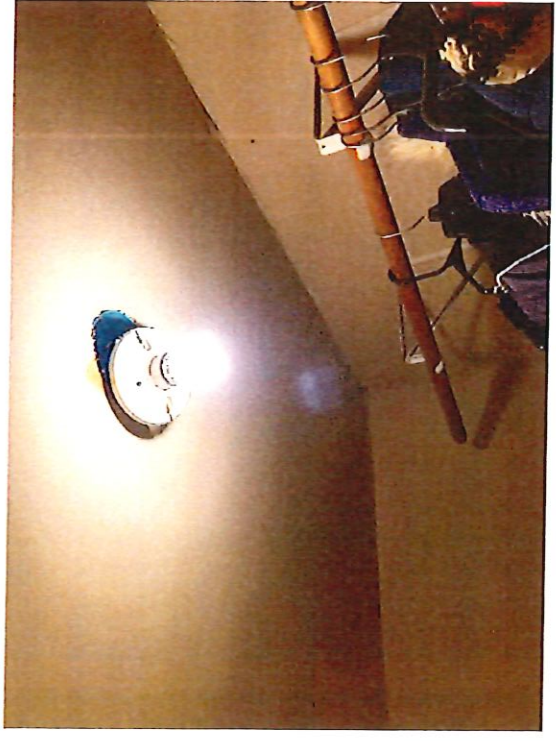
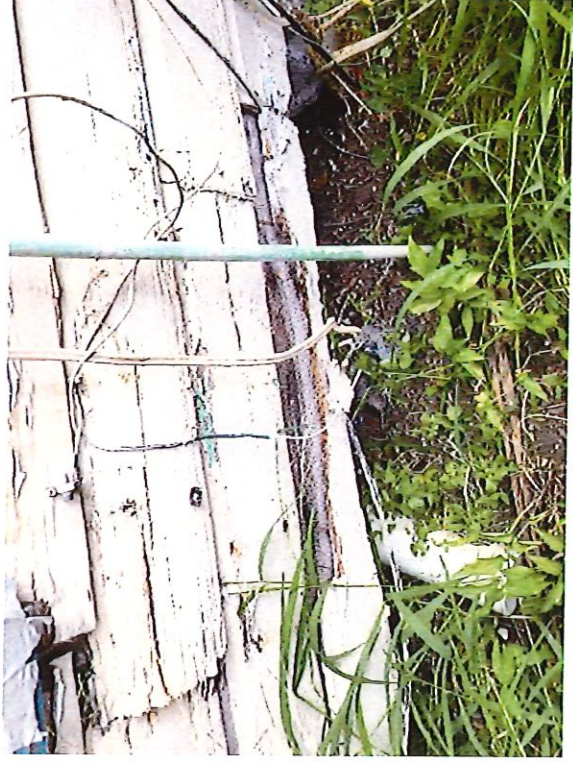
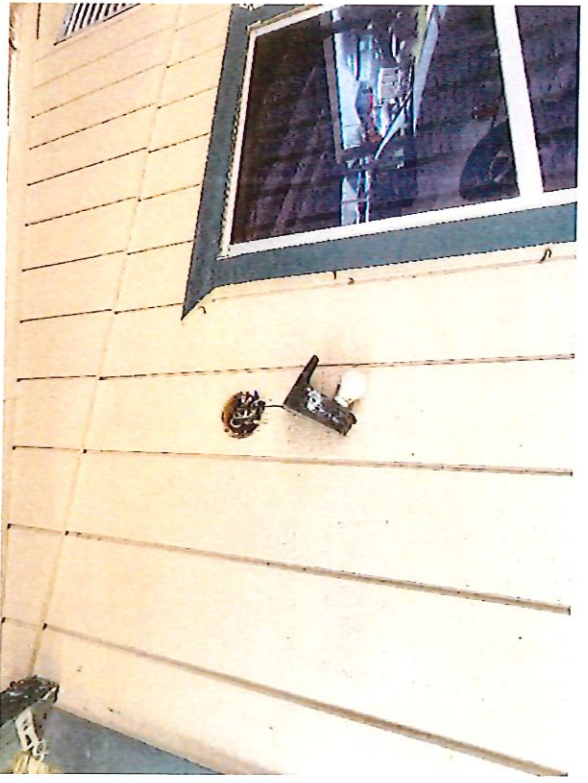
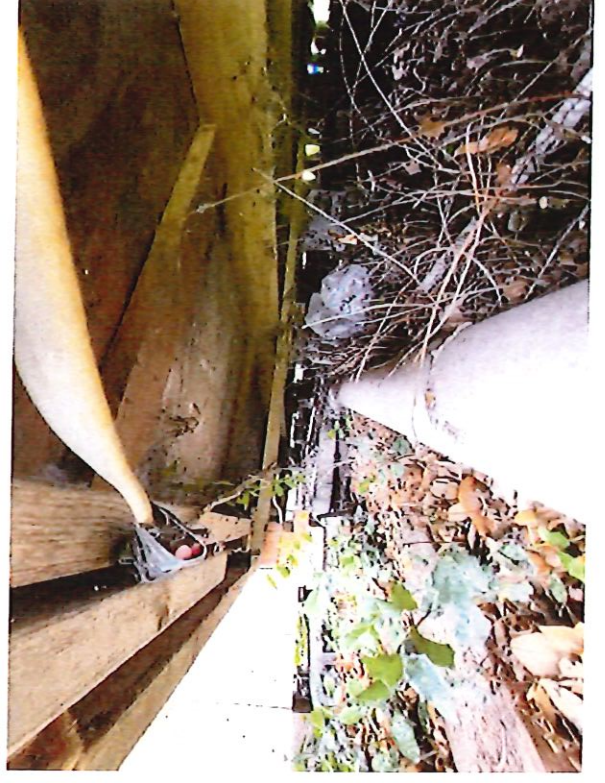
Location(s): Electrical wires under the house not properly protected from the elements, broken light fixtures exposing live wires.

Notes: There were several plugs throughout the house that were not working. Several ceiling light fixtures in the house were also not working. Electrical needs to be inspected for electrical shorts.

Electrical Deficiencies
