Housing Rehab Program

PROJECT: Reconstruction of a single-family housing unit located at: 2704 Limon Dr. Mission Texas

INITIAL INSPECTION

2704 Limon Dr. Mission TX

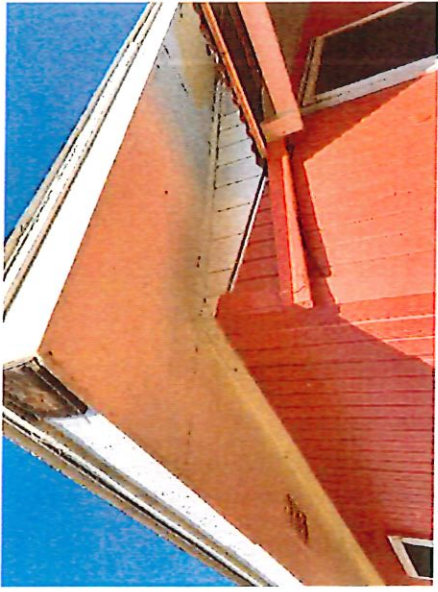
Notes: The overhang is in bad shape. There are many areas where the overhang has deteriorated due to moisture or termites. Overhang needs to be replaced and sealed to prevent future deterioration. The trim needs to be replaced due to deterioration.

Soffit and Fascia

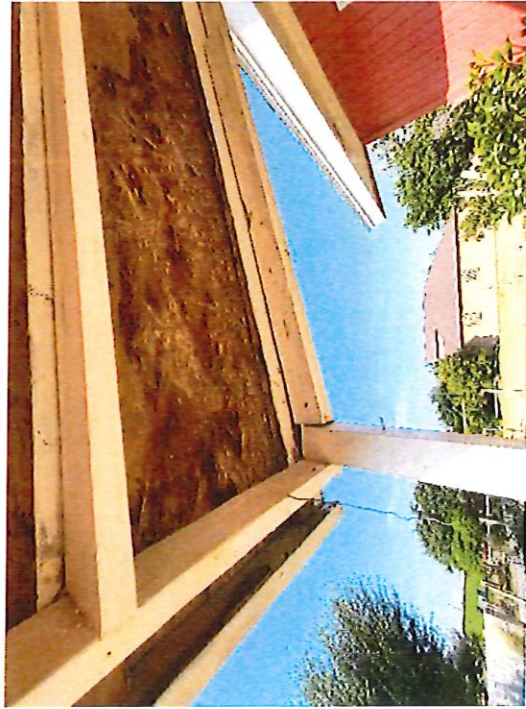
Front porch has mold and water damage

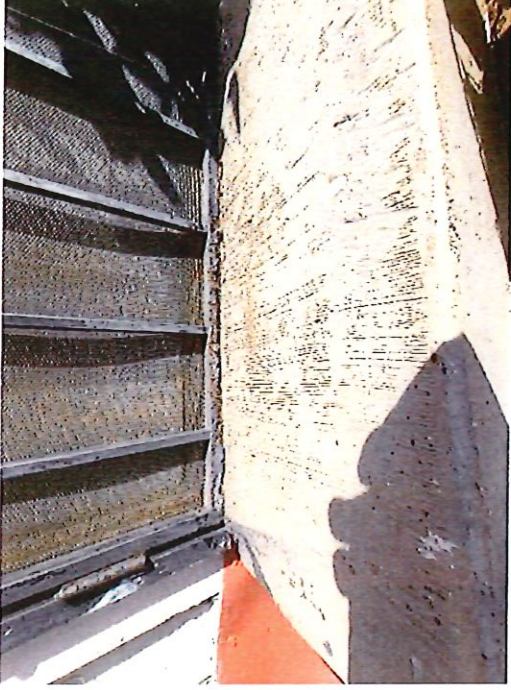
Notes: The front and rear exterior doors need to be replaced. The door frames is damaged and cracked due to the shifting of the house.

front door does not open

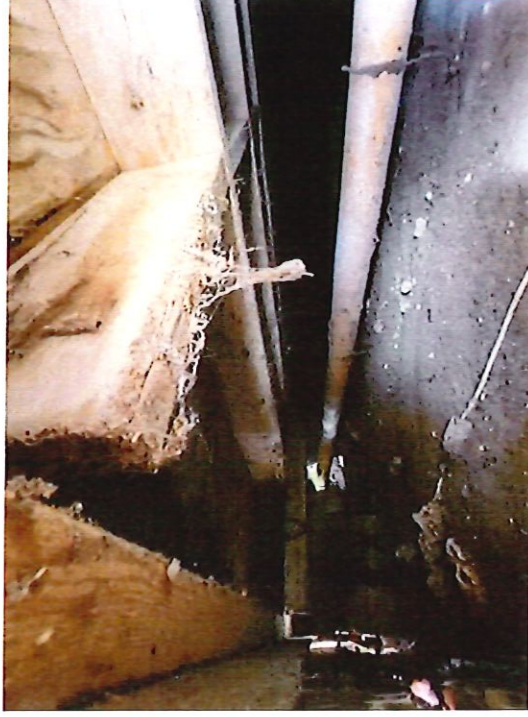
Sub-floor shows signs of water damage and rot

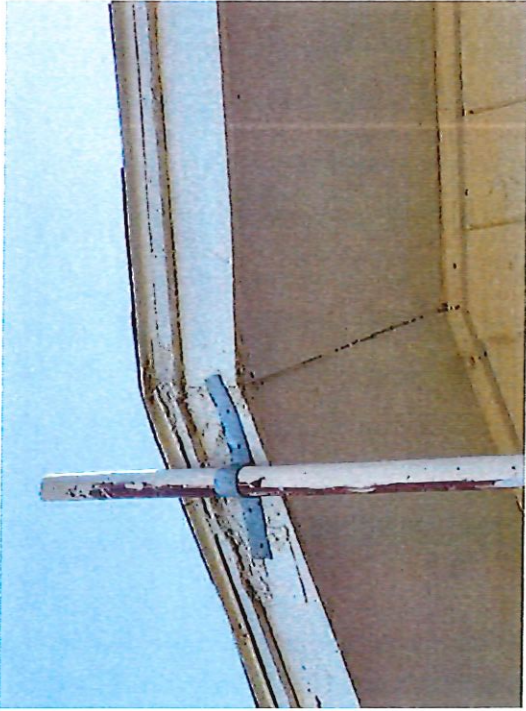
12. **Other observations about all Exterior Plumbing/Drain/Sewer:**
Plumbing is exposed throughout the entire home; vent pipes not properly secured and exposed.

Exposed Plumbing

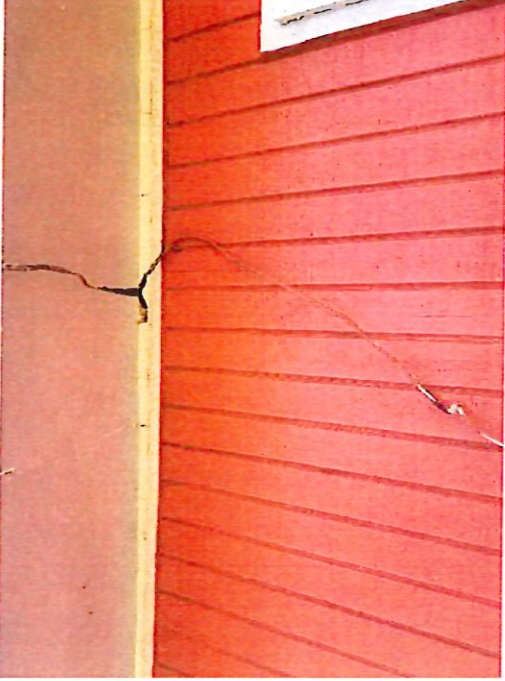
Location(s): Electrical wires without proper conduit alongside of the house.

Exposed electrical wires

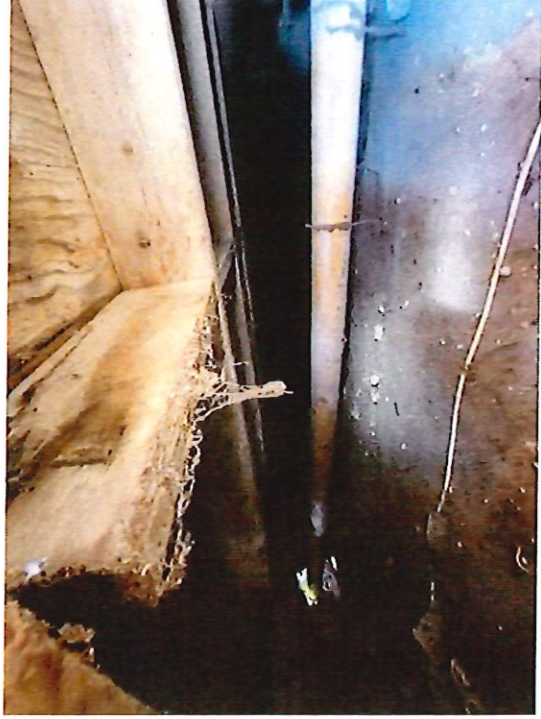
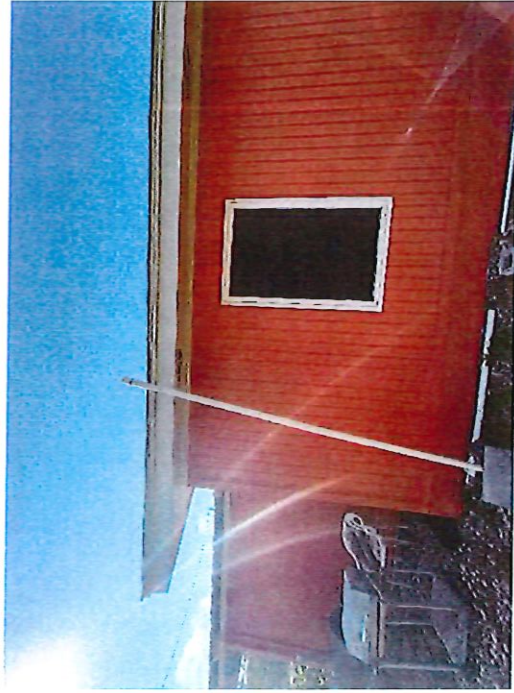
Sewer pipes not properly suspended or secured

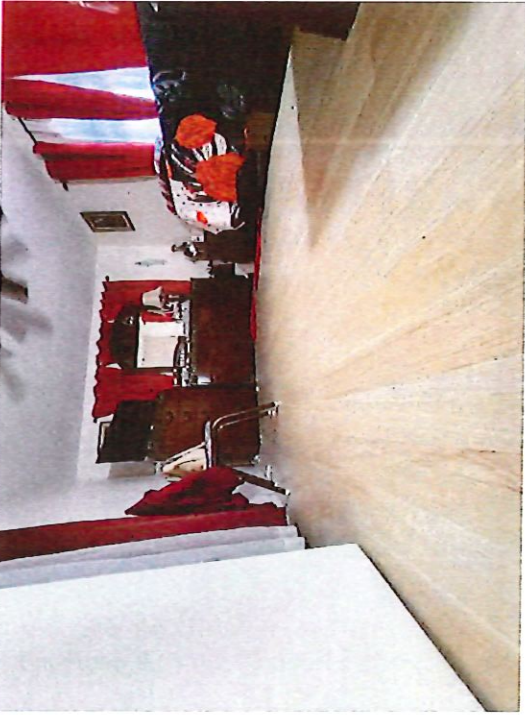
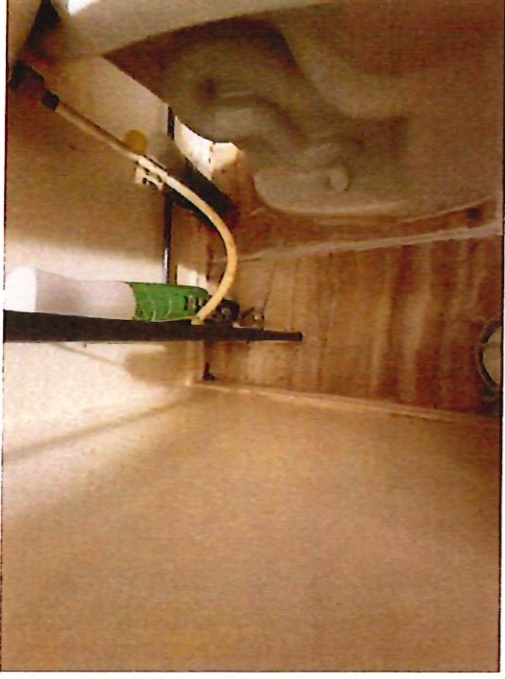
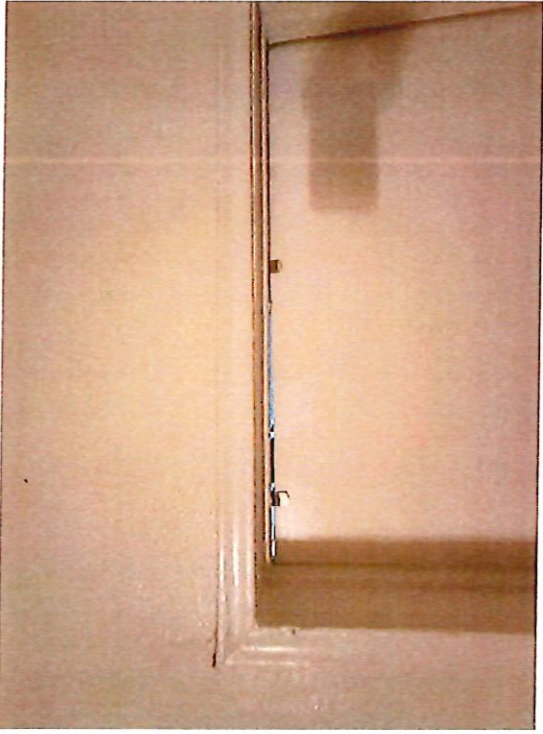
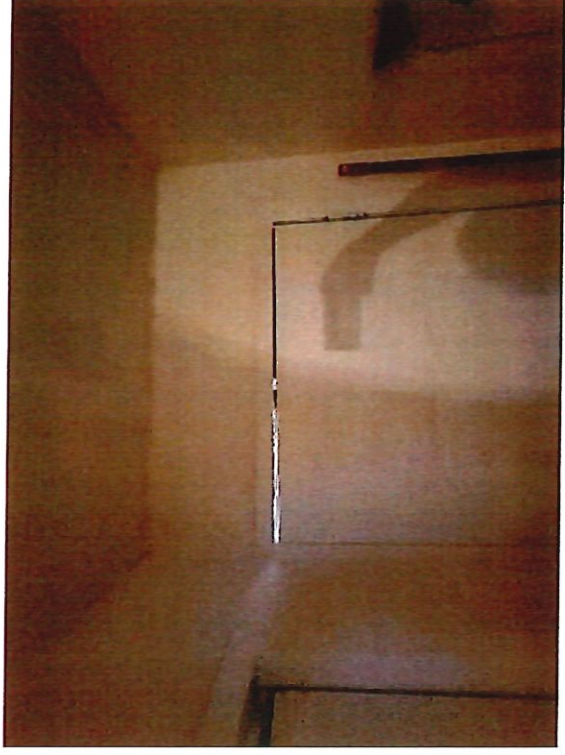
The flooring for the entire house needs to be replaced. In several areas in the house the VCT has come unglued and the subfloor is uneven .

Floor and Sub Floor warped and uneven

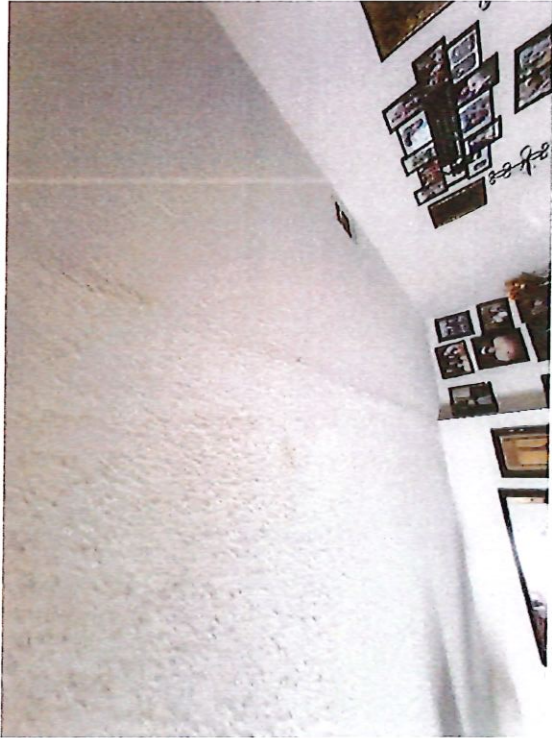
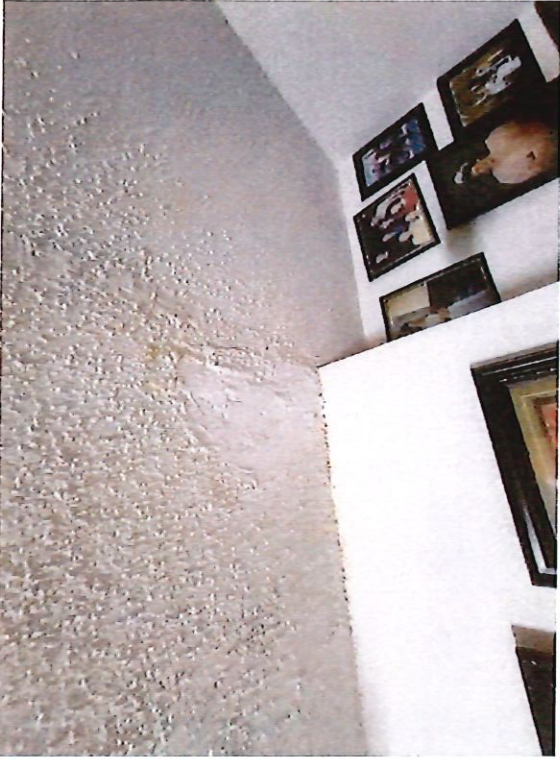
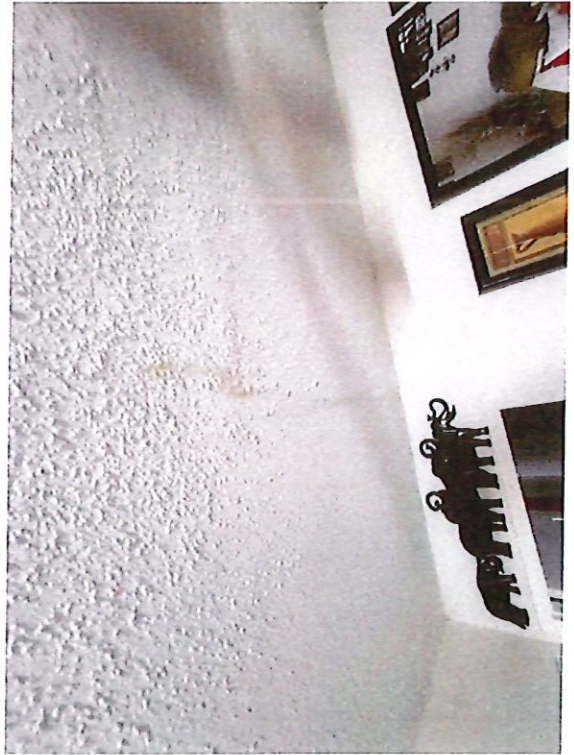
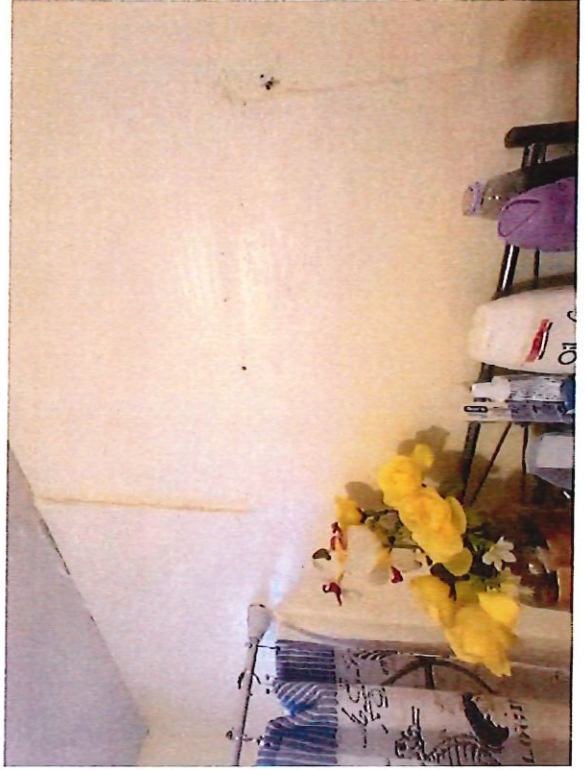
Notes: The ceiling coverings have cracks around the perimeter walls due to foundation movement. There are several areas where water damage has stained the ceiling.

Ceiling and wall Deficiencies

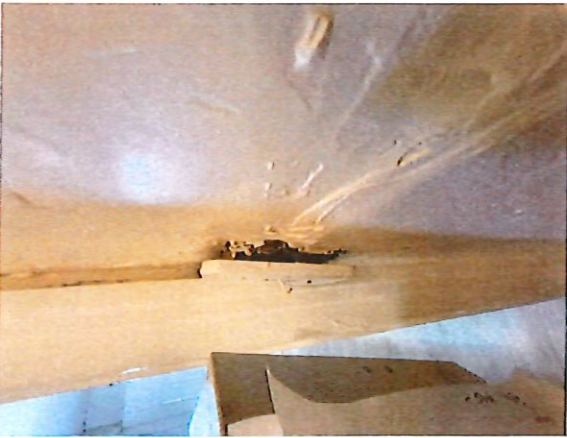
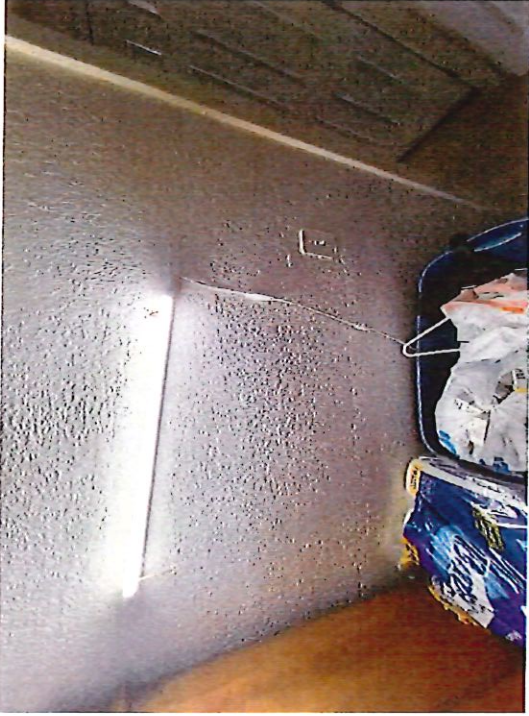
Notes: There were several plugs throughout the house that were not working. Several ceiling light fixtures in the house were also not working. Electrical needs to be inspected for electrical shorts.

Electrical Deficiencies
