Housing Rehab Program

PROJECT: Reconstruction of a single-family housing unit located at: 1475 E Hwy 281
Mercedes Texas

INITIAL INSPECTION

Address: 1475 E Hwy 281

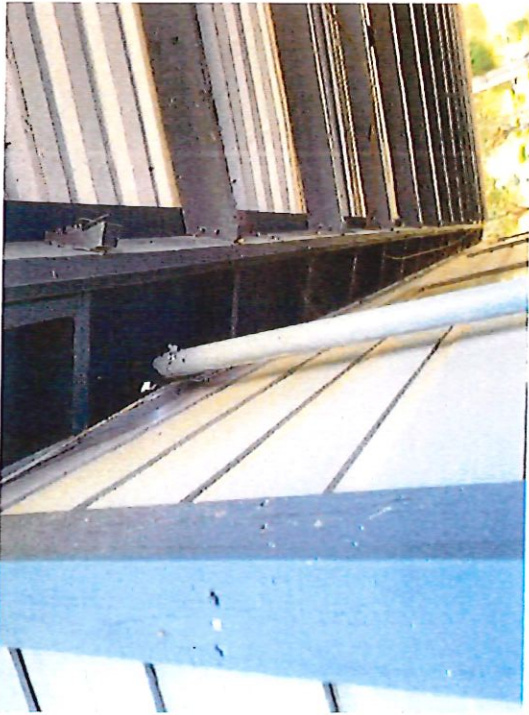
Soffit and Fascia

Notes: The overhang is in bad shape. There are many areas where the overhang has deteriorated due to moisture or termites. Overhang needs to be replaced and sealed to prevent future deterioration. The trim needs to be replaced due to deterioration.

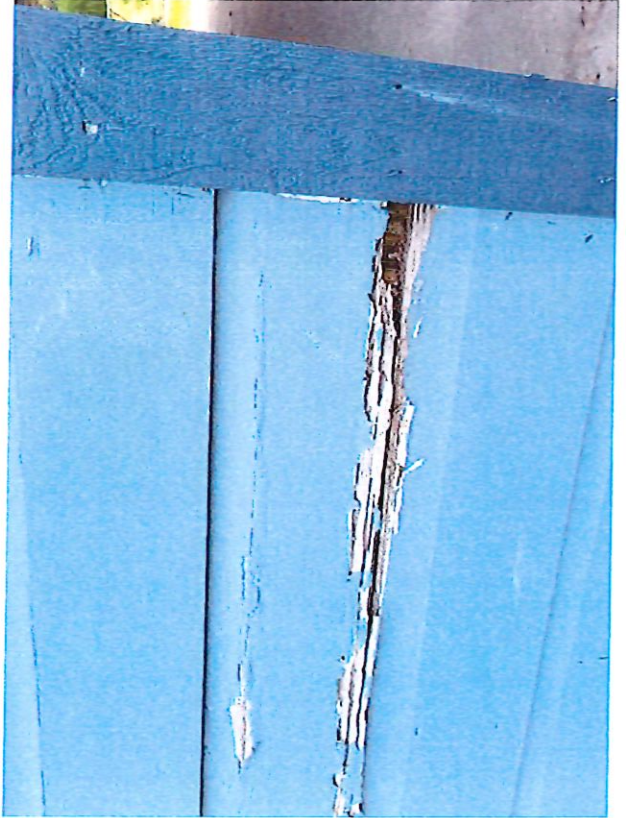
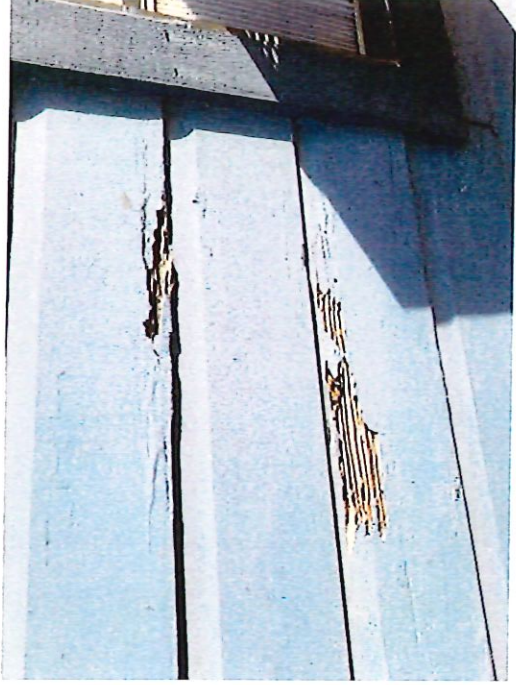
Exterior Siding

Notes: The exterior wall siding is in bad shape. There are many areas where the wood siding has deteriorated due to moisture or termites. Wood siding needs to be replaced and sealed to prevent future deterioration.

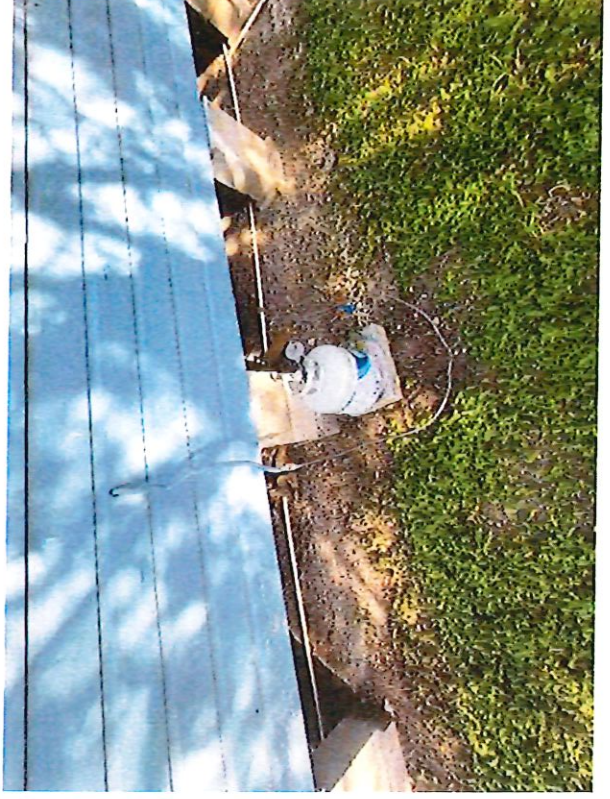
Notes: Improper gas line used outside the house, and the tank is not the proper size and is too close to a window and needs to be relocated 10' from the home.

Propane line and tank improperly installed

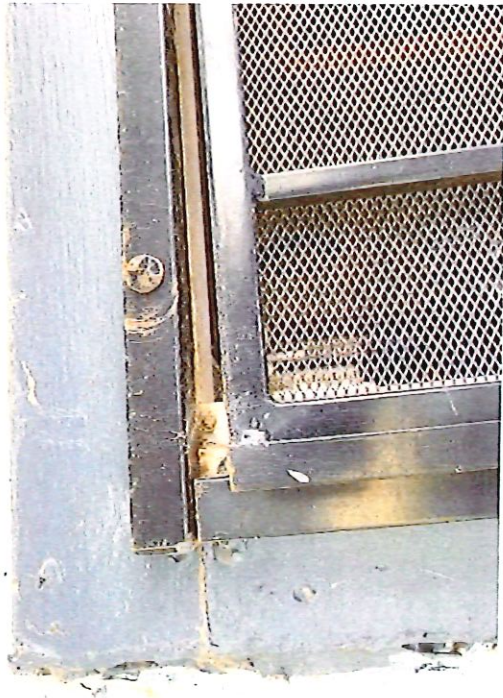
Notes: The front and rear exterior doors need to be replaced. The door frames is damaged and cracked due to the shifting of the house.

Exterior doors do not close properly.

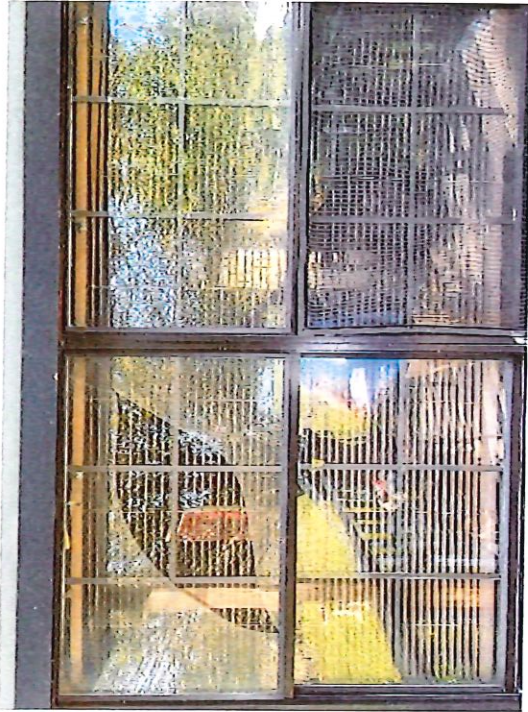
Notes: The window broken the other windows appear to be new and in working order

Broken windows

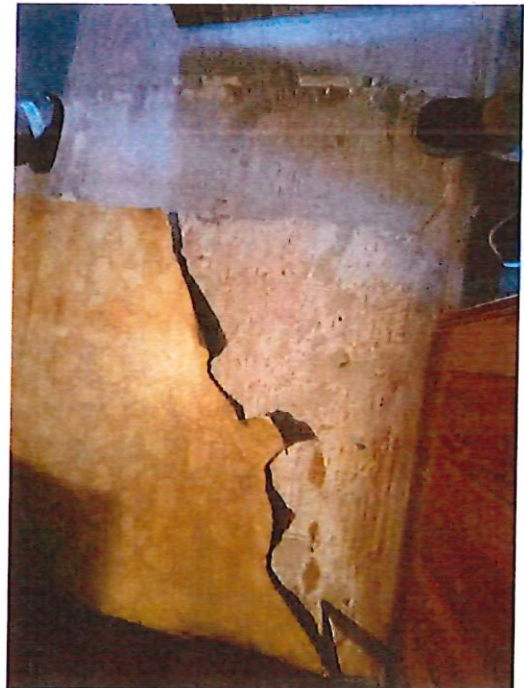
The flooring for the entire house needs to be replaced. In several areas in the house the VCT has come unglued and or worn down to the subfloor.

Vinyl Flooring has holes and is peeling up in many areas

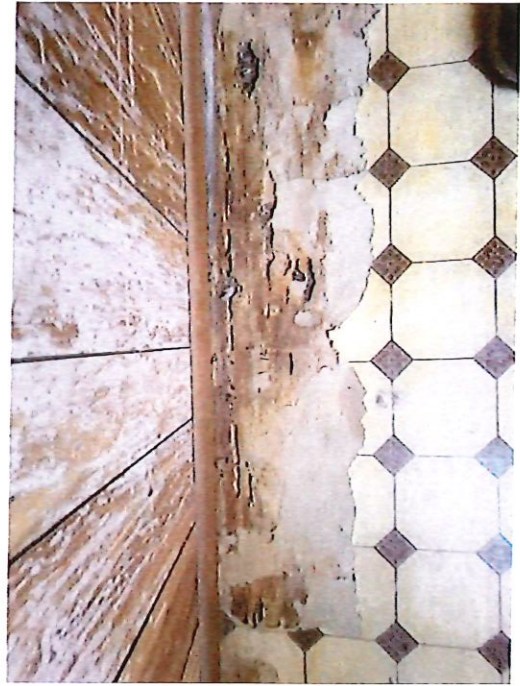
Sub-Floor shows signs of advanced termite Damage

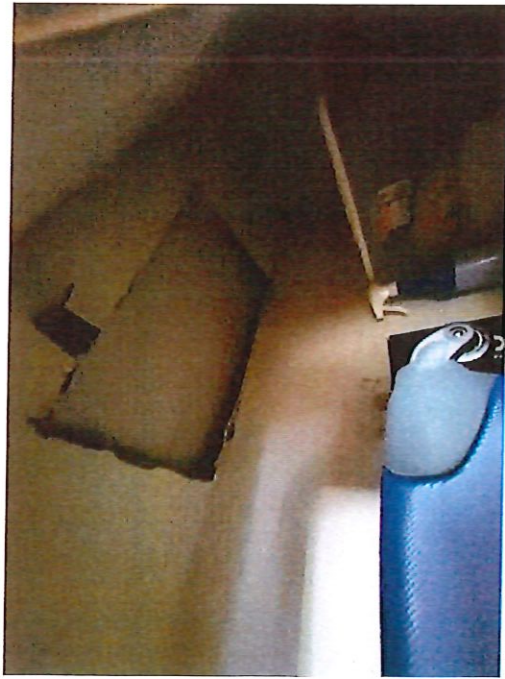
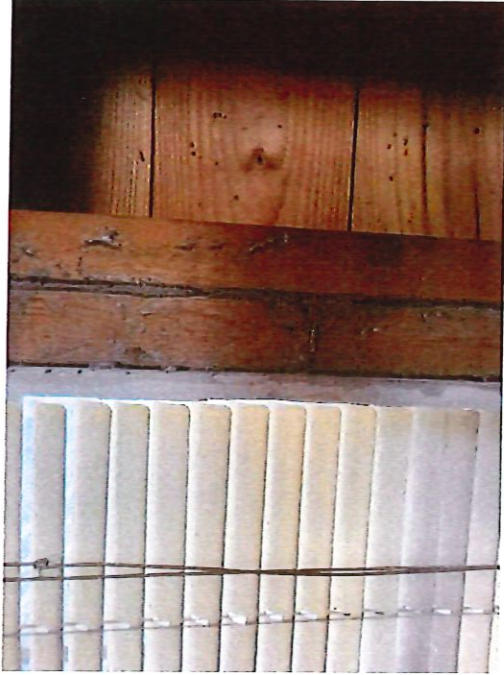
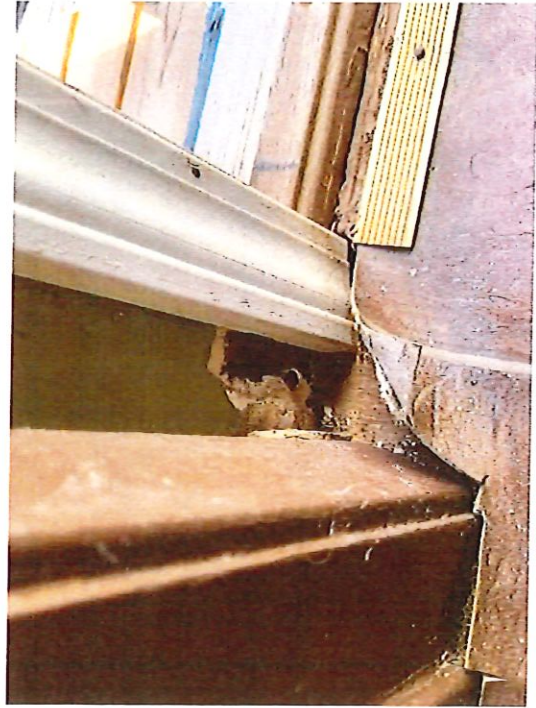
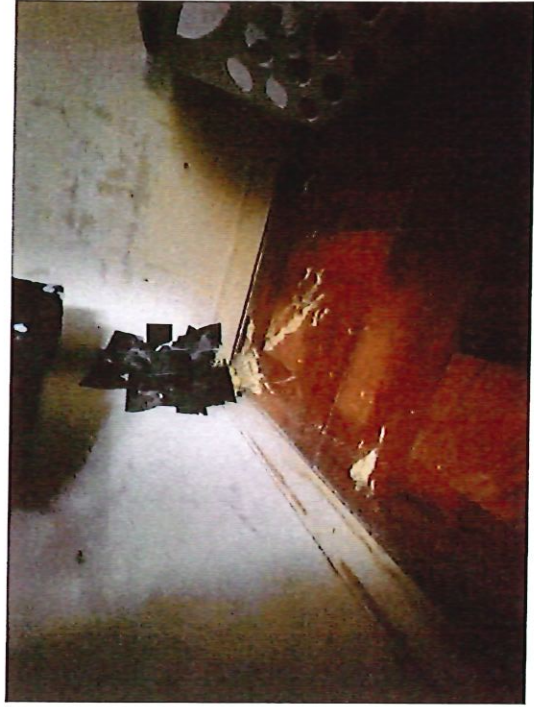
Notes: The ceiling coverings have cracks around the perimeter walls due to foundation movement. There are also signs of termites and rodent infestation.

Notes: The wall coverings and trim are in need of repair. There are holes in walls and cracks due to foundation movement. Door frames and trims are broken and do not close properly. There are also signs of termites and rodent infestation.

Interior walls & Ceiling Deficiencies

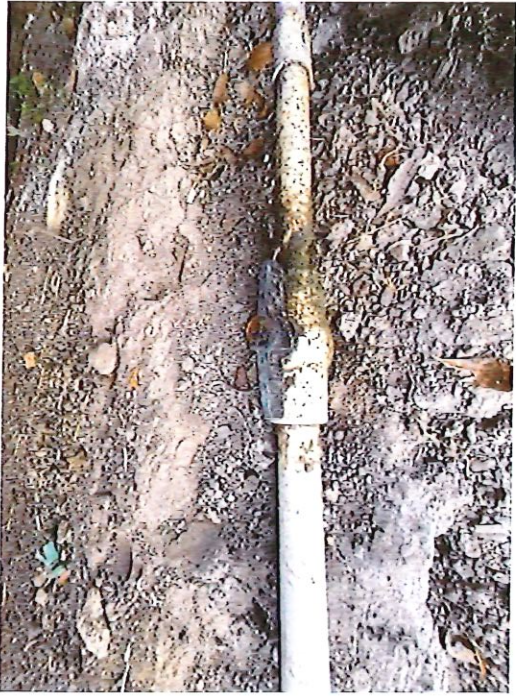
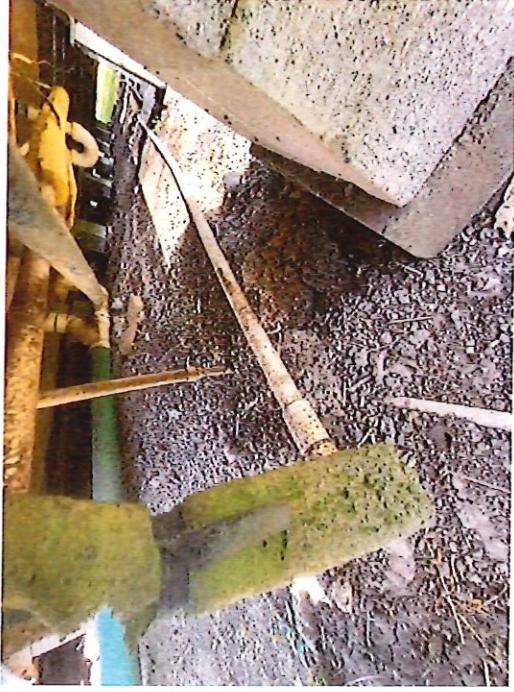
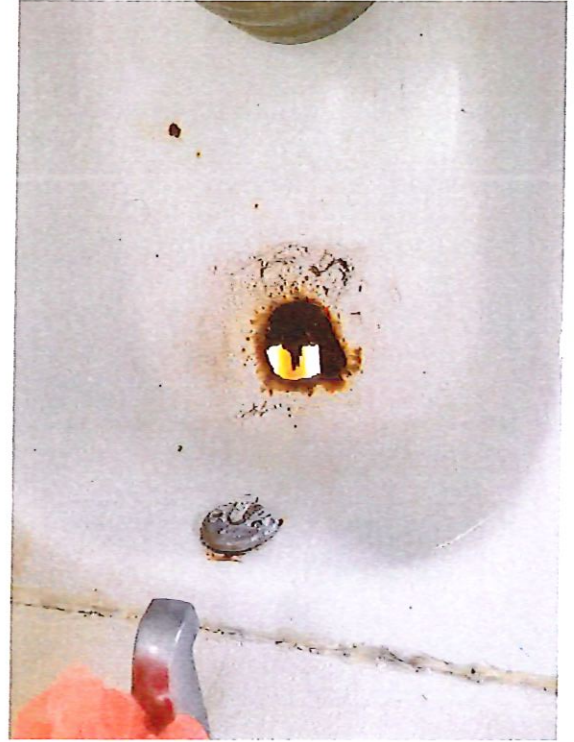
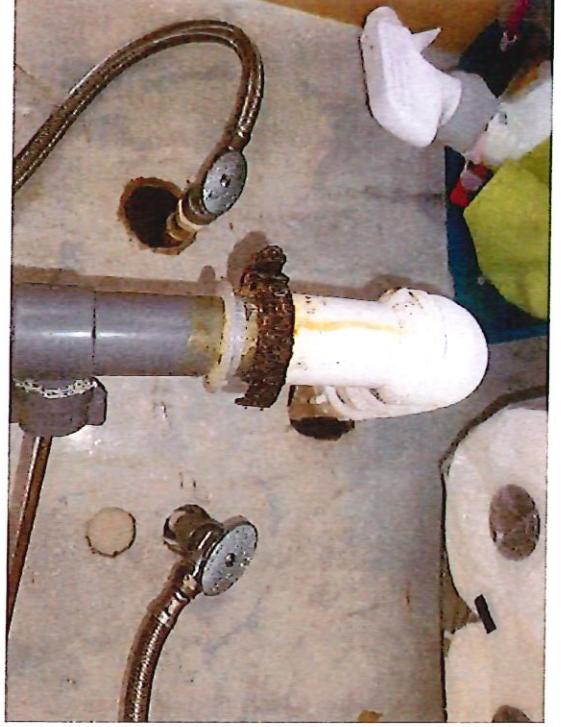
Notes: Water Line is not underground and has a visible leak.

12. **Other observations about all Exterior Plumbing/Drain/Sewer:**
Plumbing is exposed underneath the home and is not properly supported.

Notes: The bath tub has rusted away

Plumbing Deficiencies

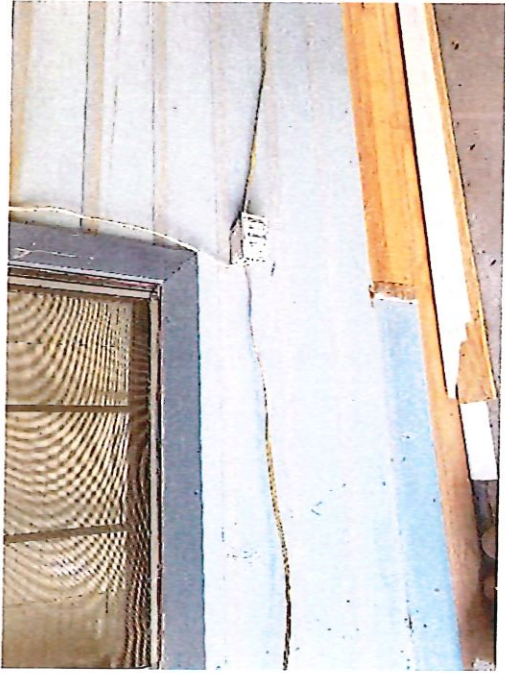
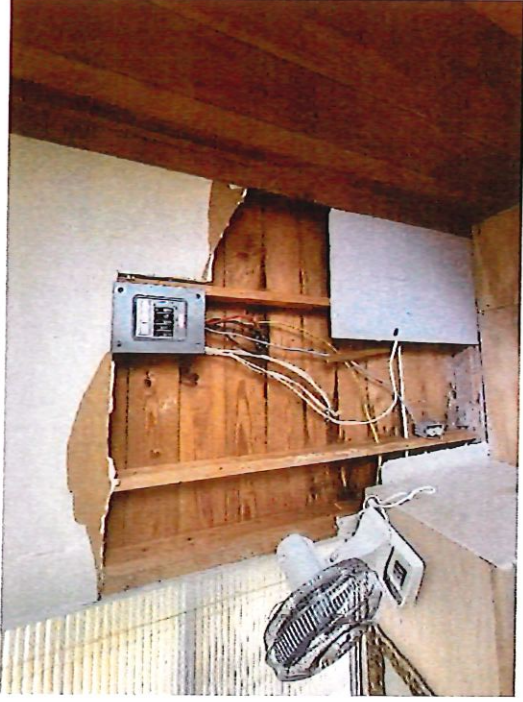
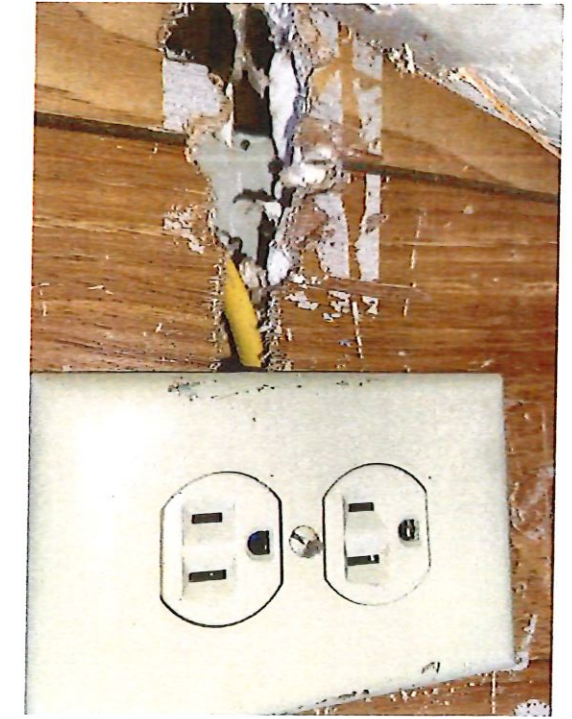
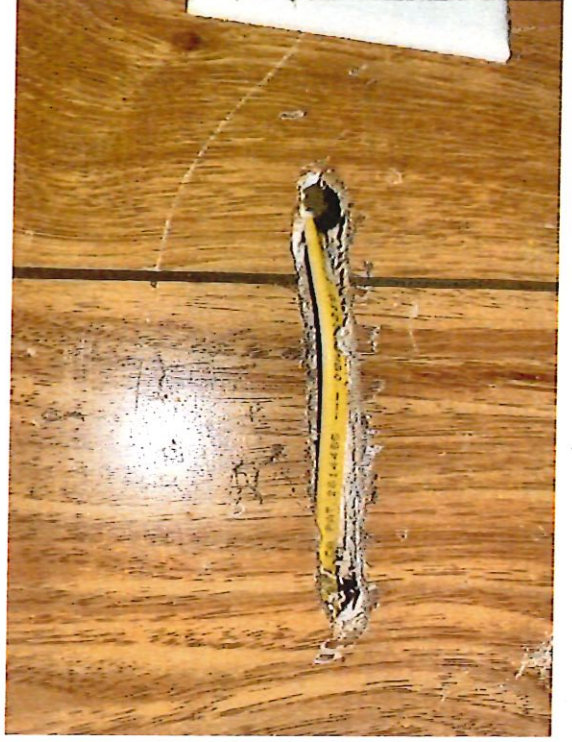
Location(s): Electrical wires are exposed and do not have the proper conduit protection from the elements.

Notes: There were several plugs throughout the house that were not working. Several ceiling light fixtures in the house were also not working. Electrical needs to be inspected for electrical shorts.

Electrical Deficiencies
