## Certificate of Substantial Completion

**PROJECT:** *(name and address)*  
Hidalgo County El Paraiso Health Clinic & Community Resource Center

**CERTIFICATE INFORMATION:**  
Certificate Number: 001  
Date: June 15, 2026

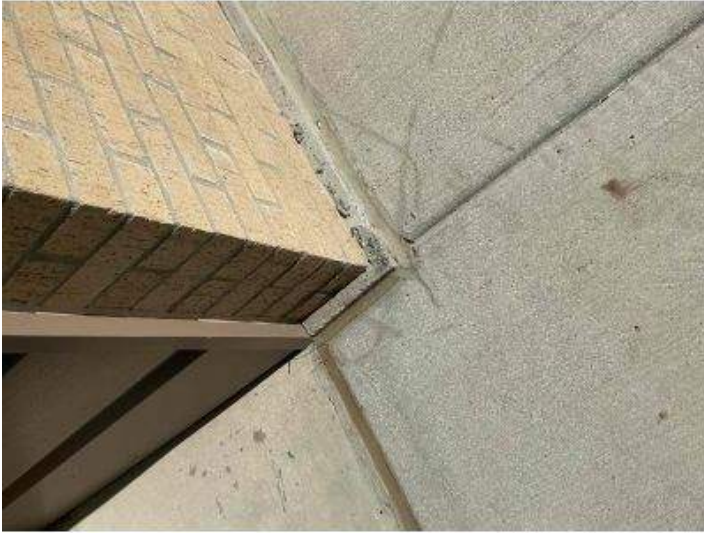
<b>Description</b>	smooth and clean excess concrete	Completed
<b>Assigned to</b>	—	
<b>Created by</b>	<b>Yesenia Tijerina</b> (ERO Architects)	
<b>Created on</b>	Aug 28, 2025	
<b>Issue owner</b>	<b>Yesenia Tijerina</b> (ERO Architects)	
<b>Location</b>	—	
<b>Location details</b>	—	
<b>Due date</b>	Sep 30, 2025	
<b>Root cause</b>	—	
<b>Reference drawing</b>	<a href="#">AE101 [V1]</a>

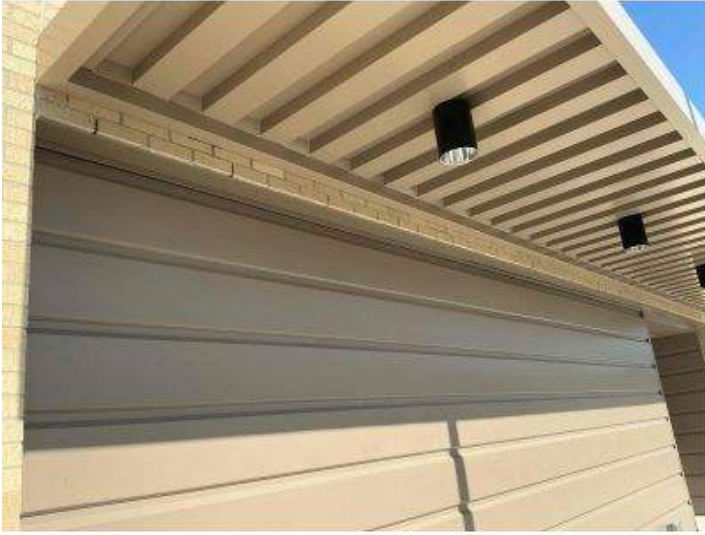
<b>Description</b>	weep vent missing	Pending
<b>Assigned to</b>	—	
<b>Created by</b>	Yesenia Tijerina (ERO Architects)	
<b>Created on</b>	Aug 28, 2025	
<b>Issue owner</b>	Yesenia Tijerina (ERO Architects)	
<b>Location</b>	—	
<b>Location details</b>	—	
<b>Due date</b>	Sep 30, 2025	
<b>Root cause</b>	—	
<b>Reference drawing</b>	<a href="#">AE101 [V1]</a>

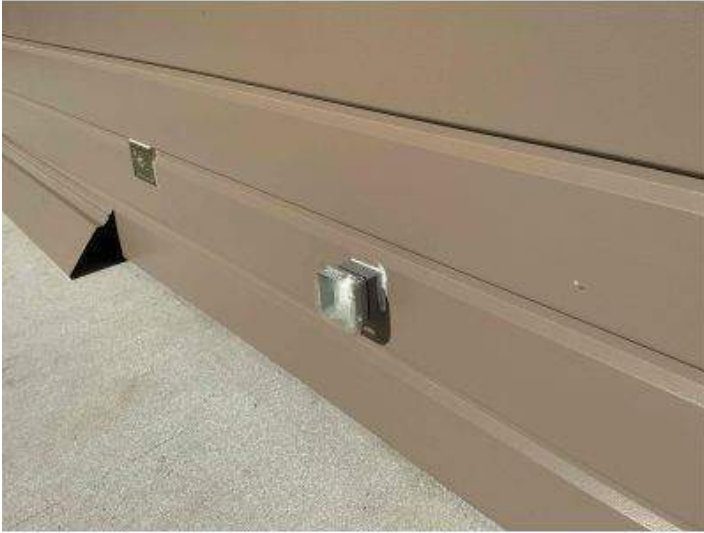
<b>Description</b>	needs to be recessed	Completed
<b>Assigned to</b>	—	
<b>Created by</b>	Yesenia Tijerina (ERO Architects)	
<b>Created on</b>	Aug 28, 2025	
<b>Issue owner</b>	Yesenia Tijerina (ERO Architects)	
<b>Location</b>	—	
<b>Location details</b>	—	
<b>Due date</b>	Sep 30, 2025	
<b>Root cause</b>	—	
<b>Reference drawing</b>	<a href="#">AE101 [V1]</a>

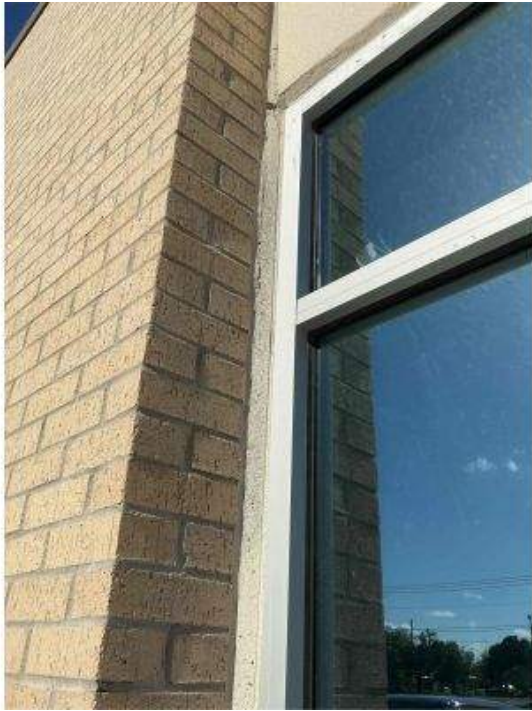
<b>Description</b>	Fill-in and smooth out all window edges at all concrete tilt-wall locations for both buildings. Paint and texture as needed.	Completed
<b>Assigned to</b>	—	
<b>Created by</b>	<b>Yesenia Tijerina</b> (ERO Architects)	
<b>Created on</b>	Aug 28, 2025	
<b>Issue owner</b>	<b>Yesenia Tijerina</b> (ERO Architects)	
<b>Location</b>	—	
<b>Location details</b>	—	
<b>Due date</b>	Sep 30, 2025	
<b>Root cause</b>	—	
<b>Reference drawing</b>	<a href="#">AE101 [V1]</a>

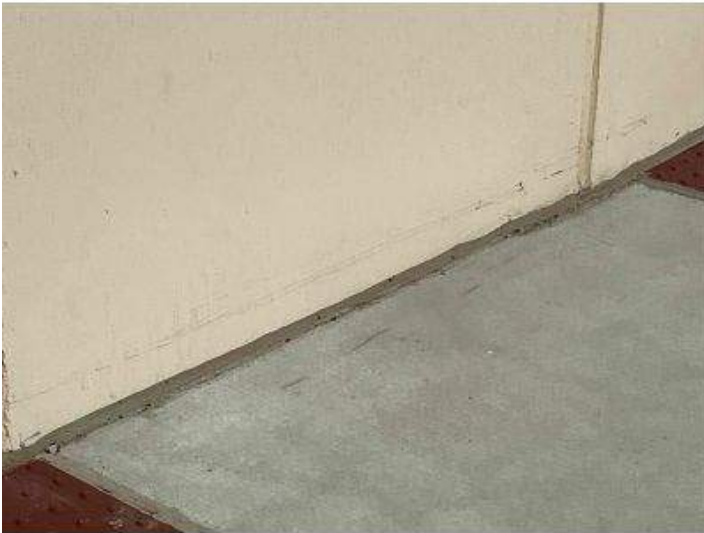
<b>Description</b>	Clean wall surface, paint touch-up, and re-texture. Prepare the concrete surface to reapply primer where paint has detached from it. <span style="background-color: yellow;">Completed</span>
<b>Assigned to</b>	—
<b>Created by</b>	<b>Yesenia Tijerina</b> (ERO Architects)
<b>Created on</b>	Aug 28, 2025
<b>Issue owner</b>	<b>Yesenia Tijerina</b> (ERO Architects)
<b>Location</b>	—
<b>Location details</b>	—
<b>Due date</b>	Sep 30, 2025
<b>Root cause</b>	—
<b>Reference drawing</b>	<a href="#">AE101 [V1]</a>

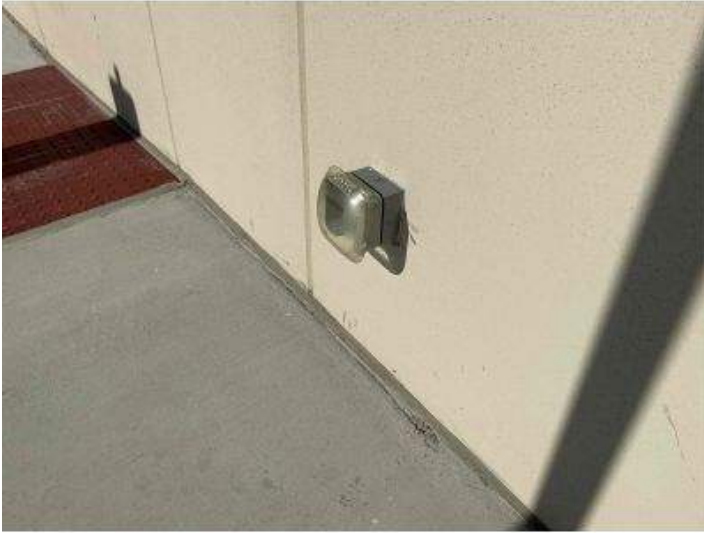
<b>Description</b>	all power boxes need to be recessed	Completed
<b>Assigned to</b>	—	
<b>Created by</b>	<b>Yesenia Tijerina</b> (ERO Architects)	
<b>Created on</b>	Aug 28, 2025	
<b>Issue owner</b>	<b>Yesenia Tijerina</b> (ERO Architects)	
<b>Location</b>	—	
<b>Location details</b>	—	
<b>Due date</b>	Sep 30, 2025	
<b>Root cause</b>	—	
<b>Reference drawing</b>	<a href="#">AE101 [V1]</a>

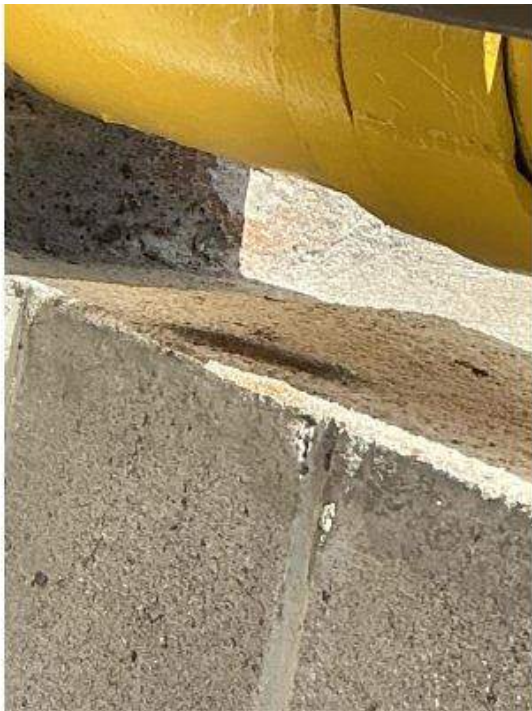
<b>Description</b>	Repair, touch up and clean stucco	<b>Completed</b>
<b>Assigned to</b>	—	
<b>Created by</b>	<b>Yesenia Tijerina</b> (ERO Architects)	
<b>Created on</b>	Aug 28, 2025	
<b>Issue owner</b>	<b>Yesenia Tijerina</b> (ERO Architects)	
<b>Location</b>	—	
<b>Location details</b>	—	
<b>Due date</b>	Sep 30, 2025	
<b>Root cause</b>	—	
<b>Reference drawing</b>	<a href="#">AS101 [V1]</a>

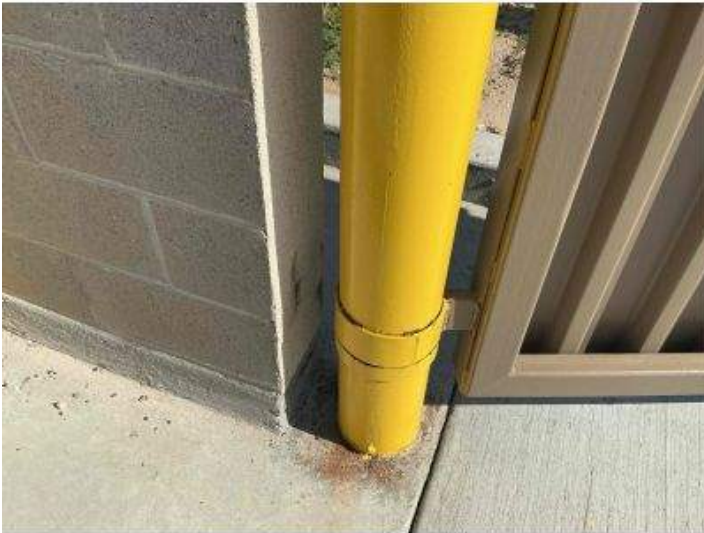
<b>Description</b>	Repair and touch up stucco as needed	<b>Completed</b>
<b>Assigned to</b>	—	
<b>Created by</b>	<b>Yesenia Tijerina</b> (ERO Architects)	
<b>Created on</b>	Aug 28, 2025	
<b>Issue owner</b>	<b>Yesenia Tijerina</b> (ERO Architects)	
<b>Location</b>	—	
<b>Location details</b>	—	
<b>Due date</b>	Sep 30, 2025	
<b>Root cause</b>	—	
<b>Reference drawing</b>	<a href="#">AS101 [V1]</a>

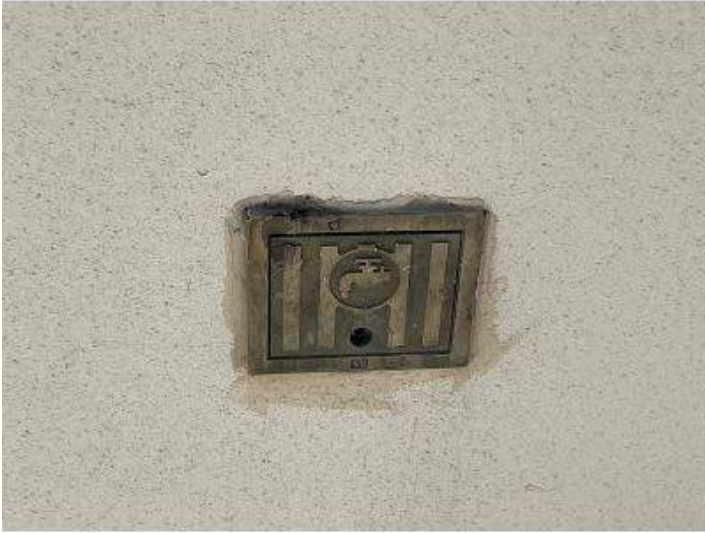
<b>Description</b>	clean exess caulk	Completed
<b>Assigned to</b>	—	
<b>Created by</b>	Yesenia Tijerina (ERO Architects)	
<b>Created on</b>	Aug 28, 2025	
<b>Issue owner</b>	Yesenia Tijerina (ERO Architects)	
<b>Location</b>	—	
<b>Location details</b>	—	
<b>Due date</b>	Sep 30, 2025	
<b>Root cause</b>	—	
<b>Reference drawing</b>	<a href="#">AE101 [V1]</a>

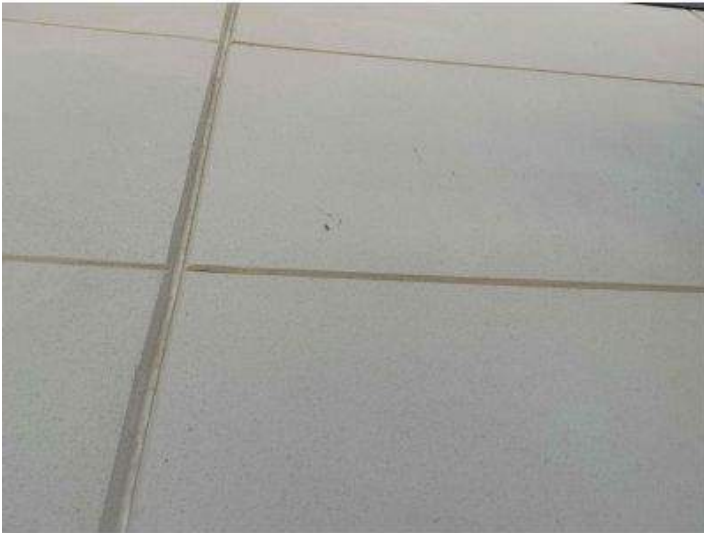
<b>Description</b>	Clean wall surface, paint touch-up, and re-texture. Prepare the concrete surface to reapply primer where paint has detached from it. <span style="background-color: yellow; color: red; padding: 2px;">Pending</span>
<b>Assigned to</b>	—
<b>Created by</b>	<b>Yesenia Tijerina</b> (ERO Architects)
<b>Created on</b>	Aug 28, 2025
<b>Issue owner</b>	<b>Yesenia Tijerina</b> (ERO Architects)
<b>Location</b>	—
<b>Location details</b>	—
<b>Due date</b>	Sep 30, 2025
<b>Root cause</b>	—
<b>Reference drawing</b>	<a href="#">AE101 [V1]</a>

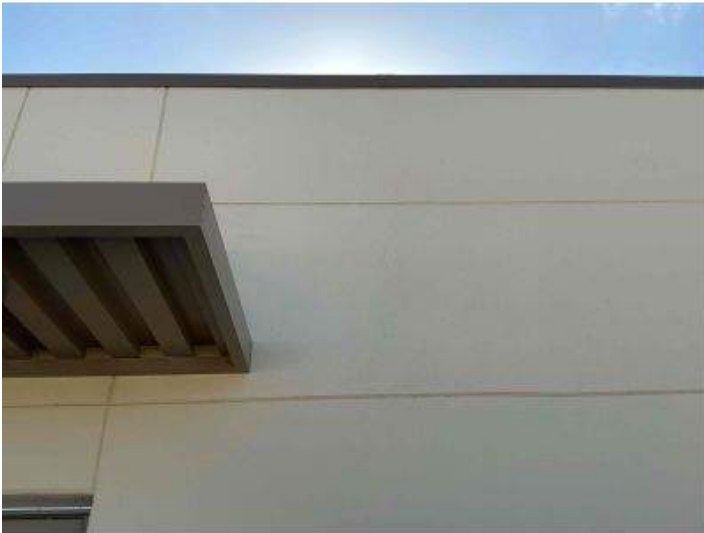
<b>Description</b>	Clean wall surface, paint touch-up, and re-texture. Prepare the concrete surface to reapply primer where paint has detached from it. Remove excess material at camera patch work. <span style="background-color: yellow;">Pending</span>
<b>Assigned to</b>	—
<b>Created by</b>	<b>Yesenia Tijerina</b> (ERO Architects)
<b>Created on</b>	Aug 28, 2025
<b>Issue owner</b>	<b>Yesenia Tijerina</b> (ERO Architects)
<b>Location</b>	—
<b>Location details</b>	—
<b>Due date</b>	Sep 30, 2025
<b>Root cause</b>	—
<b>Reference drawing</b>	<a href="#">AE101 [V1]</a>

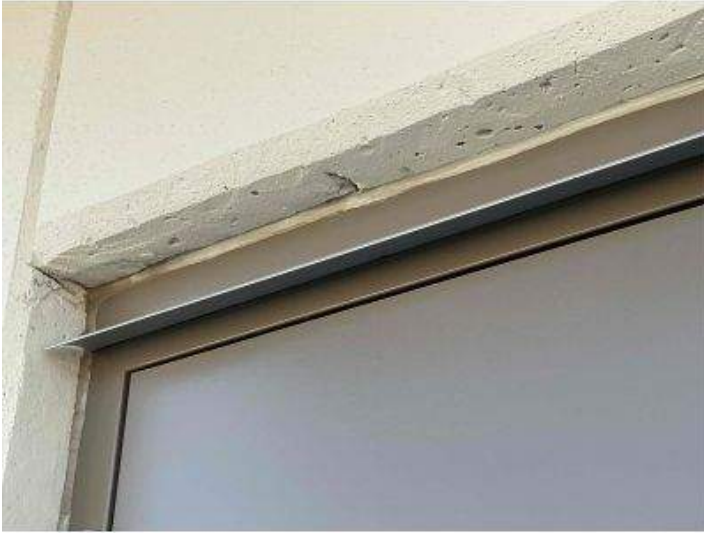
<b>Description</b>	Fill-in and smooth out all door edges at all concrete tilt-wall locations for both buildings. Paint and texture as needed. <span style="background-color: yellow; color: red; padding: 2px;">Pending</span>
<b>Assigned to</b>	—
<b>Created by</b>	<b>Yesenia Tijerina</b> (ERO Architects)
<b>Created on</b>	Aug 28, 2025
<b>Issue owner</b>	<b>Yesenia Tijerina</b> (ERO Architects)
<b>Location</b>	—
<b>Location details</b>	—
<b>Due date</b>	Sep 30, 2025
<b>Root cause</b>	—
<b>Reference drawing</b>	<a href="#">AE101 [V1]</a>

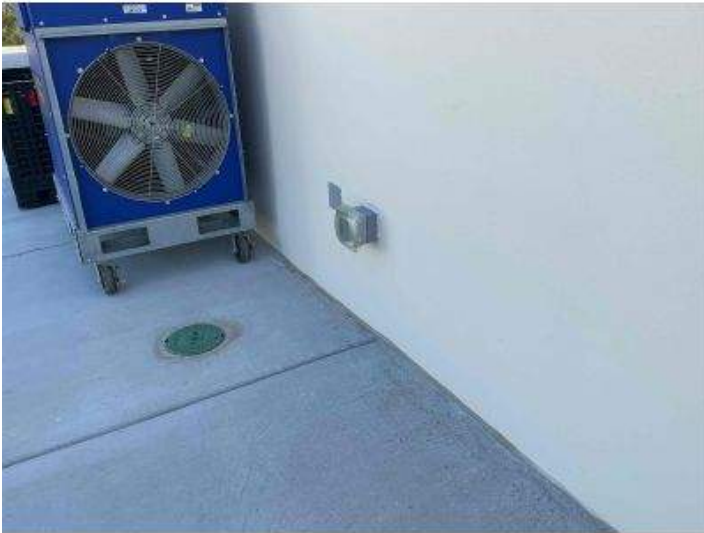
<b>Description</b>	all power boxes need to be recessed	Completed
<b>Assigned to</b>	—	
<b>Created by</b>	Yesenia Tijerina (ERO Architects)	
<b>Created on</b>	Aug 28, 2025	
<b>Issue owner</b>	Yesenia Tijerina (ERO Architects)	
<b>Location</b>	—	
<b>Location details</b>	—	
<b>Due date</b>	Sep 30, 2025	
<b>Root cause</b>	—	
<b>Reference drawing</b>	<a href="#">AE101 [V1]</a>

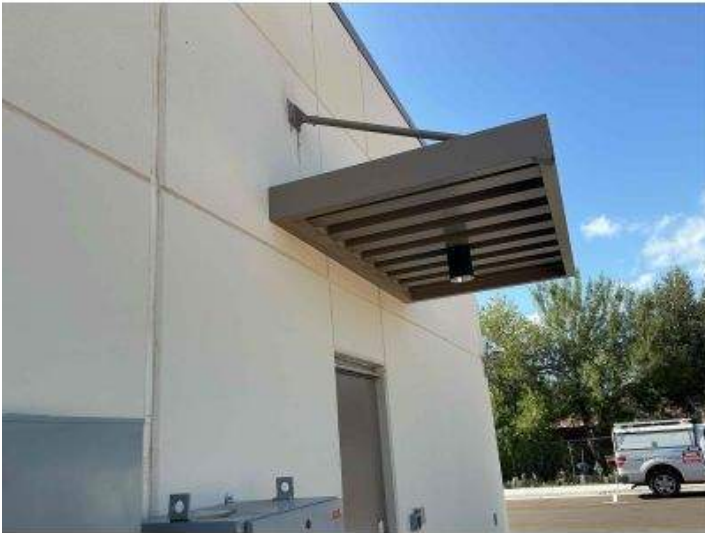
# #138: Repair and paint

<b>Description</b>	Patch and repair the concrete surface affected by canopy anchors. Paint touch-up and re-texture. Prepare the concrete surface to reapply primer where paint has detached or is missing. <span style="background-color: yellow;">Completed</span>
<b>Assigned to</b>	—
<b>Created by</b>	<b>Yesenia Tijerina</b> (ERO Architects)
<b>Created on</b>	Aug 28, 2025
<b>Issue owner</b>	<b>Yesenia Tijerina</b> (ERO Architects)
<b>Location</b>	—
<b>Location details</b>	—
<b>Due date</b>	Sep 30, 2025
<b>Root cause</b>	—
<b>Reference drawing</b>	<a href="#">AE101 [V1]</a>

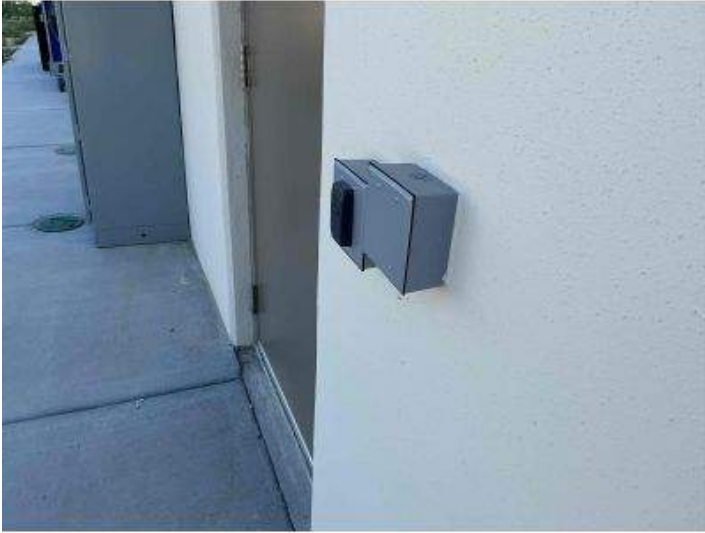
<b>Description</b>	Recess all power and low voltage boxes	Pending
<b>Assigned to</b>	—	
<b>Created by</b>	Yesenia Tijerina (ERO Architects)	
<b>Created on</b>	Aug 28, 2025	
<b>Issue owner</b>	Yesenia Tijerina (ERO Architects)	
<b>Location</b>	—	
<b>Location details</b>	—	
<b>Due date</b>	Sep 30, 2025	
<b>Root cause</b>	—	
<b>Reference drawing</b>	<a href="#">AE101 [V1]</a>

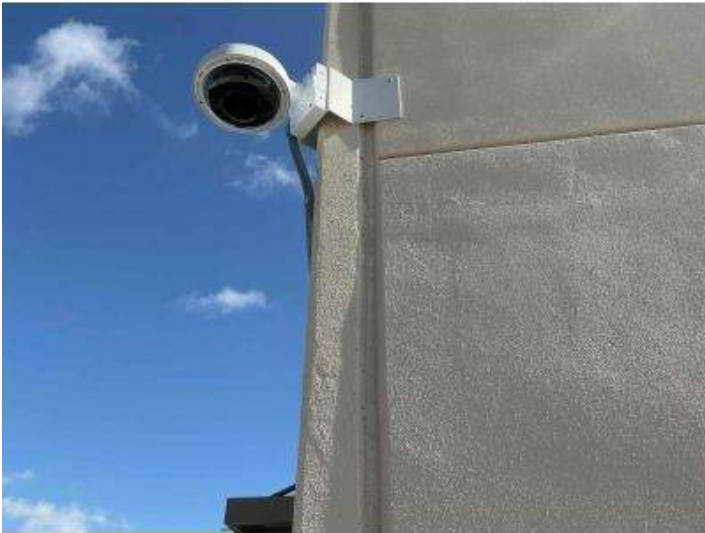
<b>Description</b>	Fill-in and smooth out the wall edge at the concrete tilt-wall. Paint and texture as needed. <span style="background-color: yellow; color: red;">Pending</span>
<b>Assigned to</b>	—
<b>Created by</b>	<b>Yesenia Tijerina</b> (ERO Architects)
<b>Created on</b>	Aug 28, 2025
<b>Issue owner</b>	<b>Yesenia Tijerina</b> (ERO Architects)
<b>Location</b>	—
<b>Location details</b>	—
<b>Due date</b>	Sep 30, 2025
<b>Root cause</b>	—
<b>Reference drawing</b>	<a href="#">AE101 [V1]</a>

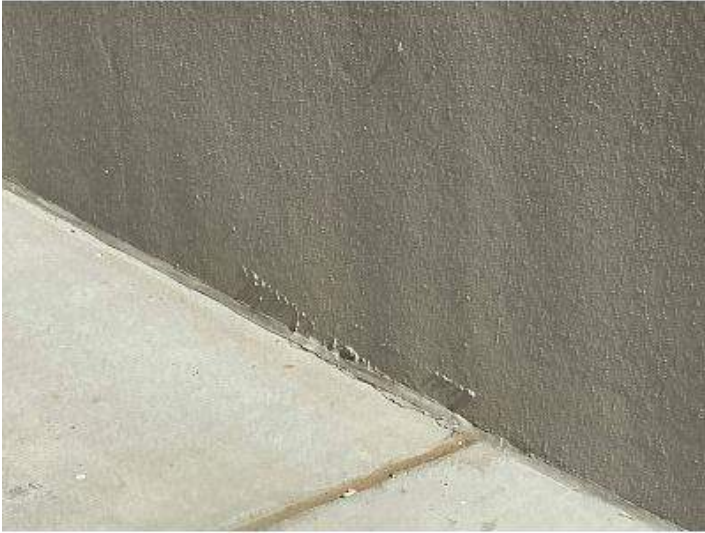
<b>Description</b>	Fill in to even out the tilt-wall surface. Smooth out excess paint/texture. Paint and texture as needed. <span style="background-color: yellow; color: red; padding: 2px;">Pending</span>
<b>Assigned to</b>	—
<b>Created by</b>	<b>Yesenia Tijerina</b> (ERO Architects)
<b>Created on</b>	Aug 28, 2025
<b>Issue owner</b>	<b>Yesenia Tijerina</b> (ERO Architects)
<b>Location</b>	—
<b>Location details</b>	—
<b>Due date</b>	Sep 30, 2025
<b>Root cause</b>	—
<b>Reference drawing</b>	<a href="#">AE101 [V1]</a>

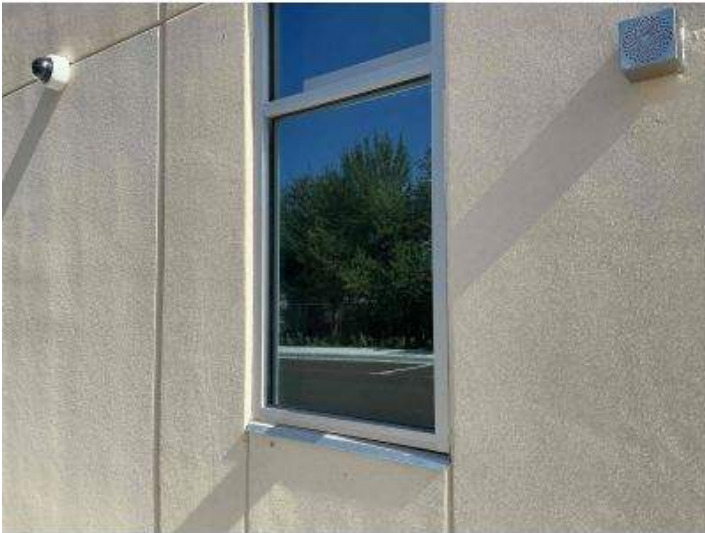
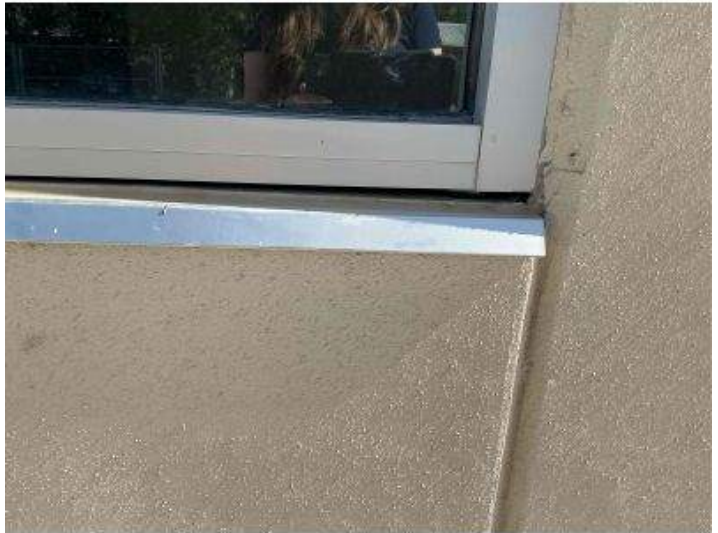
<b>Description</b>	close gap, aligned and level window metal flashing	Completed
<b>Assigned to</b>	—	
<b>Created by</b>	Yesenia Tijerina (ERO Architects)	
<b>Created on</b>	Aug 28, 2025	
<b>Issue owner</b>	Yesenia Tijerina (ERO Architects)	
<b>Location</b>	—	
<b>Location details</b>	—	
<b>Due date</b>	Sep 30, 2025	
<b>Root cause</b>	—	
<b>Reference drawing</b>	<a href="#">AE101 [V1]</a>

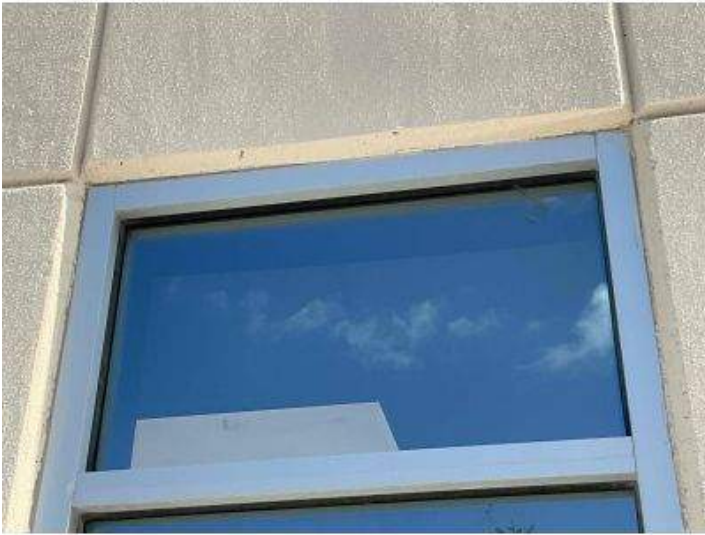
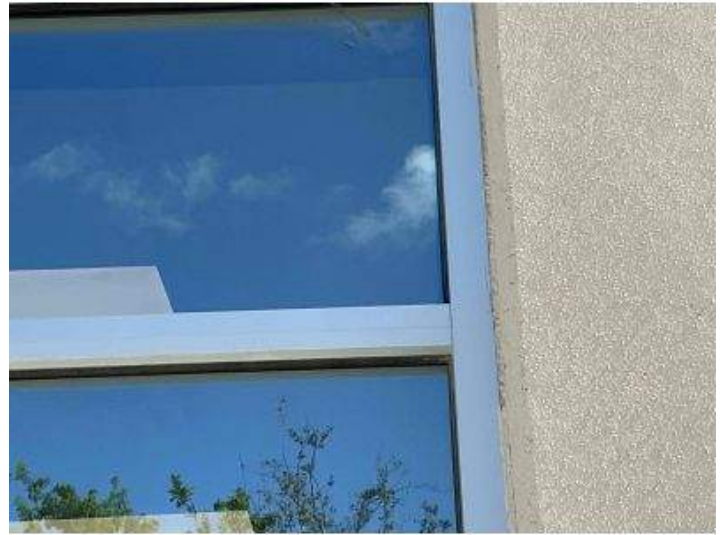
<b>Description</b>	Fill-in and smooth out all window edges at all concrete tilt-wall locations for both buildings. Paint and texture as needed. <span style="background-color: yellow; color: red; padding: 2px;">Pending</span>
<b>Assigned to</b>	—
<b>Created by</b>	<b>Yesenia Tijerina</b> (ERO Architects)
<b>Created on</b>	Aug 28, 2025
<b>Issue owner</b>	<b>Yesenia Tijerina</b> (ERO Architects)
<b>Location</b>	—
<b>Location details</b>	—
<b>Due date</b>	Sep 30, 2025
<b>Root cause</b>	—
<b>Reference drawing</b>	<a href="#">AE101 [V1]</a>

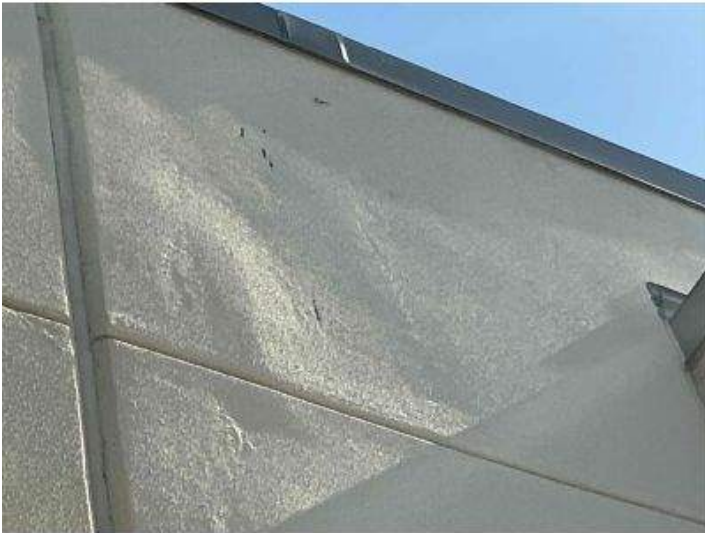
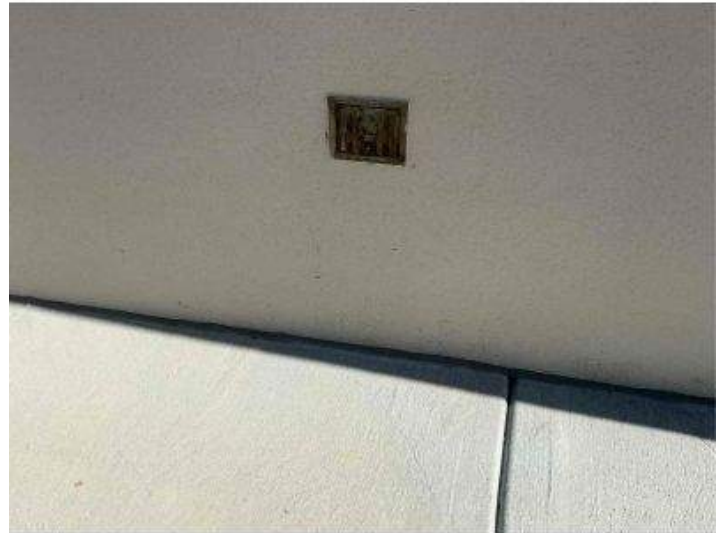
<b>Description</b>	Clean wall surface, paint touch-up, and re-texture. Prepare the concrete surface to reapply primer where paint has detached from it. <span style="background-color: yellow; color: red; padding: 2px;">Pending</span>
<b>Assigned to</b>	—
<b>Created by</b>	<b>Yesenia Tijerina</b> (ERO Architects)
<b>Created on</b>	Aug 28, 2025
<b>Issue owner</b>	<b>Yesenia Tijerina</b> (ERO Architects)
<b>Location</b>	—
<b>Location details</b>	—
<b>Due date</b>	Sep 30, 2025
<b>Root cause</b>	—
<b>Reference drawing</b>	<a href="#">AE101 [V1]</a>

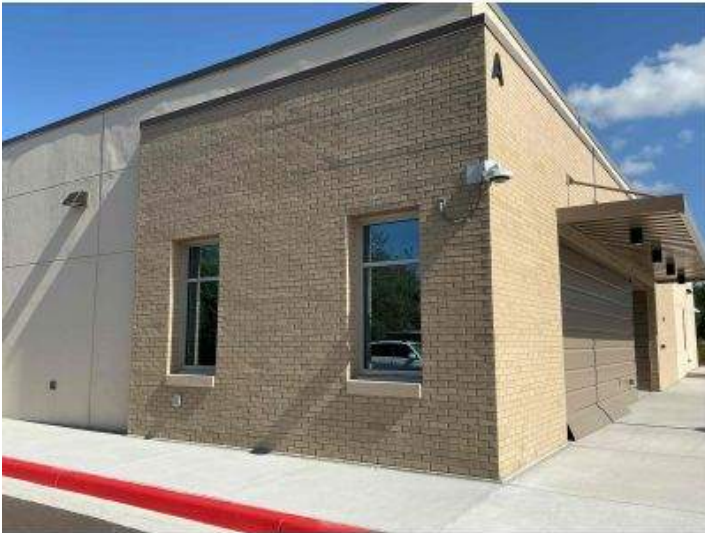
# #146: Brick damaged and installation

<b>Description</b>	Remove and replace damaged brick and uneven lines and levels not conforming to specification 04 26 13 3.03 TOLERANCES. <span style="background-color: yellow;">Completed</span>
<b>Assigned to</b>	—
<b>Created by</b>	<b>Yesenia Tijerina</b> (ERO Architects)
<b>Created on</b>	Aug 28, 2025
<b>Issue owner</b>	<b>Yesenia Tijerina</b> (ERO Architects)
<b>Location</b>	—
<b>Location details</b>	—
<b>Due date</b>	Sep 30, 2025
<b>Root cause</b>	—
<b>Reference drawing</b>	<a href="#">AE101 [V1]</a>

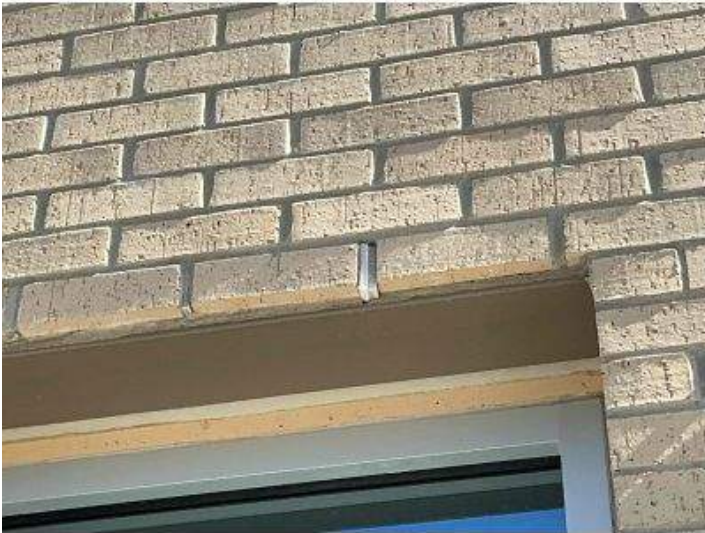
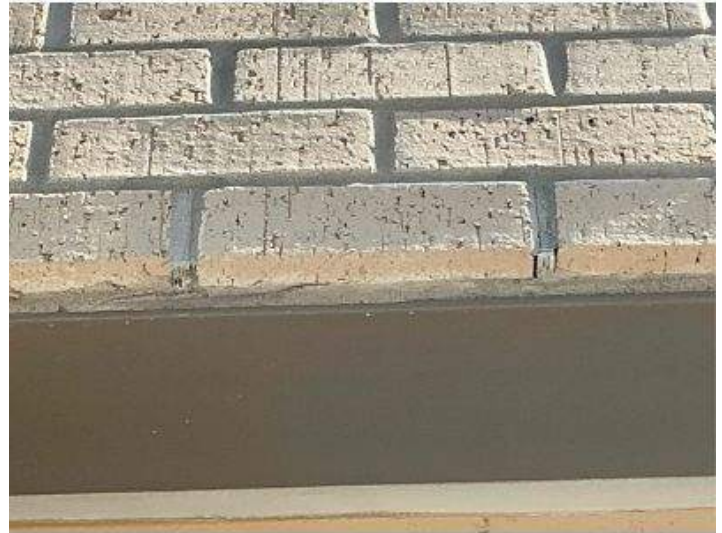
<b>Description</b>	remove grout from all weep vents. Weep holes at 24 inches o.c. unless otherwise specified. <span style="background-color: yellow;">Pending</span>
<b>Assigned to</b>	—
<b>Created by</b>	<b>Yesenia Tijerina</b> (ERO Architects)
<b>Created on</b>	Aug 28, 2025
<b>Issue owner</b>	<b>Yesenia Tijerina</b> (ERO Architects)
<b>Location</b>	—
<b>Location details</b>	—
<b>Due date</b>	Sep 30, 2025
<b>Root cause</b>	—
<b>Reference drawing</b>	<a href="#">AE101 [V1]</a>

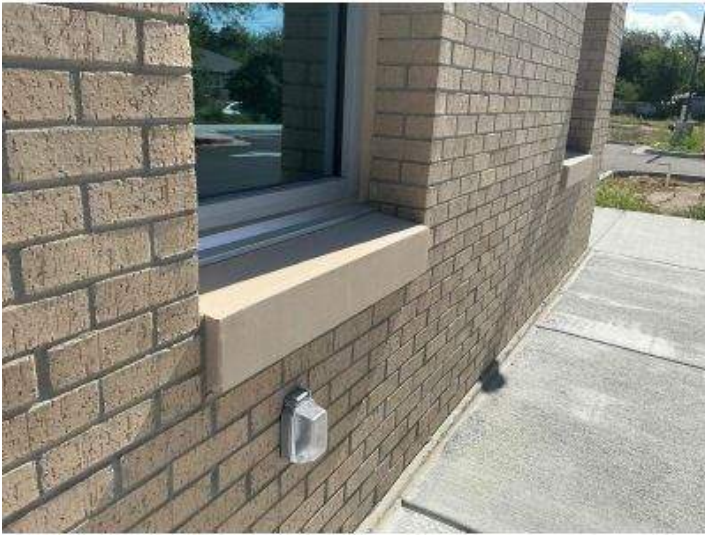
# #148: Cast Stone Damaged

<b>Description</b>	repair and or replace as needed all damaged cast stones for both buildings.
<b>Assigned to</b>	— <span style="background-color: yellow; padding: 2px;">Pending</span>
<b>Created by</b>	<b>Yesenia Tijerina</b> (ERO Architects)
<b>Created on</b>	Aug 28, 2025
<b>Issue owner</b>	<b>Yesenia Tijerina</b> (ERO Architects)
<b>Location</b>	—
<b>Location details</b>	—
<b>Due date</b>	Sep 30, 2025
<b>Root cause</b>	—
<b>Reference drawing</b>	<a href="#">AE101 [V1]</a>

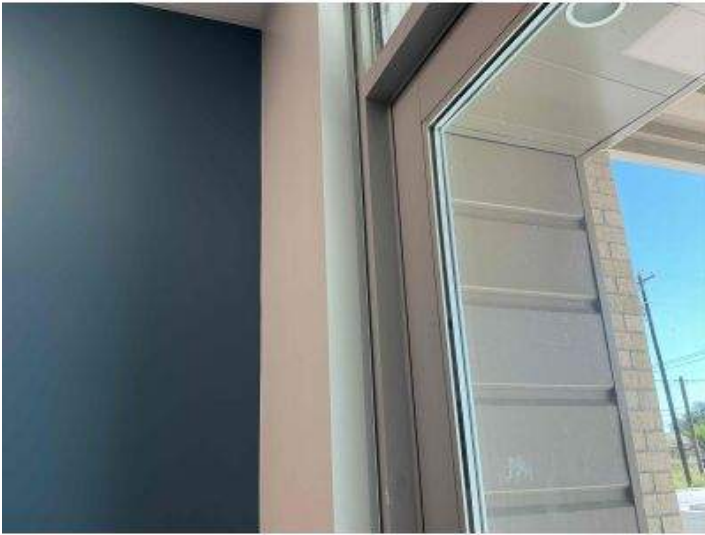
<b>Description</b>	fill in gaps around door trim	Completed
<b>Assigned to</b>	—	
<b>Created by</b>	<b>Yesenia Tijerina</b> (ERO Architects)	
<b>Created on</b>	Aug 28, 2025	
<b>Issue owner</b>	<b>Yesenia Tijerina</b> (ERO Architects)	
<b>Location</b>	—	
<b>Location details</b>	—	
<b>Due date</b>	Sep 30, 2025	
<b>Root cause</b>	—	
<b>Reference drawing</b>	<a href="#">AE101 [V1]</a>

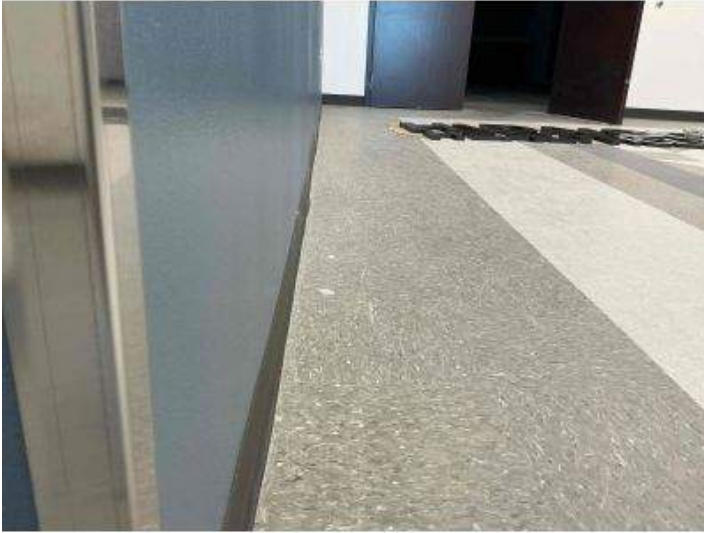
<b>Description</b>	uneven wall base	<b>Pending</b>
<b>Assigned to</b>	—	
<b>Created by</b>	<b>Yesenia Tijerina</b> (ERO Architects)	
<b>Created on</b>	Aug 28, 2025	
<b>Issue owner</b>	<b>Yesenia Tijerina</b> (ERO Architects)	
<b>Location</b>	—	
<b>Location details</b>	—	
<b>Due date</b>	Sep 30, 2025	
<b>Root cause</b>	—	
<b>Reference drawing</b>	<a href="#">AE101 [V1]</a>
