## Housing Rehab Program

**PROJECT:** Reconstruction of a single-family housing unit located at: 2209 George Washington St Weslaco Texas

# INITIAL INSPECTION

Date: October 30, 2024

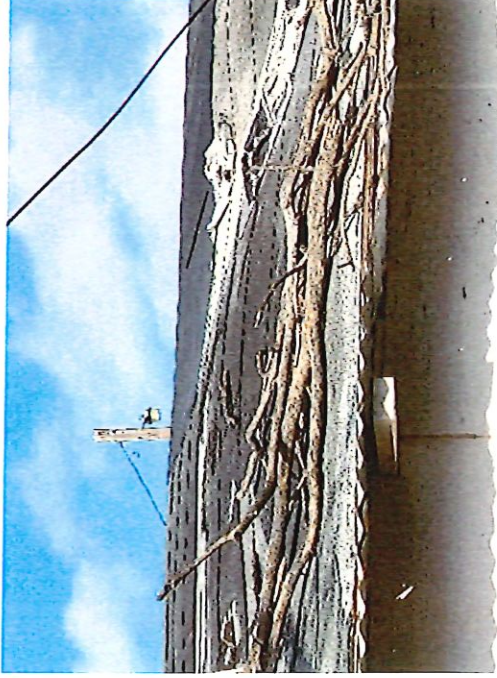
Notes: The roofing is half metal roof and half asphalt paper. There are signs of water leaking inside the house.

No soffit and roof decking appears damaged

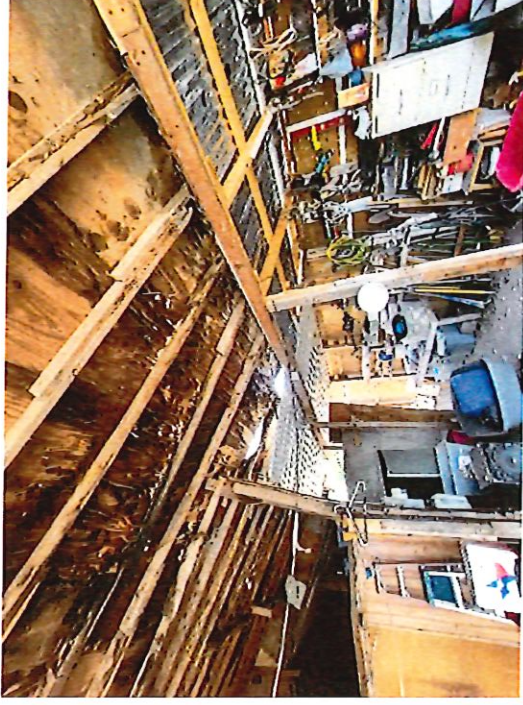
Notes: The ceiling coverings have cracks around the perimeter walls due to foundation movement. There are several areas where water damage has stained the ceiling. There are also signs of rodent infestation and mold.

water damage and mold

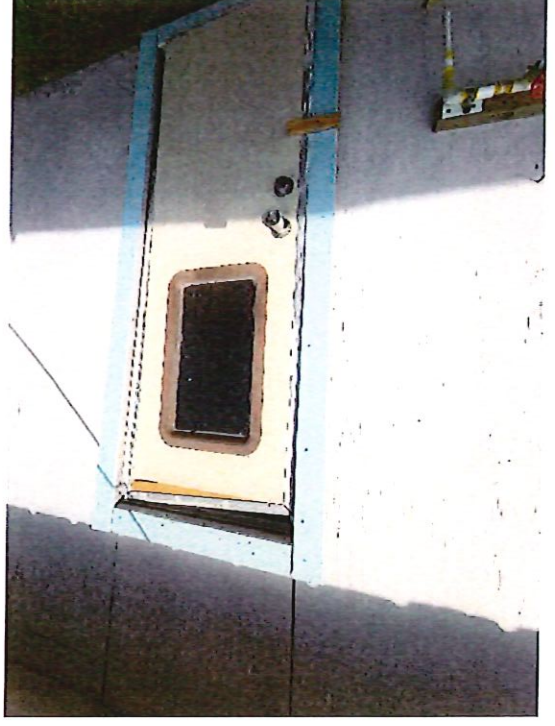
Notes: The exterior doors need to be replaced. The door frames is damaged and do not open all the way

Exterior doors do not seal properly

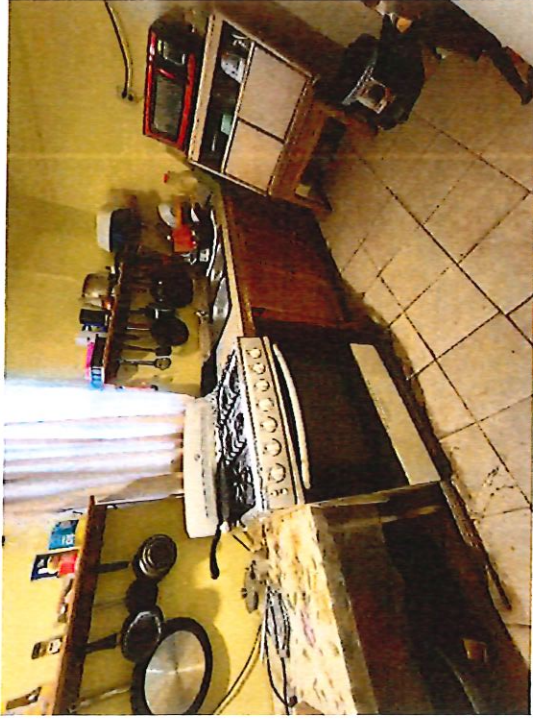
The flooring for the entire house needs to be replaced. In several areas tile is cracked or broken and uneven.

Notes: The kitchen cabinets are in need of repair. Repair is needed under the sink and behind the faucet where water damage has taken place. Only 5 feet of counter is present, a table is used along the wall as counter space. No cabinets in the kitchen.

No cabinets and broken flooring

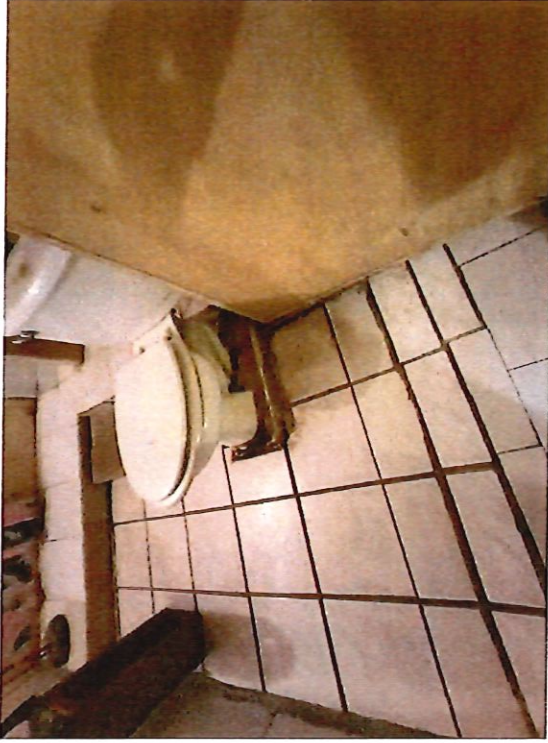
Raised uneven flooring

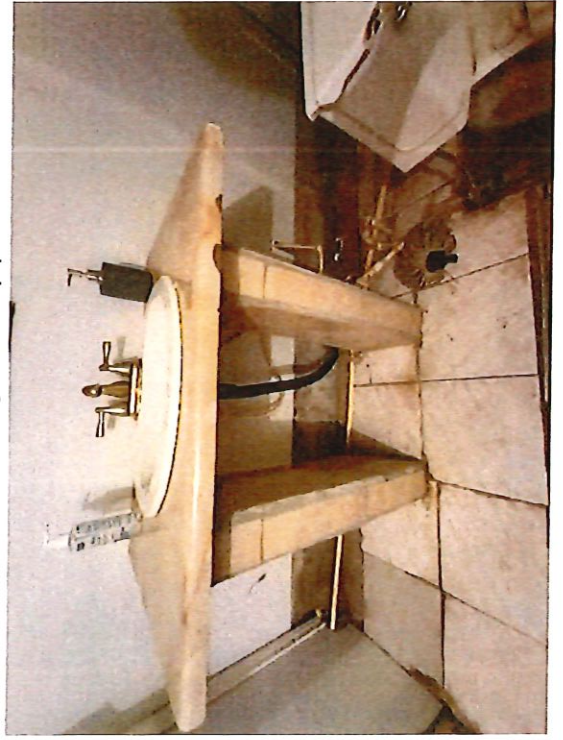
Notes: Make shift sewer lines were used

Make shift plumbing & Drain pipes

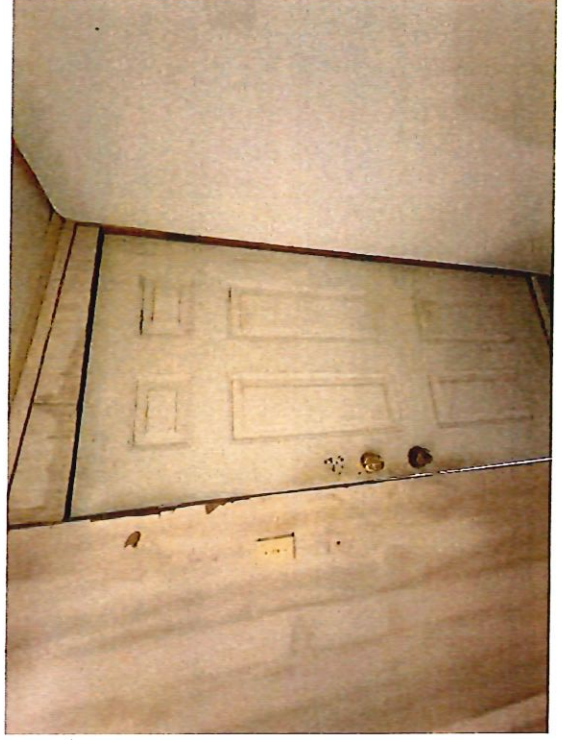
Exterior doors do not operate or seal properly

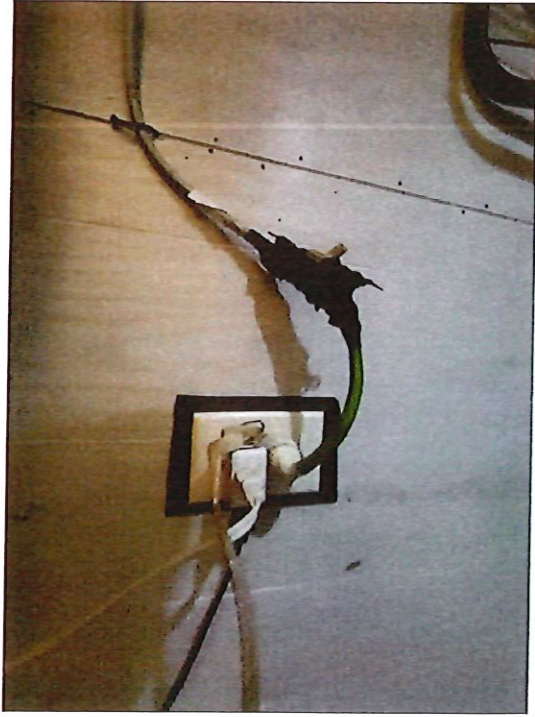
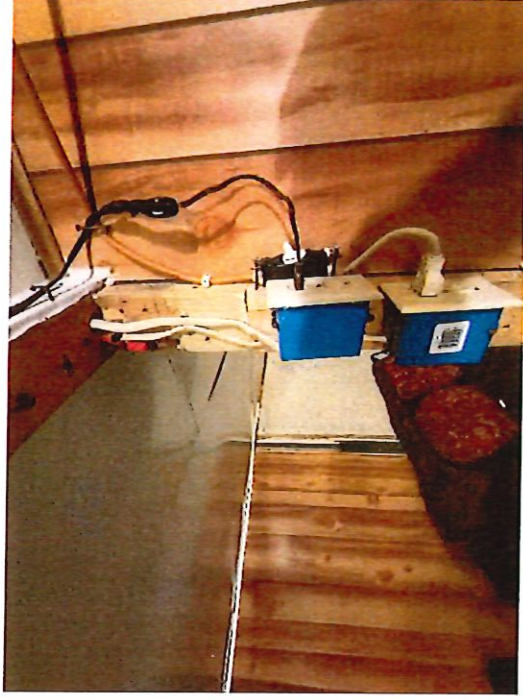
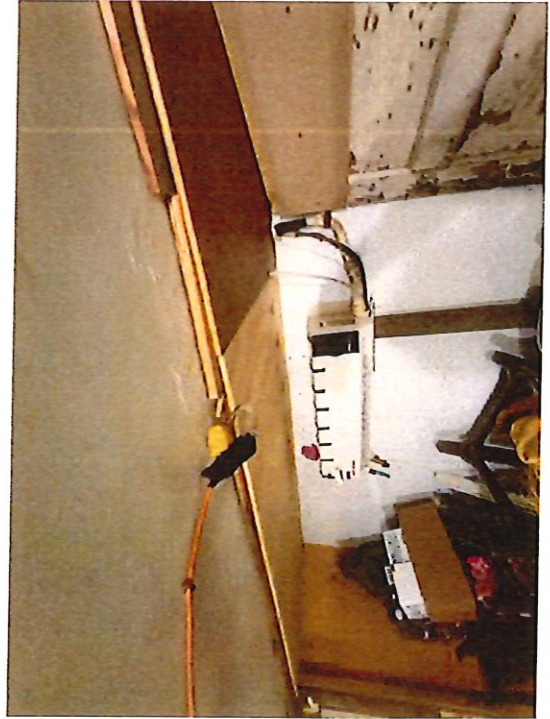
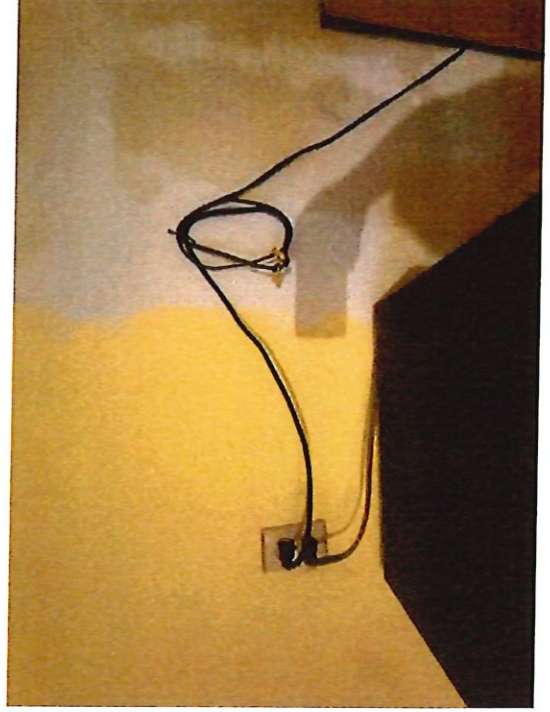
Location(s): Electrical wire all along the house with no conduit exposed to the elements. Open J boxes with bare wire.

Notes: There were several plugs throughout the house that were not working. Several ceiling light fixtures in the house were also not working. Extension cords are used around the house over loading plugs. Electrical needs to be inspected for electrical shorts.

Electrical Deficiencies

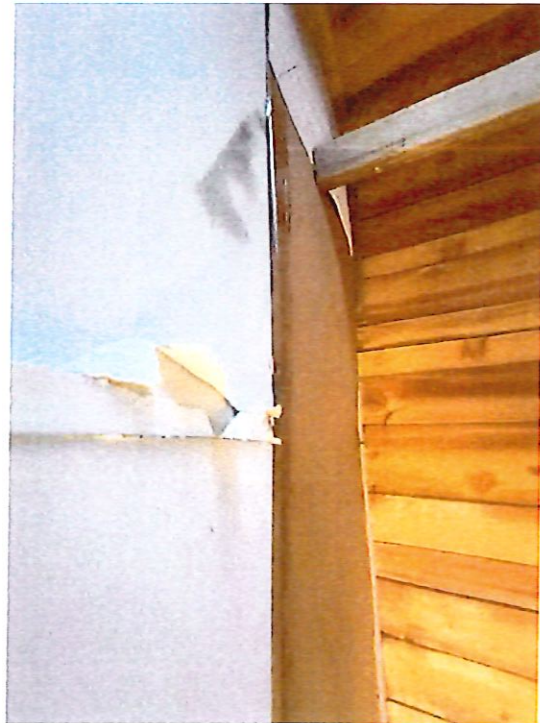
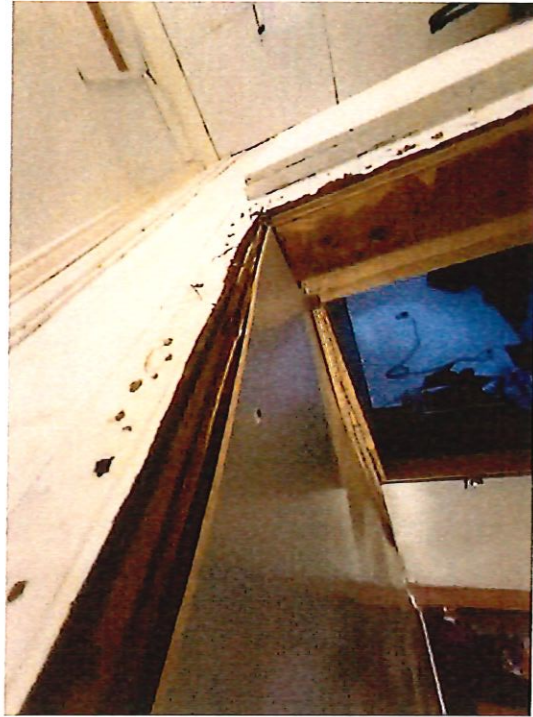
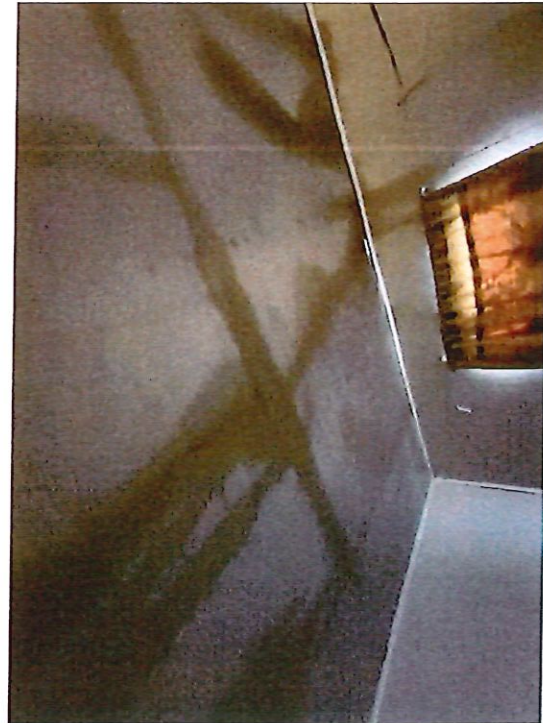
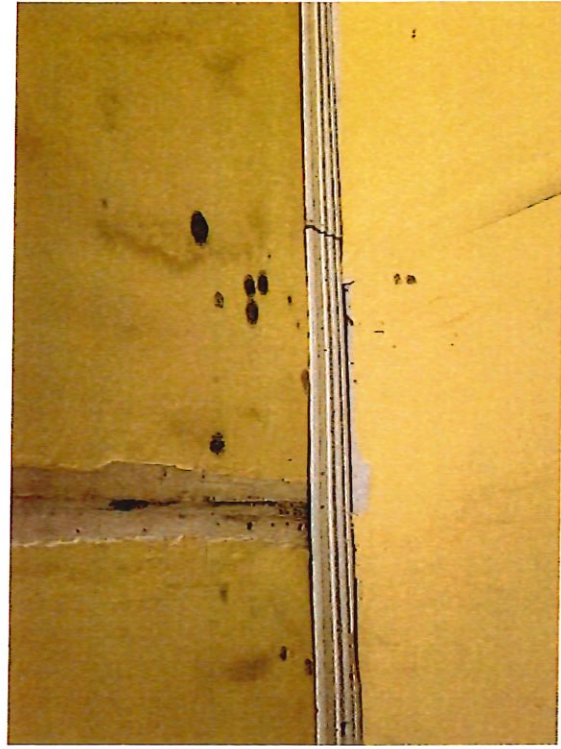
Ceiling Deficiencies
