## Housing Rehab Program

**PROJECT:** Reconstruction of a single-family housing unit located at: 4309 Monreal Rd  
Edinburg Texas

# INITIAL INSPECTION

Address: 4309 Monreal Rd. Edinburg Tx 78541

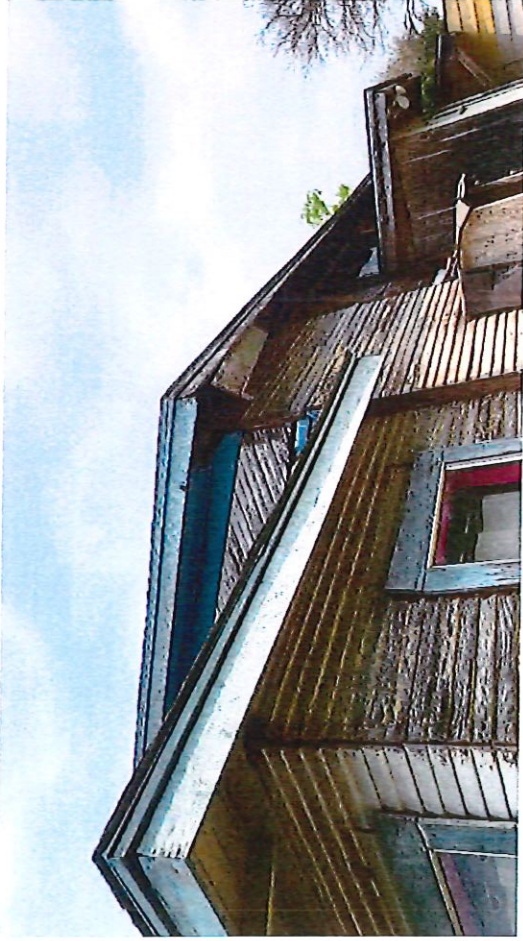
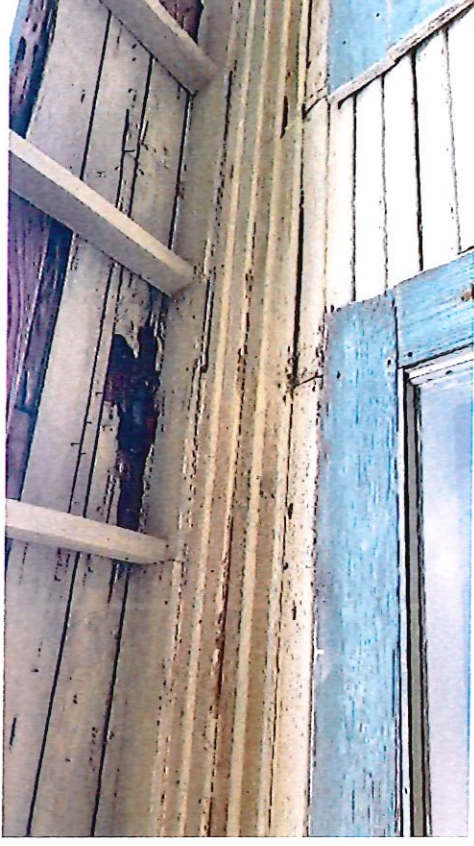
Roof Soffit and Fascia

Notes: The overhang is in bad shape. There are many areas where the overhang has deteriorated due to moisture or termites. Overhang needs to be replaced and sealed to prevent future deterioration. The trim needs to be replaced due to deterioration.

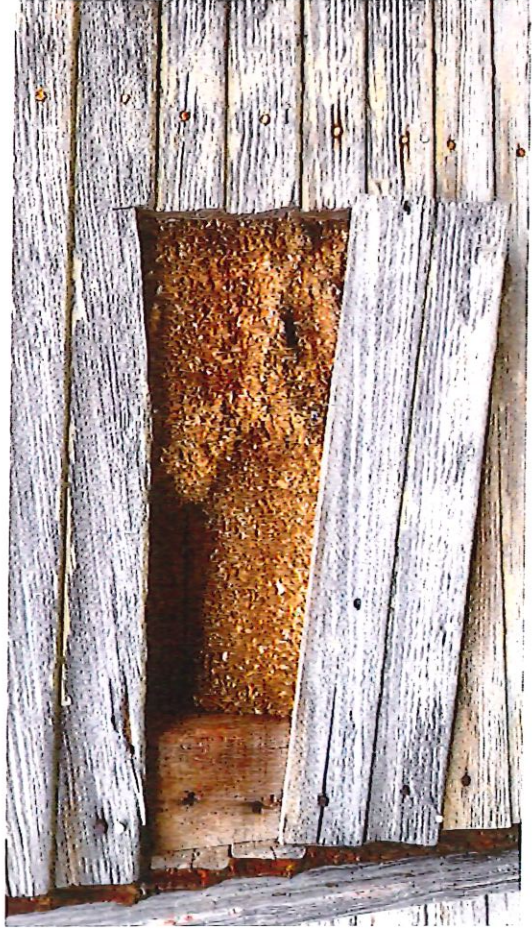
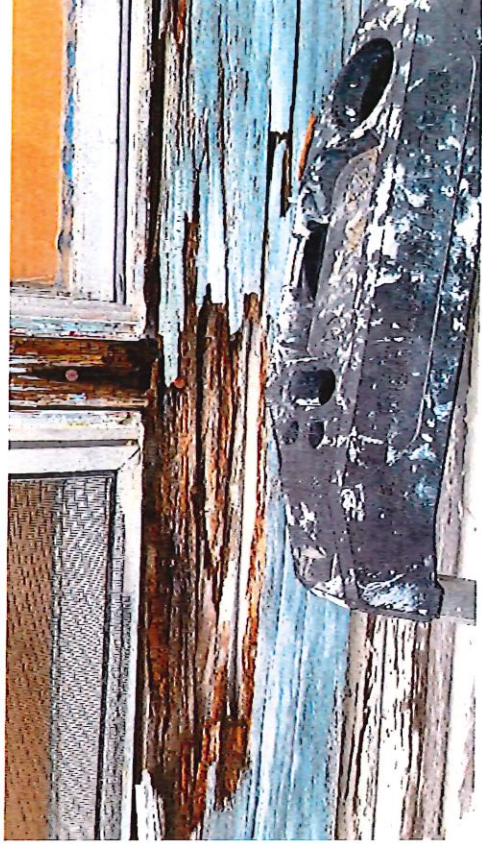
Exterior Siding

Notes: The exterior wall siding is in bad shape. There are many areas where the wood siding has deteriorated due to moisture or termites. Wood siding needs to be replaced and sealed to prevent future deterioration.

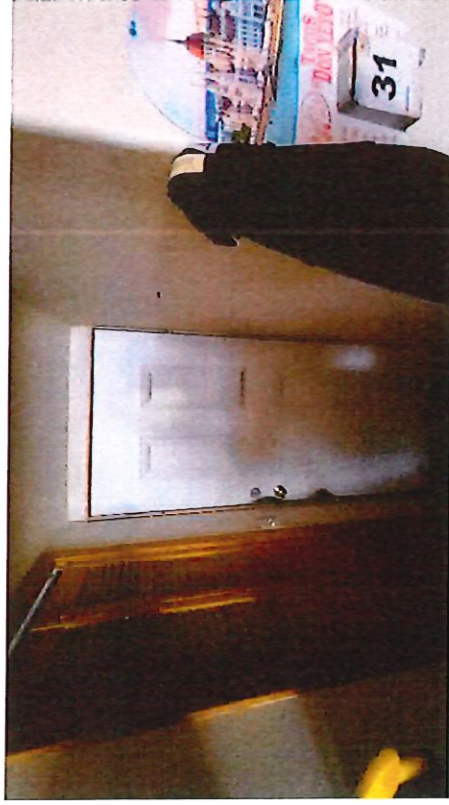
Notes: The front and rear exterior doors need to be replaced. The door frames is damaged and cracked due to the shifting of the house.

Exterior doors do not close properly.

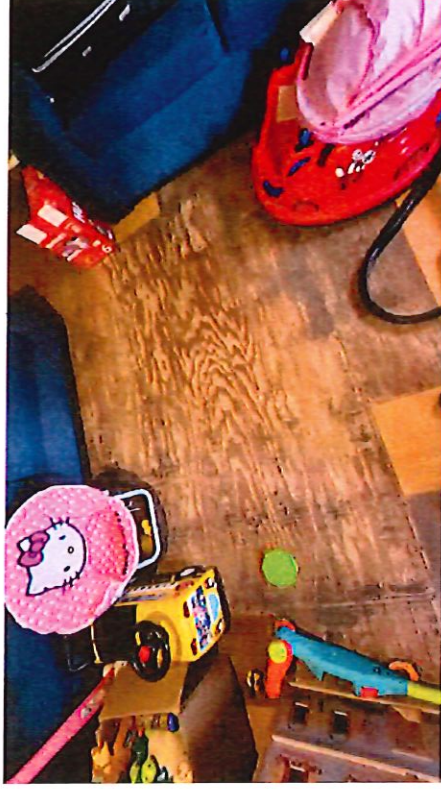
The flooring for the entire house needs to be replaced. In several areas in the house the VCT has come unglued and or worn down to the subfloor.

Subfloor exposed in 90% of the home

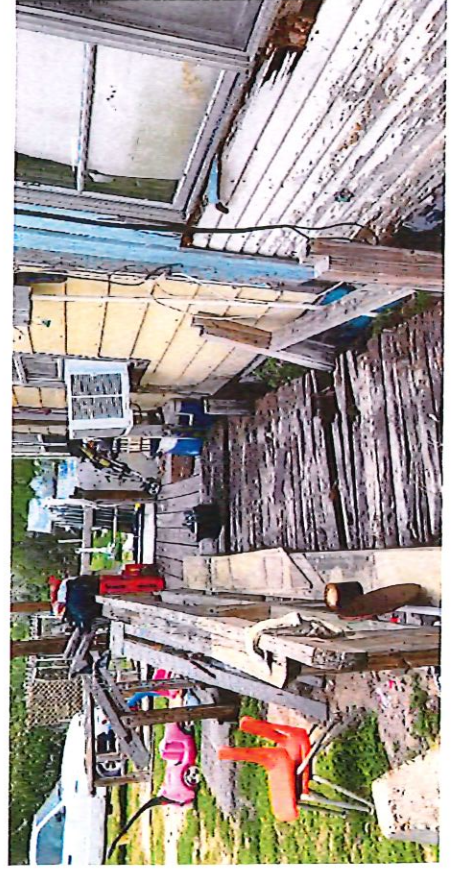
Notes: The Side porch and steps need to be replaced.

Ramp needs to be replaced

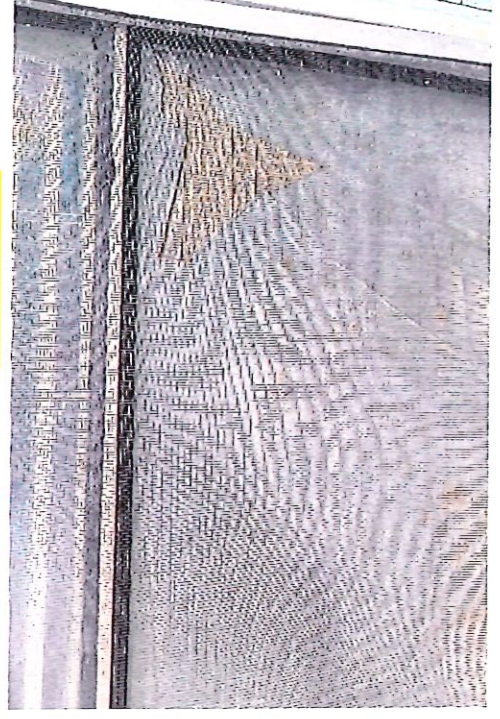
Notes: The windows appear to be single pane and broken

Broken windows

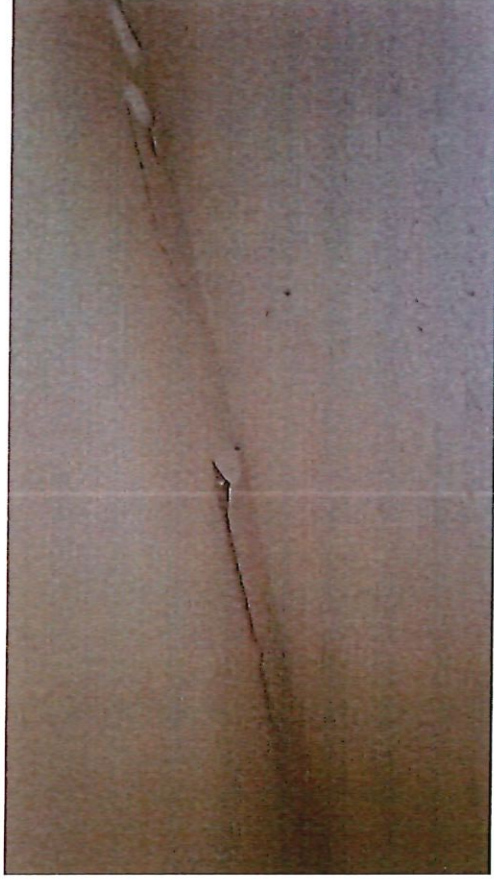
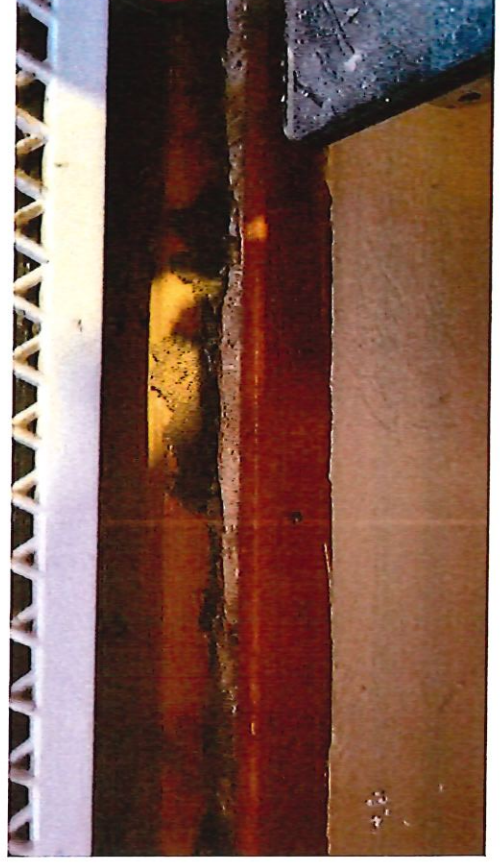
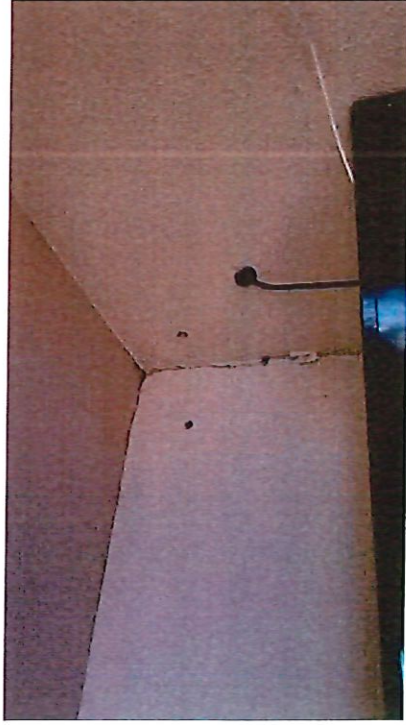
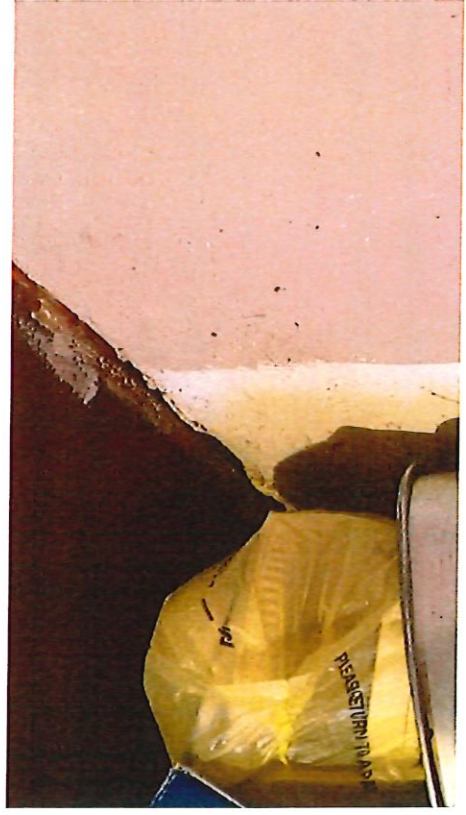
Interior walls & Ceiling Deficiencies

Notes: The ceiling coverings have cracks around the perimeter walls due to foundation movement. There are several areas where water damage has stained the ceiling. There are also signs of termites and rodent infestation. Mold is present in several areas of the house.

Notes: The wall coverings and trim are in need of repair. There are holes in walls and cracks due to foundation movement. Door frames and trims are broken and do not close properly. There are also signs of termites and rodent infestation.
