## Housing Rehab Program

**PROJECT:** Reconstruction of a single-family housing unit located at: 223 S. Salinas Blvd  
Donna, Texas

# INITIAL INSPECTION

223 Salinas Ave. Donna TX

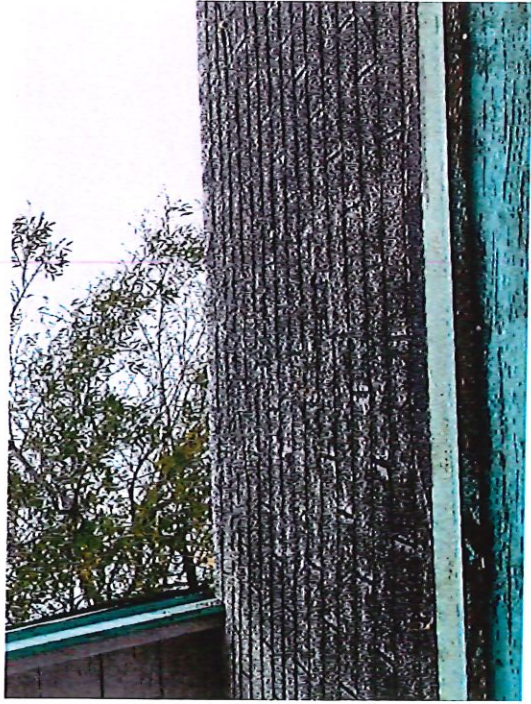
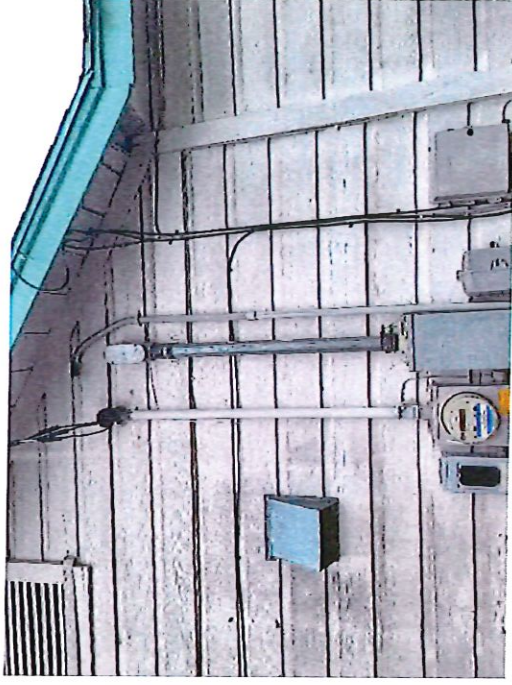
Roof Soffit and Fascia

Notes: The overhang is in bad shape. There are many areas where the overhang has deteriorated due to moisture or termites. Overhang needs to be replaced and sealed to prevent future deterioration. The trim needs to be replaced due to deterioration.

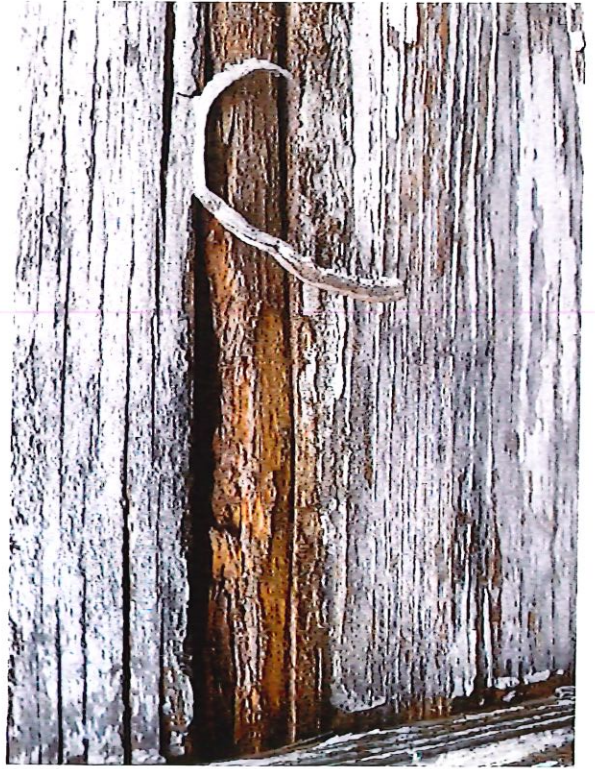
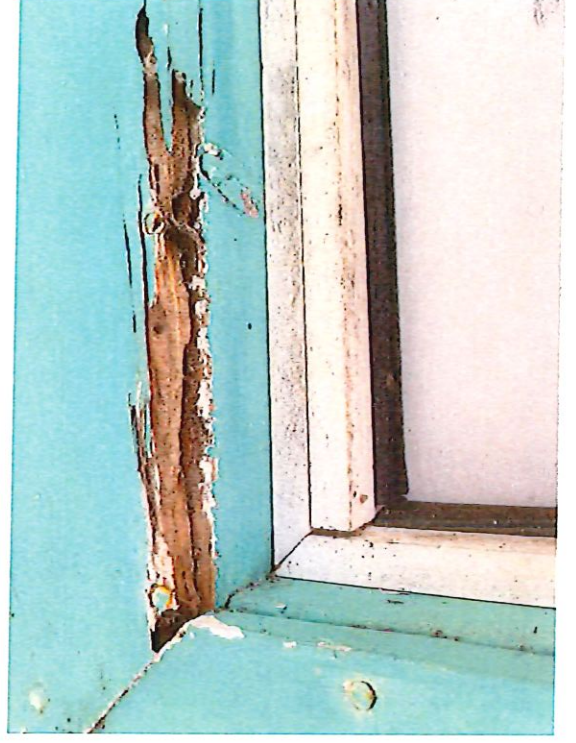
Exterior Siding

Notes: The exterior wall siding is in bad shape. There are many areas where the wood siding has deteriorated due to moisture or termites. Wood siding needs to be replaced and sealed to prevent future deterioration.

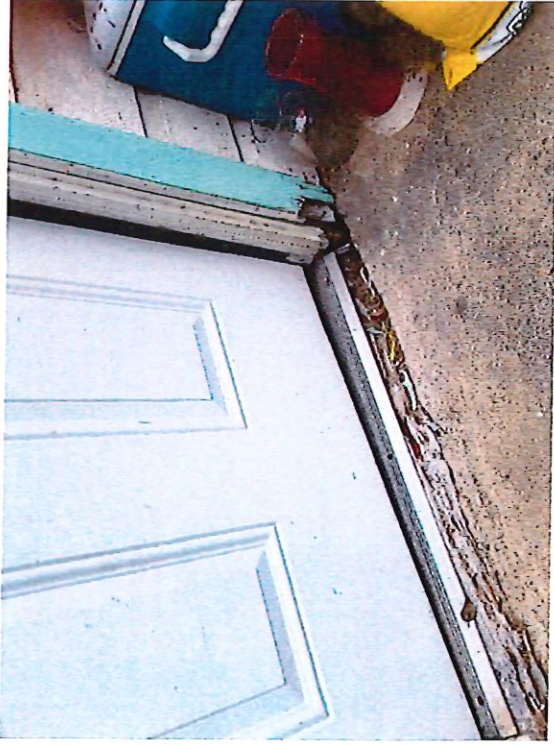
Notes: The front and rear exterior doors need to be replaced. The door frames is damaged and cracked due to the shifting of the house.

Exterior doors do not close properly.

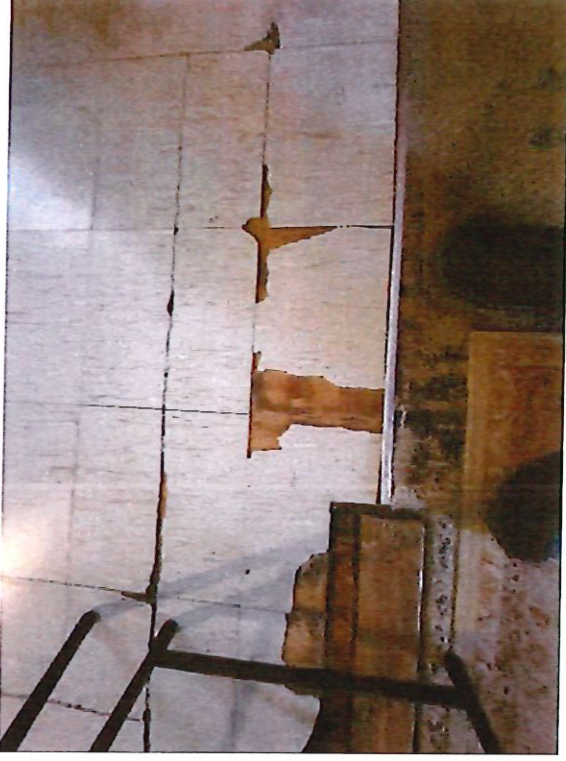
The flooring for the entire house needs to be replaced. In several areas in the house the VCT has come unglued and or worn down to the subfloor.

Subfloor exposed in 60% of the home

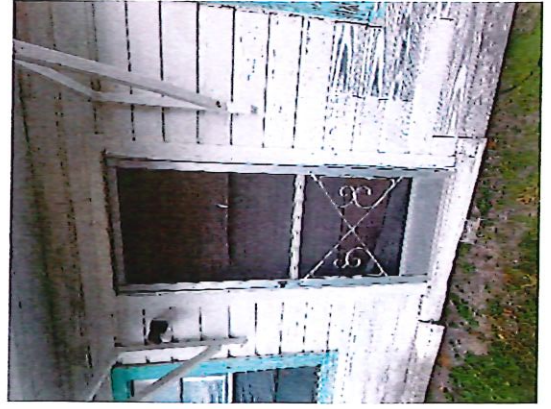
Notes: The Side porch and steps need to be replaced.

Steps need to be replaced

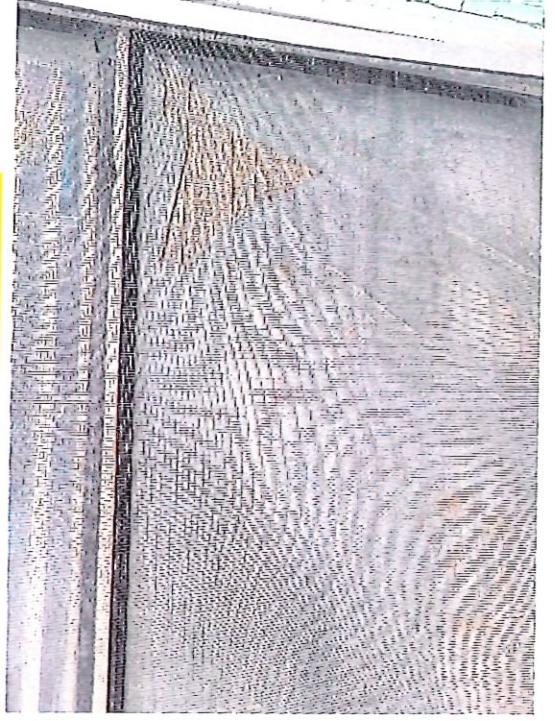
Notes: The windows appear to be single pane and broken

Broken windows

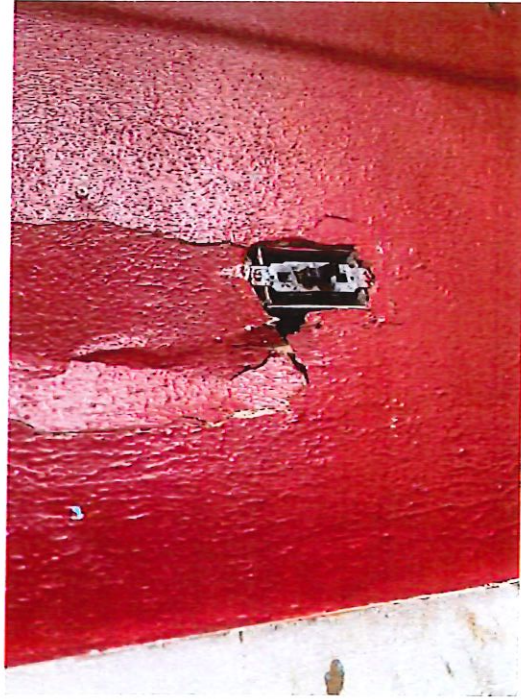
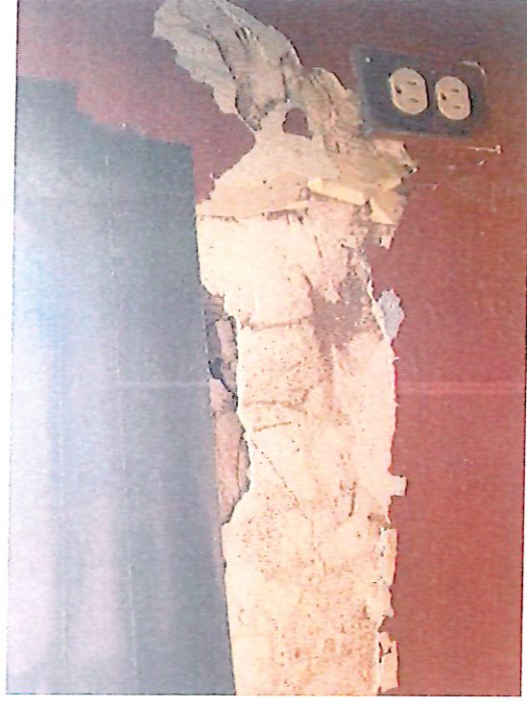
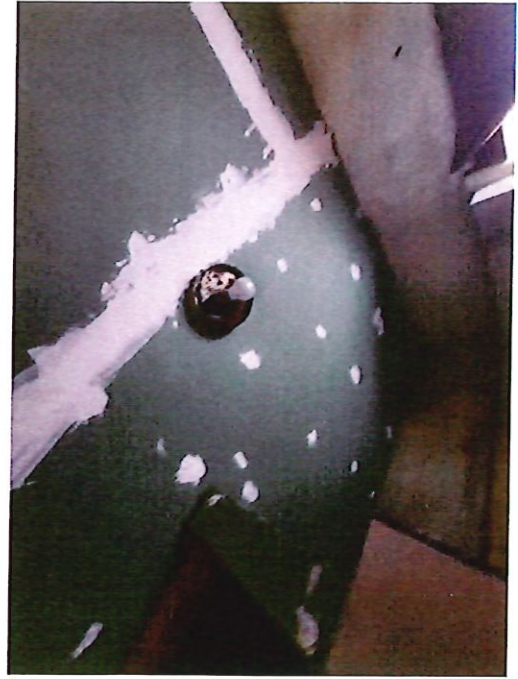
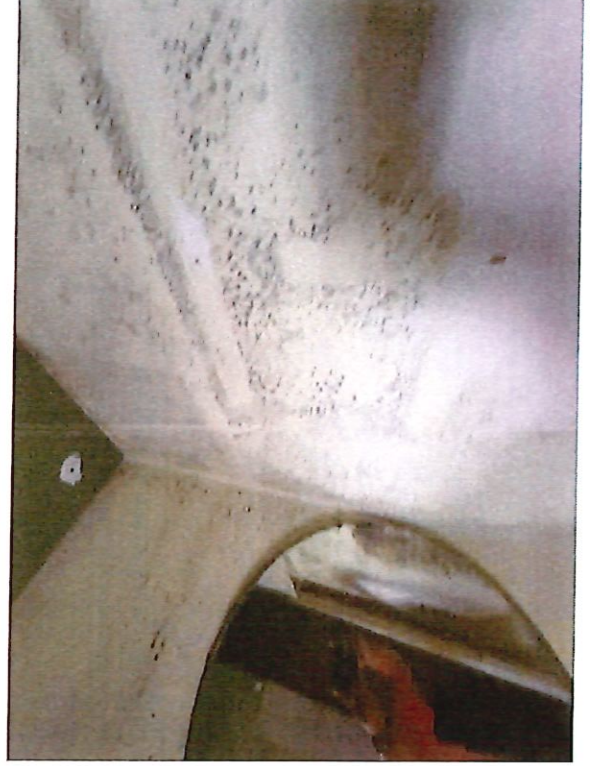
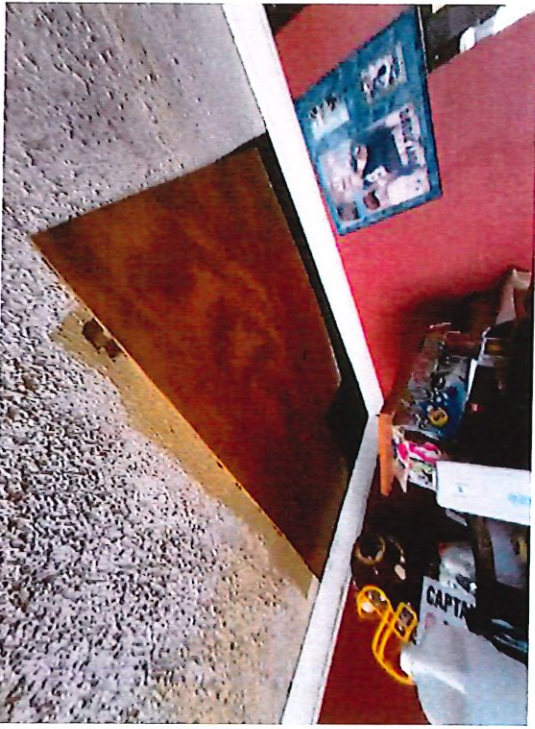
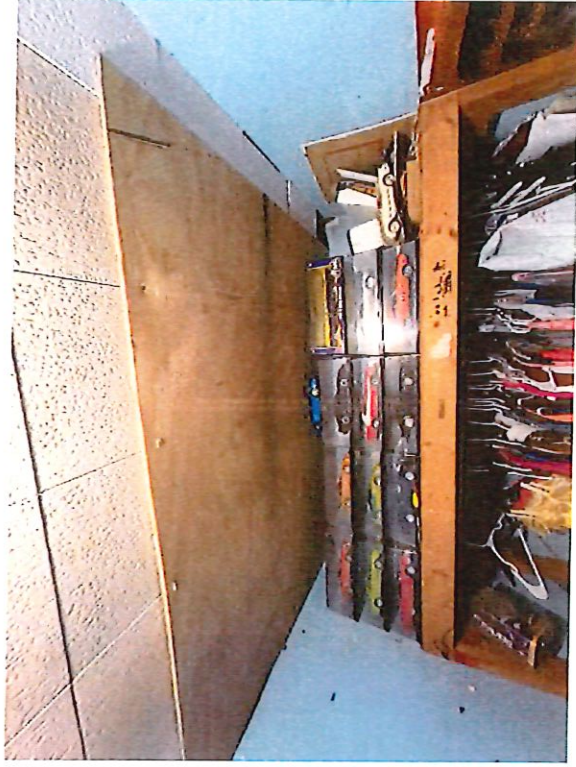
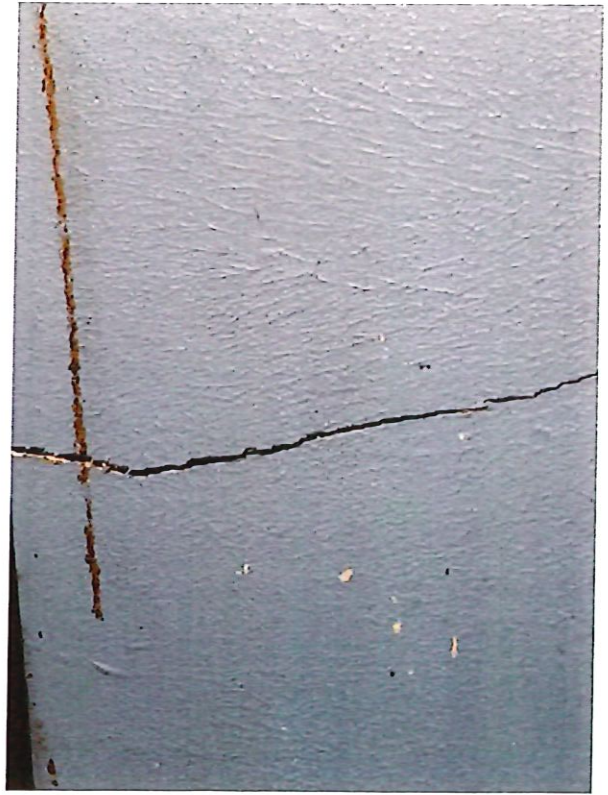
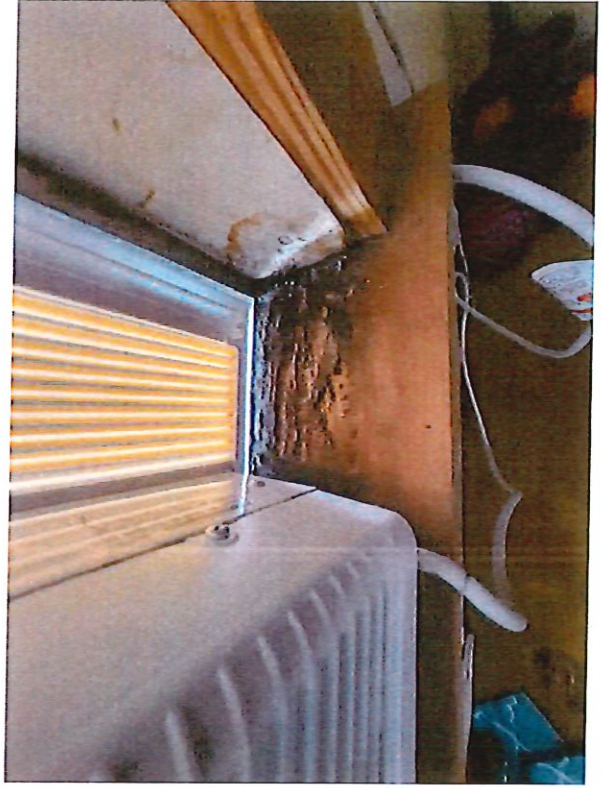
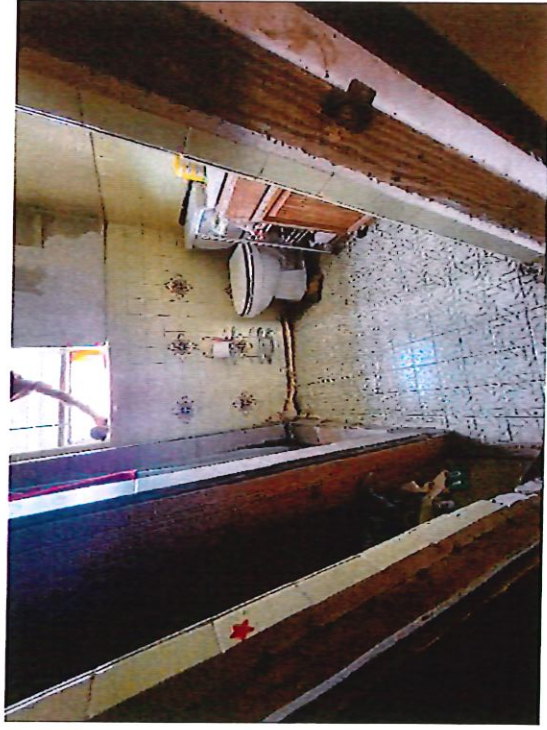
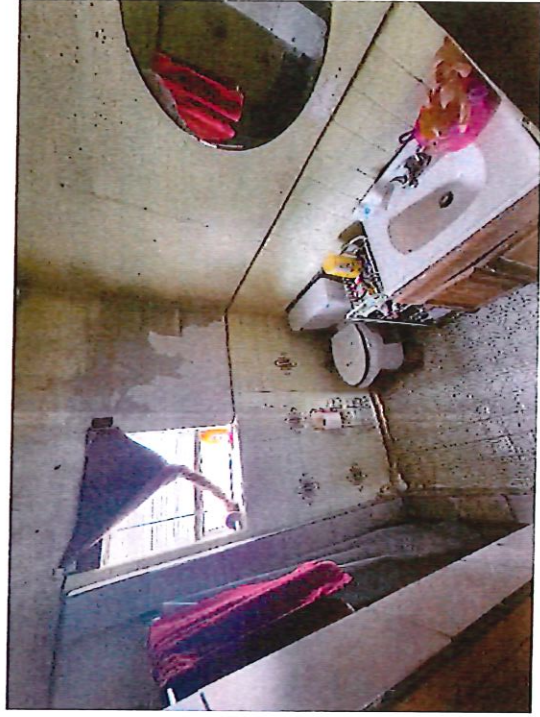
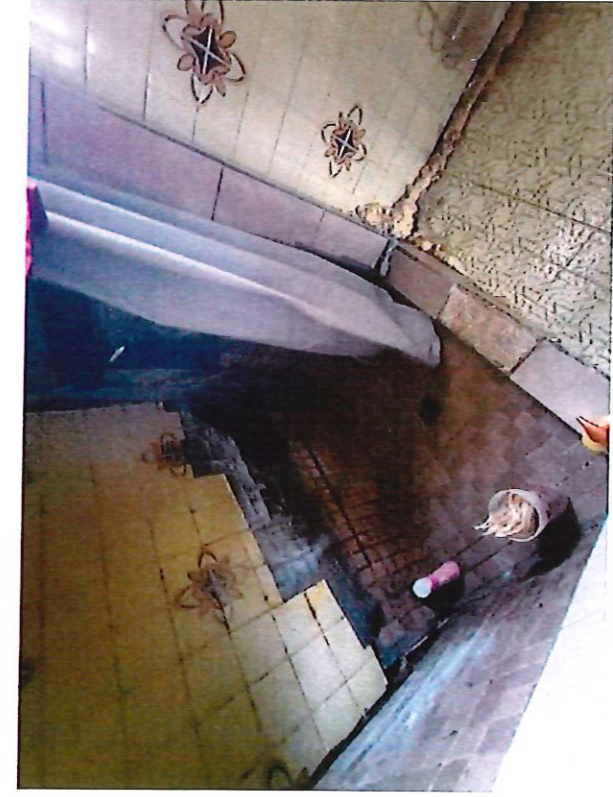
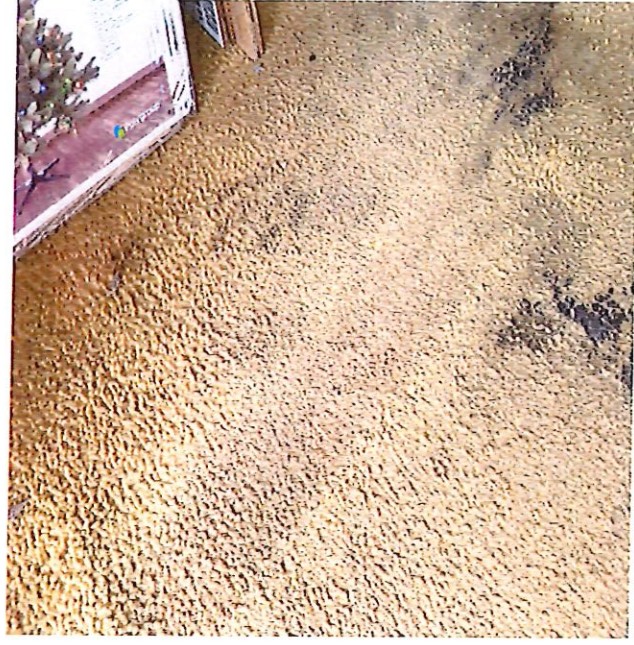
Notes: The ceiling coverings have cracks around the perimeter walls due to foundation movement. There are several areas where water damage has stained the ceiling. There are also signs of termites and rodent infestation. Mold is present in several areas of the house.

Notes: The wall coverings and trim are in need of repair. There are holes in walls and cracks due to foundation movement. Door frames and trims are broken and do not close properly. There are also signs of termites and rodent infestation.

Interior walls & Ceiling Deficiencies
