**NOVEMBER 22, 2022**

**Copyright 2022 Kleinfelder  
All Rights Reserved**

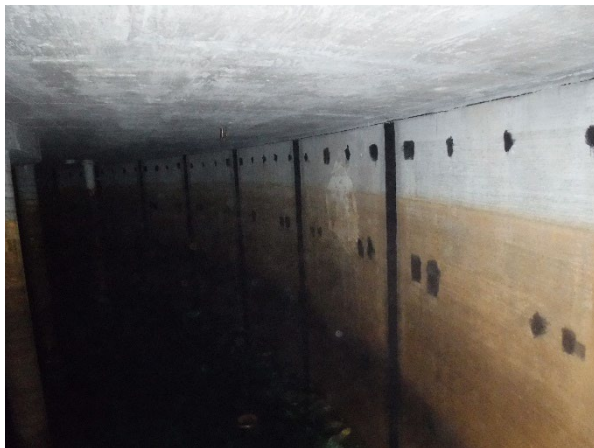
**Photo No. 4 High rust deposit on interior surface of tank**

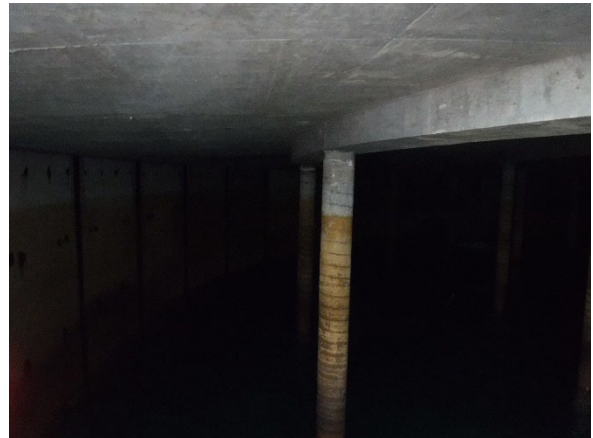
**Photo No. 5 High rust deposit on interior column of the tank**

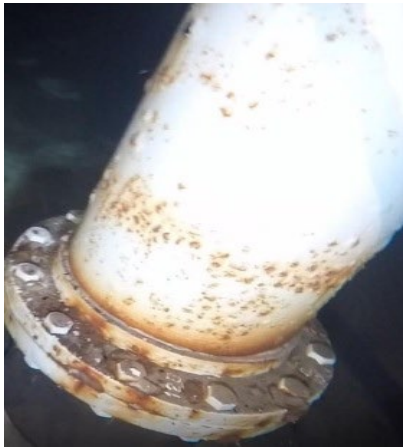
Photo No. 6 Inlet Pipe

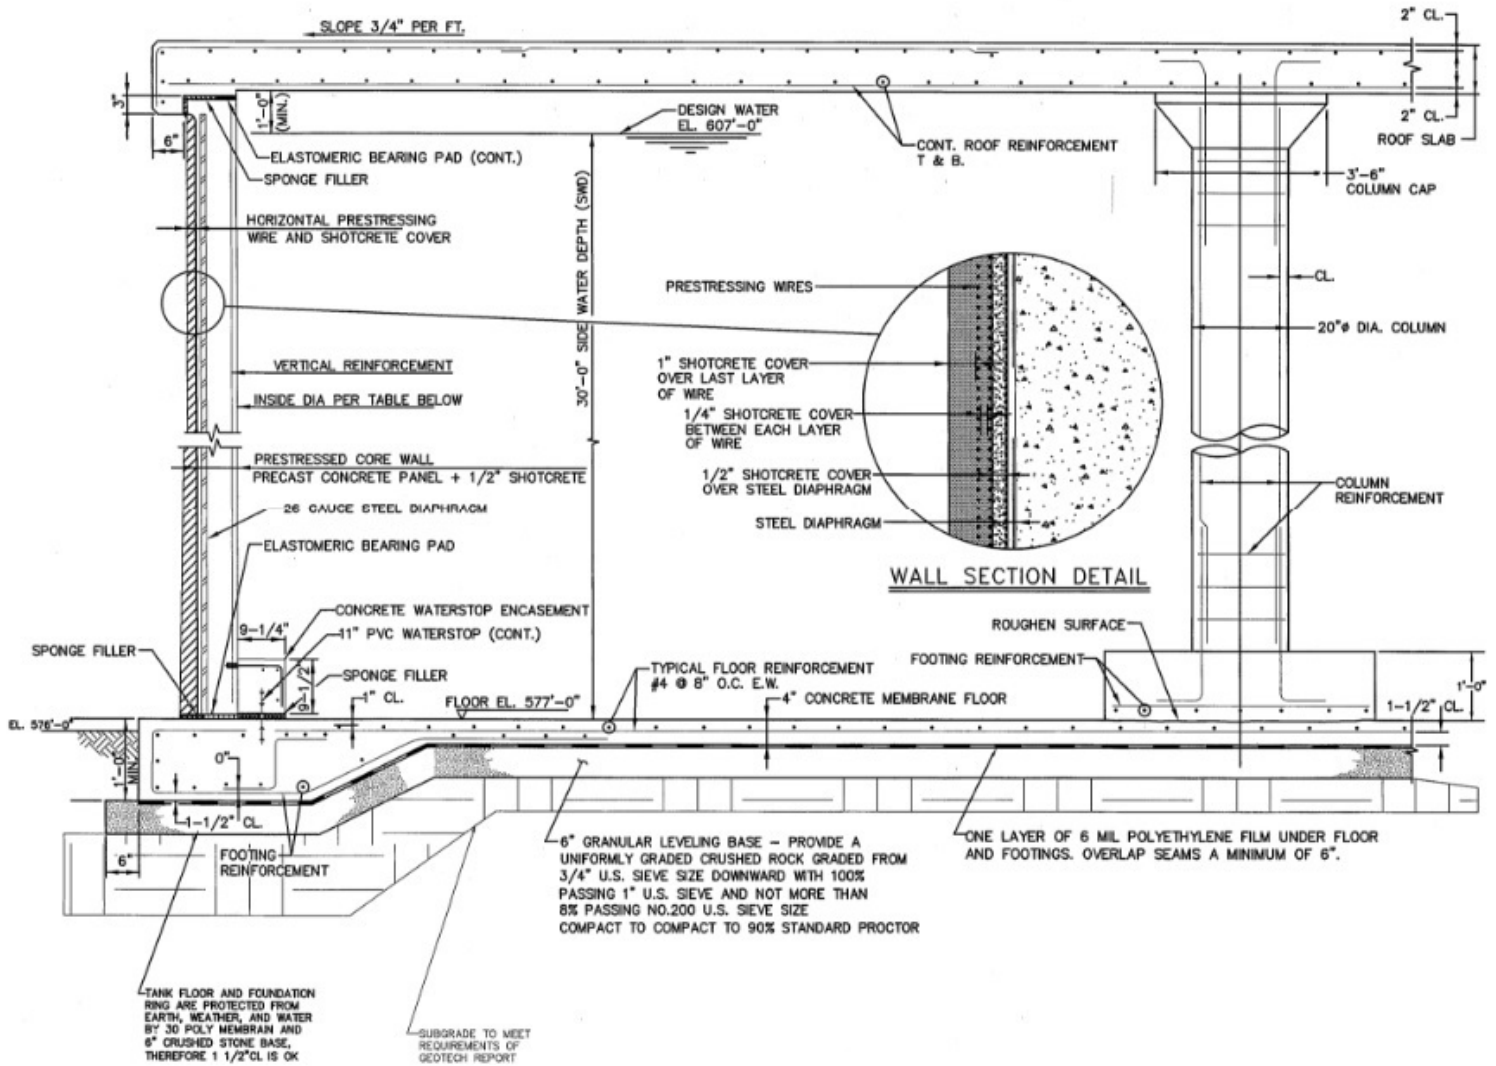
Photo No. 9 Structural details of wall, column, and foundation

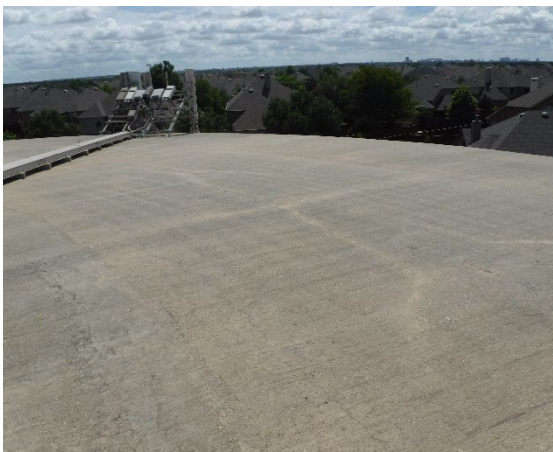
**Photo No. 10 Cracks at Roof Slab (Exterior)**

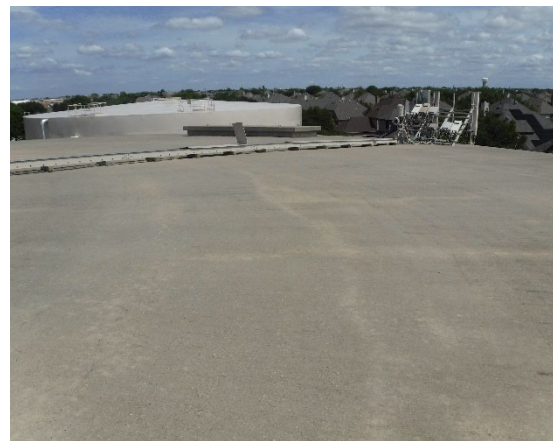
**Photo No. 11 Minor Spalling on Roof Slab (Exterior)**

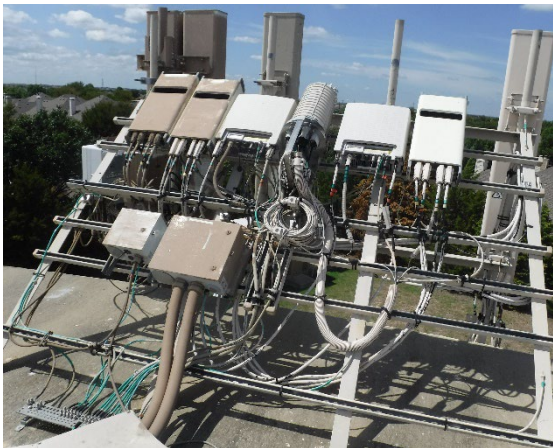
**Photo No. 12 ATT antenna at Roof**

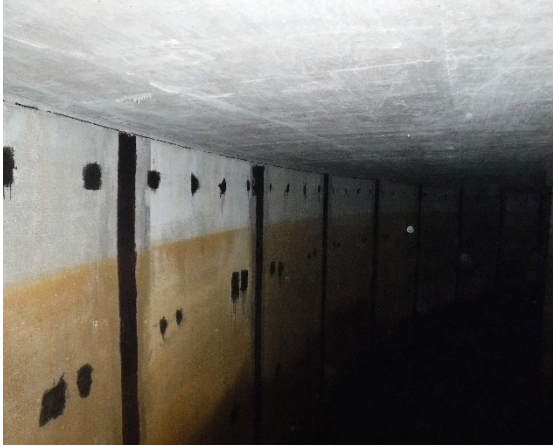
**Photo No. 14 Interior Roof in good condition**

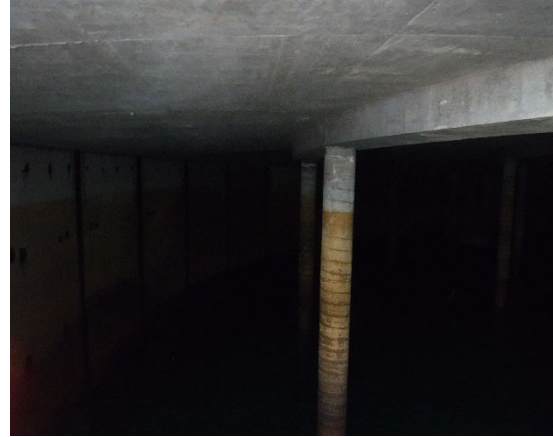
**Photo No. 15 Interior Roof beam in good condition**

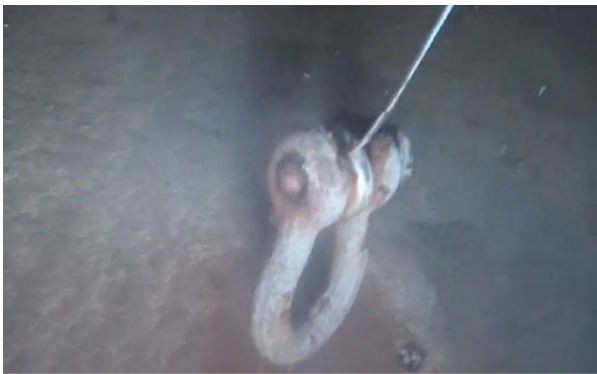
**Photo No. 16 Bottom of Float Cable**

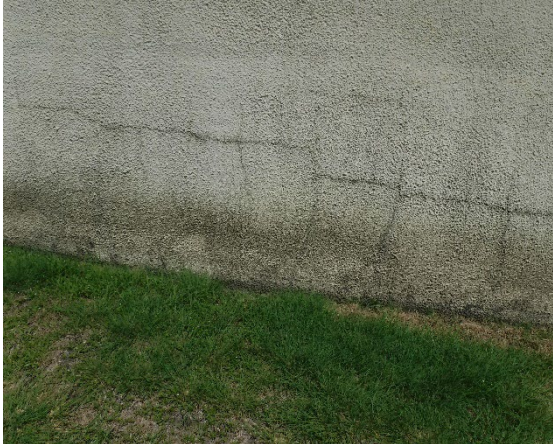
**Photo No. 18 Possible Cracks Forming**

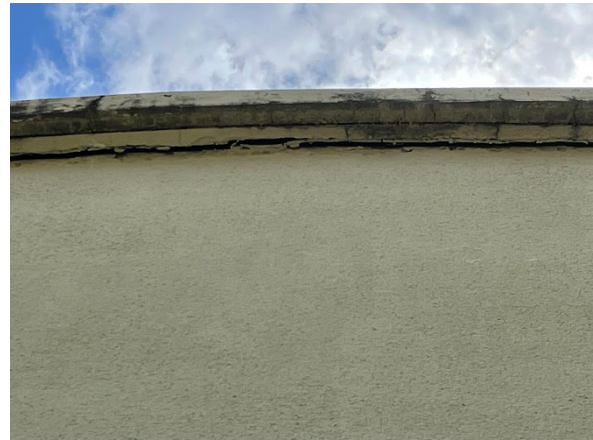
**Photo No. 19 Gap between roof slab and wall**

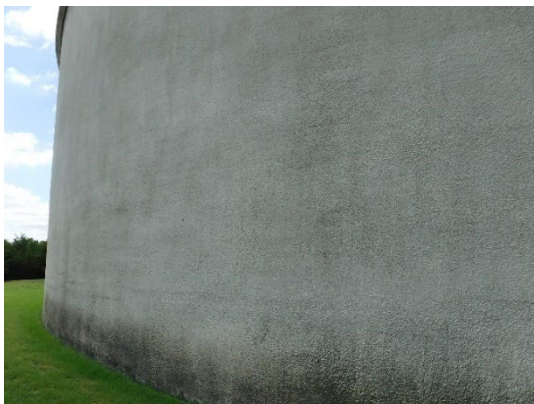
**Photo No. 20 Discoloration observed at bottom of the walls**

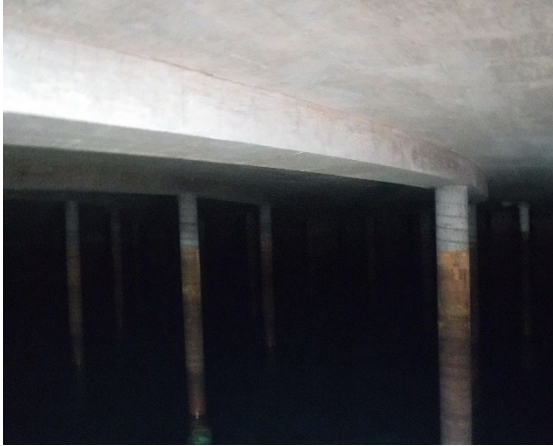
**Photo No. 21 Interior Roof, Beam & Column**

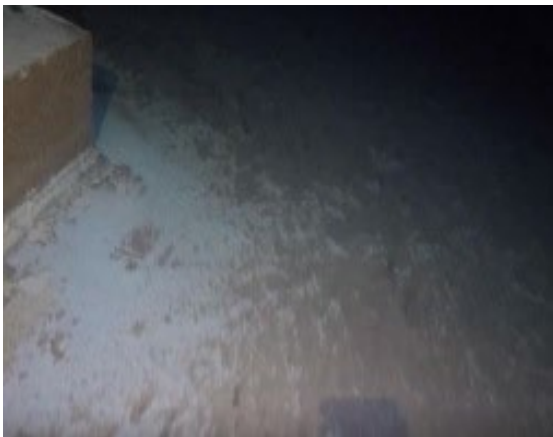
**Photo No. 23 Sediment deposit**

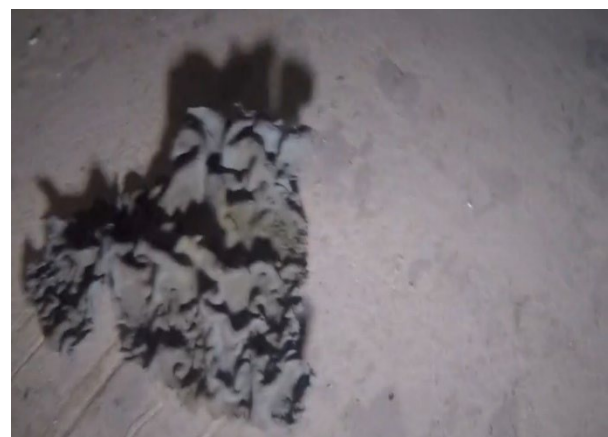
**Photo No. 24 Debris near inlet pipe**

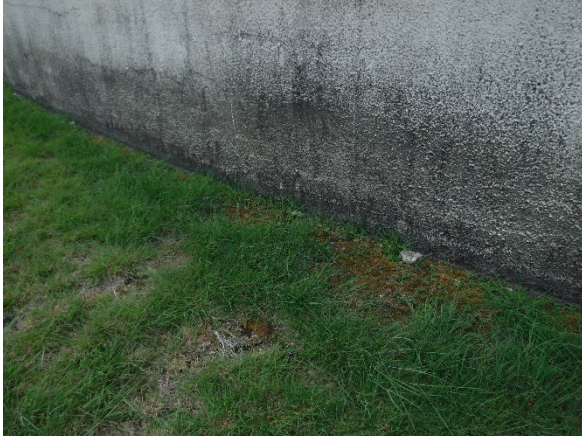
**Photo No. 25 Base of Tank Wall**

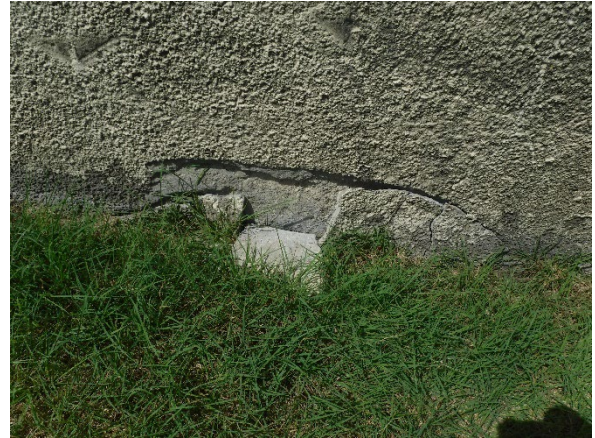
**Photo No. 26 Spalling of Concrete**

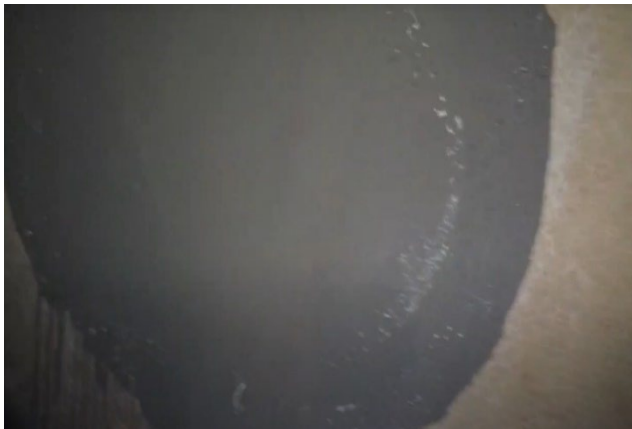
**Photo No. 27 Patched Manway - Inside**

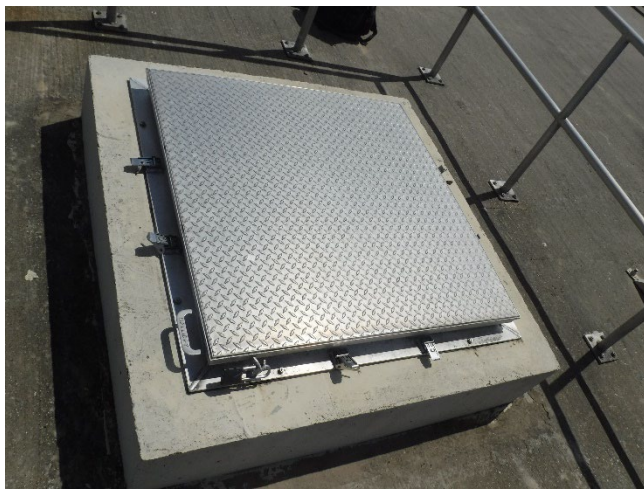
**Photo No. 29 North Roof Access Hatch – Closed**

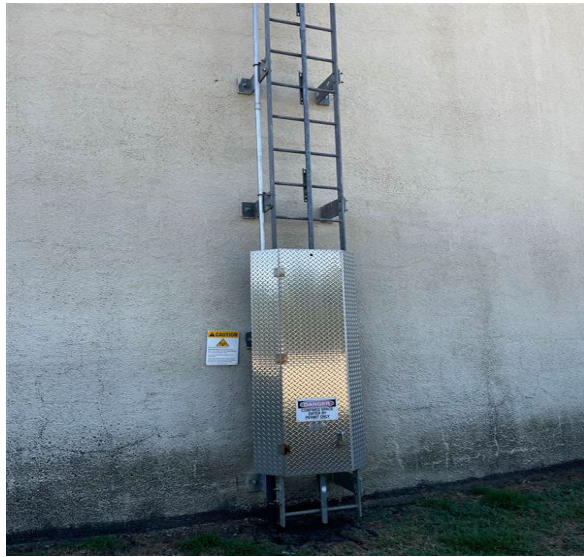
**Photo No. 35 Exterior to Roof Access**

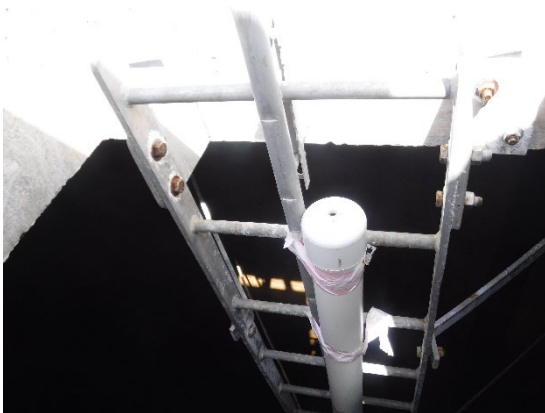
**Photo No. 39 Interior Ladder and Fall Protection System**

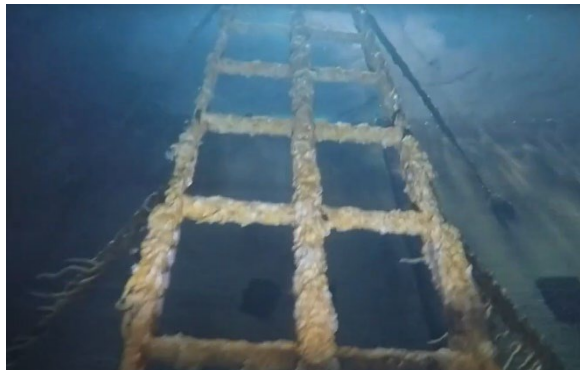
**Photo No. 40 Interior Ladder Corrosion**

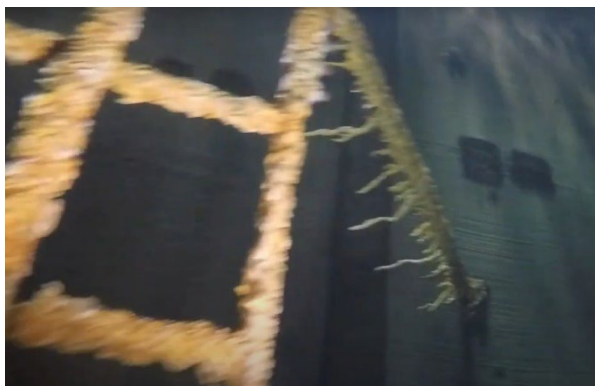
**Photo No. 41 Biological Growth below water line**

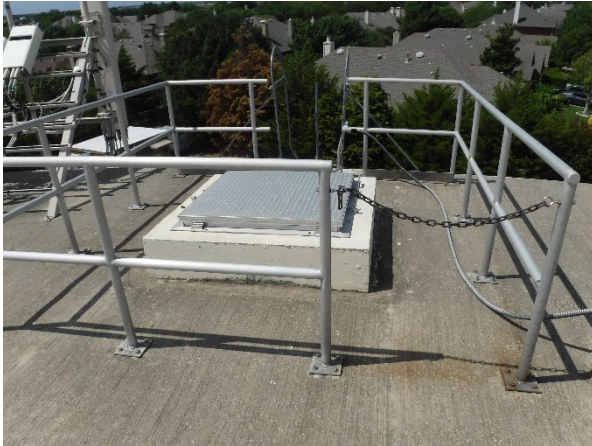
**Photo No. 43 West Access Hatch Roof Railing**

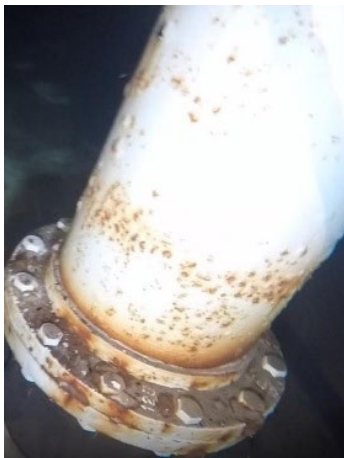
**Photo No. 45 Inlet Pipe Inside tank**

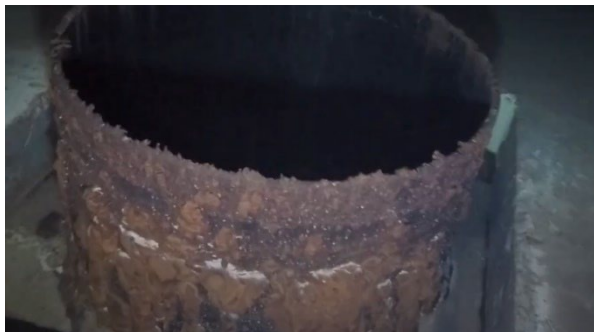
**Photo No. 47 Outlet Pipe Inside tank**

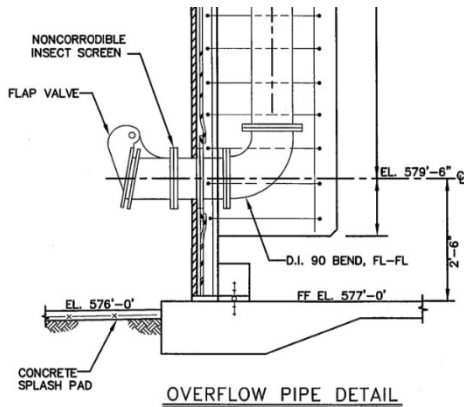
**Photo No. 49 Overflow Pipe Detail**

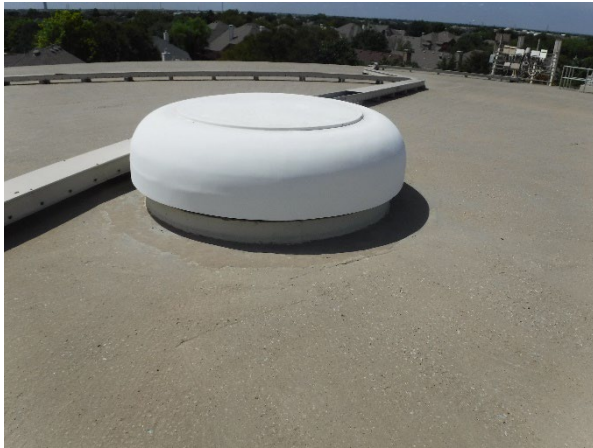
**Photo No. 53 Mushroom Roof Vent**

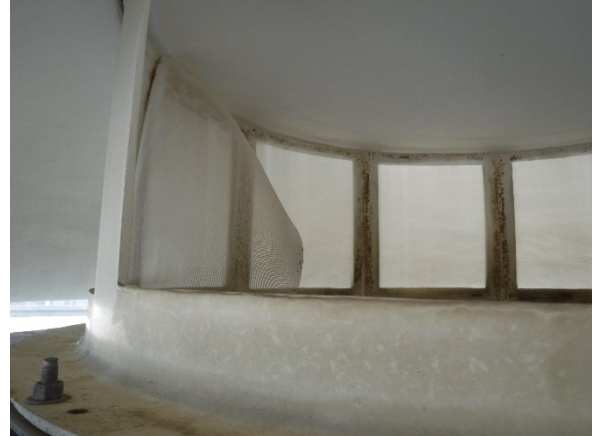
**Photo No. 54 Damaged Roof Vent Screen**

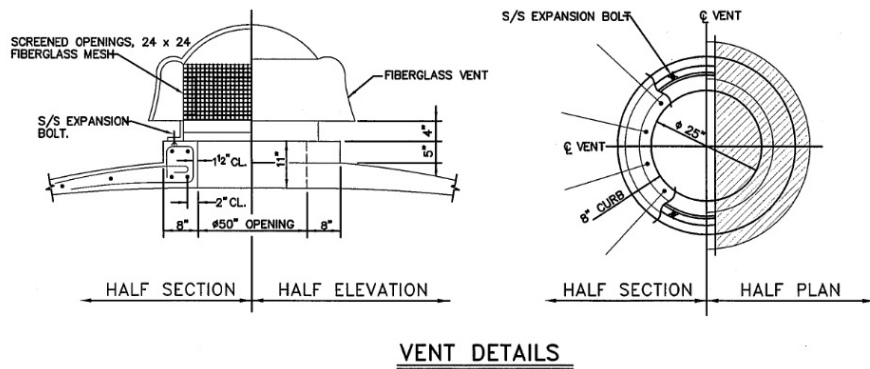
**Photo No. 55 Vent Details**

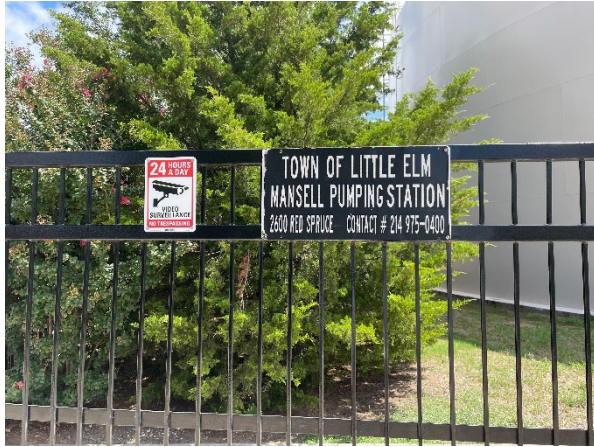
**Photo No. 56 Entrance Gate at North end**

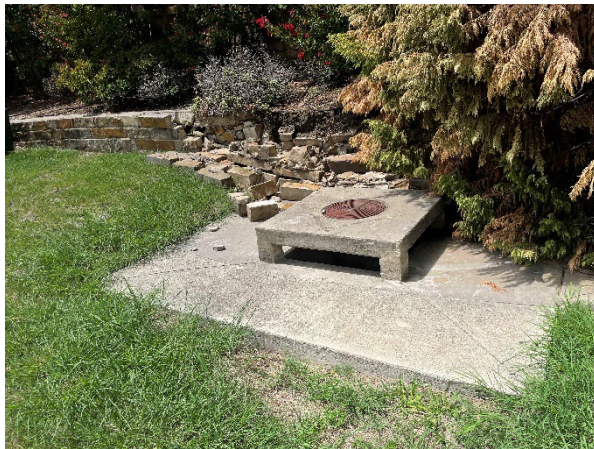
**Photo No. 58 Storm Drain inlet on West W/ damaged landscape**

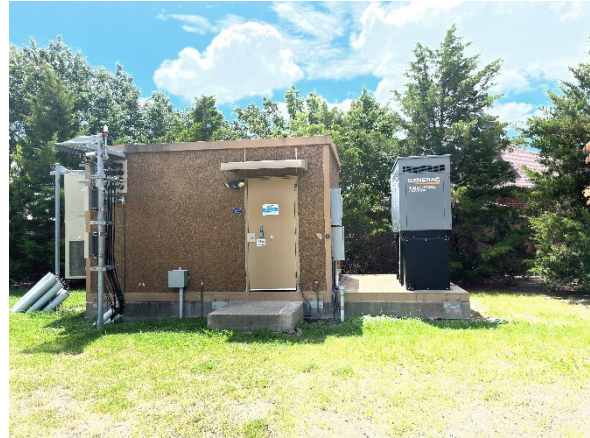
**Photo No. 59 ATT building for antenna on SW corner**

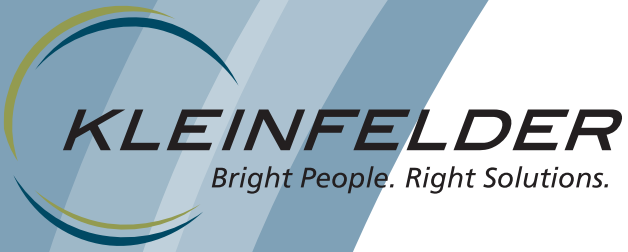
<b>Sub Total</b>	<b>\$ 135,000</b>
	Contingency (~30%)	\$ 40,500
	<b>Total OPCC (approximate)</b>	<b>\$ 175,500</b>

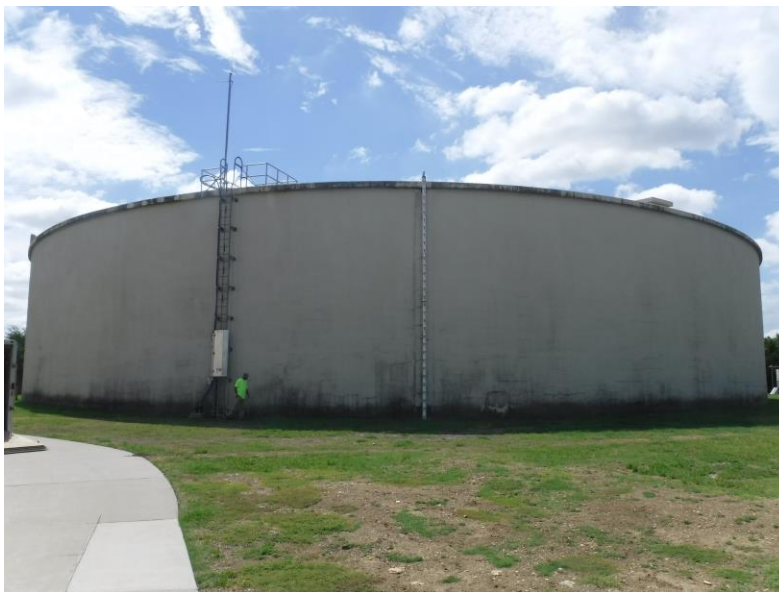
(A) Ground and elevated storage tank inspections must determine that the vents are in place and properly screened, the roof hatches closed and locked, flap valves and gasketing provide adequate protection against insects, rodents, and other vermin, the interior and exterior coating systems are continuing to provide adequate protection to all metal surfaces, and the tank remains in a watertight condition.

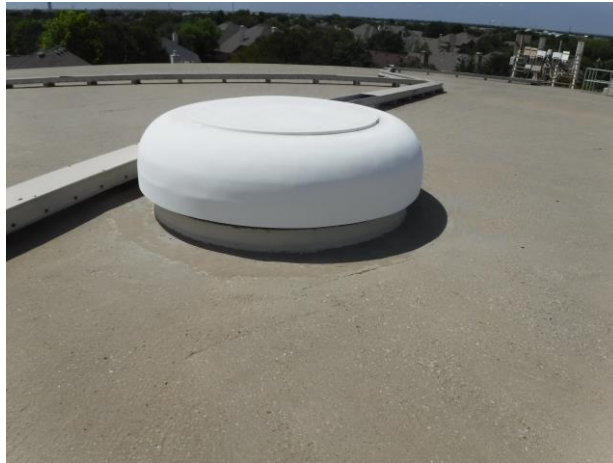
**STATE RULE:** TCEQ Title 30. CHAPTER 290.43 (c) (1) Roof vents shall be gooseneck or roof ventilator and be designed by the engineer based on the maximum outflow from the tank. Vents shall be installed in strict accordance with current AWWA standards and shall be equipped with approved screens to prevent entry of animals, birds, insects and heavy air contaminants. Screens shall be fabricated of corrosion-resistant material and shall be 16-mesh or finer. Screens shall be securely clamped in place with stainless or galvanized bands or wires and shall be designed to withstand winds of not less than tank design criteria (unless specified otherwise by the engineer).

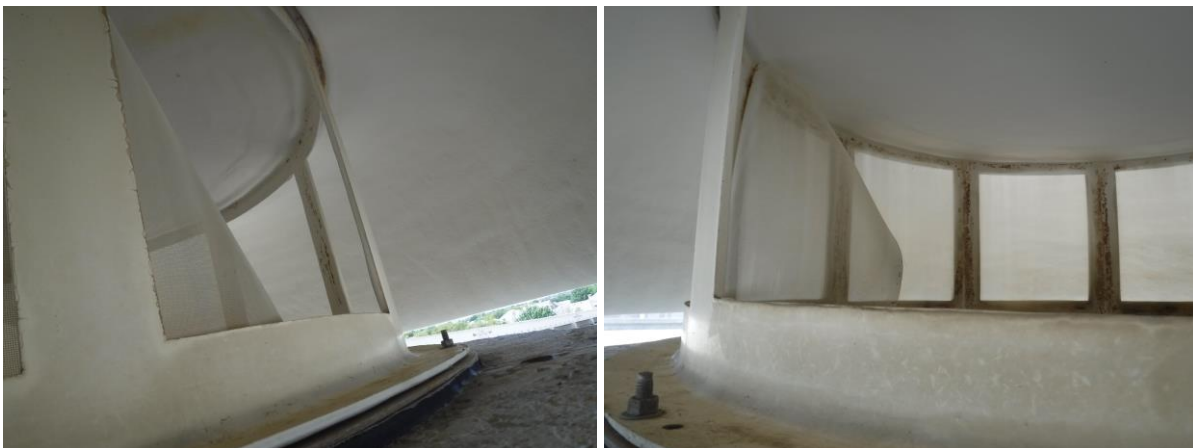
Top vent screen needs to be replaced

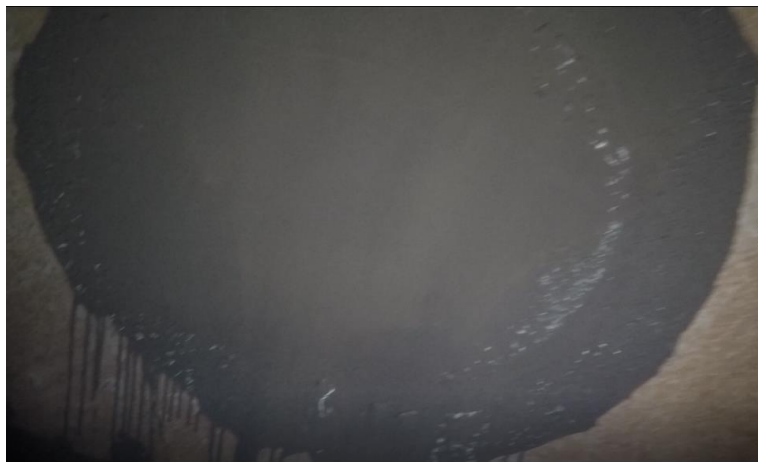
Inside of manway that was filled in

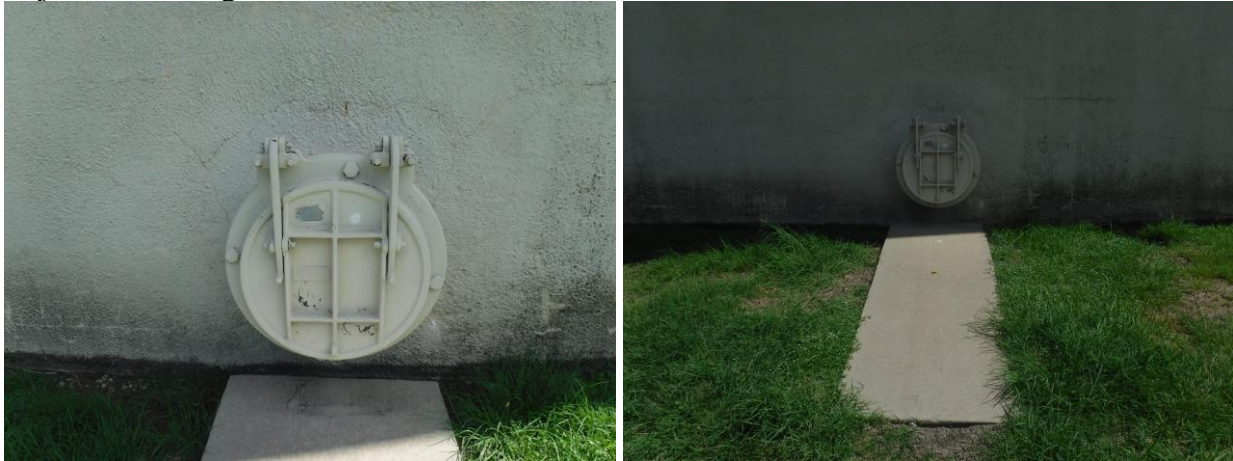
Overflow flapper and splashpad

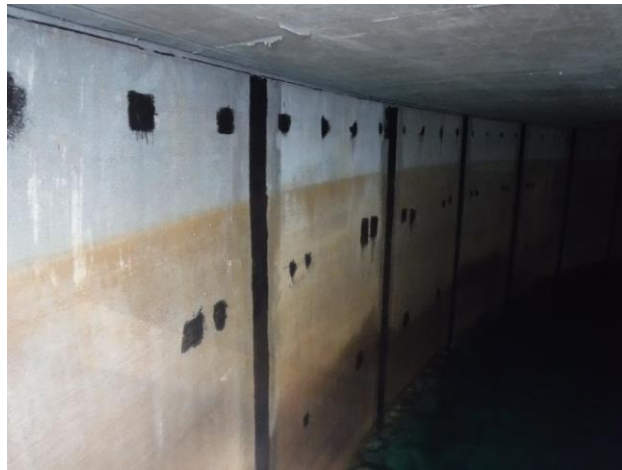
Interior was found in **good** condition.

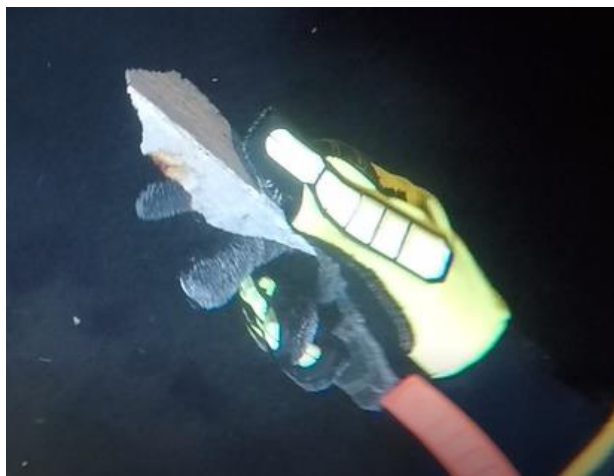
One piece of concrete found on the floor from an edge somewhere in the tank

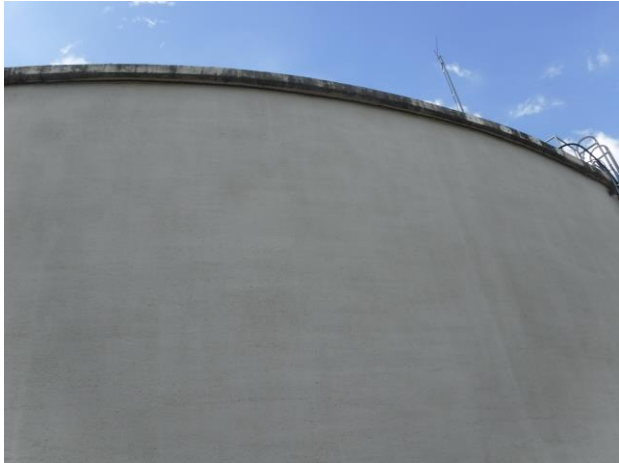
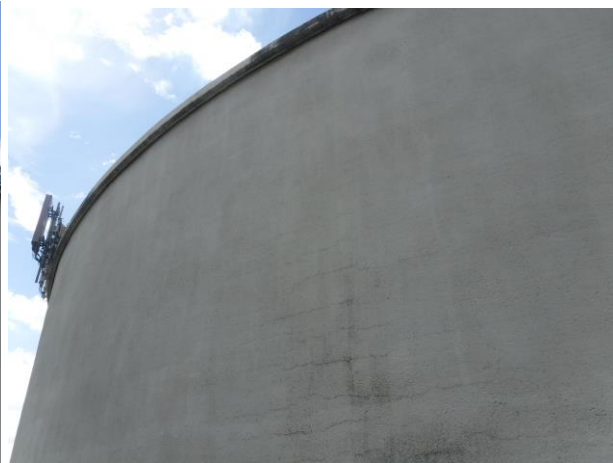
**STATE RULE:** TCEQ Title 30. CHAPTER 290.43 (c) (8) All clearwells, ground storage tanks, standpipes, and elevated tanks shall be painted, disinfected, and maintained in strict accordance with current AWWA standards. However, no temporary coatings, wax grease coatings, or coating materials containing lead will be allowed. No other coatings will be allowed which are not approved for use (as a contact surface with potable water) by the EPA, National Sanitation Foundation (NSF), or United States Food and Drug Administration (FDA). All newly installed coatings must conform to American National Standards Institute/National Sanitation Foundation (ANSI/NSF) Standard 61 and must be certified by an organization accredited by ANSI.

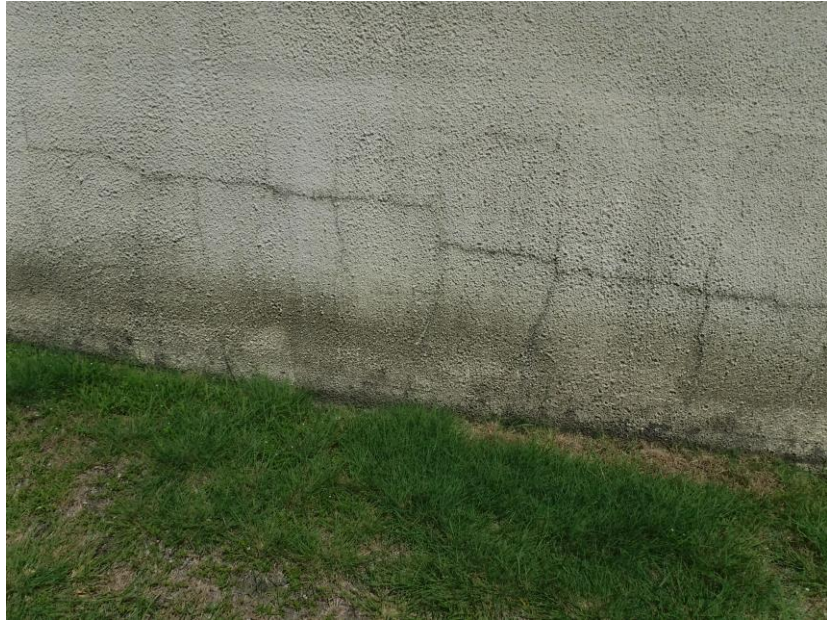
Side of tank with cracking in the texture

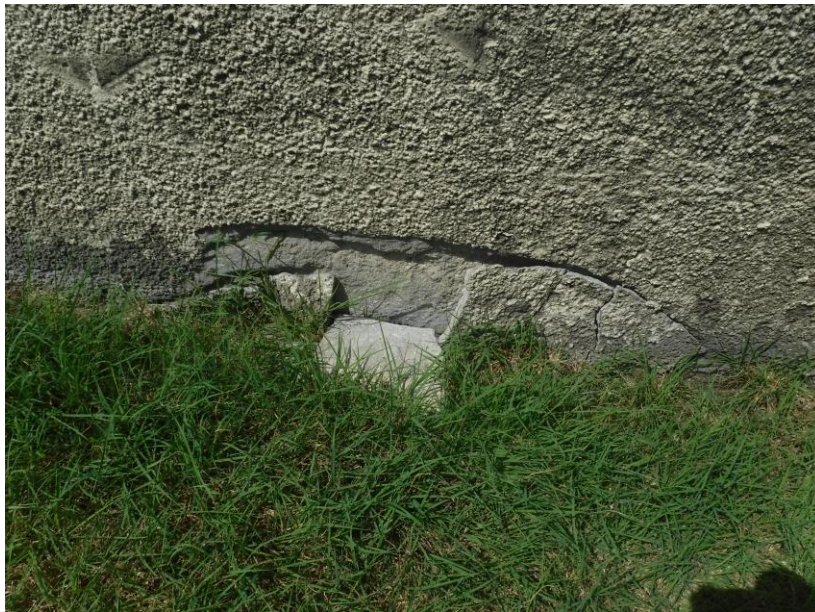
Side of tank with some chipped texture

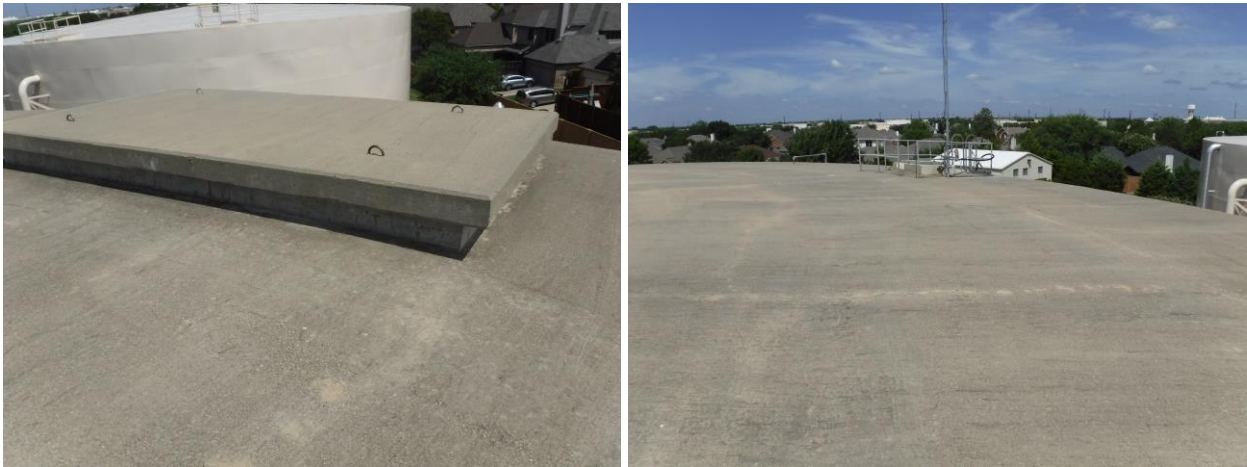
Roof of tank and concrete hatch

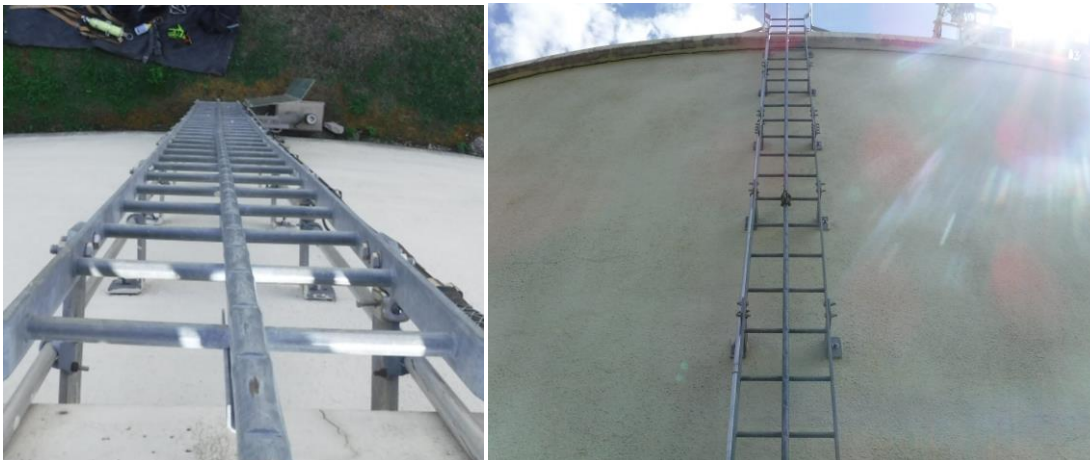
The outside ladder was found in **good** condition.

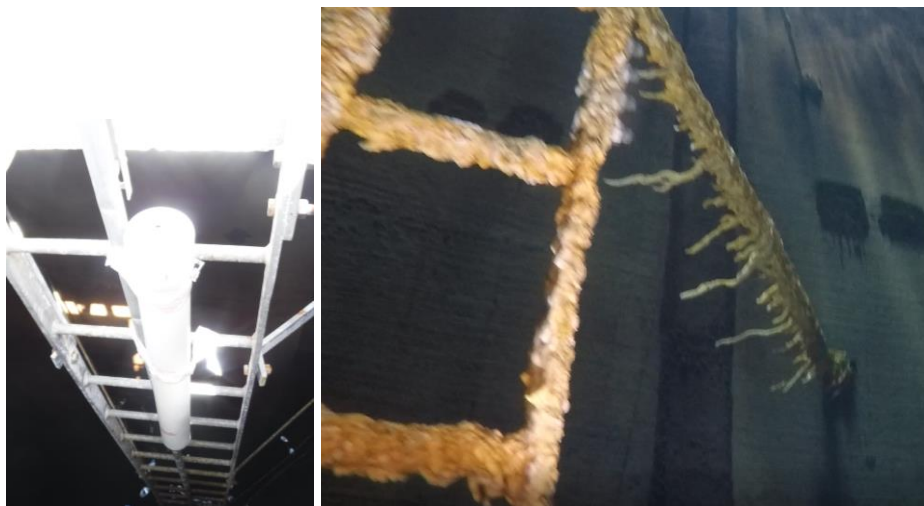
Inside Ladder growth on lower ladder

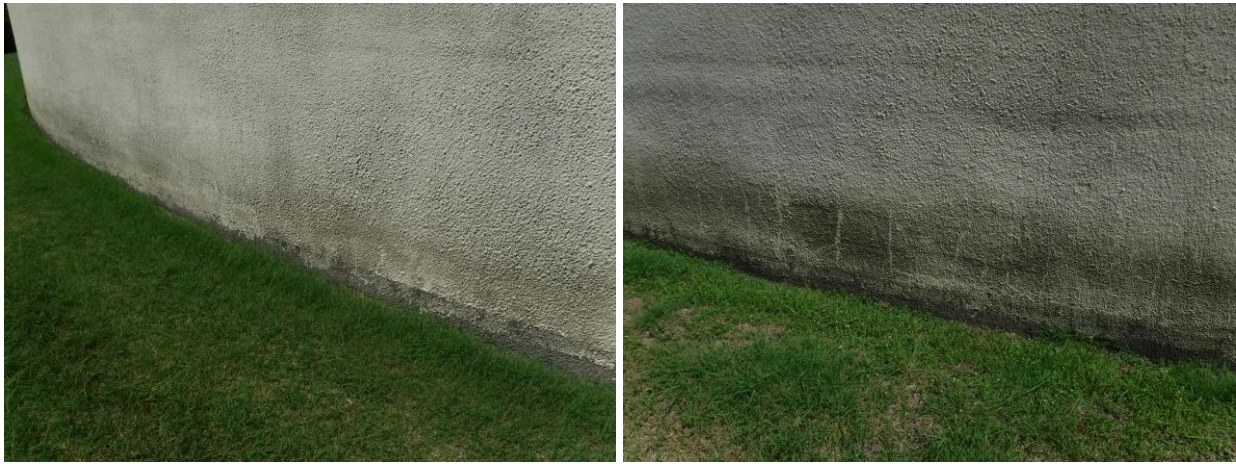
Foundation was found in **good** condition
