February 10, 2025  
Woodshire Drive  
City Project No. 11120

**To:** Mayor, City Council and City Manager  
**From:** Alec Pietz, P.E. – Interim City Engineer  
**Subject:** Woodshire Drive Condition

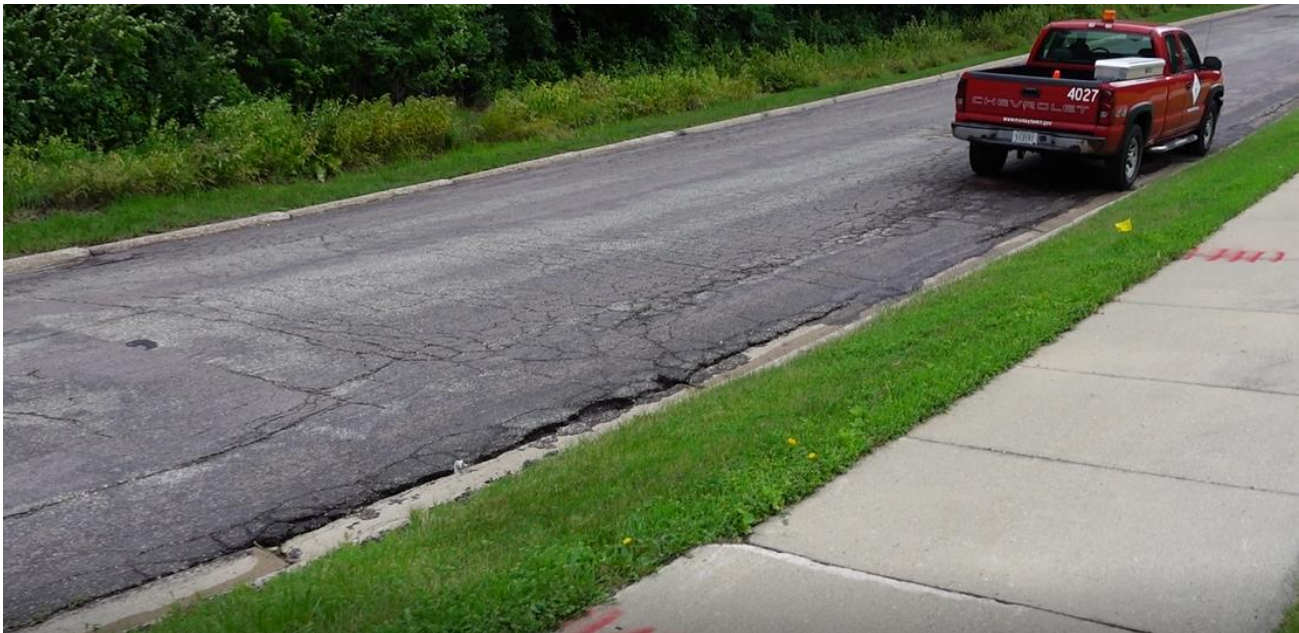
**Image 1 – Bottom of Woodshire Drive near Madison Avenue**

Deficiencies – severe alligator cracking, evidence of pavement patch, deteriorating curb
