February 10, 2025  
**Updated February 18, 2025**  
Woodshire Drive  
City Project No. 11120

**To:** Mayor, City Council and City Manager  
**From:** Alec Pietz, P.E. – Interim City Engineer  
**Subject:** Woodshire Drive Condition

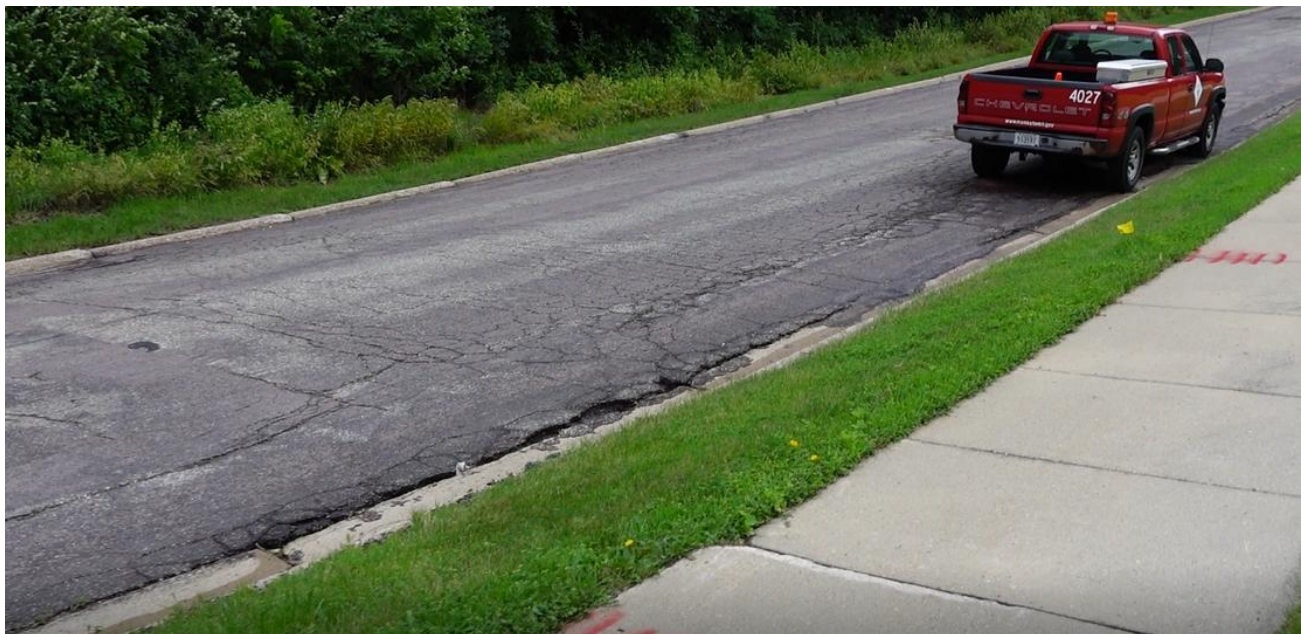
**Image 1 – Bottom of Woodshire Drive near Madison Avenue**

Deficiencies – severe alligator cracking, evidence of pavement patch, deteriorating curb

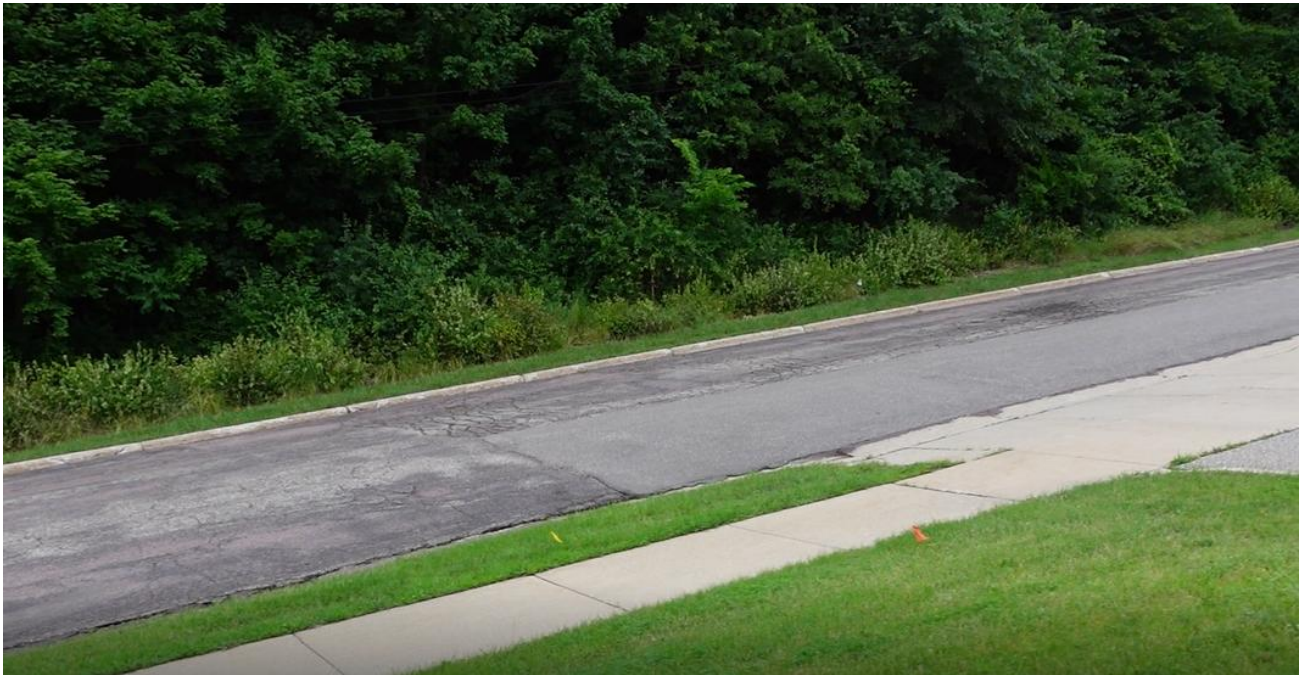
**Image 2 – Midway Uphill of Woodshire Drive**

Similar deficiencies to Image 1. A somewhat recent large patch of pavement replacement is seen, providing context of what newer and good pavement condition represents.

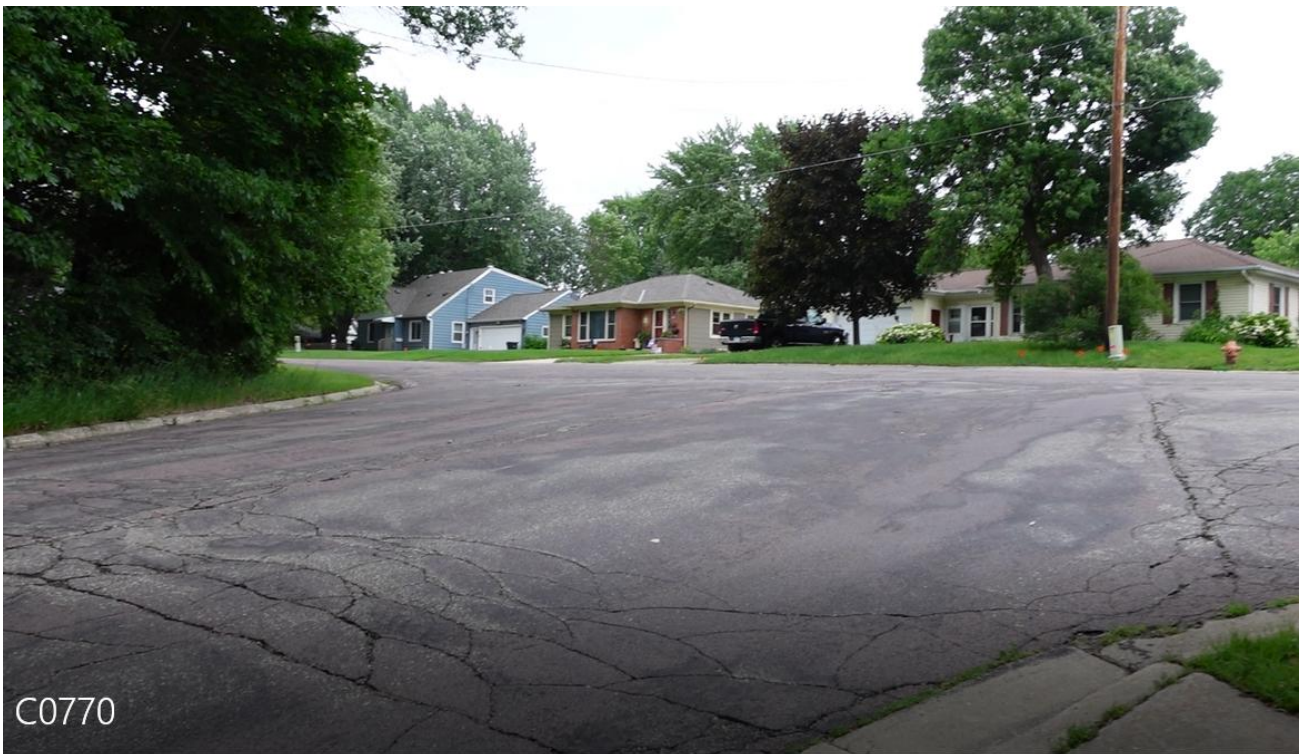
**Image 3 – Hillside Top Intersection**

Continued signs of deteriorating pavement.

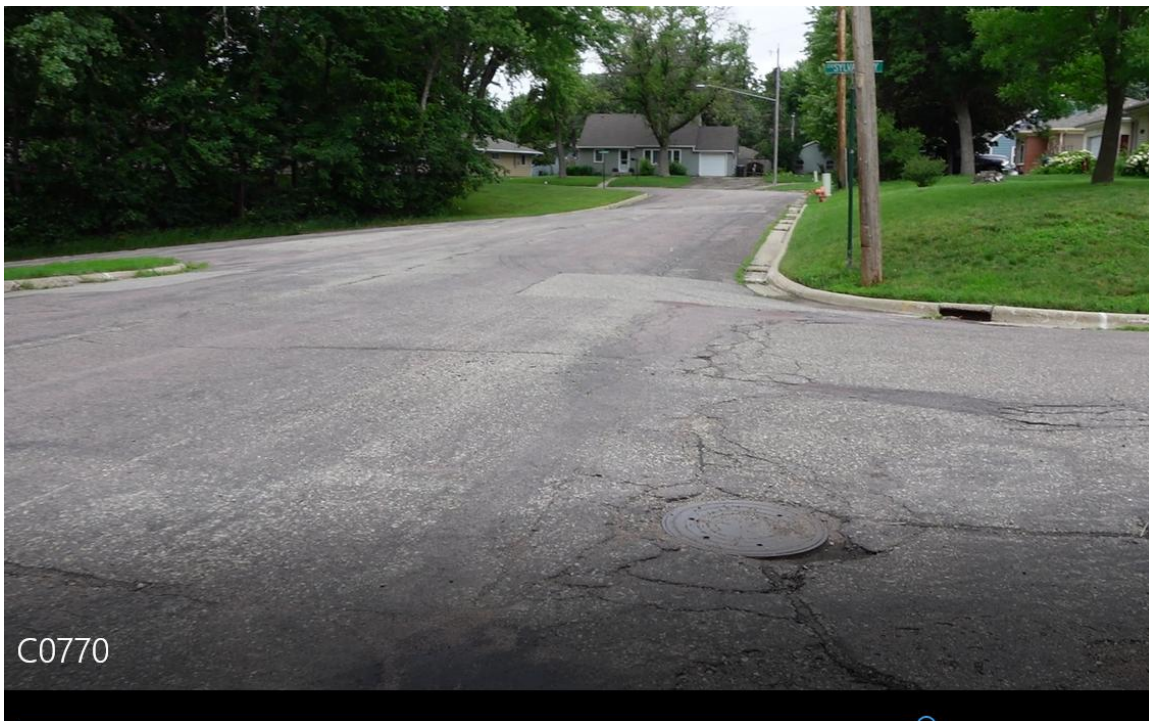
**Image 4 – Top of Hill Facing Northbound to Intersection**

Similar if not better conditions are observed in this segment of Woodshire Drive compared to that of the Hillside.

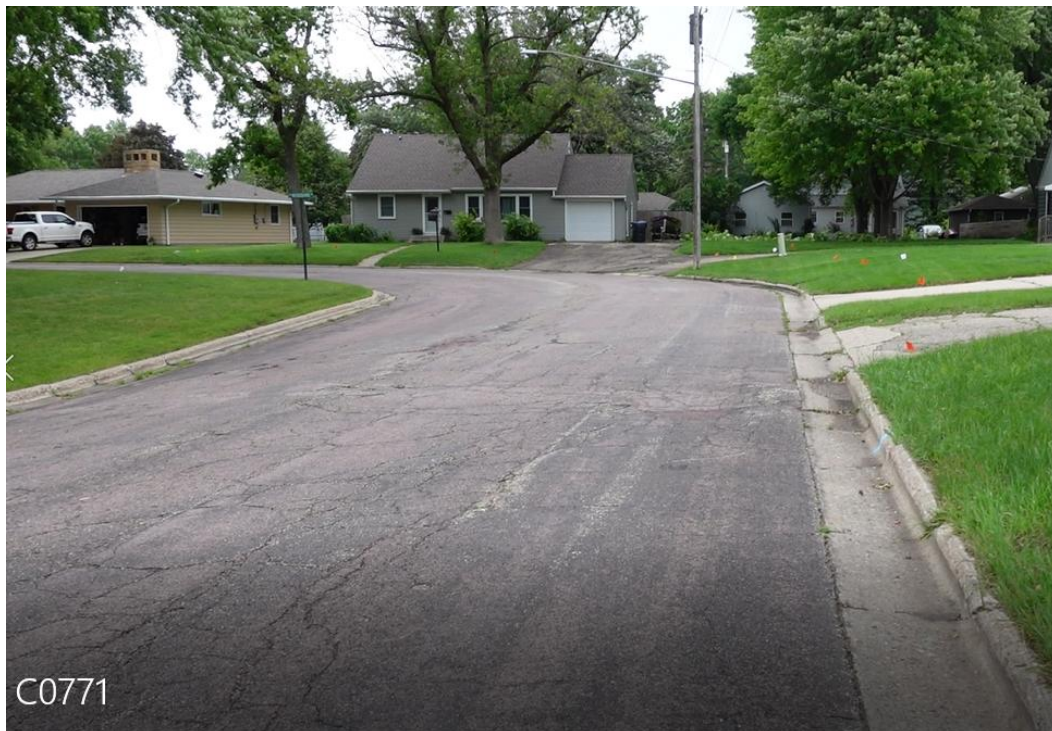
**Image 5 – Northbound Facing Prior to the Roadway Curve**

Similar conditions to the hillside segment. However, less alligator cracking is observed.

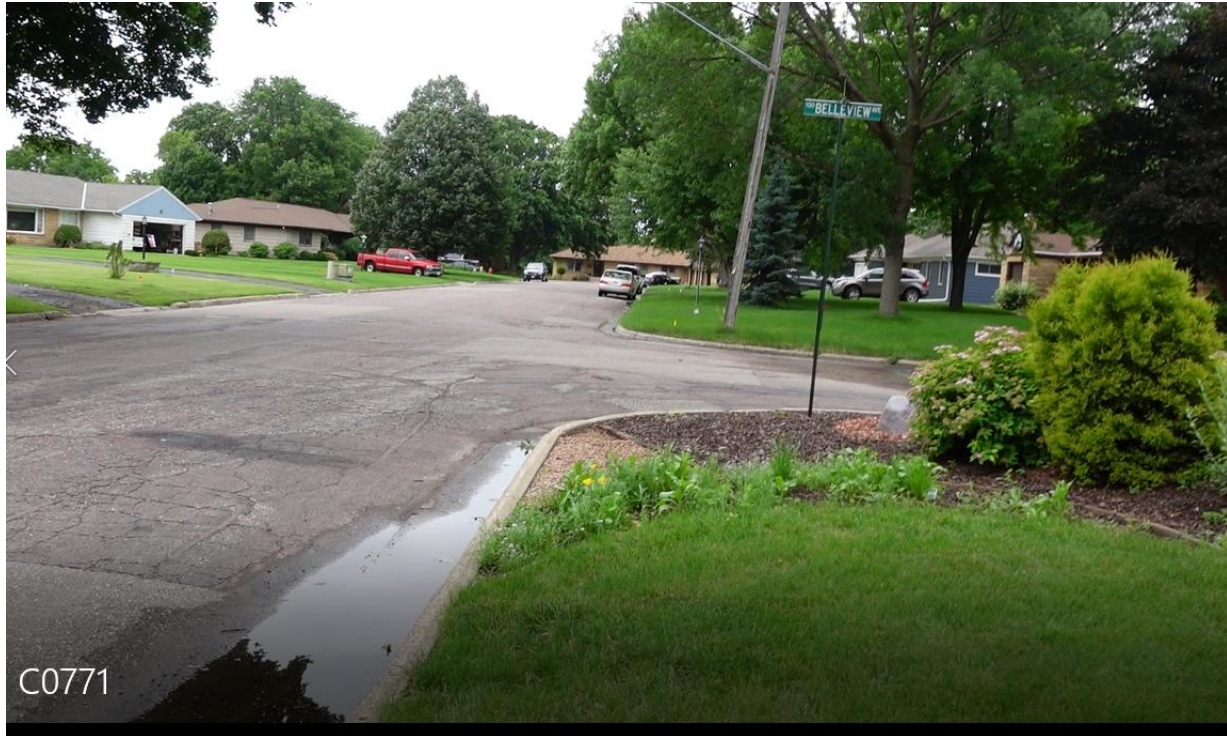
**Image 6 – Intersection of Woodshire and Belleview Facing Northbound**

Highly similar pavement conditions to the hillside, indicating similar need for reconstruction.

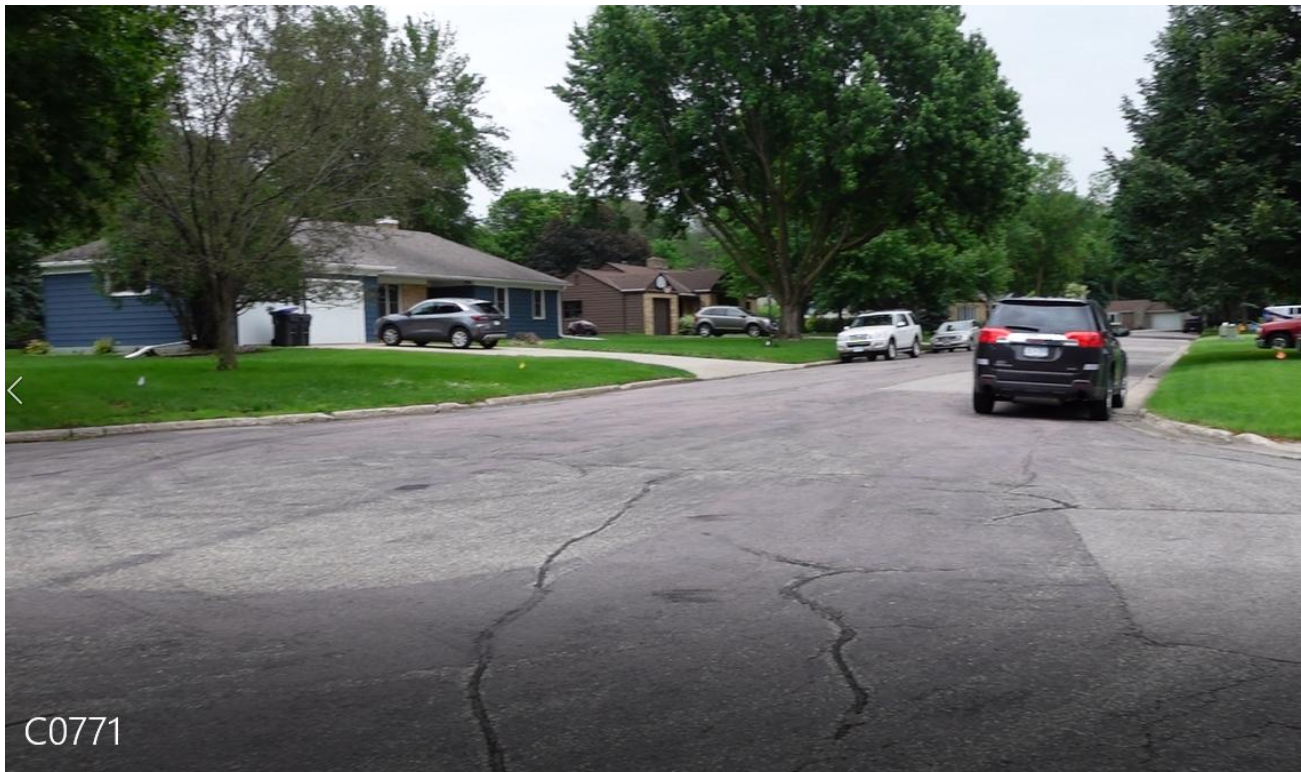
**Image 7 – Woodshire Cul-de-sac Facing Southbound**

Cracking and pavement patches are present but in better condition than the hillside.
