**NOTICE OF MEETING
TOURISM ADVISORY BOARD
August 17, 2021
11:00 AM
Council Chambers
504 N. Queen Street
Palestine, TX**

MT. VERNON AME
913 E. Calhoun Street
Palestine, Texas

Preservation Master Plan – Phase 1
February 10, 2021

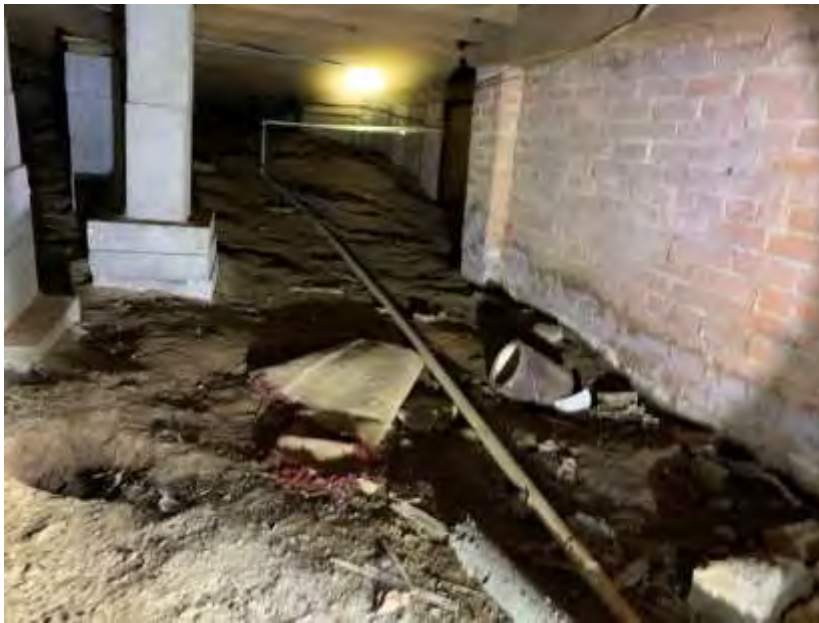
The site slopes upward from south to north. When observed from the crawl space, evidence of water infiltration was present along the south wall as well as high moisture content in soils along the southern areas of the east and west grade beams. It is probable site and/or roof runoff has been either ponding or running along the east and west perimeter walls and at some location(s) water is making its way into the crawl space. See Roof section of this report. In addition to a subsurface drain system, fine grading along the east and west exterior walls should be conducted to provide a slope of at least ¼ inch per foot away from the building. Swales extending north-south should be constructed to move surface runoff towards the south (Calhoun Street).

Crawl space. Presence of moisture along the east grade beam.

1. Eliminate water running along the exterior side of west and east walls by sloping grade away from the walls. Phase I.
2. All piers located in the crawl space should be examined individually to ensure shims are in contact with pier top and sill above. Phase I.
3. Install a wire mesh door to access crawl space to secure the opening and to allow ventilation. Phase II.
4. Remove all wood lumber and debris to reduce possibility of termite infestation. Phase I.
5. Apply termiticide to wood framing in the crawl space. Phase I.

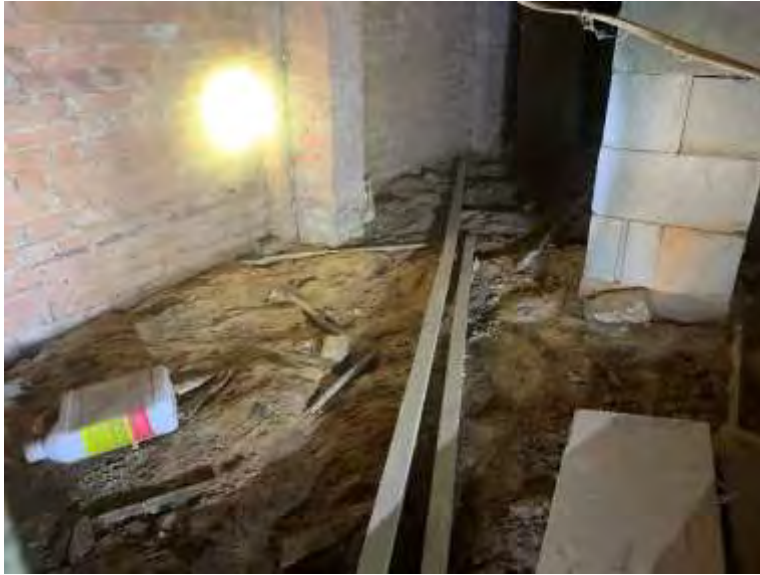
Crawl space. Evidence water had run along the south grade beam due to a previous heavy rain event.

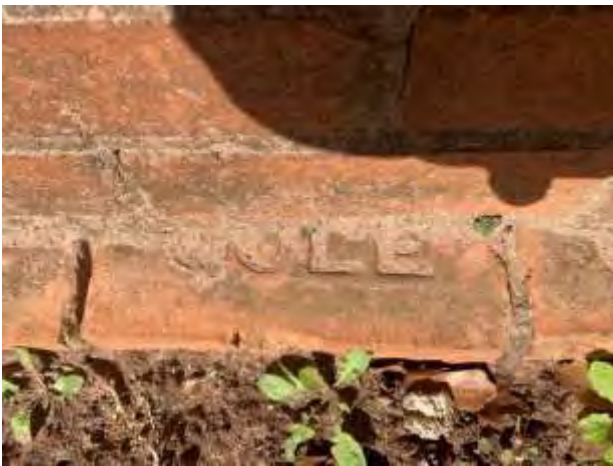
The foundation consists of original brick piers and a supplement of added modern concrete block piers. The perimeter grade beams are constructed of corbeled brick to an unknown depth.

Exterior, west grade beam. The bottom of the grade beam appears to contain a corbeled brick footing in lieu of concrete as noted in the structural report.

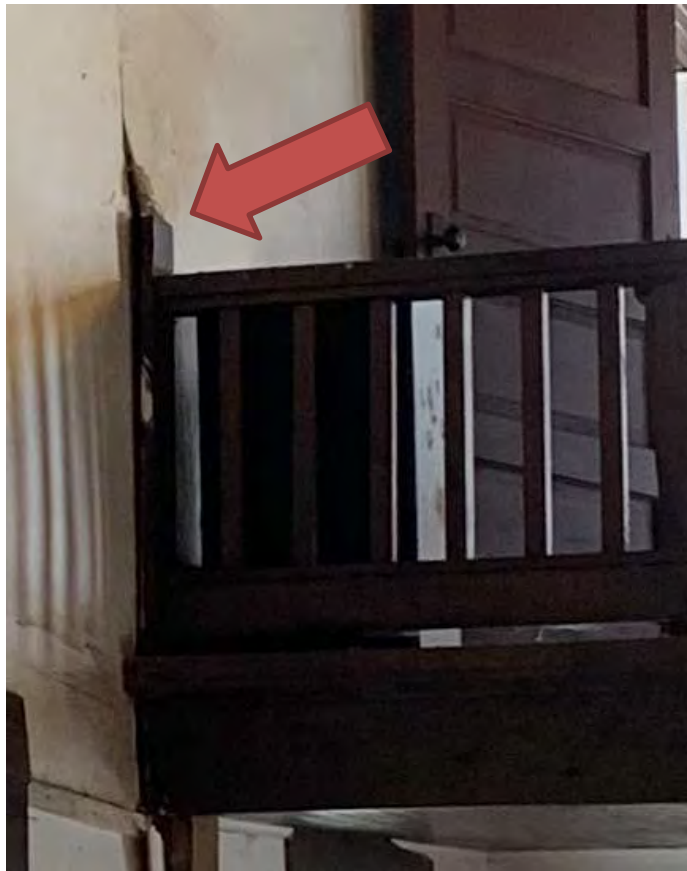
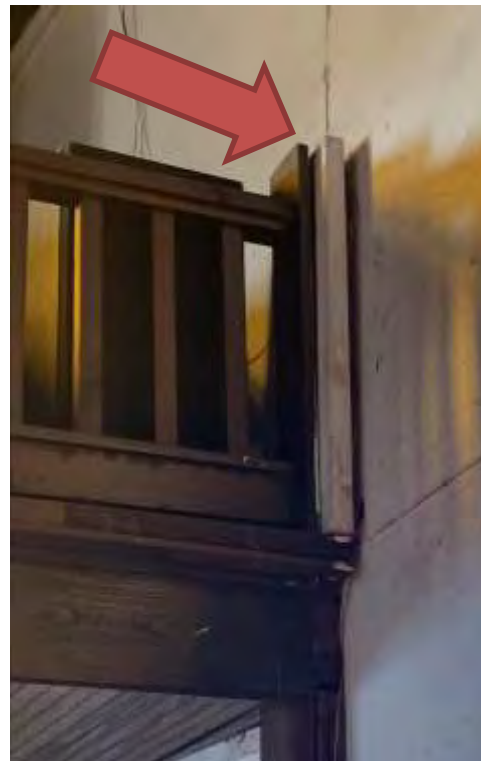
Exterior walls are of the initial brick veneer construction; ca 1921 was the era of transition from the bonded wall systems to the common brick veneer systems where a single wythe of brick are installed and secured laterally to wood framing. Exterior masonry is included in this section because it is an integral part of the exterior wall system. Note that this early veneer system did not incorporate a moisture barrier between the wood sheathing and back of brick.

Balcony railing. Possible evidence of outward wall movement.

1. Remove brick from the west and east Sanctuary gables. Phase II.
2. Reinforce walls and add additional framing for cable bracing. Phase II.
3. Install cable bracing in exterior west and east walls to restrain further outward movement. Phase II.
4. Reinstall brick masonry. Phase II.
5. Secure connections and install additional reinforcement in attic. Phase II.
6. Repair and restore interior finishes in Sanctuary. Phase III.
7. Replace deteriorated roof decking and replace the roof system. Phase II.
8. Repoint all exterior masonry on remainder of building. This work can take place under any phase after cable bracing has been installed. Phase III.

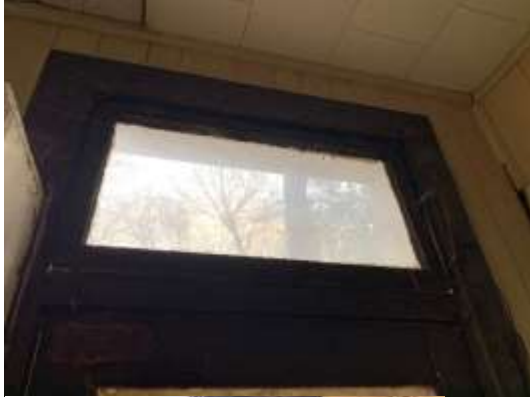
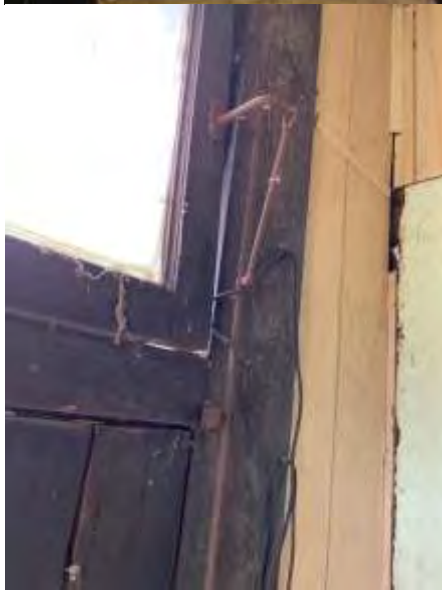
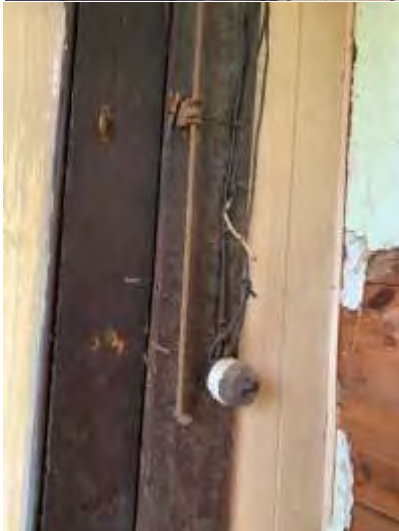
Exterior door near southeast building corner. Transom window with original hardware.

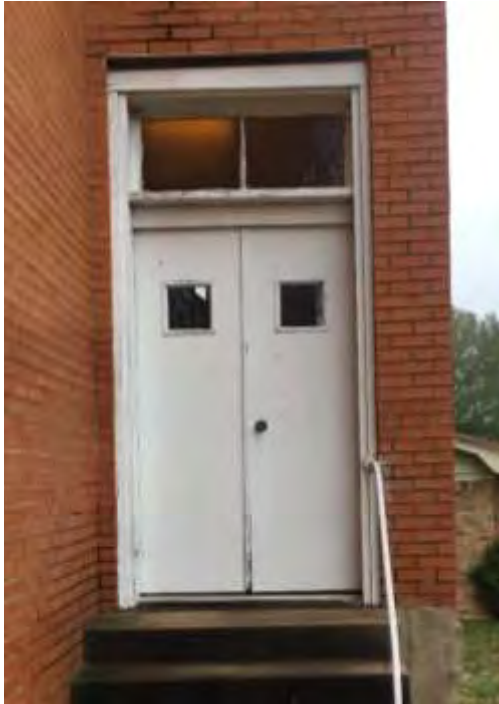
Modern exterior doors consist of laminated doors with metal surface panels. They are currently exhibiting signs of corrosion and will have a limited life. The oldest doors (ca. 1950's) are located as door pairs for the two towers facing Calhoun Street. The exterior door into the Multipurpose room near the northwest corner is ca. 1970 to present era. These two door pair and the single door should be replaced during Phase V.

Southeast tower ca. 1950's door pair. Wood transom and frame are original.

1. Repair doors so they will function properly. Conduct minor repairs on hardware. Phase IV.
2. Restore original Multipurpose room door and hardware. Phase V.
3. Replace all hollow metal doors with replica wood doors. Phase V.

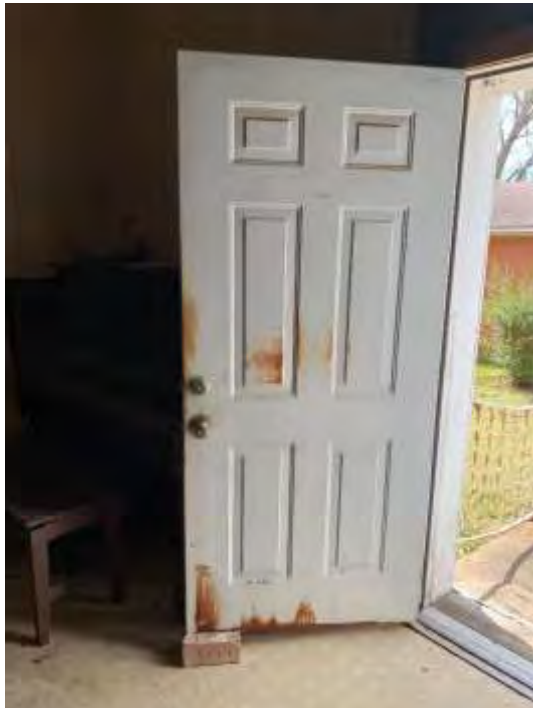
Modern residential hollow metal door. Wood frame members appear to have been selectively replaced.

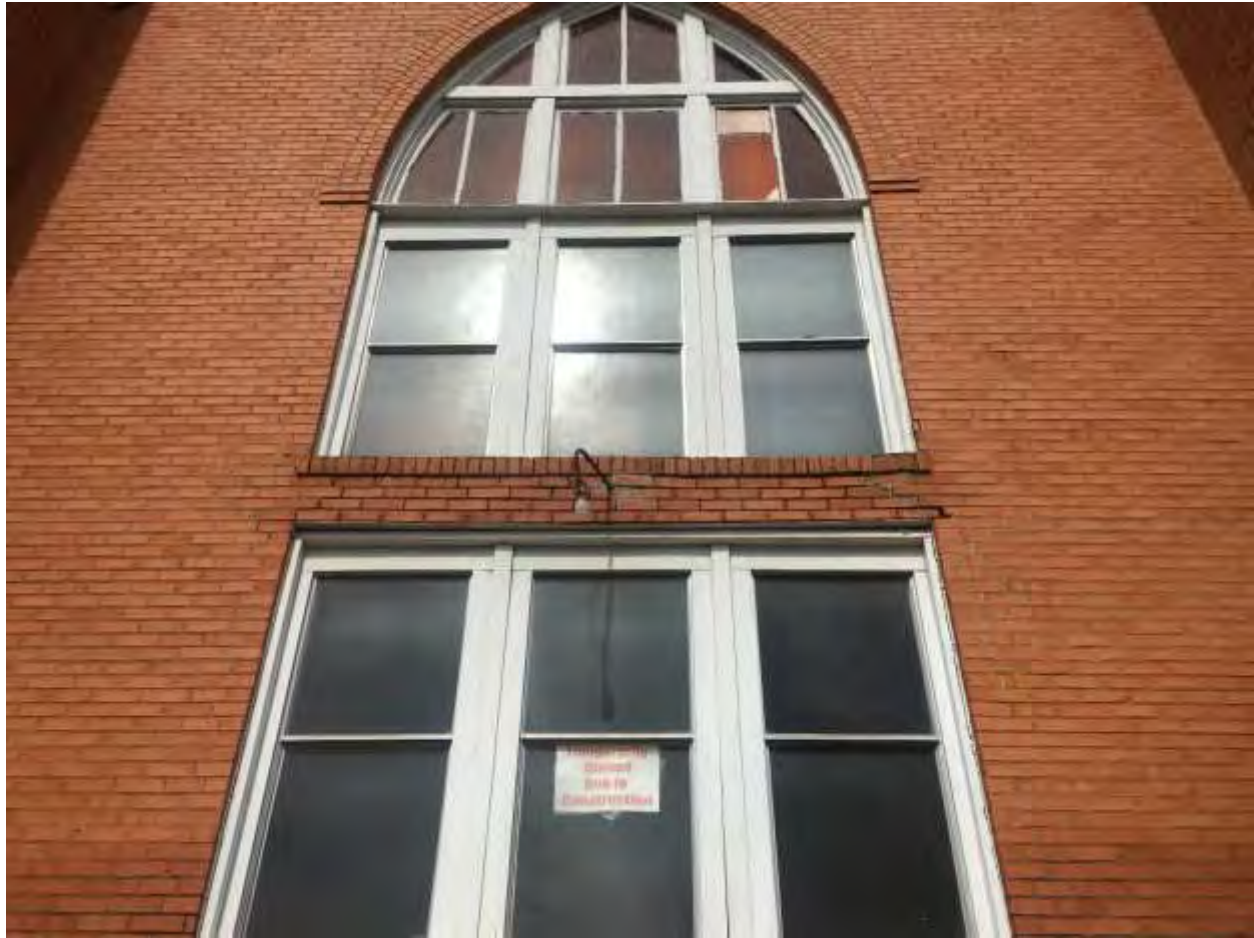
Original wood windows are in poor but restorable condition, most retain the original glazing. The glazing puddy is in need of replacement on almost all. Due to cost and other needed repairs of higher priority, restoration of the original wood windows has been placed under Phase IV. It would be beneficial if the original wood windows could be simply painted with a white primer to cover exposed bare wood in an effort to temporarily preserve the frames and sashes.

Upper gothic window is original wood framed. Six lower are aluminum. Typical for 3 locations of Sanctuary.

1. Remove all aluminum framed windows and install new replica windows. Phase V.
2. Restore all original wood windows. Phase IV.

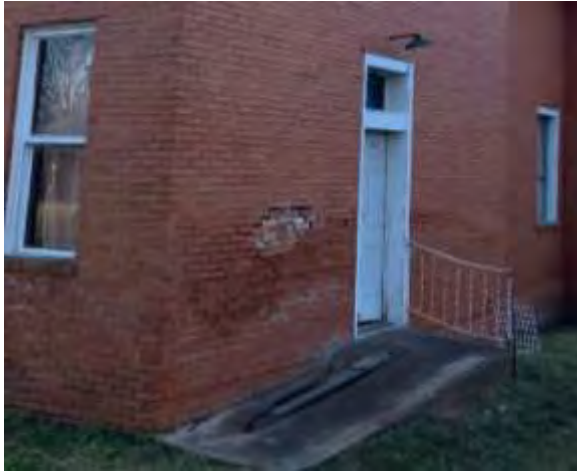
The northwest entry has had a ramp constructed to replace an earlier stair. The ramp does not comply with the Texas Accessibility Standards (TAS) or the Americans with Disabilities Act (ADA). Since this is a secondary entry/ exit located on a secondary façade, the existing ramp should be replaced with a compliant ramp and handrails. The opening facilitates a 36 inch wide door.

1. Remove the existing concrete ramp and replace with an accessible ramp with handrails. Phase IV.

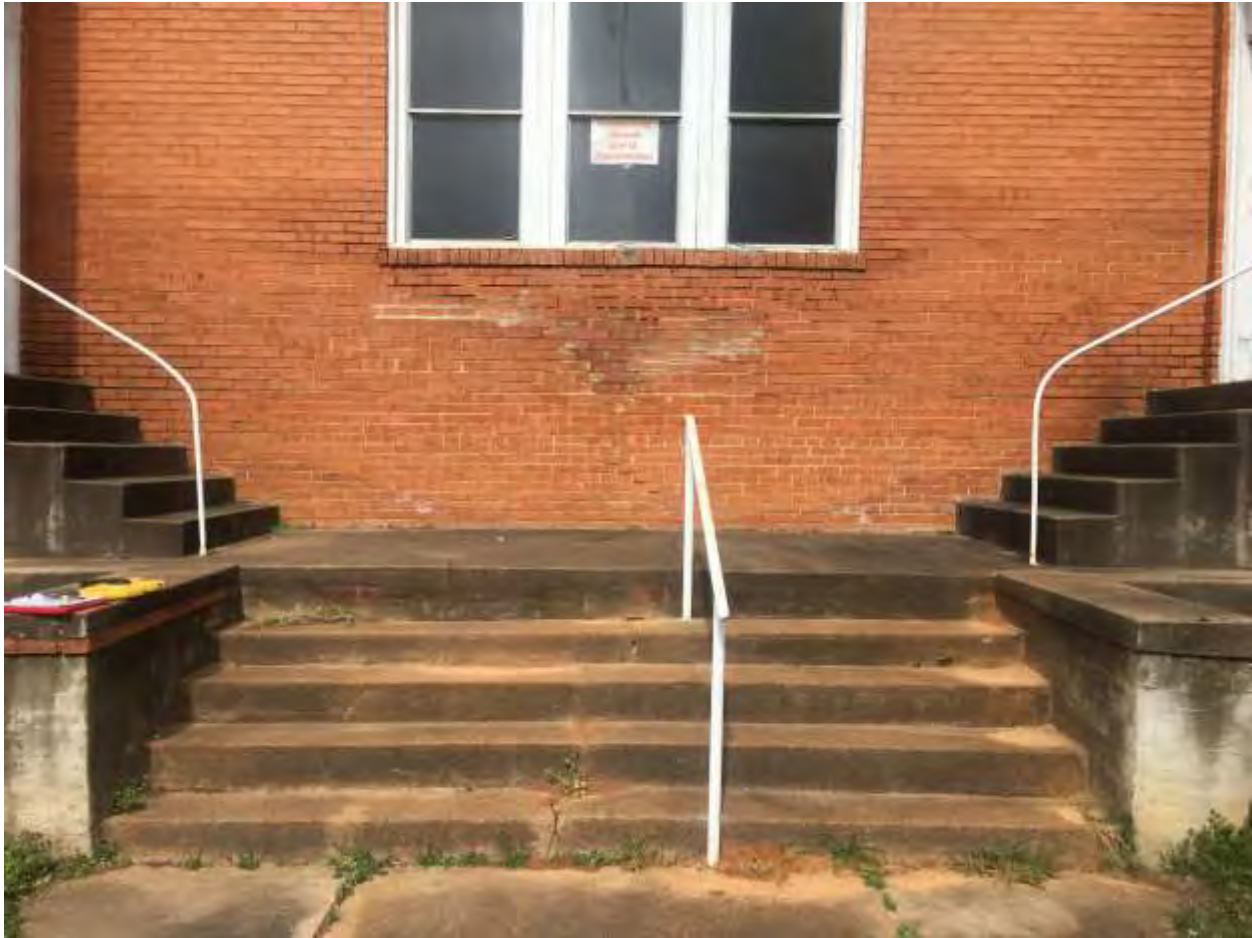
South stair.

There is a significant grade difference between the street and the stair system. It is doubtful that persons with difficulty walking will utilize this entry/ exit, they will park at the rear of the Church and use ramps recommended in other sections of this report.

1. Add pipe handrails. Phase IV.

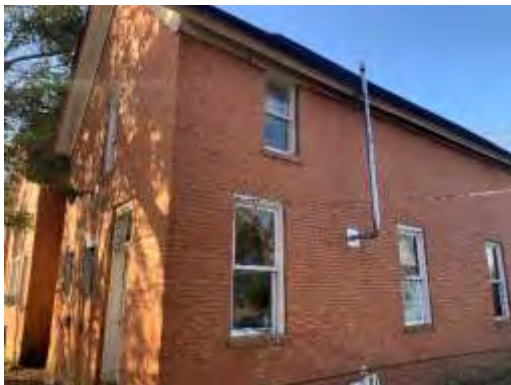
Northeast building corner.

A stair once existed at this door location; it is suspected it was of wood construction. This door location should serve as an egress door, it is on a secondary façade, and should contain an accessible ramp similar to the replacement ramp described for the Northwest door. Phase IV.

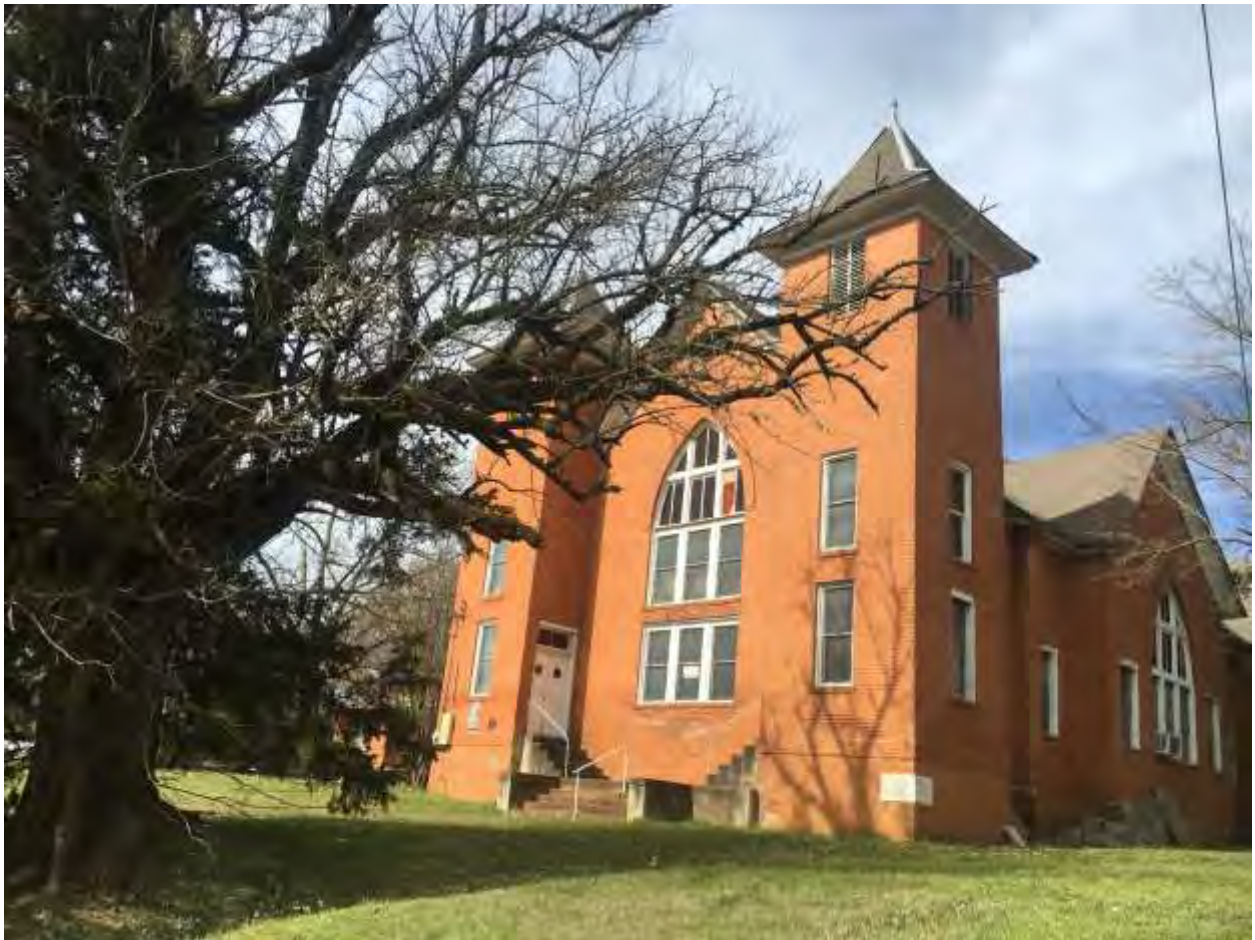
The exterior side of original window frames and sashes were painted white. All exposed wood trim and casings were painted white. All subsequent repainting were variations of basic whites. No other colors were discovered during a limited paint investigation.

View of southeast building corner showing painted white trim.

It is recommended to paint all exterior exposed wood white under Phase IV.

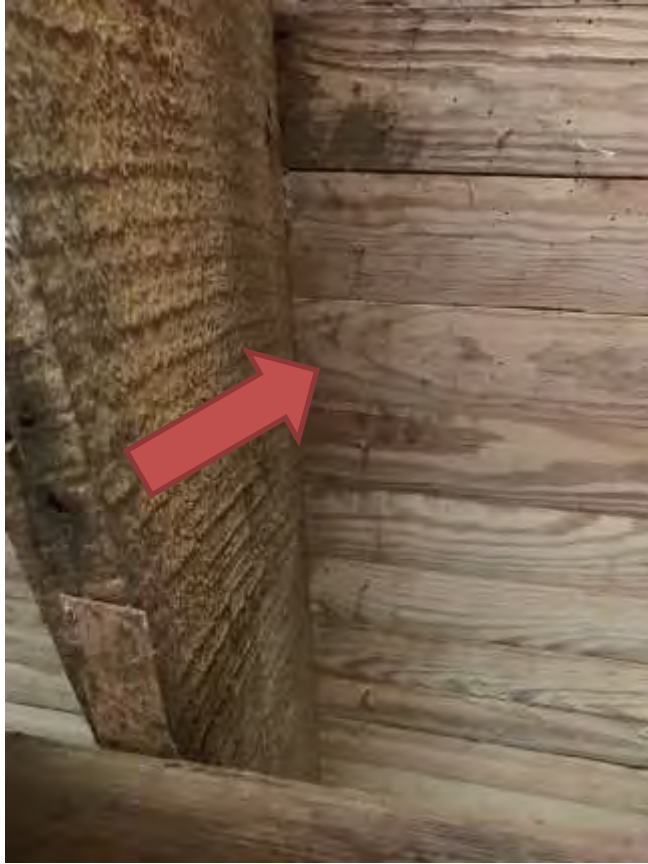
The foundation system has been repaired at least twice. There are a number of floor areas which appear to be unlevel but it can't be determined if the issue is with the overlay materials or if the original wood floor is unlevel due to inconsistent joist elevation or isolated deterioration.

View upward from crawl space. Underside of long leaf pine flooring of Sanctuary.

1. Remove all carpet (that is not glue applied) and debris. Phase I.
2. Conduct environmental investigation and abatement (if necessary). Phase I.
3. Determine level and soundness of original wood flooring. Phase II.
4. Replace deteriorated long leaf pine flooring where necessary. Protect with plywood. Phase IV.
5. Restore and finish all long leaf pine flooring. Phase V.

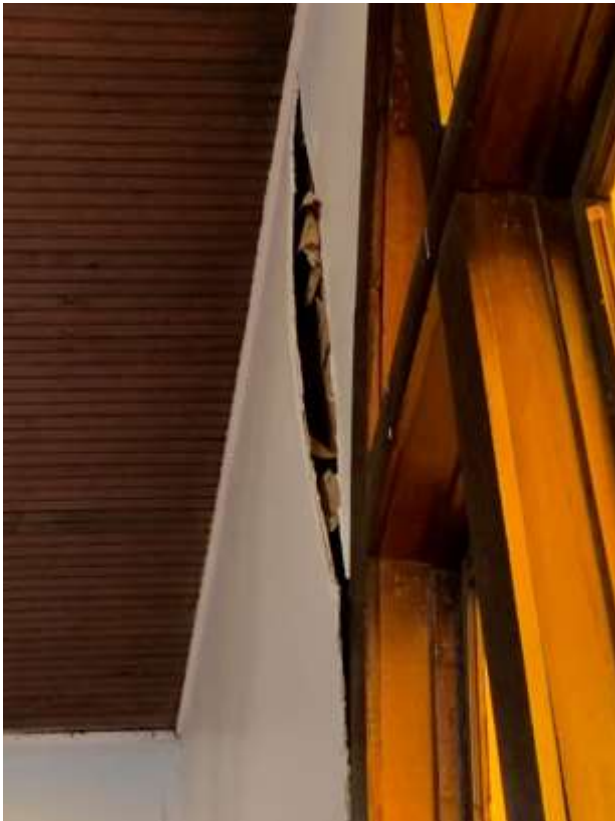
It is anticipated that structural repairs and modifications will require removal and subsequent damage to interior wall finishes. Since most gypsum board has been damaged due to various issues; it is recommended to completely remove in all prominent rooms.

Sanctuary. Example of later added gypsum board damage due to outward wall movement and moisture.

1. Remove all gypsum board material (pending environmental report). Phase I.
2. Remove all wall paneling. Phase I.

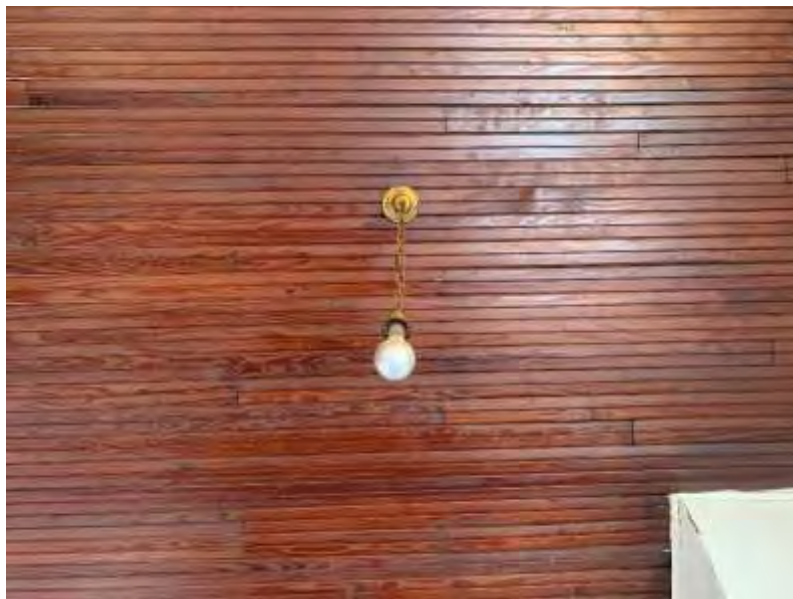
Bead board ceilings, casings, doors, base boards, and wainscoting were all of natural wood finish. It appears the material was varnished with a mix of light stain. This would have resulted in a medium dark appearance such as light walnut and would have brought out the wood graining. One protected ceiling location was observed which revealed an aged dark color suggesting the stain was low quality; much of the darkness has developed by a century of aging. All bead board ceilings had a wood moulding matching the ceiling finish (most have now been replaced or painted).

Bead board ceiling. Shiny areas are possibly a later application of polyurethane.

1. Remove all ceiling material back to wood (material should be tested for asbestos prior to disturbance). Phase III.
2. Replace deteriorated bead board in Sanctuary. Phase IV.
3. Install ceiling wall paper where it originally occurred. Phase V.

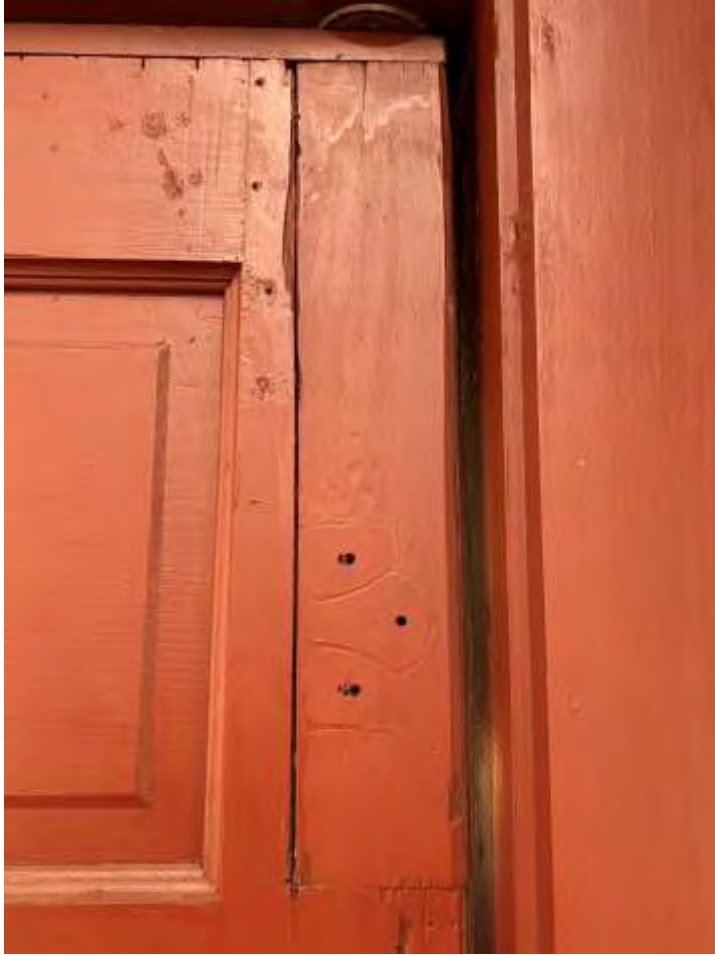
Crude repair to original door.

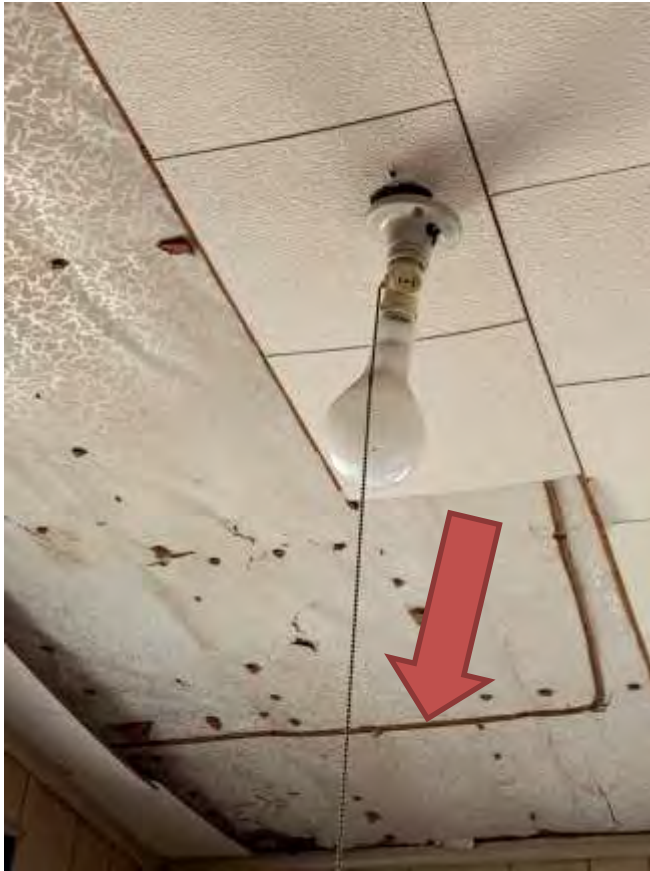
The existing electrical system is a multitude of wiring and switchgear types, installed over various eras of time. The entire system should be replaced; initially from the meter to a new disconnect and main panel board. The new main panel board should be sized to accommodate future phases and ultimately a completely new system. Sufficient spares should be included to facilitate new electrical HVAC and instantaneous water heaters.

Wiring sandwiched between second generation ceiling wall paper and fiberboard ceiling tile.

1. Replace electrical infrastructure from meter to a new main panel board and disconnect. Phase III.
2. Replace selected areas of electrical components to provide limited HVAC, lighting and power. Phase III.
3. Completely replace all electrical components. Phase IV.
4. Install a smoke alarm system. Phase III.
5. Install emergency egress lighting. Phase IV.
6. Install wireless internet service. Phase V.
7. Install supplemental can light fixtures. Phase IV.
8. Rewire and reinstall original light fixtures. Phase V.

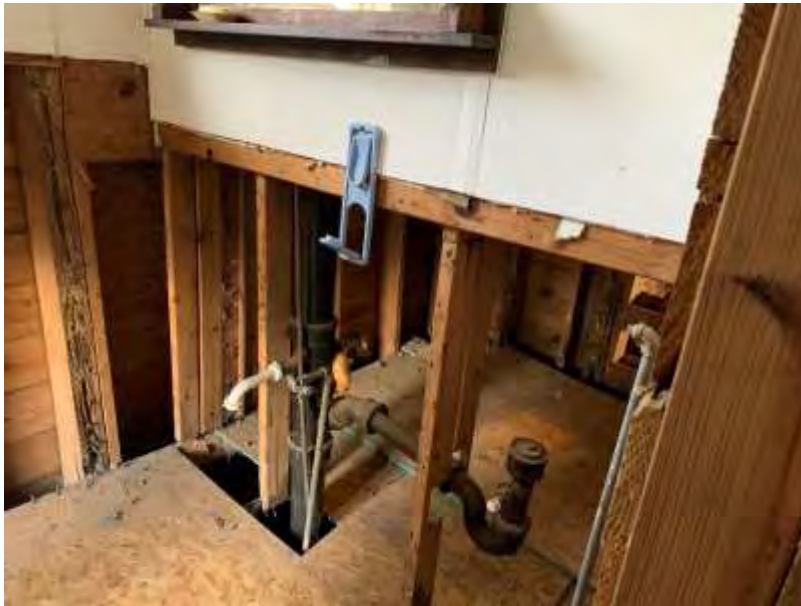
Cast iron waste plumbing in restroom area.

1. Replace limited water supply piping. Phase III.
2. Construct at least one working rest room with rough finishes. Phase III.
3. Reconstruct the second rest room and Pastor's rest room on the second level. Phase IV.
4. Install plumbing in Multi-purpose Room to make room functional. Phase V.

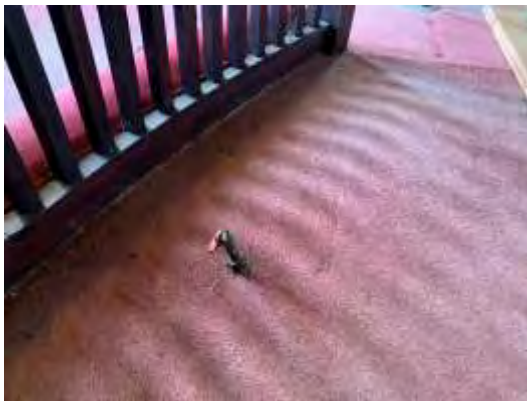
Gas jet. Potential trip hazard.

1. Remove all gas piping, heaters and water heaters. Phase I.
2. Install a new electric heat system with a new HVAC system. Install instantaneous water heaters for hot water. Phase IV.

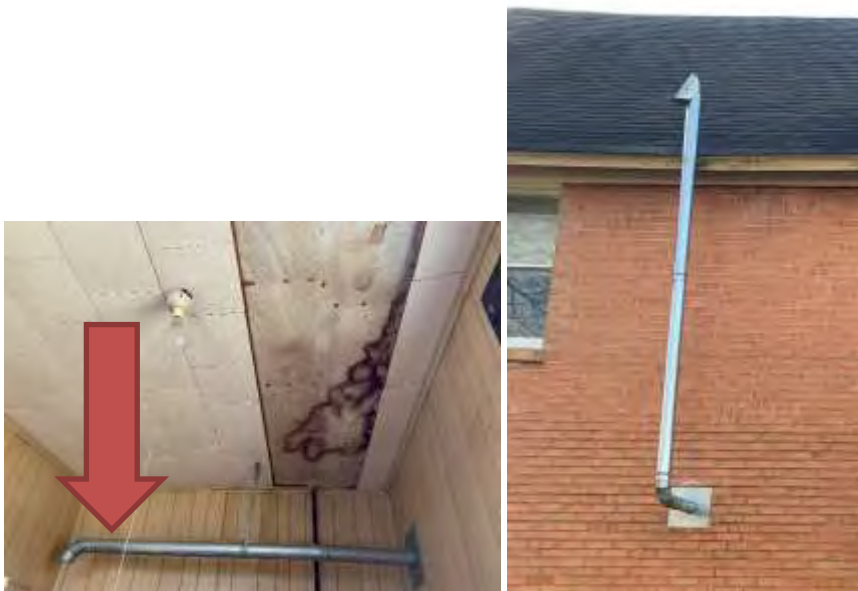
Vestibule, west end. Gas water heater flue. North elevation. Water heater flue.

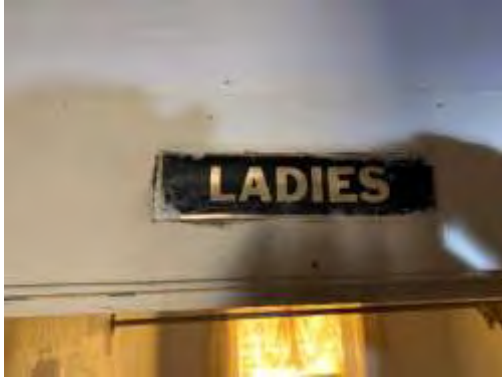
Ca. 1970's signage.

1. Remove non-original signage. Phase I.
2. Install period appropriate signage. Phase V.
3. Install TAS compliant signage. Phase V.

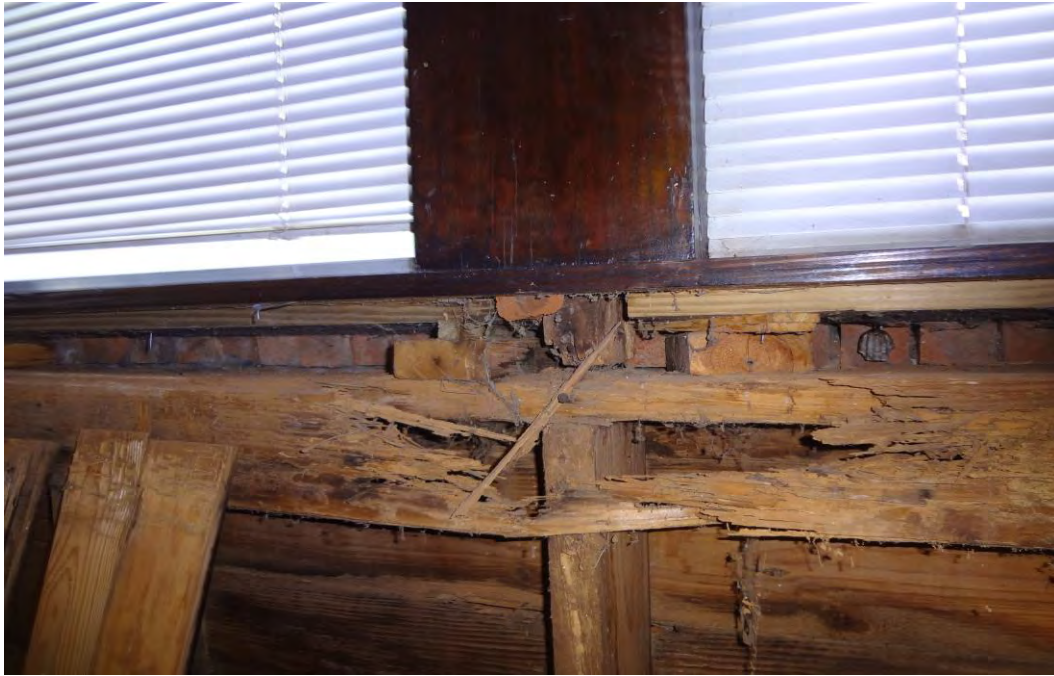
Photograph 1 – Typical Termite Damage at Windows along East and West Walls of the Sanctuary.

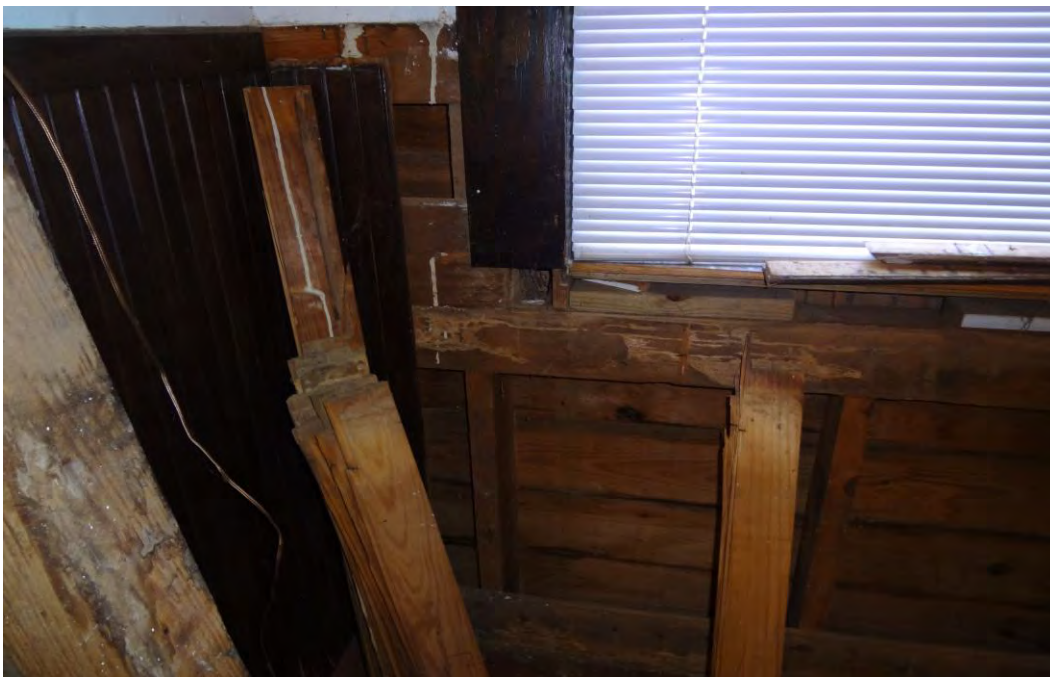
Photograph 2 – Typical Termite Damage at Windows along East and West Walls of Sanctuary.

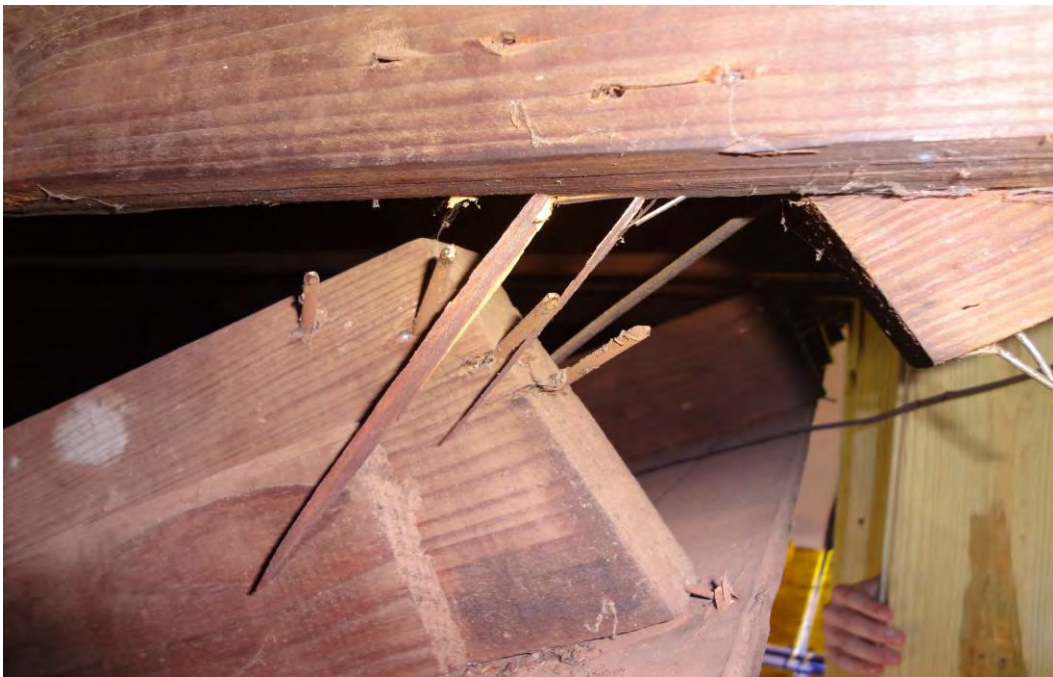
Photograph 6 – Typical Sloped Bottom Chord Connection Failure.
