Section 3  
Rum River Hills Golf Club

## **Rum River Hills Golf Club**

### **Summary**

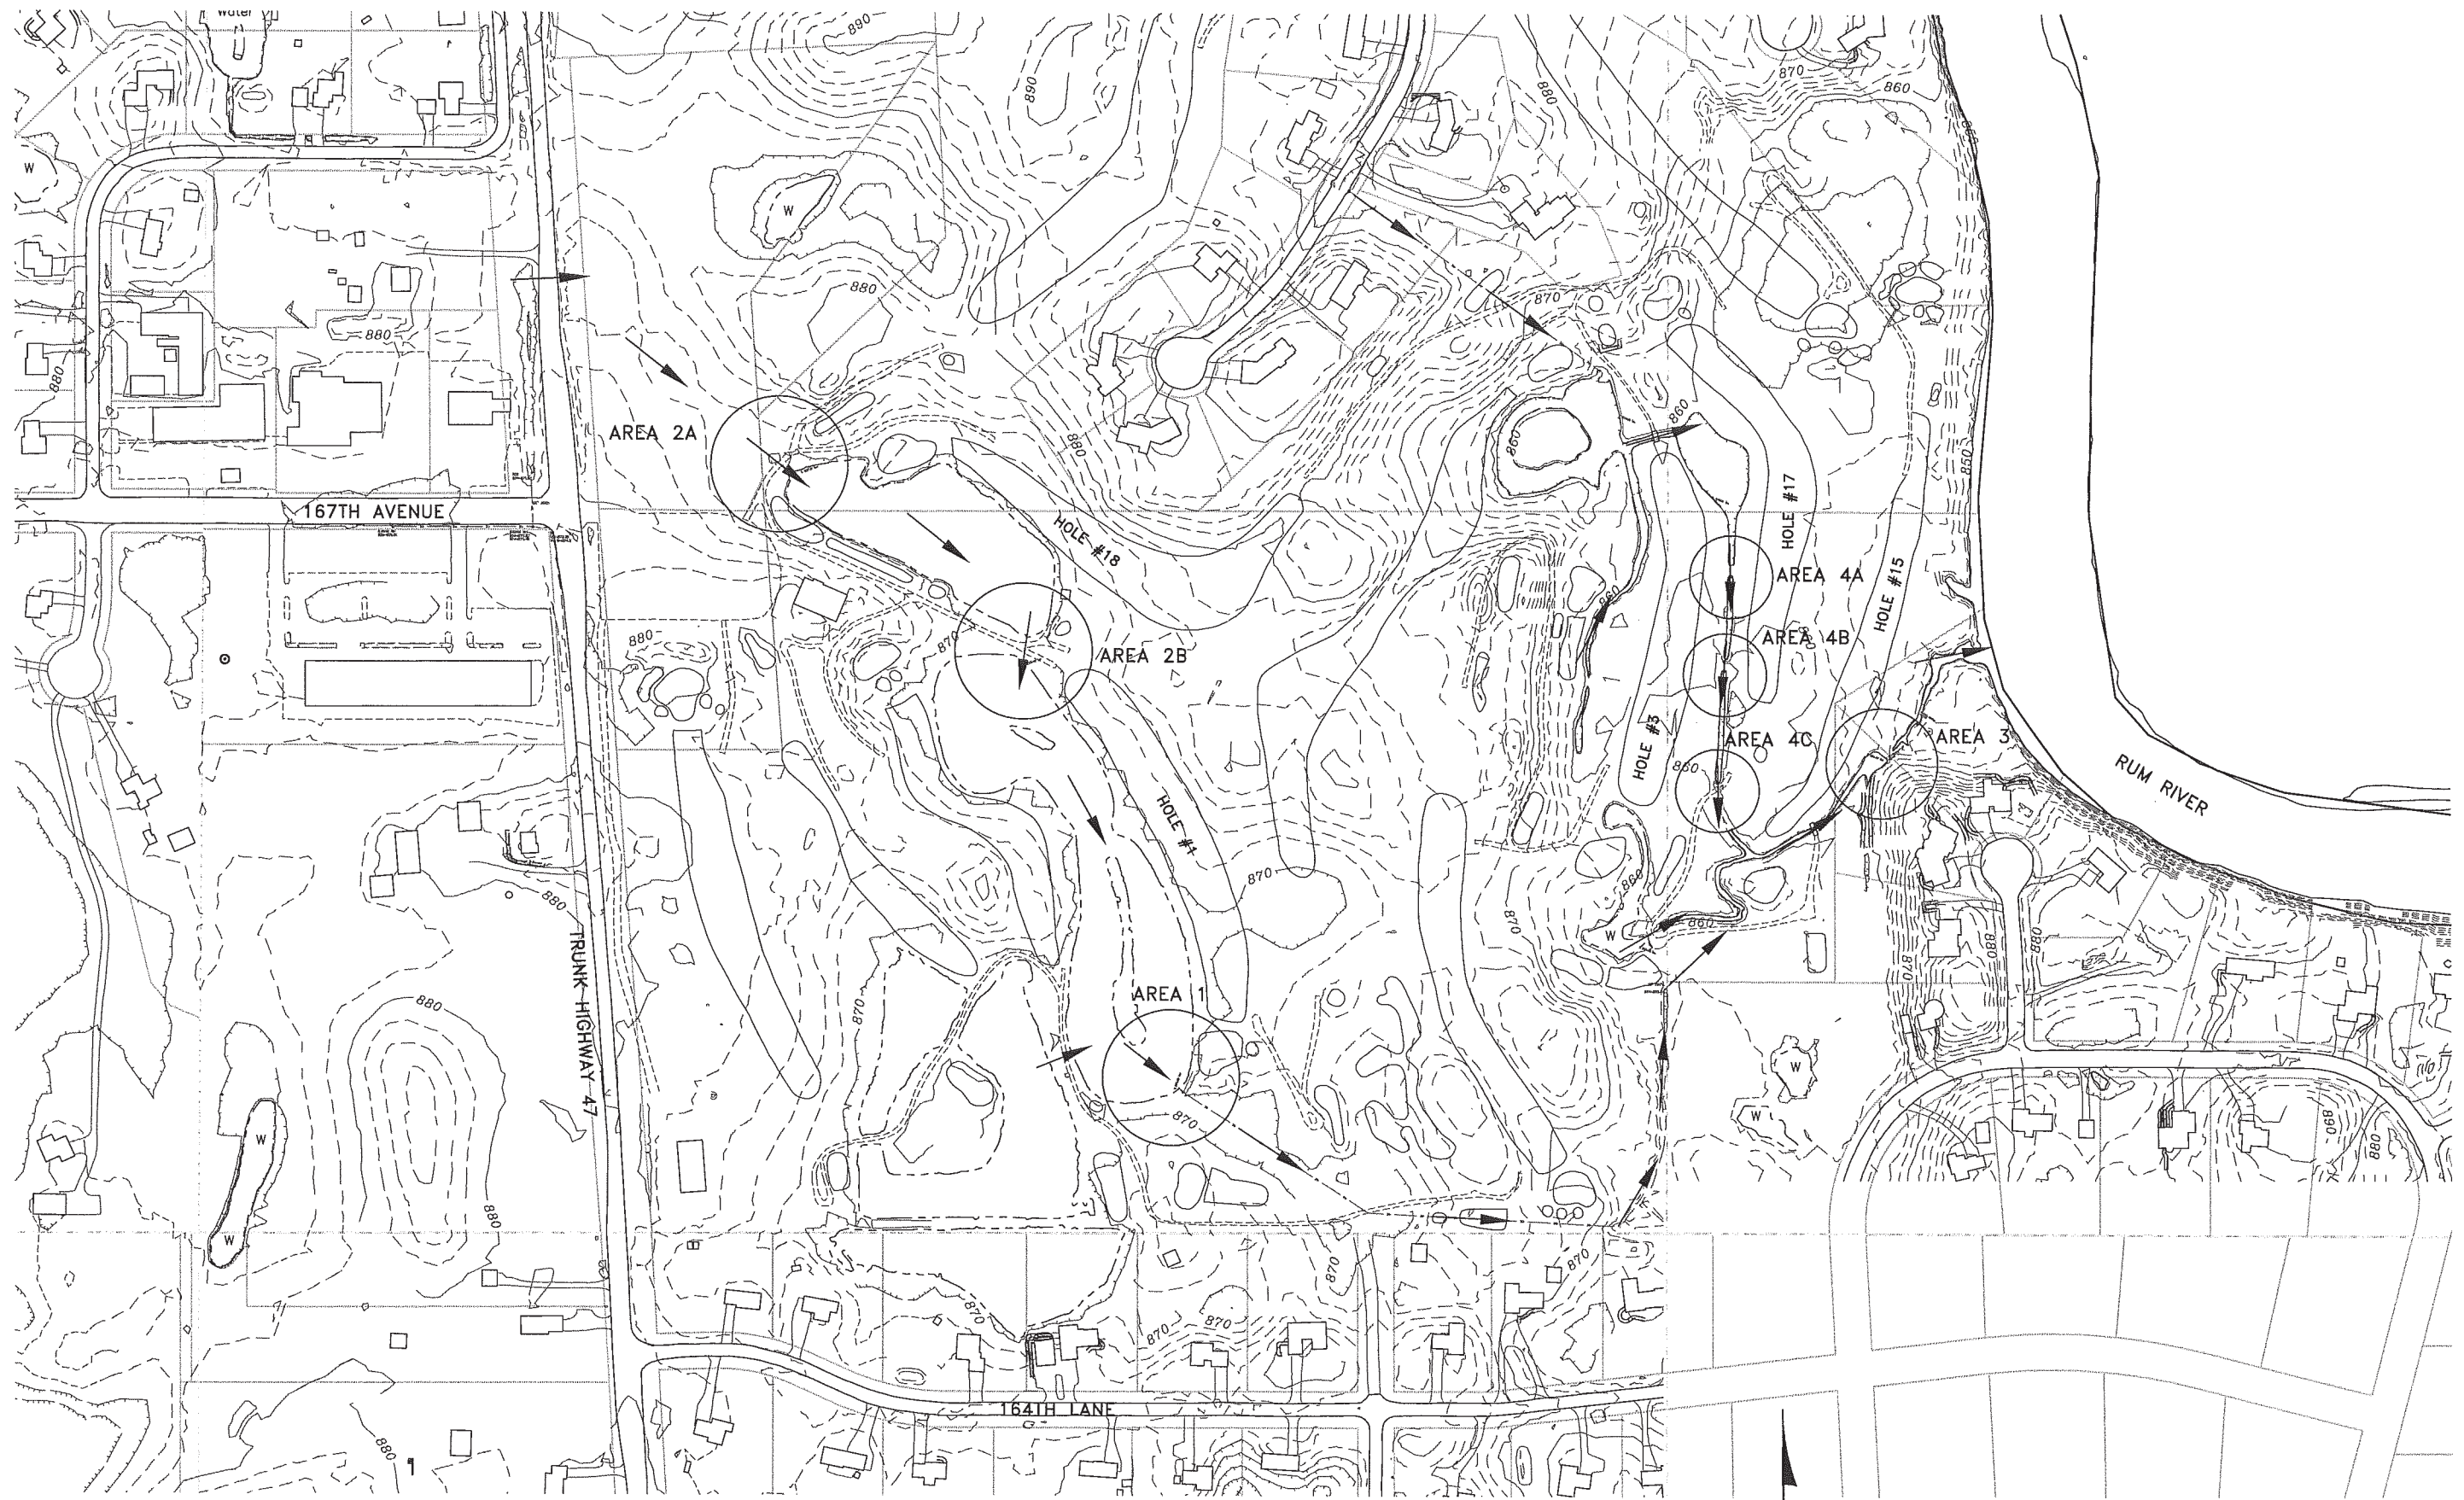
EXHIBIT 9  
RUM RIVER HILLS GOLF CLUB  
EXISTING CONDITIONS  
CITY OF RAMSEY, MINNESOTA

Rum River Hills Golf Club has recently experienced flooding on some fairways and cart paths. Exhibit 9 shows the discharge points and problem areas throughout the golf course. The following will address the problem areas throughout the golf course.

The first area of concern includes flooding of the large pond along Hole #1. This pond discharges through an existing concrete outlet structure and a 12" plastic pipe to the east. The outlet is labeled as Area 1 on Exhibit 9. It is our understanding that after large storm events, the pond remains elevated for long periods of time. The 100-year high water level (HWL) is 870.3.

After reviewing video recordings of the outlet pipe, it appears that the pipe has several sags in it and several joints have been compromised. The outlet pipe is relatively shallow and may have been affected by frost heave. This outlet pipe is likely causing the pond to operate inefficiently.

Based on the HWL of the pond along Hole #1, it appears that there could be an issue with the cart paths flooding near the clubhouse, Areas 2A and 2B on Exhibit 9. The existing culverts under the cart paths are a 15" diameter and 12" diameter. If flooding the cart paths is an issue, the best alternative would be to install larger diameter culverts under the cart paths.

Another issue is occurring along Hole #15 near the Rum River. The soil in the area is saturated. There is an existing rock dam, Area 3 on Exhibit 19, southeast of the most saturated area of the fairway. Part of the fairway was excavated to help to determine the problem and drain the area.

Based on our review, it appears that the water being contained by the rock dam may be infiltrating into the soil and causing the saturation. There is a dropped of approximately seven feet from the rock dam to the bottom of the downstream channel. We also noticed that the existing drain tile that was excavated along Hole #15 was plugged with roots and soil.

Flooding of Hole #3 and #17 is also an issue at the golf course. The stormwater drains south through three 15” culverts, labeled Area 4A, Area 4B and Area 4C on Exhibit 9, and then to the Rum River.

We believe that the best alternative for this outlet is to remove the existing outlet structure and the 12" outlet pipe and replace them with a new 4-foot diameter concrete outlet structure and 18" high density polyethylene pipe outlet in the same location as the existing pipe. Exhibit 10 shows the proposed outlet structure. The new pipe would be installed at a lower elevation than it exists now, reducing the impact of frost heave on the pipe. The polyethylene pipe is also more rigid and is solid (no air voids) and therefore more resistant to frost heave or buoyancy when soils are saturated. A removable, weir wall would be installed in the new outlet structure. We would propose to leave the weir height at the same elevation as existing. By installing the weir wall, it will allow for greater flexibility in controlling the water elevations of the pond. Installing this outlet structure would result in a 100-year HWL of 870.0.

Installing 24" diameter culverts will reduce the flooding during small storm events. However, since the HWL elevation for the area is controlled by the downstream outlet structure discussed above, the paths will still flood during large storm events. To reduce the flooding during the large storm events, the cart paths would have to be raised

We recommend two alternatives to address the soil saturation along Hole #15. First, the drain tile should be replaced to improve the drainage in the area. Second, the area of the creek that is being contained by the rock dam should be lined with an impermeable material to eliminate the water infiltrating through the soil. Lining the creek will eliminate the infiltration into the soil and the new drain tile will help to keep the existing soil dry.

One alternative to lower the HWL’s in the area would be to install bigger culverts. A 21” culvert was modeled to replace the culverts at Area 4A and 4B and a 24” culvert was modeled to replace the culvert at 4C. The following table summarizes the 100-year HWL’s for the three areas:
