# Coon Rapids Dam Pool Shoreline Inventory

*The Minnesota Department of Natural Resources*

December 2012

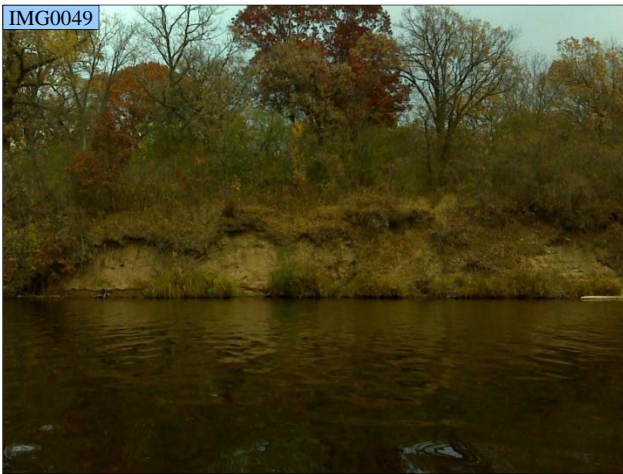
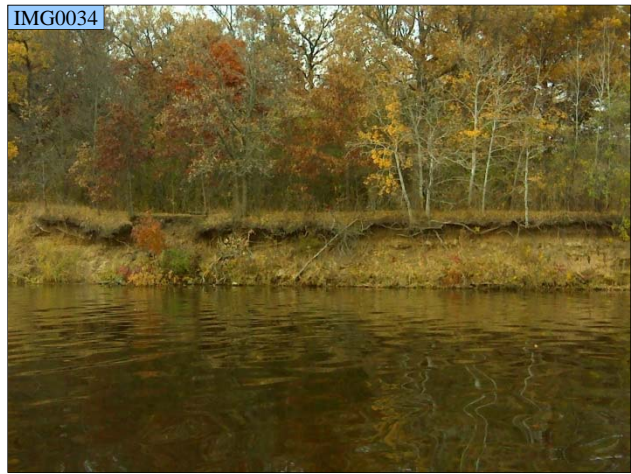
**Additional Info:** This site is located on the outside of a curve in the river, called a cut-bank. This makes it likely to be hit by large ice sheets and moving water during the spring melt. Many fallen trees and vegetative overhangs of several feet show the fast pace of erosion here. The bank varies in height between 12 and 20 feet. A paved bike trail runs along the top of the bank, often 5 feet or less from the edge of the bank. Within a few years the bank could threaten the stability of the trail.

Site Information	Estimated Annual Soil Loss	Severe Erosion Length	Typical Slope	Property Ownership	Atlas Page #	Photo #
	1871 tons	2051 feet	1.5-2.0 to 1	Anoka County	6-12	31-60

**Potential Solution:** Protect the toe of this bank from ice damage by arming it with large rip rap or boulders. Use native planting on the slope to hold the soil in place. Turf reinforcement material may be necessary on the steepest slopes.

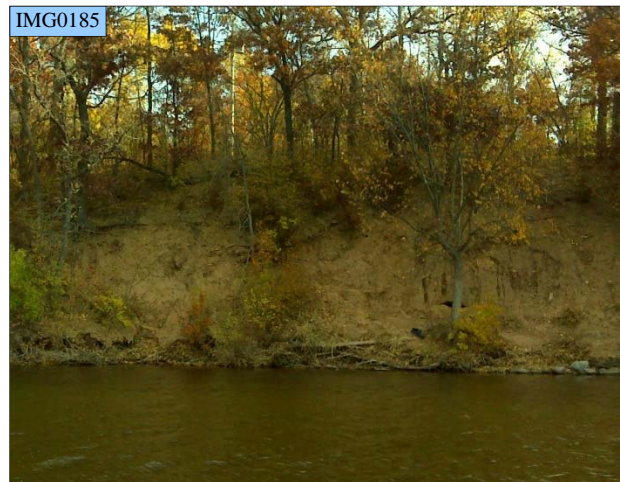
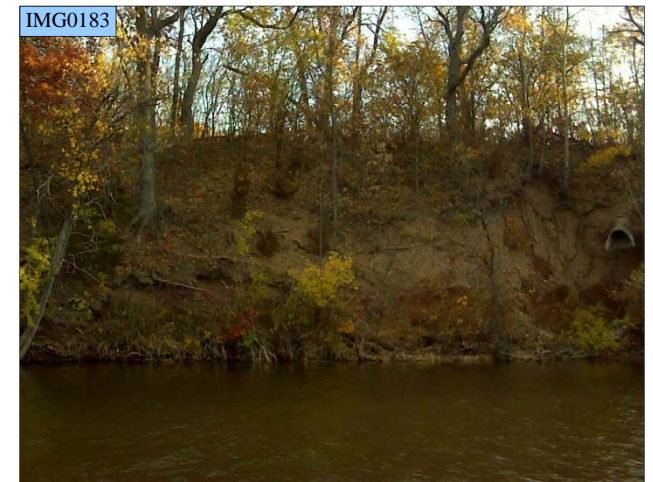
**Additional Info:** This site is located on the outside of a curve in the river, called a cut-bank. It is likely hit by large ice sheets and moving water during the spring melt. As shown in picture 183, a concrete storm water culvert is sticking 5 feet out from the sheer bank. This along with the many slumping trees at the site show the large amount of sediment lost.

Site Information	Estimated Annual Soil Loss	Severe Erosion Length	Typical Slope	Property Ownership	Atlas Page #	Photo #
	510 tons	312 feet	1.4 to 1	Anoka-Ramsey Community College	37-39	178-191

**Potential Solution:** Protect the toe of this bank from ice damage by armoring it with large rip rap or boulders. Use native planting on the slope to hold the soil in place. Turf reinforcement material may be necessary on the steepest slopes. This site has the highest ratio of soil loss per linear foot of any site inventoried, which could potentially make it a more cost-effective project.

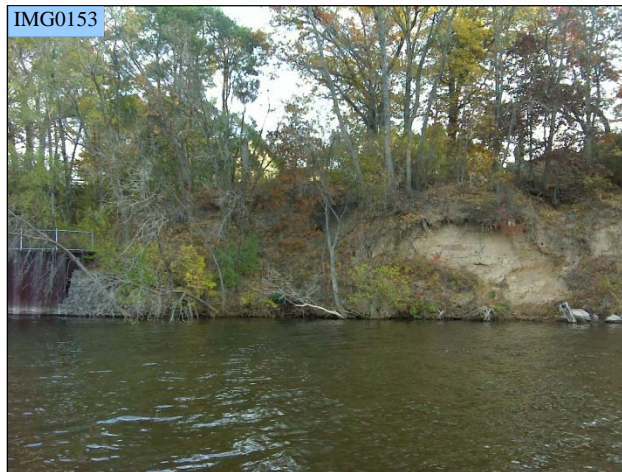
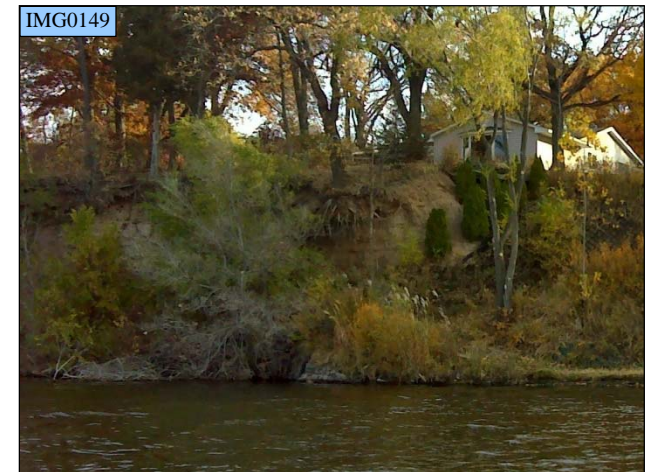
**Additional Info:** At least one large tree has been lost here since the last photo inventory in 2004. Several others are slumping and have their roots exposed. Vegetative overhangs of a few feet are common.

Site Information	Estimated Annual Soil Loss	Severe Erosion Length	Typical Slope	Property Ownership	Atlas Page #	Photo #
	439 tons	341 feet	1.4 to 1	Private	33-34	149-159

**Potential Solution:** Protect the toe of the bank from ice damage using large rip rap or boulders. The bank is so steep here that grading of the slope might be necessary to produce a stable bank. Native planting with a turf control material might also be an option for some of the slope. This site has a high ratio of soil loss per linear foot, which could make it more cost-effective than other potential projects.

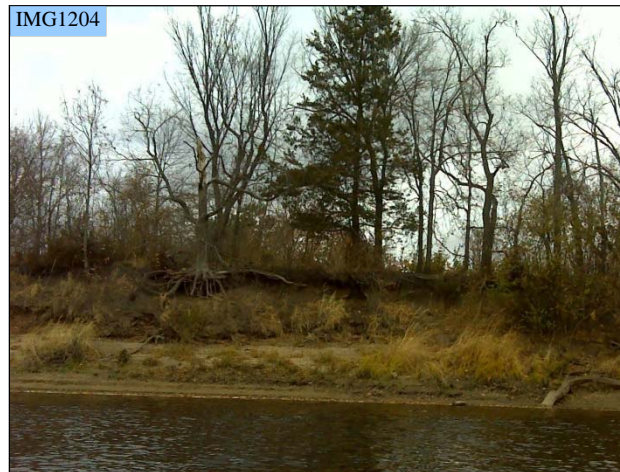
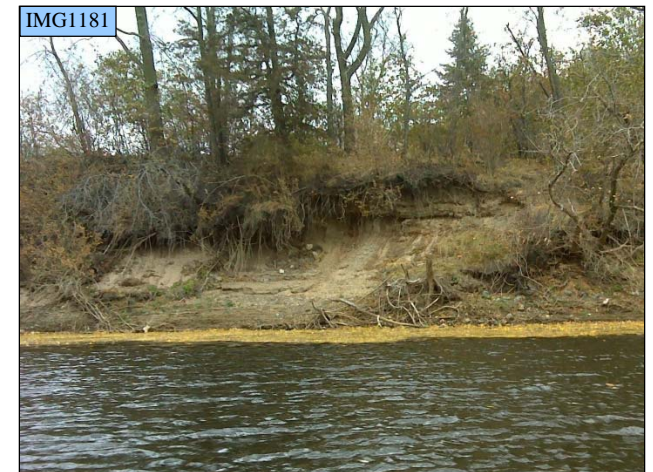
**Additional Info:** Located on a cut-bank, this area is likely to be hit by large sheets of ice in the spring. Many slumping and recently fallen trees show the fast pace of soil loss here. Root overhangs of several feet are widespread in the areas marked severe and very severe. A paved City of Anoka bike trail runs along the top of the bank, between 10 and 15 feet away from the steep bank. Within a few years erosion could threaten the integrity of the trail.

Site Information	Estimated Annual Soil Loss	Severe Erosion Length	Typical Slope	Property Ownership	Atlas Page #	Photo #
	581 tons	738 feet	2.0 -2.5 to 1	City of Anoka	102-105	1179-1209

**Potential Solution:** Protect the toe of this bank from ice damage by armoring it with large rip rap or boulders several feet above the waterline. Use native plants to cover and stabilize the upper slopes. A turf stabilization material may also be needed for the steepest sections of the bank.

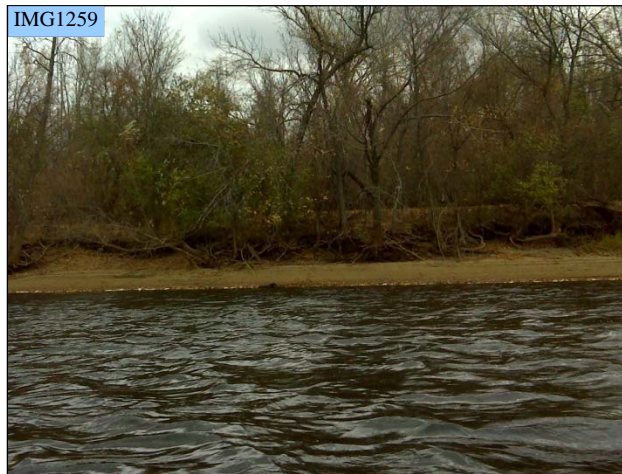
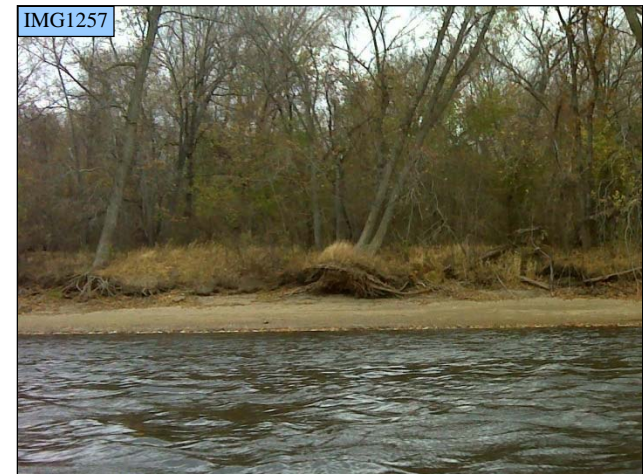
**Additional Info:** This site is located on the northern end of King’s Island in Anoka. It is located on a cut-bank, which likely means it is hit by large ice sheets in the spring. All of the trees along the shoreline have heavily exposed roots and a few are beginning to slump. The bank is only a few feet tall, so the total amount of soil loss here is not as great.

Site Information	Estimated Annual Soil Loss	Severe Erosion Length	Typical Slope	Property Ownership	Atlas Page #	Photo #
	51 tons	159 feet	2.5 to 1	City of Anoka	111-112	1255-1265

**Potential Solution:** Protecting the bank from ice using rip rap or boulders will help the bank rebuild itself over time. Native plants will help hold the soil in place.

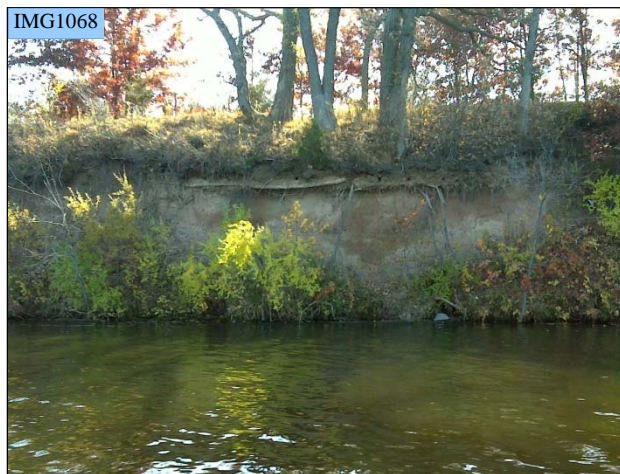
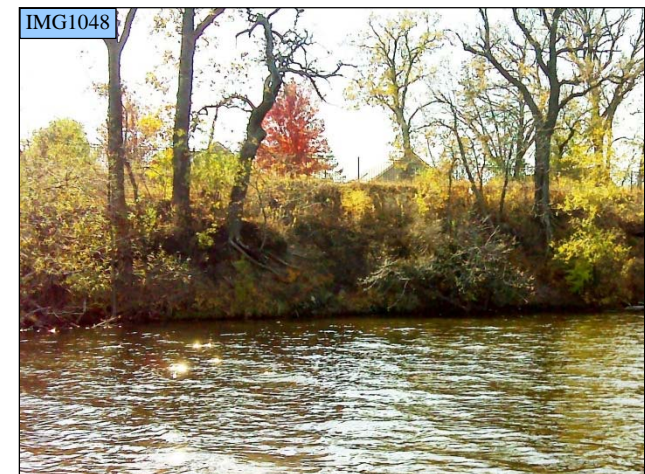
**Additional Info:** Located on a cut-bank, this area is likely hit by large sheets of ice and moving water in the spring. The downstream portion of this site, where erosion is worst, is part of the Coon Rapids Dam Regional Park. Root overhangs of several feet are widespread and the bank is mostly bare. The upstream portion is owned by a local HOA. The erosion is less concentrated here, but a paved bike trail and West River Road are only a few feet from the top of the steep bank.

Site Information	Estimated Annual Soil Loss	Severe Erosion Length	Typical Slope	Property Ownership	Atlas Page #	Photo #
	1142 tons	1446 feet	1.5-2.0 to 1	Three Rivers Park District & Private	201-206	1030-1082

**Potential Solution:** Protect the toe of this bank from ice damage by armoring it with large rip rap or boulders several feet above the waterline. Use native plants to cover and stabilize the upper slopes. The bank is very steep in some areas, so a turf stabilization material may also be needed.

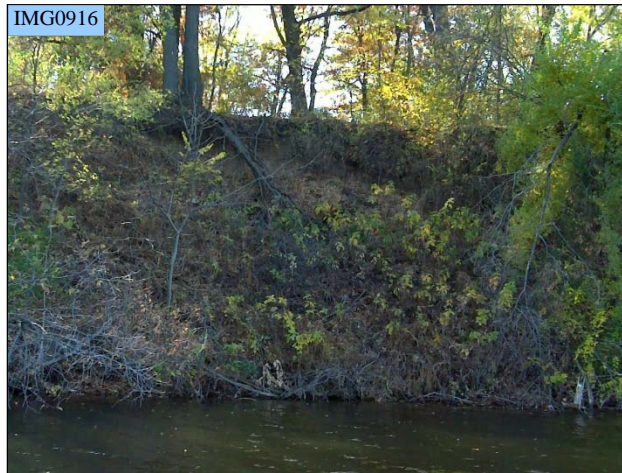
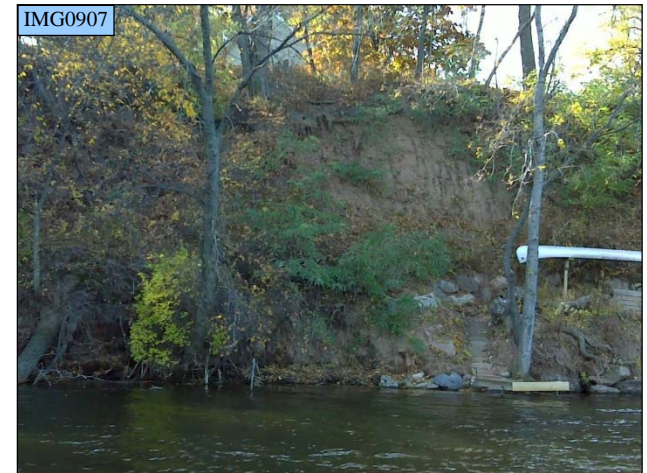
**Additional Info:** Located on a cut-bank, this area is likely to be hit by large sheets of ice and moving water in the spring. Most of the erosion at this site is currently happening above water level. The bank in this location is tall (30+ feet) and very steep. Much of the bank is bare with many exposed tree roots indicating a fast pace of erosion.

Site Information	Estimated Annual Soil Loss	Severe Erosion Length	Typical Slope	Property Ownership	Atlas Page #	Photo #
	209 tons	186 feet	1.4 to 1	Private	184-185	902-918

**Potential Solution:** Protect the toe of this bank from ice damage by armoring it with large rip rap or boulders several feet above the waterline. Use native plants to cover and stabilize the upper slopes. A turf stabilization material may be needed for the steepest sections of the bank. Some thinning of the tree canopy would allow more sunlight to reach the bank and promote plant growth.

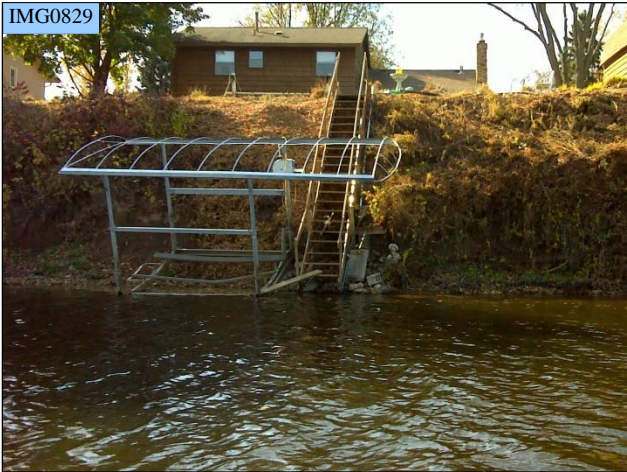
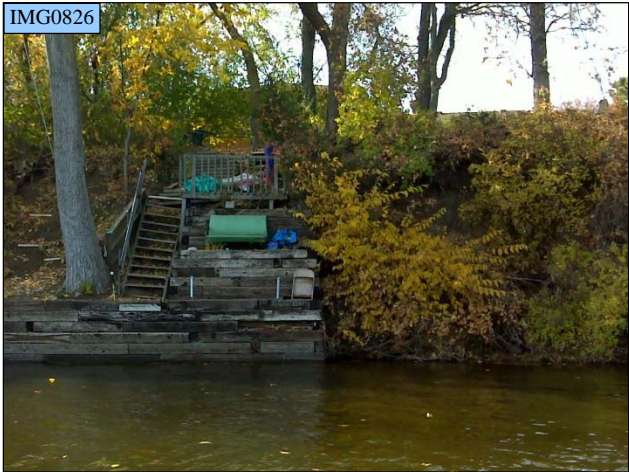
**Additional Info:** The bank here is not particularly high, but it is quite steep. Very few trees are growing on part of the southern end of the bank. This may be the result of or a contributing factor to the erosion. The erosion here seems aggravated by yard waste dumping which smothers vegetation.

Site Information	Estimated Annual Soil Loss	Severe Erosion Length	Typical Slope	Property Ownership	Atlas Page #	Photo #
	168 tons	283 feet	1.5 to 1	Private	174-175	820-833

**Potential Solution:** Promote plant growth here by disposing of yard waste properly and thinning the tree canopy in some places to allow in more sunlight. Some turf stabilization material may also be necessary to stabilize the steepest sections of the bank.

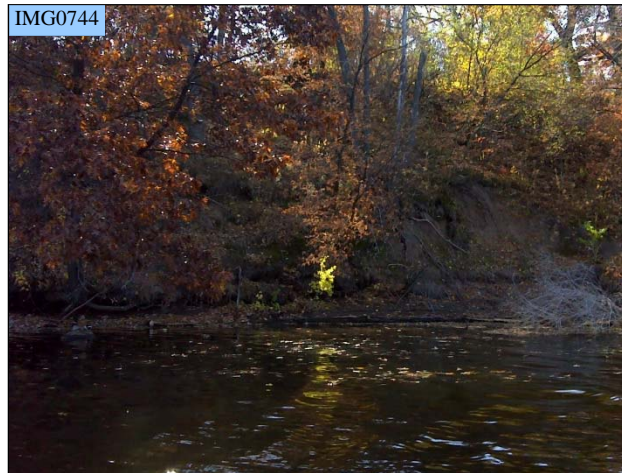
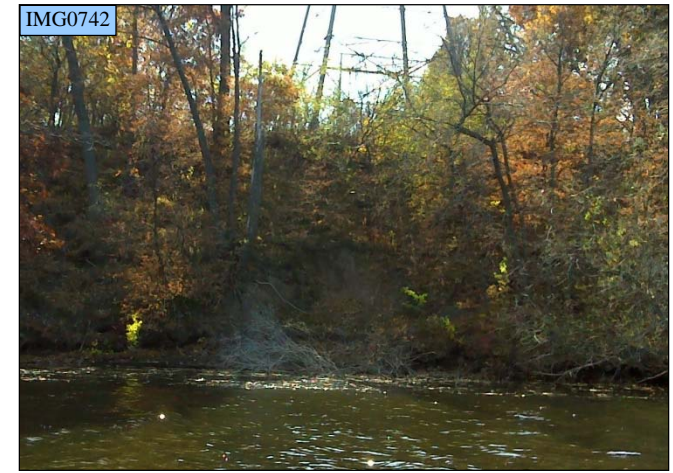
**Additional Info:** The erosion here is located directly below a transmission line. Repeated cutting of trees below the line might be contributing to the erosion here. The base of the tower is approximately 15 feet back from the top of the steep bank.

Site Information	Estimated Annual Soil Loss	Severe Erosion Length	Typical Slope	Property Ownership	Atlas Page #	Photo #
	64 tons	63 feet	1.8 to 1	City of Champlin	165	741-744

**Potential Solution:** Protect this bank by armoring the toe with rip rap or boulders. Consider removing trees and planting grass cover to stop repeated cutting of trees. Some turf stabilization material may also be needed on the steepest part of the slope.

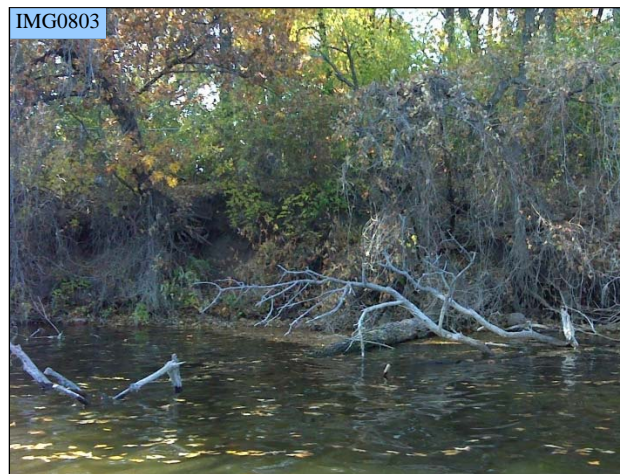
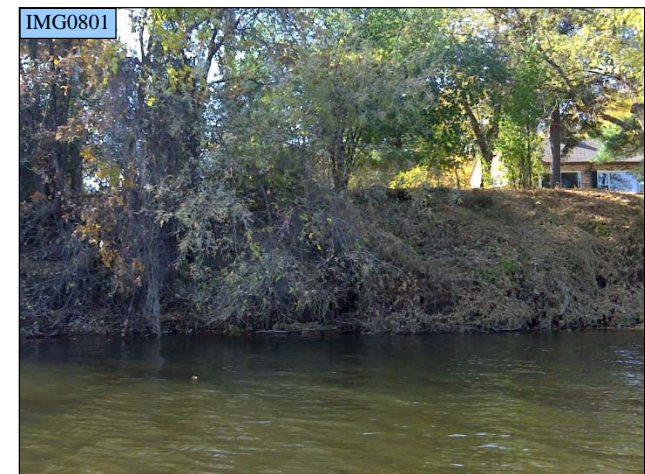
**Additional Info:** The erosion here is located mostly below a power line crossing the river. Repeated cutting of trees away from the line may contribute to the erosion problem here. Yard waste dumping was also apparent here.

Site Information	Estimated Annual Soil Loss	Severe Erosion Length	Typical Slope	Property Ownership	Atlas Page #	Photo #
	55 tons	124 feet	2.0 to 1	Private	172	798-806

**Potential Solution:** Avoid the repeated cutting of trees by replacing them with grass cover. Also, promote more robust vegetation growth by disposing of yard waste properly and potentially thinning the tree canopy to allow more sunlight to reach the plants.

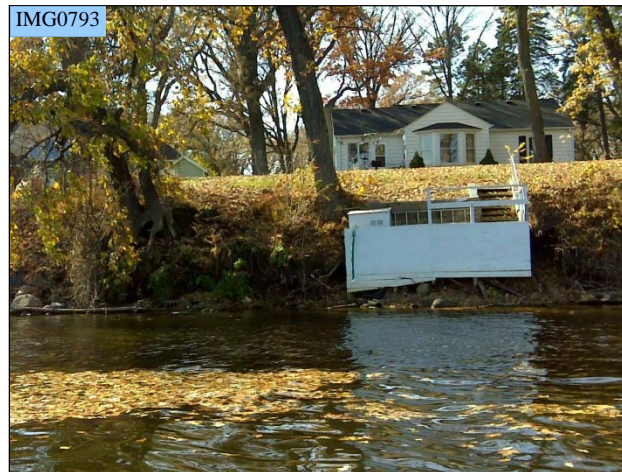
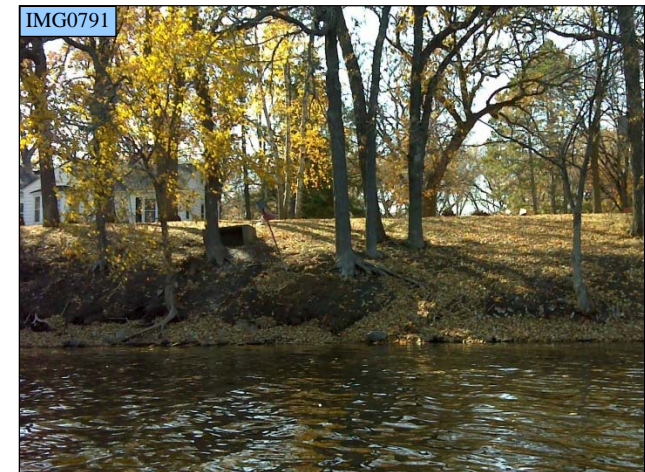
**Additional Info:** Many roots of the large trees along the top of the bank are exposed. These trees could be threatened if the erosion here continues. It appears the grass is mowed all the way to the edge of the bank, which often leads to erosion.

Site Information	Estimated Annual Soil Loss	Severe Erosion Length	Typical Slope	Property Ownership	Atlas Page #	Photo #
	55 tons	154 feet	2.0 to 1	Private	171	788-795

**Potential Solution:** Allow a buffer of un-mowed vegetation to grow along the top of the bank. Some armoring of the toe would also help stabilize the bank.

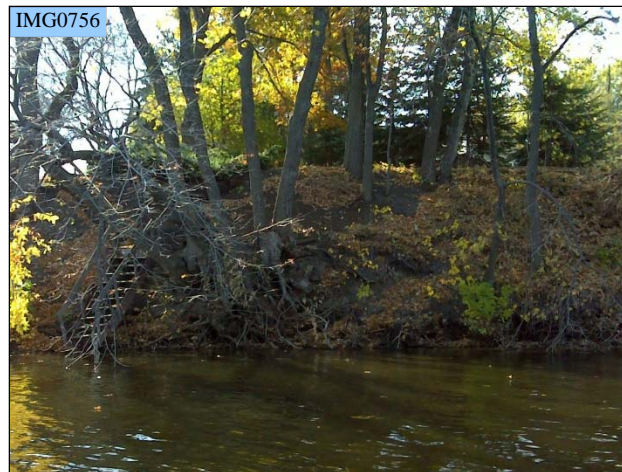
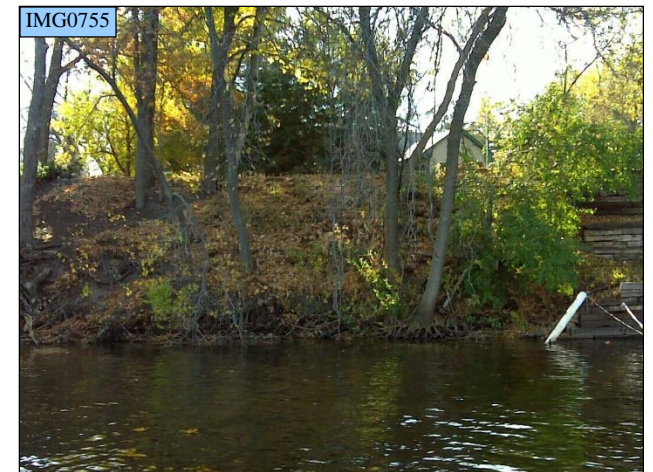
**Additional Info:** This site is marked by several slumping trees and a lot of exposed soil. These trees could be lost in a few years if the erosion continues. It appears the grass is mowed all the way to the edge of the bank, which often leads to erosion.

Site Information	Estimated Annual Soil Loss	Severe Erosion Length	Typical Slope	Property Ownership	Atlas Page #	Photo #
	38 tons	67 feet	1.8 to 1	Private	166	754-756

**Potential Solution:** Promote vegetation growth by thinning the tree canopy to allow more sunlight to reach the ground. Also allow a buffer of un-mowed vegetation to grow along the top of the bank.

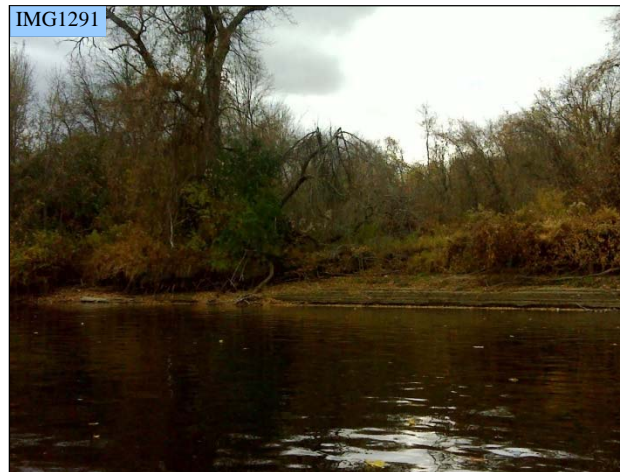
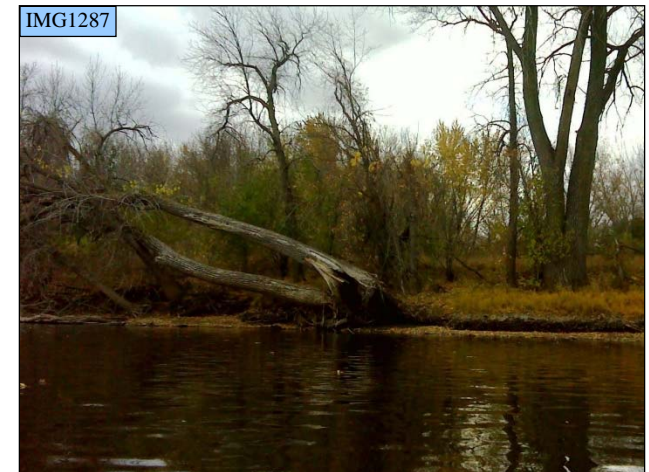
**Additional Info:** This site is part of Donnie Galloway Park in Champlin. Most of the shoreline in this park is unprotected and eroding at least moderately. One large tree has fallen recently here and vegetative overhang is widespread. The bank is only a few feet tall, so the total soil loss here is not great.

Site Information	Estimated Annual Soil Loss	Severe Erosion Length	Typical Slope	Property Ownership	Atlas Page #	Photo #
	32 tons	138 feet	2.0 to 1	City of Champlin	116	1287-1294

**Potential Solution:** Because the site is not on a cut-bank, hard armoring may not be necessary. Instead, lining the bank with cut cedar trees might allow sediment to rebuild the bank. Planting native shrubs such as dogwood along the shore would help to hold the soil long-term.
