Executive Summary

The City of Ramsey contracted the Anoka Conservation District to complete an inventory of riverbank condition along the entire 5.8 miles of City that border the Mississippi River. The inventory provides the City with a comprehensive record of bank condition. Ten stretches of riverbank with severe or very severe erosion were identified, which if stabilized, would reduce sediment loading to the river by 5,148 tons per year.

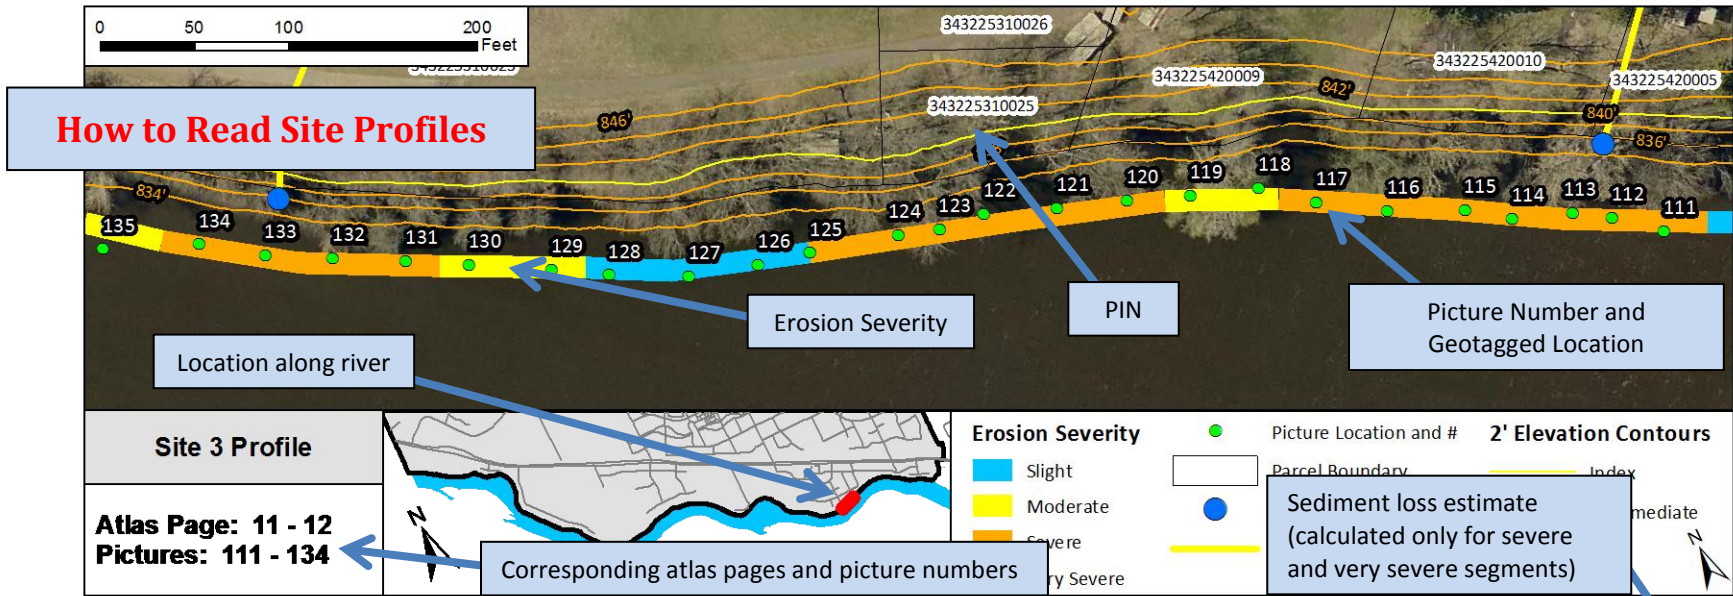
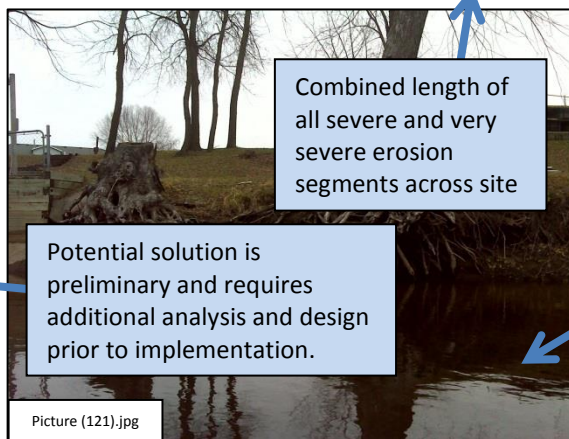
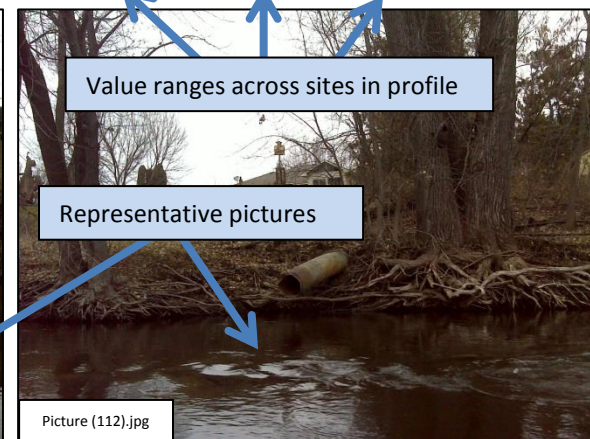
Additional Information: This site consists of five properties, four of which are private and one public (Anoka County). Erosion severity was categorized as severe because of the many exposed tree roots and undercut banks.

Site Information	Ownership	Erosion Length (ft)	Height (ft)	Depth (ft)	Slope (H:V)	Soil Loss (tons/yr)
	Private/Anoka County	566	6 - 10	22 - 40	3.7 - 4.2	323.7

Potential Solution: Preservation of some of the severely undercut trees could be difficult, and regrading of the bank may be necessary. Stabilization could be accomplished using a combination of hard armoring at the toe of the slope and bioengineering on the upper portions of the bank.

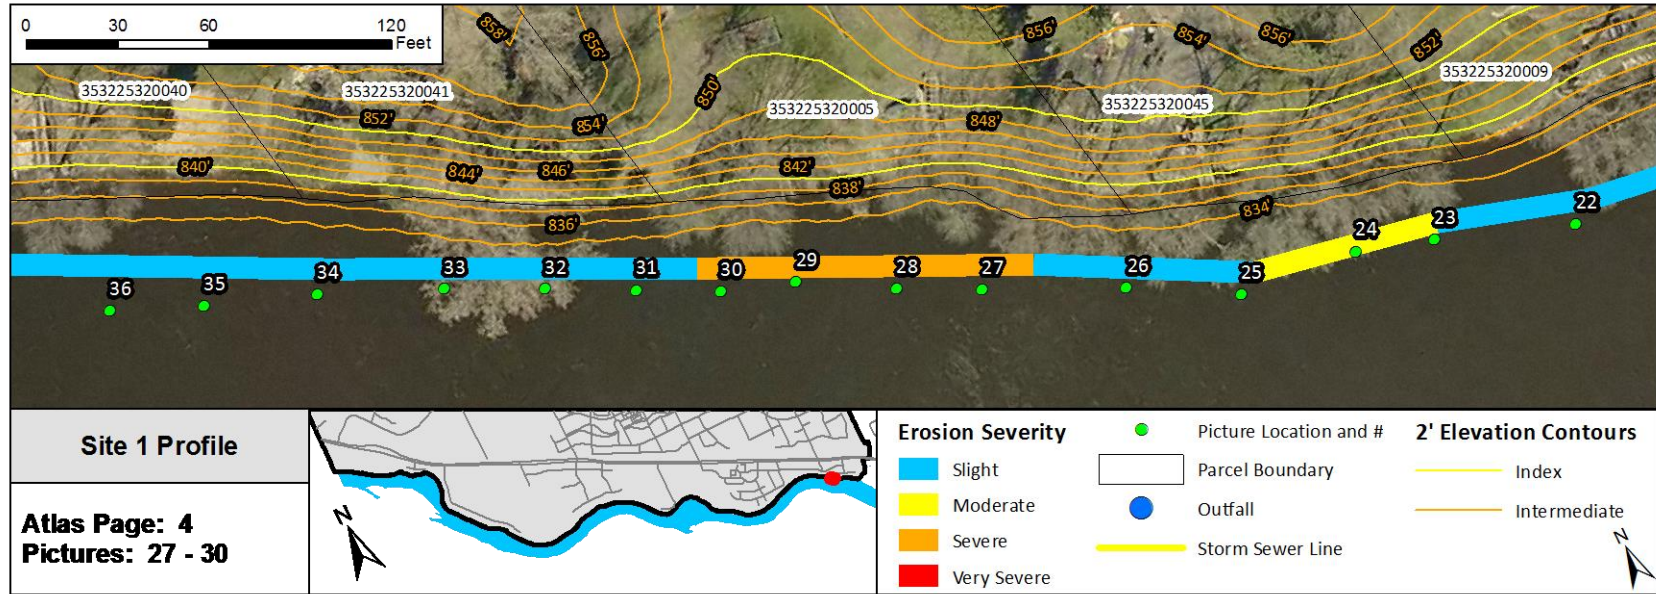
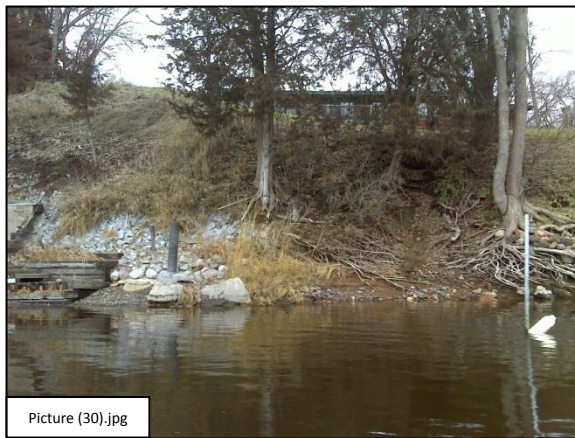
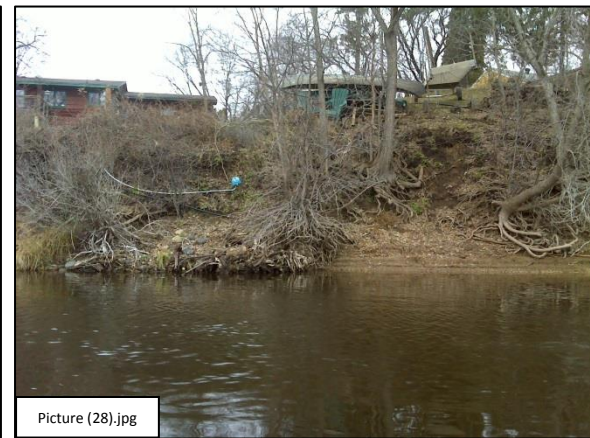
Additional Information: This site consists of one private residential property. Erosion severity was categorized as severe because of the many exposed tree roots and several areas with bank slumps.

Site Information	Ownership	Erosion Length (ft) Severe/Very Severe	Height (ft)	Depth (ft)	Slope (H:V)	Soil Loss (tons/yr)
		Private	111	12	25	2.1:1

Potential Solution: Stabilization of the riverbank could be accomplished using a combination of hard armoring at the toe of the slope and bioengineering on the upper portions of the bank. A cedar tree revetment could also be a possibility. Thinning of the canopy may be necessary to promote growth of native vegetation on the upper portions of the bank.

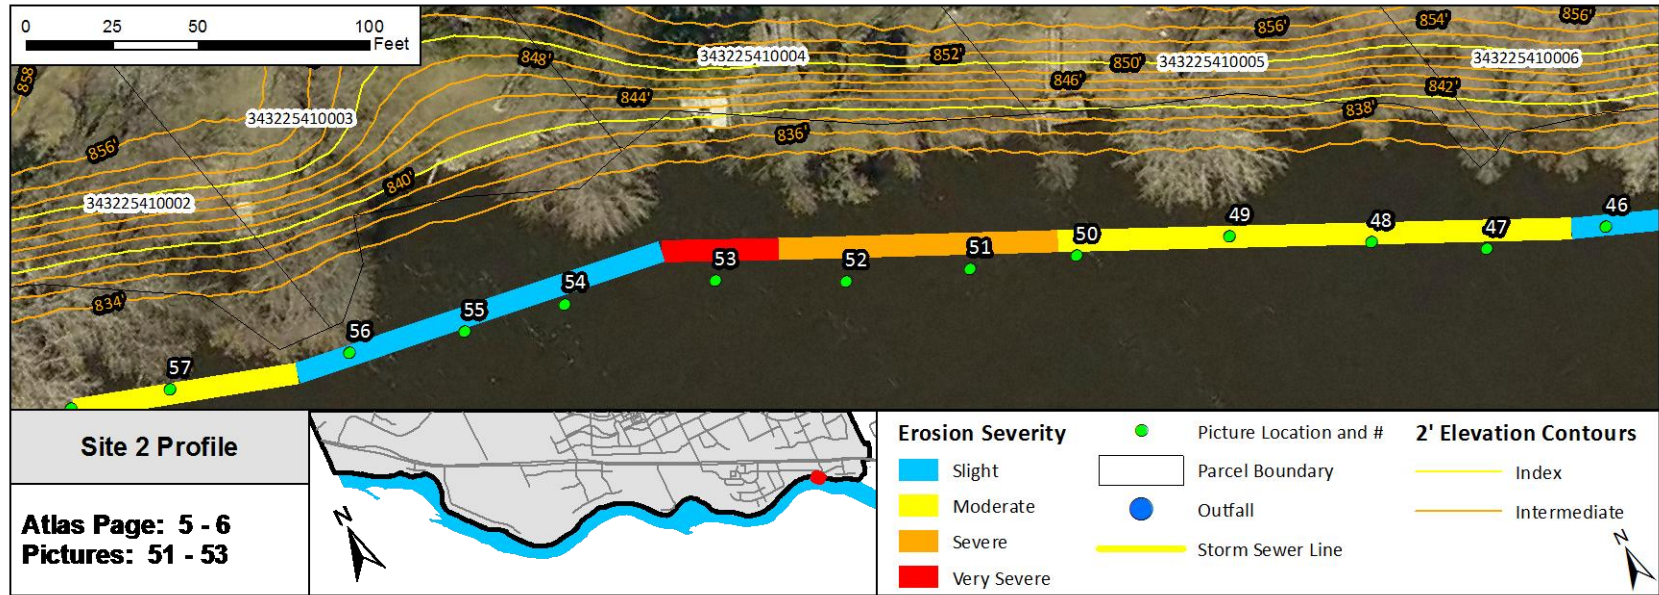
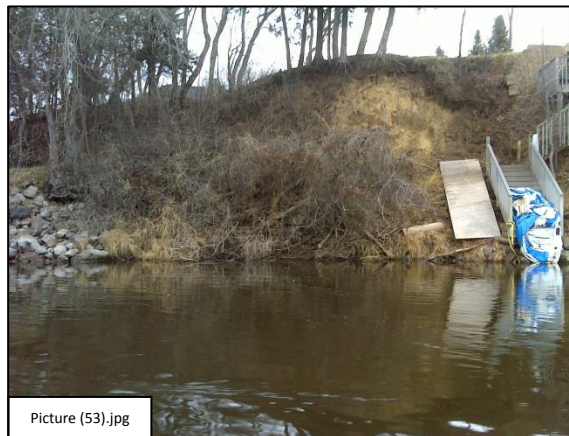
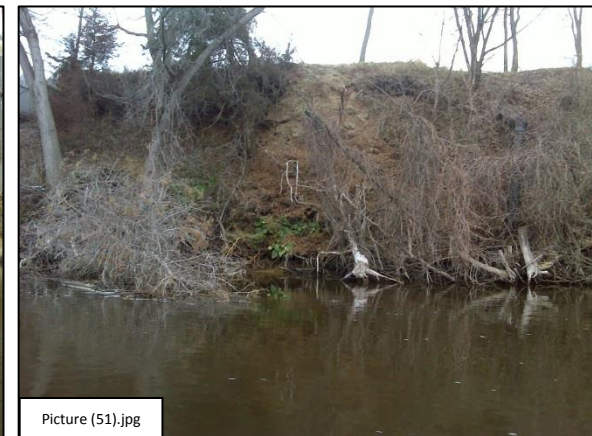
Additional Information: This site consists of one private residential property. Erosion severity was categorized as severe and very severe. The many fallen trees on the upstream stretch of the property resulted in the very severe categorization.

Site Information	Ownership	Erosion Length (ft) Severe/Very Severe	Height (ft)	Depth (ft)	Slope (H:V)	Soil Loss (tons/yr)
	Private	116	22	36	1.6	123.0

Potential Solution: Stabilization of the riverbank could be accomplished using a combination of hard armoring at the toe of the slope and bioengineering on the upper portions of the bank. Because of the large bank slumps, regrading of the bank will likely be required.

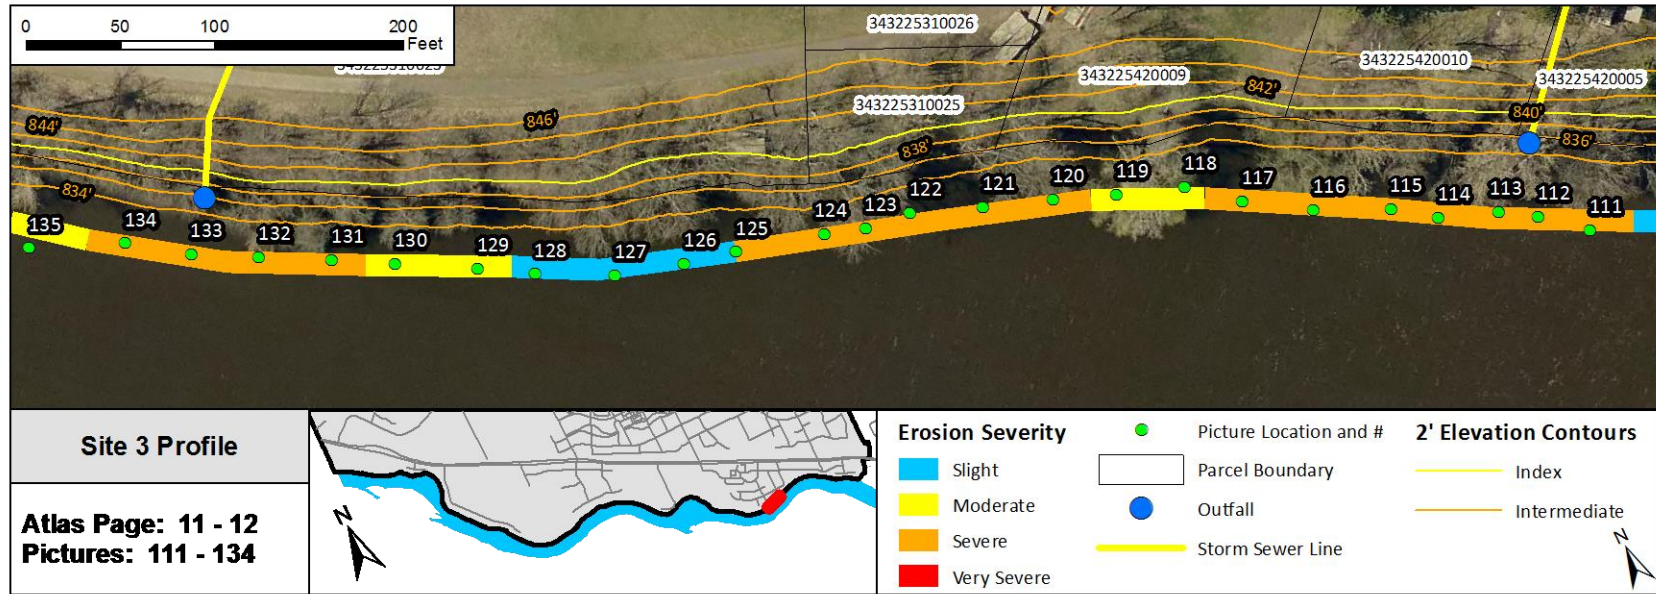
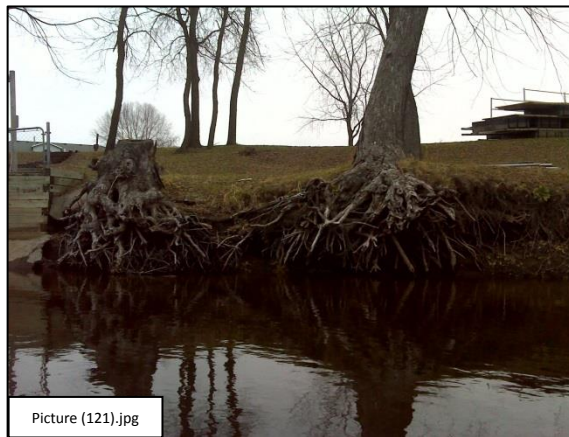
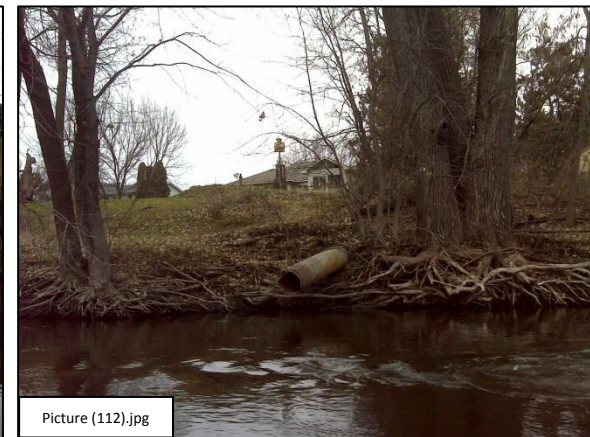
Additional Information: This site consists of five properties, four of which are private and one public (Anoka County).

Erosion severity was categorized as severe because of the many exposed tree roots and undercut banks.

Site Information	Ownership	Erosion Length (ft) Severe/Very Severe	Height (ft)	Depth (ft)	Slope (H:V)	Soil Loss (tons/yr)
	Private/Anoka County	566	6 - 10	22 - 40	3.7 - 4.2	323.7

Potential Solution: Preservation of some of the severely undercut trees could be difficult, and reshaping the bank may be necessary. Stabilization could be accomplished using hard armoring at the toe of the slope and bioengineering on the upper portions of the bank. Cedar tree revetments may also be an option.

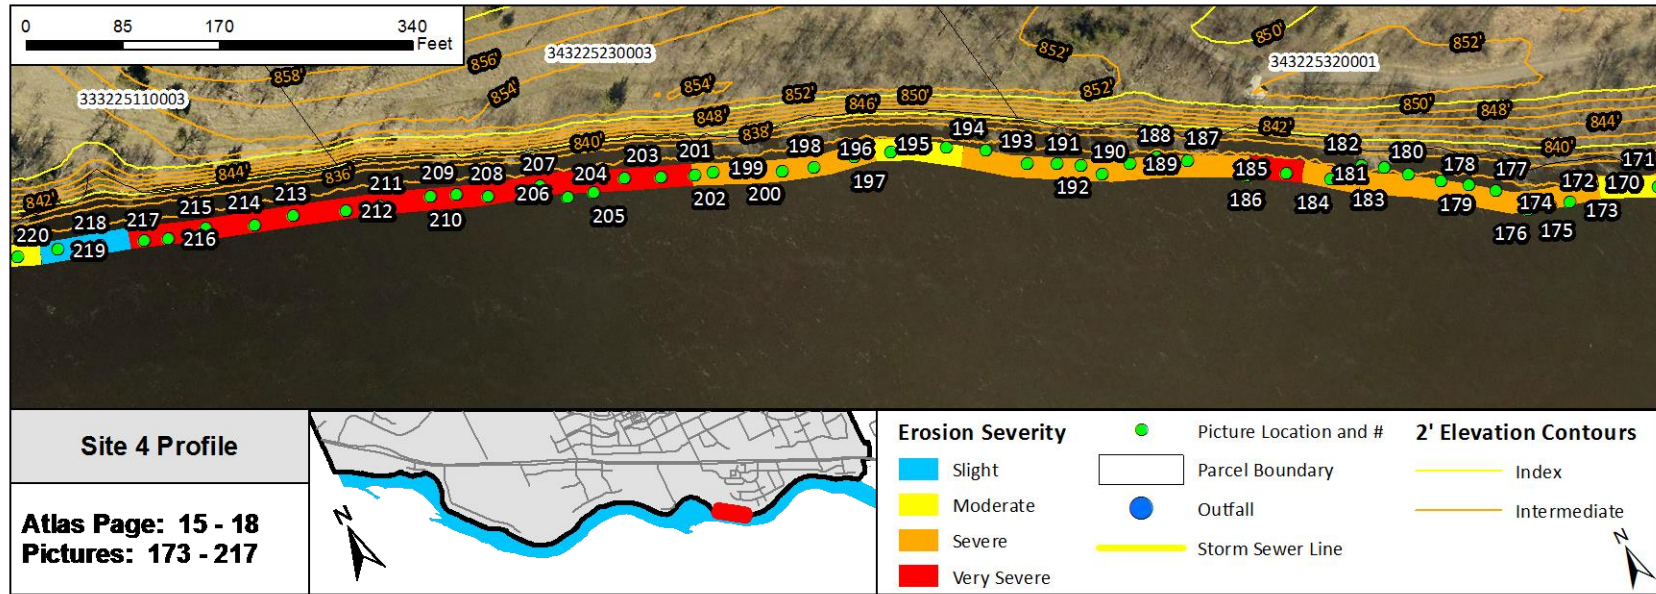
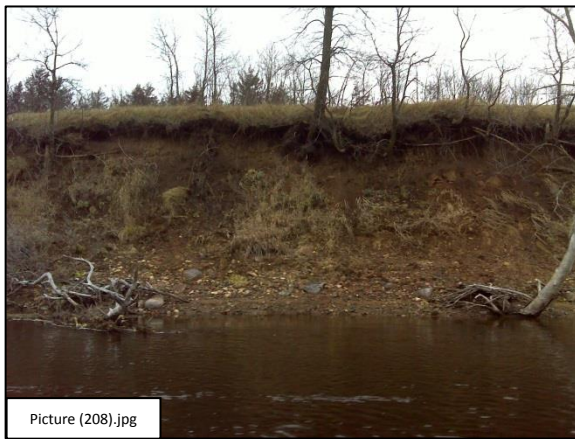
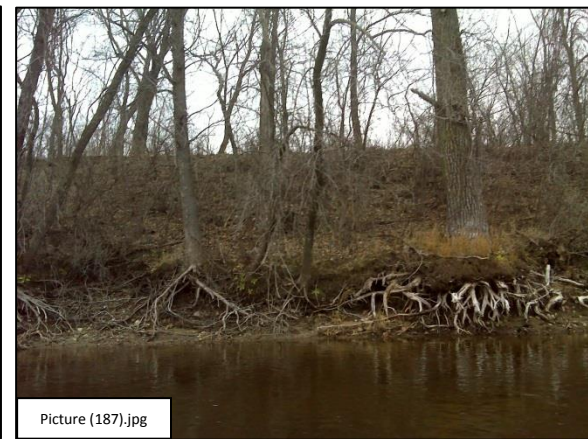
Additional Information: This site consists of three parcels, all of which are owned by Anoka County. Erosion ranged from severe to very severe along this section with one small area categorized as moderate. The large sections of bare bank were categorized as very severe.

Site Information	Ownership	Erosion Length (ft) Severe/Very Severe	Height (ft)	Depth (ft)	Slope (H:V)	Soil Loss (tons/yr)
	Anoka County	1227	4 - 16	7 - 30	1.8 - 2.5	821.0

Potential Solution: Stabilization of some areas categorized as severe could be stabilized using cedar tree revetments and native vegetation. The sections of steep, bare bank could be stabilized using a combination of regrading, hard armoring at the toe of the slope, and bioengineering.

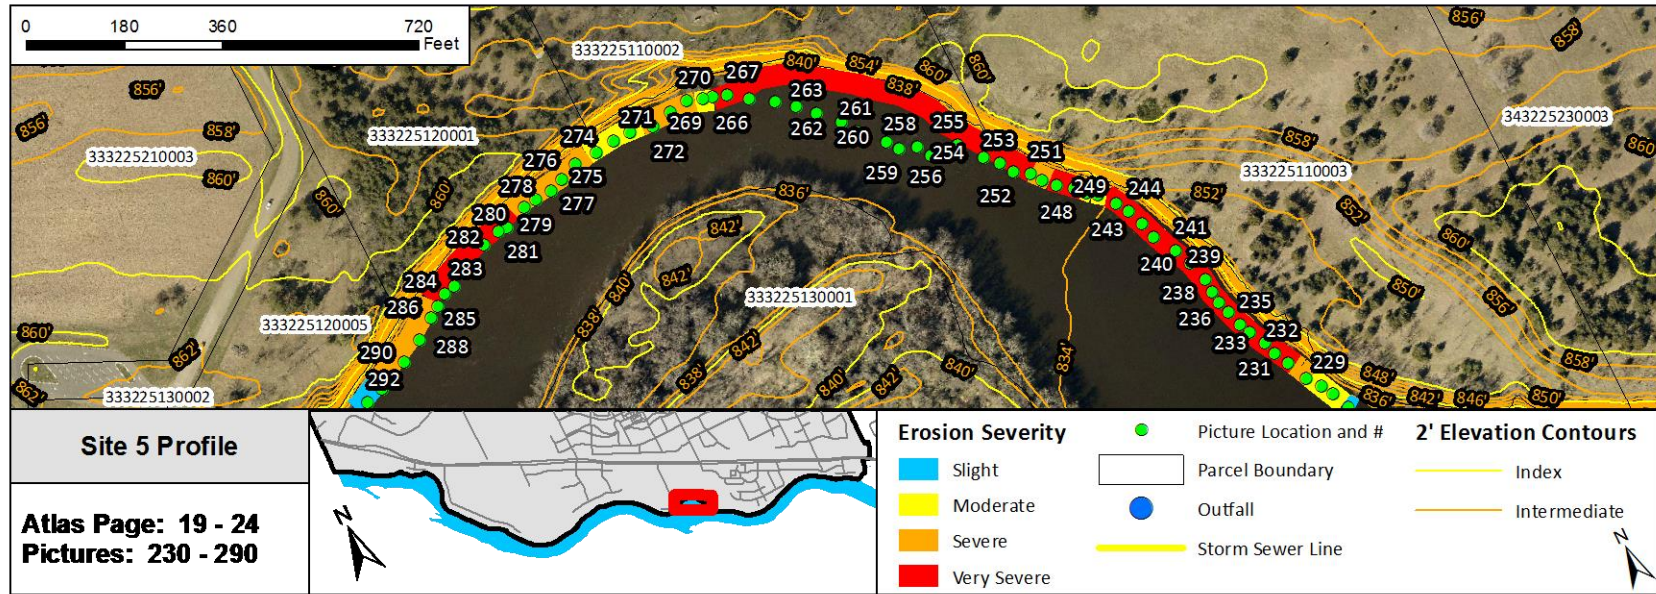
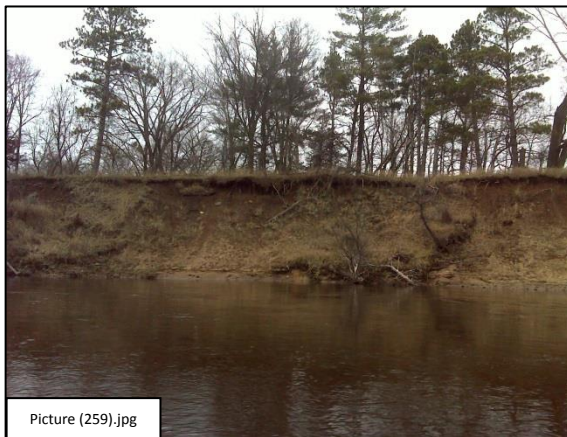
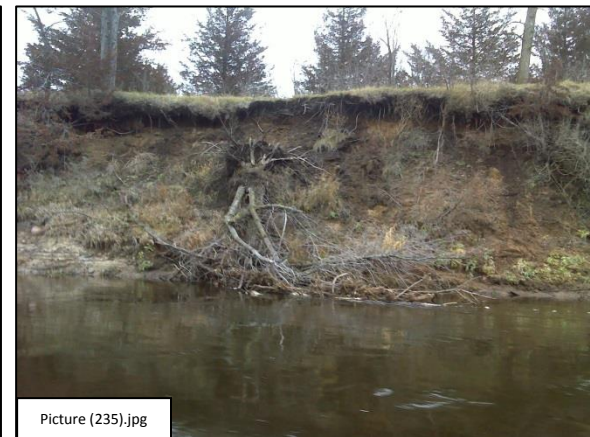
Additional Information: This site consists of four parcels, all of which are owned by Anoka County. Erosion ranged from severe to very severe along this section with short sections categorized as moderate. The large sections of bare bank were categorized as very severe.

Site Information	Ownership	Erosion Length (ft)	Height (ft)	Depth (ft)	Slope (H:V)	Soil Loss (tons/yr)
	Anoka County	Severe/Very Severe				
	Anoka County	1920	4 - 20	8 - 33	1.5 - 2.0	1869.6

Potential Solution: Stabilization of some areas categorized as severe could be stabilized using cedar tree revetments and native vegetation. The sections of steep, bare bank could be stabilized using a combination of regrading, hard armoring at the toe of the slope, and bioengineering.

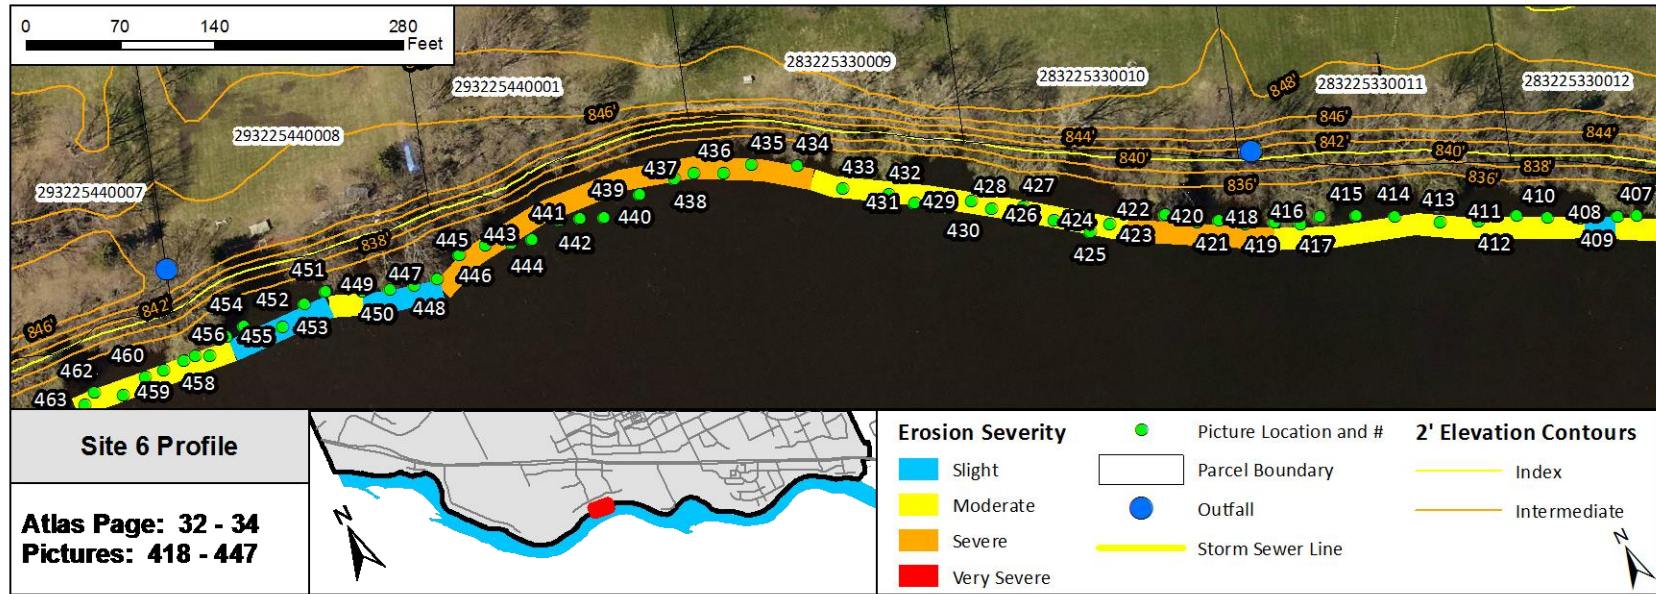
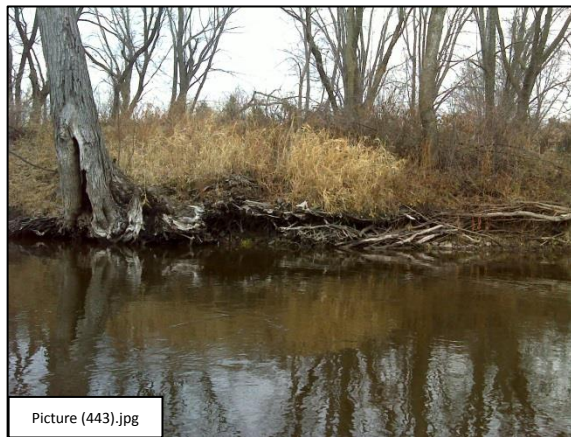
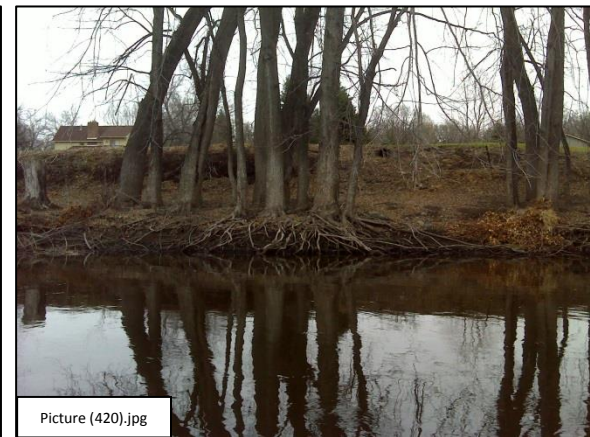
Additional Information: Two sections of severe erosion span a total of four privately owned properties in this site profile.

The many exposed tree roots and bank undercutting resulted in the severe categorization.

Site Information	Ownership	Erosion Length (ft) Severe/Very Severe	Height (ft)	Depth (ft)	Slope (H:V)	Soil Loss (tons/yr)
	Private	412	6	15 - 24	2.5 - 4.0	152.0

Potential Solution: Much of the erosion could possibly be addressed using cedar tree revetments inter-planted with native vegetation (e.g. Sandbar Willow or Buttonbush). Areas with more severe undercutting may need to be regraded and may warrant hard armoring at the toe with native vegetation higher on the bank.

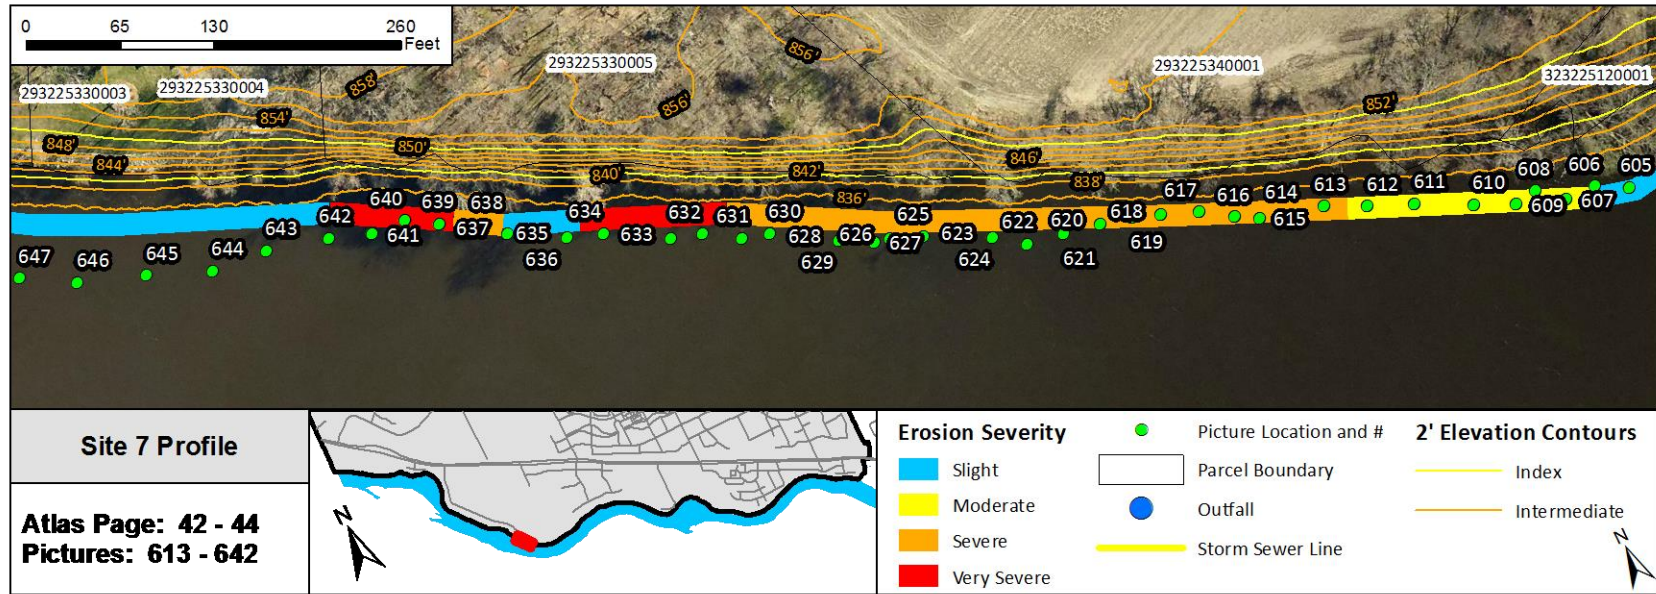
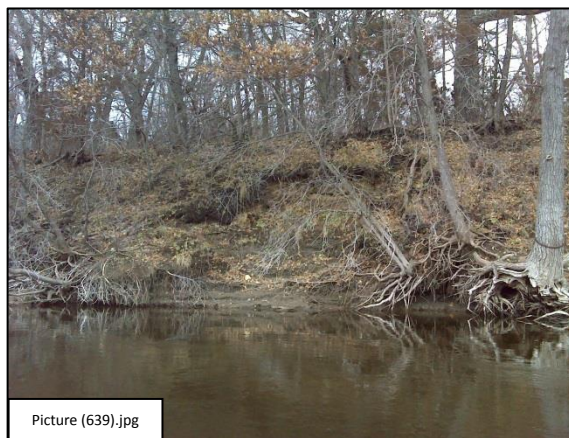
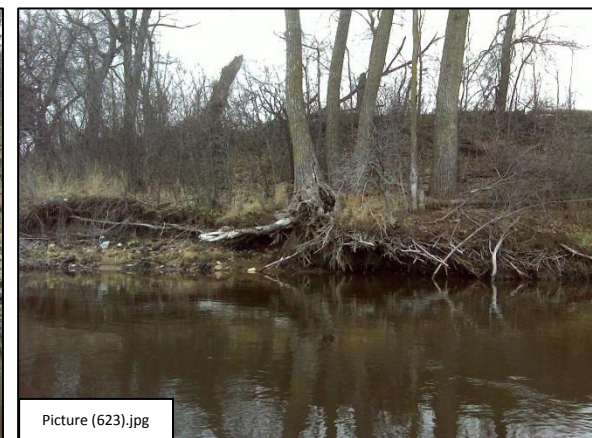
Erosion at this site spans two private properties and ranges from severe to very severe.

Much of the severe erosion consists of exposed tree roots and some bank undercutting. The very severe sections have fallen trees and bare bank.

Site Information	Ownership	Erosion Length (ft)	Height (ft)	Depth (ft)	Slope (H:V)	Soil Loss (tons/yr)
	Private	Severe/Very Severe	4 - 12	7 - 24	1.7 - 2.5	280.4

Potential Solution: The severe sections may be effectively stabilized with cedar tree revetments and native vegetation (e.g. Sandbar Willow or Buttonbush). Areas with fallen trees and bare bank may need to be regraded and hard armored at the toe with native vegetation farther up the bank.

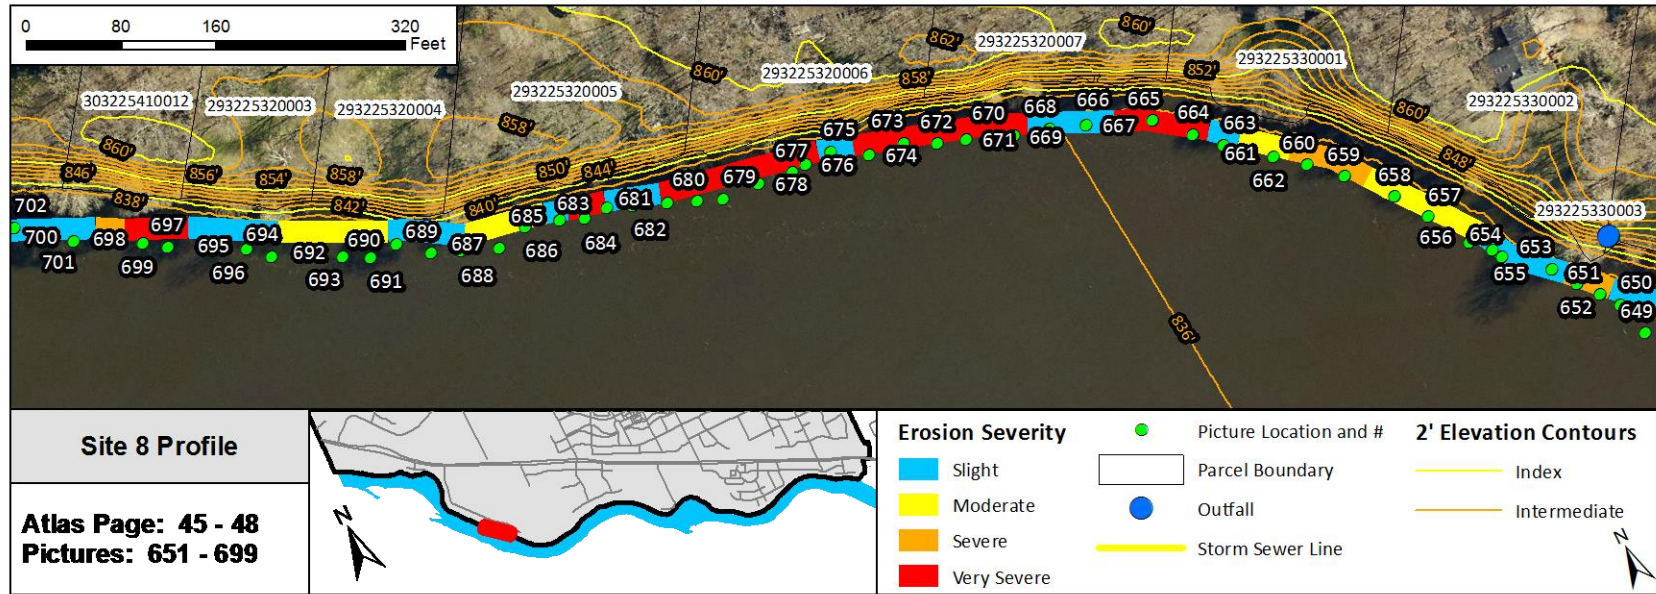
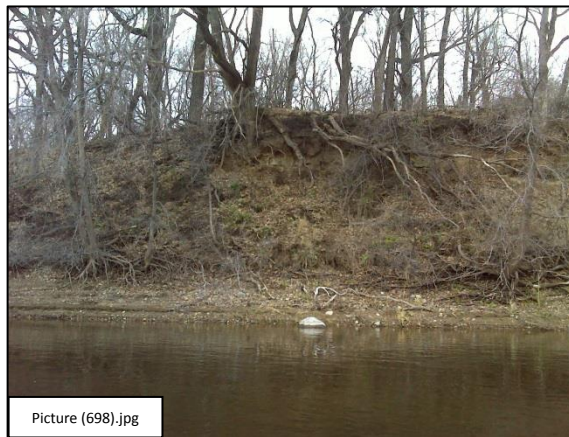
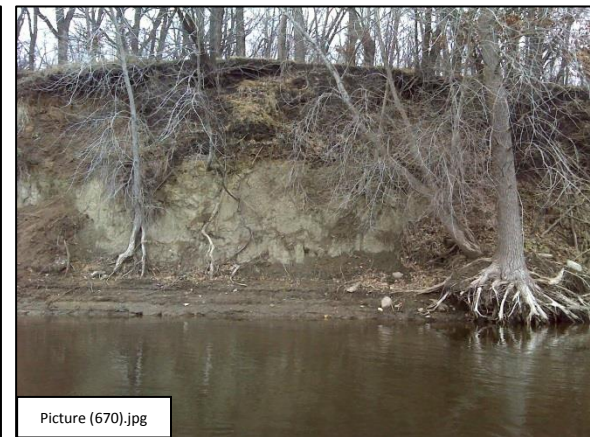
Additional Information:
Erosion at this site spans eight private properties and ranges from severe to very severe.

The very severe sections have fallen trees and bare bank.

Site Information	Ownership	Erosion Length (ft) Severe/Very Severe	Height (ft)	Depth (ft)	Slope (H:V)	Soil Loss (tons/yr)
	Private	589	8 - 22	12 - 33	1.5 - 1.9	653.5

Potential Solution: Most of the erosion sections are very severe and will likely require regrading of the bank. Hard armoring of the slope toe up to a modest elevation (e.g. 2-year or 5-year flood elevation) with native vegetation establishment on the remaining areas higher up the bank may be an effective stabilization option.

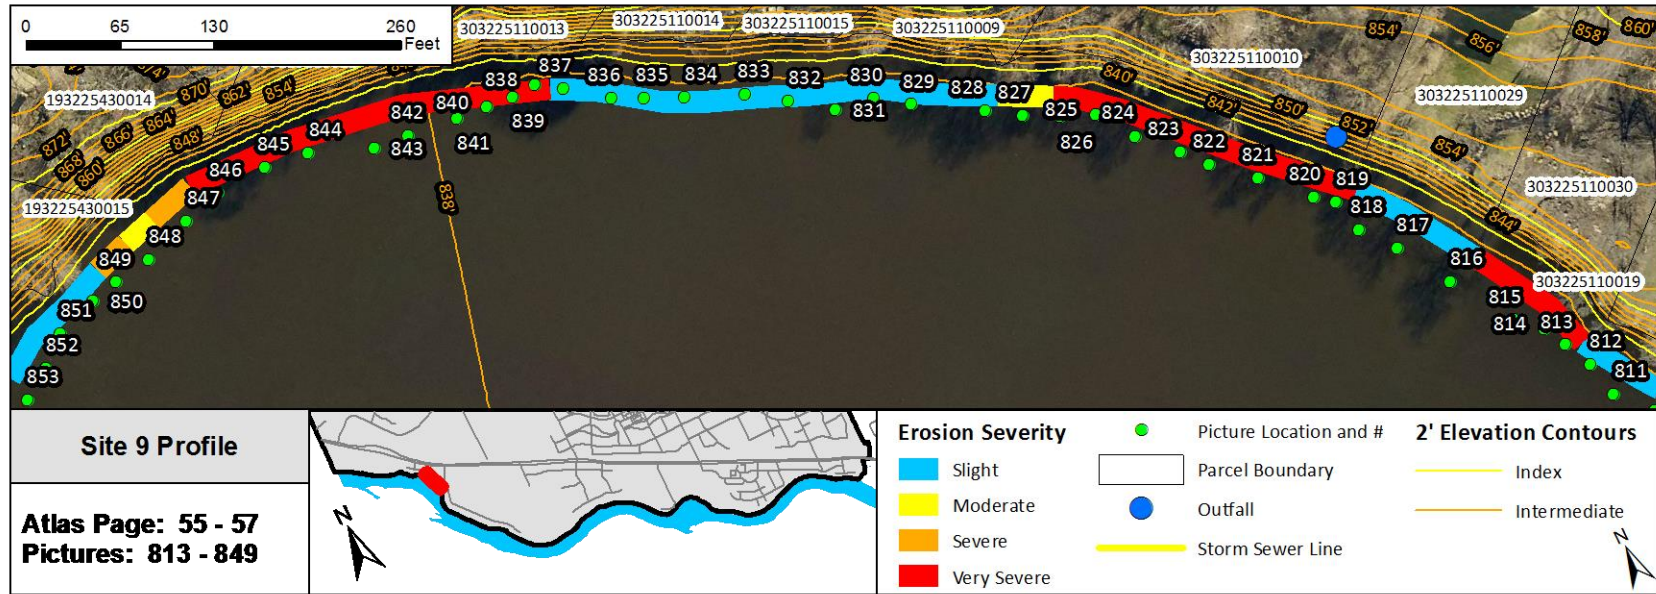
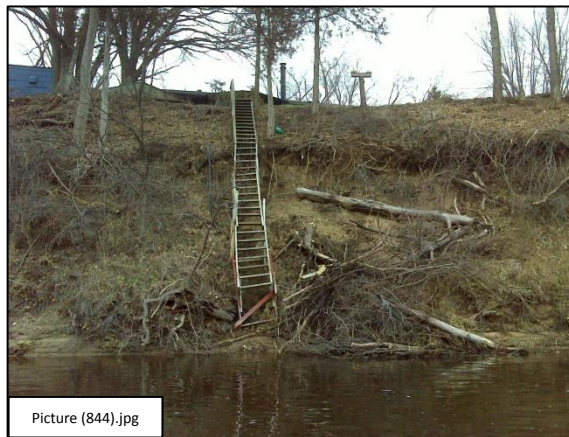
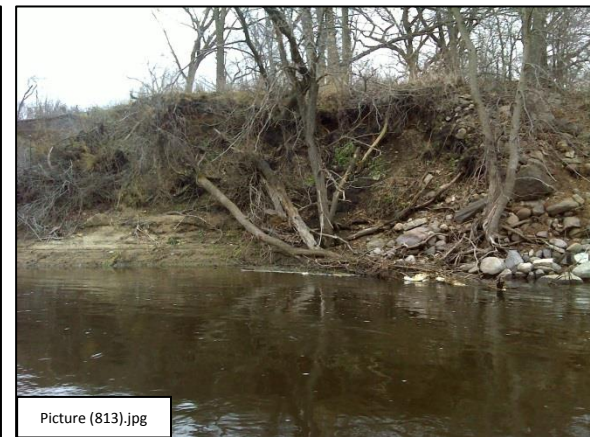
Erosion at this site spans seven private properties and ranges from severe to very severe, with most areas categorized as very severe. The very severe sections have fallen trees and bare bank.

Site Information	Ownership	Erosion Length (ft)	Height (ft)	Depth (ft)	Slope (H:V)	Soil Loss (tons/yr)
	Private	Severe/Very Severe	6 - 24	11 - 35	1.5 - 2.1	770.9

Potential Solution: Most of the erosion sections are very severe and will likely require regrading of the bank. Hard armoring of the slope toe up to a modest elevation (e.g. 2-year or 5-year flood elevation) with native vegetation establishment on the higher bank areas may be an effective stabilization option.

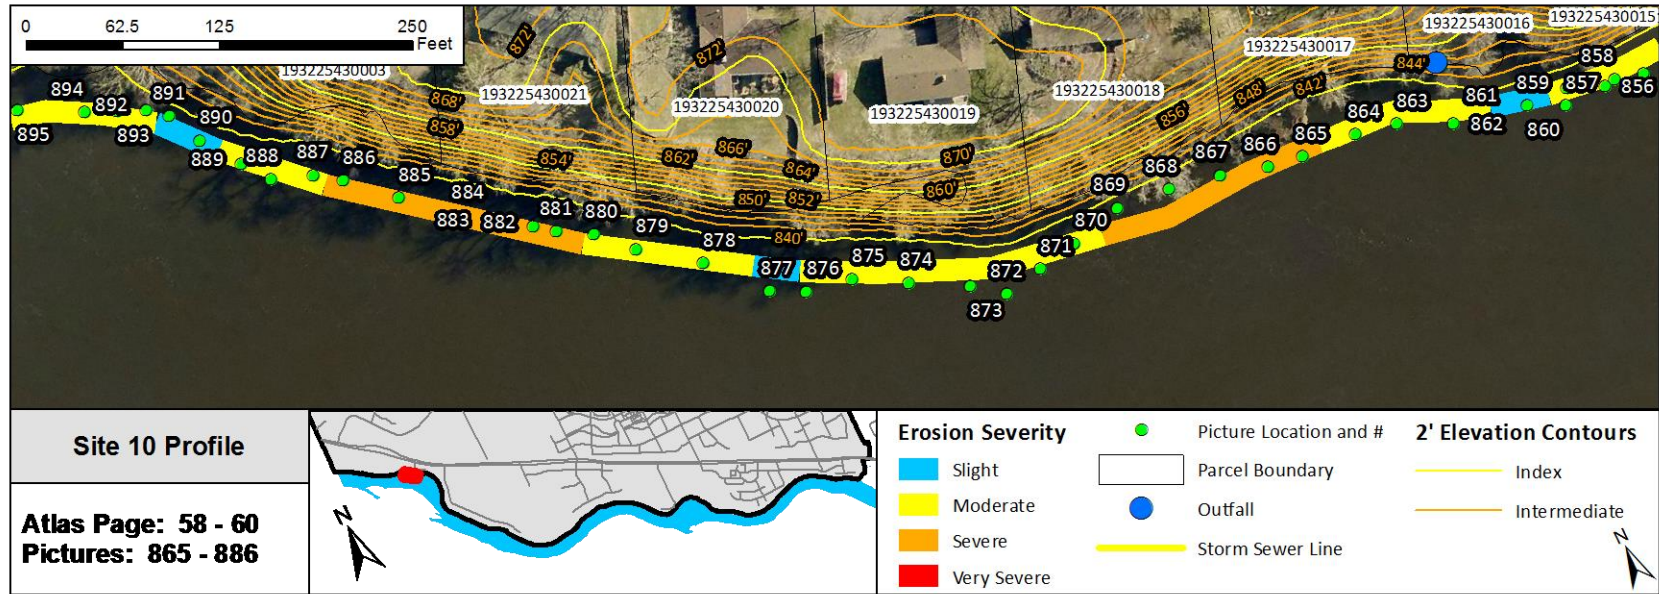
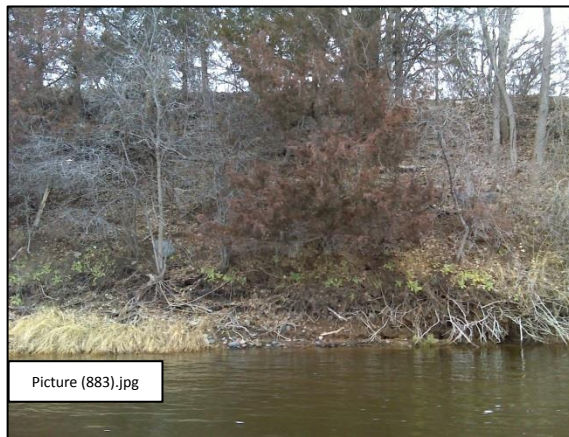
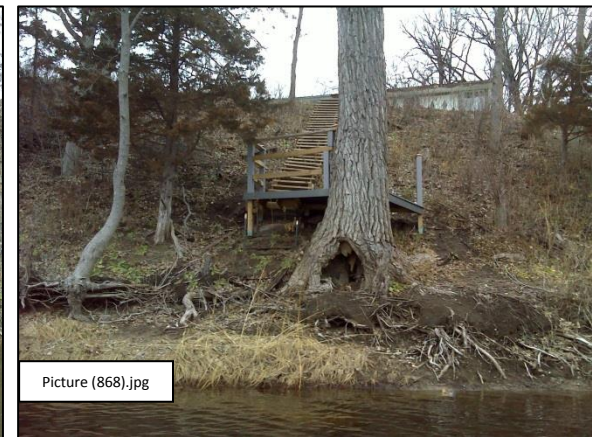
Additional Information: Two sections of severe erosion span four private properties in this site profile. The erosion is characterized by exposed tree roots and some undercutting of the bank.

Site Information	Ownership	Erosion Length (ft)	Height (ft)	Depth (ft)	Slope (H:V)	Soil Loss (tons/yr)
	Private	Severe/Very Severe	325	6 - 8	11 - 14	1.8

Potential Solution: Much of the erosion could possibly be addressed using cedar tree revetments inter-planted with native vegetation (e.g. Sandbar Willow or Buttonbush). Areas with more severe undercutting may need to be regraded and may warrant hard armoring at the toe with native vegetation higher on the bank.
