Memorandum

Re: Pavement Coring Forensic Report
City of Ramsey
WSB Project No. 015656-000

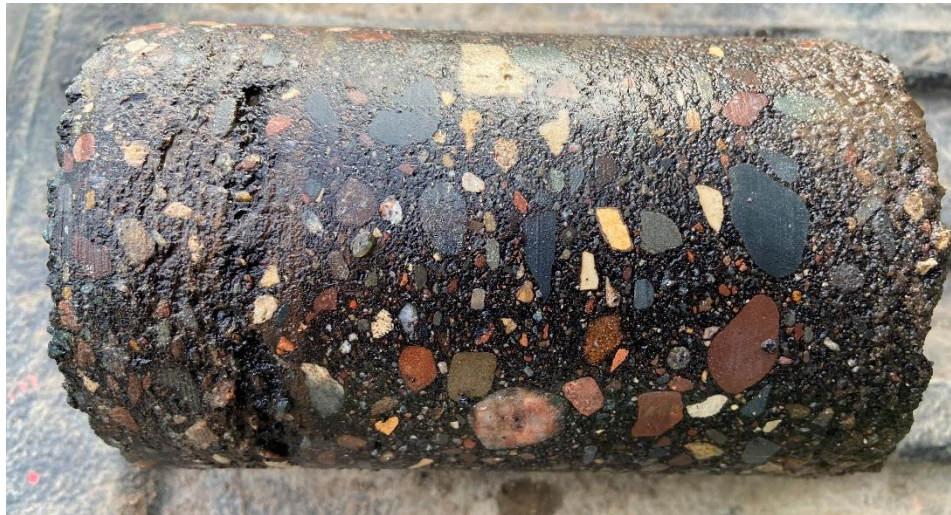
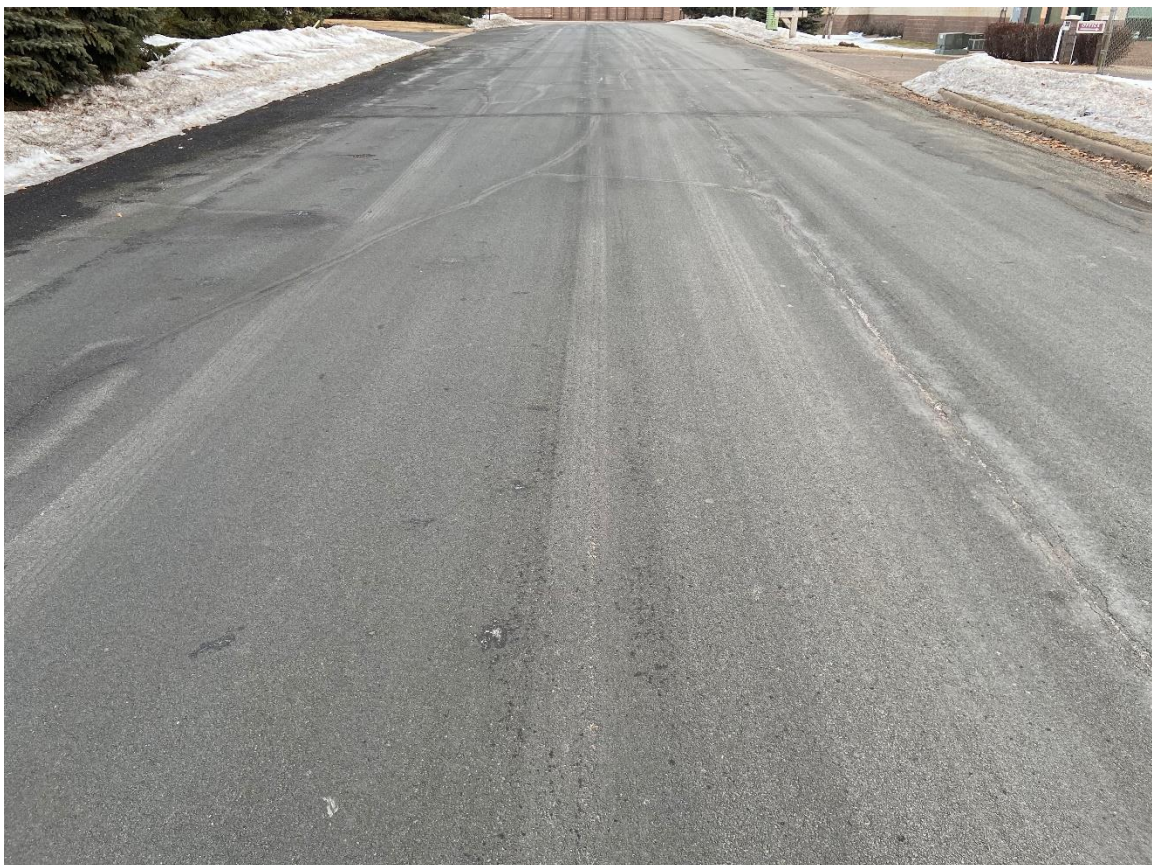
Core 1 (Unity Street)

Core ID	Location	Bit Depth (inches)	Agg. Depth ¹ (inches)	Notes	Recommended Maintenance
1	Unity Street	6	6	The top lift of pavement was 1.25 inches. This layer was starting to show signs of deterioration losing fines and binder. The rest of the core was bonded and showing minimal signs of aging.	2 Inch Mill and Overlay
2	Unity Street (On a Patched Area)	7	8	The top lift of pavement was 2 inches. This layer was starting to show signs of deterioration losing fines and binder. The patch was not bonded to the pavement section and was completely delaminated. The rest of the core was in decent shape.	2.5 Inch Mill and Overlay
3	140 th Avenue (On a Patched Area)	5	5.5	The top lift of pavement was 2.5 inches. The core completely fell apart upon removal from the hole.	Full Depth Reclamation, Full Bituminous Removal and Replacement or Reconstruction
4	Unity Street (On a Patched Area)	8	5.5	The top lift of pavement was 2 inches. The top 4 inches of pavement broke off from the rest of the core and showed parts were delaminated with no bond. Below the top 4 inches, the core completely fell apart.	Full Depth Reclamation, Full Bituminous Removal and Replacement or Reconstruction

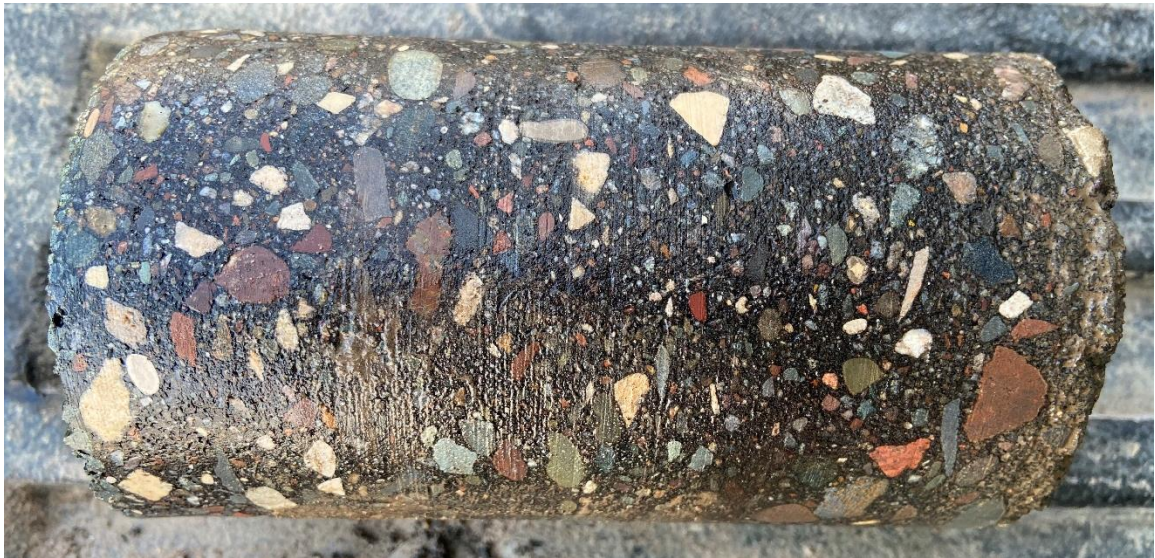
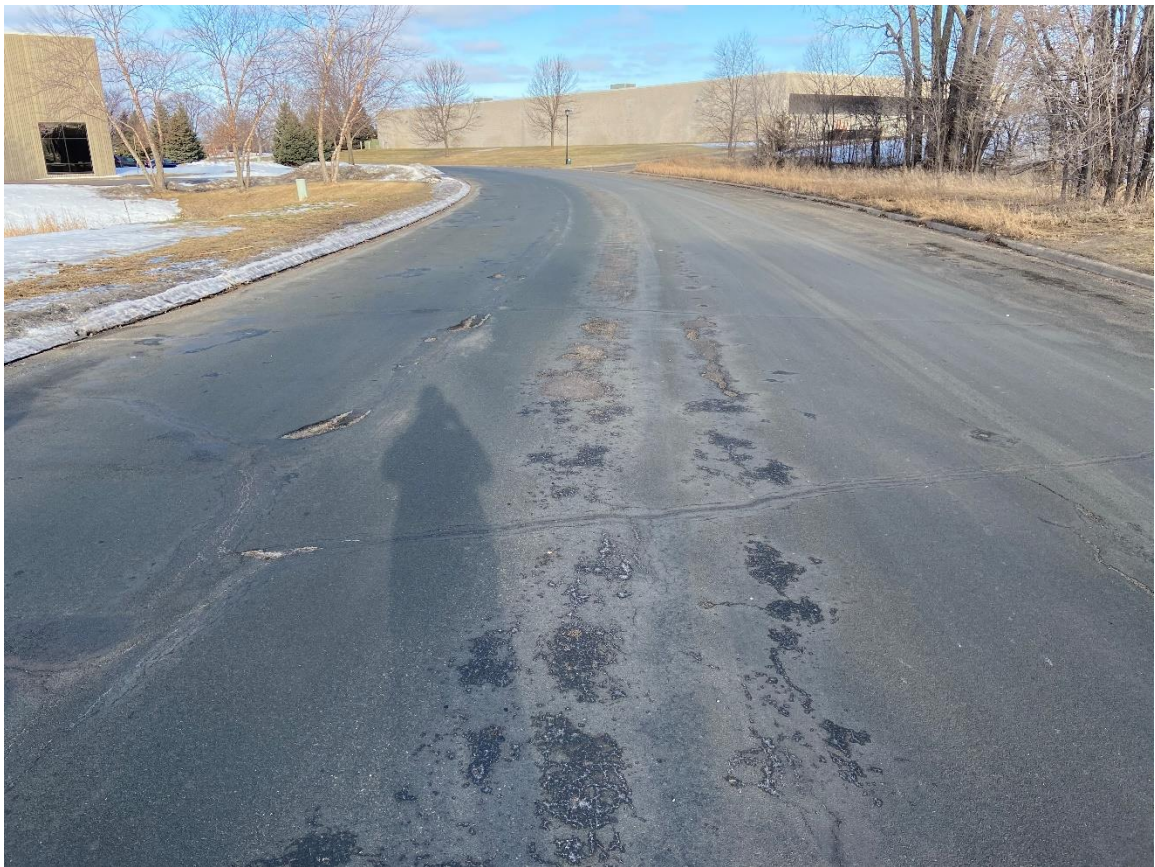
Core 5 (McKinley Street)

5	McKinley Street	6.5	6.5	The top lift of pavement was 1.75 inches. The core was in good shape, all the layers were bonded together well.	2 Inch Mill and Overlay

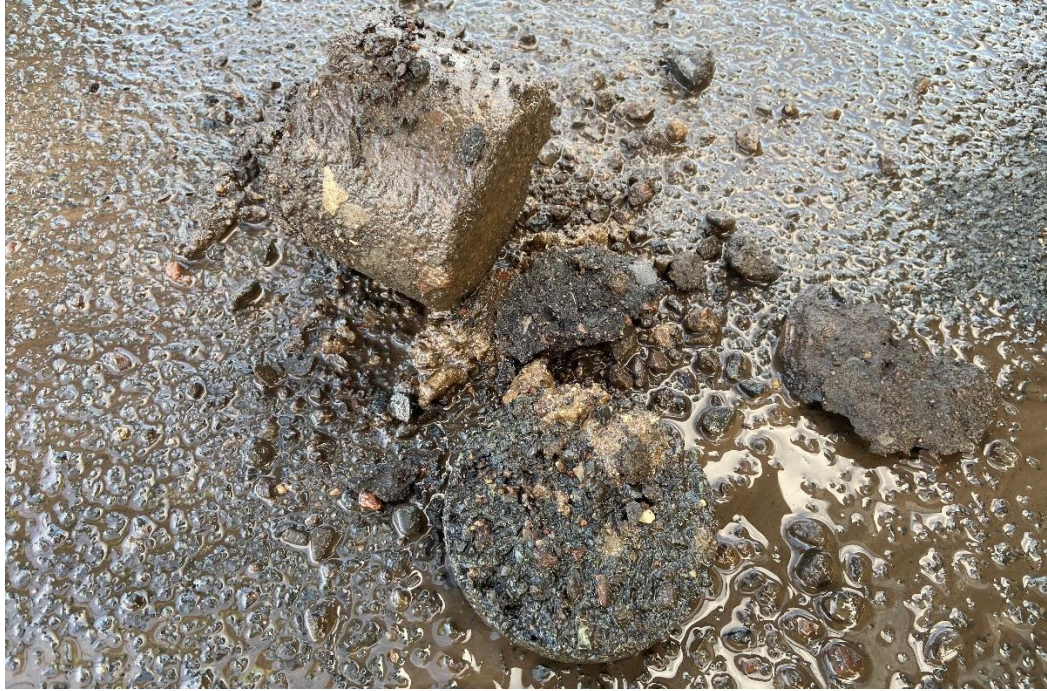
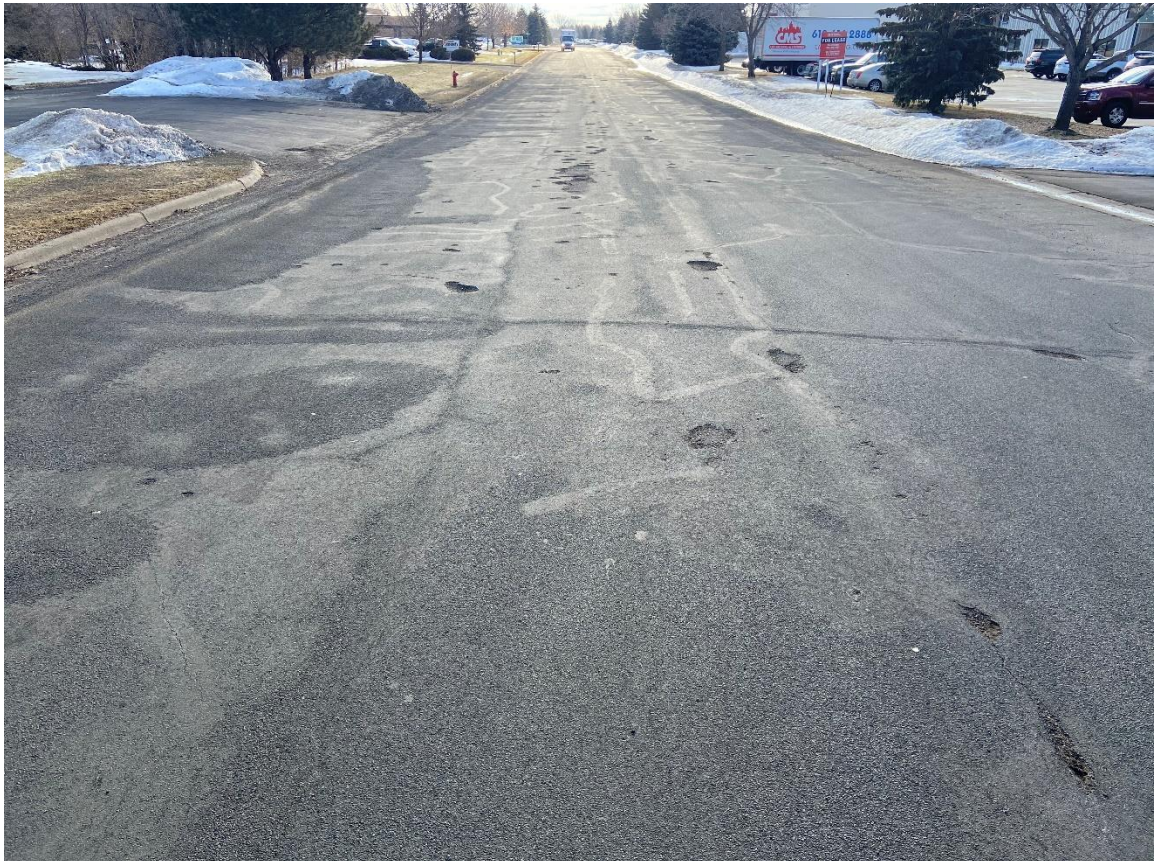
Core 6 (McKinley Street on a Patched Area)

6	McKinley Street (On a Patched Area)	6	9.5	The top 3 inches of pavement was completely raveled and broke apart upon removal from the core hole. The bottom 3 inches was bonded together. Because the top 3 inches crumbled the lift thickness of the wear course could not be determined.	Full Depth Reclamation, Full Bituminous Removal and Replacement or Reconstruction
7	McKinley Street (On a Patched Area)	4.75	9	This core was in very poor condition with delamination of the patch as well as a severe loss of fines and binder throughout.	Full Depth Reclamation, Full Bituminous Removal and Replacement or Reconstruction
8	Radium Street (On a Patched Area)	4	5	This core was in very poor condition with delamination of the patch as well as a severe loss of fines and binder throughout. The core broke apart upon removal from the core hole.	Full Depth Reclamation, Full Bituminous Removal and Replacement or Reconstruction

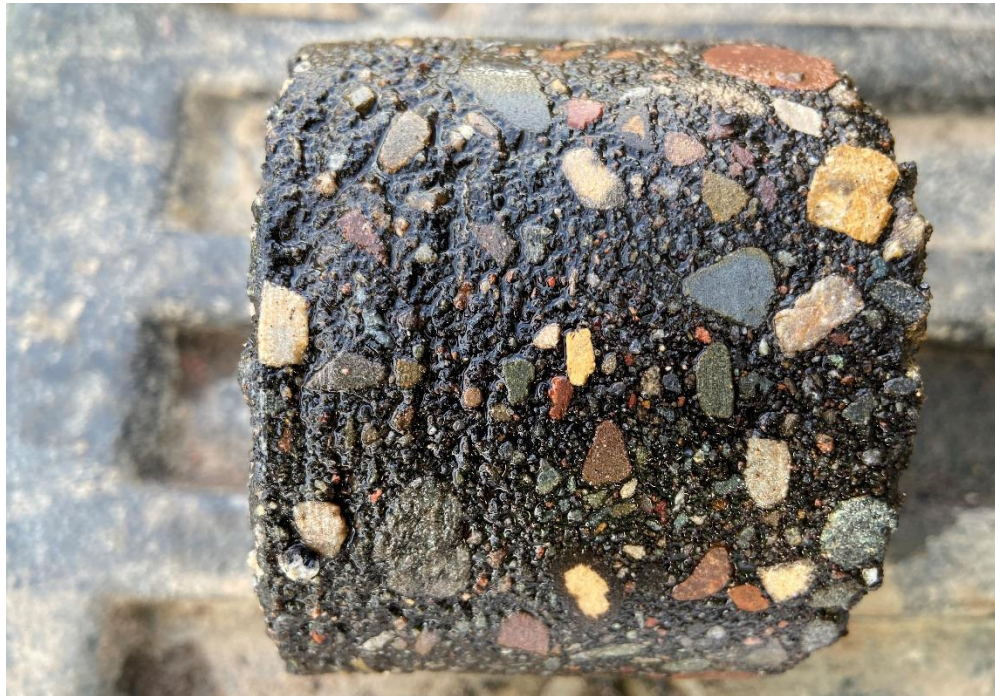
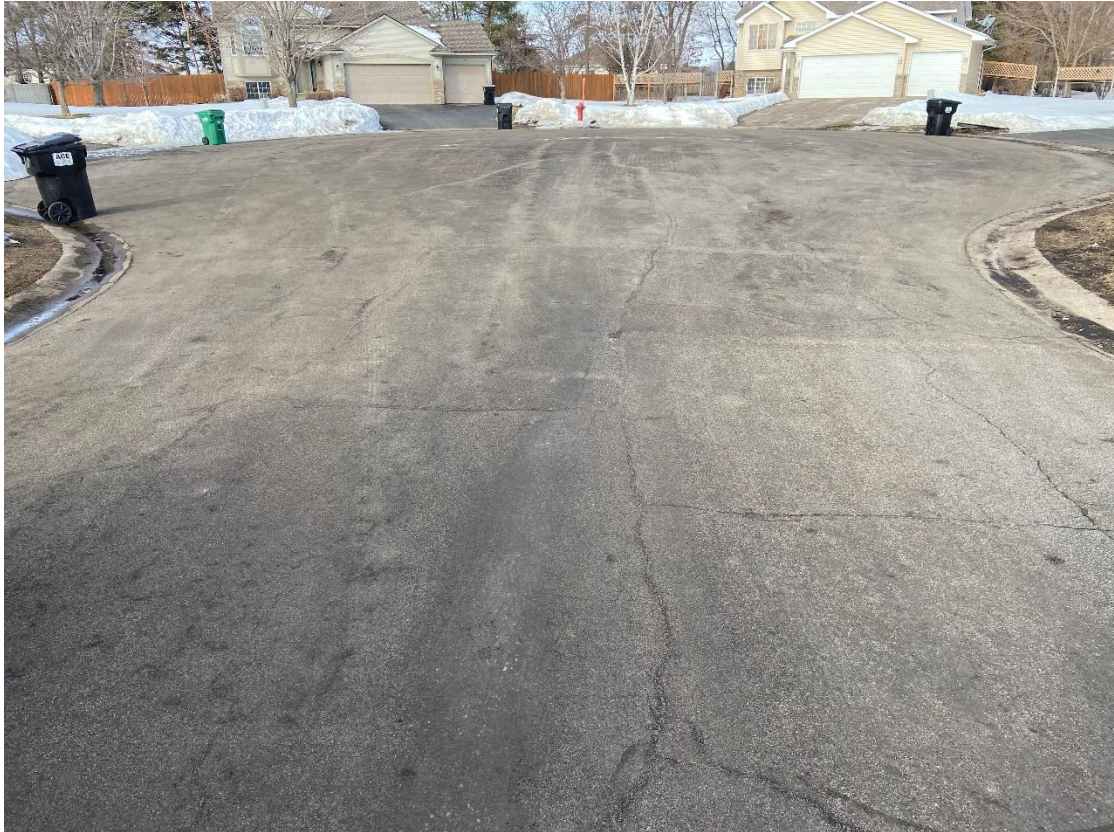
Core 9 (148th Lane)

9	148 th Lane	3	6	The core was in fair condition. The layers were bonded together. The core was starting to show signs of aging losing fines and binder.	Full Depth Reclamation, Full Bituminous Removal and Replacement or Reconstruction
10	148 th Lane	3	4	This core was in very poor condition and broke apart upon removal from the core hole.	Full Depth Reclamation, Full Bituminous Removal and Replacement or Reconstruction
11	148 th Lane	2.5	5	The core was in fair to poor condition. The layers were bonded together. The core was starting to show signs of aging losing fines and binder.	Full Depth Reclamation, Full Bituminous Removal and Replacement or Reconstruction
12	Limonite	2	4.5	The core was in fair condition. This was a very thin lift of	Full Depth Reclamation, Full Bituminous Removal

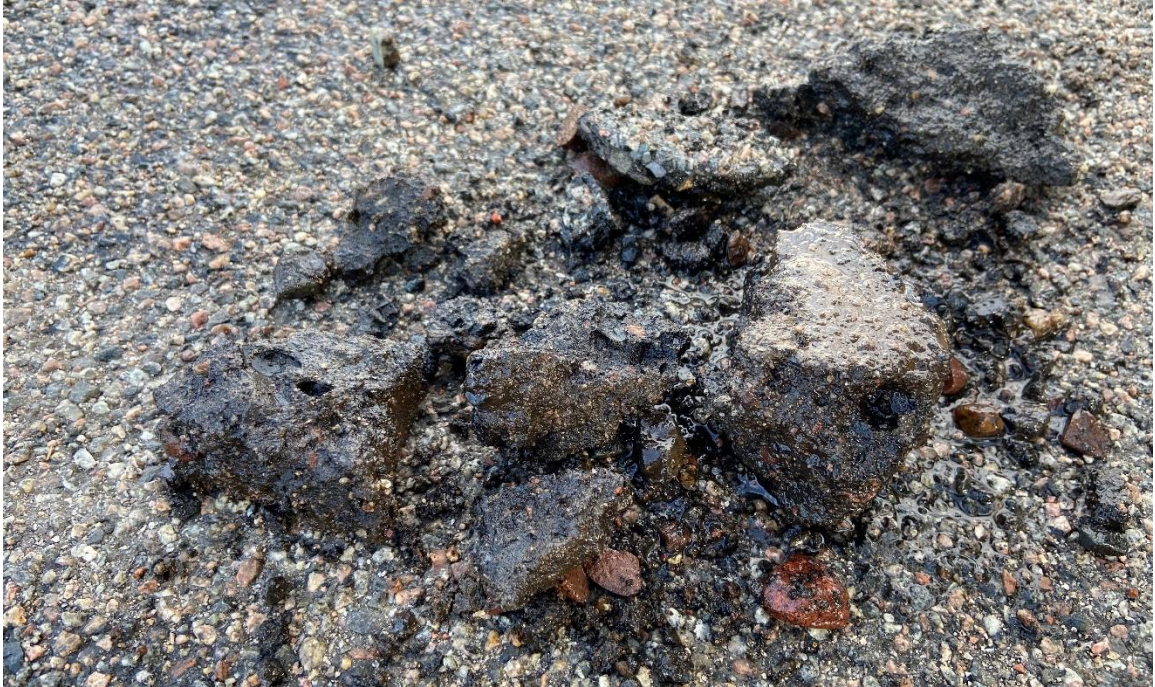
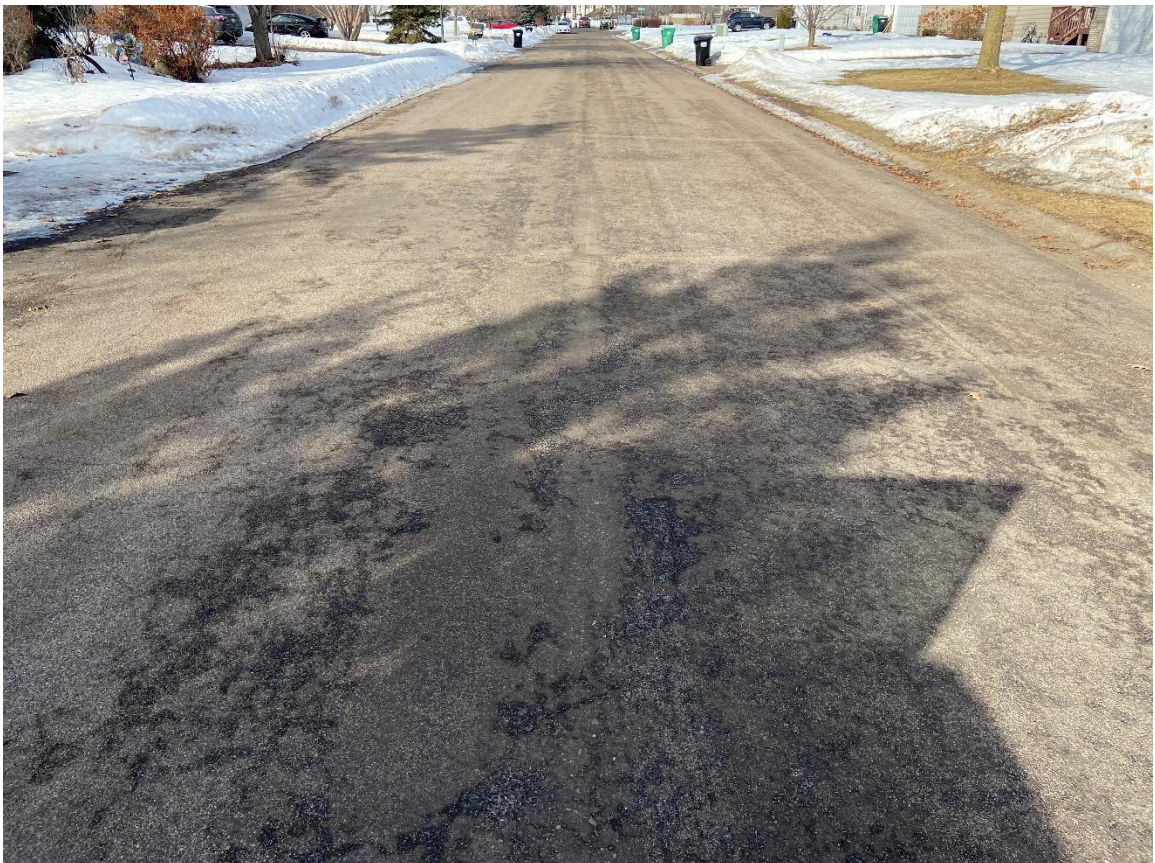
Core 13 (148th Avenue)

pavement and was starting to show signs of aging, losing fines and binder.	and Replacement or Reconstruction
13	148 th Avenue	2	6	This core was in very poor condition and broke apart upon removal from the core hole.	Full Depth Reclamation, Full Bituminous Removal and Replacement or Reconstruction
14	Kamacity Street	2.75	3.75	The core was in fair to poor condition. The layers were bonded together. The core was starting to show signs of aging losing fines and binder.	Full Depth Reclamation, Full Bituminous Removal and Replacement or Reconstruction
15	Limonite	2	7	This core was in very poor condition and broke apart upon removal from the core hole.	Full Depth Reclamation, Full Bituminous Removal and Replacement or Reconstruction
16	Limonite	2	5	The core was in fair condition. This was a very thin lift of pavement.	Full Depth Reclamation, Full Bituminous Removal and Replacement or Reconstruction

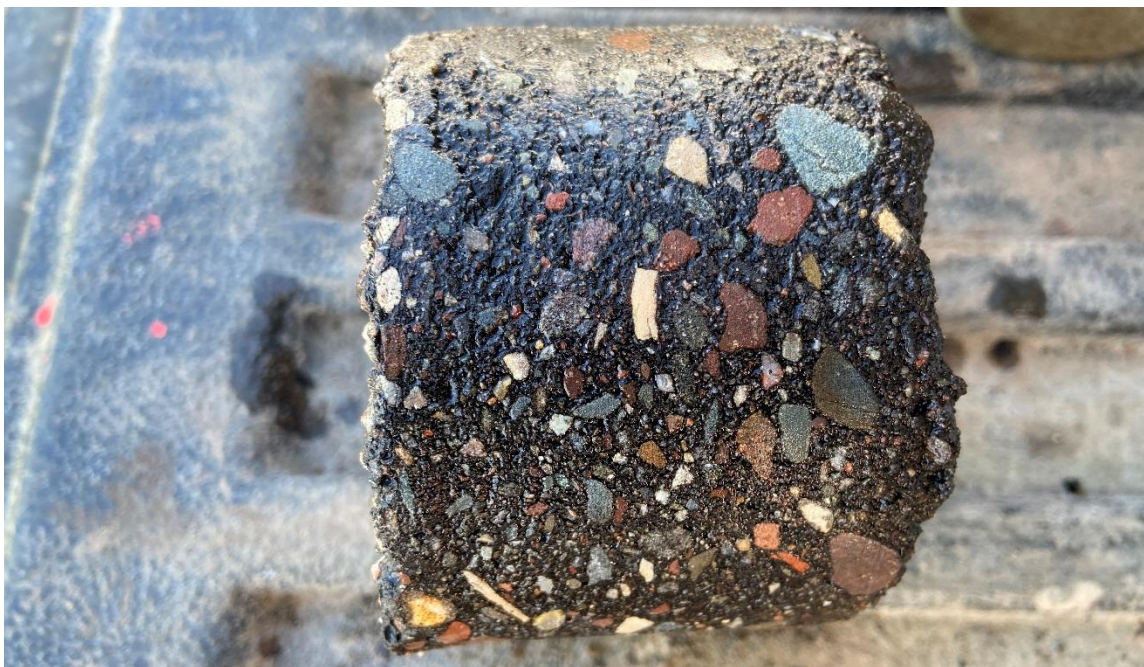
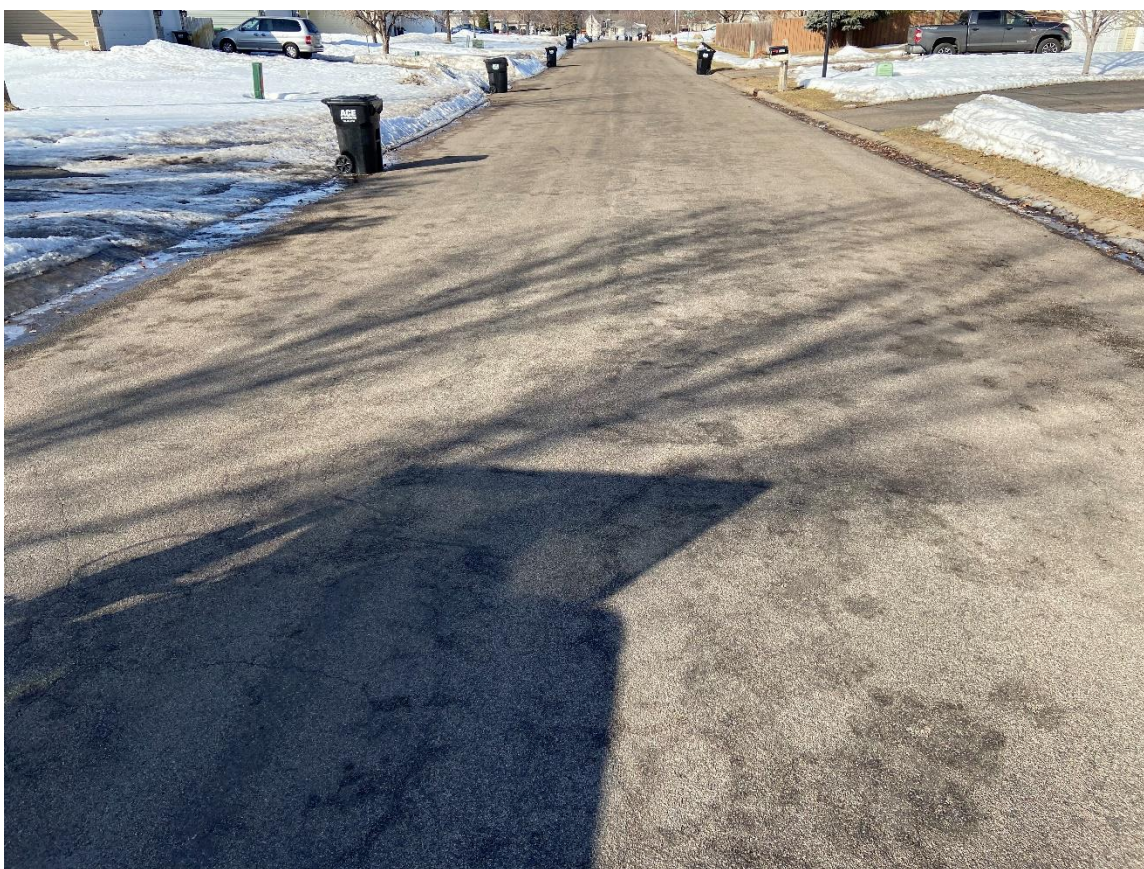
Core 17 (147th Avenue)

17	147 th Avenue	3	4	The core was in fair condition. The layers were bonded together. The core was starting to show signs of aging losing fines and binder.	Full Depth Reclamation, Full Bituminous Removal and Replacement or Reconstruction
18	147 th Avenue	4	5	This core was in very poor condition and broke apart upon removal from the core hole.	Full Depth Reclamation, Full Bituminous Removal and Replacement or Reconstruction
19	Hematite	3.75	4.75	The core was in fair condition. The layers were bonded together. The core was starting to show signs of aging losing fines and binder.	Full Depth Reclamation, Full Bituminous Removal and Replacement or Reconstruction
20	146 th Circle	2.5	11	The core was in good to fair condition. This was a thin lift of pavement.	Full Depth Reclamation, Full Bituminous Removal and Replacement or Reconstruction
¹ Subgrade material was observed to be sand material on Cores 1 through 10 and sand/gravel on Cores 11 through 20.
