Historic Ramsey Town Hall: Ramsey, MN

Prepared by

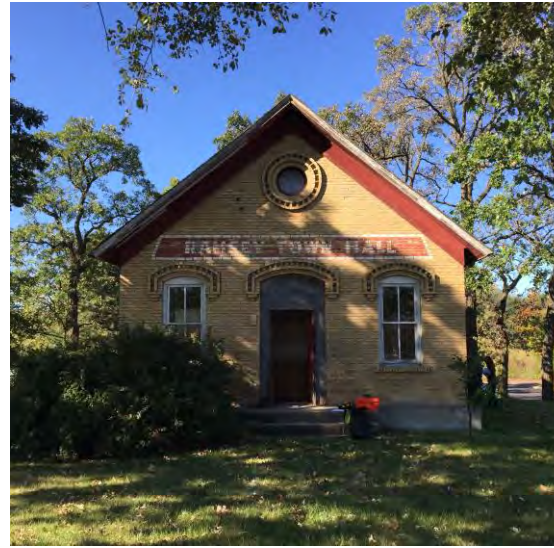
Figure 1 – Ramsey Town Hall Primary Façade

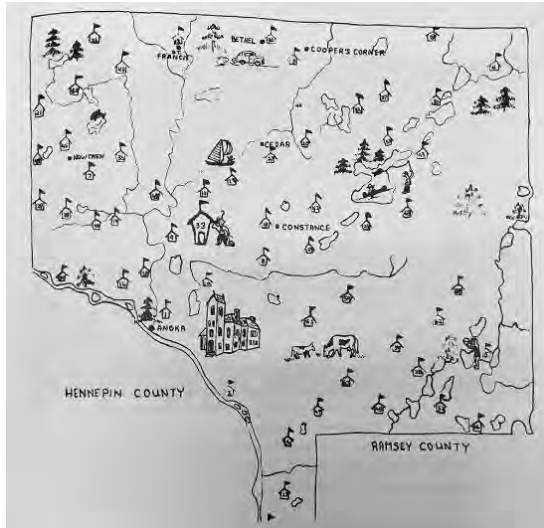
Figure 3 – Anoka Co Schools, No. 28 in Blue

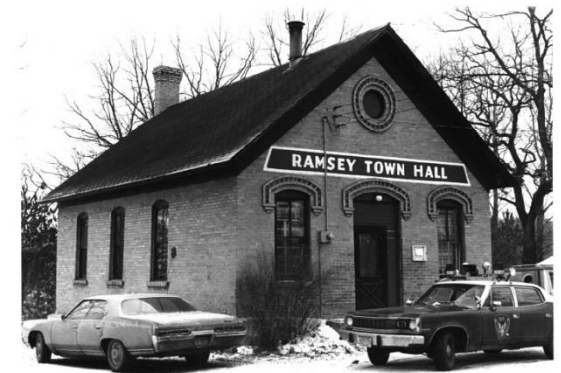
Figure 4 – Ramsey Town Hall 1978

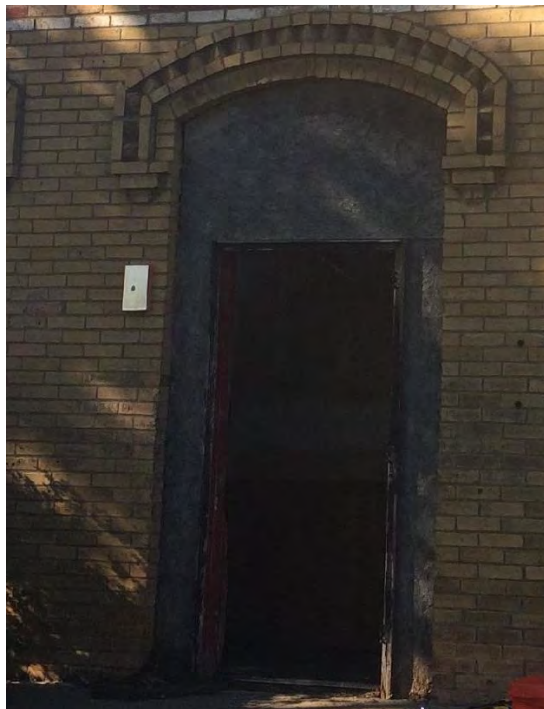
Figure 5 – Front Entrance with Particleboard

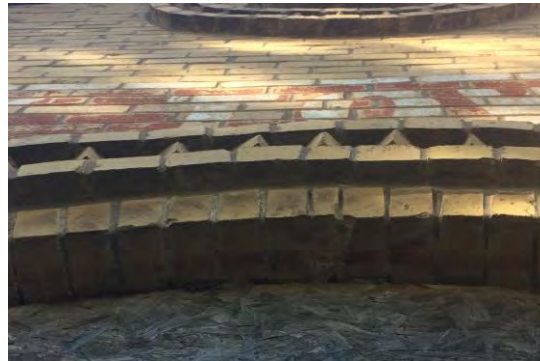
Figure 6 – Red Paint on Overhead Framing

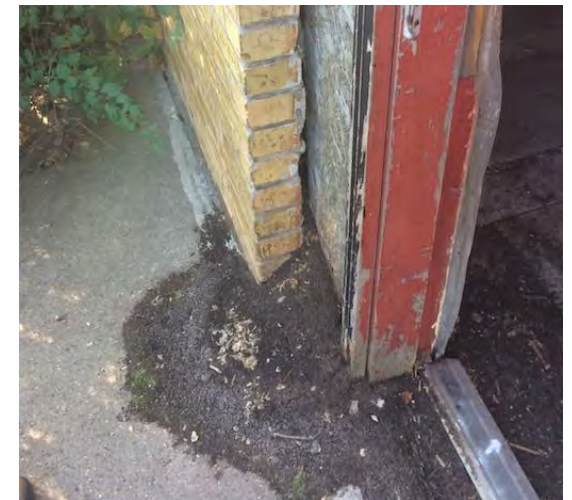
Figure 8 – Organic Matter near Front Door

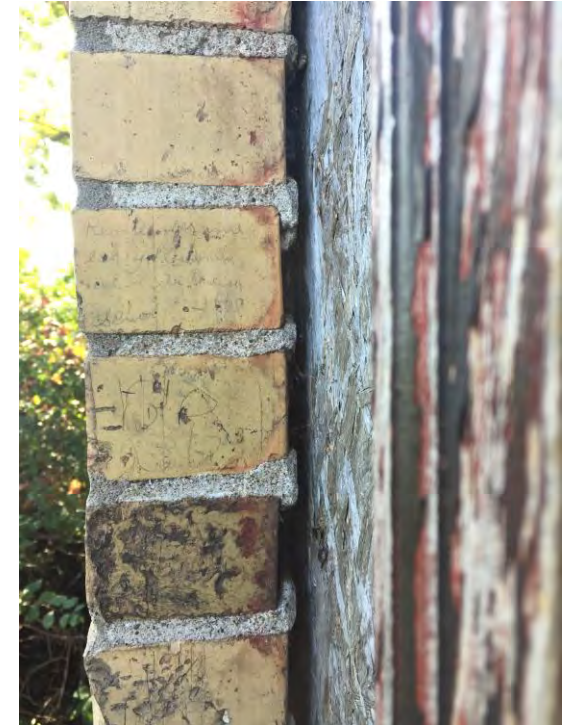
Figure 10 – Accessible Gap Behind Brick

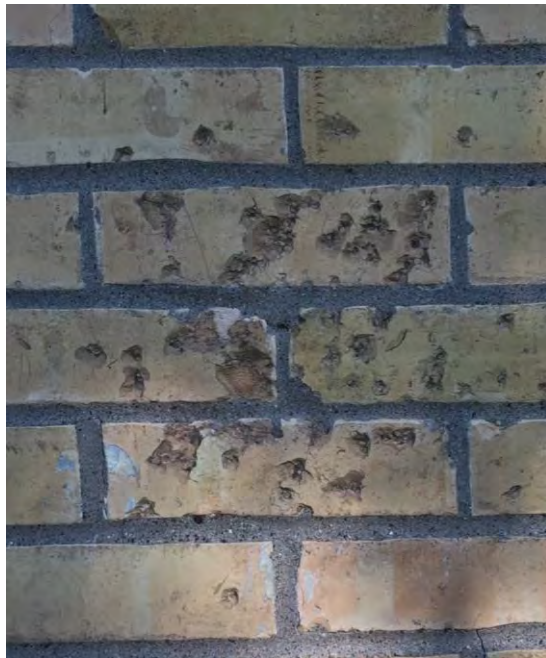
Figure 12 – Gunshot Pattern in Brick

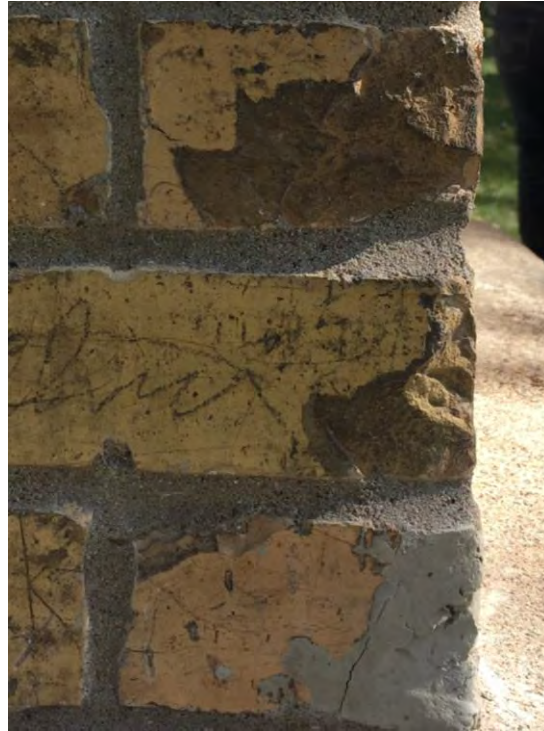
Figure 13 – Broken Brick at Corner

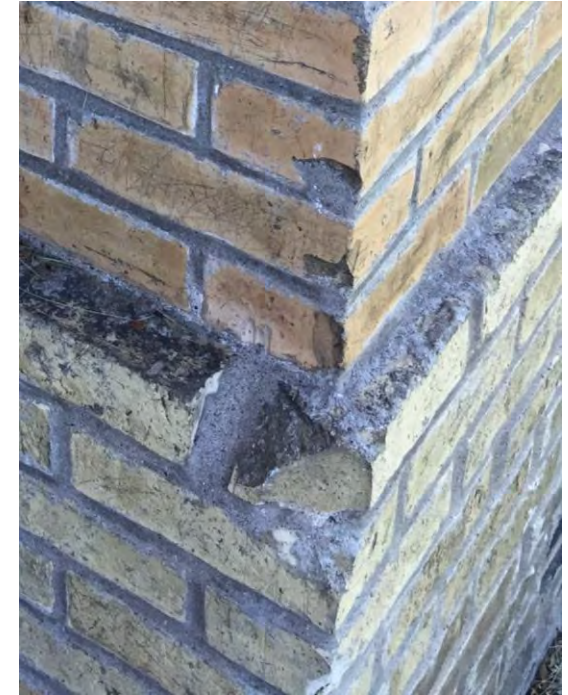
Figure 14 – Environmental Degradation

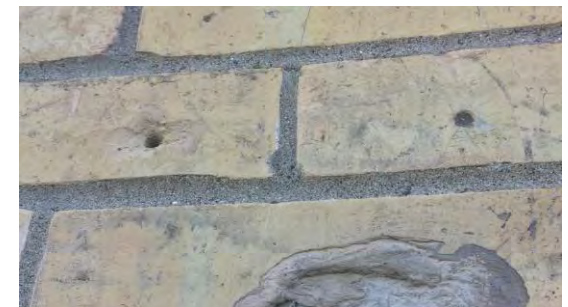
Figure 15 – Holes in Brick from Sign

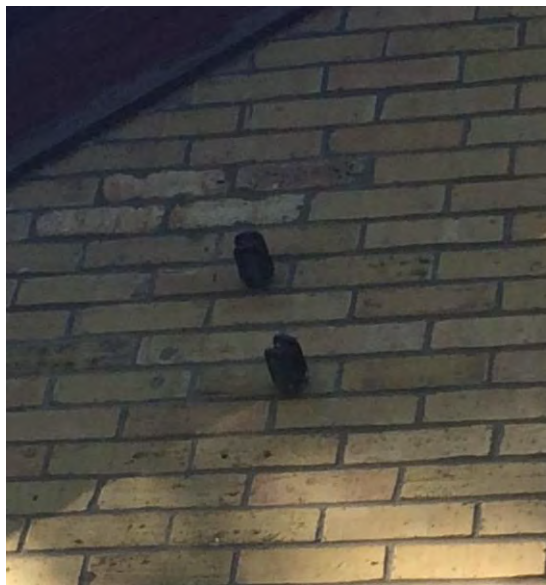
Figure 17 – Metal Brackets in Brick

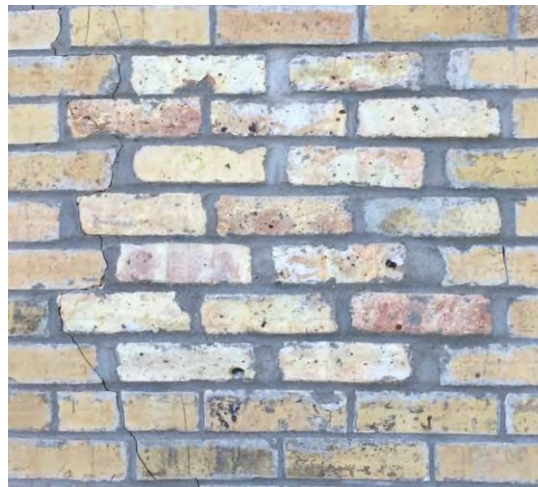
Figure 18 – Attempted Repointing

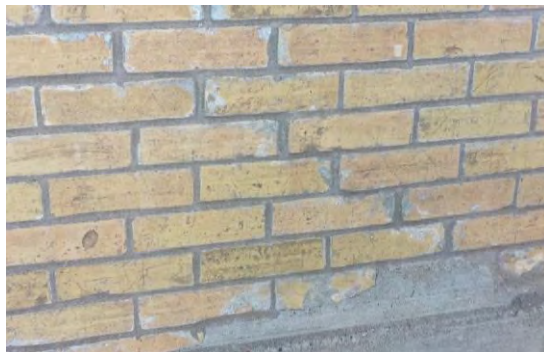
Figure 21 – Mortar Replacement to Fill Voids

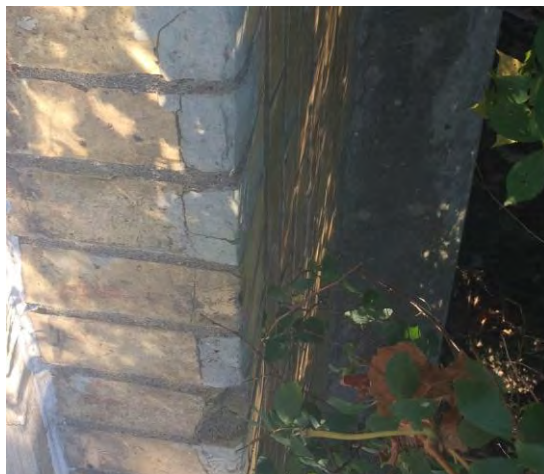
Figure 22 – Mortar Replacement to Fill Voids

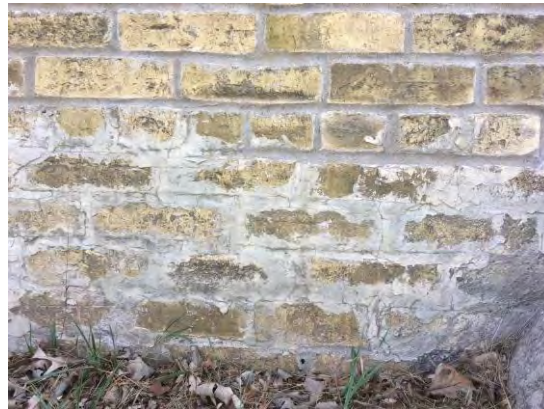
Figure 23 – Deteriorated Brick with Mortar

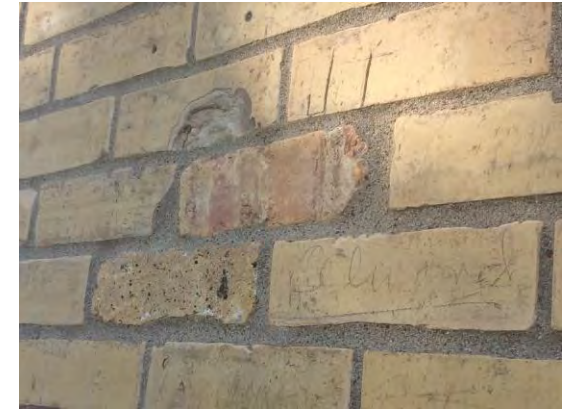
Figure 23 – Replacement Bricks

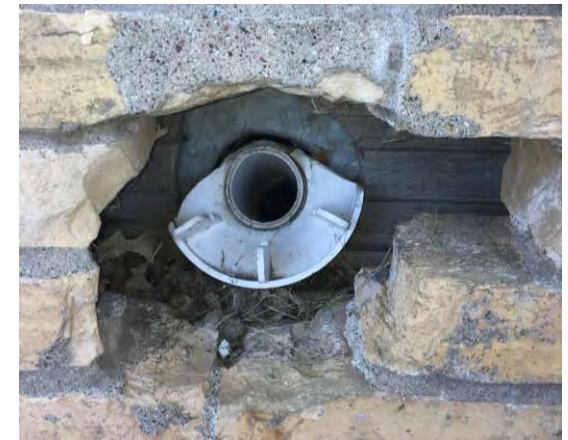
Figure 23 – Exterior Pipe Penetration

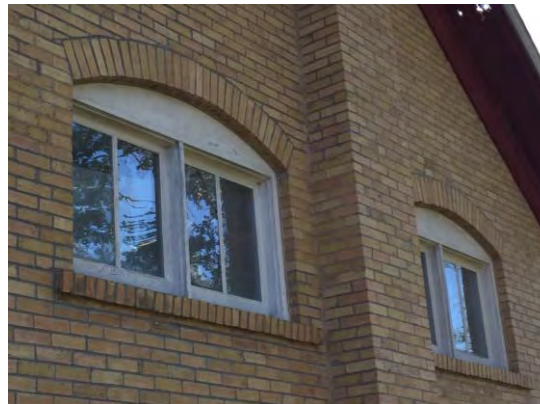
Figure 24 – Rear Window

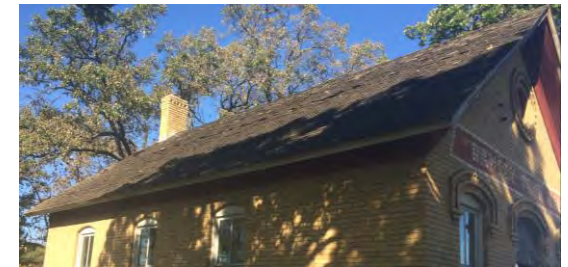
Figure 28 – Asphalt Shingles

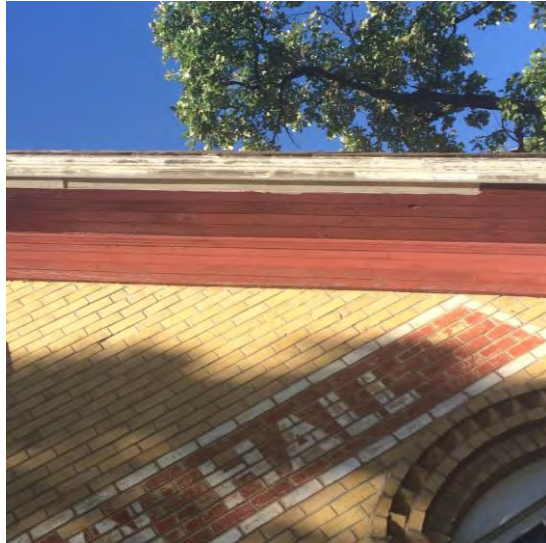
Figure 29 – Wooden Soffit and Fascia

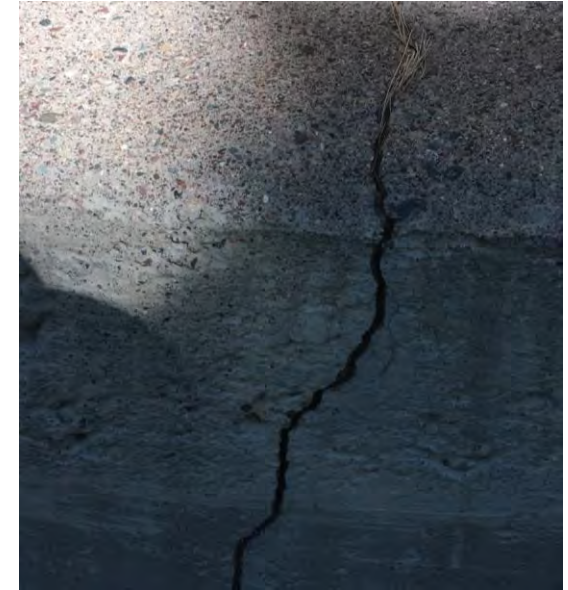
Figure 30 – Concrete Curb Crack

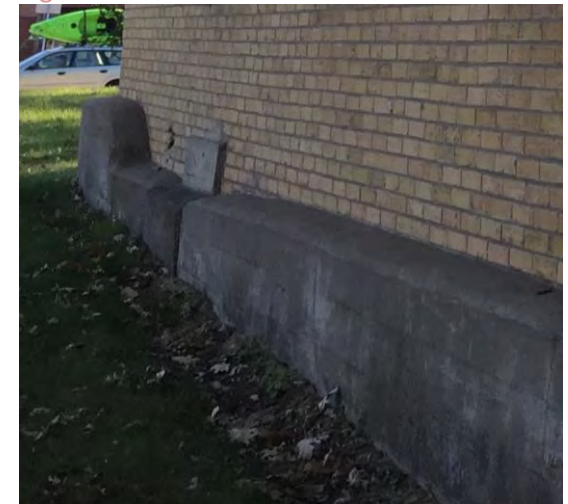
Figure 31 – North Elevation Window

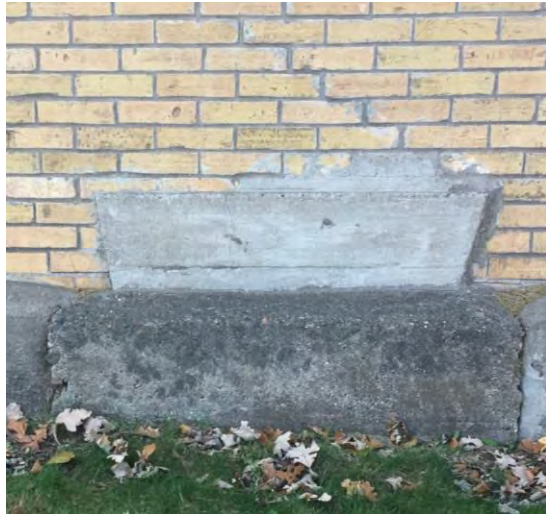
Figure 30 – South Elevation Window

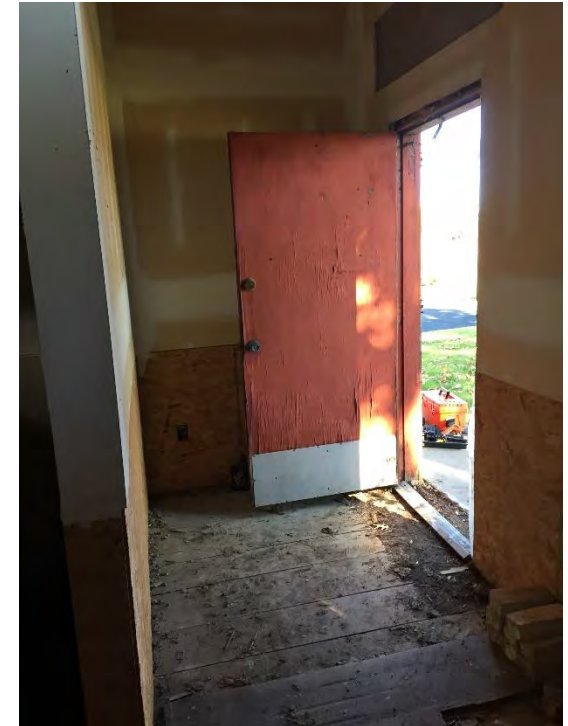
Figure 31 – Entry Hall

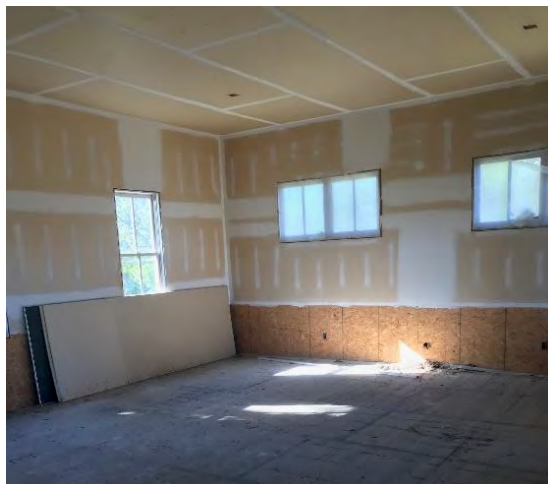
Figure 34 – Main Room, Northwest Corner

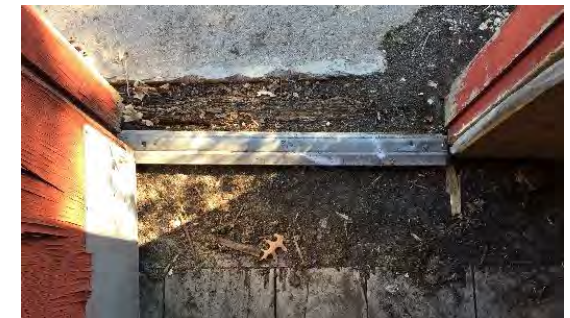
Figure 34 – Entry Hall Flooring at Threshold

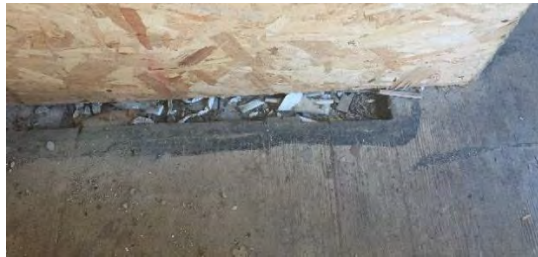
Figure 35 – Main Room, Holes in Floor

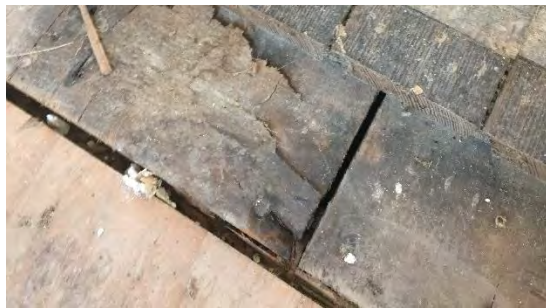
Figure 35 – Bathroom Water Damage

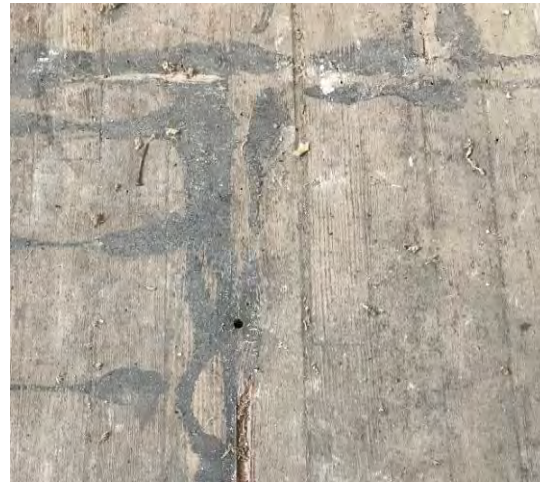
Figure 36 – Holes Along Wood Grain

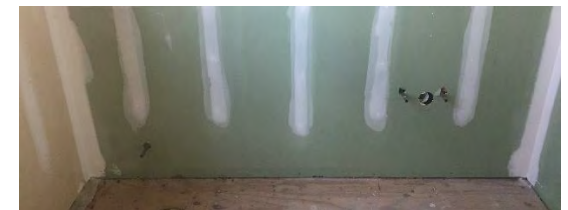
Figure 38 – Bathroom Plumbing

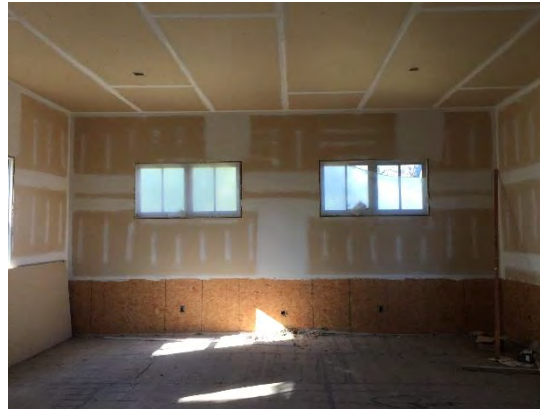
Figure 39 – Main Room, West Wall

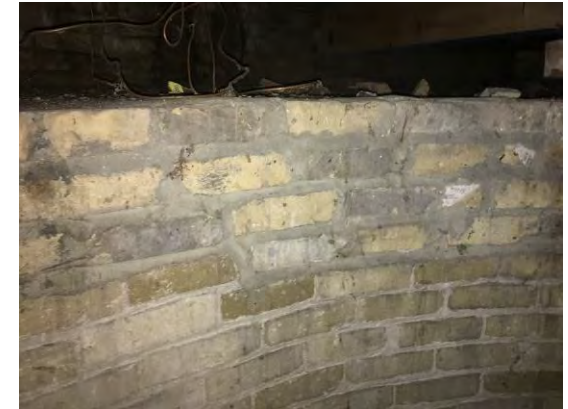
Figure 40 – Clay Masonry Wall

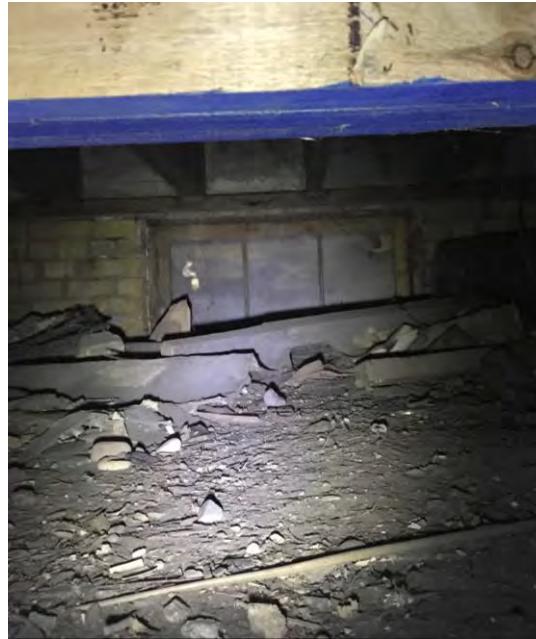
Figure 42 – Exterior Basement Window

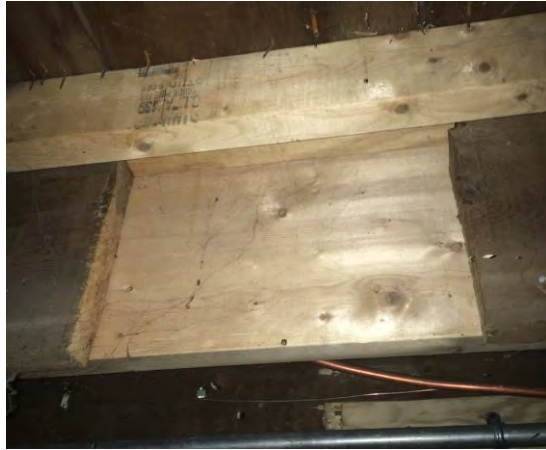
Figure 44 – Replacement Floor Joist

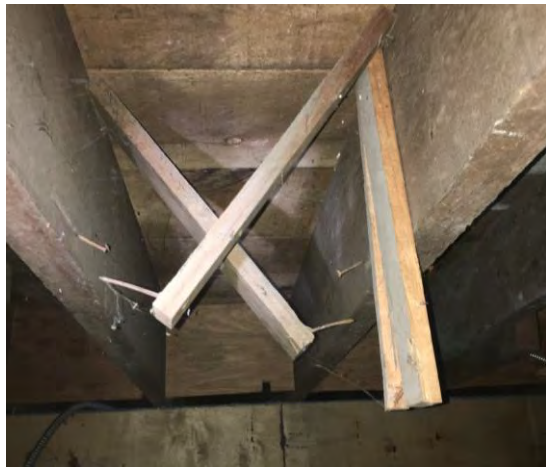
Figure 45 – Joist Cross Bracing

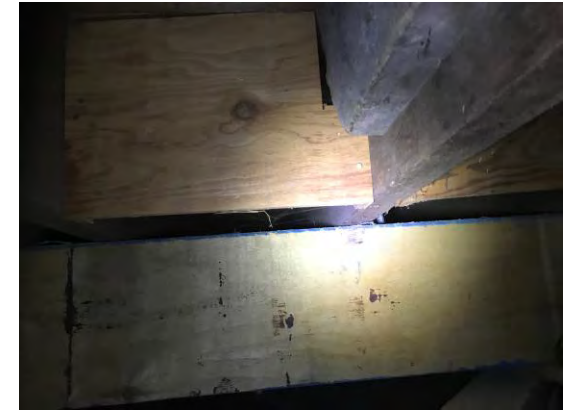
Figure 46 – Intermediate Beam

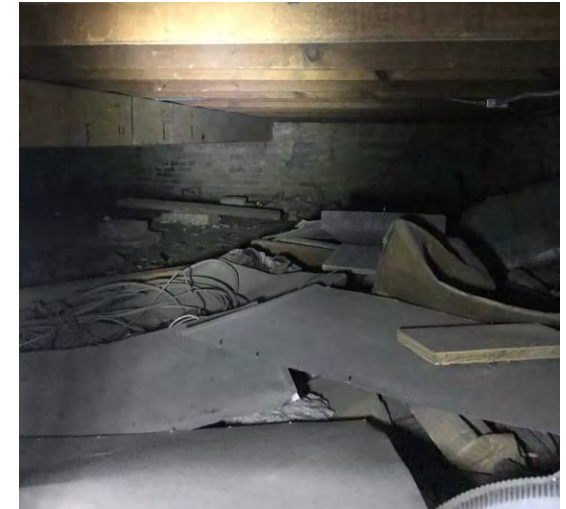
Figure 50 – Crawl Space with Debris
