# Historic Ramsey Town Hall: Ramsey, MN

Corinne Deger, Morgan Kuehn, Kate Stanger, and  
Vanessa Walton

Students in ARCH 5672: Historic Building Conservation  
Instructor: Todd Grover  
College of Design

Prepared in Collaboration with  
Kurt Ulrich  
City Administrator, City of Ramsey

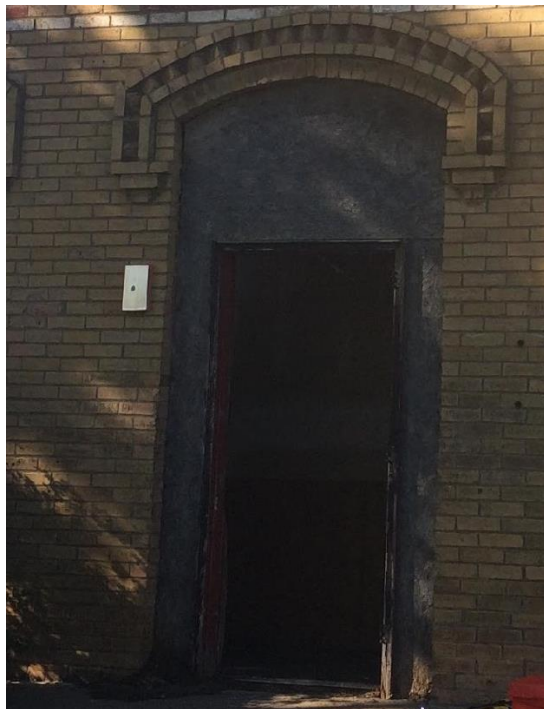
The entrance of the building is fitted with particleboard, which has allowed the use of a standard size door in place of what was likely a door and curved transom window.

Figure 5 – Front Entrance with Particleboard

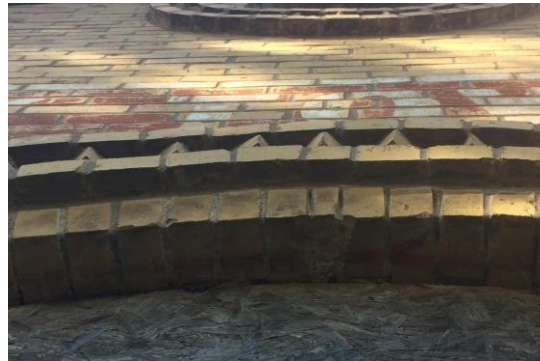
By the looks of the paint that is left on the brick near top and sides of the particleboard insert, the original wood door and framing was red. The door that is currently present, while functioning, is in poor condition.

Figure 6 – Red Paint on Overhead Framing

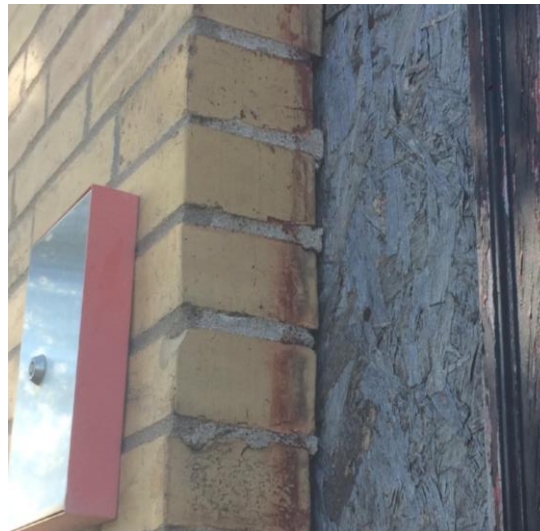
Figure 7 – Red Paint on Side Framing

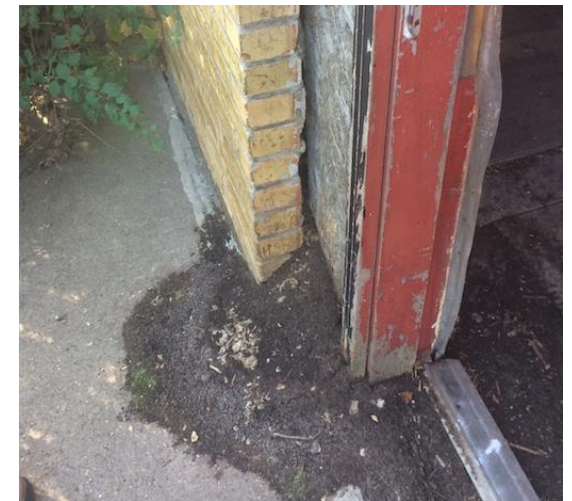
Organic matter from bats is piled on the left side of the front door.

Figure 8 – Organic Matter near Front Door

Primarily, the pile of organic matter at the entrance of the door should be removed. It poses a health hazard.

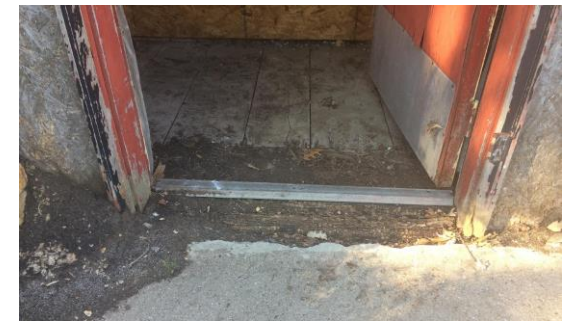
There is damage to the threshold of the front door and beyond the entrance exposing what looks to be part of the wood subfloor of the building.

Figure 9 – Front Door Threshold

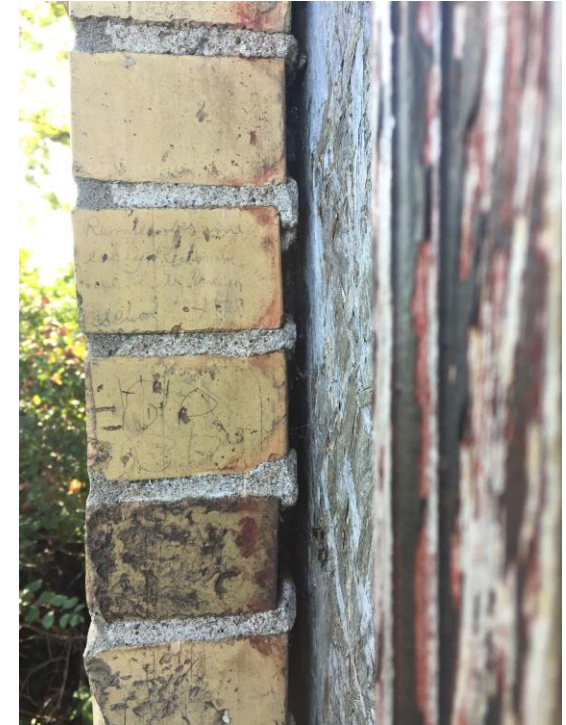
The façade is covered in a yellow Chaska brick veneer. While there have been some repairs to several sections of the facade; there are still a few problem areas. On the front facade, the use of plywood around the door caused gaps in between the plywood and the brick. These gaps gave us an opportunity to get a better look at the wood structure without taking out any bricks.

Figure 10 – Accessible Gap Behind Brick

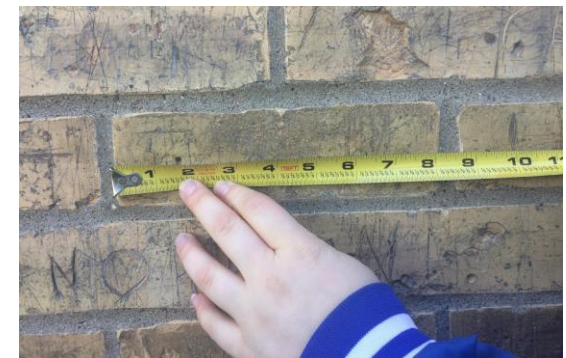
There is some deterioration of the brick caused by humans. Many of the bricks have carvings and etchings.

Figure 11 – Carvings and Etchings in Brick

Carvings in the brick are not currently a problem. Some would argue that leaving them provides a specific aesthetic that is worth keeping. However, spalling and holes should be repaired. The large penetration in the brick around the pipe should be repaired, and sealant should be applied.

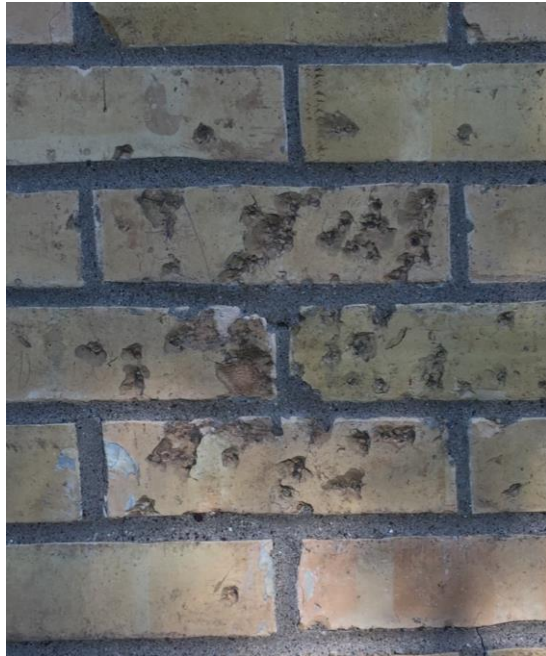
Additionally, there are a series of chips in the brick on the South facade that appear to be in a gunshot pattern.

Figure 12 – Gunshot Pattern in Brick

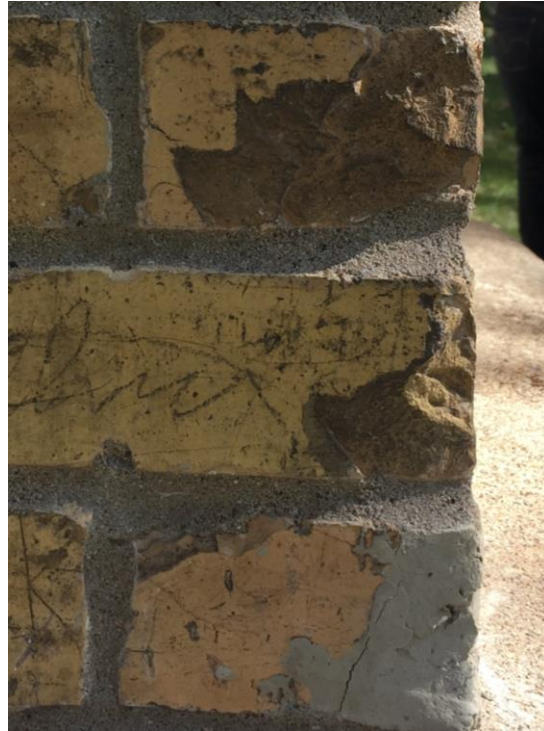
There are multiple areas where there is broken brick. This is most evident on the window sills on the North and South elevations, around the front entrance, and on the chimney on the West elevation. This damage could have been caused by humans, objects hitting the brick, or water damage.

Figure 13 – Broken Brick at Corner

If possible, use Chaska brick when replacing damaged bricks. Bricks could potentially be found at a salvage site, new Chaska bricks could be special ordered and produced, or bricks from the basement that are no longer visible could be used. If Chaska bricks are not available, find a brick of a similar strength, size, porosity, and color. A chimney cap matching the brick should be added.

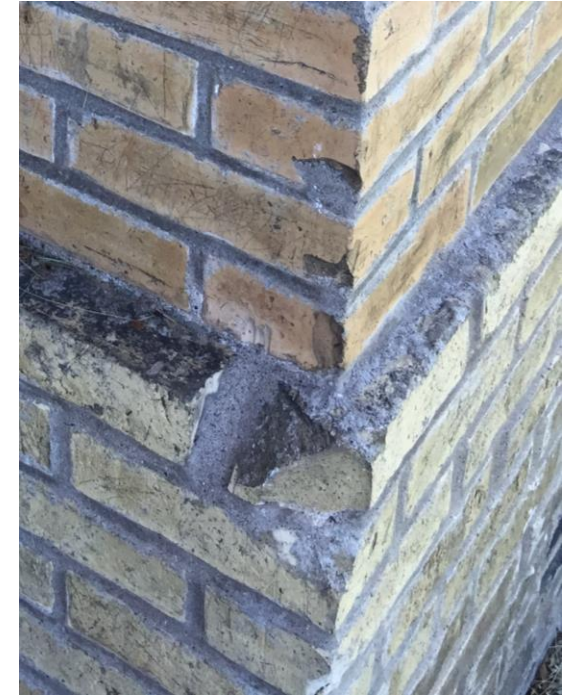
There is also deterioration of the brick that was caused by the environment. There are bricks on all four facades that are experiencing spalling, especially near the entrance of the building. Spalling is caused by water being absorbed into the brick and cracking the front face of the brick when the water freezes, therefore, it is evidence that water is not able to drain properly behind the veneer. The freezing and thawing of water can also crack large parts of the brick off in the locations noted previously.

Figure 14 – Environmental Degradation

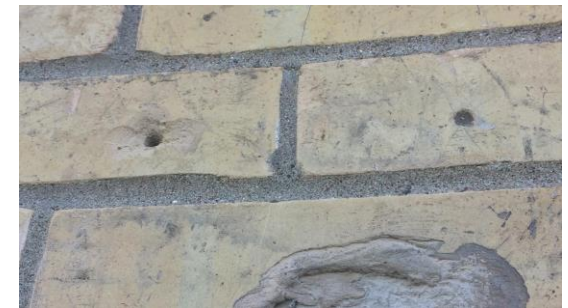
Figure 15 shows several small holes where a sign may have been hung in the past.

Figure 15 – Holes in Brick from Sign

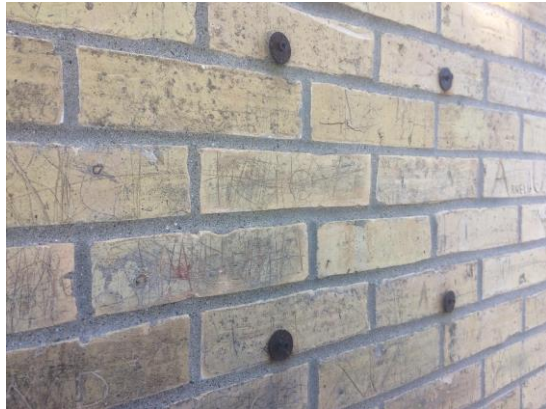
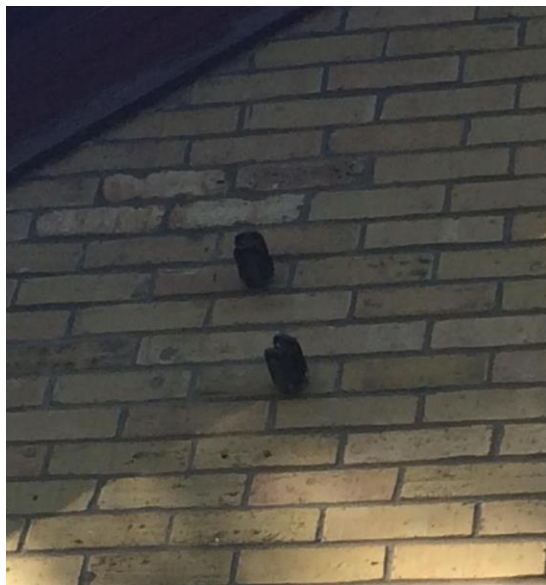
There are also some metal brackets in the façade; these were where electric lines and some services were connected.

Figure 16 – Metal Brackets in Brick

Figure 17 – Metal Brackets in Brick

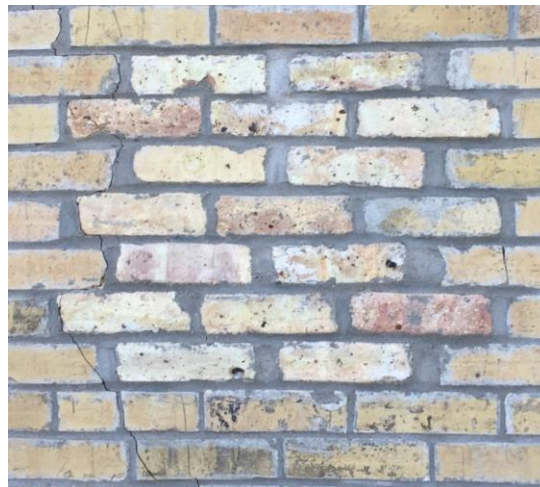
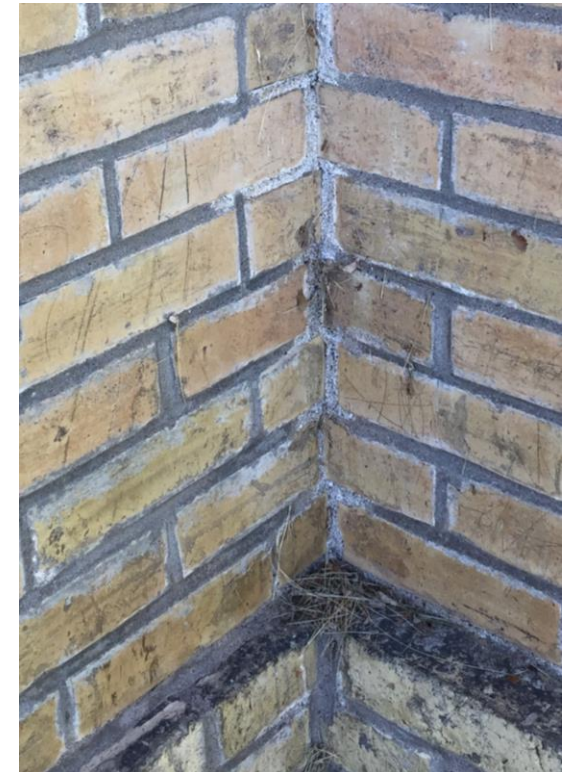
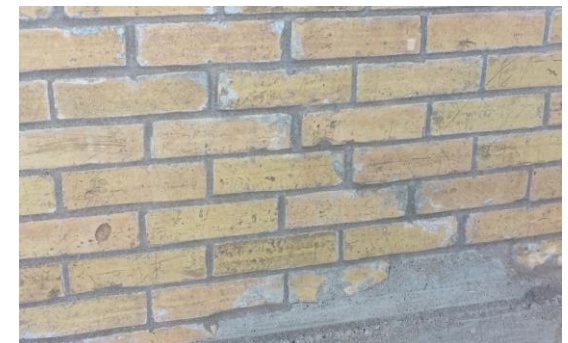
There are several sections of the primary façade where it looks like some repointing has taken place, specifically under the window on the right-hand side, where the mortar is a different color, and to the top of the circular window at the top of the structure. Figures 18, 19 and 20 show other areas where repointing was done, including the chimney. The mortar joints where the repointing was done are much more prominent due to the following characteristics: over-grinding during repointing process damaged the brick around the repointed areas, a different color of mortar was used, possibly a different strength of mortar was used, and the size of the mortar joints are larger. The mortar is supposed to be weaker than the brick so that it cracks before the brick can.

Figure 18 – Attempted Repointing

Figure 19 – Attempted Repointing

Figure 20 – Attempted Repointing

Any repointing done going forward must be done in a manner so as not to not grind into the bricks while removing the mortar. The mortar and brick used for any replacements must be of quality strength and grades as the original.<sup>3</sup>

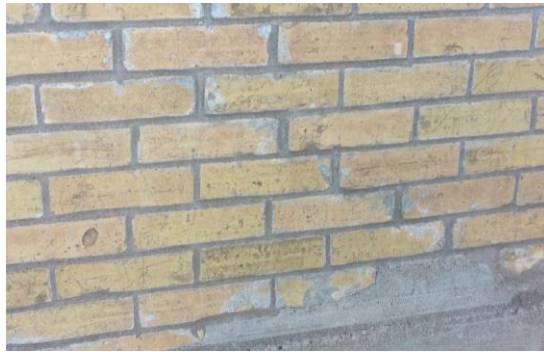
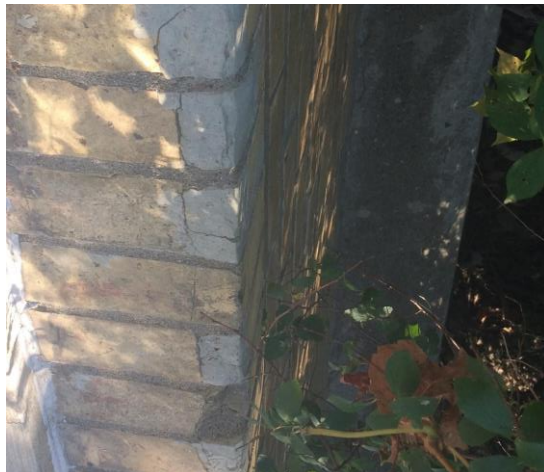
There have been some attempts to repair some of the damaged brick in several places. Several of the repairs are closer to the concrete foundation on the Southern elevation. However, rather than replacing the brick that was broken off, concrete or mortar was used to fill in the broken pieces.

Figure 21 – Mortar Replacement to Fill Voids

Figure 22 – Mortar Replacement to Fill Voids

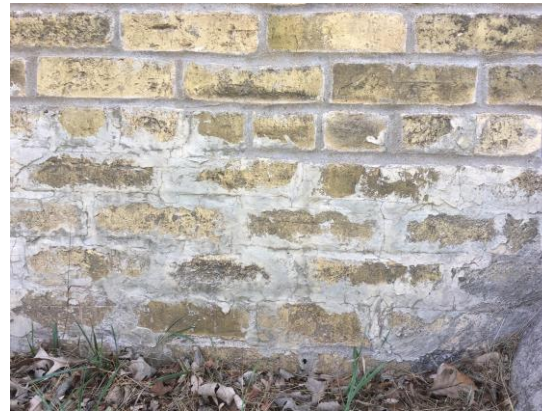
In one location, area of brick that was smeared with mortar on the rear elevation. The concrete curb that is located around the base of the North, South, and West elevations is most likely covering up deteriorated brick.

Figure 23 – Deteriorated Brick with Mortar

The mortar that is covering the brick should be removed if possible. This process must be done by hand without damaging the brick. Replace the bricks as needed.

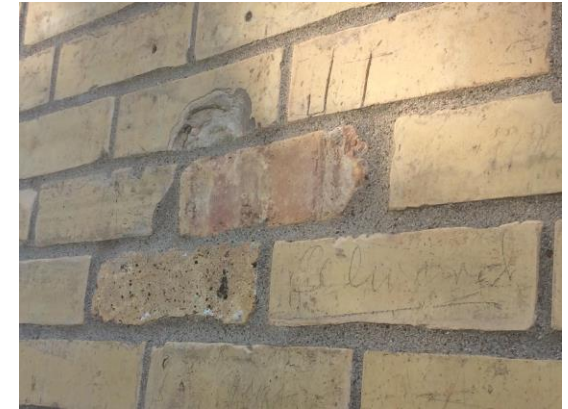
There are a couple of bricks that look like they were replaced with a different type of brick. The new bricks don't have the same coloring as the Chaska brick; they have more hints of red than yellow. These replacement bricks look like they have been damaged, which implies that they aren't as strong as the original Chaska brick.

Figure 23 – Replacement Bricks

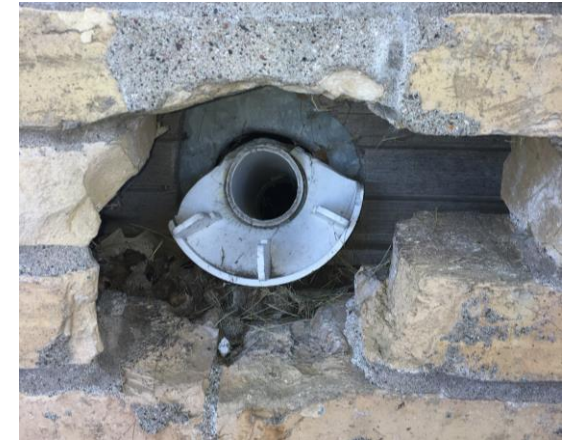
There is a pipe that runs from the basement to the exterior on the North elevation. The area around the pipe was not filled in, so there is currently a hole in the wall that exposes the wood structure.

Figure 23 – Exterior Pipe Penetration

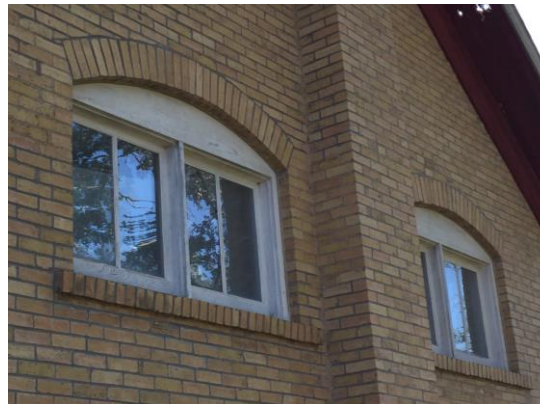
Figure 24 – Rear Window

A pane is broken on one of the windows on the rear elevation. It is our understanding that the windows were replaced in 1946, but we do not have any confirmation about other replacements. We have been assuming that the windows were replaced again around 1990 because the existing windows appear to be newer since they are in decent condition. The paint has worn around the frame, which exposes the wood. If the windows were older than 1990, then there would be significant deterioration from the lack of maintenance. We found a tag in that states Marvin Windows is the manufacturer.

The sashes and other portions of window showing mold should be replaced. The window frames should be painted to match the fascia/soffit. Broken and missing glass, like on the rear elevation, should be replaced with clear glass. The window frames should be secured to the wooden structure, and caulking should be installed around the interior and exterior frame to create a seal.<sup>4</sup>

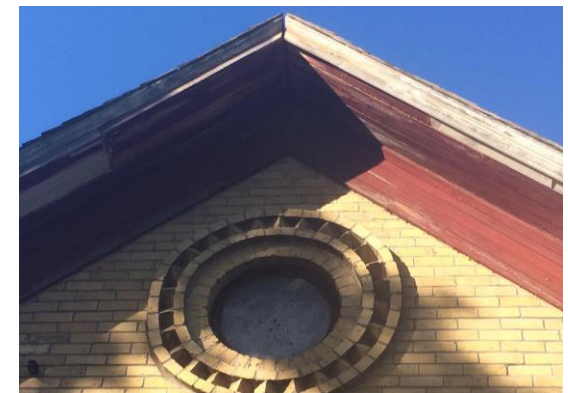
Figure 26 – Circular Front Window

For the front circular window, the plywood should be removed, and glass should be installed. If another style/pattern of glass is found when doing more research, then replace with what is historically appropriate.

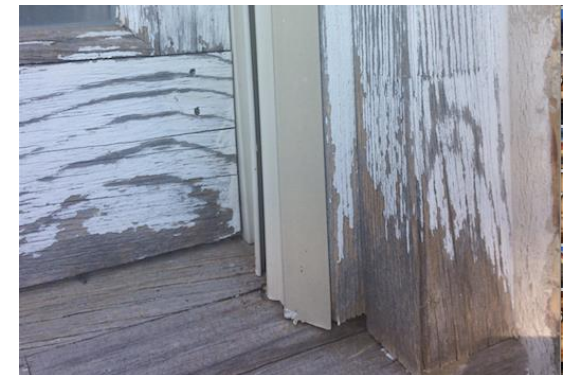
The painting around the frame is patchy, and there is caulk missing around the window frames.

Figure 27 – Paint Chipping on Window Frame

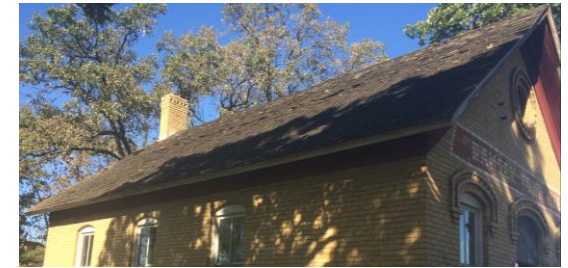
The existing roof has asphalt shingles, and the soffit and fascia are solid wood. The original roof has wood shingles. We could not access the roof to determine the condition, but the shingles appear to be in poor condition. Many of the shingles are not flat, meaning water is being shedding improperly.

Figure 28 – Asphalt Shingles

Additionally, the roof should be re-shingled, and any holes should be repaired. The new roof material can be asphalt shingles, but wooden shingles would be more appropriate. The roof and chimney must be properly flashed.

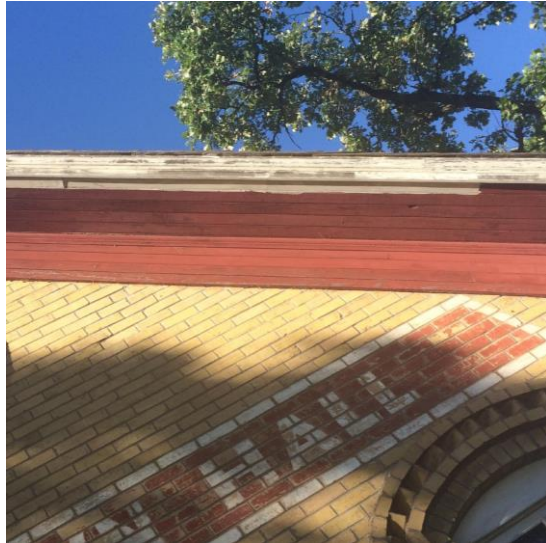
The apex of the roof appears to be split. This could be due to the walls not providing enough support to the roof, so the roof is slowly failing. It could be due to the wood shrinking over time as well. There are pieces of the soffit and fascia that have fallen off, and there are holes in the soffit on the West elevation.

Figure 29 – Wooden Soffit and Fascia

The soffit and fascia should be repaired with wood similar to the existing. They should then be painted.<sup>5</sup>

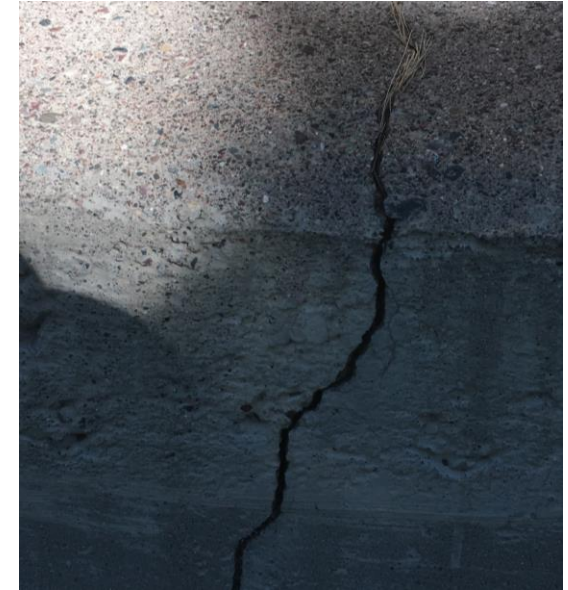
There is a concrete curb that runs from the side elevations to the rear elevation. It is not original or historic. It was most likely installed to cover up deteriorated brick in addition to providing structural support to the wall. The settling of the concrete could be cracking the brick behind. There is no sealant between the concrete and the brick. The concrete has major cracks that is allowing water to penetrate the structure.

Figure 30 – Concrete Curb Crack

The cracks in the concrete should be sealed. Additionally, the joint where the bricks meet the concrete should be sealed.

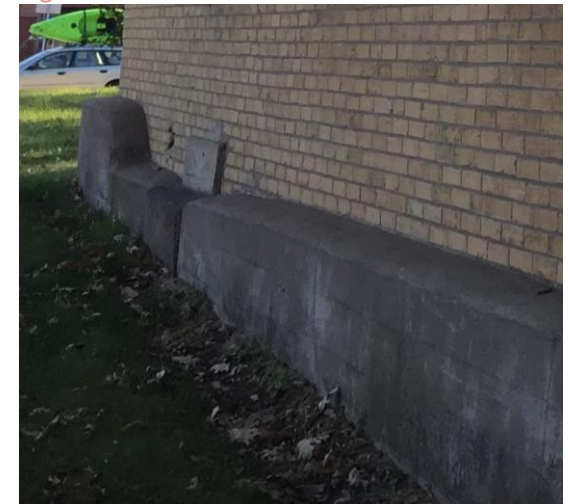
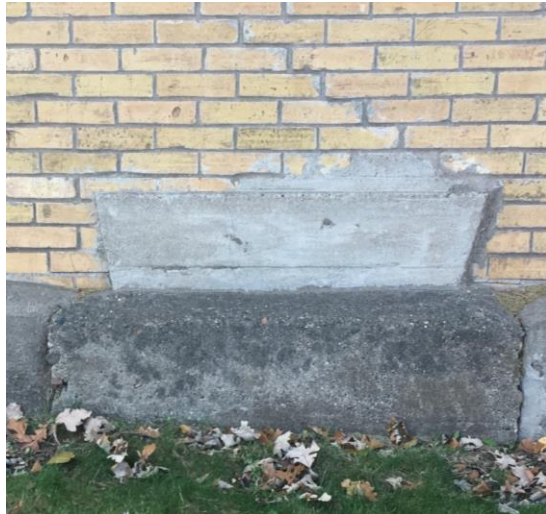
The concrete is covering up two garden level windows on the North and South elevations. These windows can be seen while standing in the basement.

Figure 31 – North Elevation Window

Figure 30 – South Elevation Window

If there are future plans to remove the concrete, the following is recommended. The concrete should be removed carefully as to not damage the garden level window lintels. The brick veneer should be reattached to the wood stud wall, and damaged bricks should be replaced.

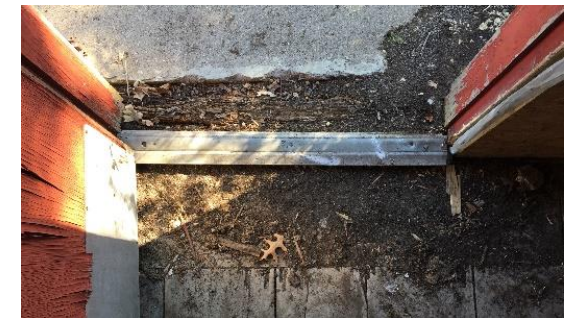
Approximately half of the original wood floor is intact in the entry hall. A section of the original flooring has been removed immediately upon entry. The subfloor that remains has significant damage from exposure to the weather.

Figure 34 – Entry Hall Flooring at Threshold

In the entry hall, replacement of the front door should help protect the floor from further deterioration due to weather exposure. If not, a more durable flooring choice may appropriate around the threshold, since the original flooring is no longer intact.

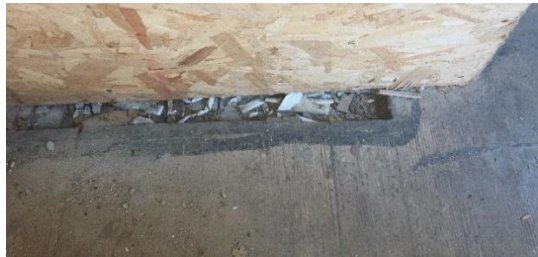
Throughout the main room, the original wood flooring is intact. Unfortunately, redesign of the interior walls has left holes in the floor. There are holes along the north and south walls for venting to the basement. There is a small amount of water damage on the boards in the doorway to the bathroom.

Figure 35 – Main Room, Holes in Floor

Restoration of the existing floor should be based on the Secretary of the Interior's Standards for Rehabilitation. Overall, the floors need to be cleaned and sanded to remove debris and adhesive. According to SOIS, both chemical and physical treatments may be undertaken in the gentlest means possible. If necessary, complementary wood flooring which matches in design, color, texture, and possibly material, should be used to fill in any spaces of missing flooring.<sup>7</sup> Finally, a protective coating should be applied.

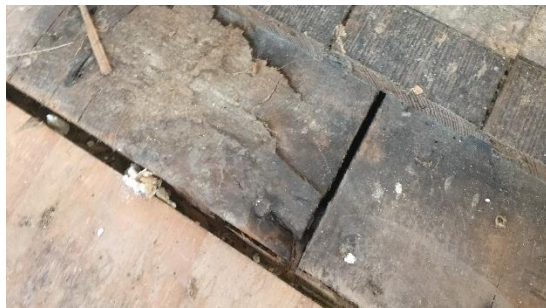
Figure 35 – Bathroom Water Damage

In the main room, the minimal water damage should be examined to determine its full extent, otherwise, it is not enough to make the flooring structurally unsound.

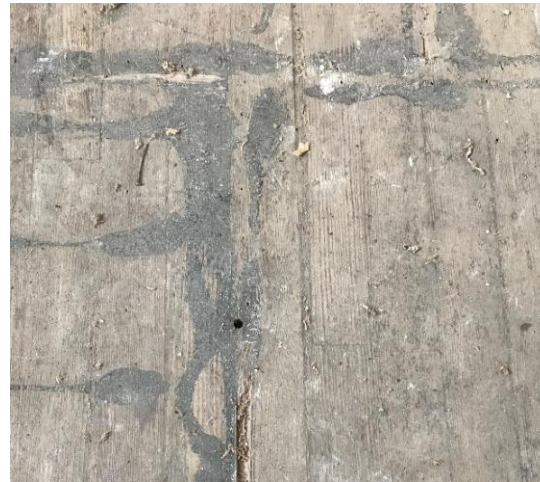
Overall, the original flooring in both rooms is very dirty, there are some holes along the wood grain caused by wear and previous renovations, and there is remnant of adhesive from the vinyl flooring.

Figure 36 – Holes Along Wood Grain

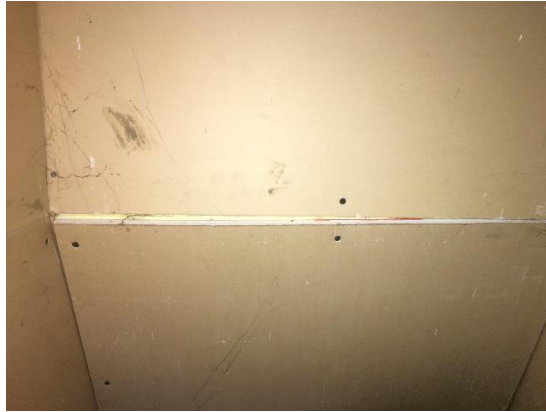
The stairwell is located in the entry hall. The walls and ceiling of the stairwell have been covered in modern gypsum board, however the joints have not been taped or mudded and are starting to pull from the frame. In current condition, the stairs appear sturdy but have no railing.

Figure 37 – Stairway Ceiling

The gypsum board should be removed to determine the cause of it pulling from the wall. If no distinguishable cause can be determined, the boards may just need to be taped, mudded, and primed for painting.

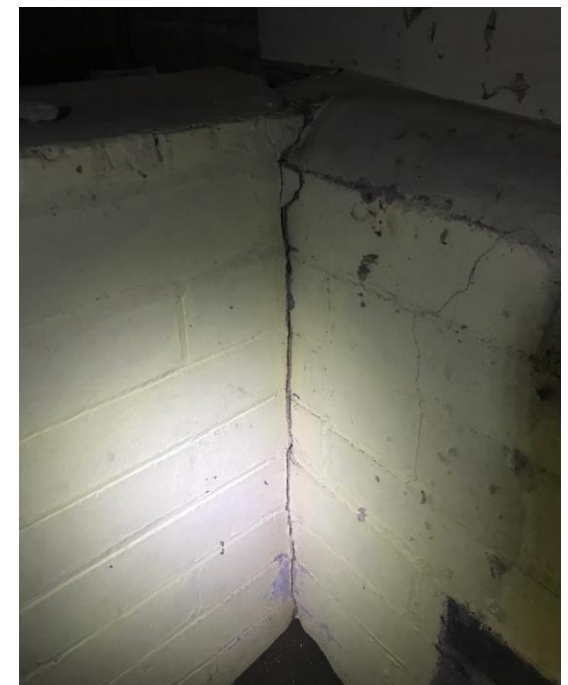
Figure 41 – Concrete Masonry Wall

The concrete masonry wall should be examined. Cracks in below-grade structures can cause complications with soil pressures and ground water flow. Sealing and stabilizing the cracks may be the best option.

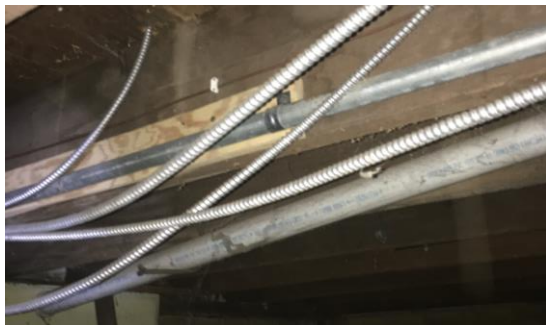
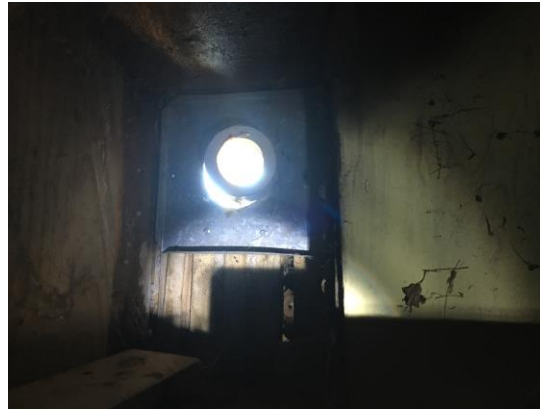
Figure 48 – Utilities Hole in Exterior Wall

Figure 49 – Utilities Hole in Exterior Wall

The hole is not original to the structure. It should either be used to provide modern amenities or taken out. The discontinuity can be easily patched with cementitious material.

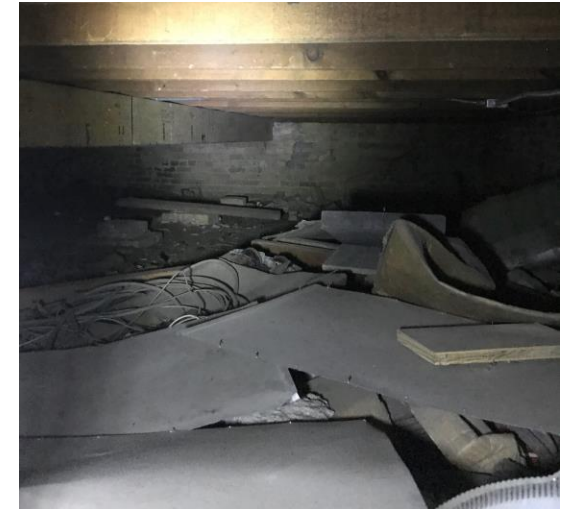
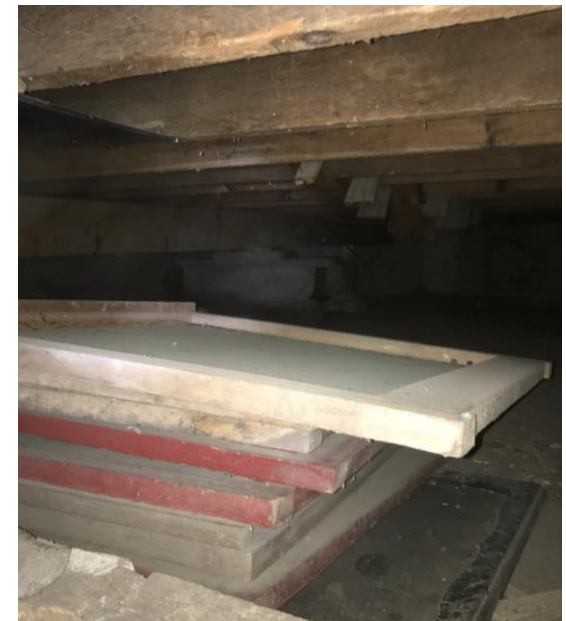
Figure 50 – Crawl Space with Debris

Figure 51 – Crawl Space with Debris

Additionally, the building's stability cannot be determined until all structural elements are examined individually. The debris makes this analysis impossible. Once it is cleared, an engineer should evaluate the floor joists and exterior walls in the crawl space.
