November 22, 2024

**RE: Landfill Erosion Inspection Report, Roswell Municipal Landfill, Chaves County, New Mexico**

**ATTACHMENT A – October 29, 2024 Photographic Log**

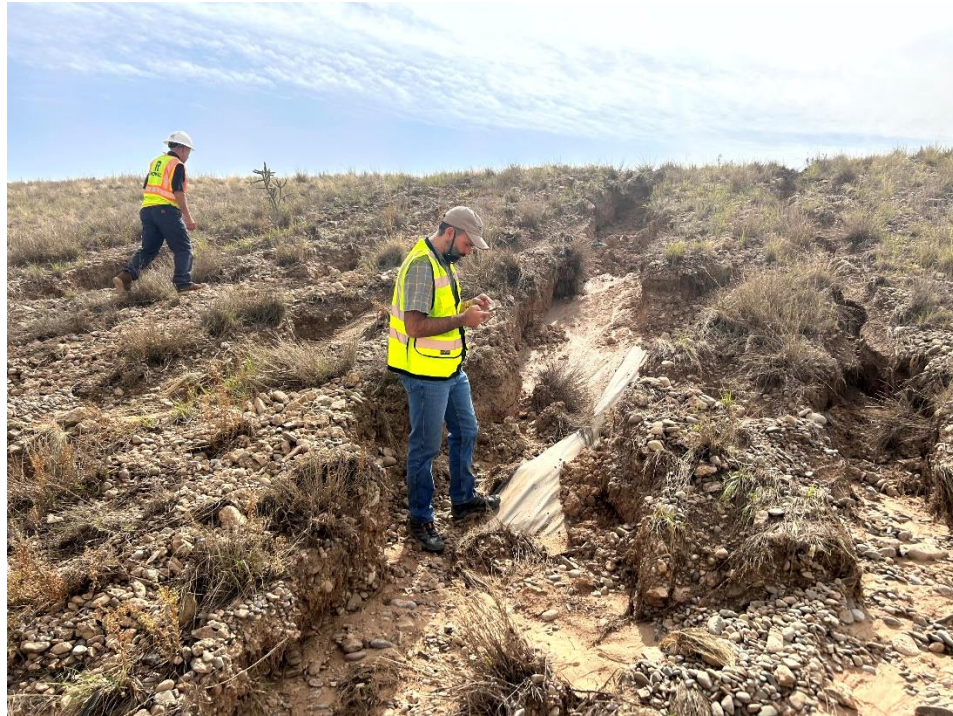
The inspection of the closed Unit 1 cell identified significant and widespread erosion to the sidewalls of the cell. Cover material appears to have been removed in many places to a depth in excess of two feet, revealing portions of black, geotextile material in at least six different locations on the north and south-facing side slopes. The geotextile material appears to be a permeable fabric which was placed below the vegetative topsoil above the low-permeability cap. However, outside of the four areas of major erosion, the majority of damage is limited to rills and smaller channels with depths less than one foot. No encapsulated solid waste material appears to have been uncovered because of the erosion. The top of the landfill cap above side slopes appeared to be in good condition with no evidence of erosion or channel development. Photographs of erosion on Unit 1 are included as Photographs 1-3 in Attachment A.

**Photo 1.** Geotextile exposed along northern side slope of Unit 1 Cell

SMA did not observe any damage to cell liners or low-permeable clay caps/covers on any unit at the Roswell Municipal Landfill. As such, SMA believes re-grading of the units to fill erosional channels and cover any exposed liner should be sufficient to repair the cover and mitigate potential impacts to the cover by future precipitation events. The re-grading should be completed on all side slopes of Units 1, 2, and 3, and should be completed on the entirety of Unit 4. Re-grading should be followed by re-seeding of native grasses on Units 1-3 to provide additional stability for the cover.

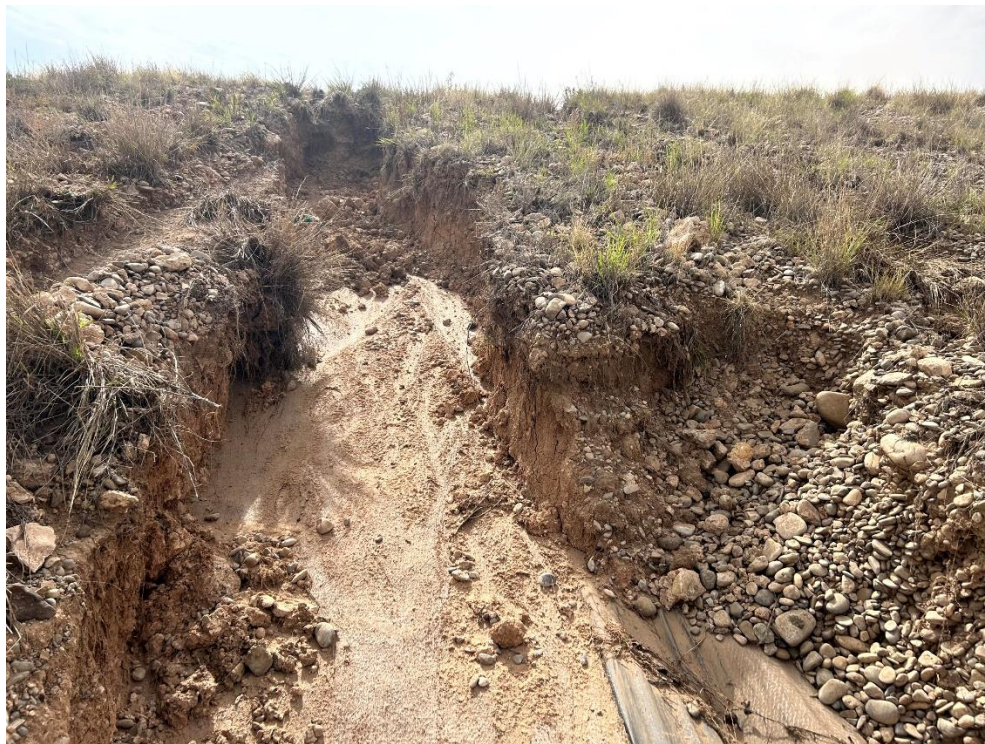
**Photo 2.** Geotextile underlying vegetative top cover on northern Unit 1 slope

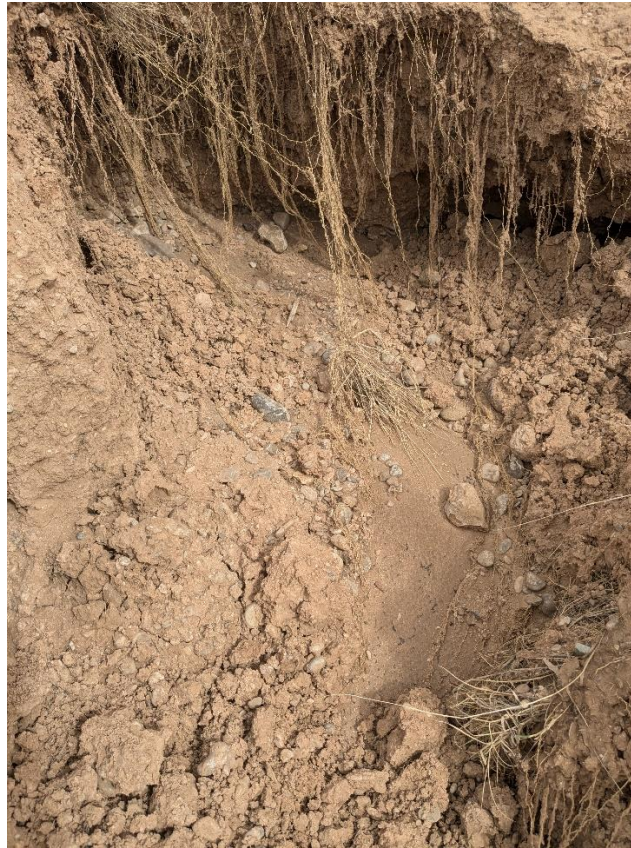
**Photo 3.** Erosion and geotextile on Unit 1 southern slope

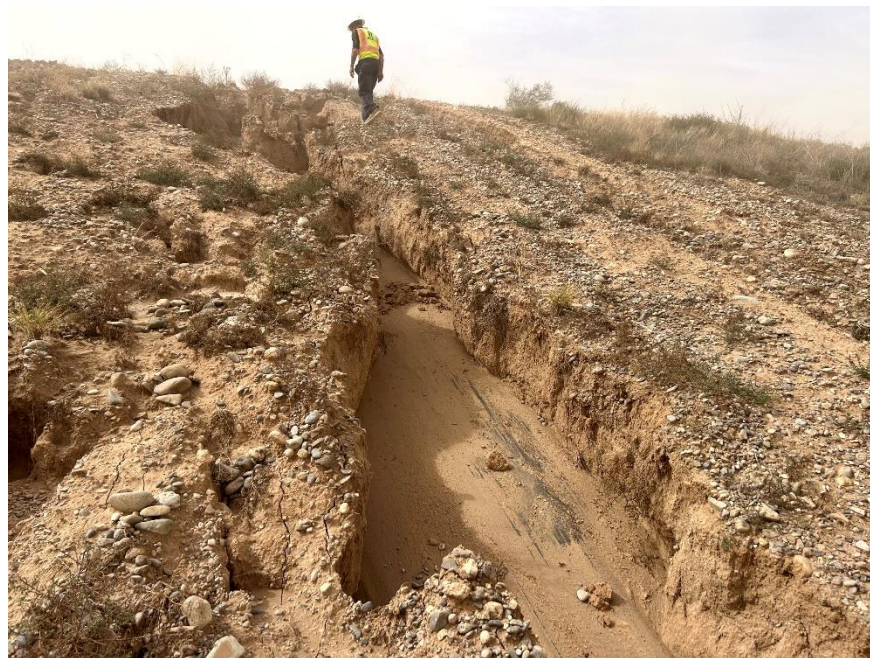
of two feet, revealing portions of black, geotextile material located below the upper top soil/vegetative cover at two locations. However, outside of the four areas of major erosion, the majority of damage is limited to rills and smaller channels with depths less than one foot. No encapsulated solid waste material appears to have been uncovered as a result of the erosion. The top of the landfill cap above side slopes appeared to be in good condition with no evidence of erosion or channel development. Photographs of erosion on Unit 2 are included as Photographs 4-5.

**Photo 4.** Erosion and Rilling with exposed geotextile along Unit 2 side slope

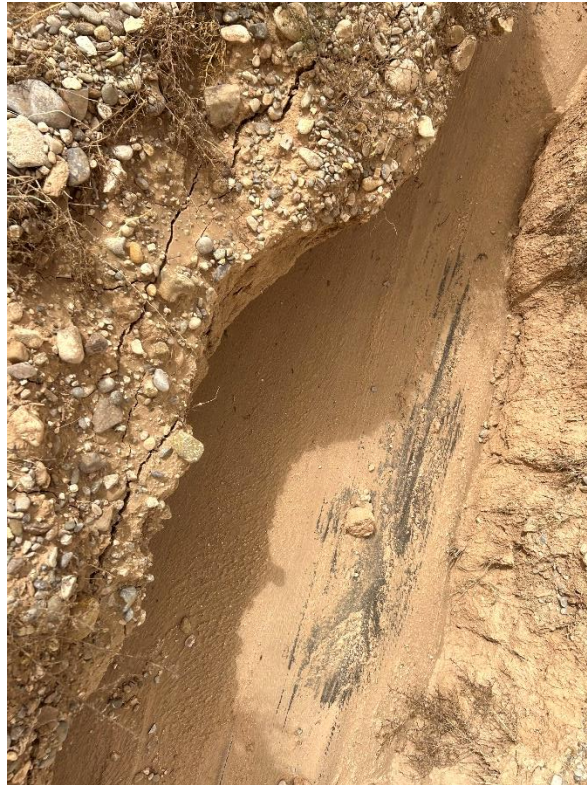
**Photo 5.** Geotextile exposed near base of Unit 2 side slope

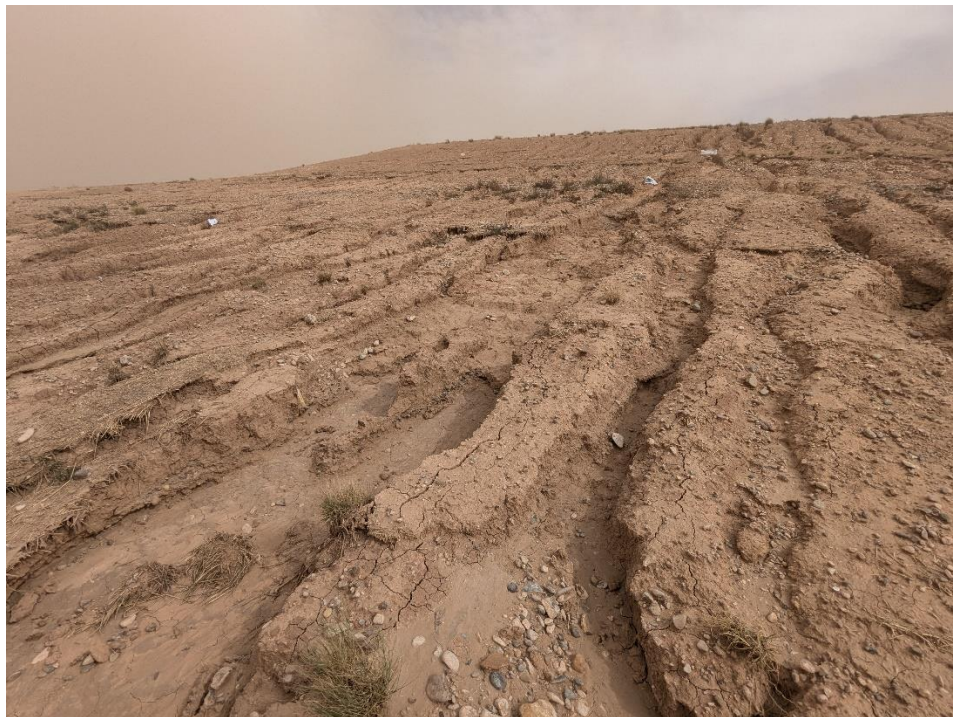
The inspection of the closed Unit 3 cell identified significant and widespread erosion throughout the cell cover (Photograph 6, 7). Rills and channels have developed over the majority of the cover, and in some cases have depths exceeding two feet. Some erosional channels were of sufficient depth to reveal the underlying, compacted clay layer which functions as the low-permeability cover for the unit (Photograph 8); however, SMA did not observe any obvious or significant erosion to the clay layer. The stormwater drainage channels graded atop the cover have been damaged (Photograph 9) and will need to be re-formed to ensure efficient, future drainage of the cell. No encapsulated solid waste material appears to have been uncovered as a result of the erosion.

**Photo 6.** Erosion and Rilling along Unit 3 side slope

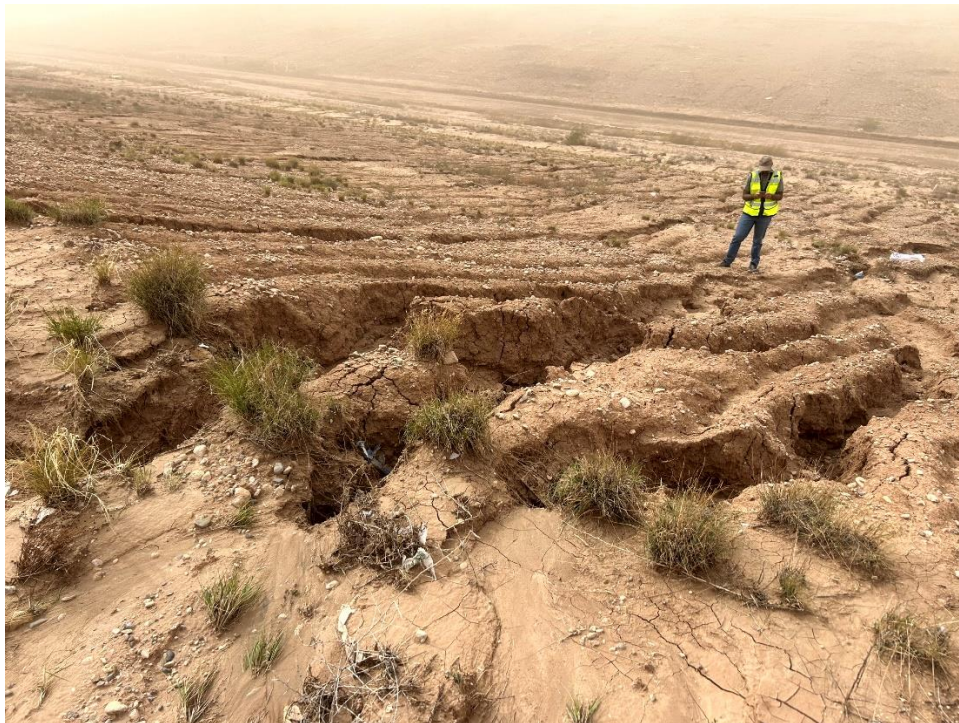
**Photo 7.** Erosional channels on western-facing side slope of Unit 3 side slope

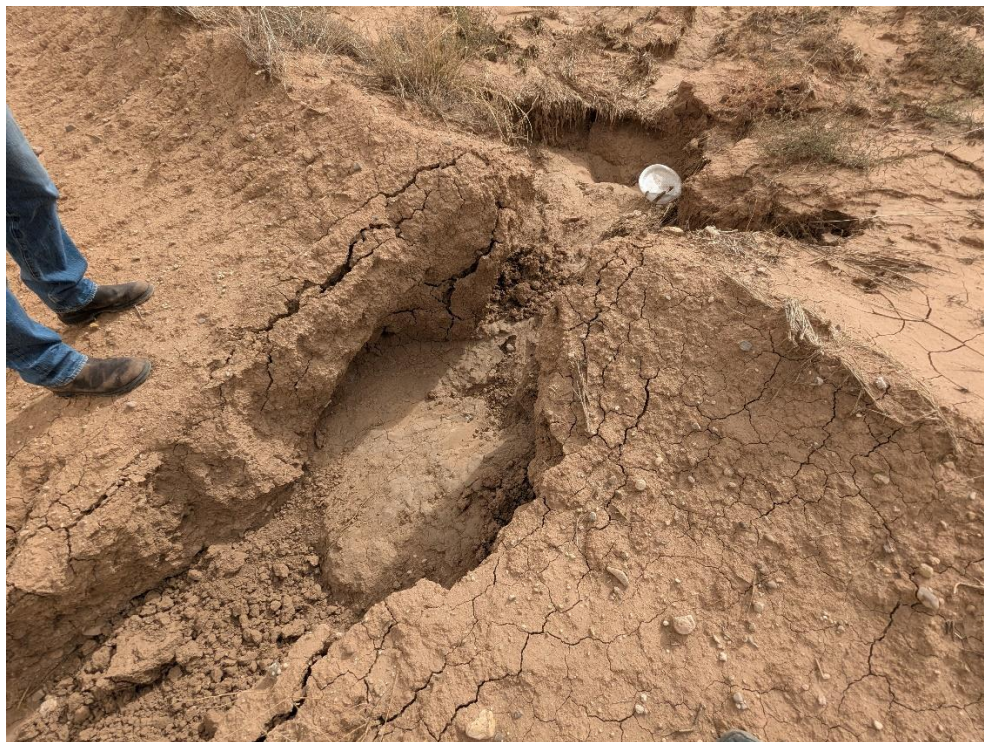
**Photo 8.** Exposed compacted clay layer, Unit 3 side slope

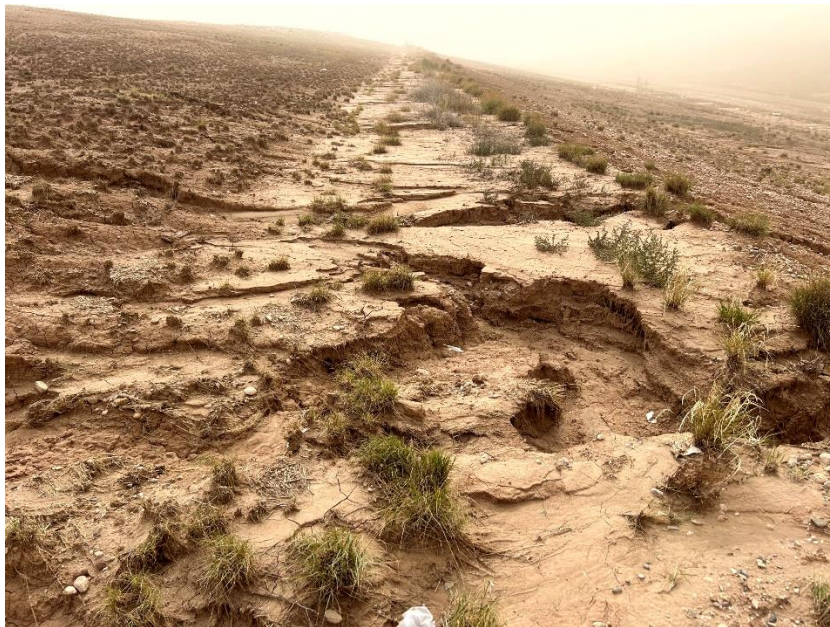
**Photo 9.** Damage to existing graded stormwater flow path atop Unit 3.

In addition to the landfill unit/cell repairs, SMA also recommends the repair, replacement, or construction of stormwater swales throughout portions of the landfill to help direct stormwater flow. SMA recommends that swales be repaired around each of the closed or active landfill units, along the southern boundary of the landfill,

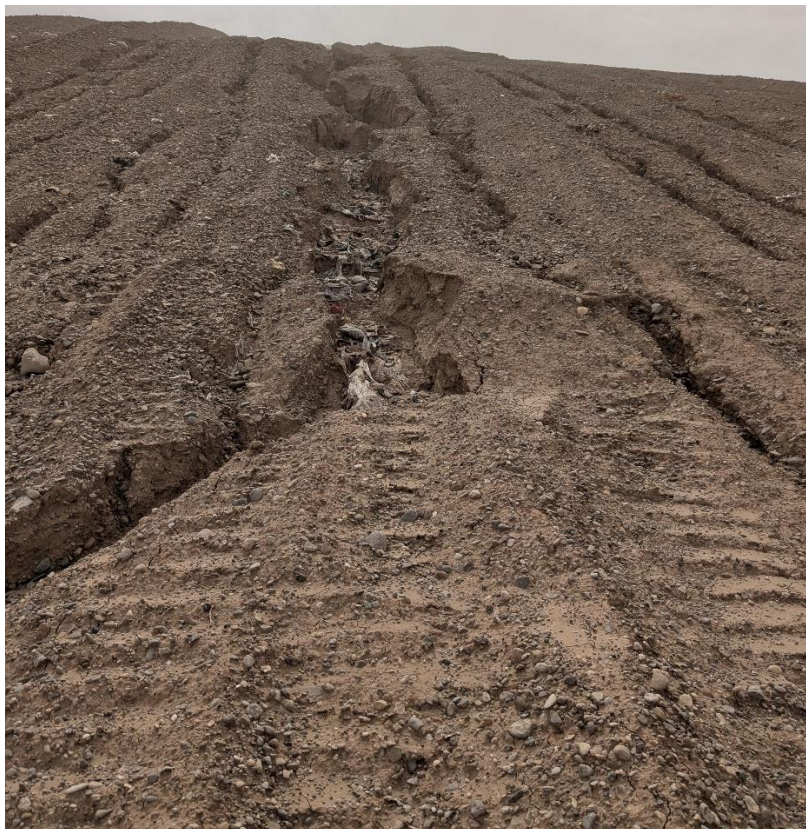
The inspection of the Unit 4 cell identified significant and widespread erosion throughout the cell cover, primarily within sidewall slopes. Erosion on unit four was generally limited to channels/rills less than 1-foot deep. One area on the north-facing slope of the unit has been sufficiently eroded to expose buried solid waste material (Photograph 10); however the material appeared to be in-place and no waste appeared to have been mobilized. One area within the eastern-facing side slope has exposed the liner and anchor trench of the Unit 5A cell (Photograph 11). The liner, although exposed, appeared to be in good condition with no signs of damage.

**Photo 10.** Channel and erosion of buried waste material on the northern face of Unit 4.

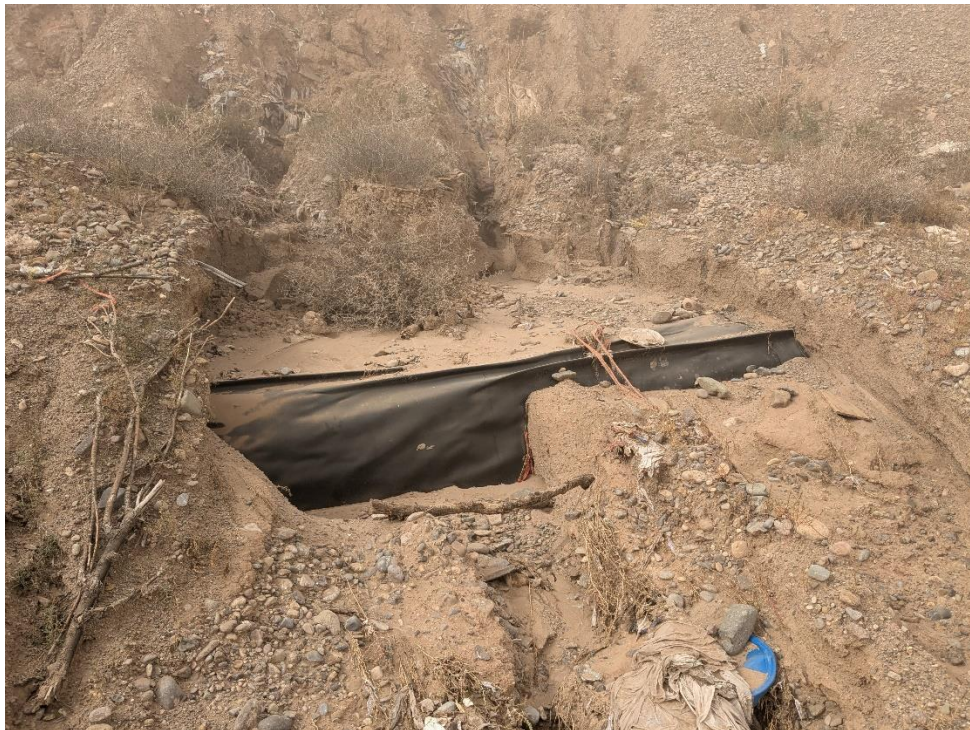
SMA did not observe any significant erosion or damage to the active 5A cell. As described in Section 2.4, erosion on the eastern face of Unit 4 exposed a small area of the Unit 5A liner near the anchor trench (Photograph 11) and an area of liner was also exposed near the southwest corner of the cell near the liner tie-in with Unit 4 (Photograph 12). The area of the liner which has been exposed is limited and the liner appeared to be undamaged. As Unit 5A is actively being utilized for waste disposal, any other erosion that occurred on the footprint of the cell will be repaired during daily cover activities.

**Photo 11.** Anchor Trench of Unit 5A liner exposed on Unit 4 eastern-facing side slope

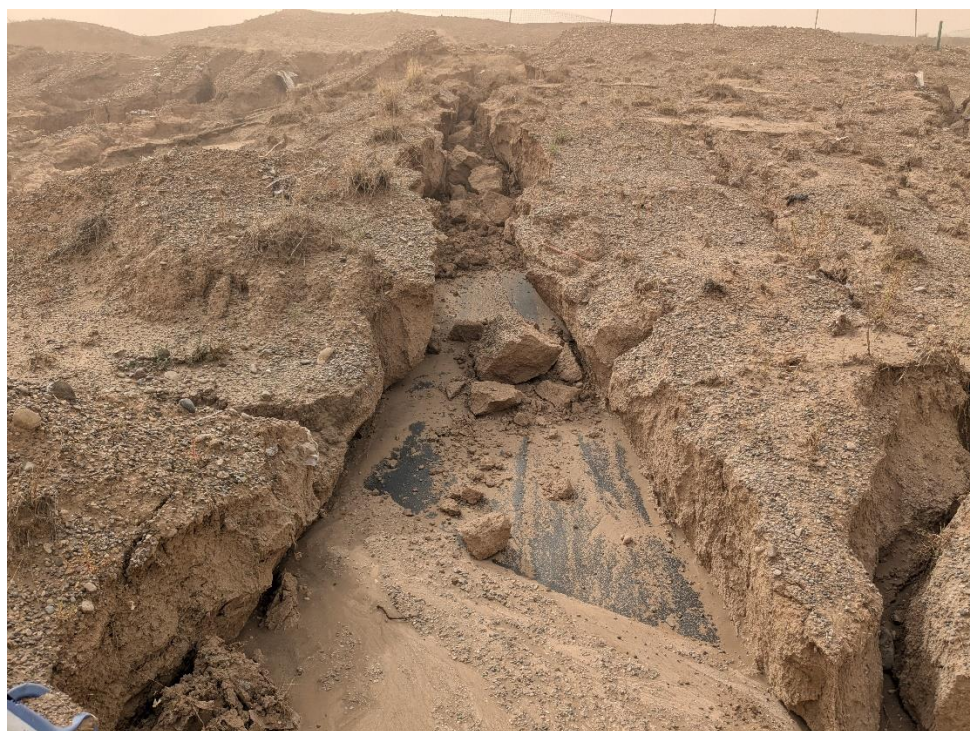
**Photo 12.** Exposed Unit 5A liner southwest of tie-in with Unit 4
