2024 CACHE CREEK ANNUAL STATUS REPORT
(BOARD OF SUPERVISORS DRAFT)

2024 Cache Creek Annual Status Report

Prepared by the Cache Creek Technical Advisory Committee

for the 2024 Water Year
(October 1, 2023 – September 30, 2024)

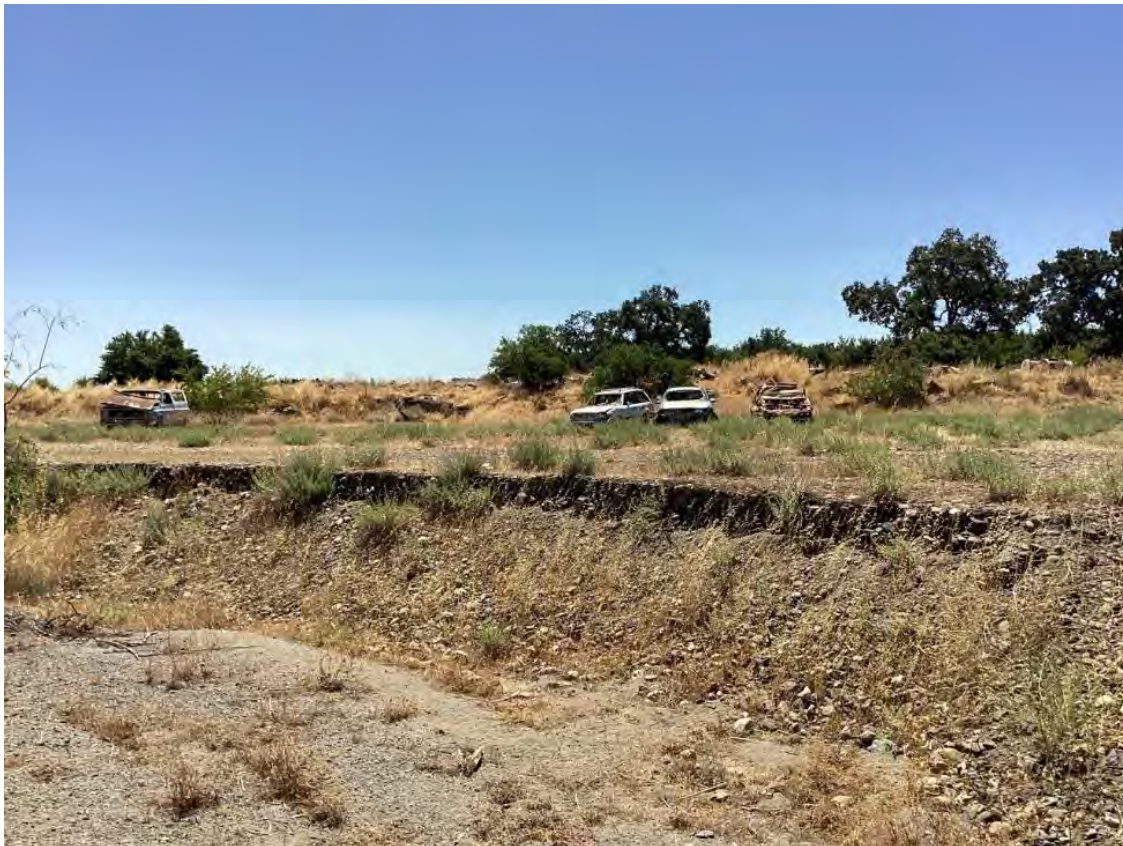
In 2024, the abandoned/disabled vehicles, construction materials and debris, and other deleterious waste were again observed on the creek overbank near river mile 25.4 as in recent years (Fig. 2-11). These abandoned vehicles and waste materials present a similar hazard to the “Boneyard” site, but they are closer to the creek itself. The CCTAC Hydraulic Engineer recommends the County consider available enforcement actions against this property owner.

Figure 2-11. Abandoned vehicles near RM 25.4.

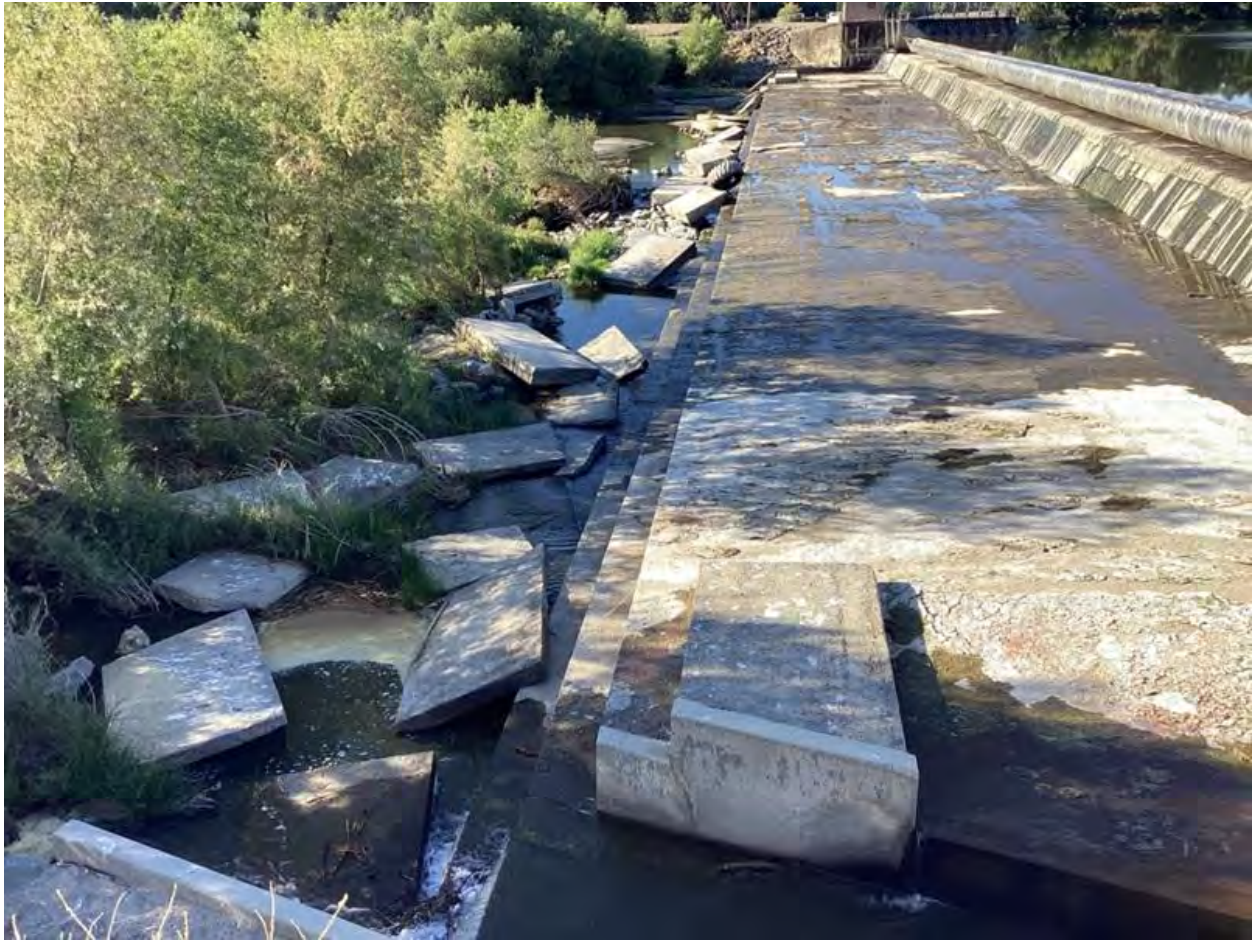
For years the TAC has recommended removal of the failed energy dissipation blocks at the Capay Dam apron and noted the presence of surficial cracks in the apron throughout. No significant new damage was noted this year, but the concrete blocks continue to affect the creek and should be removed from its bed (Fig. 2-13).

Figure 2-13. Capay Dam and apron. (2024)

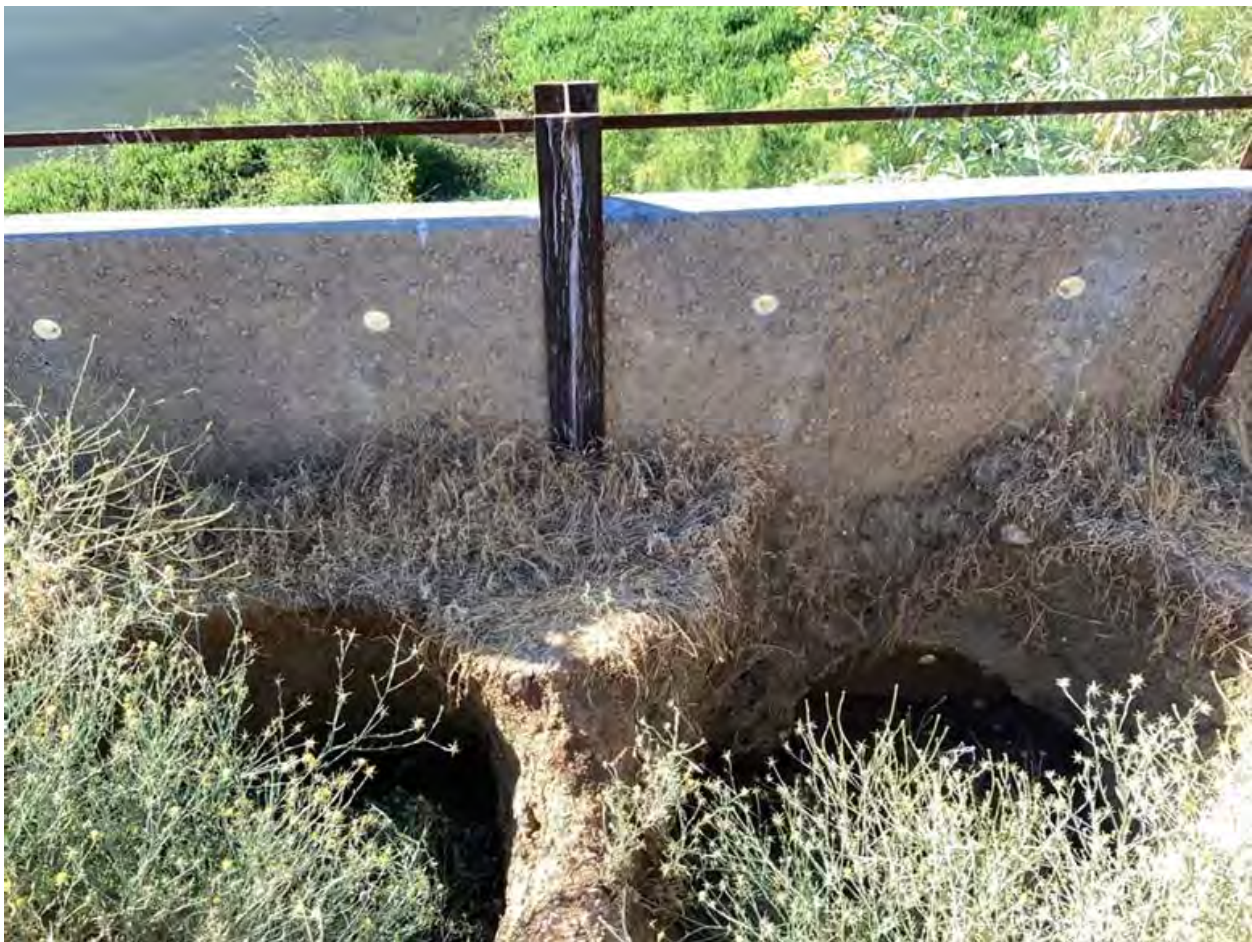
The emergency retaining wall structure built in 2017 immediately downstream of the Capay Dam continues to exhibit signs that water is running off behind the wall and compromising its integrity, and in 2024, new evidence of additional erosion was clear compared to 2023. “Scalloping” or deep holes forming alternately behind each concrete panel was observed and continue to increase in size due to overland flow of stormwater off the adjacent access road and down behind the wall (Fig. 2-14). This erosion will eventually compromise the access road adjacent to the irrigation canal if not addressed. As has been the recommendation for several years, this appears to be an issue needing action from the Yolo County Flood Control and Water Conservation District.

Figure 2-14 View of soil erosion behind Bank Repair Wall at Capay Dam. (2024)

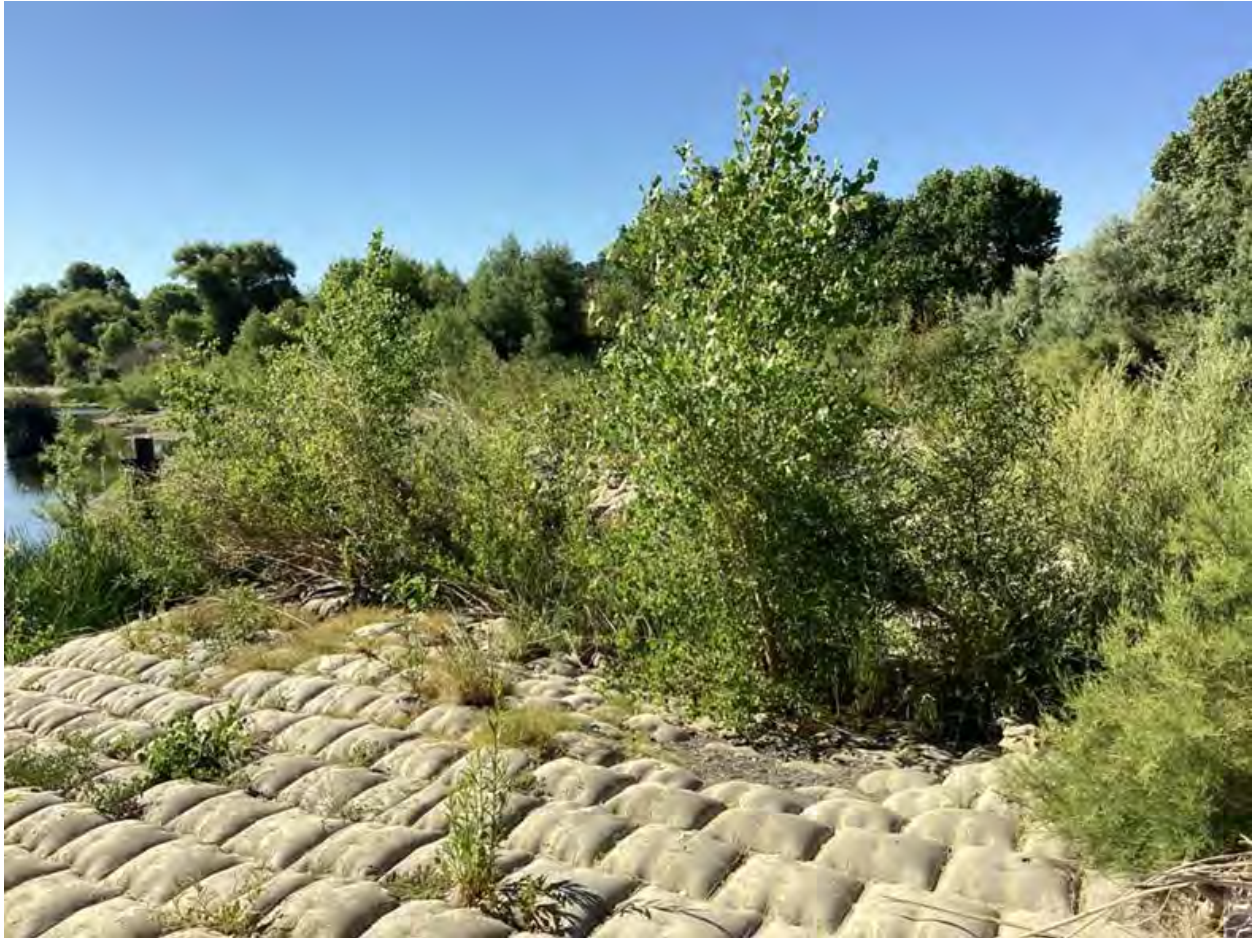
No new signs of damage or erosion were observed at the PG&E palisades and erosion control blanket were observed in 2024 (Fig. 2-15). The increasing trend in vegetation growth observed in the last few years continued again. The long-planned removal project has still not occurred, and the TAC continues to recommend that this removal occur as soon as possible. As vegetation continues to establish on and around the concrete blanket (including willows, cottonwoods, and wetland plants) the impacts of removal will only increase.

Figure 2-15. Photo showing current state of erosion control blanket at PG&E Palisades site including substantial riparian vegetation growth (2024 Creek Walk).

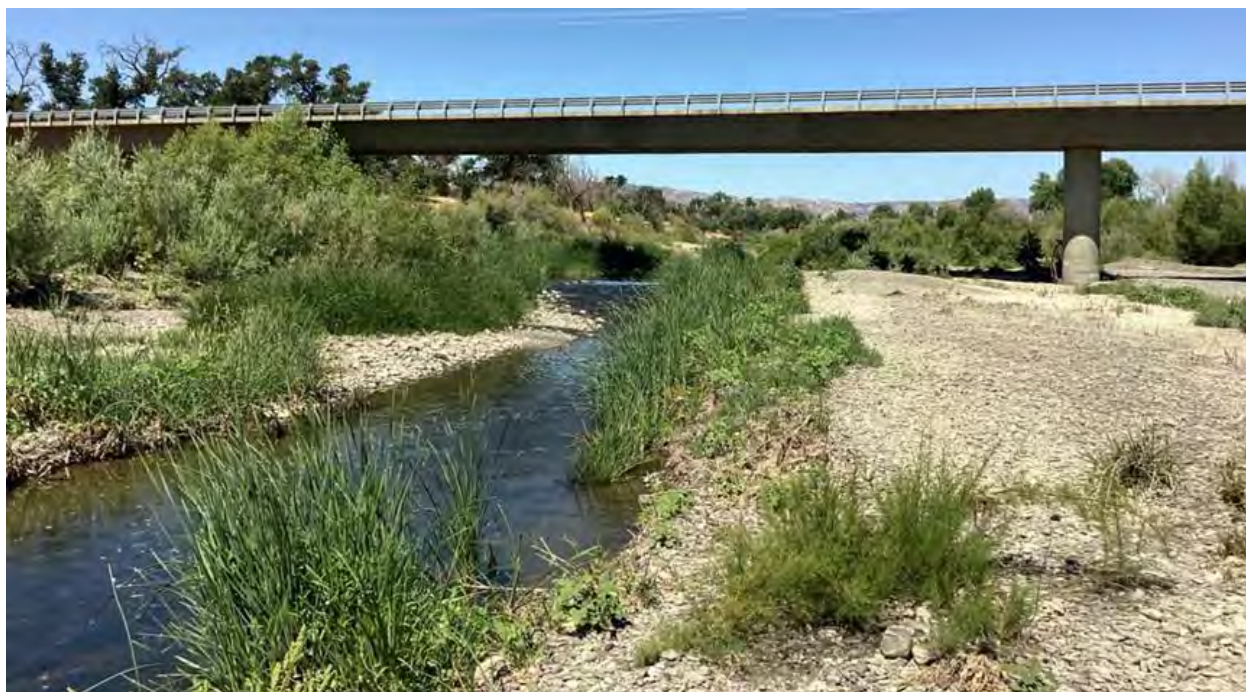
The Capay Bridge did not exhibit any signs of erosion or scour in 2024 but rather showed increased vegetation growth from observations in 2023 (Fig. 2-16). Curiously, 2023 and 2024 were remarkably similar water years in terms of durations and magnitudes of flow events and while scouring of vegetation was evident in the aftermath of 2023 storms, it was not this year. However, there are currently no concerns about the Capay Bridge which seems to be exhibiting variable patterns of vegetation growth and scour without deleterious erosion that would compromise the structure.

Figure 2-16. Photo showing Capay Bridge and increase vegetation growth after the 2024 winter flows (2024 Creek Walk).

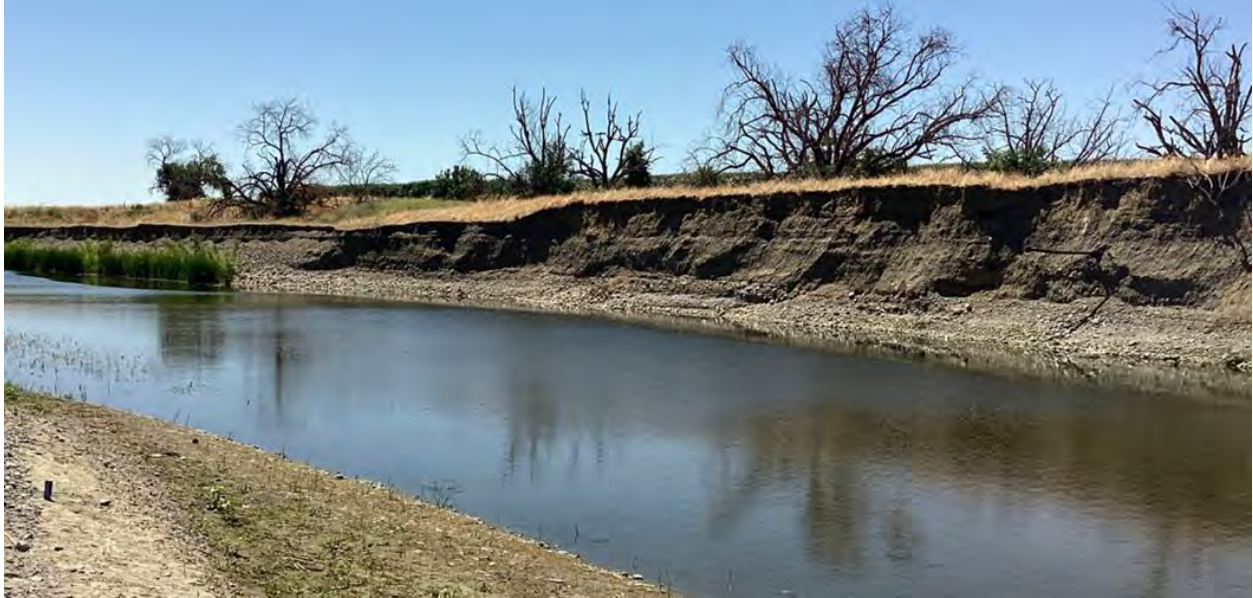
This car, first observed in 2021, was not observed in 2024. The photo in Figure 2-17 shows the location where the car was observed in 2023. It appears to have been removed by an unknown party.

Figure 2-17. Photo showing the streambank at River Mile 25.9 where a car has been previously observed in the bank. (2024)

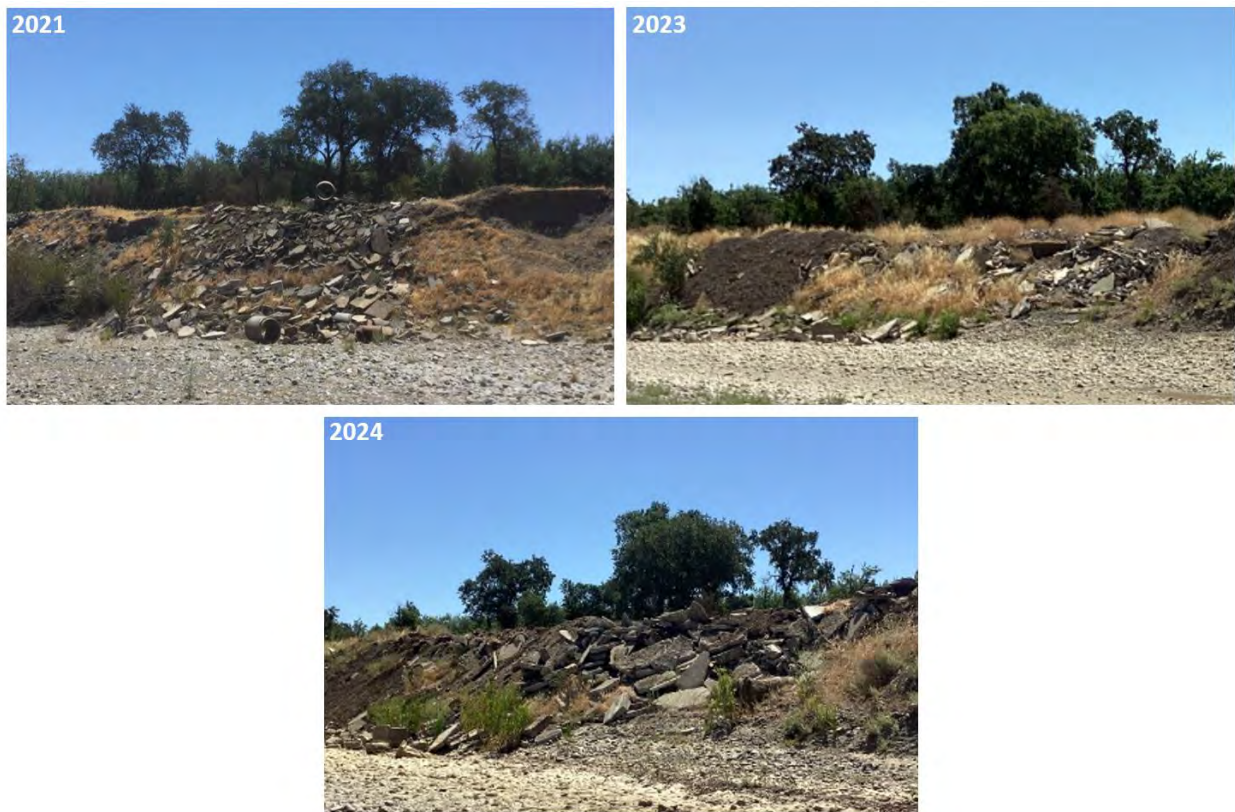
In 2021, new rubble (waste concrete and similar materials) armoring was observed at the bend along the right (south) bank of the creek near River Mile 25.4. In 2023, new soil fill at this location was observed, and in 2024 it appeared that additional concrete rubble was installed. Figure 2-18 shows conditions at this site in 2021, 2023, and 2024. The soil fill has not been stabilized with vegetation and is likely to erode, adding fine sediment to the creek while the concrete rubble prevents riparian vegetation from establishing.

Figure 2-18. South (right) bank at River Mile 25.4 showing installation of concrete rubble in 2021, addition of new soil fill in 2023, and addition of new rubble in 2024.

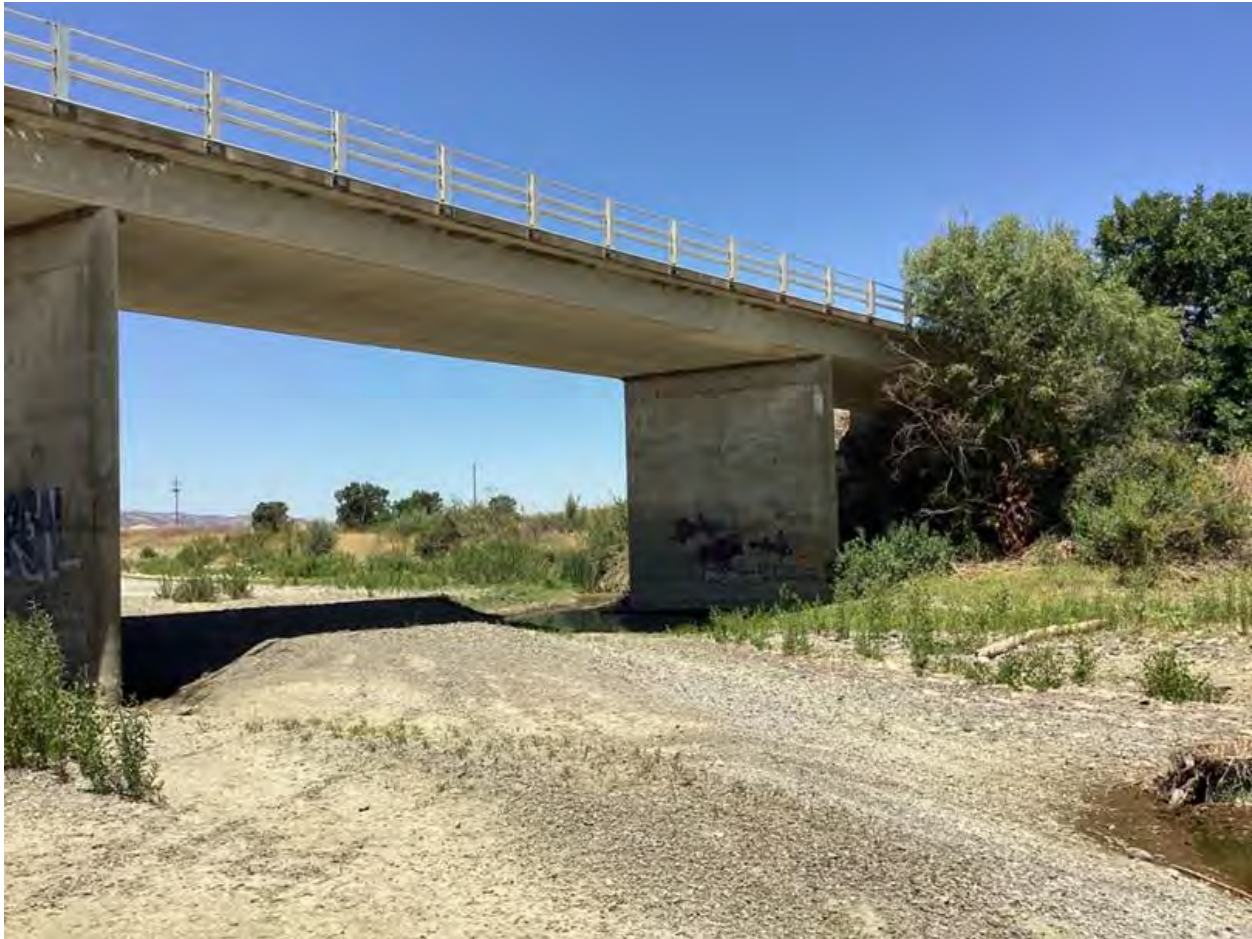
Figure 2-19. Photo from 2024 Creek Walk showing Esparto Bridge piers with no significant change from last year.

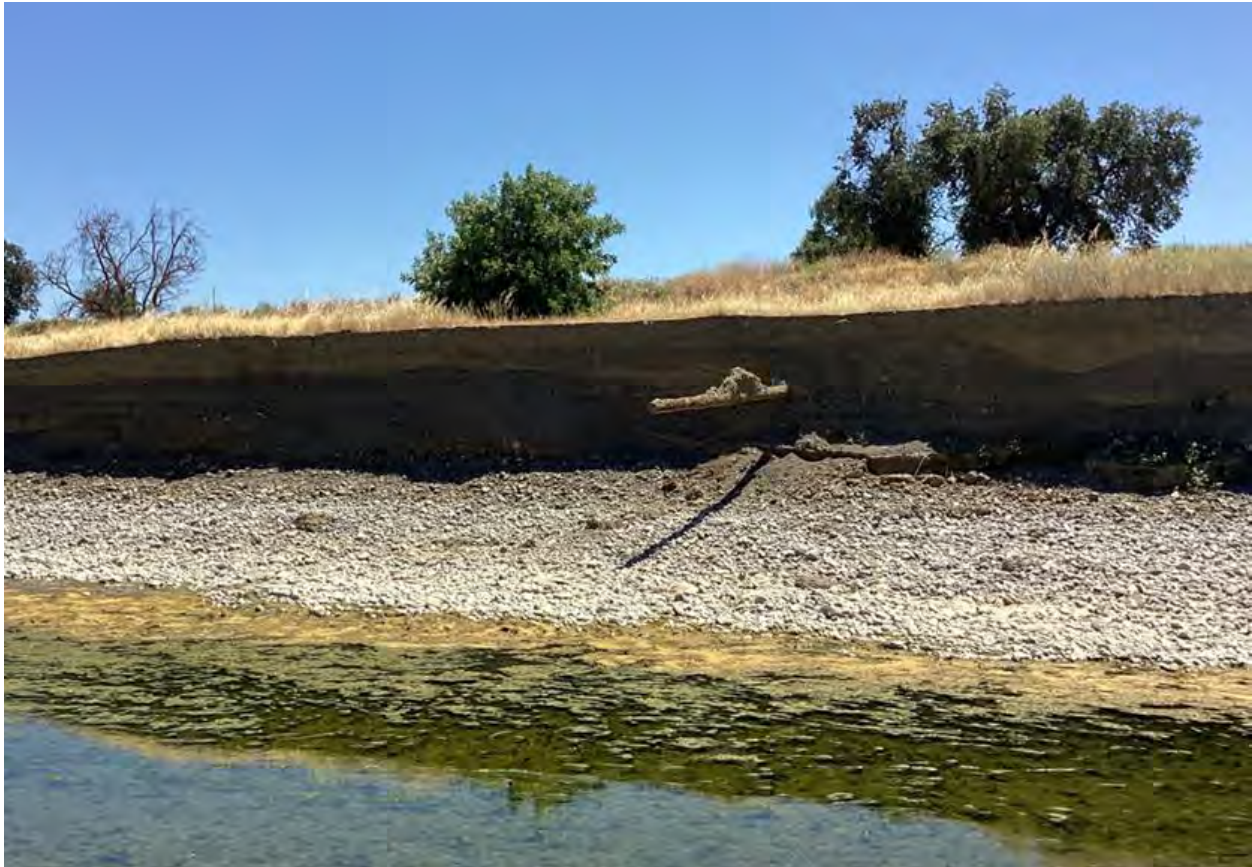
Figure 2-21. Exposed pipe in south (right) bank at River Mile 22.5.

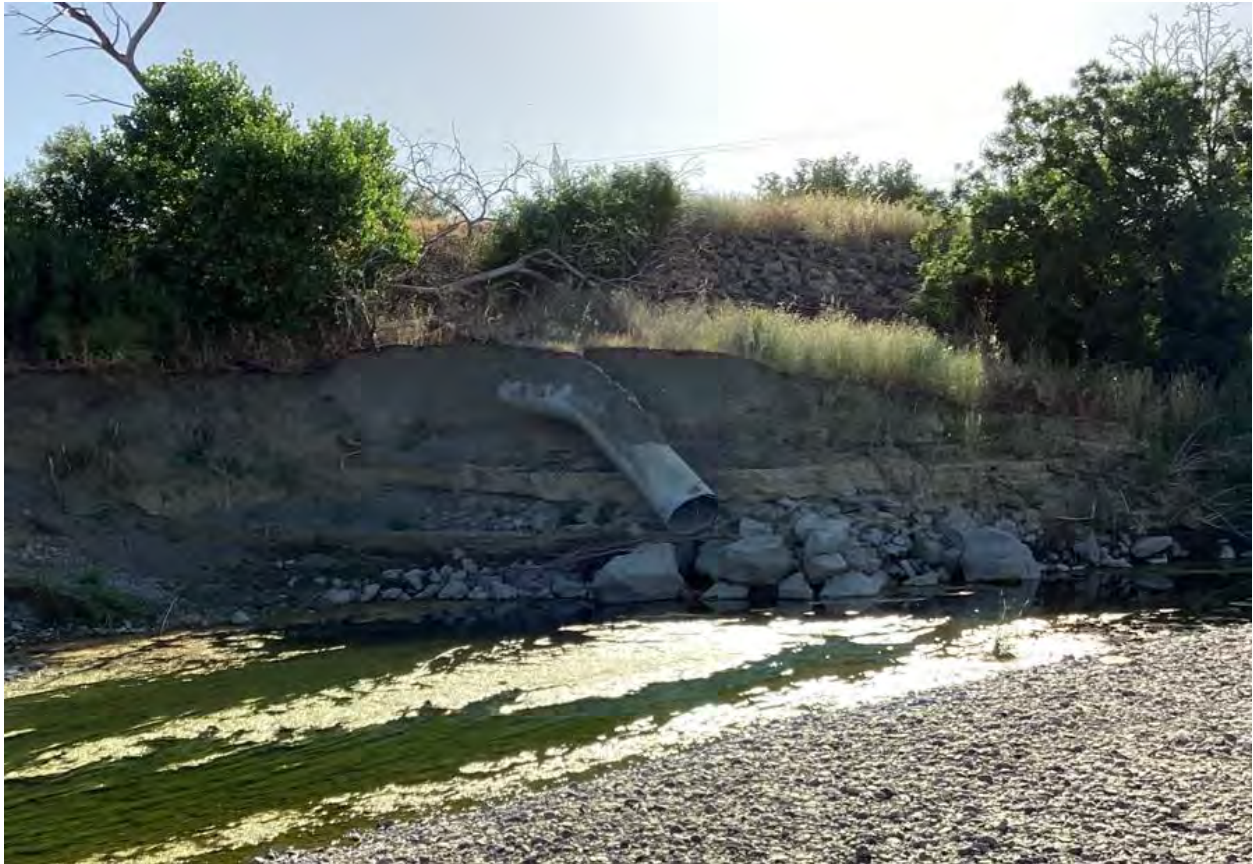
Figure 2-22. Newly eroded bank and exposed pipe at I-505 Bridge.

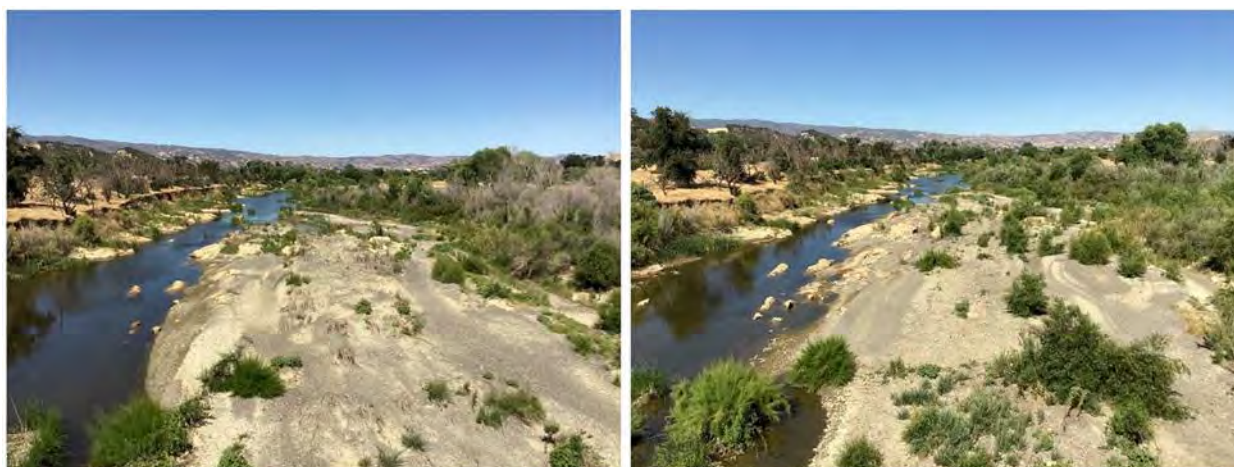
Figure 3-3. Looking upstream of CR-85 in Water Year 2023 (left) and 2024 (right) showing loss of vegetation, sediment deposition, and minor erosion, scour, and channel migration in Water Year 2023.

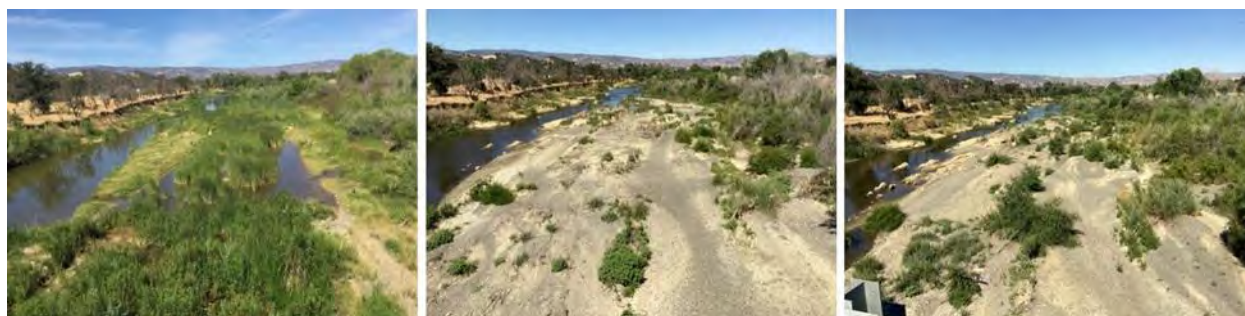
Figure 4-2. In-channel vegetation upstream of County Road 85 bridge at RM 26.3 in the Hungry Hollow Reach in 2022 (left), 2023 (center), and 2024 (right). Note significantly reduced vegetation in 2023 due to relatively high winter 2022-2023 flows, with some recovery in 2024.

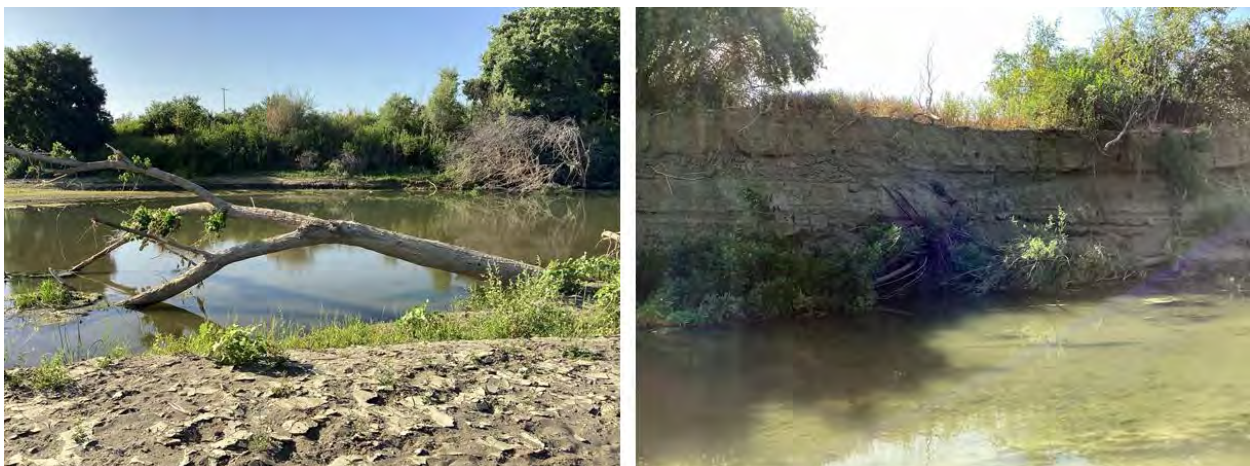
Figure 4-4. Examples of native woody vegetation displaced from banks into the main stream channel by bank erosion resulting from winter 2023-2024 flows in the Hoppin Reach at RM 15.7 (left) and RM 15.0 (right).

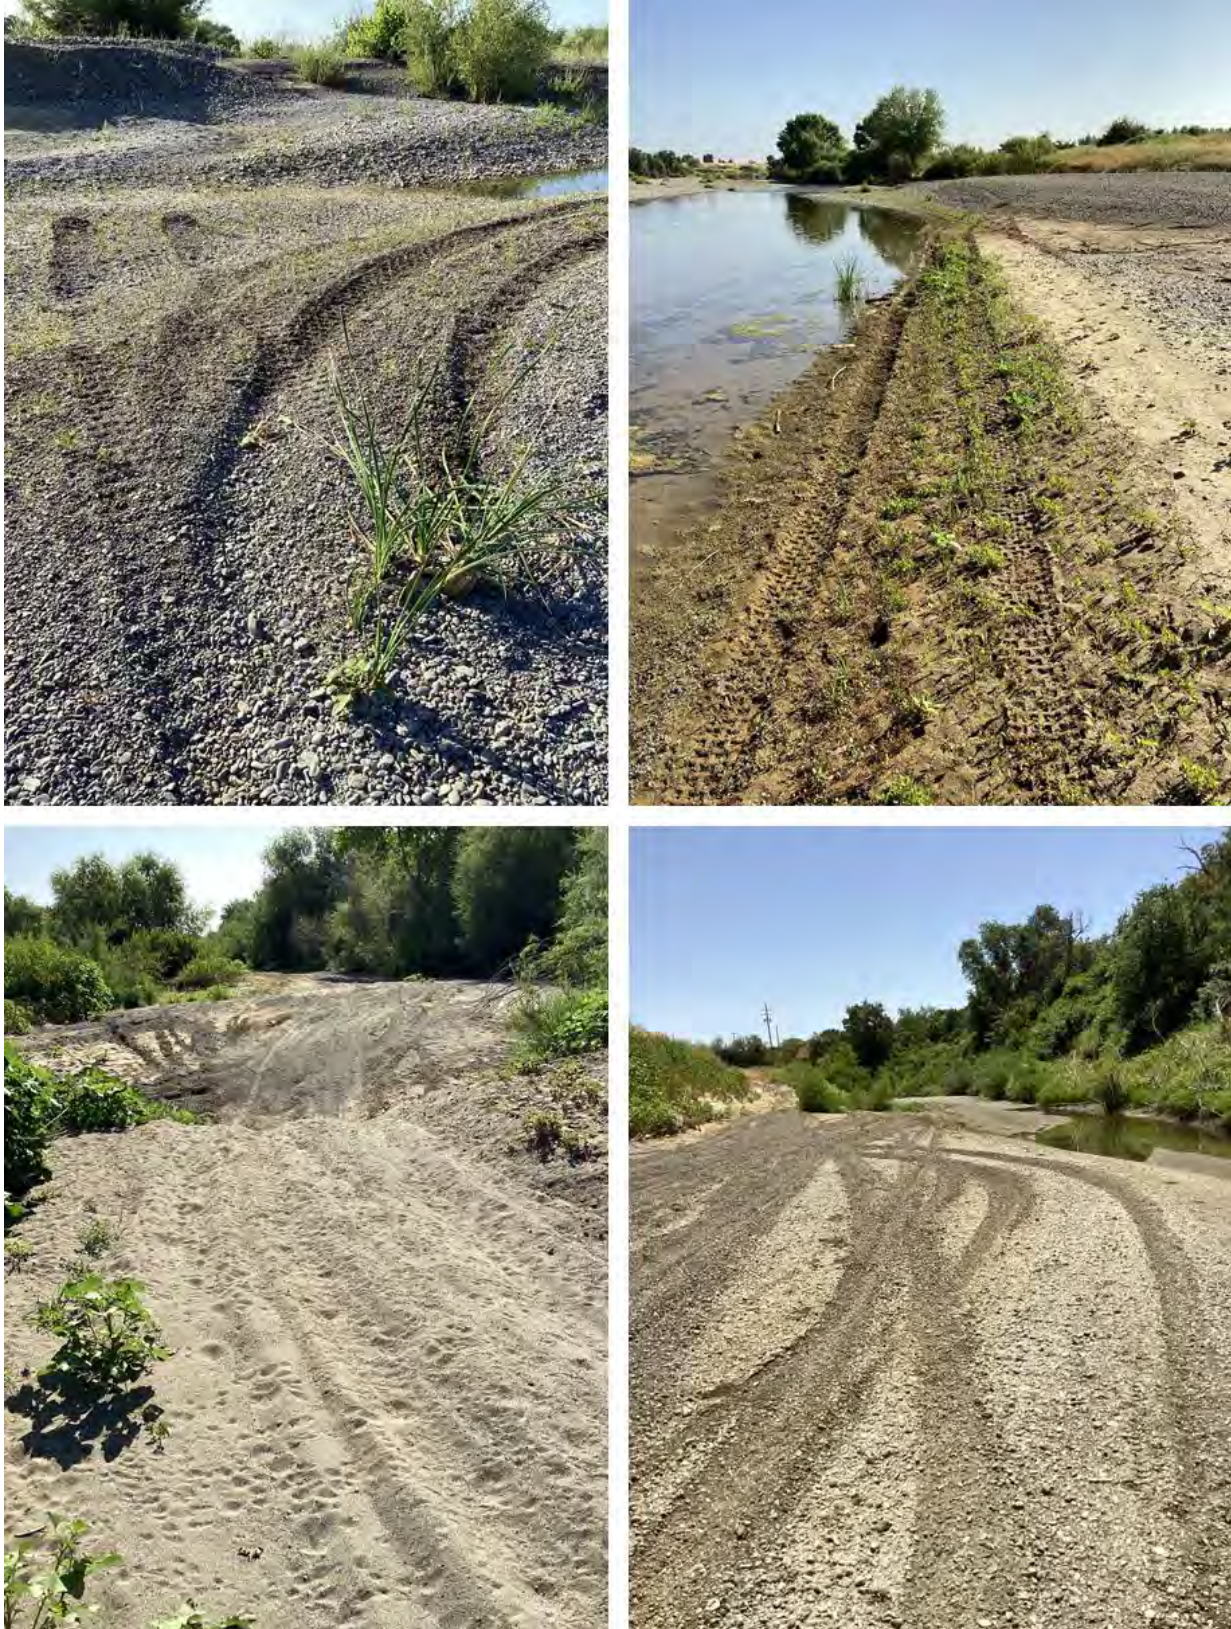
Figure 4-5. OHV tracks, soil disturbance, and vegetation impacts observed during the 2024 Creek Walk. Photos from RM 21.4 in the Madison Reach (upper left), RM 15.3 in the Hoppin Reach (upper right), RM 14.9 in the Hoppin Reach (lower left), and RM 12.4 in the Rio Jesus Maria Reach (lower right).

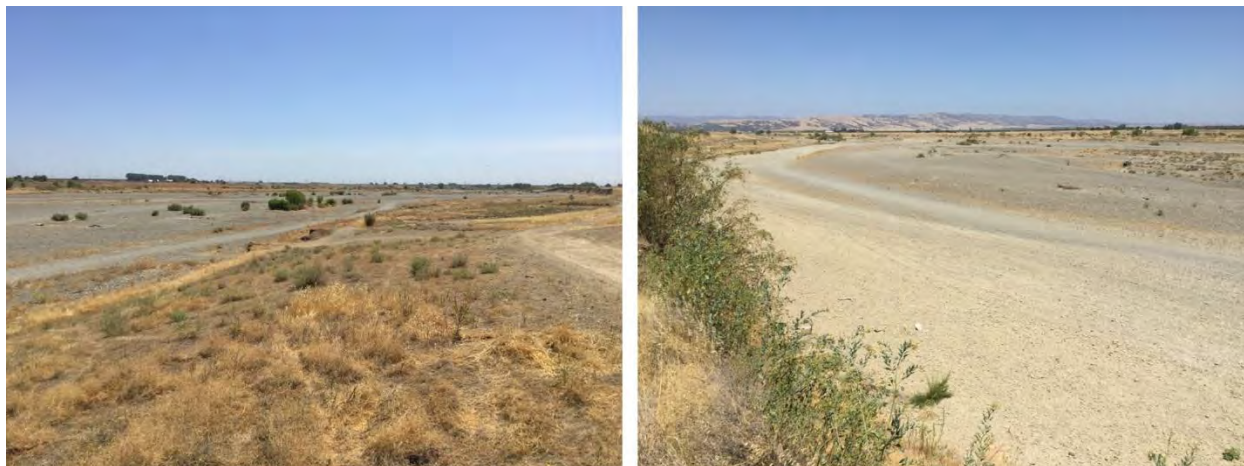
Figure 4-6. Representative photographs of two locations at which establishment and persistence of native vegetation is severely constrained by site conditions (left: downstream of County Road 87 bridge in the Hungry Hollow reach; right: Madison Reach). Photos from 2020; sites were in a similar condition in 2021, 2022, and 2023.

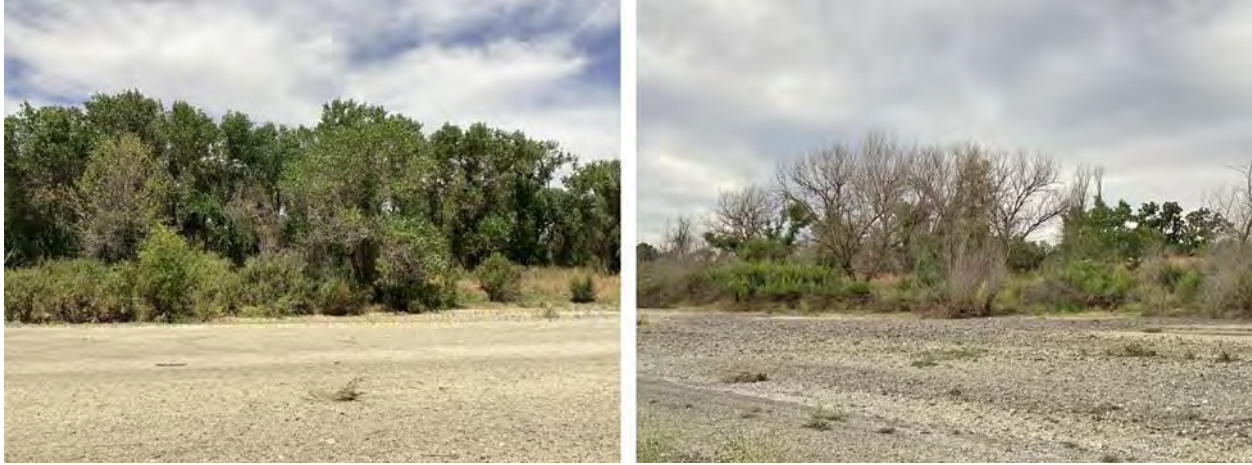
Figure 4-7. Healthy, stable mature riparian forest on the north bank at RM 17.2 in the Dunnigan Hills Reach (right), and drought-stressed mature riparian forest on the south bank at RM 21.1 in the Guesisosi Reach (right). Some drought recovery was observed at RM 21.1 in 2024 (photo not shown).

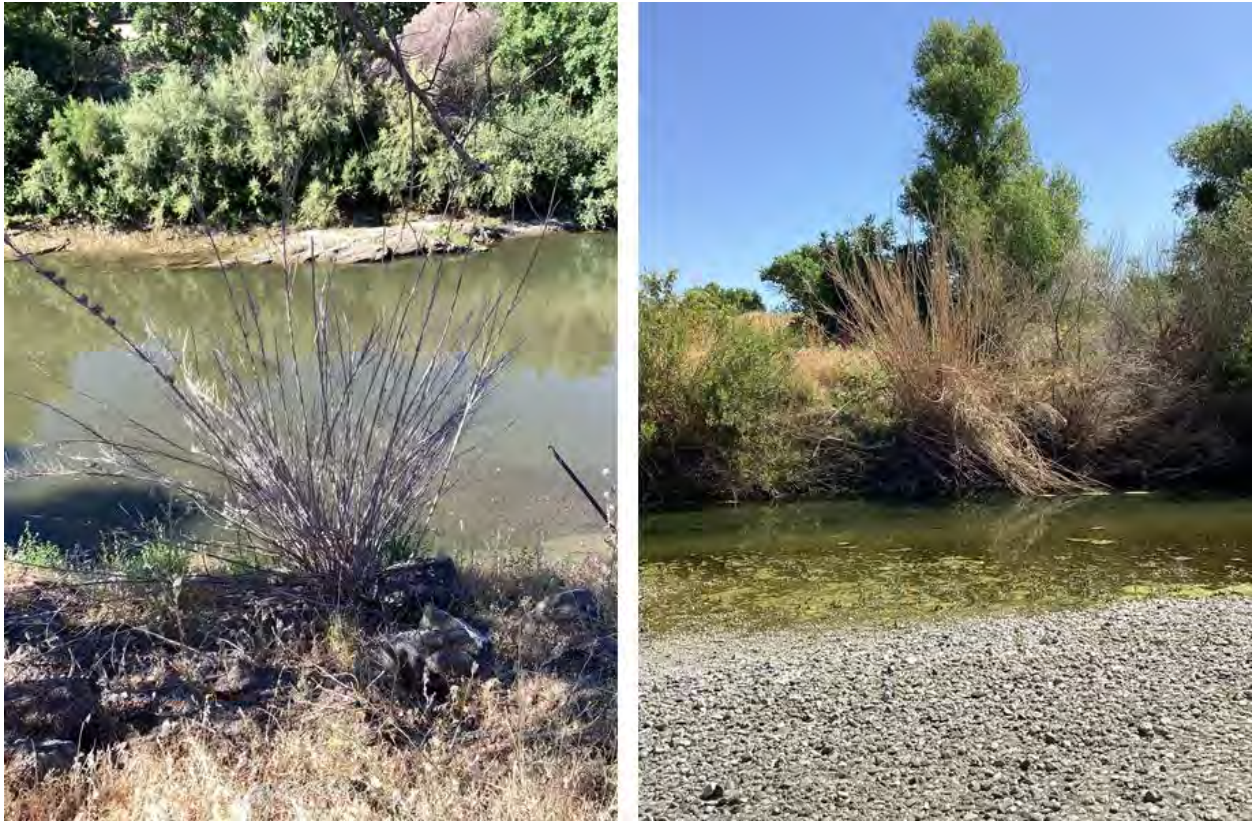
Figure 4-14. Treated stands of invasive arundo at RM 28.0 in the Capay Reach (left) and RM 19.3 in the Guesisosi Reach (right).

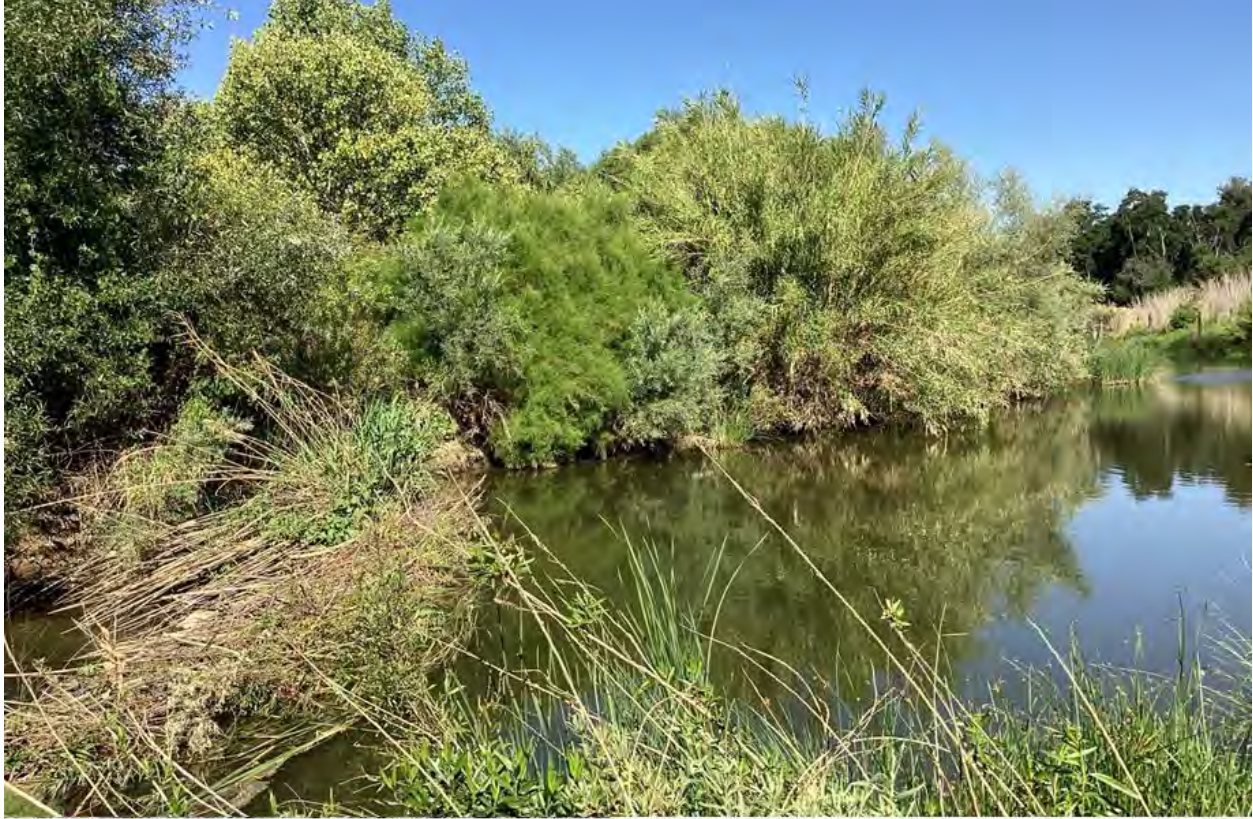
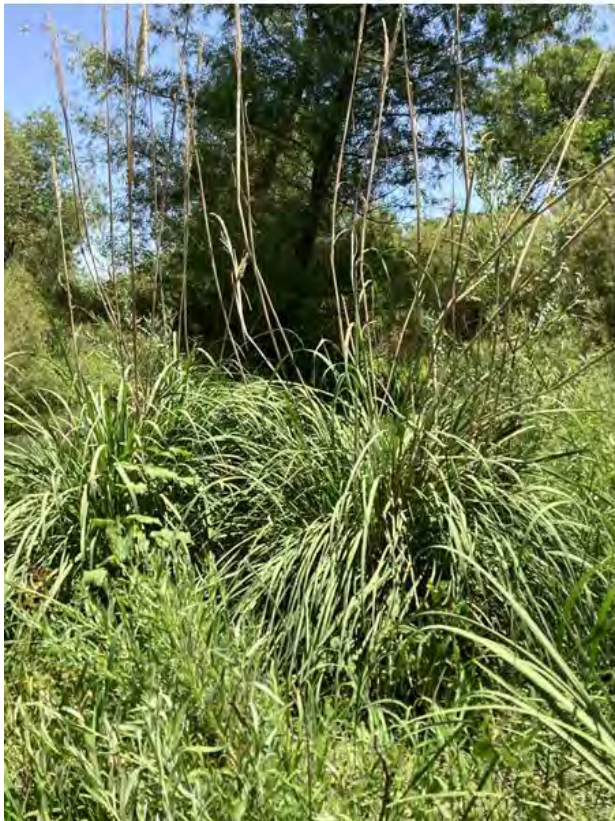
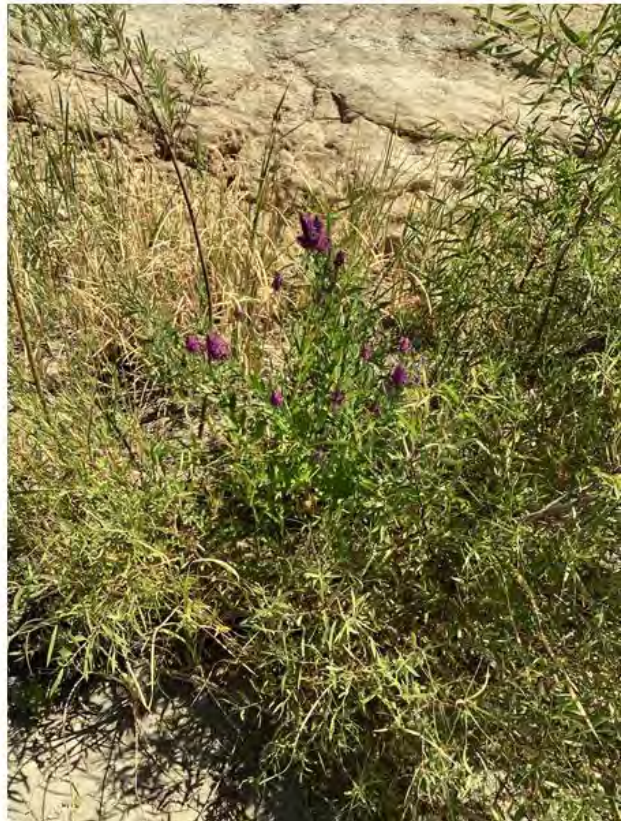
Figure 4-15. Stands of invasive arundo and tamarisk at RM 26.8 in the Capay Reach (top), Ravenna grass at RM 17.2 in the Dunnigan Hills Reach (bottom left), and purple loosestrife at RM 26.1 in the Hungry Hollow Reach (bottom right).

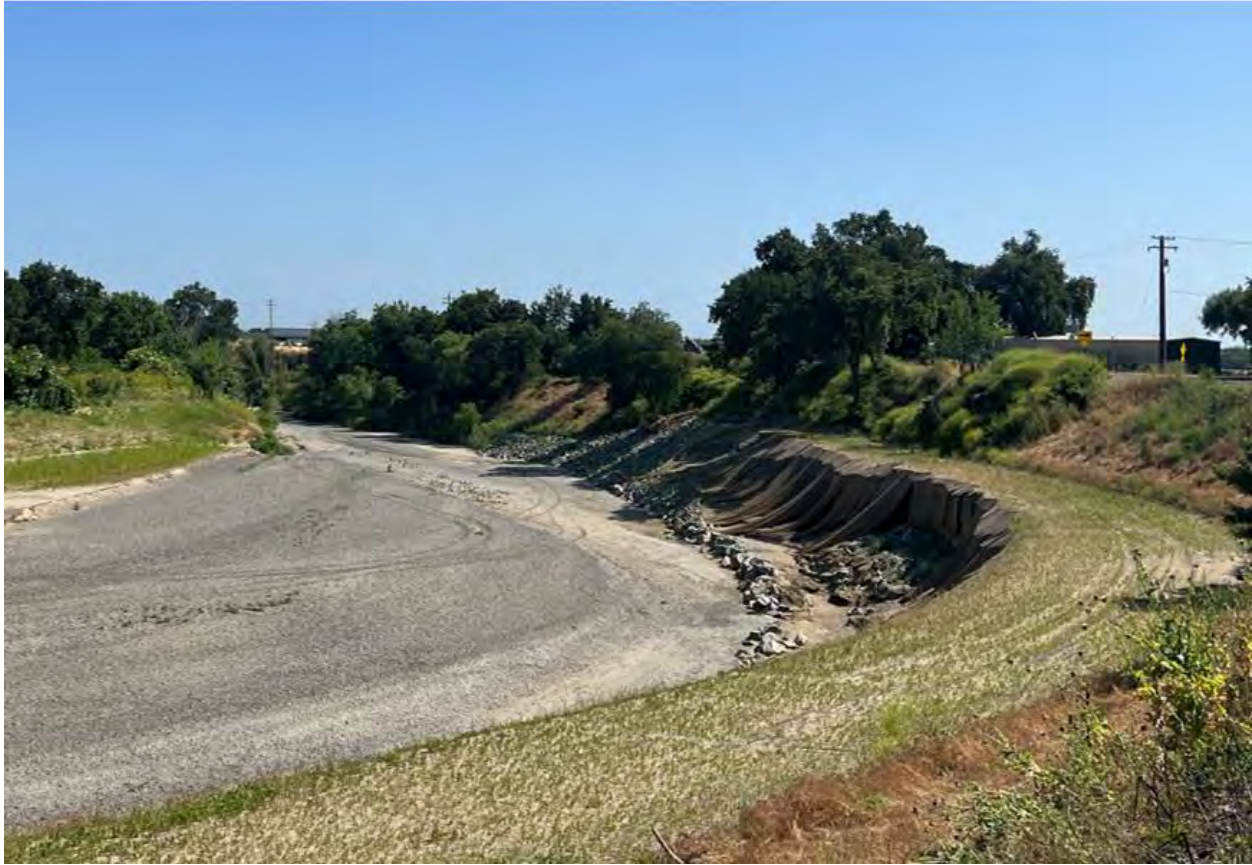
Figure 3. State of the Huff's Corner In-Channel Reconfiguration Project after Winter 22-23 flows damaged the newly constructed right bank terrace. Photo taken June 2, 2023.
