# Cochise County Board Meeting

## Naco Transboundary Flows

### Catalyzing a project to assist Naco, Sonora to mitigate transboundary flows to Arizona

February 6, 2019

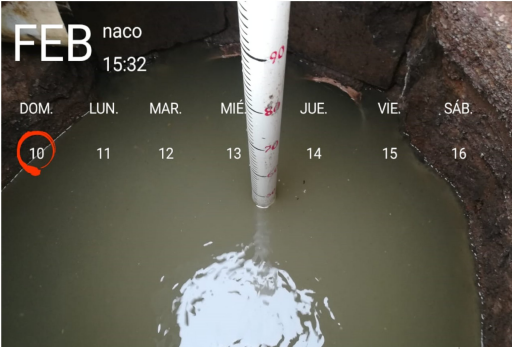
## WW System Key Point Level Measurements -- TODAY

| | Measurement | Target | Comments | Trend |
|---|---|---|---|---|
| Man hole #01 "Bad Muro" | 16-inches (0.4 meters) | 12-inches (0.3 meters) | Stable since 1/11 | ↔ |
| East Lagoon | 22-inches | Level Zero (1,414 m SL) | Slightly down | ↓ |

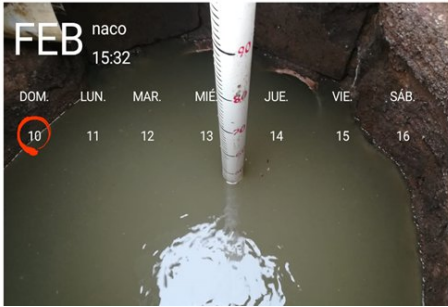
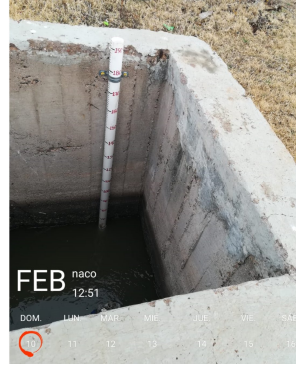
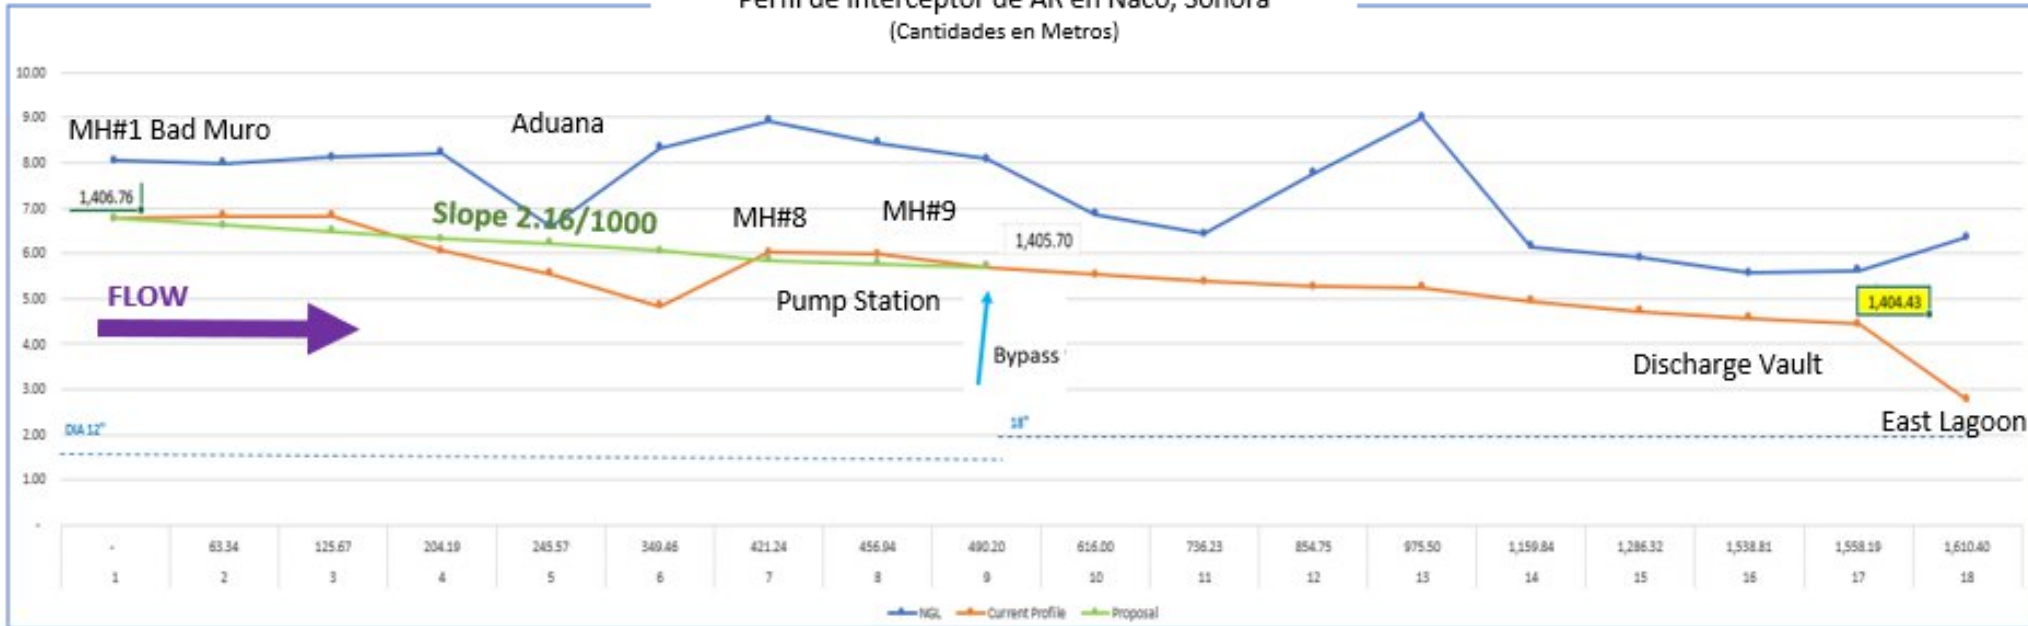
# Proposed WW Interceptor Replacement Area (MH#1 to MH#9)

Perfil de Interceptor de AR en Naco, Sonora  
(Cantidades en Metros)

- ❑ Continue monitoring MH#1, East Lagoon and MH#9
  - ❑ Continue pipe cleaning
    - Connect MH#8 to MH#9 directly (remove #40)
    - Improve flows from MH#01 to MH#02 ....
  - ❑ Rehab International Pump Station (NADB/ADEQ)?
  - ❑ Identification of mid-term solution
    - Implement a redundancy system through by-passes (vs pump station)
    - Interceptor replacement MH #1 to MH #9 (approx. 450 meters)
- Cost Estimates (order of magnitude)
- Open Trench US\$42,600
  - Open Trench + Directional Drilling Aduana/INDABBIN US\$ 178,000
- Determine optimum solution for lagoon operations and discharge

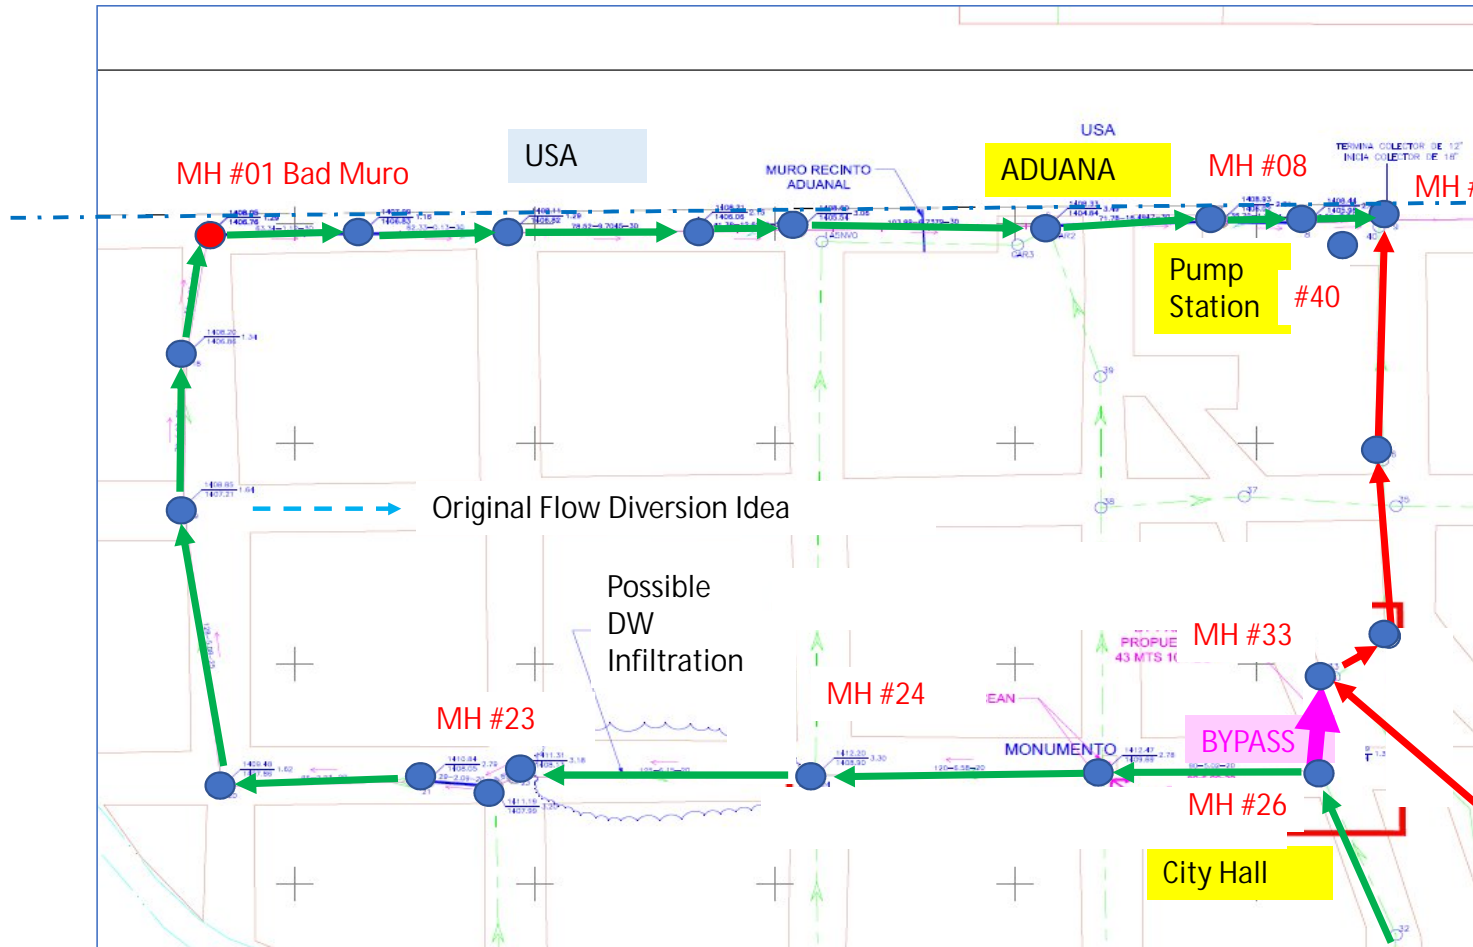
# North West WWC Area Interceptor Bypass

Bypass Data  
PVC Clase 20  
10-inch  
128 lps  
capacity

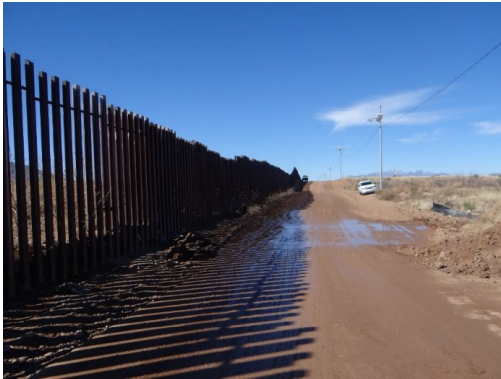
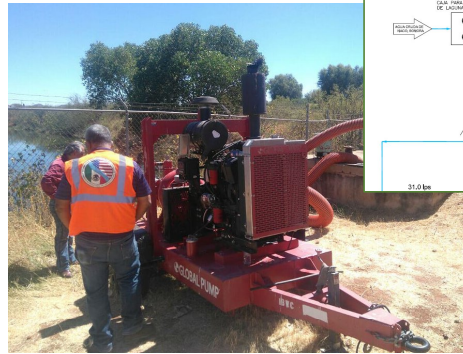
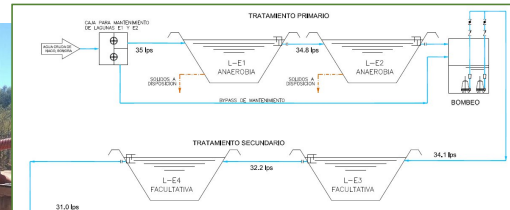
## 9/17 IBWCs pump in East Lagoon

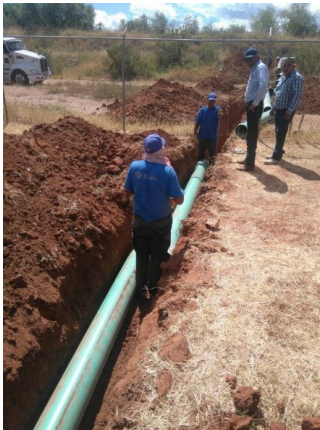
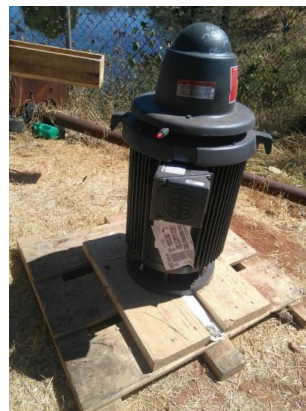
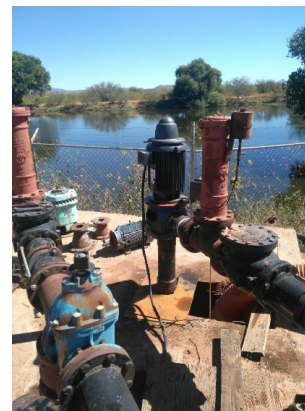
## 9/17 Materials provided by NADB, Pump by CEA

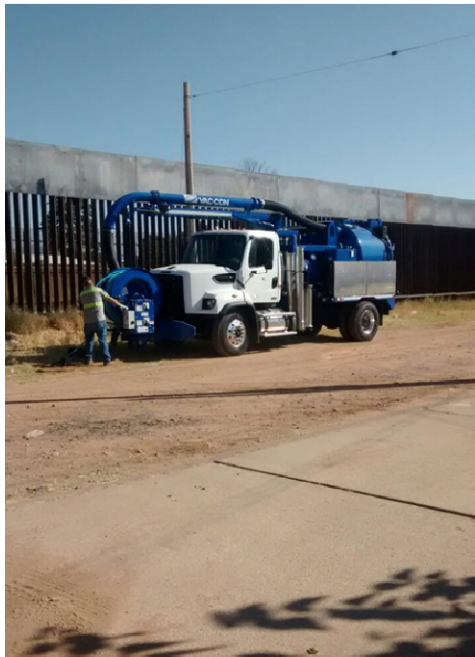
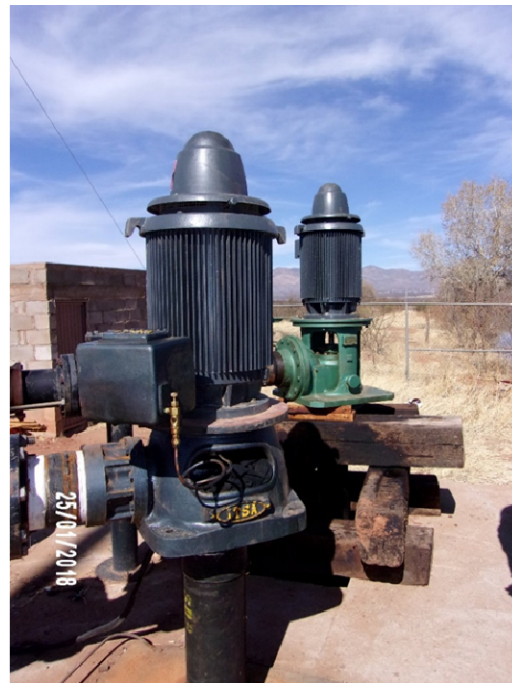
10/17 NADB hires cleaning equipment and CEA donates pump

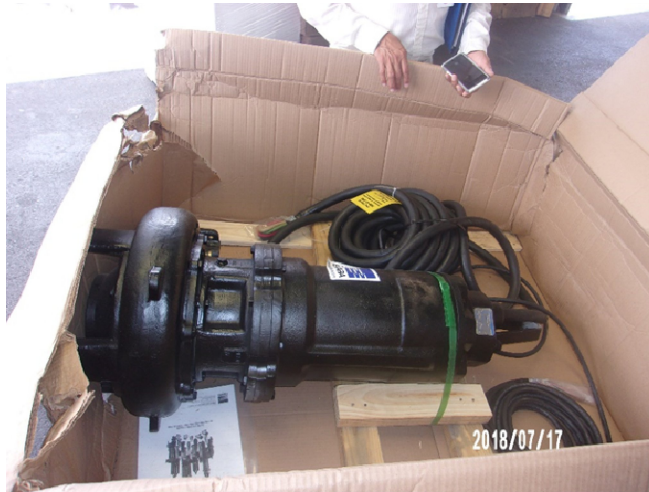
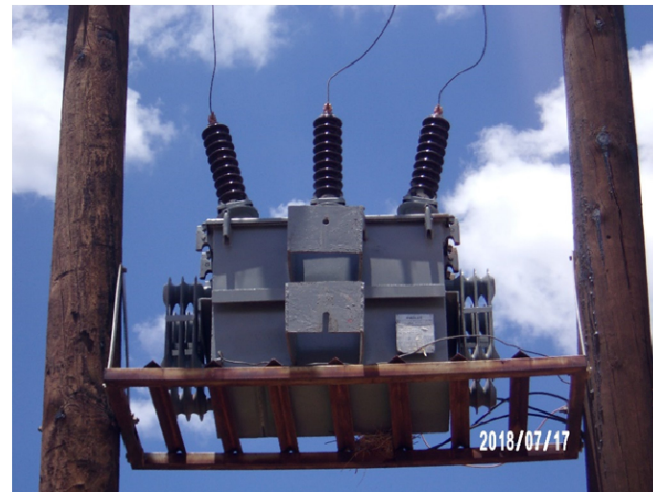
7/18 In coordination with ADEQ, NADB installs submersible pump and transformer in International Pump Station

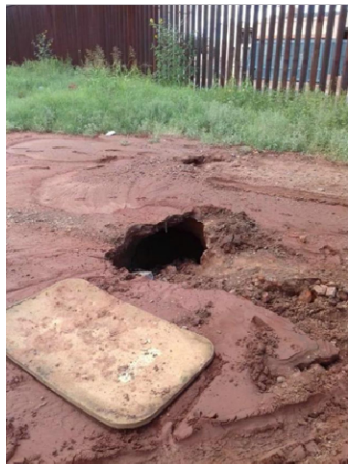
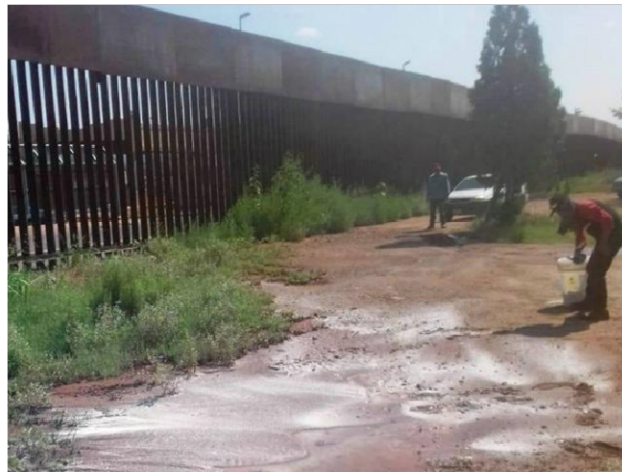
9/18 Force main fails and generates a discharge for several hours that is contained in the US side using berms.

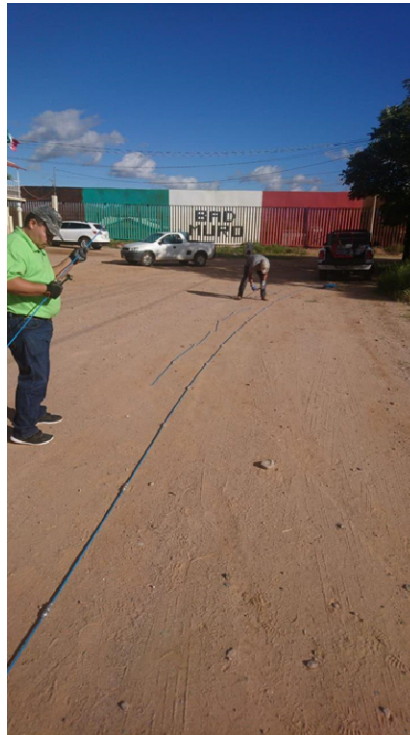
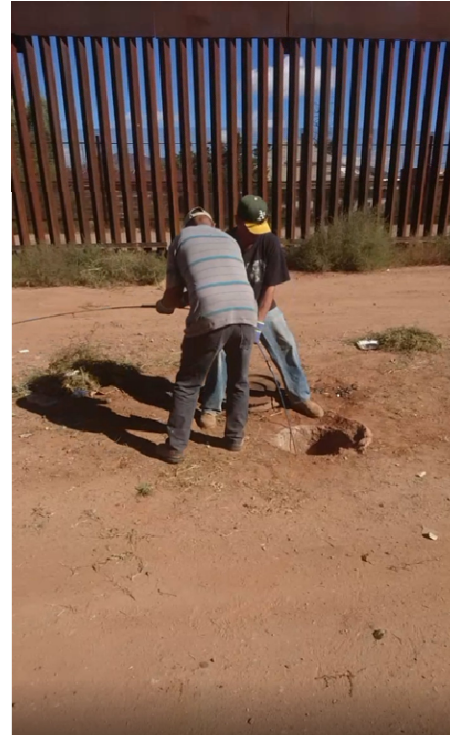
9/18 CILA clean West interceptor using sewer cleaning rods (roto-probe) and finds a blockage east of the west man hole.

NADB in coordination with ADEQ provides machinery to excavate and remove the blockage.

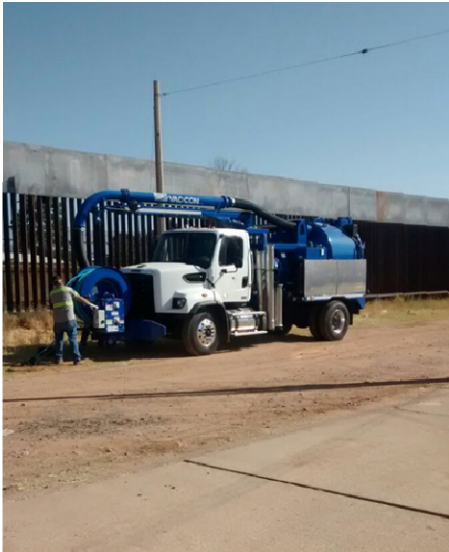
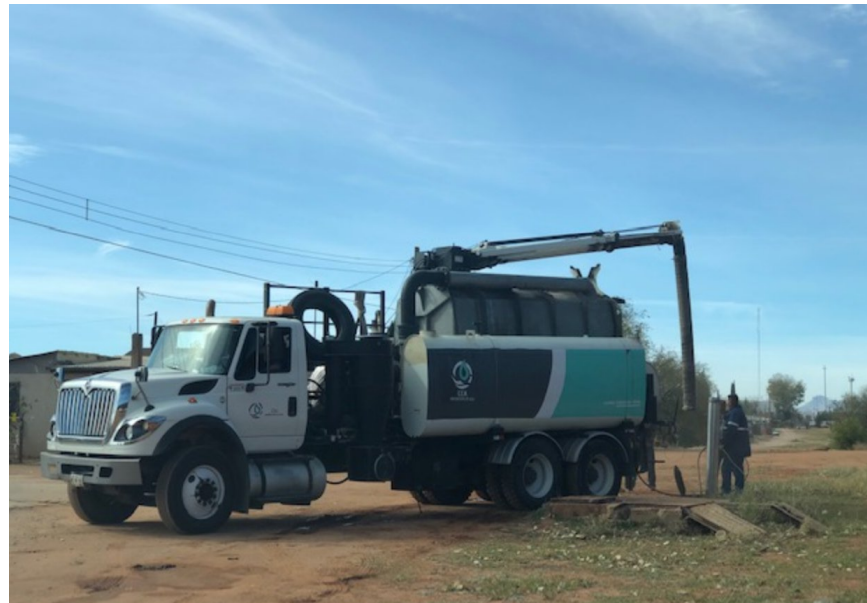
11/18 NADB/ADEQ contracts a vacuum trucks from Nogales and covers expenses of CEA's truck to complete two weeks cleaning of West Interceptor.

WW Levels are reduced.

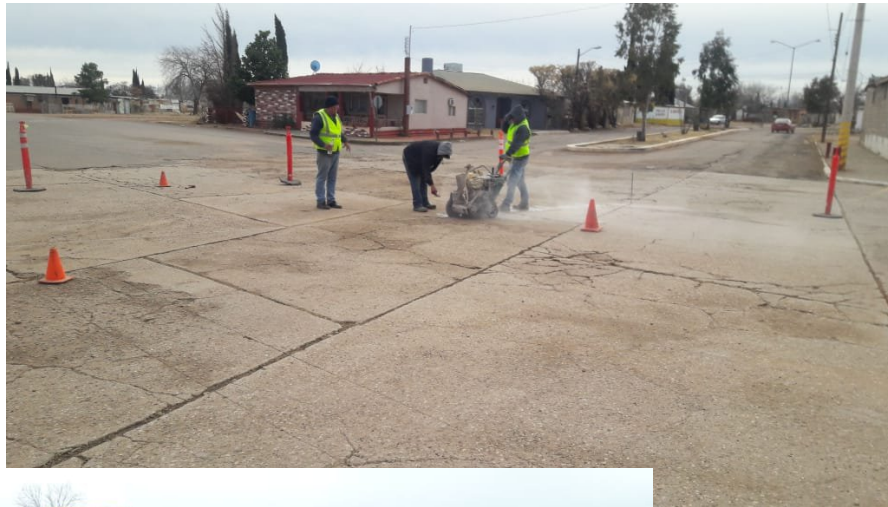
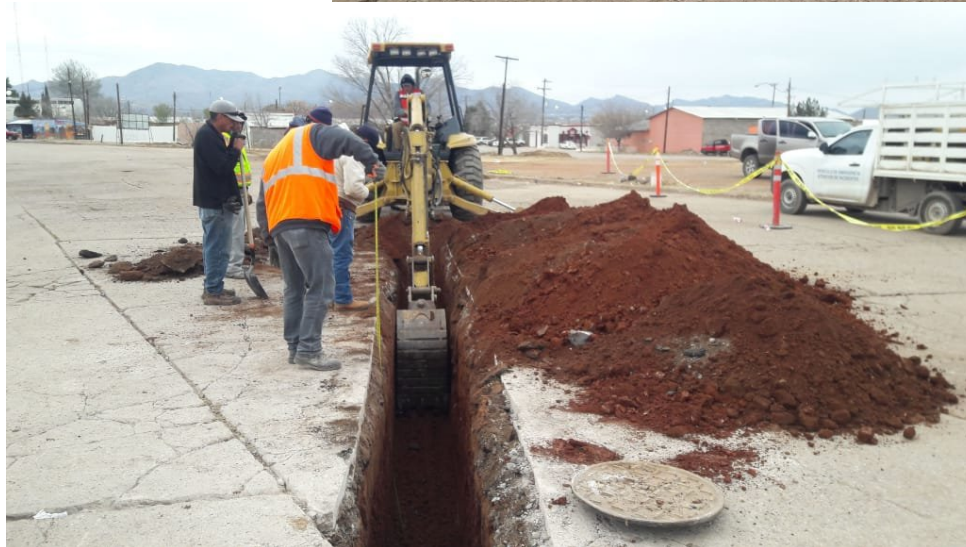
## Construction of Libertad Bypass to divert WW flows from West to East

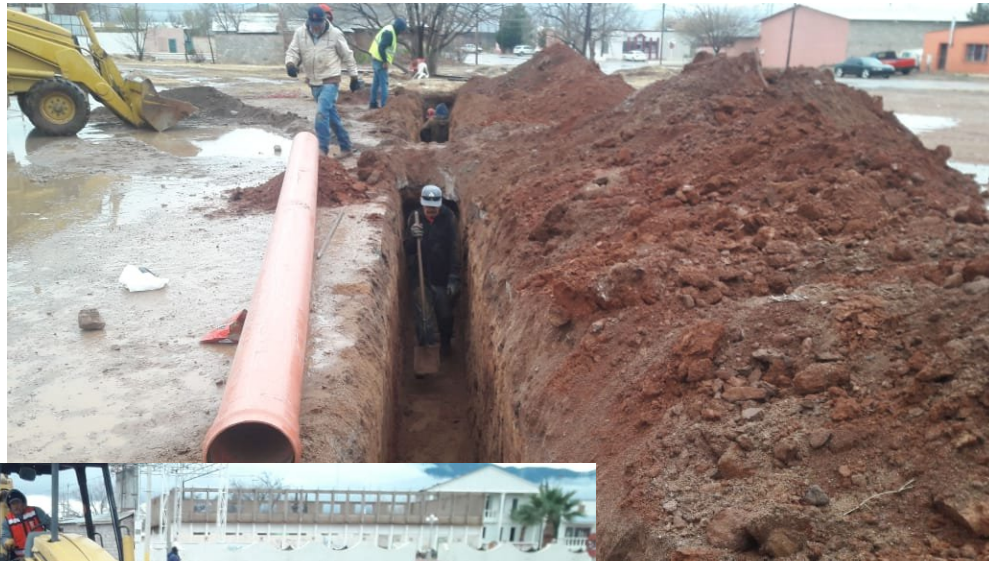
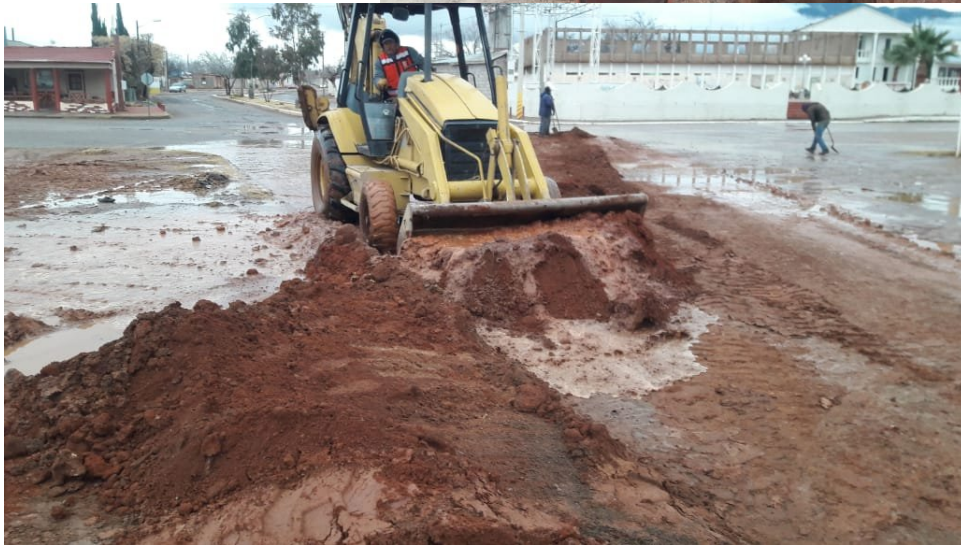
## Construction of Libertad Bypass to divert WW flows from West to East

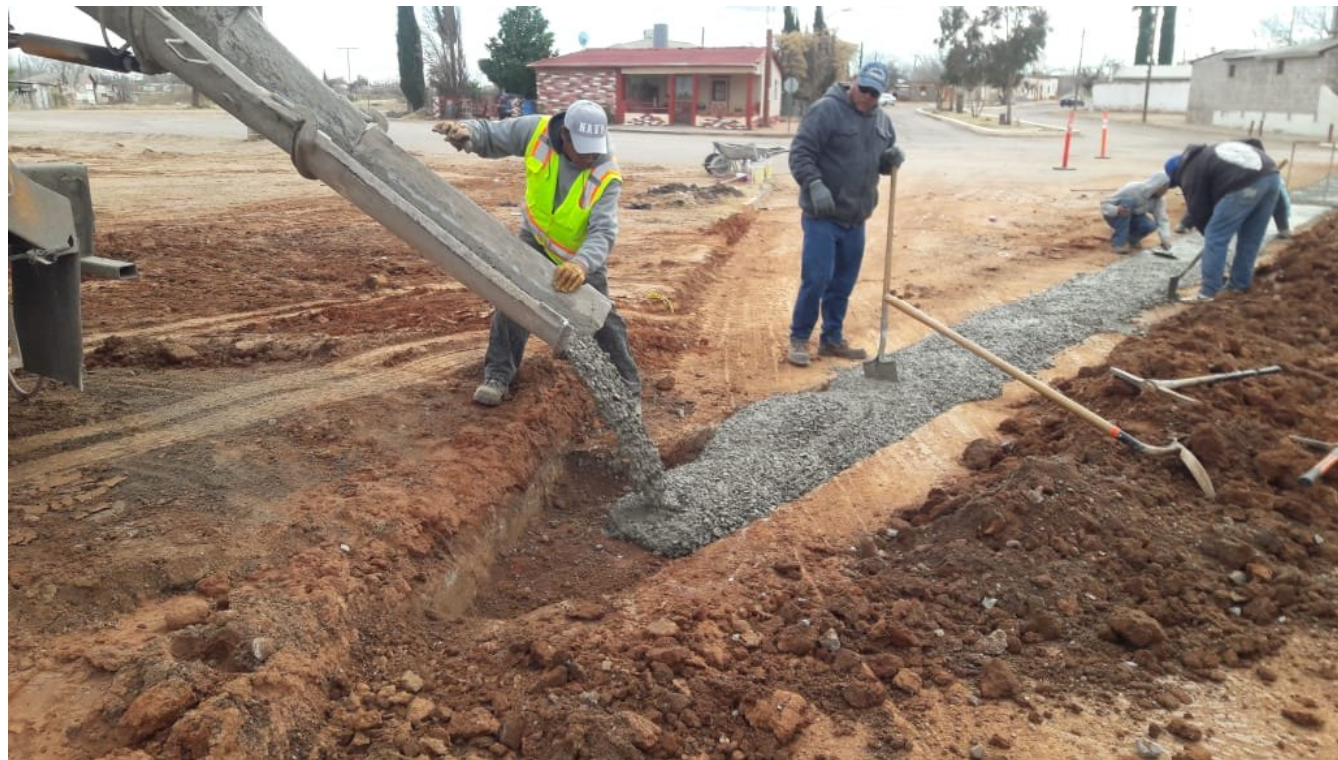
## Construction of Libertad Bypass to divert WW flows from West to East

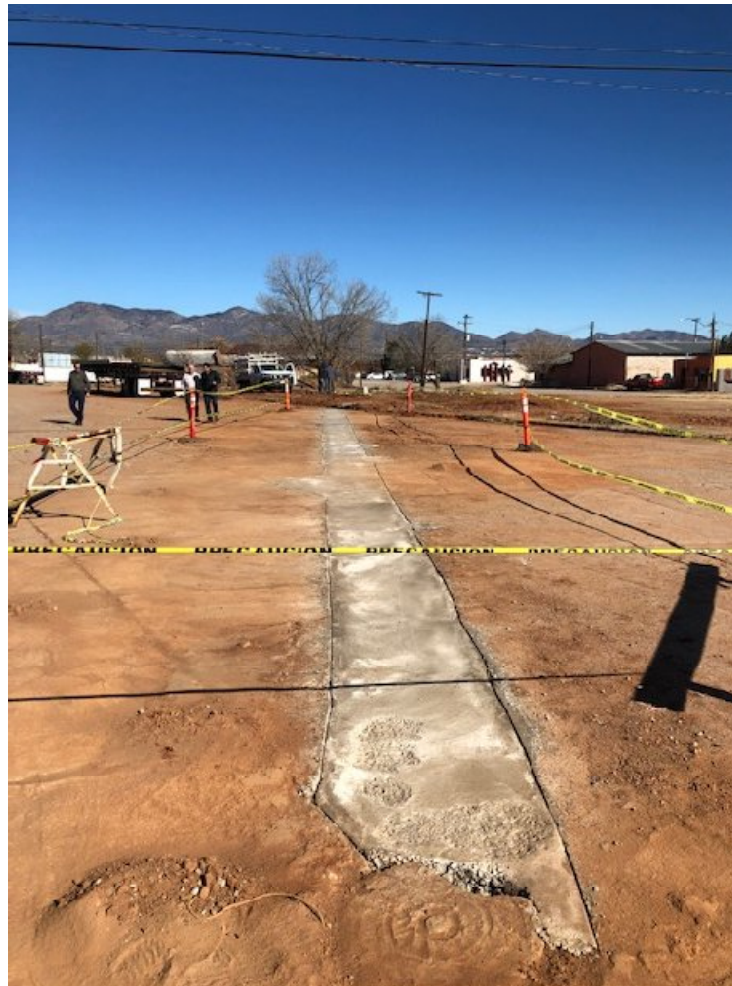
## Libertad Bypass completed and in operation (South to North view)

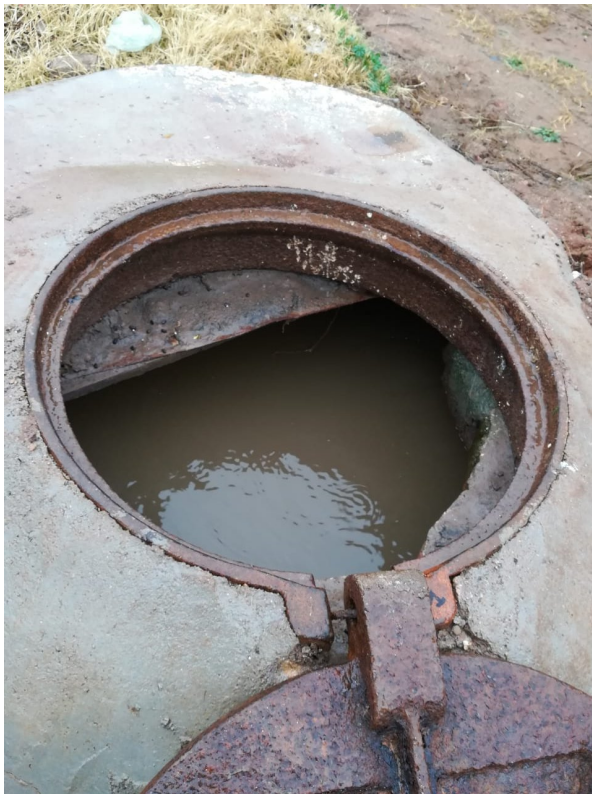
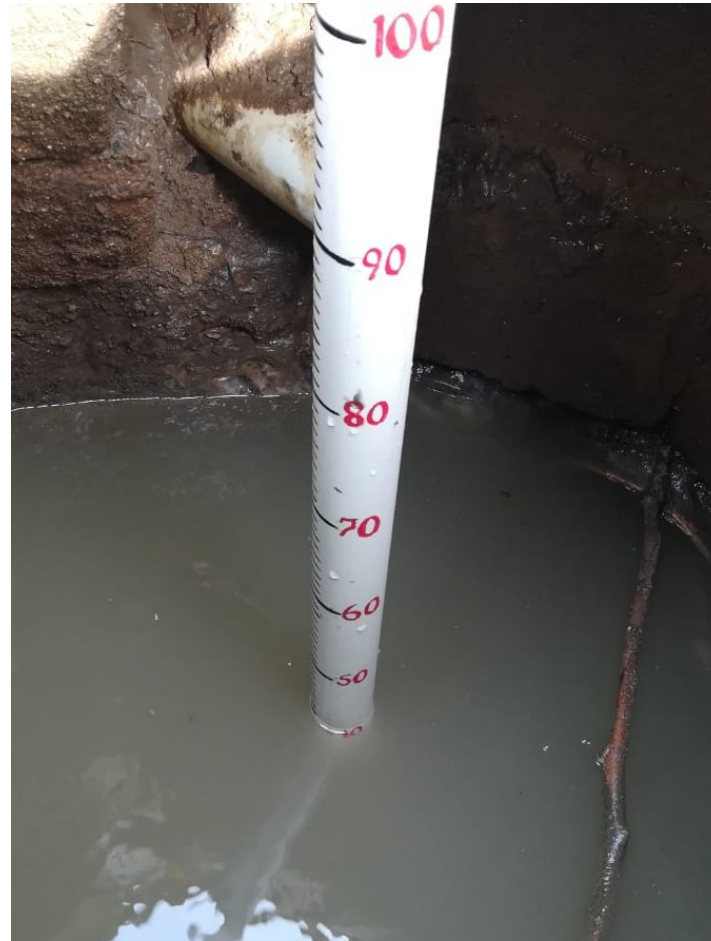
## Monitoring Sewer Levels at Manhole #1 – BEFORE and AFTER the Bypass

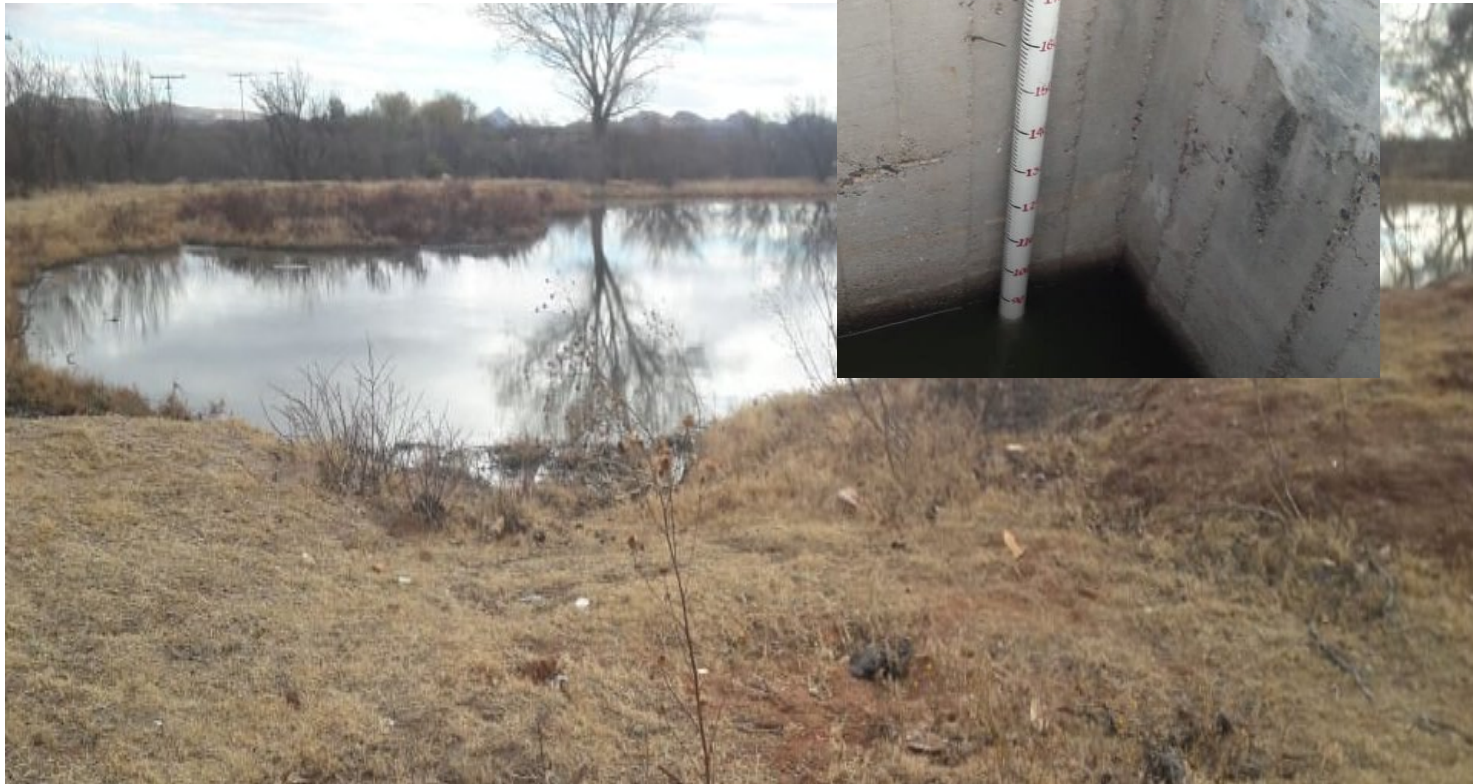
## East Lagoon Monitoring WW Levels at Discharge Vault

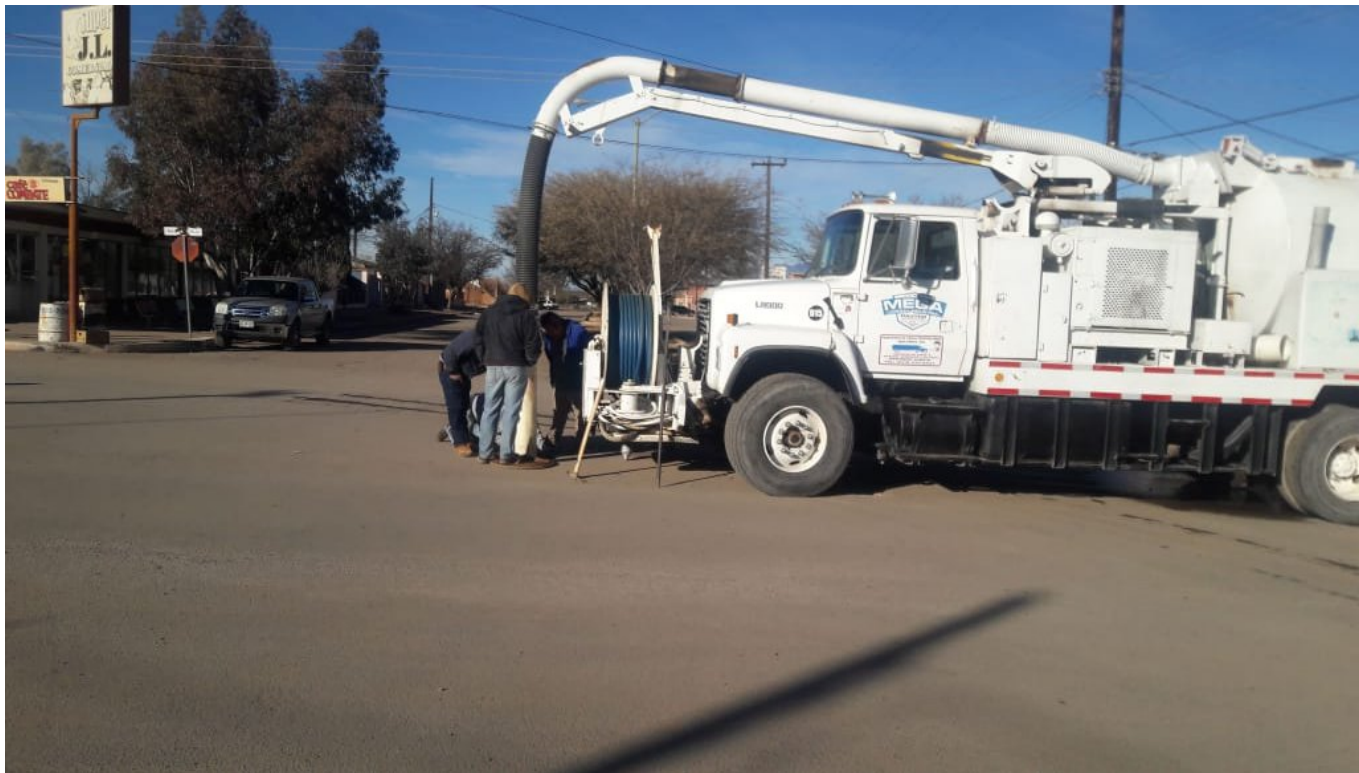
## Sewer cleaning using a Vacuum-Water Jet truck – “Vector Type”
