**PHASE I ENVIRONMENTAL SITE ASSESSMENT OF
302 WEST OAK AVENUE IN FLAGSTAFF, ARIZONA**

TALLPINES JOB NO. 20TEC116.ESA

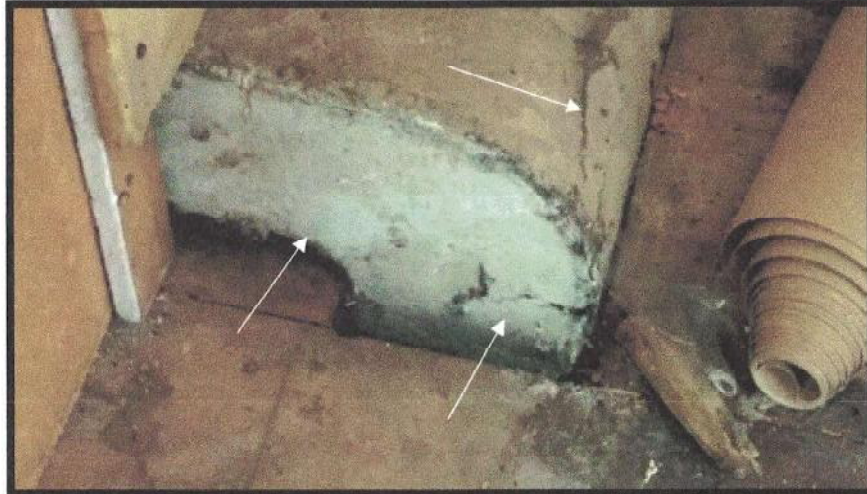
Photo #11: Inside the preparation room is a closet with a portion of a metal duct that connects to a boiler in the basement. The friable (easily crumbled with hand pressure, when dry), white duct wrap insulation is significantly damaged, and suggestive of incomplete removal. The duct wrap insulation (DWI) is reported with a 20-30% chrysotile asbestos content. Viewing down, and to the southwest.

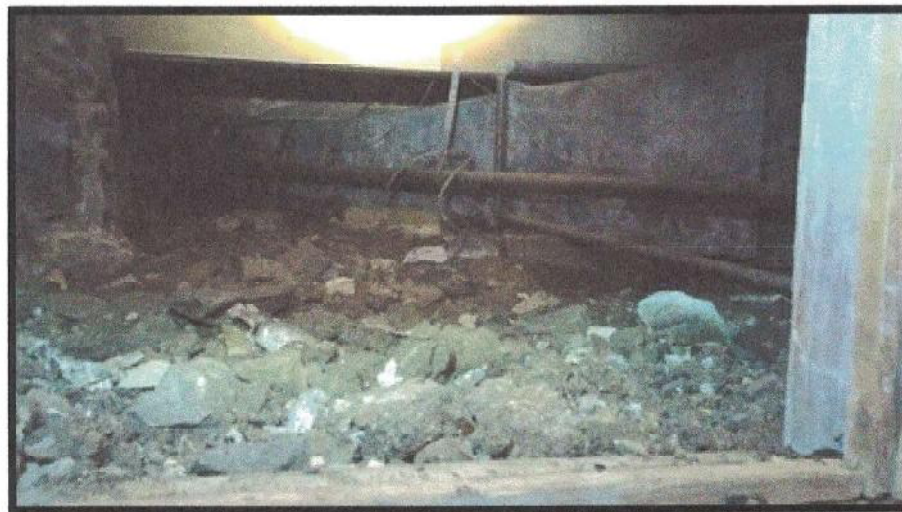
Photo #12: Partial view inside the crawlspace located west of the basement boiler room shows the metal ductwork that leads southwestward toward additions on the west side of the building. Although there is no visible DWI on the metal duct, it appears to be present as debris on the soil. Viewing northwest.

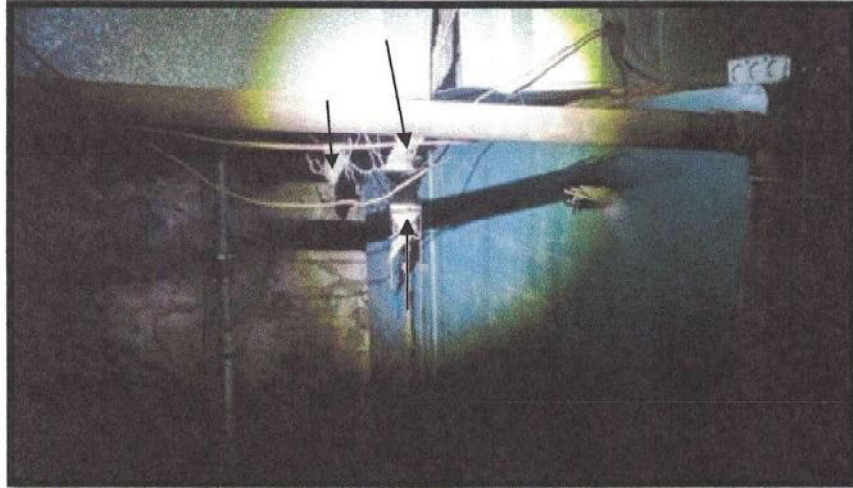
Photo #13: Significantly damaged vibration dampening cloth (VDC) on the boiler ductwork (arrows). The VDC is friable, and assumed to be asbestos containing because it was inaccessible the day of sampling. The concrete boiler room was flooded with 3.5 feet of water from recent heavy rainfall. Viewing northeast inside the boiler room.

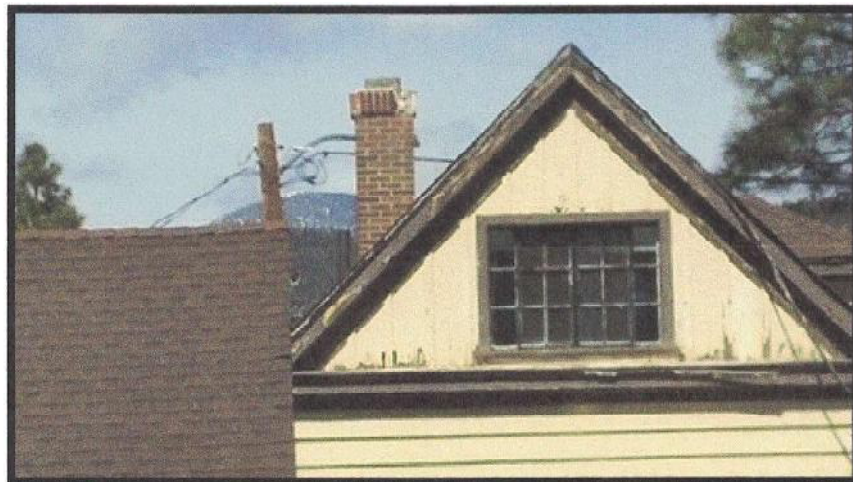
Photo #14: Roof dormer on upstairs east apartment accessed by entering the office. Viewing northwest.

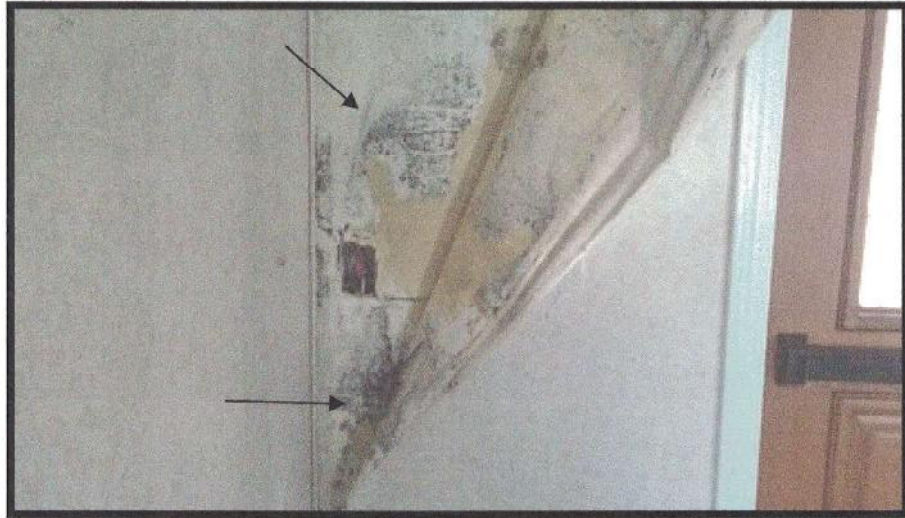
Photo #25: The interior of the chapel contains patterned wallpaper with well-developed mold contamination at a location of water-damage (arrows). The mold appears to be the result of a roof leak that drained down the interior of the wall system. Viewing northwest.

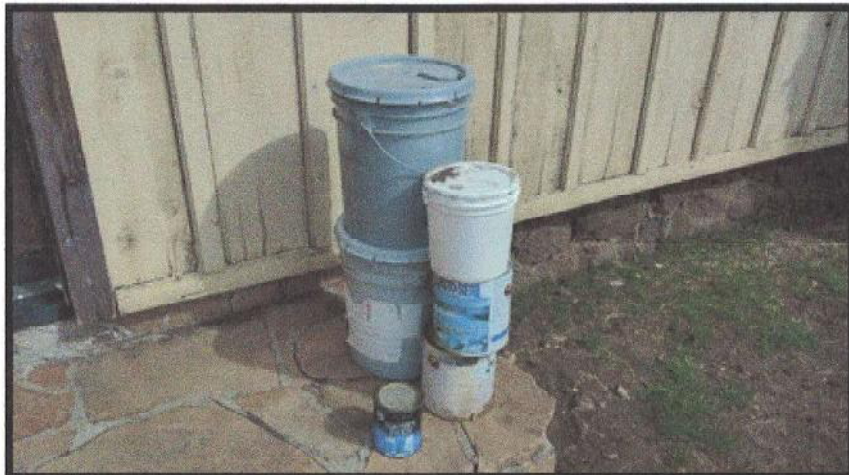
Photo #26: During the field reconnaissance, Tallpines noted no stockpiling or release of hazardous substances or petroleum products. Five-gallon buckets of paint, stockpiled on the exterior of the building, are considered a *de minimis* condition. Viewing down, and to the northwest.

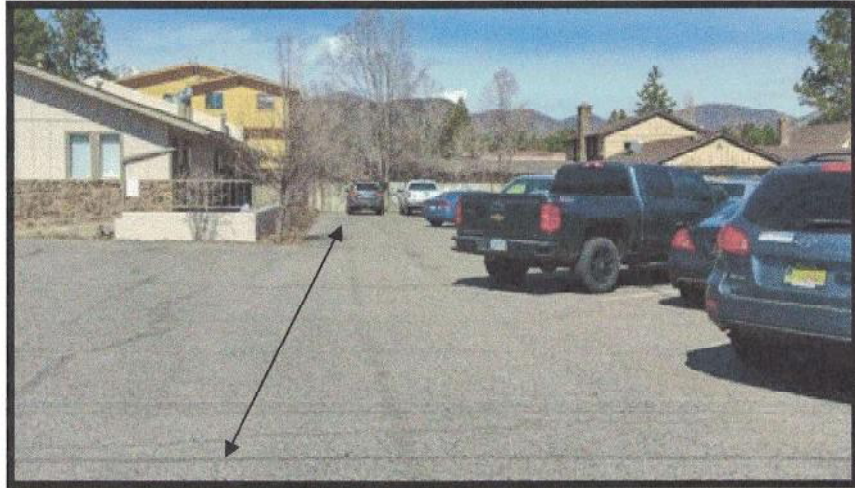
Photo #27: West boundary of the Property (arrow). Viewing northwest from the paved parking lot.
