COA 17-25

518 N 2nd Street

Consideration of an approval for the replacement of the existing metal shingle roof with 5V Crimp metal panel roof, and replacement of upper level wooden windows with vinyl high impact windows.

HISTORIC PRESERVATION BOARD : PUBLIC HEARING

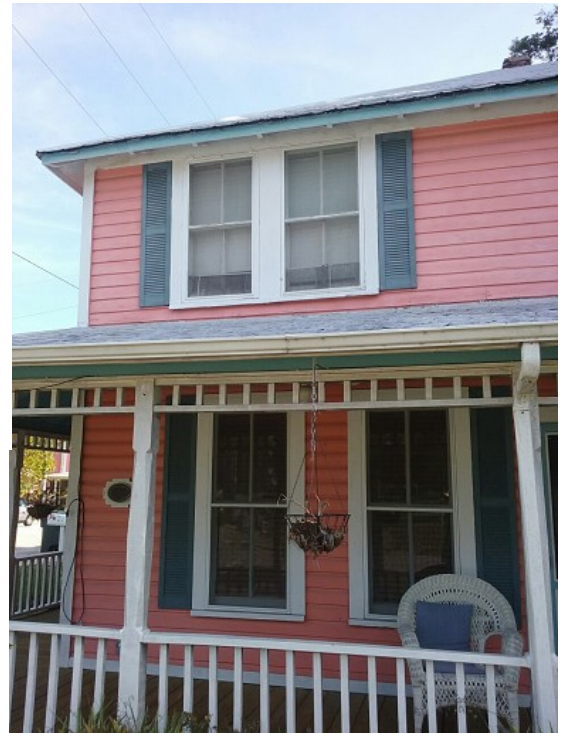
View of the existing windows

The roof leaks have also led to severe deterioration of the wooden windows and flooring rot.

The current proposal seeks to install vinyl high impact windows that are non-compatible with the materials appropriate to protect the historic integrity of the residence. Based upon Secretary of Interior Standards 2, 5 and 6, staff recommends that the Historical Review Board deny this request and recommend that the applicant attempt to repair original windows, or approve the request for installation of new windows with condition that they will be wooden windows instead of vinyl.

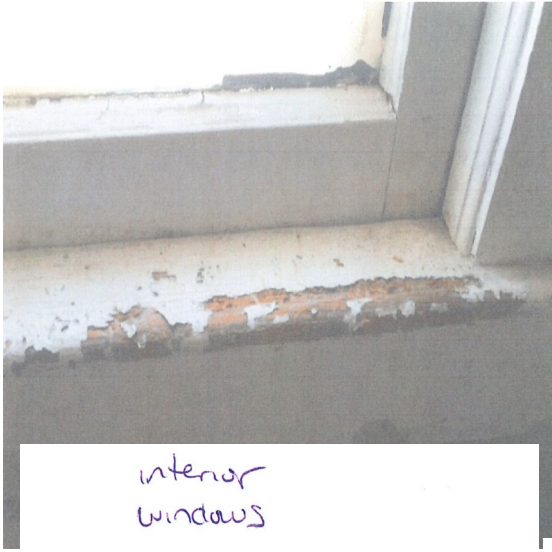
interior window

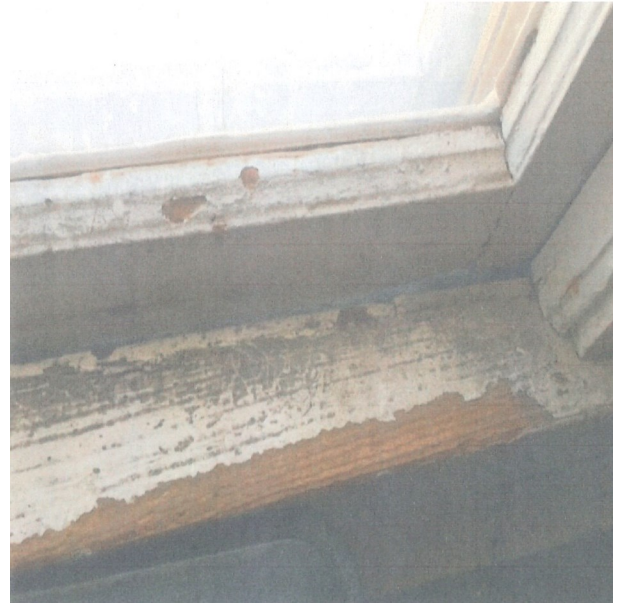
interior windows

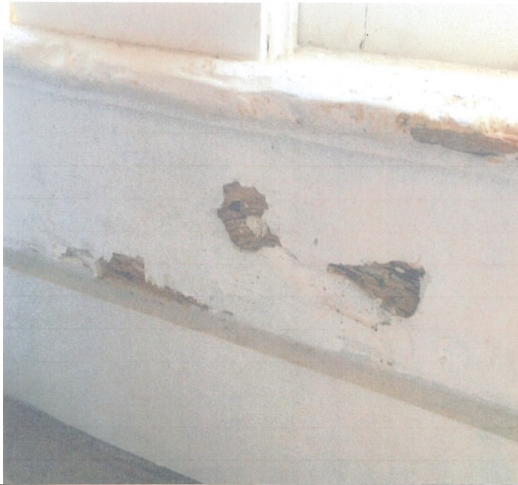
window rotted through

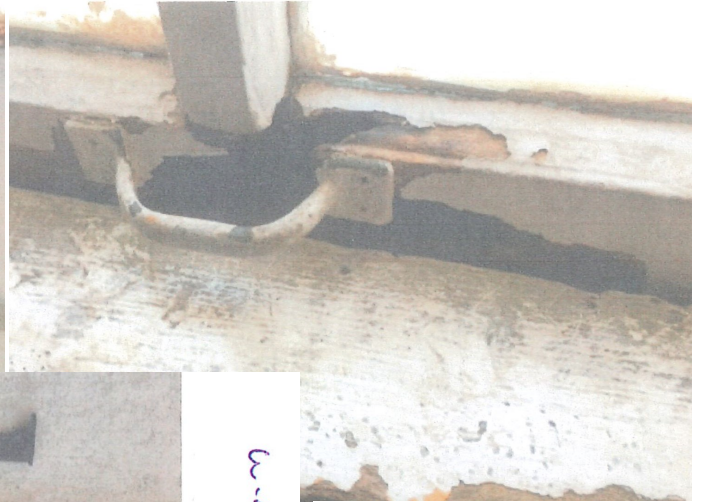
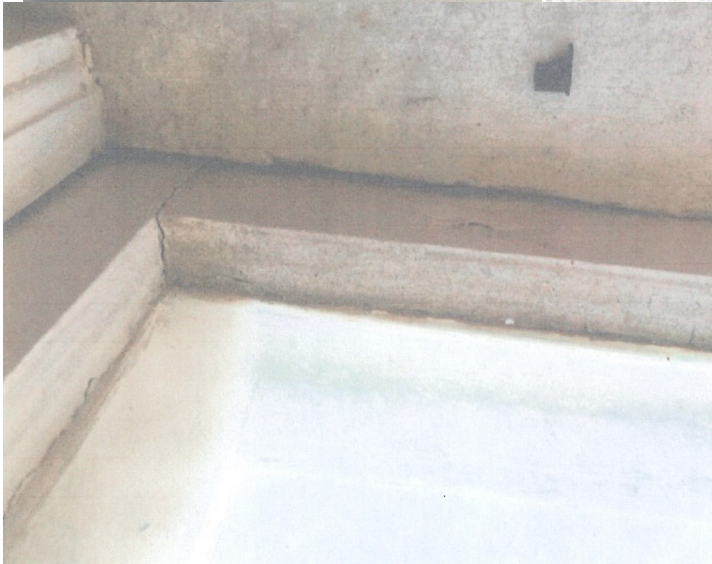
Window & wall

Living room

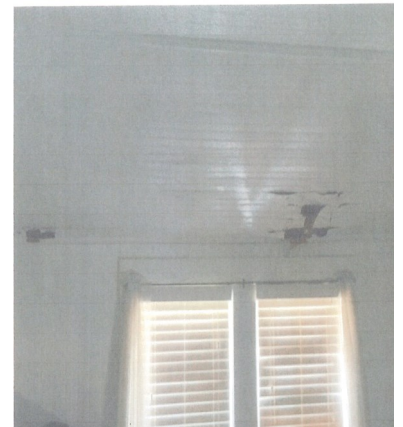
Damaged windows
