CITY OF FORT PIERCE
PLANNING DEPARTMENT

Certificate of Appropriateness Application

Address of the Site: 1009 Delaware Avenue, Fort Pierce, FL 34950

FORT PIERCE HISTORIC BOARD SUBMISSION
AUGUST 9TH, 2019

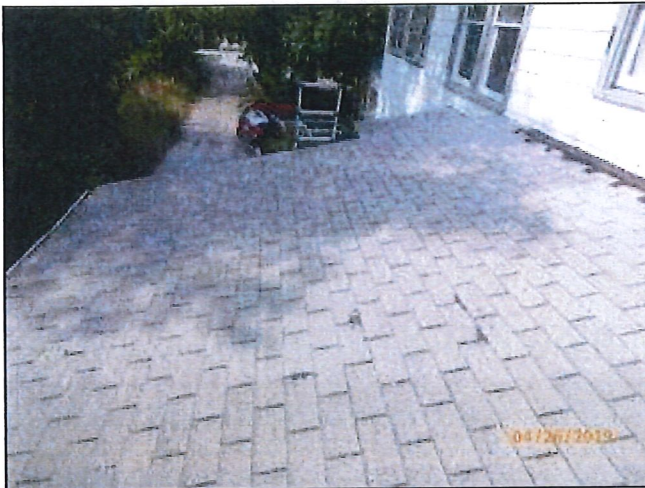
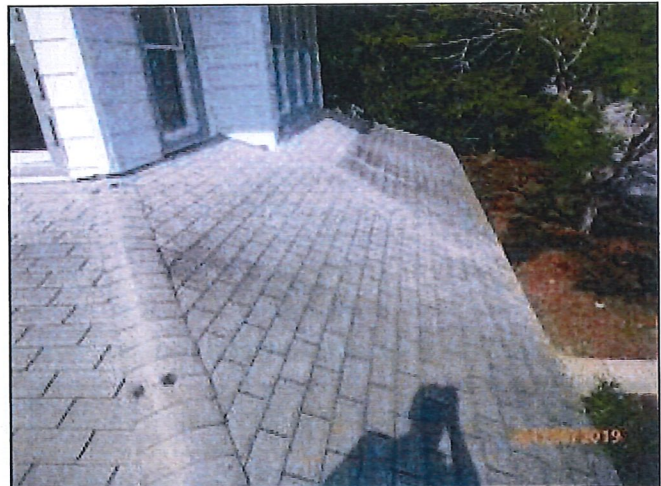
2.0

The 3 tab fiberglass roof was installed in 2004 with a permit. The roof is in poor condition. A 3 tab roof usually lasts a bout 15 years. **It needs to be replaced.**

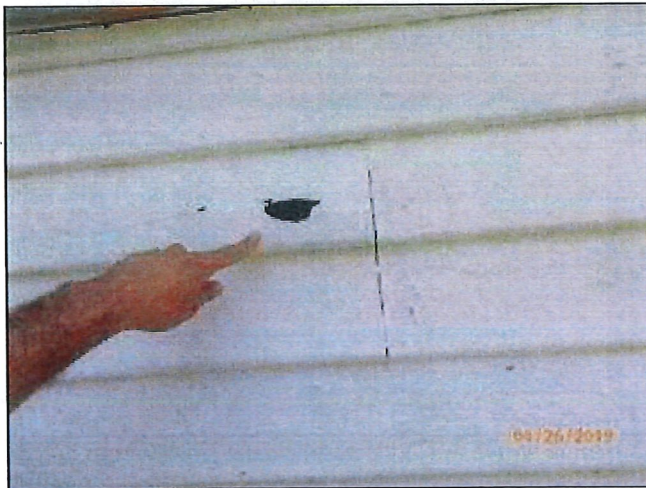
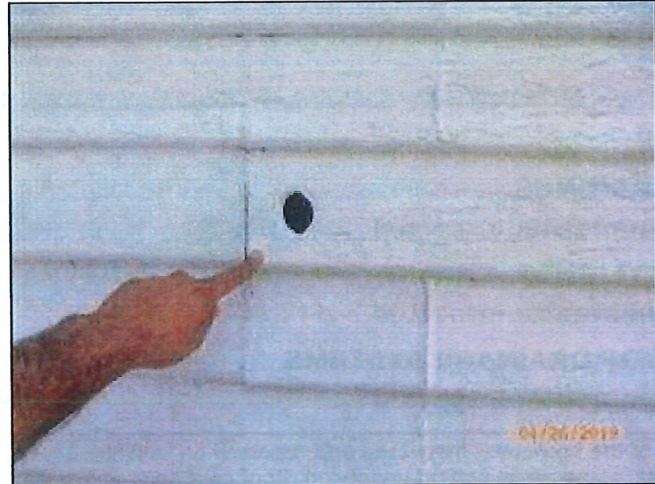
3.0

There were siding boards that need repair.

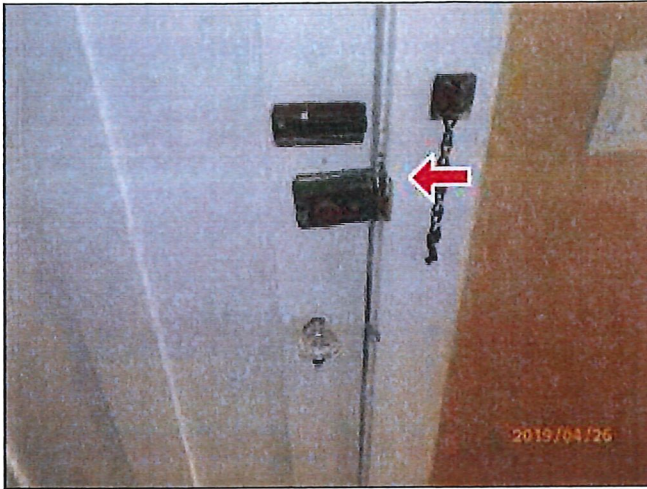
3.1

The kitchen walk out door is an out swing door installed as an inswing.

The front door lock did not work and the door could not be tested.

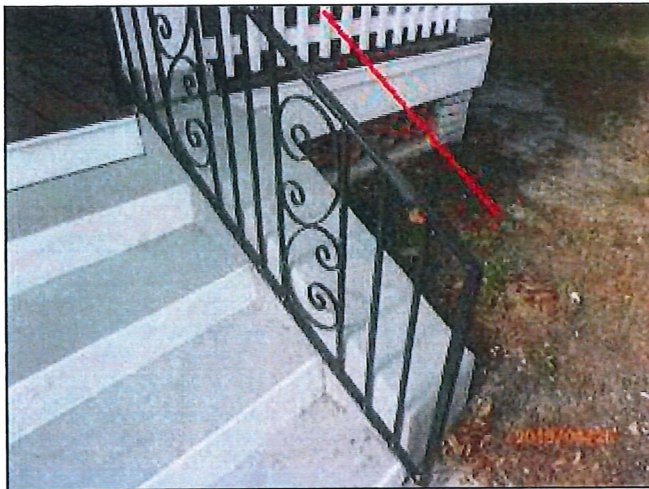
3.3

The handrail on the front entry steps is lower than today's code. There is no handicap access to the house. The bathrooms are not handicap accessible or protected.

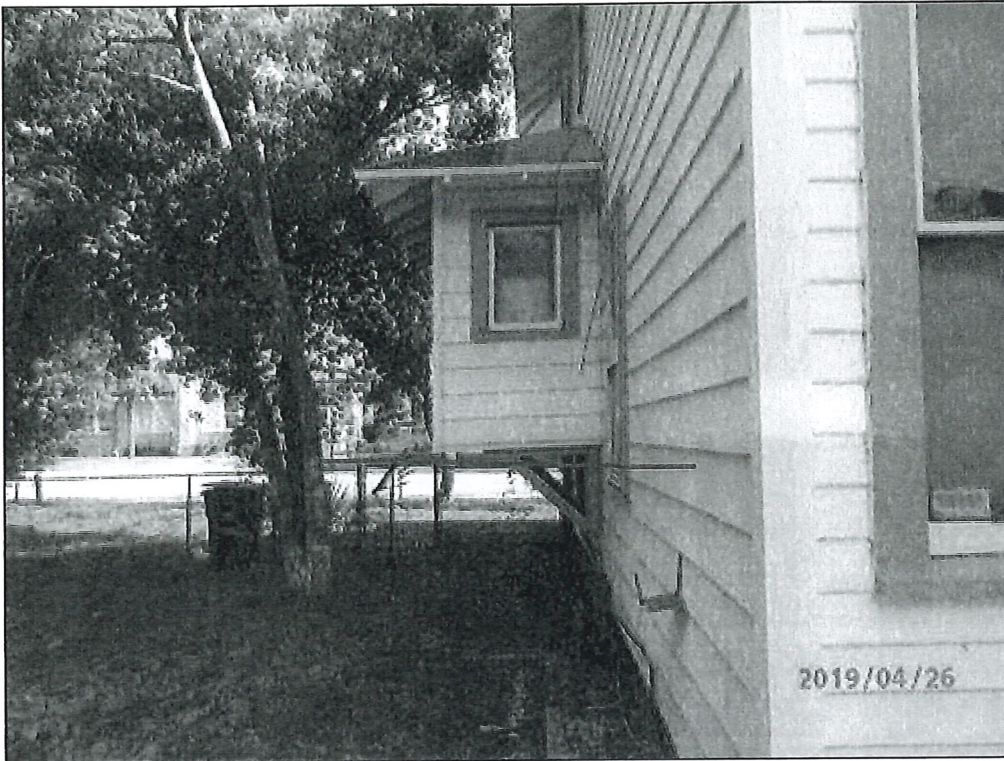
4.3

The stairwell alcove is sagging. It needs to be braced up.

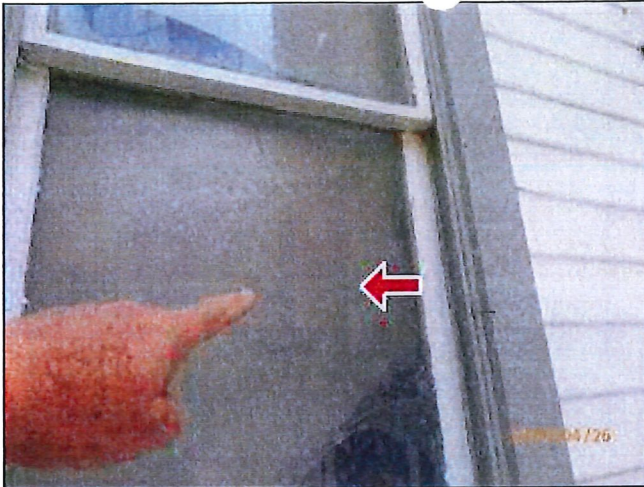
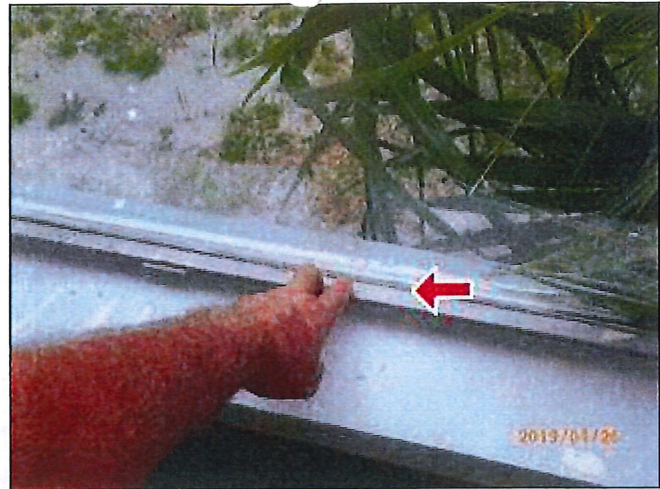
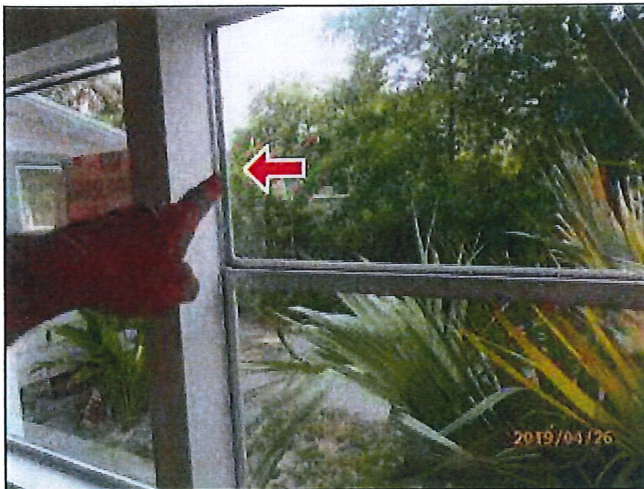
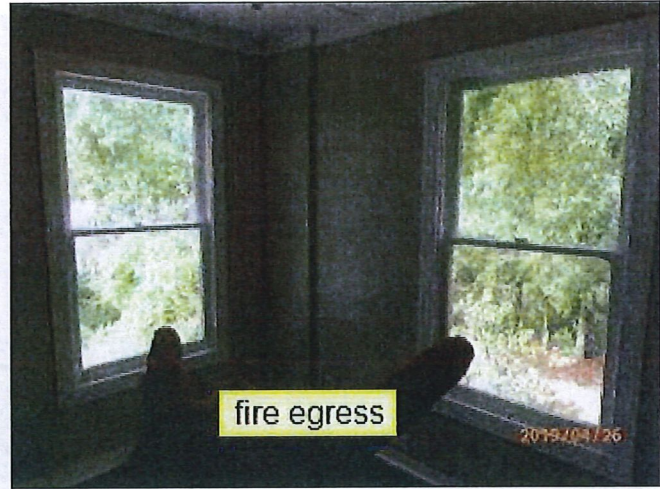
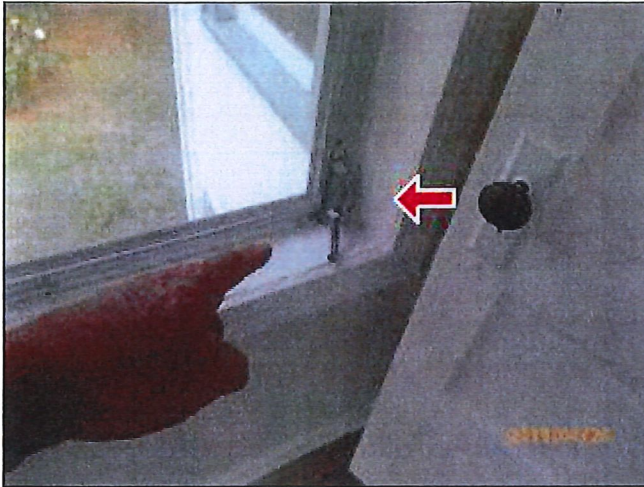
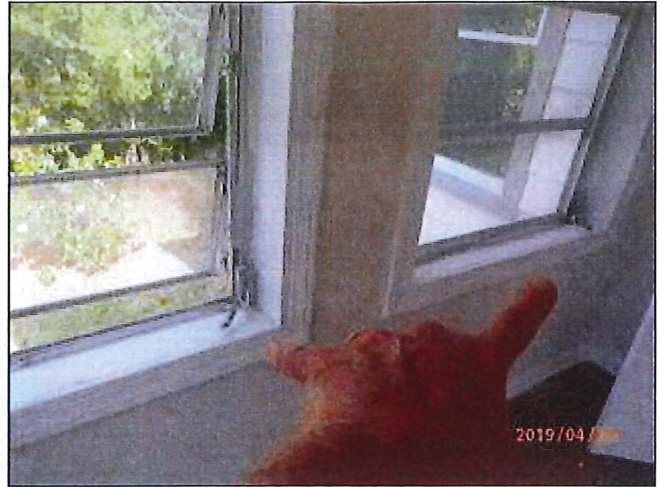
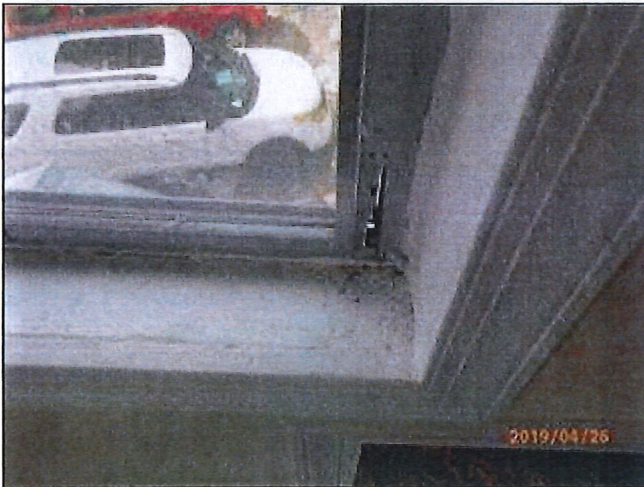
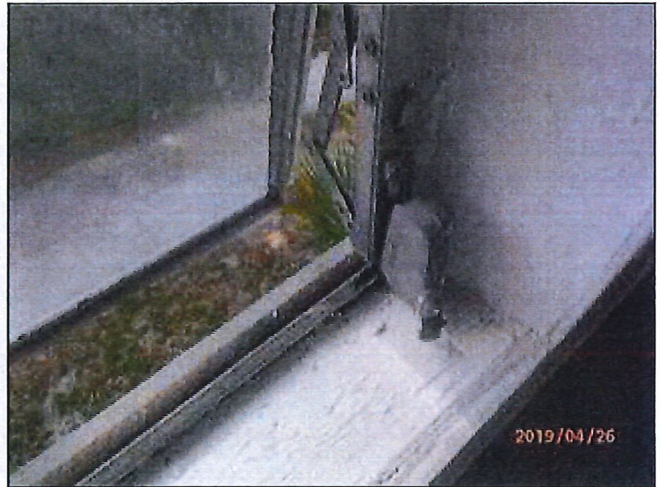
There is a cracked pane of glass on the rear of the house.

The bottom sill in the window near the kitchen is damaged. And the window balancer did not work.

If any of the rooms will be used as bedrooms a fire egress exit window will be needed. All windows are painted shut.

There are awning windows, most of the operators did not work and some were missing.
