**RE: Professional Engineering Services for Construction Materials Testing
(C-20-184-01-12) Work Authorization No. 2 ~ Construction Materials Testing
Hidalgo County Health Dept. Testing/Bio-Safety Laboratory
PO #847843**

Hidalgo County Bio-Safety Lab Geo & CMT
Contract # C-20-184-01-12
Work Authorization #2
PO# 847843
B2Z JOB: 4124

4124
Hidalgo County Health Dept Testing/Bio-Safety
Laboratory
Various
Edinburg, TX

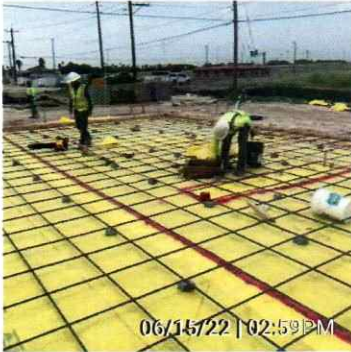
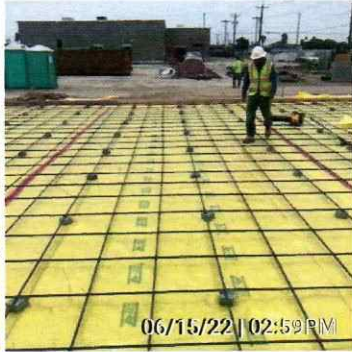
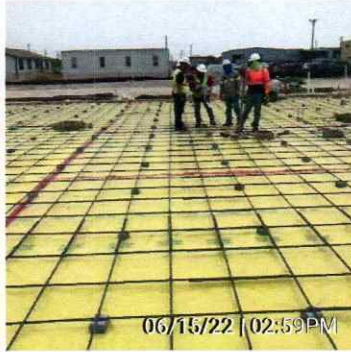
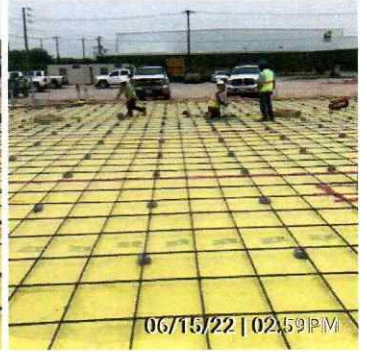
On 06/15/2022, a representative of B2Z Engineering was dispatched to the subject project to perform building pad structural rebar reinforcing inspection. See attached inspection report.

2. Clearance around rebar as specified.	<input type="checkbox"/>	<input type="checkbox"/>	<input checked="" type="checkbox"/>	All clearances as per specs Gio Mares 06/15/22 03:05PM
