**RE: Professional Engineering Services for Construction Materials Testing  
(C-20-184-01-12) Work Authorization No. 2 ~ Construction Materials Testing  
Hidalgo County Health Dept. Testing/Bio-Safety Laboratory  
PO #847843**

Hidalgo County Bio-Safety Lab Geo & CMT  
Contract # C-20-184-01-12  
Work Authorization #2  
PO# 847843  
B2Z JOB: 4124

# Inspection Report

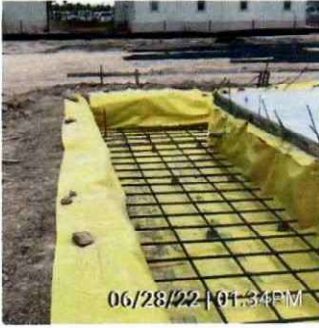
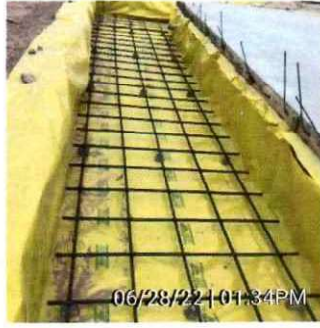
1. Conducted my inspection today at 1:36 PM for the rebar spreader footing inspection. As per observations all installation of rebar is as per plans and specs. proper spacing and overlapping was performed and proper size used as per spec

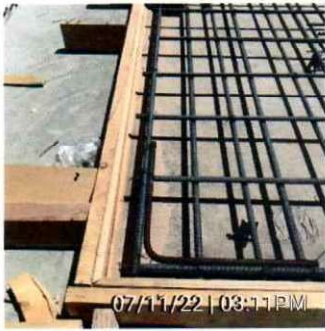
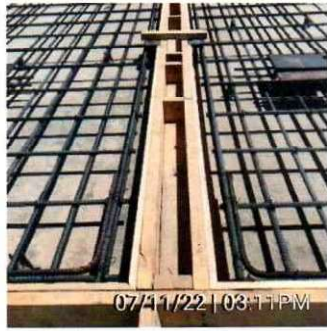
2.

<input type="checkbox"/>	<input type="checkbox"/>	<input checked="" type="checkbox"/>	All clearances around form boards properly spaced

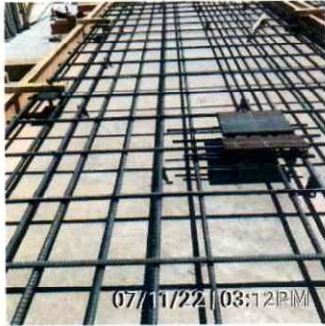
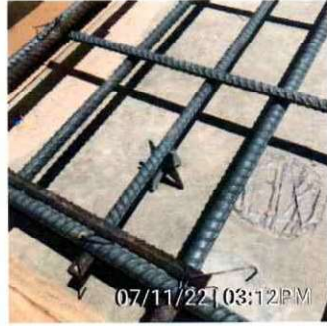
3.

<input type="checkbox"/>	<input type="checkbox"/>	<input checked="" type="checkbox"/>	All rebar properly supported by plastic chairs as specified

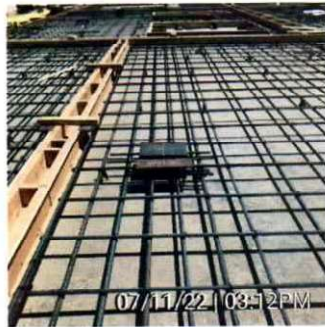
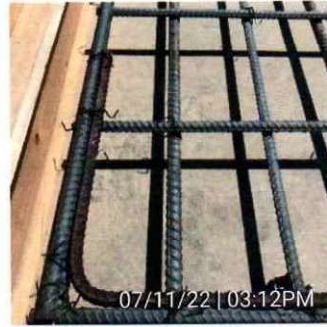
4.

<input type="checkbox"/>	<input type="checkbox"/>	<input checked="" type="checkbox"/>	All interior rebar for panels number 6 specified and number seven rebar for cords specified in plans

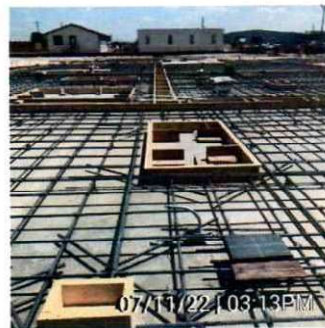
5.

<input type="checkbox"/>	<input type="checkbox"/>	<input checked="" type="checkbox"/>	All laps minimum 4 feet as specified <small>Gio Mares   07/11/22   03:15PM</small>

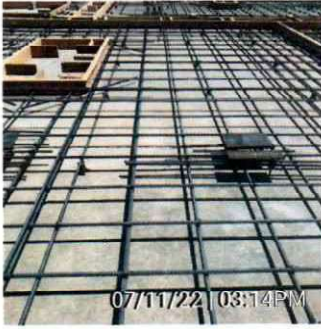
6.

<input type="checkbox"/>	<input type="checkbox"/>	<input checked="" type="checkbox"/>	All rebar 12 inch on center as specified

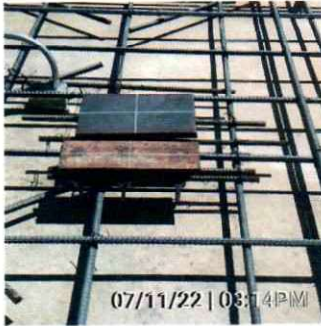
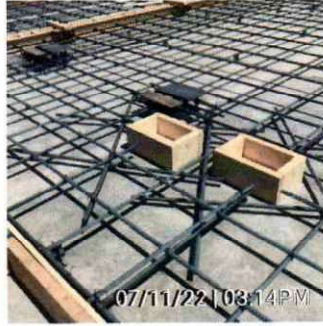
7.

<input type="checkbox"/>	<input type="checkbox"/>	<input checked="" type="checkbox"/>	All dowels properly installed and secure
