November 1, 2022

**RE: Professional Engineering Services for Construction Materials Testing
(C-20-184-01-12) Work Authorization No. 2 ~ Construction Materials Testing
Hidalgo County Health Dept. Testing/Bio-Safety Laboratory
PO #847843**

4124
Hidalgo County Health Dept Testing/Bio-Safety
Laboratory
Various
Edinburg, TX

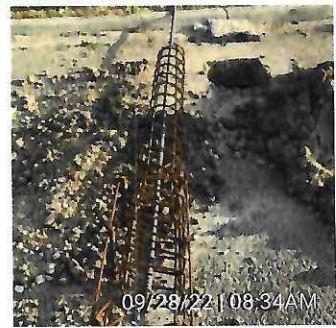
1. My rebar inspection was conducted at 8:30 am this morning. 20 rebar cages were inspected. Cages were laid next to dug piers. All rebar cages have been properly tied and secured. Correct spacing was used on rib cages #4 rebar as specified. Spacing of links at lap not greater than 6 of longitudinal bar. Links at knuckle of crank properly secure. Rebar for links #3 as specified.

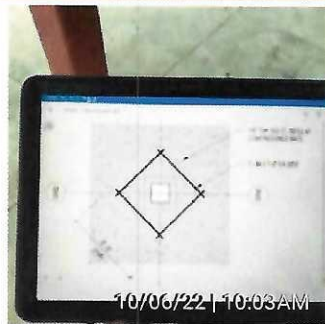
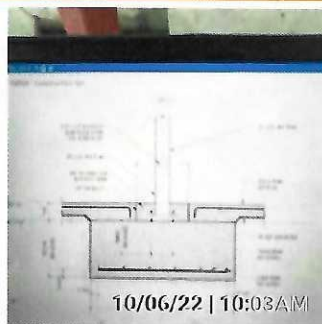
1. Meet with job superintendent at 10am. Conducted my rebar observation. All rebar for interior columns was properly installed and supported. All rebar was #4 as specified in plans. Diamonds were properly tied and in place as to plans.

9. Bars are properly laid and positioned.	<input type="checkbox"/>	<input type="checkbox"/>	<input checked="" type="checkbox"/>	Diamond properly installed and tied <small>Gio Mares 10/06/22 10:10AM</small>

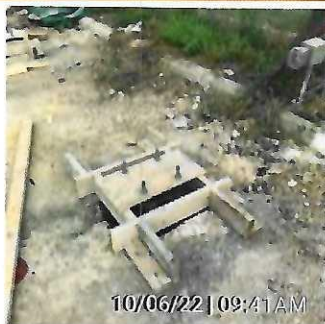
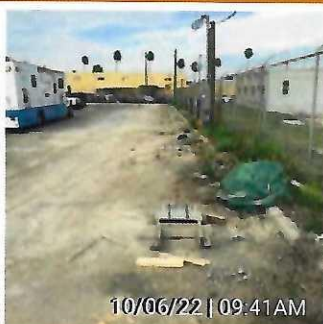
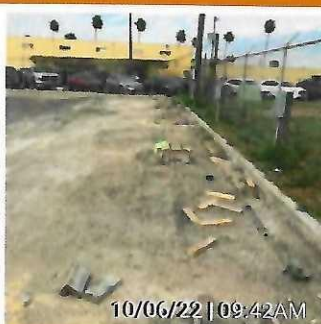
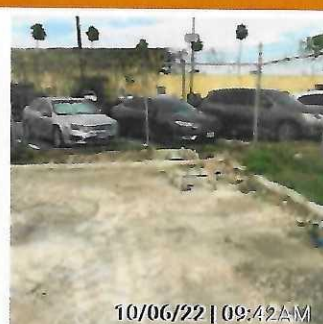
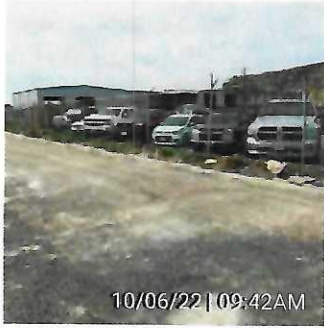
1. Conducted my rebar anchor bolt inspection this morning at 9:30 am. Upon observation all form jigs were properly installed and secured holding all anchors securely in place as to specs for columns. Form boards around piers were proper height as to plans and spacing accordingly. Concrete pour scheduled for tomorrow morning at 8am.
