Hidalgo Health Clinic | ARPA-22-340-088
P.O. 26200754 / 902394
Acct. # 1290-41-115-000-0000-507310

**RE: Contract # C-23-0417-10-31
Pct. 2 Hidalgo Health Clinic
Work Authorization #2 ~ Construction Management and CMT**

On 03/10/2026, a representative of B2Z Engineering was dispatched to the subject project to perform a rebar inspection on the sidewalk along the building. Please see attached report.

Hidalgo Health Clinic (New Constr)

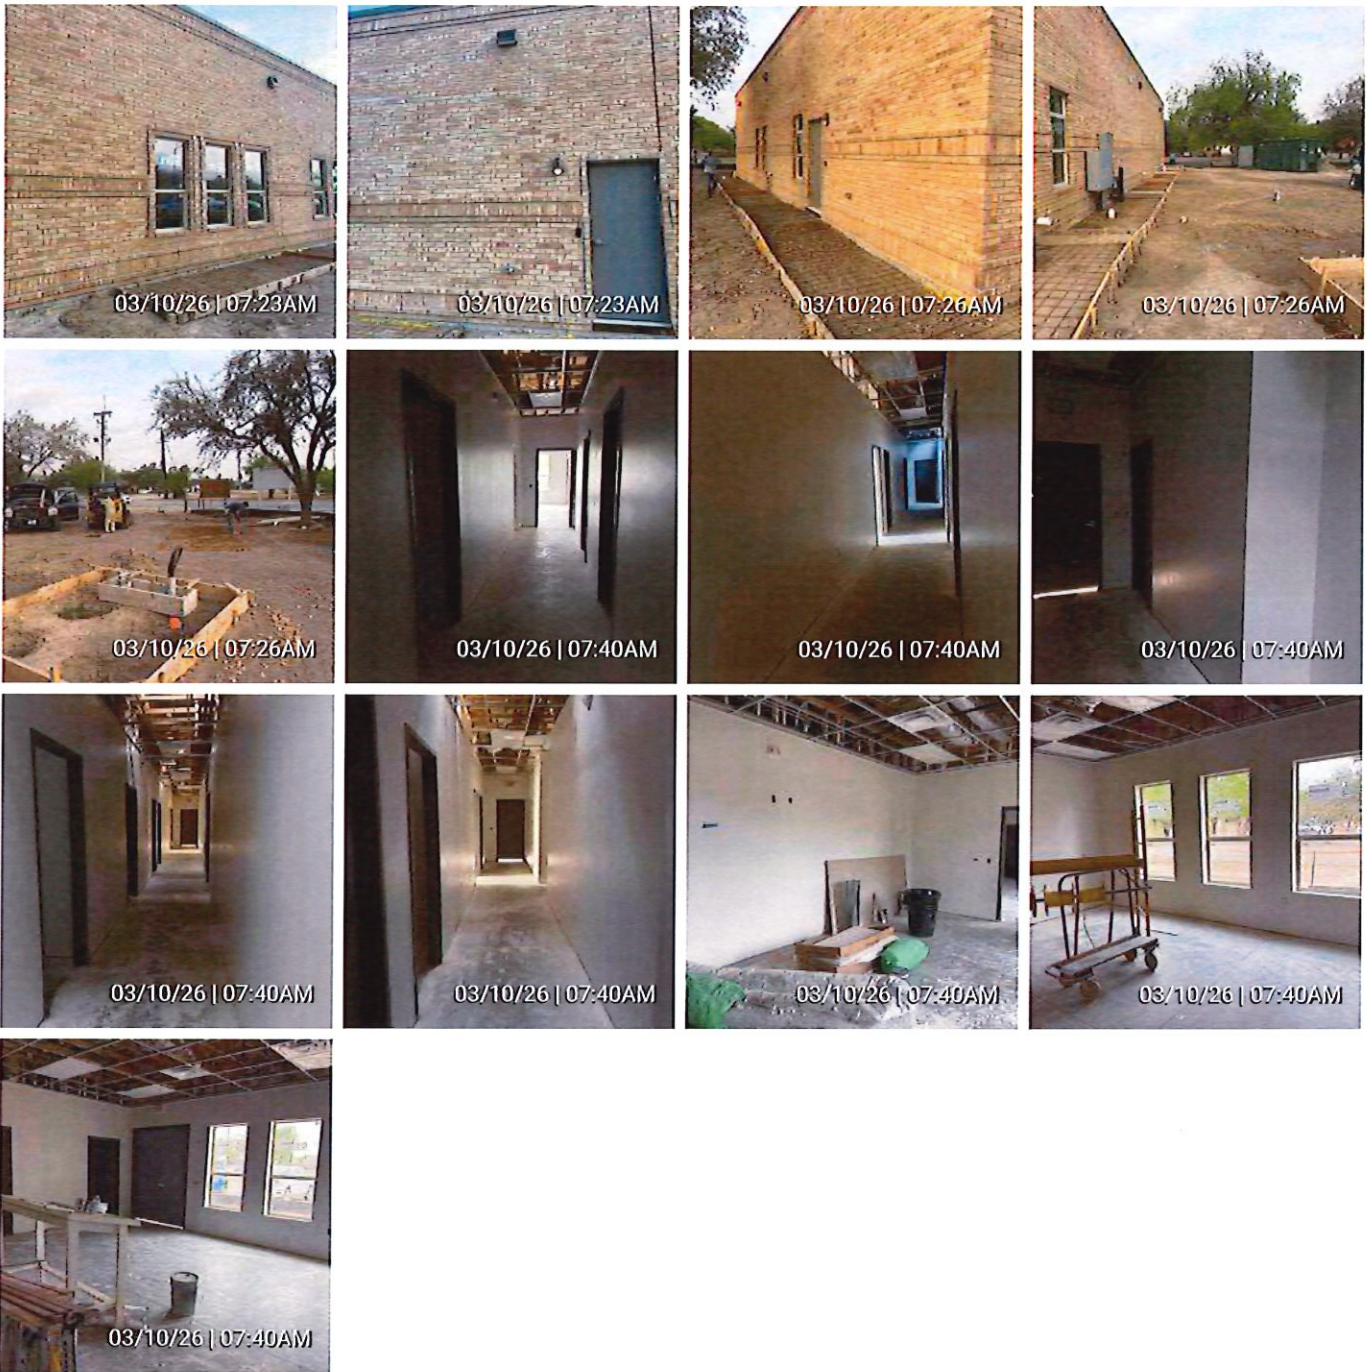
Benchmark Construction: | QTY: 1 | HRS: 9.0 | HTD: 414.0

Benchmark Construction	Construction oversight Armando Rodriguez 3/10/26, 7:23 AM	1	9	414

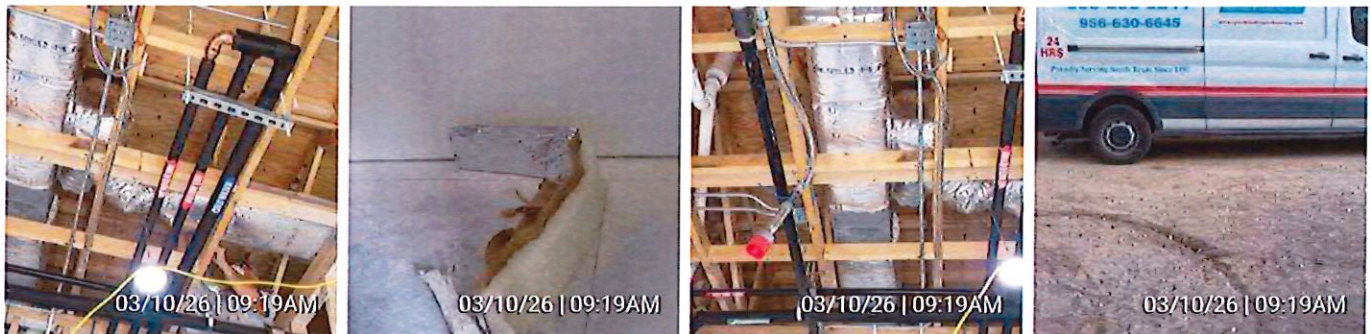
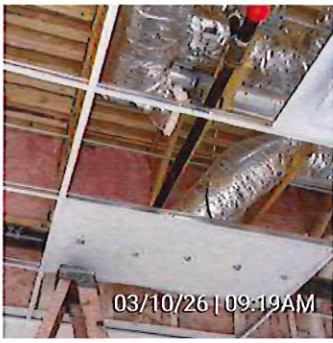
Cytech Heating and Cooling L.C.: | QTY: 2 | HRS: 9.0 | HTD: 1233.0

Cytech Heating and Cooling L.C	Insulating ducts Armando Rodriguez 3/10/26, 7:23 AM	2	18	1233

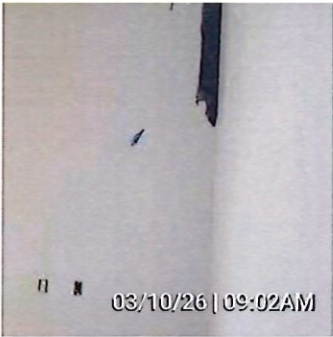
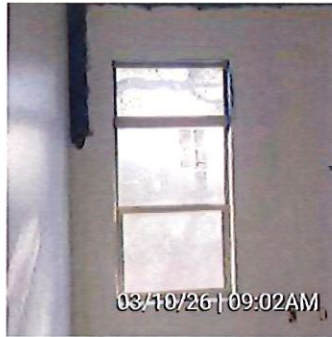
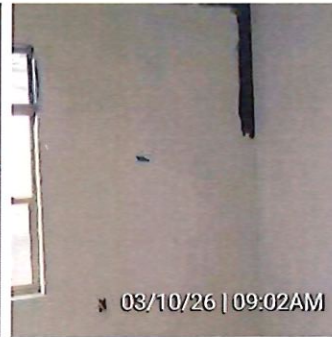
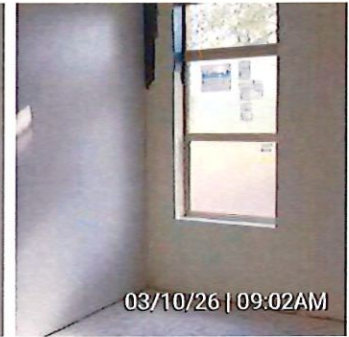
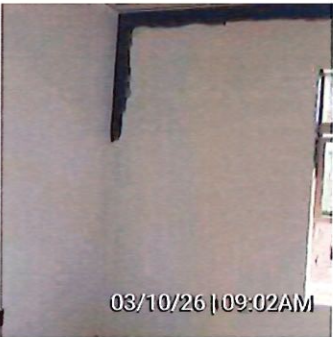
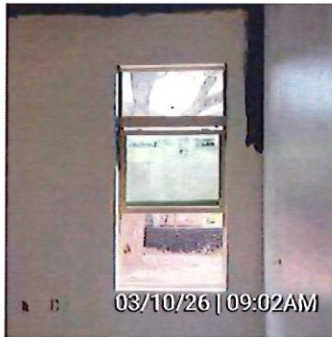
Hiram Suarez Painting: | QTY: 3 | HRS: 9.0 | HTD: 135.0

Hiram Suarez Painting	Painting accent walls and door frame jams Armando Rodriguez 3/10/26, 7:38 AM	3	27	135

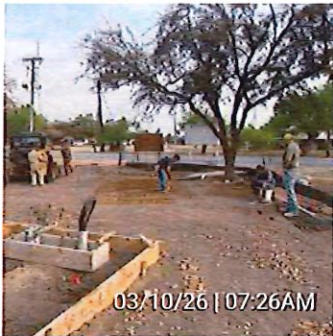
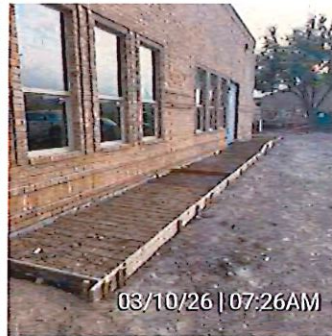
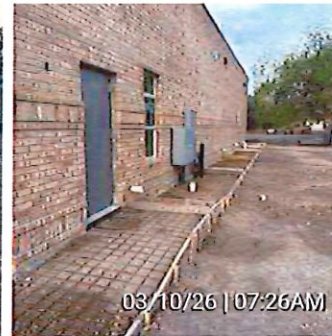
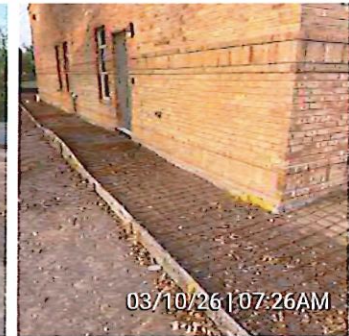
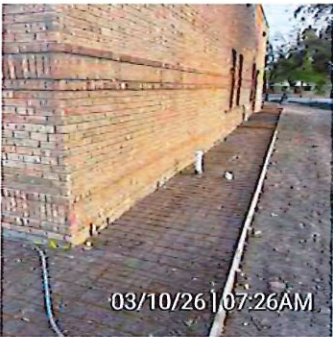
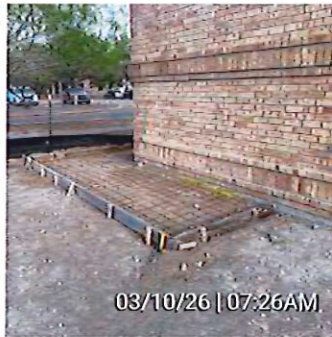
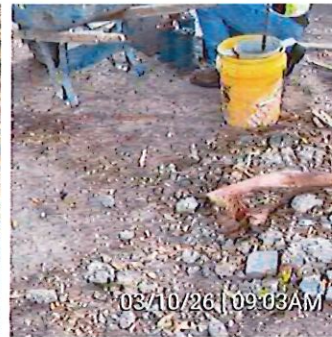
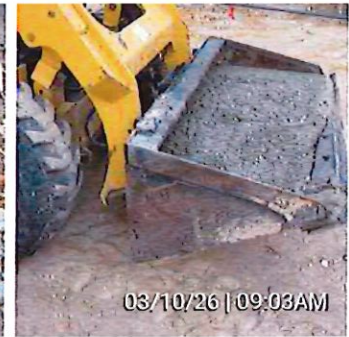
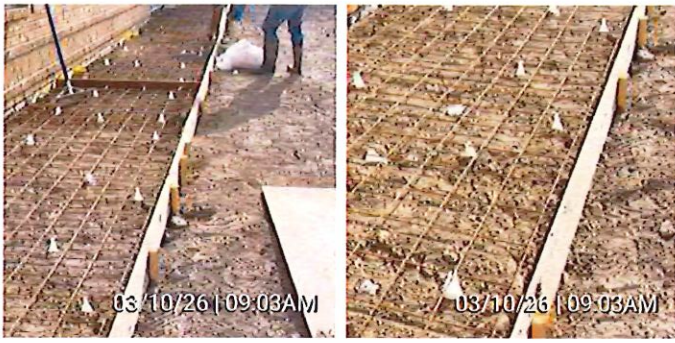
Sants Construction: | QTY: 4 | HRS: 9.0 | HTD: 234.0

Sants Construction	Pouring sidewalks along exterior of building 1 set of (4) cylinders taken Armando Rodriguez 3/10/26, 7:26 AM	4	36	234
Total		10	90	9759

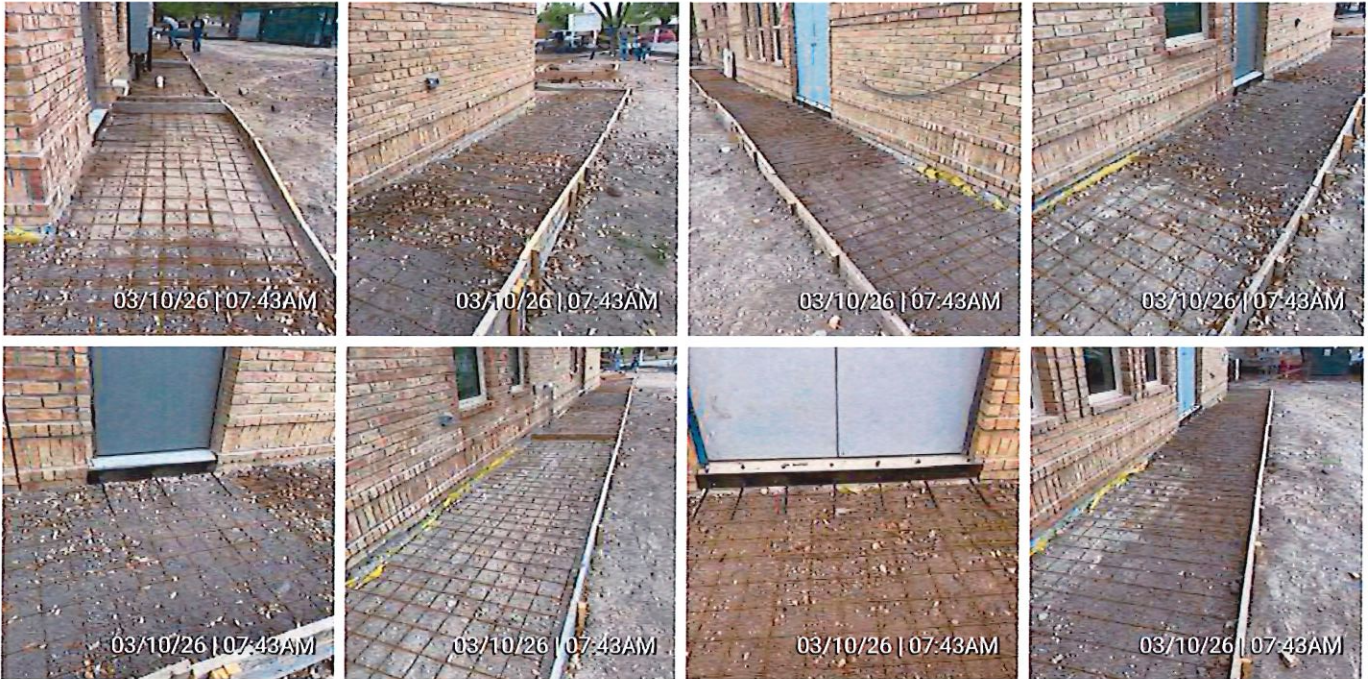
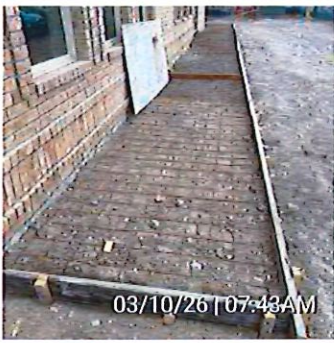
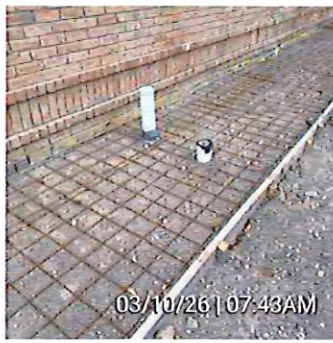
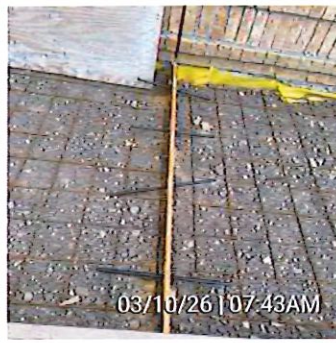
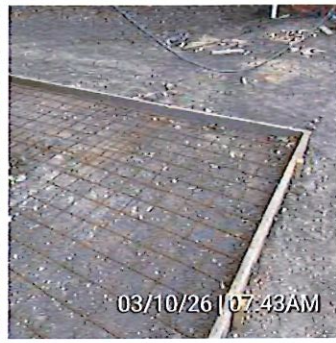
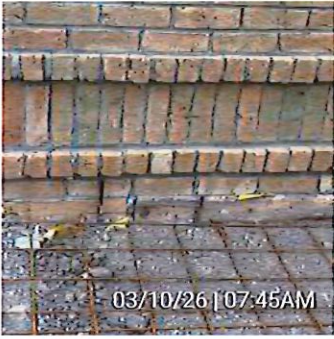
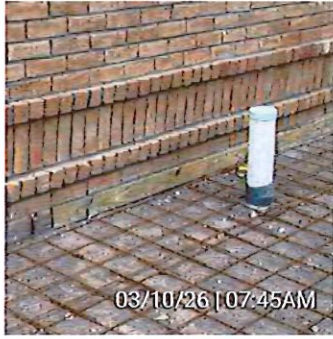
1. Rebar inspection done on sidewalks along exterior of building

*chairs missing

*remove 2x4s used to hold bricks
