**BOARD OF CONTROL  
REQUEST FORM**

**Home Repair Program Recommendation**

**Work Write-Up**

Case#: **EHR673**

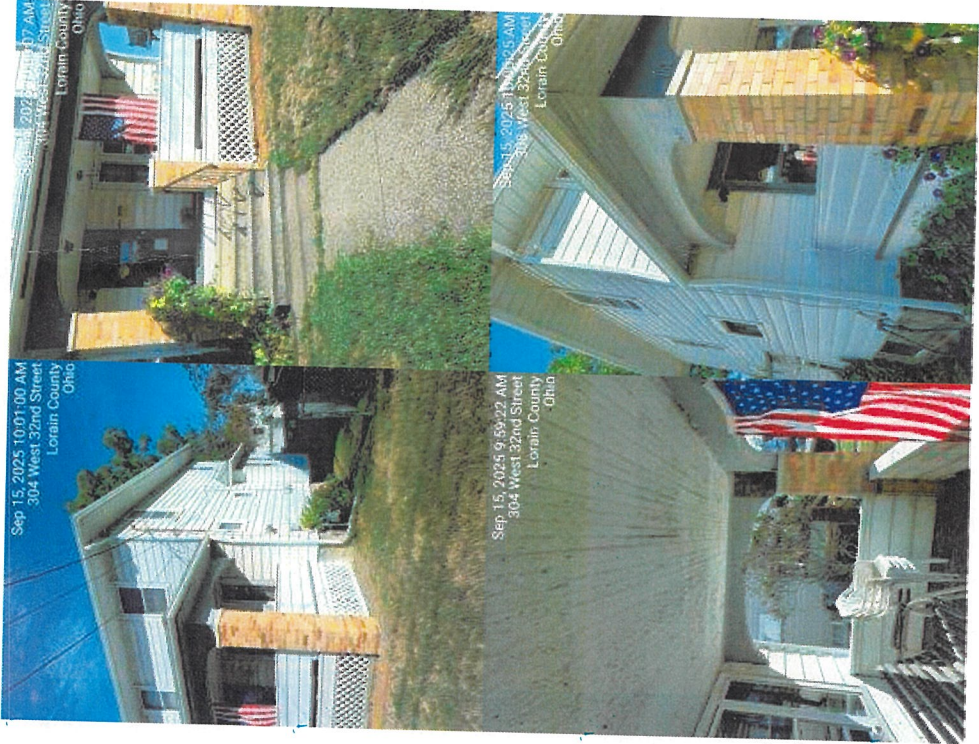
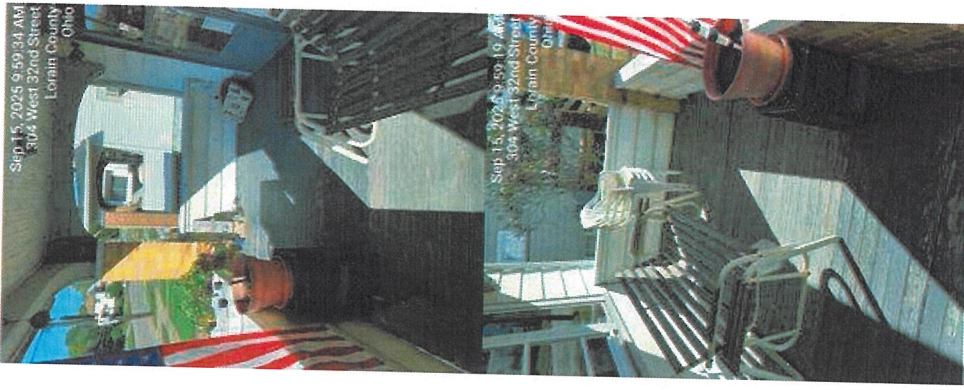
We will have the porch replaced excluding the roof portion. The roof will stay in tacked being supported by the columns. The Railings, Decking, Lattice, and all the wood supporting the porch to be replaced. **All wood installed to be treated and supported properly.** The porch is sagging on the left front side at the corner of the steps. **Strip down the porch completely minus the roof and columns.** Rebuild with new stringers and ledgers. Make sure new decking is supported all the way around properly.

**NOTE:** Bring the new railing up to code by having it at **36" height.** Currently the railing is at 28 1/2" tall.

Right now the Pickets or spindles are secured to the side of the steps and the rail post is mounted on the ground. Steps to be painted a gray close to the color.

Replace structure using all new material as specified. The rim joists should be doubled up on the house. To be anchored properly. Once dismantled, should get a better idea of anchoring methods. Treated post are to be used and the 4" x 6" post would be turned side ways to rest the **doubled up 2" x 6" Treated rim boards properly.** Install pressure treated 2" x 6" header, rim joists, and floor joists graded to proper drainage fall away from house. Joists/beams to span at 16" on center. Fasteners will be deck screws and screwed minimal flush with top of deck board and all other areas of support. **Do not have any screws** protruding outside the face of any material to prevent any bodily injury or snagging any clothing to where damage can be caused. Include porch rails, steps, and step railing. All wood materials to be pressure treated exterior grade lumber.

Replicate the steps and install a better rail with a top rail and a bottom horizontal rail with the pickets in the middle and the rail post at the bottom to be mounted on the last step.

Replace the Lattice and the framing around the bottom of the porch openings like it was before the rebuilding. Seal and paint white.

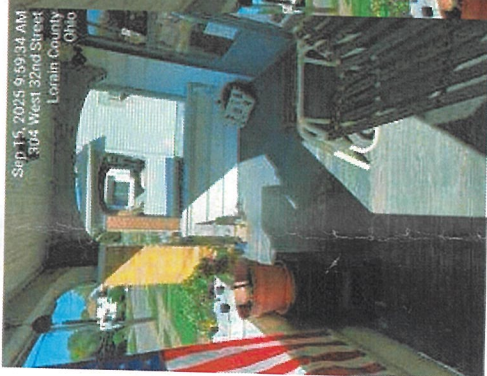
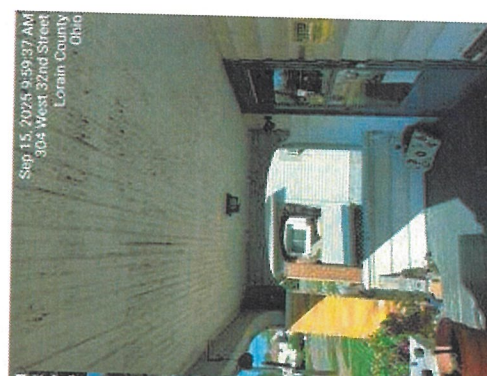
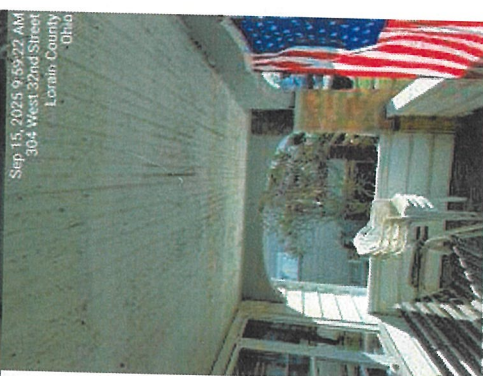
**LEAD PAINT WAS DETECTED ALL OVER PORCH: LEAD SAFE PRACTICES TO BE APPLIED:**

**NEEDS SCRAPED DOWN WITH PROPER TARPS or DROP CLOTHS TO COLLECT THE SCRAPED PAINT AND DISPOSED OF PROPERLY PER LEAD SAFE REMOVAL AND DISPOSAL REQUIREMENTS.**

We are only painting the area within the **inside portion** of the porch. This would include the ceiling as well as the arches surrounding the inside portion of the porch and the center of the arches. The outside portion of the Arches are not to be touched. Scrape the loose paint off and seal with an approved LEAD sealer then 2 coats of exterior Latex White paint of Sherman Williams or comparable equal.

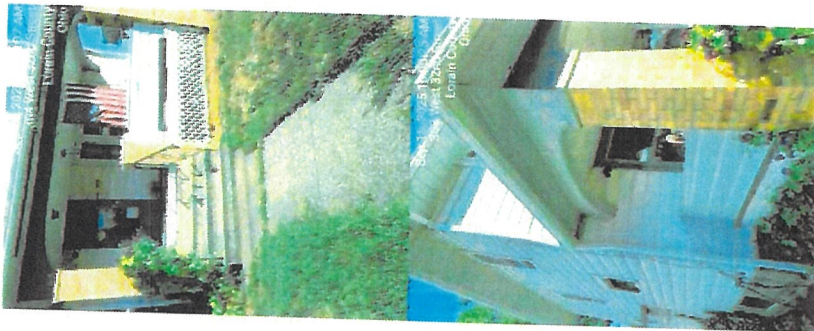
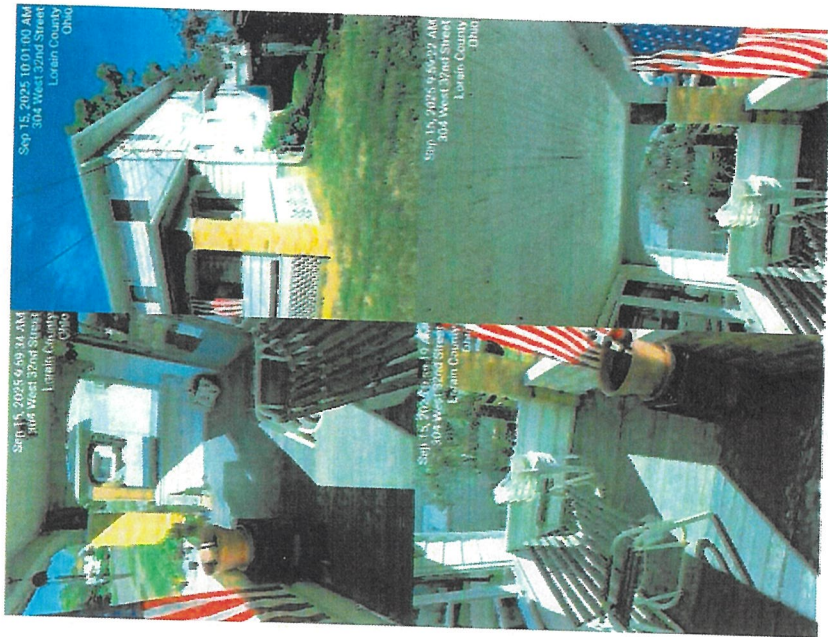
We will have the porch replaced excluding the roof portion. The roof will stay in tacked being supported by the columns. The Railings, Decking, Lattice, and all the wood supporting the porch to be replaced. **All wood installed to be treated and supported properly.** The porch is sagging on the left front side at the corner of the steps. **Strip down the porch completely minus the roof and columns.** Rebuild with new stringers and ledgers. Make sure new decking is supported all the way around properly.

**NOTE: Bring the new railing up to code by having it at 36" height.** Currently the railing is at 28 1/2" tall.

Right now the Pickets or spindles are secured to the side of the steps and the rail post is mounted on the ground. Steps to be painted a gray close to the color.

Replace structure using all new material as specified. The rim joists should be doubled up on the house. To be anchored properly. Once dismantled, should get a better idea of anchoring methods. Treated post are to be used and the 4" x 6" post would be turned side ways to rest the **doubled up 2" x 6" Treated rim boards properly.** Install pressure treated 2" x 6" header, rim joists, and floor joists graded to proper drainage fall away from house. Joists/beams to span at 16" on center. Fasteners will be deck screws and screwed minimal flush with top of deck board and all other areas of support. **Do not have any screws protruding outside the face of any material to prevent any bodily injury or snagging any clothing to where damage can be caused.** Include porch rails, steps, and step railing. All wood materials to be pressure treated exterior grade lumber.

Replicate the steps and install a better rail with a top rail and a bottom horizontal rail with the pickets in the middle and the rail post at the bottom to be mounted on the last step.

Replace the Lattice and the framing around the bottom of the porch openings like it was before the rebuilding. Seal and paint white.

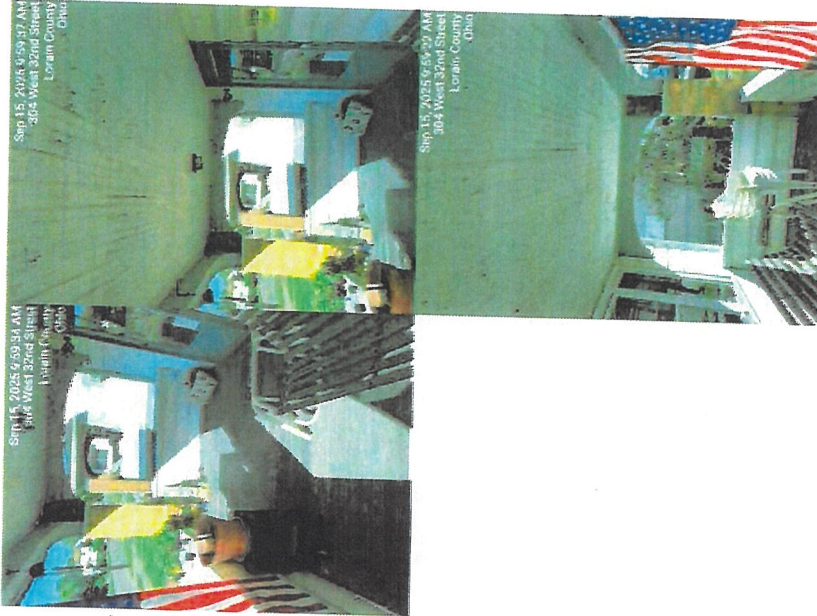
**LEAD PAINT WAS DETECTED ALL OVER PORCH: LEAD SAFE PRACTICES TO BE**

**NEEDS SCRAPED DOWN WITH PROPER TARPS or DROP CLOTHS TO COLLECT THE SCRAPED PAINT AND DISPOSED OF PROPERLY PER LEAD SAFE REMOVAL AND DISPOSAL REQUIREMENTS.**

We are only painting the area within the **inside portion** of the porch. This would include the ceiling as well as the arches surrounding the inside portion of the porch and the center of the arches. The outside portion of the Arches are not to be touched. Scrape the loose paint off and seal with an approved LEAD sealer then 2 coats of exterior Latex White paint of Sherman Williams or comparable equal.
