CITY OF PACIFIC GROVE  
CITY COUNCIL  
ERRATA SHEET

RE: Appeal for Denial of Tree Removal Permit # TP 24-176 / 10/1/2024  
105 20th Street, Pacific Grove, CA APN: 006-145-016-000

**AMANDA GATES**  
CONSULTING ARBORIST  
ISA CERTIFIED #WE-11839A

RE: Two Palms

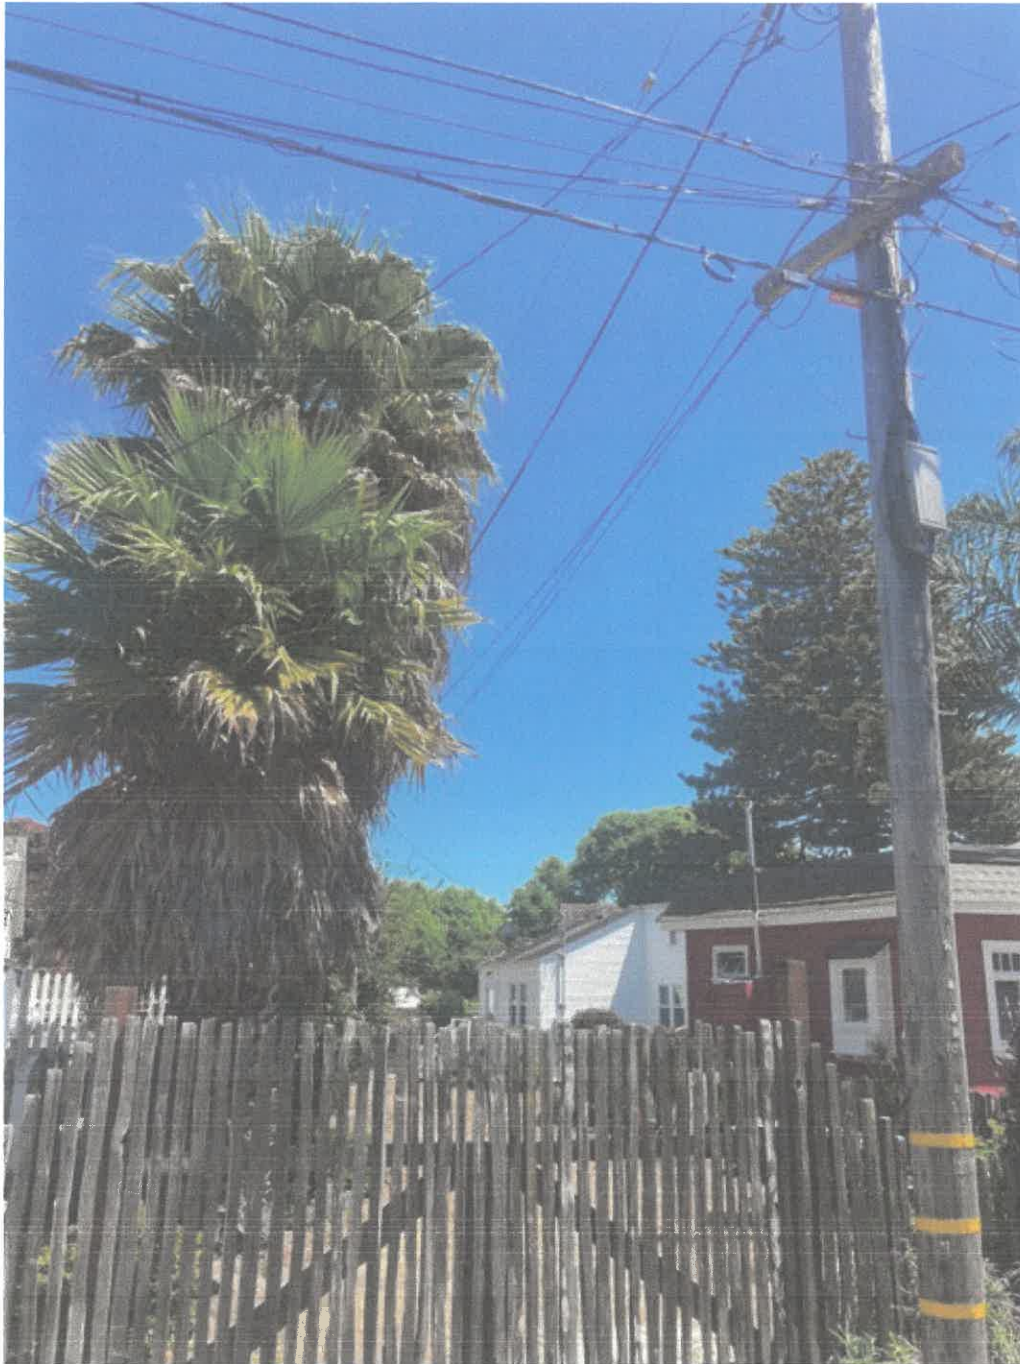
105 20<sup>th</sup> Street

As these palms are allowed to continue to grow they will also be interfering with **overhead utility power lines, which they are currently touching.** (see photos attached) These power lines service four residences.

Palm Trees intersecting with power lines

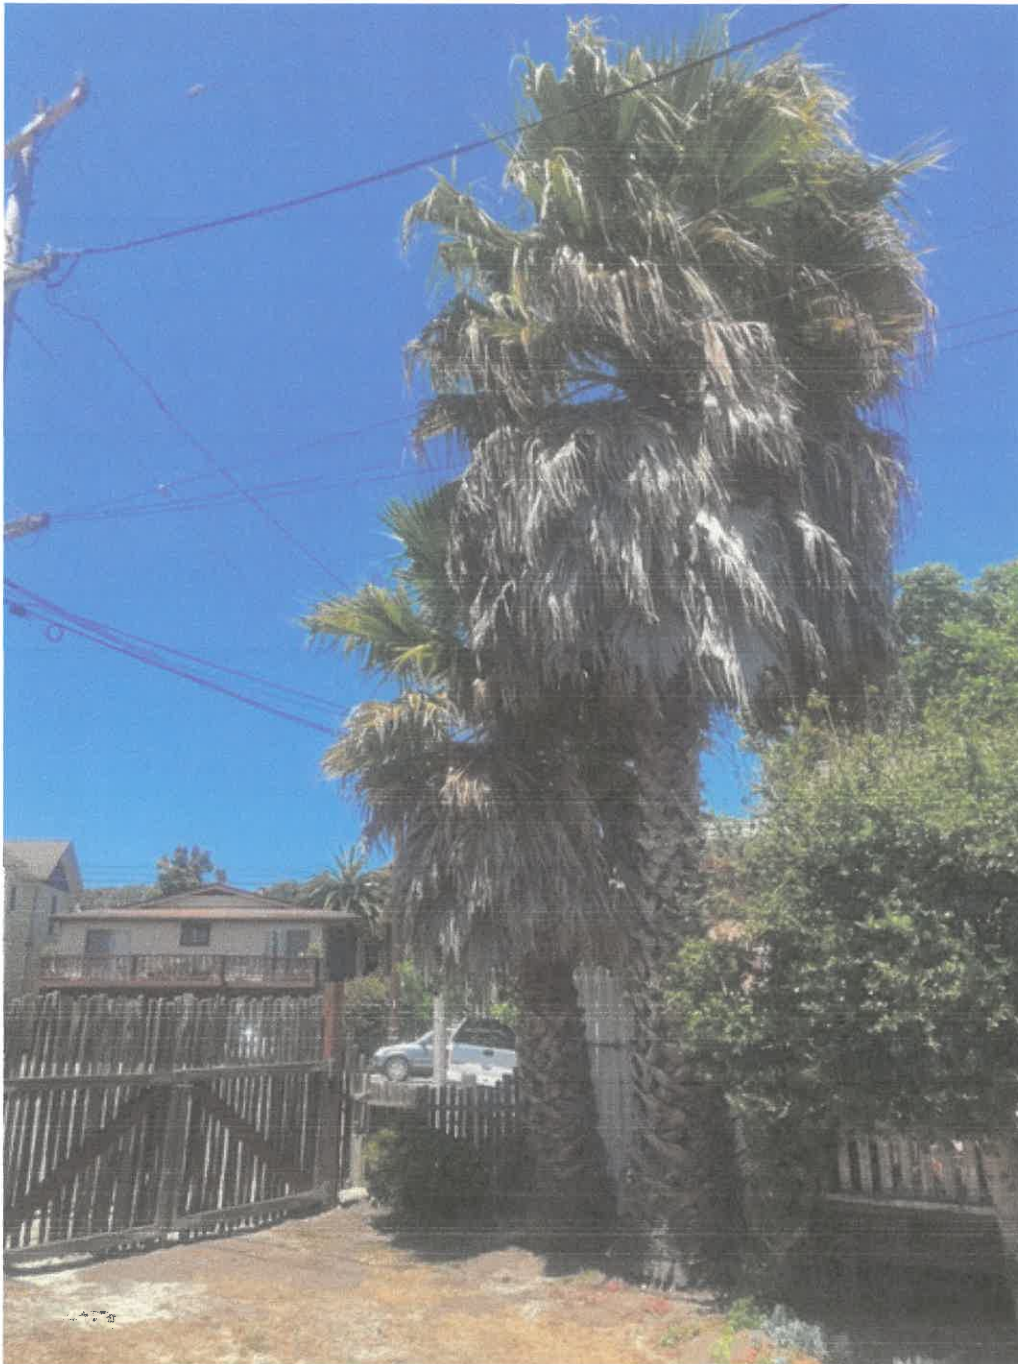
105 20th Street

Palm trees intersecting with power lines

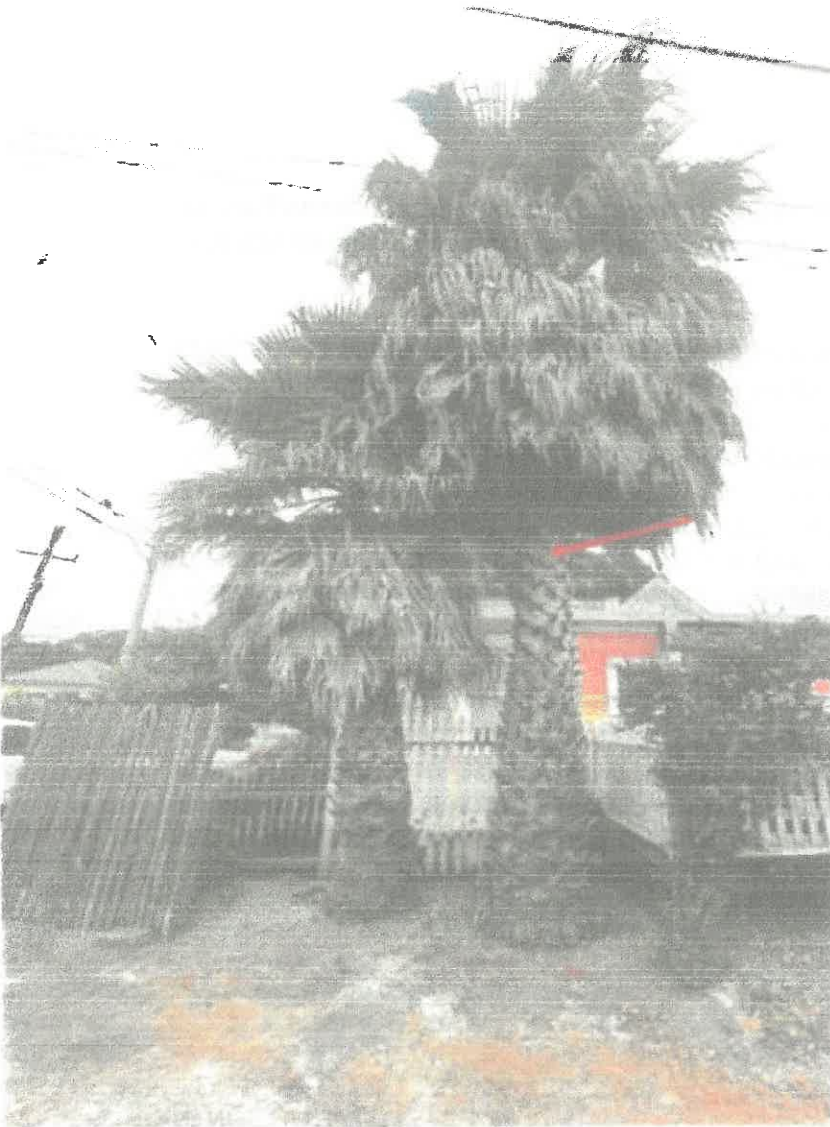
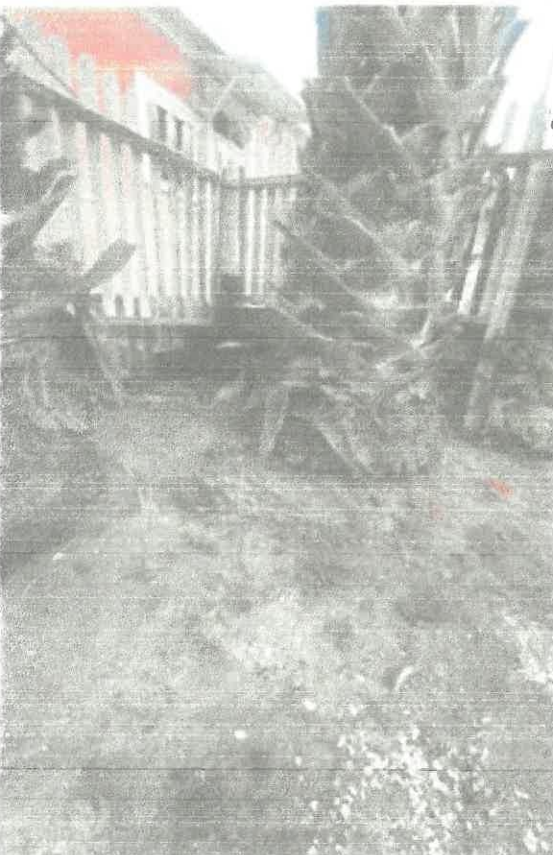
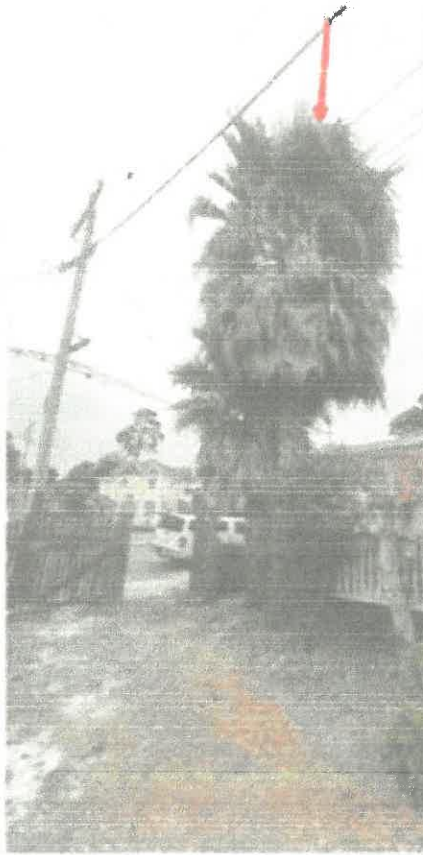
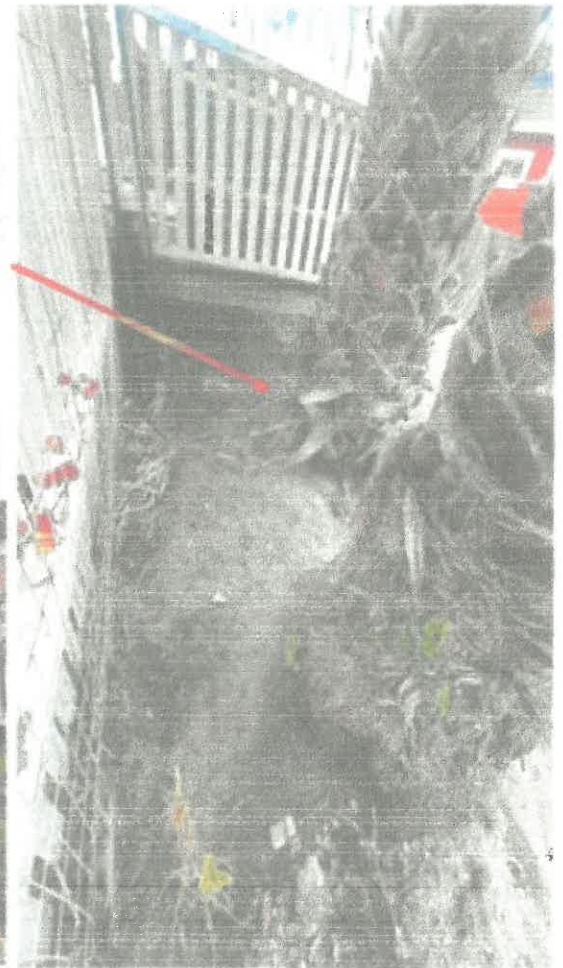
### Palm #241- Photos

This Palm tree appears to have an abundance of retained dried fronds. These dead fronds can be hazardous to pedestrians and targets around it if they are to drop. The health of this Palm is fair; however, it appears to have more dead fronds than #228, and has not been maintained. This palm exhibits conditions that can be potentially hazardous.

**I recommend removal as the primary mitigation option, as removal would eliminate all possible risk to the targets.** Palm trees are difficult to maintain, which can be a reason that regular maintenance is prolonged for too long. Due to the targets within the area, the two Palms should be removed.

Specialized pruning only conducted by a certified tree service with experience of pruning palm trees, knowing its potential hazards. These palms shed old fronds naturally, and can become a great hazard once they "shed" to the targets within the target zone. Removal of older fronds by an experienced tree service is recommended to reduce the likelihood of sudden shed if removal is not authorized.

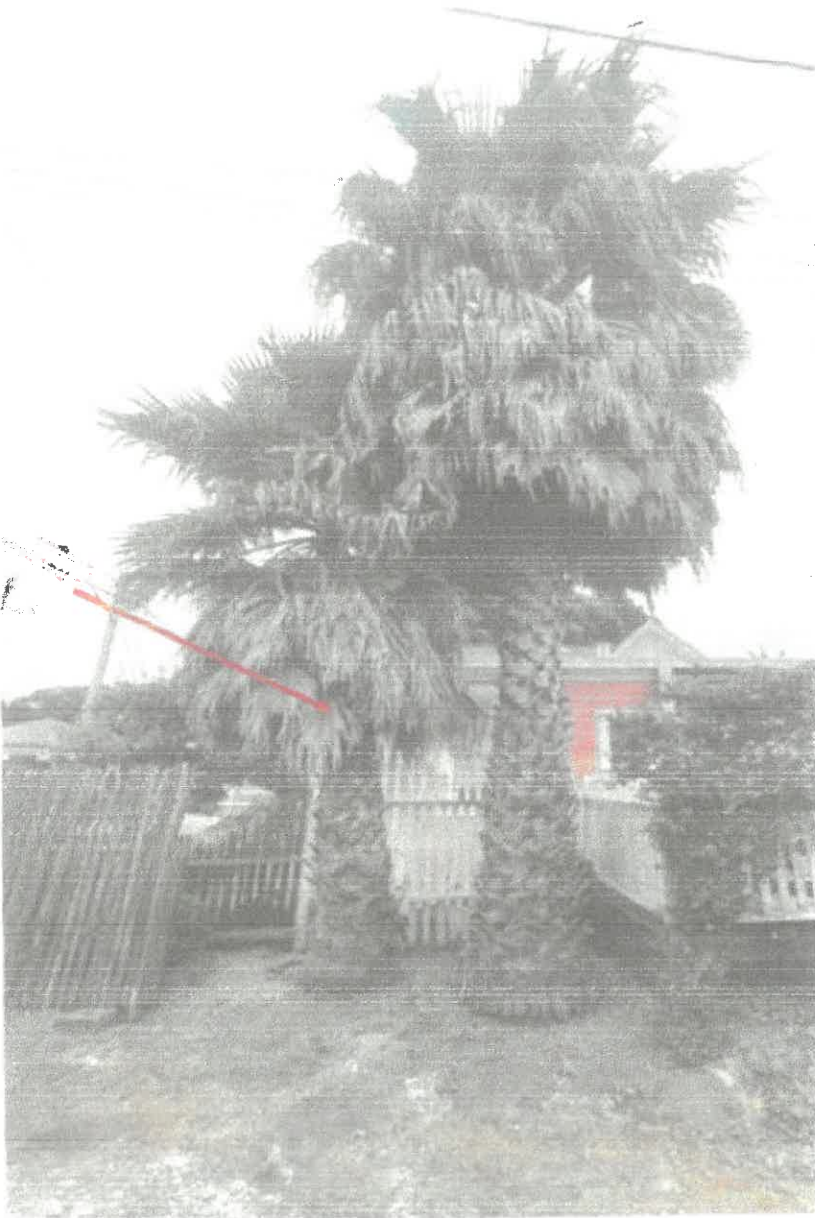
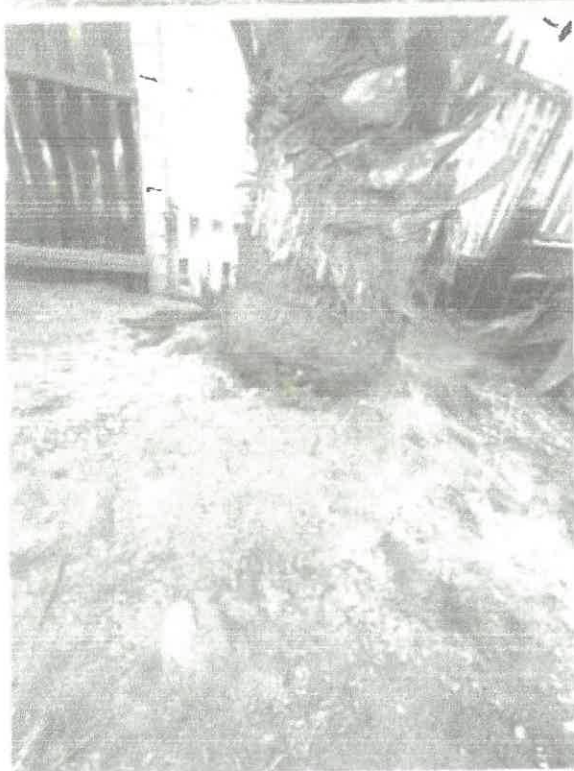
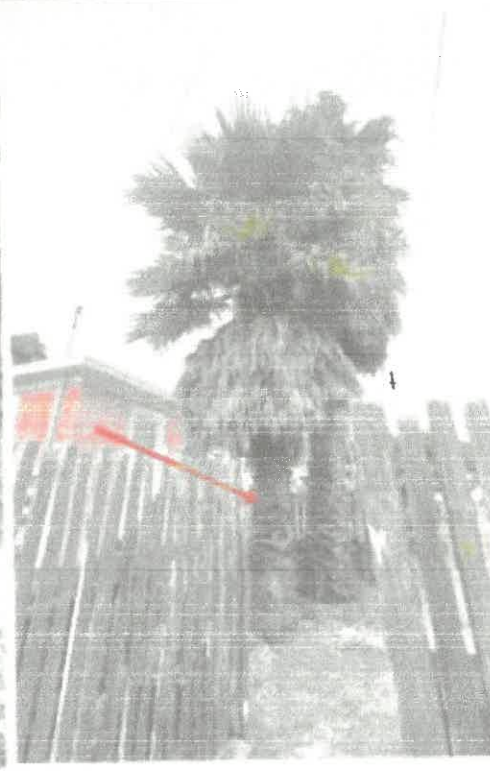
**Palm #228- Photos**

This Palm tree appears to be in fair condition. Although, there appears to be a large amount of retained dry fronds. It does not appear to have been maintained as of recently. There has been some reported frond drop, which can become hazardous.

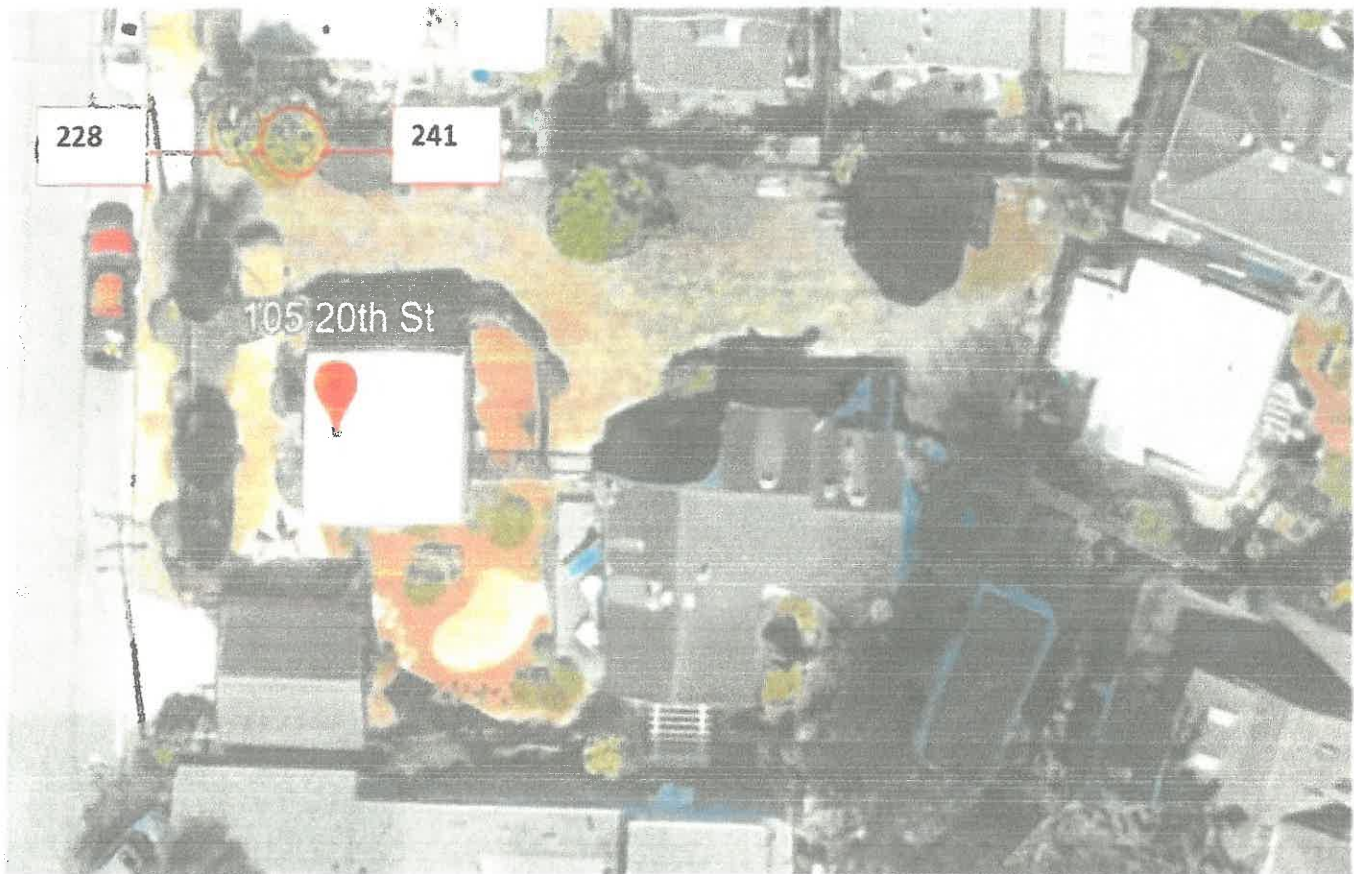
**Site Plan**

The red circles indicate the approximate location of the palms within the report.
