FEASIBILITY REPORT

AMENDED 2020 PAVEMENT OVERLAY IMPROVEMENTS

CITY IMPROVEMENT PROJECT NO. 20-02A

Re: Pavement Coring Forensic Report
City of Ramsey
WSB Project No. 015656-000

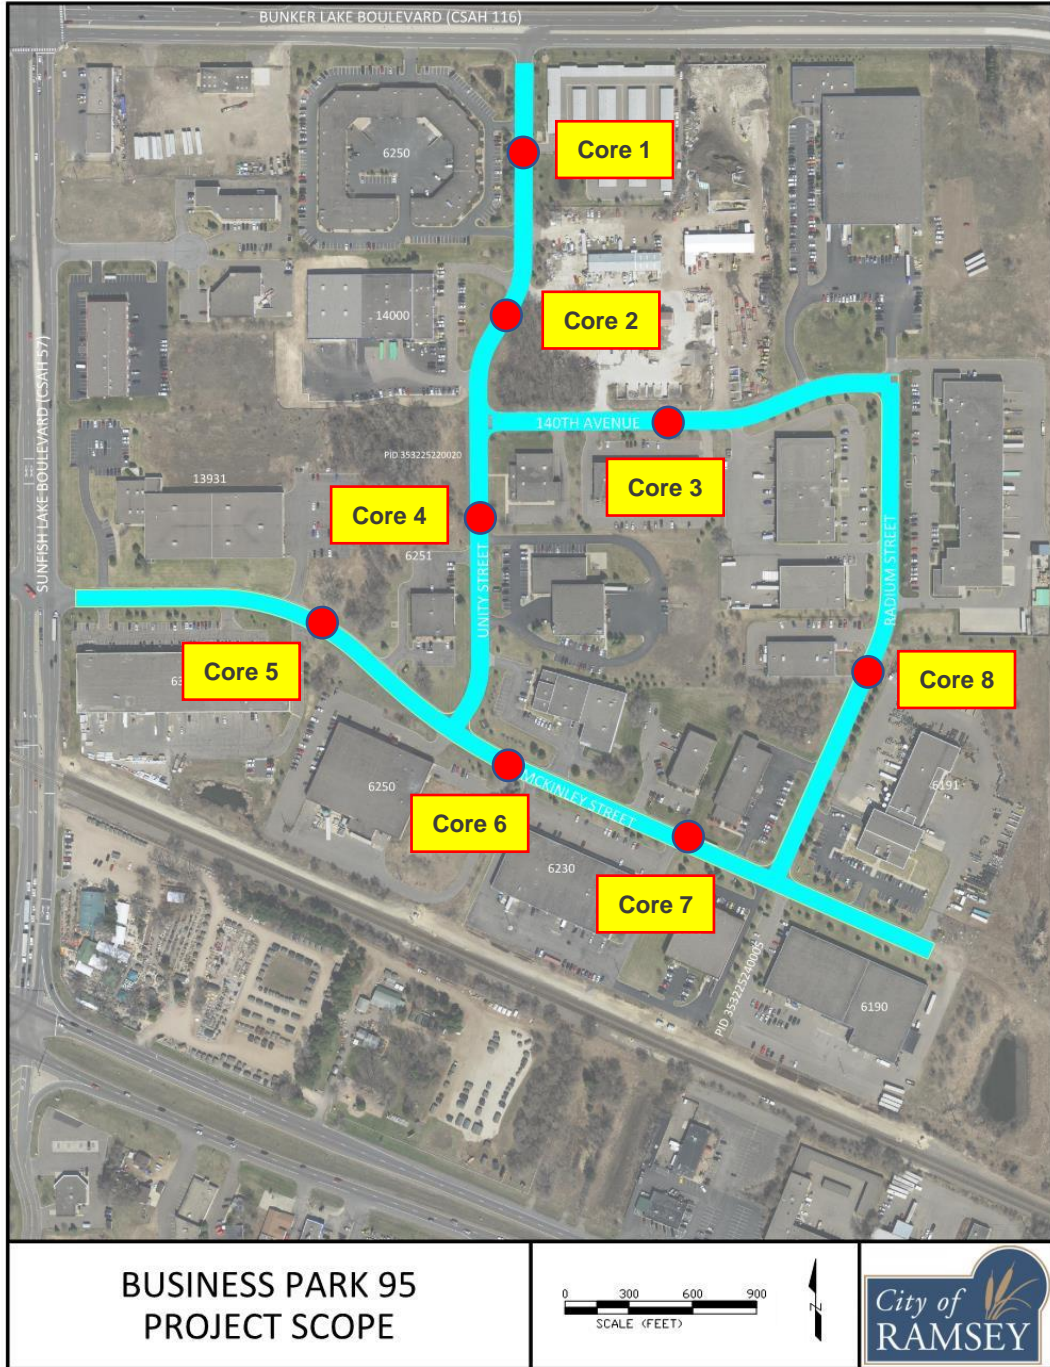
Figure 1. Pavement core locations in Business Park 95 Project Area

The cores taken along the roadways in this project area varied in bituminous thickness from 4 to 8 inches. Cores 1, 2 and 5 were in good condition with the layers bonded together well and the bituminous condition not yet showing signs of aging. However, the remainder of the pavements in this project area were either showing severe signs of aging below the pavement surface, including crumbling upon removal from the core hole. Because of this, it is recommended to perform either a full depth reclamation, full depth bituminous removal and replacement or full reconstruction in this project area. There is not enough sound material in these locations to do a partial depth mill and overlay.

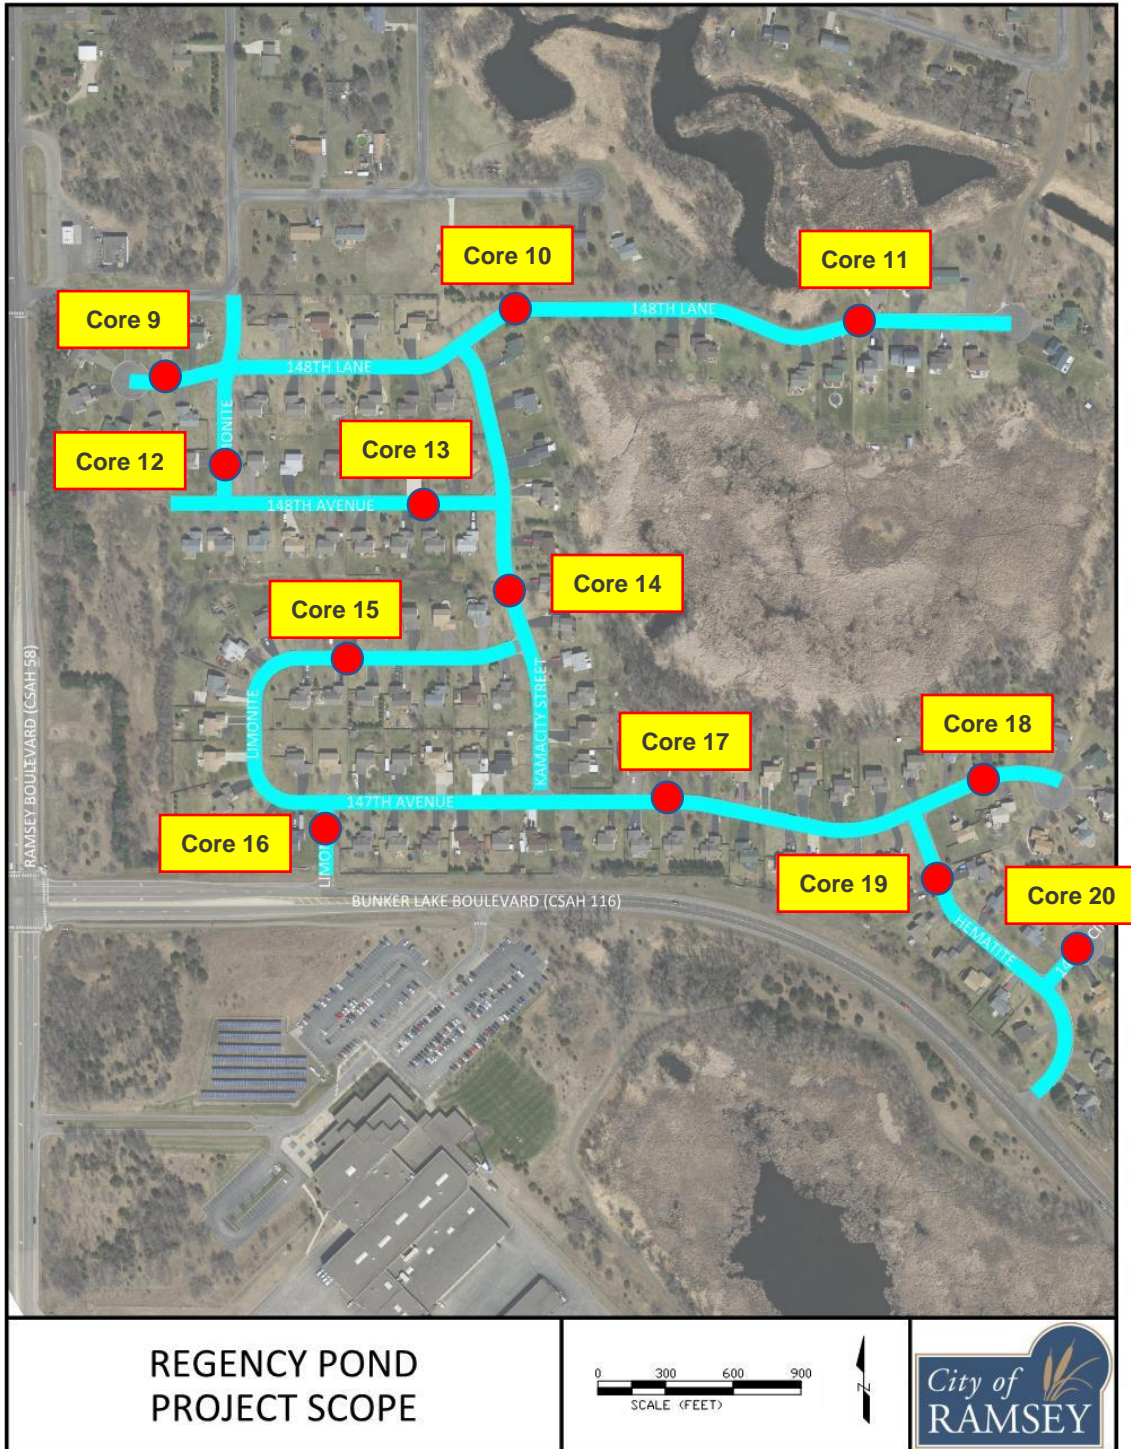
Figure 2. Regency Pond Project Area

The cores taken along the roadways in this project area varied in bituminous thickness from 2 to 4 inches. In general, the bituminous was either very thin, or shown to be in very poor condition. Because of this, it is recommended to perform either a full depth reclamation, full depth bituminous removal and replacement or full reconstruction in this project area. There is not enough sound material in these locations to do a partial depth mill and overlay.

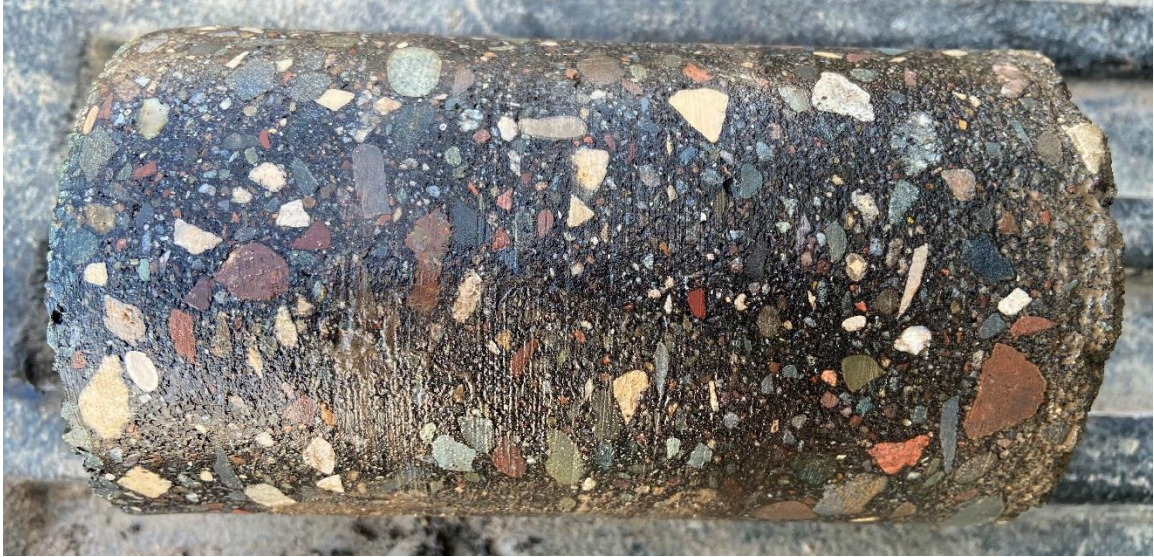
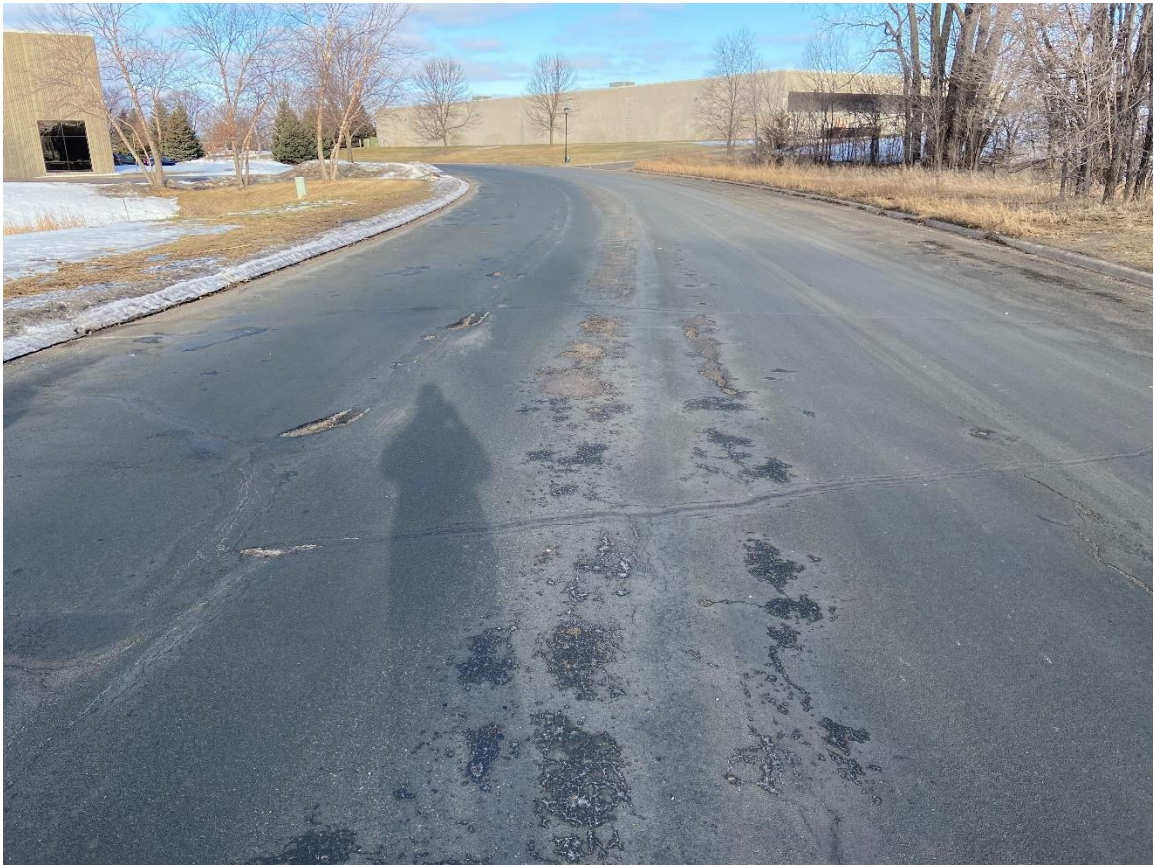
Core 5 (McKinley Street)

5	McKinley Street	6.5	6.5	The top lift of pavement was 1.75 inches. The core was in good shape, all the layers were bonded together well.	2 Inch Mill and Overlay

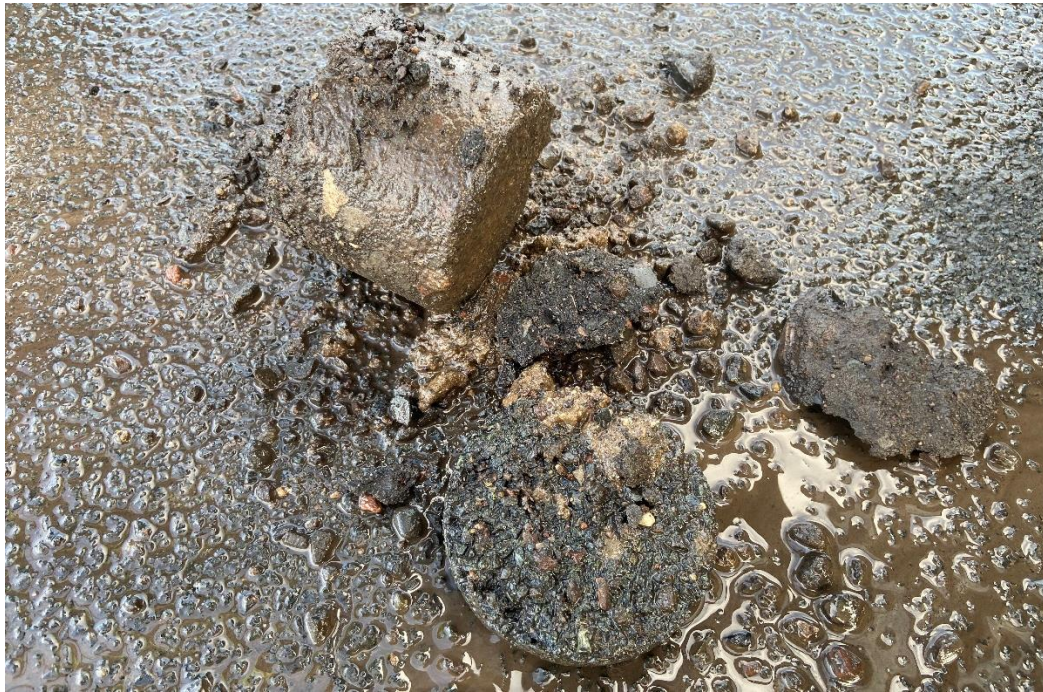
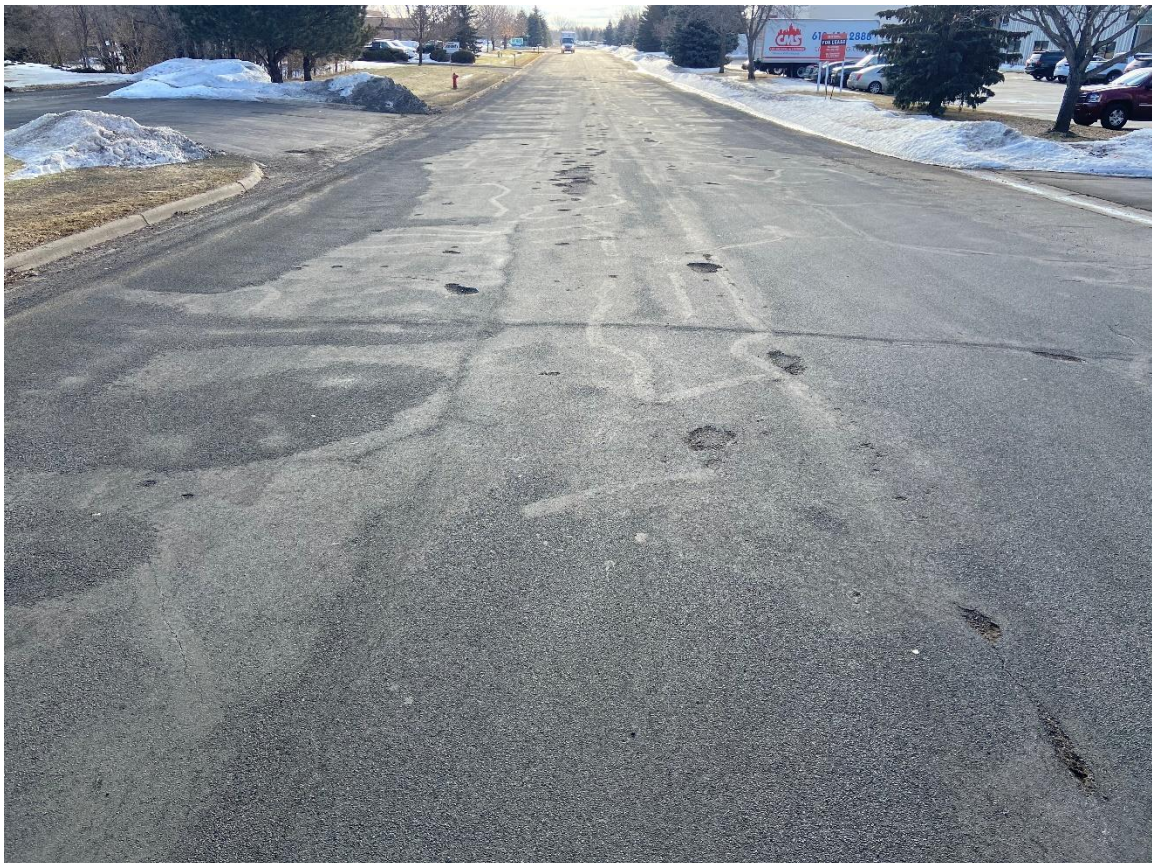
Core 6 (McKinley Street on a Patched Area)

6	McKinley Street (On a Patched Area)	6	9.5	The top 3 inches of pavement was completely raveled and broke apart upon removal from the core hole. The bottom 3 inches was bonded together. Because the top 3 inches crumbled the lift thickness of the wear course could not be determined.	Full Depth Reclamation, Full Bituminous Removal and Replacement or Reconstruction
7	McKinley Street (On a Patched Area)	4.75	9	This core was in very poor condition with delamination of the patch as well as a severe loss of fines and binder throughout.	Full Depth Reclamation, Full Bituminous Removal and Replacement or Reconstruction
8	Radium Street (On a Patched Area)	4	5	This core was in very poor condition with delamination of the patch as well as a severe loss of fines and binder throughout. The core broke apart upon removal from the core hole.	Full Depth Reclamation, Full Bituminous Removal and Replacement or Reconstruction

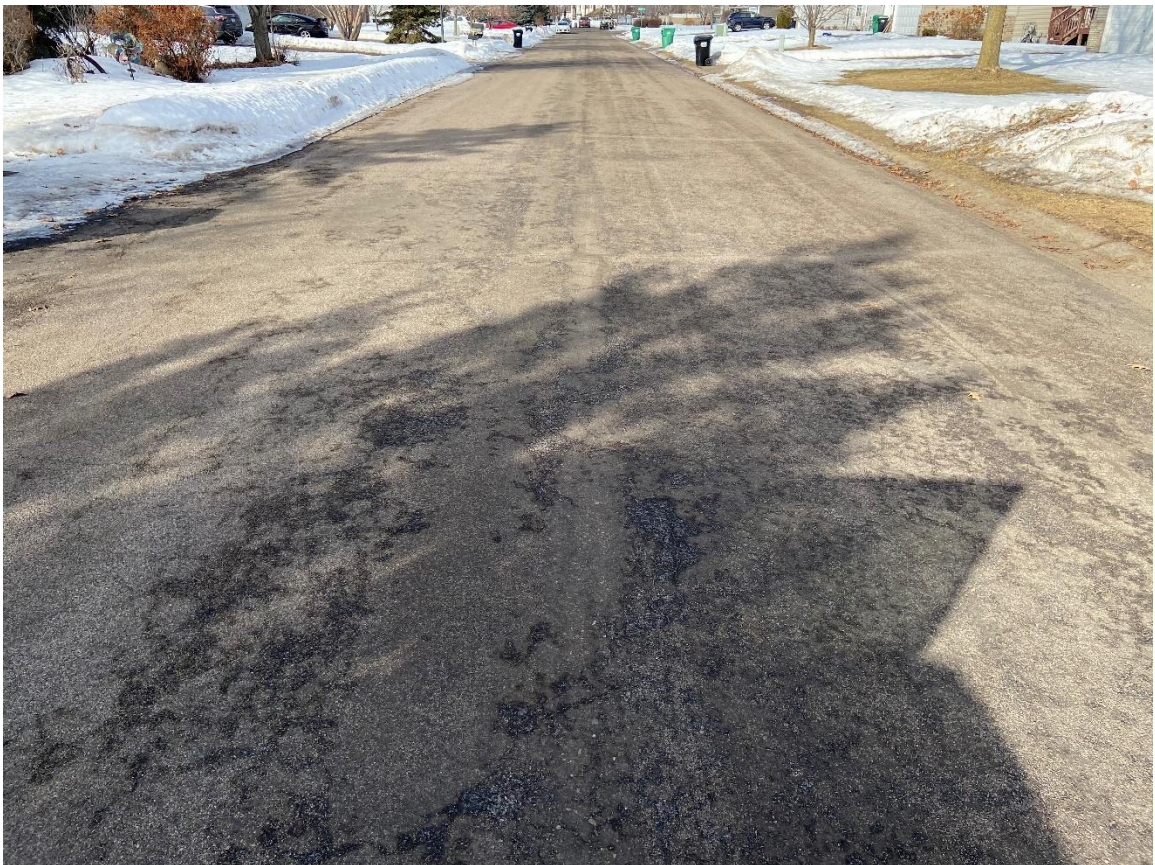
Core 13 (148th Avenue)

pavement and was starting to show signs of aging, losing fines and binder.	and Replacement or Reconstruction
13	148 th Avenue	2	6	This core was in very poor condition and broke apart upon removal from the core hole.	Full Depth Reclamation, Full Bituminous Removal and Replacement or Reconstruction
14	Kamacity Street	2.75	3.75	The core was in fair to poor condition. The layers were bonded together. The core was starting to show signs of aging losing fines and binder.	Full Depth Reclamation, Full Bituminous Removal and Replacement or Reconstruction
15	Limonite	2	7	This core was in very poor condition and broke apart upon removal from the core hole.	Full Depth Reclamation, Full Bituminous Removal and Replacement or Reconstruction
16	Limonite	2	5	The core was in fair condition. This was a very thin lift of pavement.	Full Depth Reclamation, Full Bituminous Removal and Replacement or Reconstruction

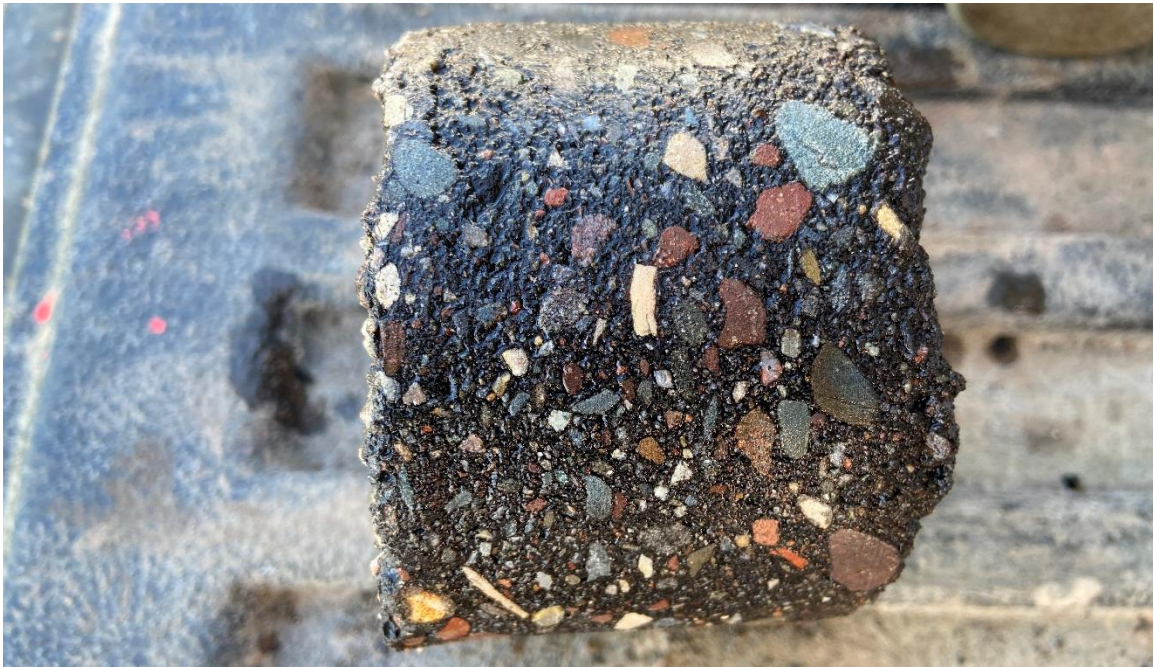
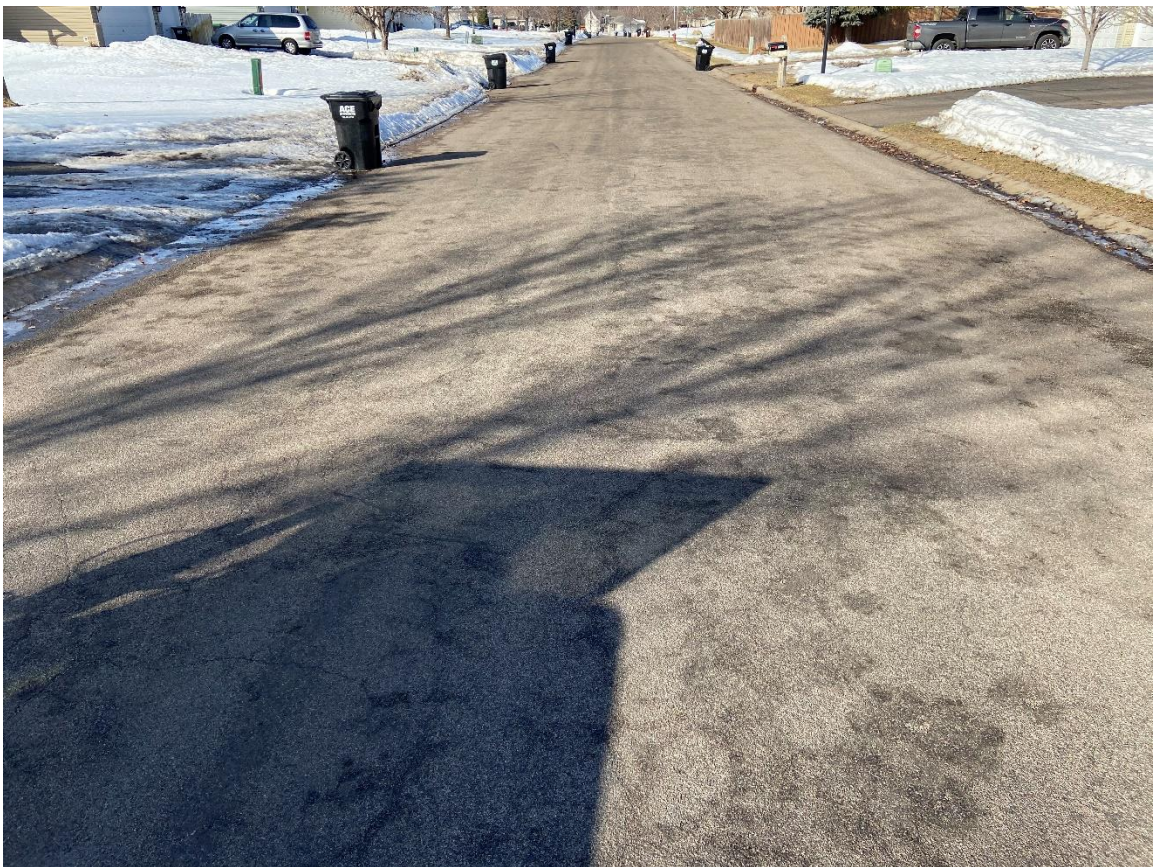
Core 17 (147th Avenue)

17	147 th Avenue	3	4	The core was in fair condition. The layers were bonded together. The core was starting to show signs of aging losing fines and binder.	Full Depth Reclamation, Full Bituminous Removal and Replacement or Reconstruction
18	147 th Avenue	4	5	This core was in very poor condition and broke apart upon removal from the core hole.	Full Depth Reclamation, Full Bituminous Removal and Replacement or Reconstruction
19	Hematite	3.75	4.75	The core was in fair condition. The layers were bonded together. The core was starting to show signs of aging losing fines and binder.	Full Depth Reclamation, Full Bituminous Removal and Replacement or Reconstruction
20	146 th Circle	2.5	11	The core was in good to fair condition. This was a thin lift of pavement.	Full Depth Reclamation, Full Bituminous Removal and Replacement or Reconstruction
¹ Subgrade material was observed to be sand material on Cores 1 through 10 and sand/gravel on Cores 11 through 20.
