CITY ZONE CHANGE Billings Zone Change # 985 - Project # P2-20-00203

RESIDENTIAL REPORT

3121-3125 Boulder Ave
Billings MT 59102

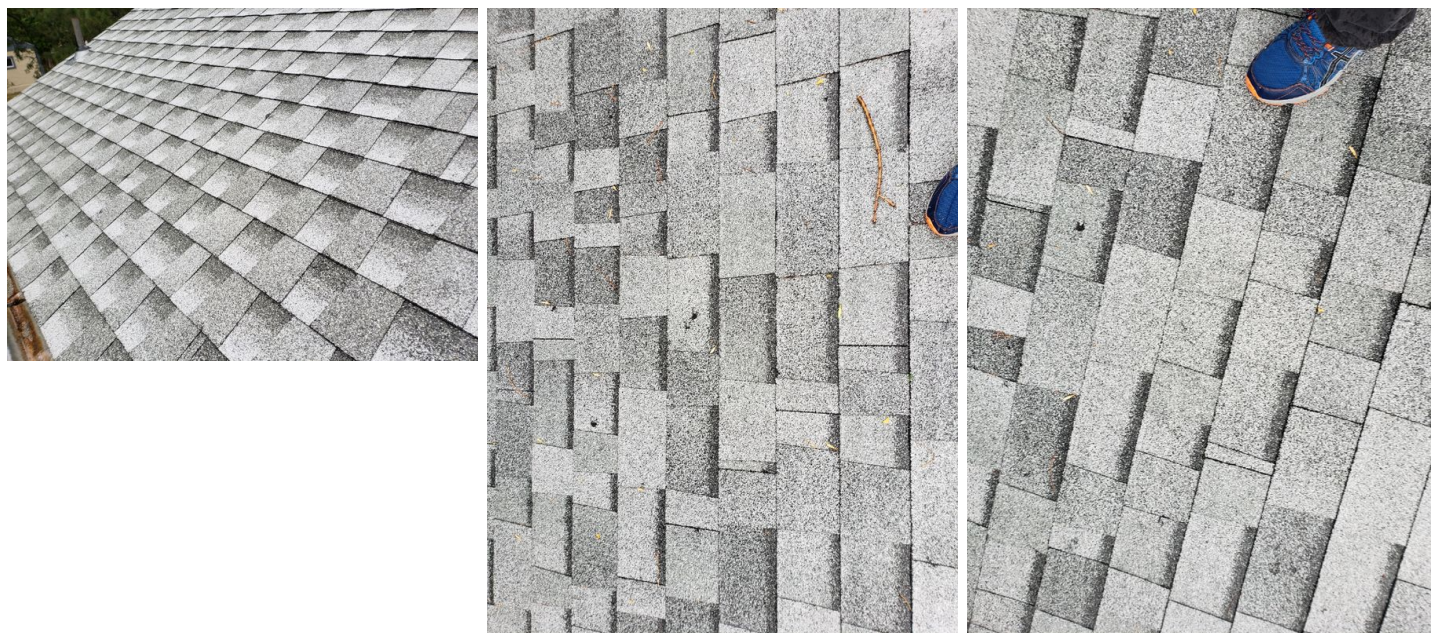
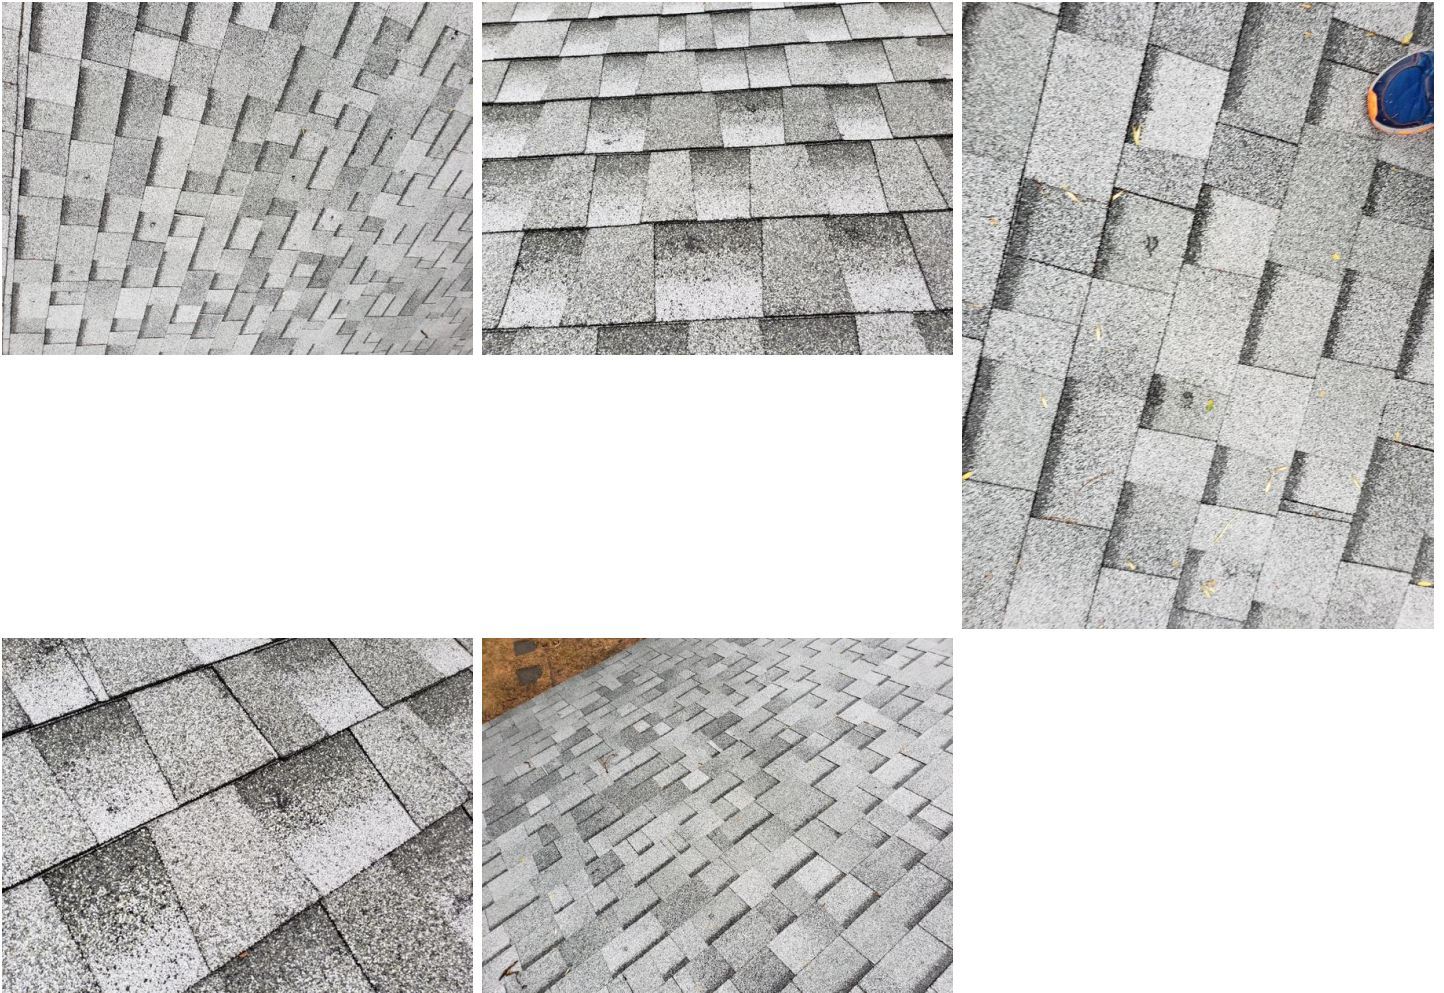
DAMAGED (GENERAL)

General damaged noted including Hail damage and damaged shingles on all 3 roofs. Recommend further evaluation by a qualified roofing professional.

Contact a qualified roofing professional.

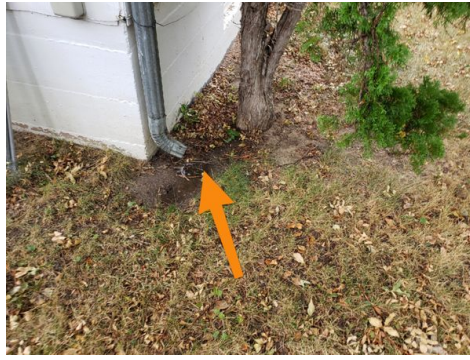
One or more downspouts drain too close to the home's foundation. This can result in excessive moisture in the soil at the foundation, which can lead to foundation/structural movement. Recommend adjusting downspout extensions to drain at least 6 feet from the foundation.

Contact a handyman or DIY project

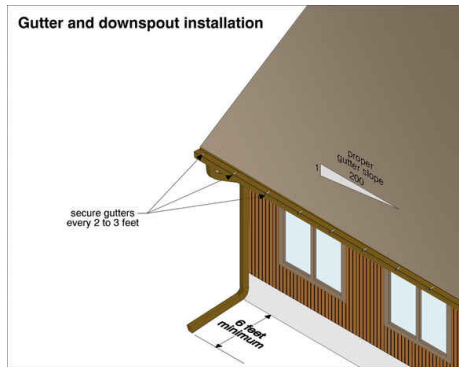
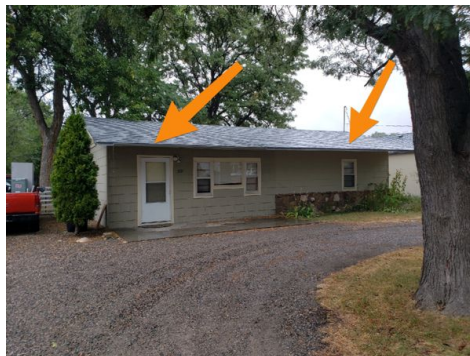
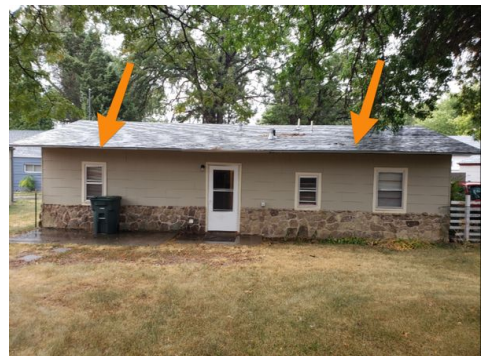
GUTTERS MISSING

Gutters and downspouts missing on the house. Installation recommended to keep water away from structure. Water can damage the soffit and siding and weaken the foundation/footings.

Contact a qualified professional.

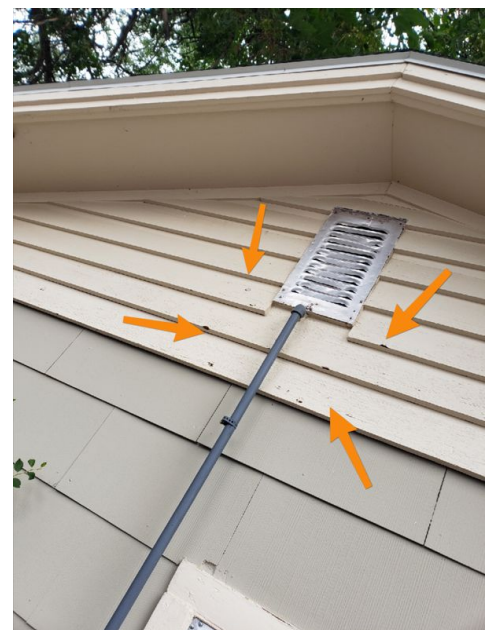
MINOR HAIL DAMAGE

Siding showed areas of minor hail damage. Recommend sealing.

Contact a qualified professional.

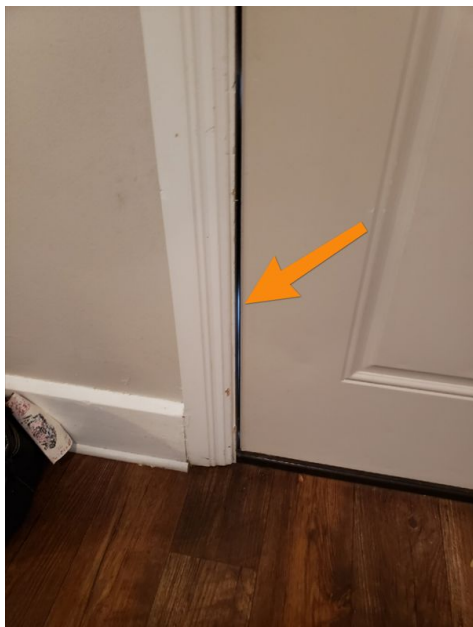
Front Door is missing adequate weatherstripping at the side. Air and light entering. This can result in significant energy loss and moisture intrusion. Recommend installation of standard weatherstripping.

Recommended DIY Project

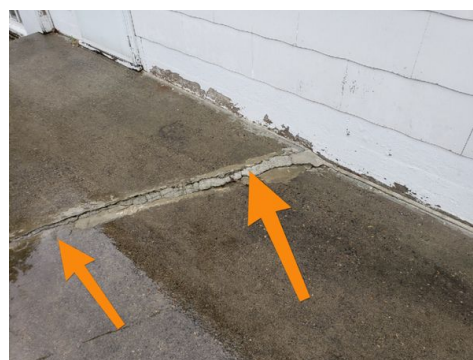
CONCRETE CRACKING

Concrete cracking at the back patio. Recommend sealing to help prevent water intrusion and further cracking. Repair may eventually be needed.

Contact a qualified professional.

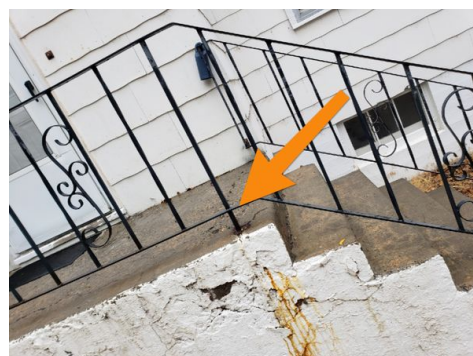
LOOSE RAILING

Railing is loose on front steps. Safety hazard. Recommend repair.

Contact a qualified professional.

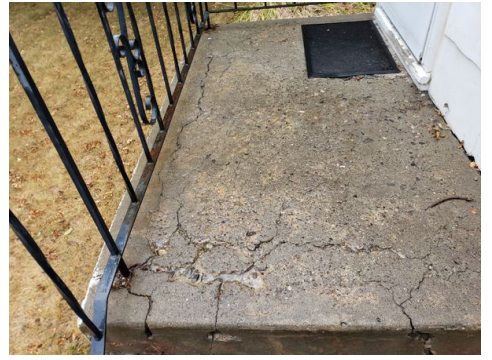
SPALLING

Concrete spalling and cracking noted at the front steps. This loosening the top, smooth layer of the cement is a common occurrence, possibly due to an improper curing process, age, or use of snow-melting materials or lack of gutters. Repair may eventually be needed.

Contact a qualified professional.

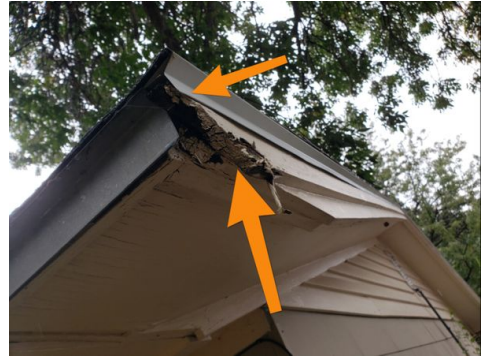
FASCIA - ROTTED

One or more sections of the fascia or rake board are rotted. Repair will eventually be needed. Possible hidden damage.

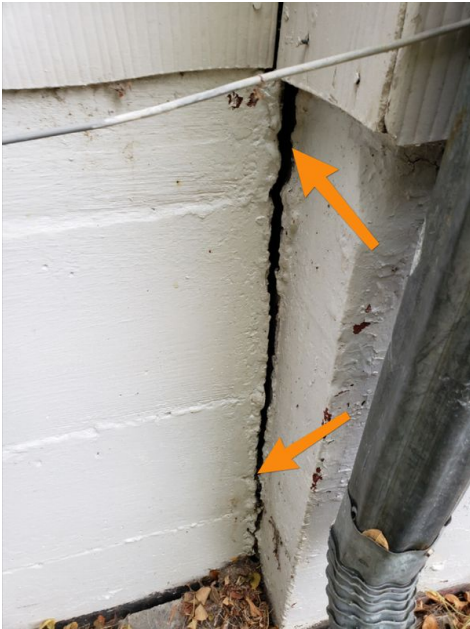
Gap in front foundation wall. Possible water intrusion into basement. Recommend sealing.

Contact a qualified professional.

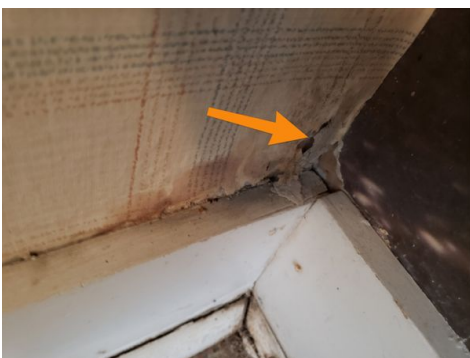
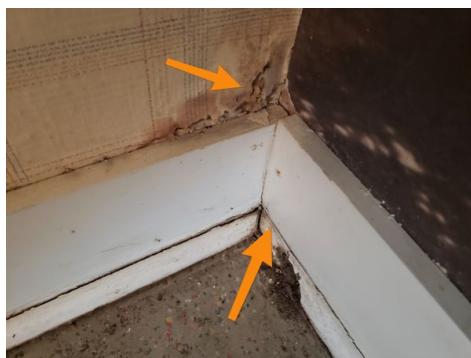
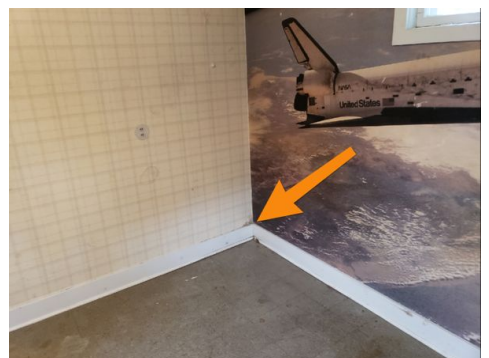
Evidence of past water intrusion at base of the wall in Sw basement room. Possible organic substance and hidden damage. Dry at the time of inspection.

Contact a qualified professional.

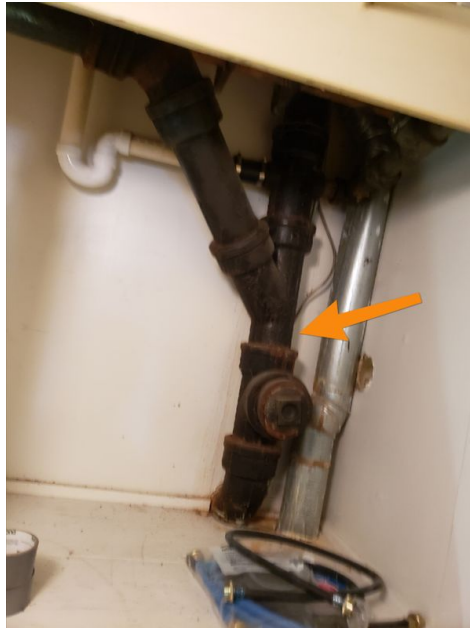
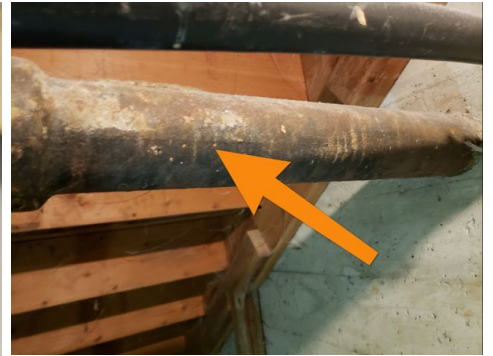
Deferred Cost: There are portions of the plumbing system with older cast iron piping. Expect unexpected repairs in any older original plumbing.

Recommend scoping main drain line.

Contact a qualified plumbing contractor.

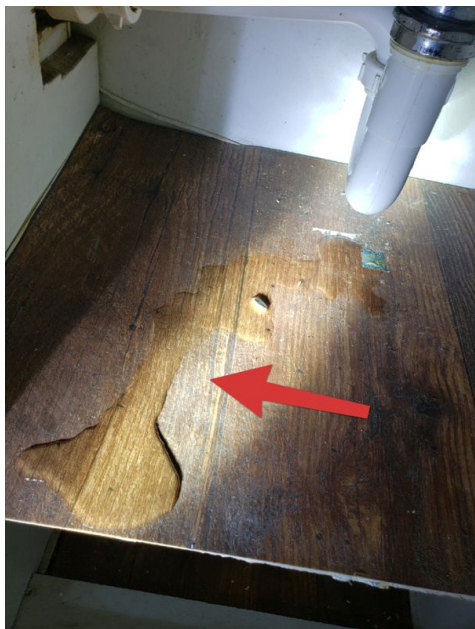
**DRAIN LINE LEAKING**

Drain line in the kitchen of 3125 has significant leaking. Bathroom drain line in 3121 is leaking. Recommend repair.

Contact a qualified professional.

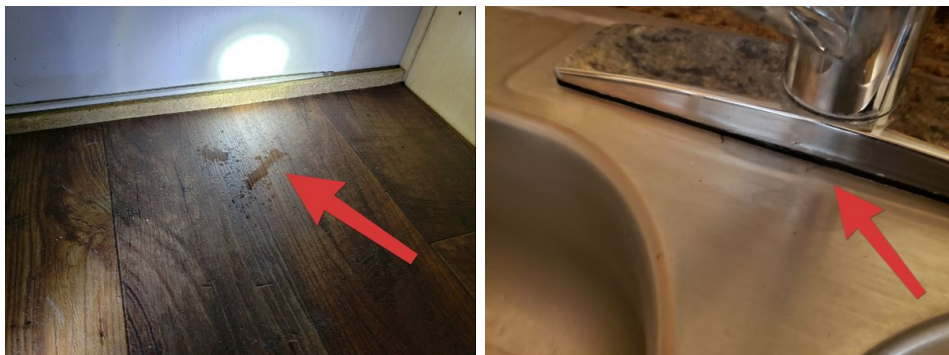
FAUCET LEAKS

Kitchen Sink faucet leaks from handle and is leaking under the sink. Recommended repair.

Contact a qualified professional.

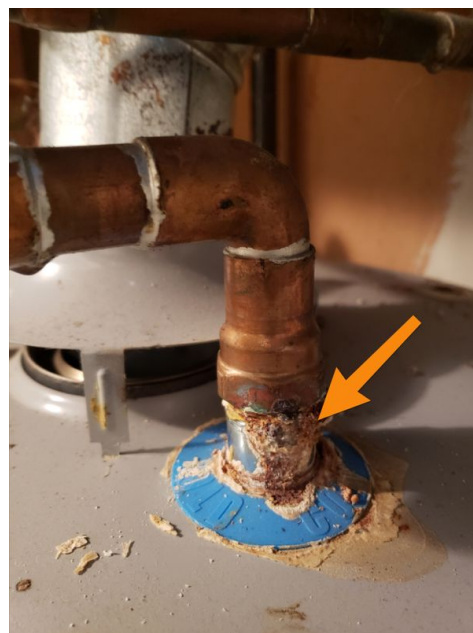
CORROSION

Corrosion was noted at the burn chamber or pipe fittings. Recommend a qualified plumber evaluate for repair/replacement.

Contact a qualified plumbing contractor.

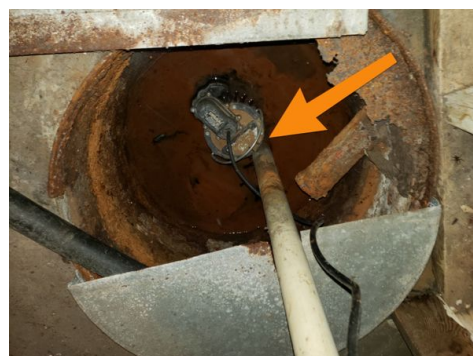
Sump pump was inoperable at the time of inspection. Recommend qualified plumber evaluate and repair.

Contact a qualified plumbing contractor.

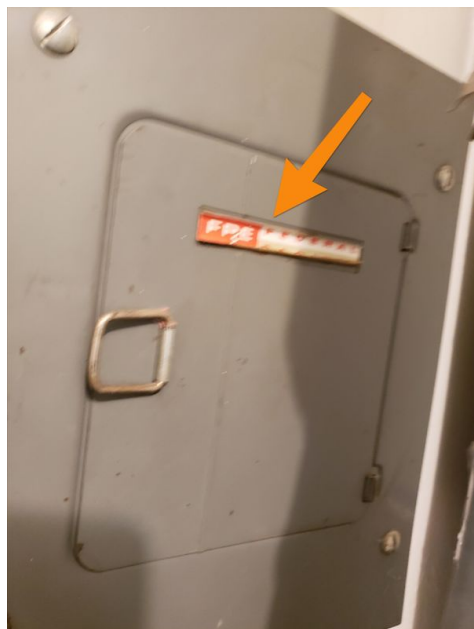
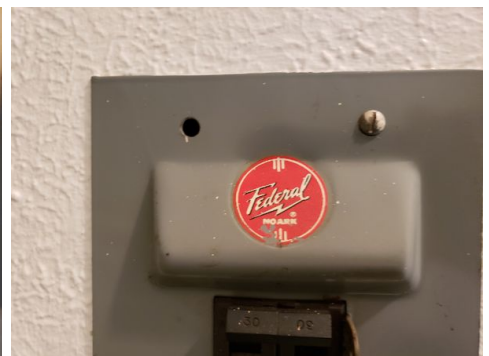
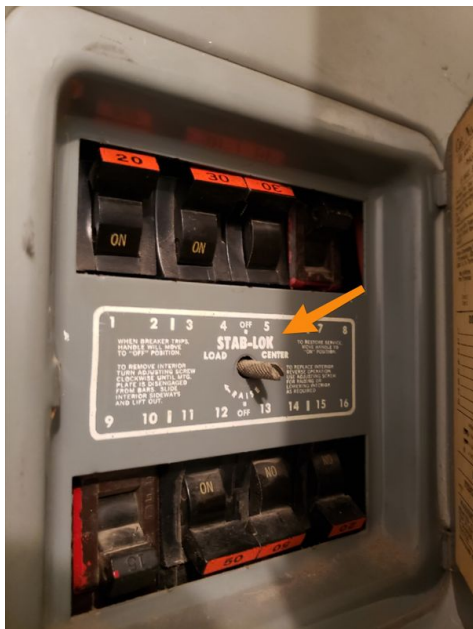
There is a Federal Pacific Electric service panel in the utility room of 3121 and stairwell of 3125. There are studies that show that some FPE circuit breakers are prone to problems that can lead to failures, lack of proper protection of circuits and other serious issues, including fire and electrocution. Although the Consumer Products Safety Commission has not issued a formal product recall, the panel is old and the company is now out of business. We cannot definitively call this panel defective, but recommend, for your peace of mind, to consult a qualified electrical contractor to get their opinion on this matter. You can learn more about this issue by searching "Federal Pacific Stab-Lok Panels". **Strongly advice replacing panel. Some insurance** companies will not insure a home with a Federal Pacific panel.

Contact a qualified electrical contractor.
