# HISTORIC PROPERTY INVENTORY FORM

Address: 376 N. Colorado St.

City or Town: City of Chandler ☐ vicinity County: Maricopa Tax Parcel No. 302 -62 -085C

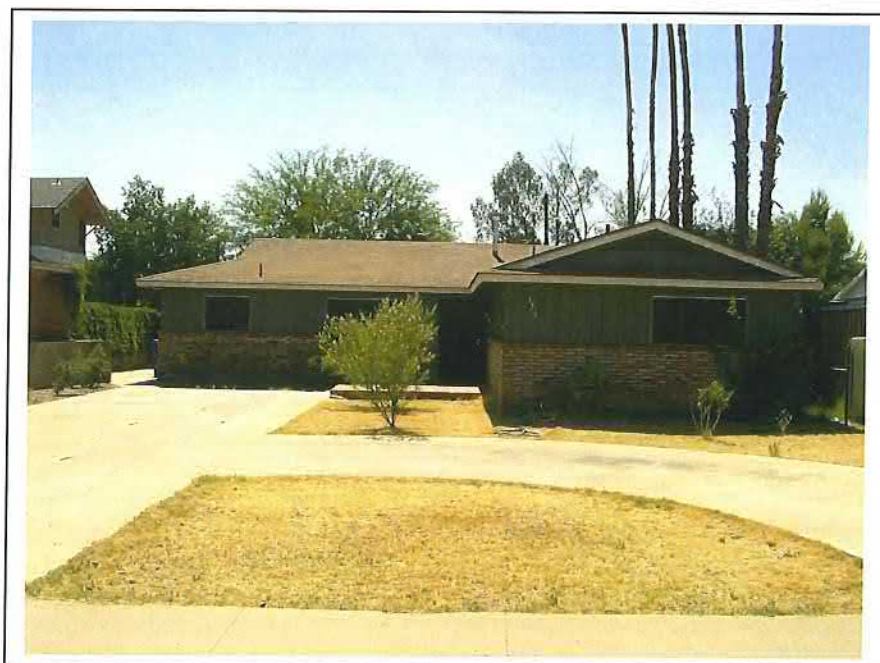
2. DESIGN (Describe alterations from the original design, including dates—known or estimated—when alterations were made)  
No alterations observed from the street.

Walls (structure): Wood frame Foundation: Concrete Roof: Asphalt shingle  
Windows: Undetermined, obscured by screens.

Structure is an ell shaped structure with a modified low-pitch hipped roof with a moderate overhang and clad in asphalt shingle with boxed rafter tails. The foundation is slab-on-grade concrete, and the exterior cladding is wood board and baton siding over decorative brick. The type of windows on the structure is unknown as they were obscured by screens at the time of observation. Fenestration is irregular. A large brick patio leads to the single-step entry that faces the street. The door is wood, and is recessed into the façade of the building. Landscaping consists of a Bermuda grass lawn and shrubs. A concrete block wall runs the property line on either side of the building, and features a modern lineal driveway with a second curved way running from the main drive to the street.

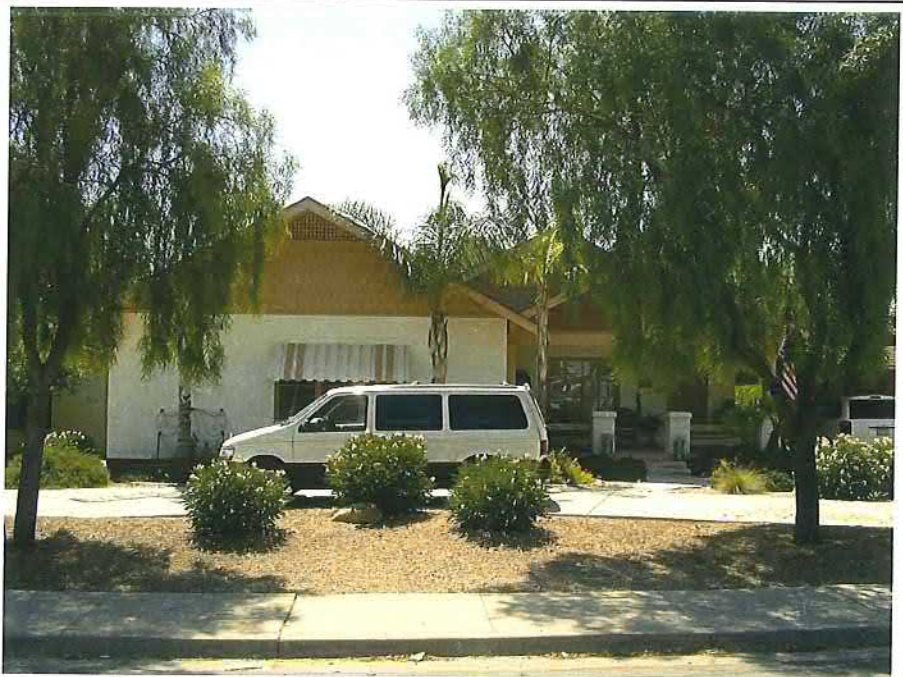
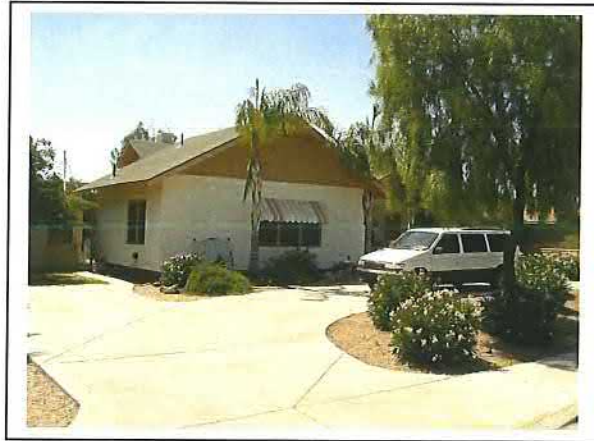
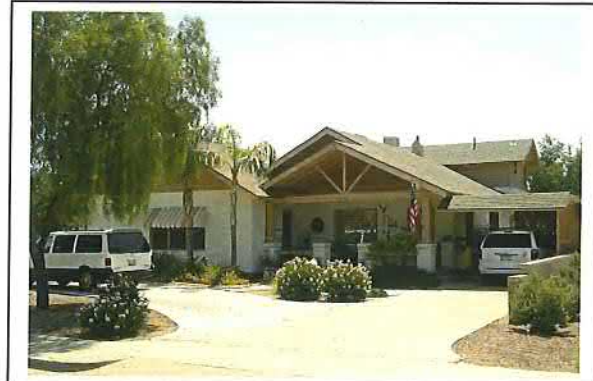
372 N. Colorado St., looking NW

Describe how the setting has changed since the property's period of significance: Some properties have removed or replaced traditional landscaping with xeriscape. There is commercial encroachment along Arizona Ave and A.J. Chandler Blvd. A circular drive and xeriscape landscaping were added in the 1990s

Walls (structure): Brick Foundation: Concrete Roof: Wood shingle

The main structure is a single-story brick structure with multiple medium-pitch front gables clad in wood shingle with stucco exterior cladding, and a concrete foundation. The gables are decorated with trusses, knee bracing, wood shingles, and lattice attic vents. Windows are wood double hung one over one and wood casement. Fenestration is irregular. The off-center three-step wood door entry is recessed under a front gable supported masonry and wood piers with a wood truss above. Additions include a large front gabled wing to the façade, built in the 1930s, a two story addition to the rear built in the 1940s, and an open flat-roofed carport on the north side of the building constructed in the 1980s. A second wood door entry is placed on the north side of the building. Landscaping includes a circular drive with gravel areas planted shrubs and trees.

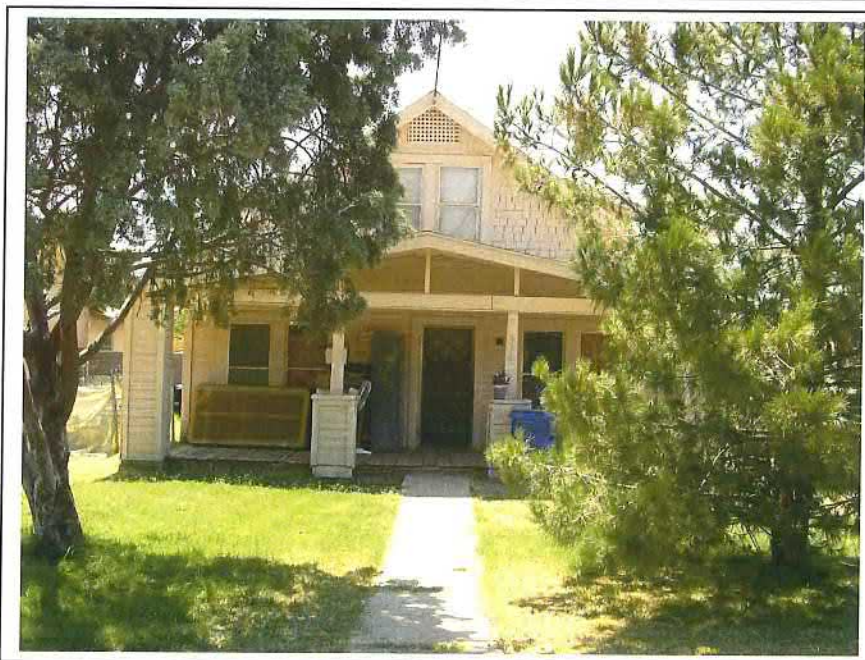
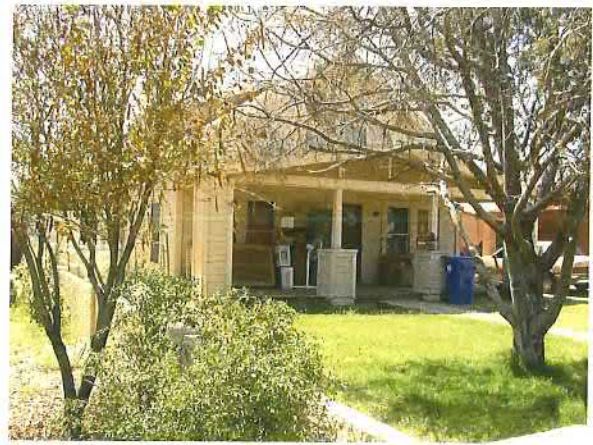
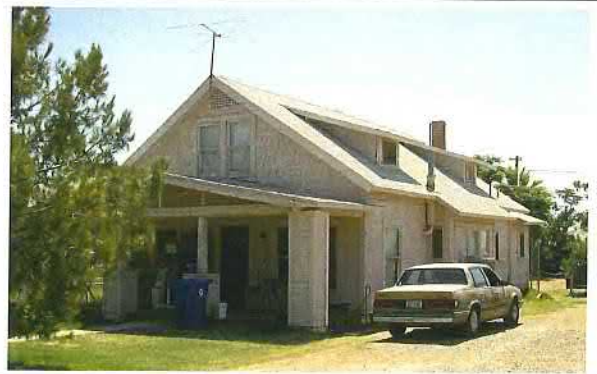
318 N. Colorado St., looking NW

4. MATERIALS (Describe the materials used in the following elements of the property)  
Walls (structure): Wood frame Foundation: Concrete Roof: Asphalt shingle  
Windows: Wood double hung 1 over 1  
If the windows have been altered, what were they originally? Some windows missing and boarded.  
Wall Sheathing: Wood ship lap siding and wood shingles at the gable  
If the sheathing has been altered, what was it originally? No alterations observed from the street.

Building is a story-and-a-half wood frame home with a concrete foundation and wood ship lap siding with wood shingles at the gables. The roof is composed two front gables, one low-pitch and the other medium-pitch, both are clad in asphalt shingle. Each has lattice vents at the peak. Two equally spaced shed dormers are placed on each roof plane of the main front gable. An exterior chimney is placed on the rear of the structure. On the north side of the building, there is a centered bay window covered by a shed roof extending from the main roof plane. Windows are wood double hung 1 over 1, although some have been boarded. Fenestration is regular. The single-step entry with a centered wood door has a rectangular light divided to diamonds. It is placed under a veranda supported on built-up massive wood columns and smaller tapered piers. No alterations were observed from the street. Landscaping consists of a Bermuda grass lawn, trees, and shrubs.

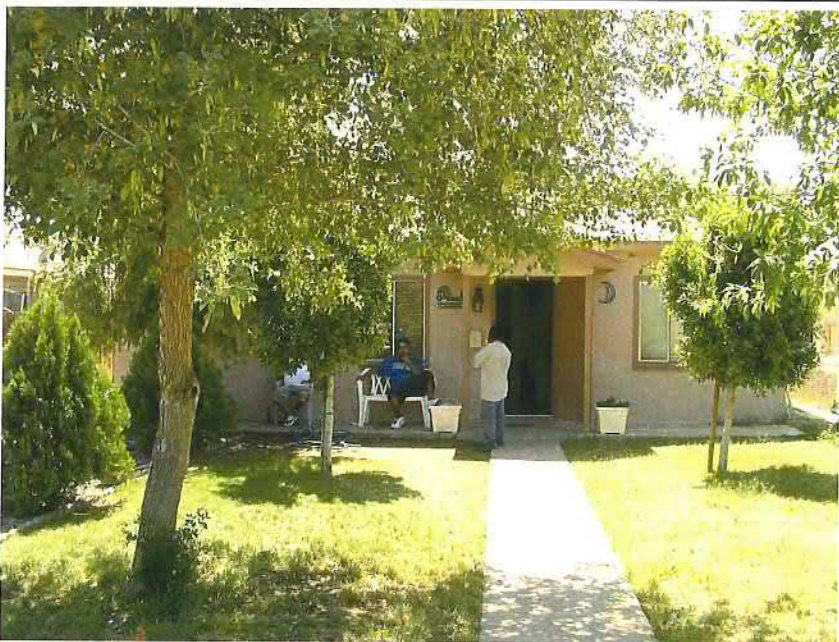
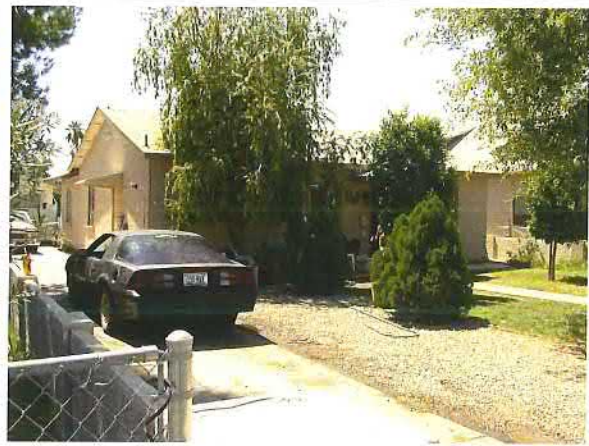
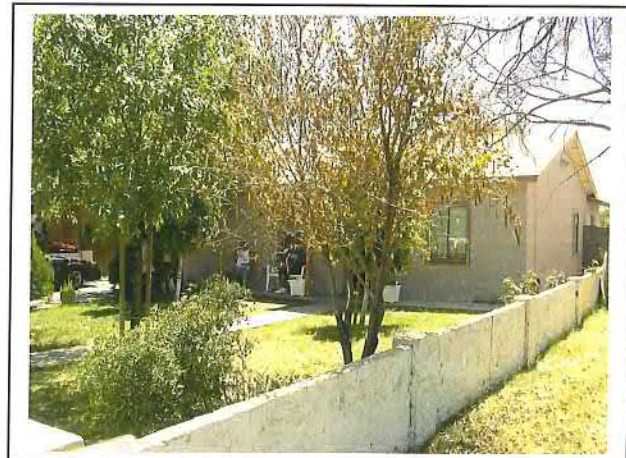
308 N. Colorado St., looking NW

2. DESIGN (Describe alterations from the original design, including dates—known or estimated—when alterations were made) Steel casement windows have been replaced by aluminum sliding windows, and the home has been re-stuccoed, most likely in the 1990s.

Walls (structure): Wood frame Foundation: Concrete Roof: Asphalt shingle  
Windows: Aluminum frame, sliding

Building is a single story home with a low-pitch side-gabled roof clad in asphalt shingle with boxed rafter ends, stucco cladding, and a concrete foundation. The original steel casement windows were replaced with sliding aluminum frame windows in the 1990s. Fenestration is regular. The centered single-step wood door entry is covered with a low-pitch front-gabled porch supported by two undecorated square wood posts. The wood siding on the porch gable has been covered in modern stucco. Landscaping consists of a Bermuda grass lawn, trees, and shrubs. A low concrete block wall runs along each side of the property line.

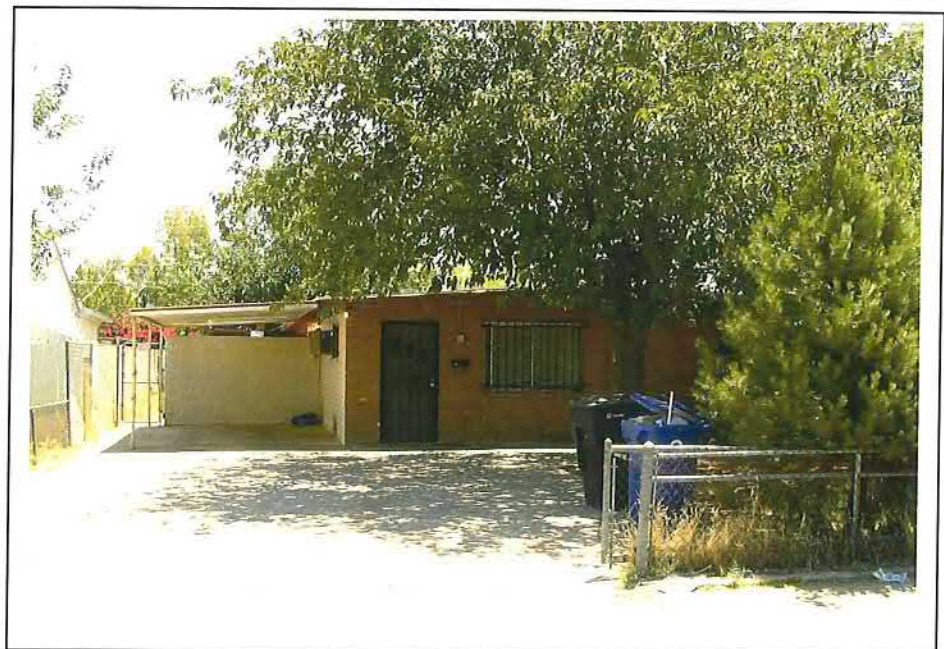
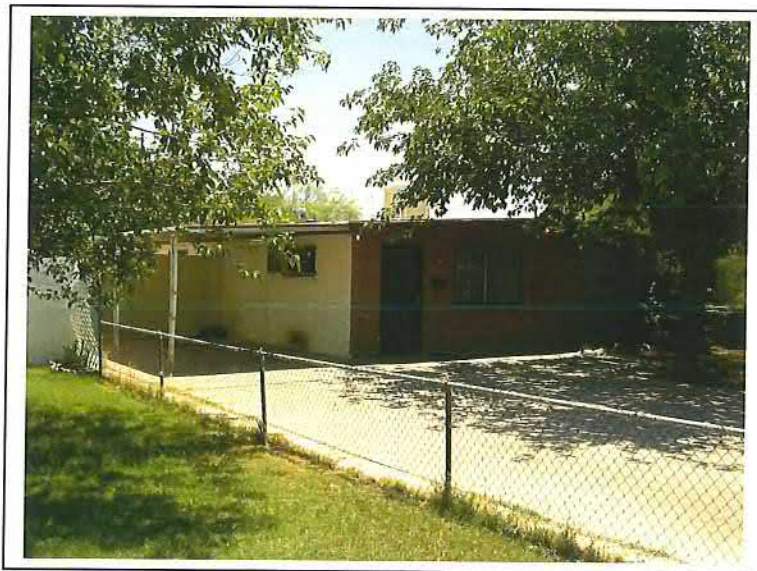
309 N. Colorado St., looking SE

4. MATERIALS (Describe the materials used in the following elements of the property)  
Walls (structure): Brick Foundation: Concrete Roof: Asphalt shingle  
Windows: Aluminum frame sliding  
If the windows have been altered, what were they originally? No alterations observed from the street.  
Wall Sheathing: Brick, some areas painted.  
If the sheathing has been altered, what was it originally? No alterations observed from the street.

Building is a single-story rectilinear brick building with a very low-pitch front gable with a slight overhang. The foundation is slab-on-grade concrete, and the windows are aluminum sliding frame. Steel bars have been added over the windows. Fenestration is irregular. The level entry is off-center and leads to a wood door covered by a security screen. A shed roof single-vehicle carport is located on the north side of the building. A six foot block wall extending from the home forms the rear wall of the carport. Landscaping consists of a Bermuda grass lawn, trees, and shrubs.

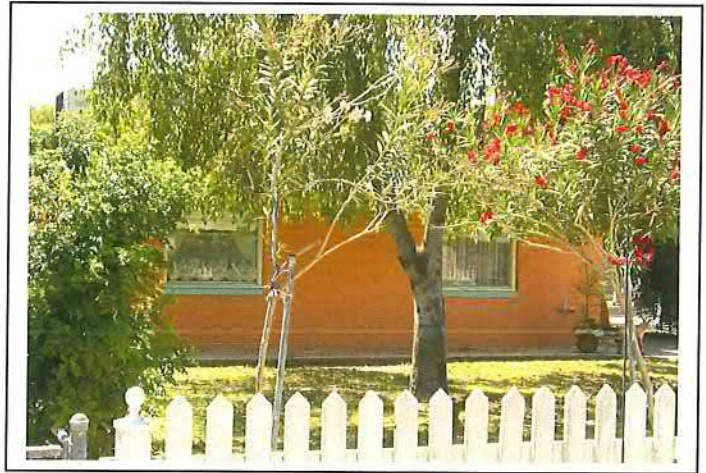
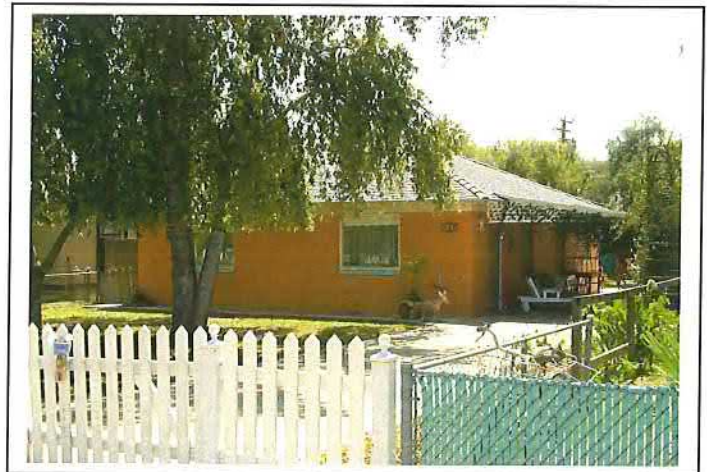
282 S. Colorado St., looking NW

Walls (structure): Concrete block Foundation: Concrete Roof: Asphalt shingle

Building is a rectilinear concrete block building with a pyramid roof clad in asphalt shingle and adorned with terra cotta tile along the roof planes. The rafter ends are boxed. The foundation is concrete. Fenestration is irregular, and the windows are multi-light steel casement windows with block sills. The level wood door entry is off center on the north side of the building parallel to the street. A shed roof carport extends from the north side of the structure over the entry, and is supported by undecorated square wood posts. Landscaping consists of a Bermuda grass lawn and shrubs.

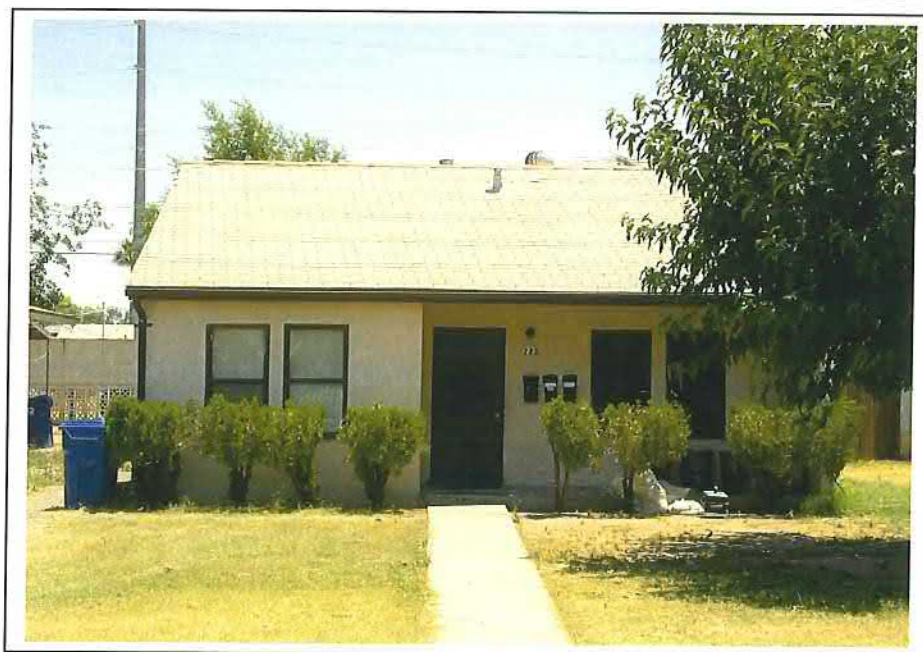
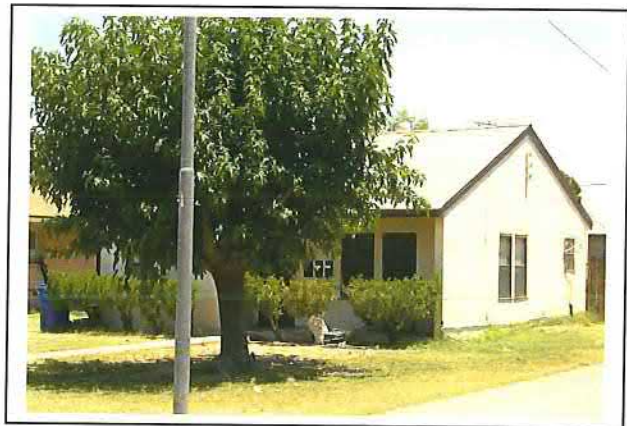
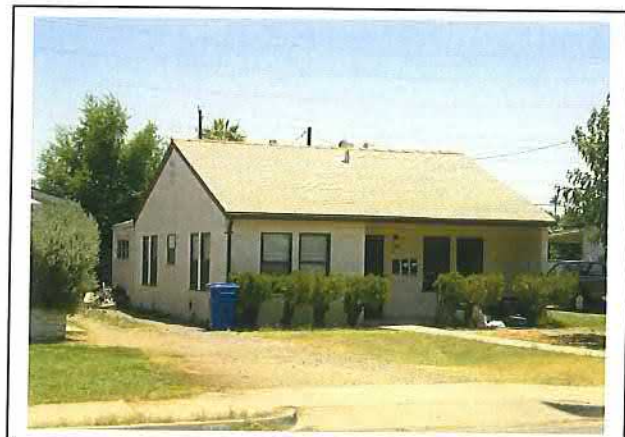
283 N. Colorado St., looking NE

1. LOCATION ☒ Original Site ☐ Moved (date \_\_\_\_\_) Original Site: 283 N. Colorado St.
2. DESIGN (Describe alterations from the original design, including dates—known or estimated—when alterations were made)  
Some of the 1 over 1 double hung sash windows have been replaced with steel casement windows around 1950. A shed roof addition has been added to the rear of the structure, also a 1950s addition.
3. SETTING (Describe the natural and/or built environment around the property) Structure is located in a suburban neighborhood setting. Landscaping consists of a Bermuda grass lawn with shrubs.

Building is a single-story rectilinear side-gabled structure with a low-pitch asphalt shingle roof with terracotta tile at the peak, stucco cladding, a concrete foundation and both 1 over 1 double hung sash and steel casement windows. The south half of the building is recessed four feet under the roof line to form a shallow porch supported by evenly spaced undecorated square wood posts. The south exterior wall extends from the structure to enclose the porch. Three terracotta roof drains are attached horizontally at the end of each gable. Fenestration is regular, and the single-step entry is centered and recessed under the porch roof. Landscaping consists of a Bermuda grass lawn, trees, and shrubs.

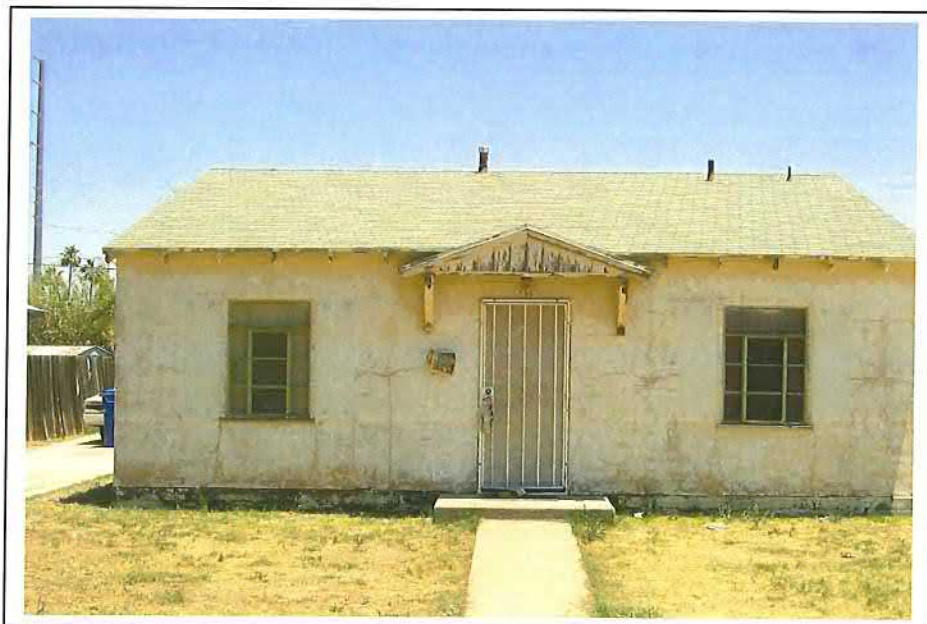
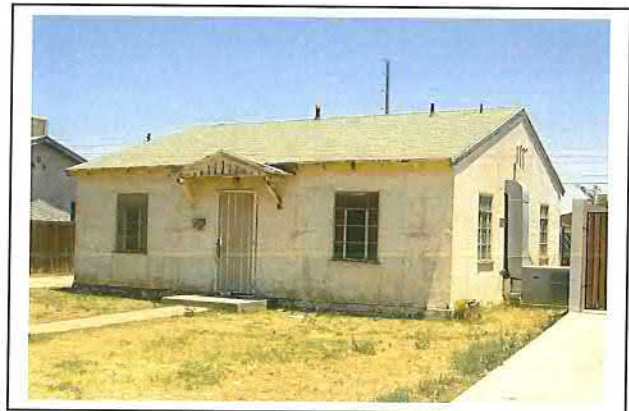
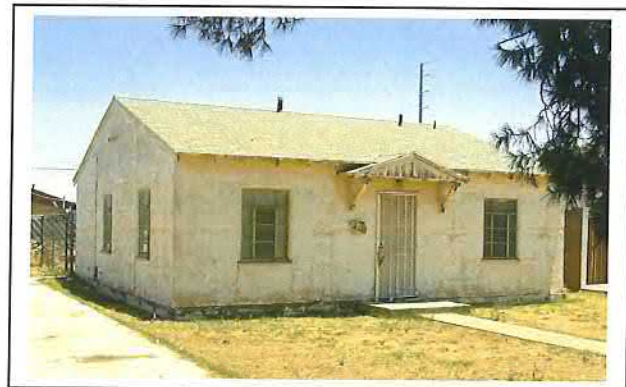
265 N. Colorado St., looking NE

4. MATERIALS (Describe the materials used in the following elements of the property)  
Walls (structure): Wood frame Foundation: Concrete Roof: Asphalt shingle  
Windows: Multi-light steel casement, with center lights operable  
If the windows have been altered, what were they originally? No alterations visible from the street.  
Wall Sheathing: stucco  
If the sheathing has been altered, what was it originally? No alterations visible from the street.

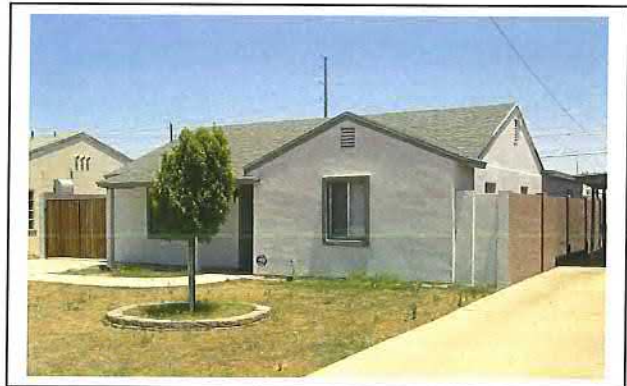
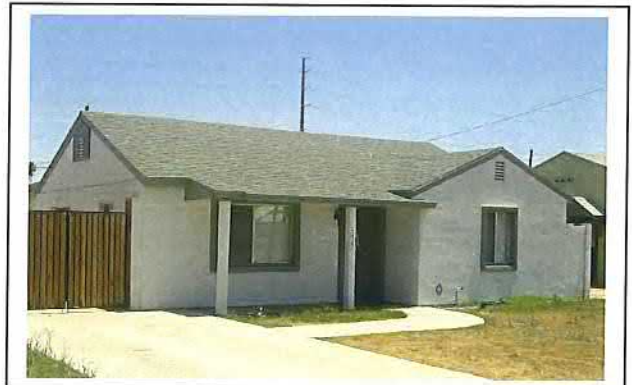
255 N. Colorado St., looking NE

Building is a single-story rectilinear home with concrete foundation, and stucco exterior wall cladding applied in the 2000s. The roof is a front cross-gable with a low-pitch clad in asphalt shingle with a minimal overhang. Windows were replaced in 2000s with aluminum sliding windows, fenestration is irregular. The level centered wood door entry is covered with a shed porch roof that extends from the roof plane. The porch is supported by two square stucco clad posts. Stucco borders surround the windows and door was added in the 2000s. Metal roof vents are placed the end of each gable. A new sidewalk and driveway have been added, most likely at the same time as the other changes. A block wall to the south, and a wood fence to the north enclose the rear and side yards, also added in the 2000s. Landscaping consists of a Bermuda grass lawn and a tree.

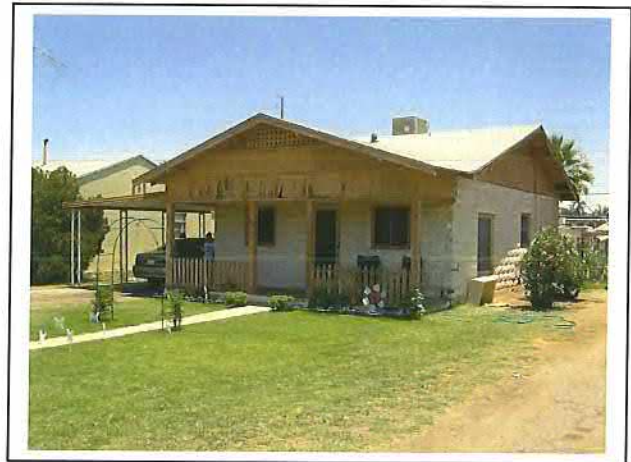
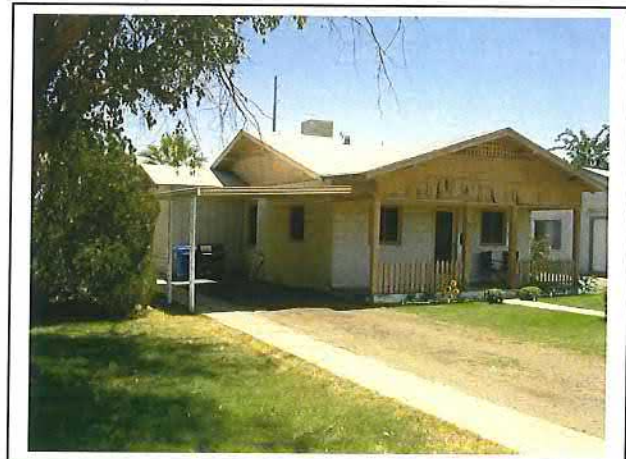
237 N. Colorado St., looking NE

Building is a single-story home with rusticated cast concrete block construction and a concrete foundation. The roof is a front-gable with a rear cross gable, both low pitch and clad in asphalt shingle. Wood lattice work, shingle, and knee bracing decorates each gable. Windows are wood casement with paired lights. Fenestration on the façade is regular, and irregular on the other building faces. The centered single-step wood door entry is recessed under the front gable. The porch is supported by four equally spaced square undecorated wood posts. A 1950s era picket railing encloses the porch. A steel shed roof carport supported by decorative steel posts was added in the 1970s to the north side of the building. Landscaping consists of a Bermuda grass lawn and shrubs.

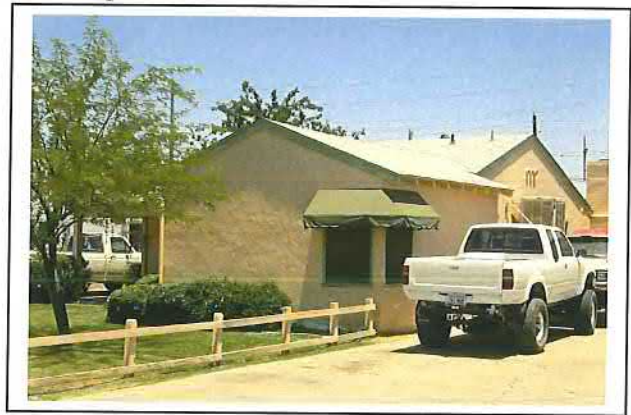
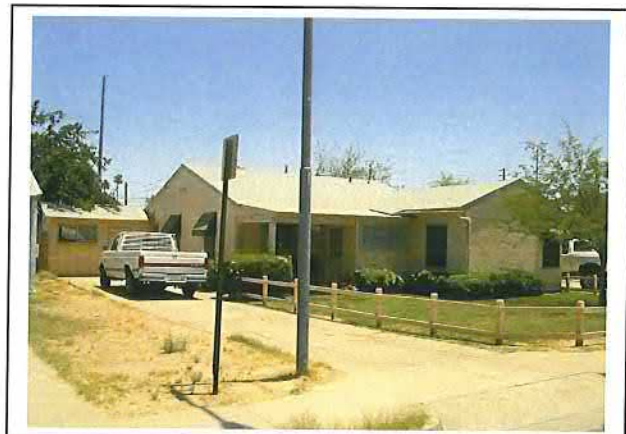
219 N. Colorado St., looking NE

Building is a single-story side-gabled home with a front-gabled wing on the south side. The low-pitch roof is clad in asphalt shingle, and has exposed rafter ends. The foundation is concrete. The exterior cladding is stucco, with the exception of the enclosed level entry and a side gabled addition to the rear and north of the building which is board and baton. A porch roof extends from the building over the entry at a shallower angle than the roof, and is supported by undecorated square wood posts. The entry is parallel to the street, and fenestration is irregular. The board and baton addition has its own separate level entry. Windows are steel casement, with decorative wood cutouts surrounding the openings. Some windows have fabric awnings. Landscaping consists of a Bermuda grass lawn, trees, and shrubs.

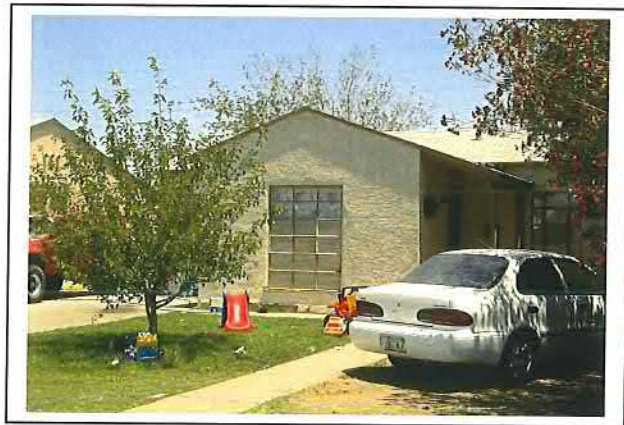
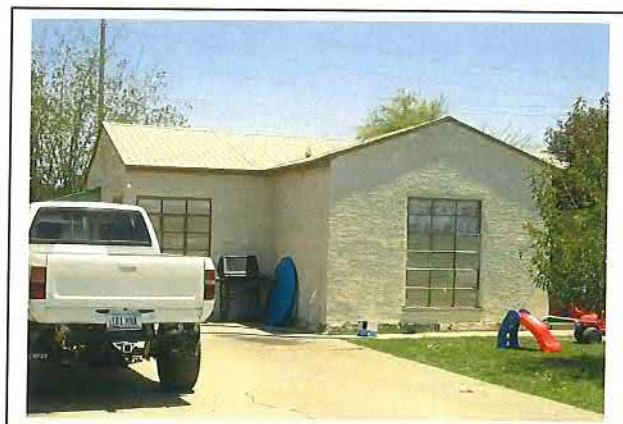
209 N. Colorado St., looking NE

Building is a single-story wood frame home with a concrete foundation. The roof is a low-pitch front-cross gable clad in asphalt shingle. The exterior wall cladding is stucco, which appears to have been redone. Windows are multi-light steel casement, with the center lights operable. Fenestration is irregular. The single-step entry is placed on the south side of the front gable with a shed roof as a continuation of the front gable. The porch is supported by undecorated square wood posts. Landscaping consists of a Bermuda grass lawn and shrubs.

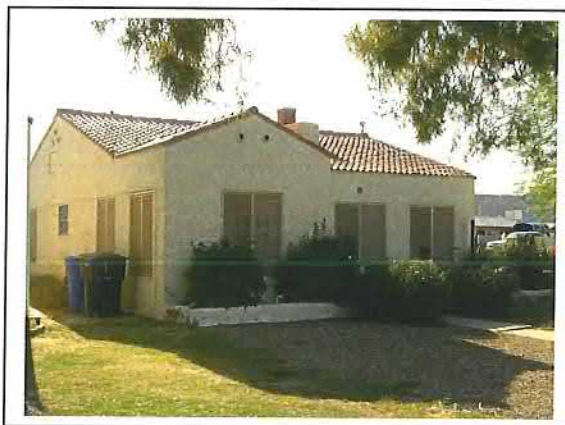
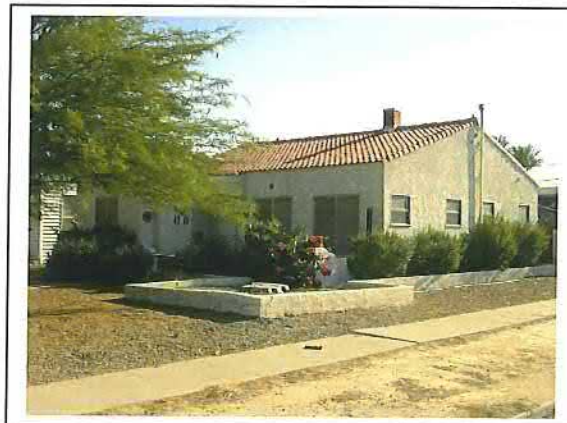
298 N. Washington St., looking NW

Building is a single-story wood frame home with a low-pitch front-gable wing added to the south side of the main low-pitch side gable. Ceramic roof vents are set at the top of each gable. Roofing is Spanish tile, cladding is modern stucco added in the 1980s, and the foundation is concrete. An exterior chimney decorated with brick patterning is situated next to the door on the north side of the front gable. Windows are aluminum sliding horizontal and aluminum single hung, and replaced the original windows in the 1980s. Fenestration is regular. The two-step wood door entry is recessed under an arched entryway, and covered with a steel security screen. Several low wall planter boxes have been added to the façade of the home and around the lot. Landscaping consists of crushed rock, foundation plantings of shrubs, and trees.

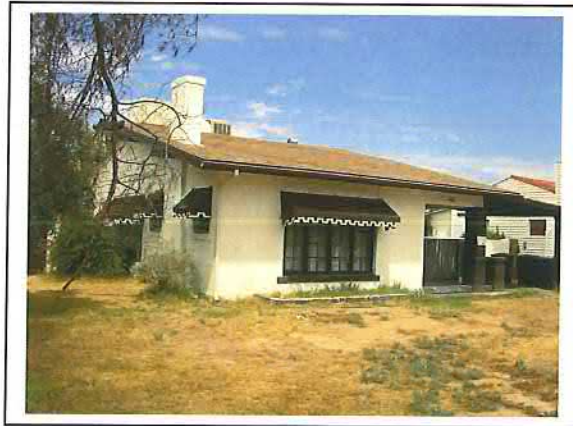
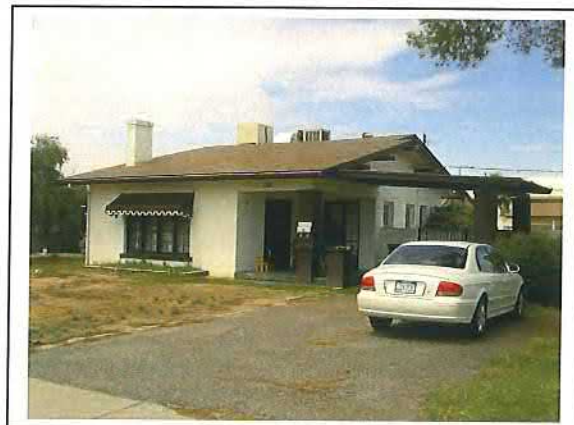
282 N. Washington St., looking NW

Building is a single story brick home with a medium-pitch side gabled roof clad in asphalt shingle with exposed rafter ends covered with aluminum gutters. Outrigger beams decorate the ends of the gable. Exterior cladding is stucco, with wood panel at the gables. The foundation is concrete. Windows are wood casement with 8 lights each with the front window consisting of 4 sashes. The wood door entry is off-center and under a single-step entry porch with is integral with the house, and is supported by stuccoed masonry columns. French doors are adjacent to the entry. A shed roof carport extends from the north side of the home and is supported by stuccoed columns similar to those on the home. This addition, the fabric awning over the front window, and the shortened porch column are c. 1950s changes. Landscaping consists of a dirt yard with patchy grass and shrubs.

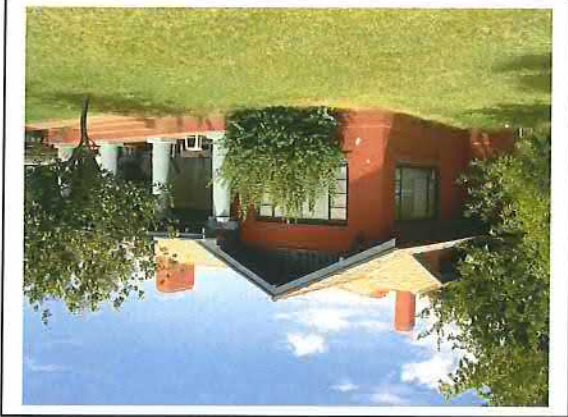
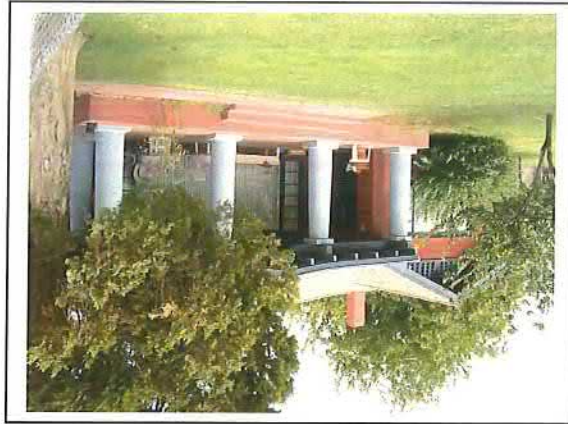
218 N. Washington St., looking NW

Building is a single story wood frame home with a low-pitch complex hip roof with a front and side gable clad in asbestos shingle with Spanish tile at the ridges, exposed rafter ends, lattice roof vents, and knee braces at the eaves. The building has two internal brick chimneys. Exterior cladding is stucco and the foundation is concrete. Windows are wood casement with a single large window with six square lights on each side. The large window was replaced around 1980. The three-step off-center entry is recessed under a large veranda supported by three equally-spaced round plaster columns. A shed roof with an arched form is at the center of the veranda. Landscaping consists of a Bermuda grass lawn with trees and shrubs. The property is surrounded by chain link fence.
