# CITY OF EL MIRAGE

## DEVELOPMENT APPLICATION FORM

Name of Project: Phoenix Motorhomes Acreage: 2.0  
 Property Address/Location: 12301 W Butler Drive, El Mirage, AZ 85335  
 Assessor's Parcel Number: 501-46-836A

On behalf of Phoenix Motor Homes, (Owner / Developer), Gilmore Planning & Landscape Architecture respectfully submits for consideration this application for Site Plan Approval and Conditional Use for the exterior storage of RV's. The Property is located at 12301 W. Butler Dr, at the southwest corner of N. El Mirage Road and W. Butler Drive, and includes 2.0 net acres (Parcel 501-46-836A). The intended use is for RV Sales & Rentals, general maintenance and repair, and RV storage. There will be no wash bays, fuel dispensing, or storage of hazardous substances. Phoenix Motor Homes (PMH) understands that the City of El Mirage must approve a site plan, civil engineering plans, and building permit applications prior to any on-site improvements being installed.

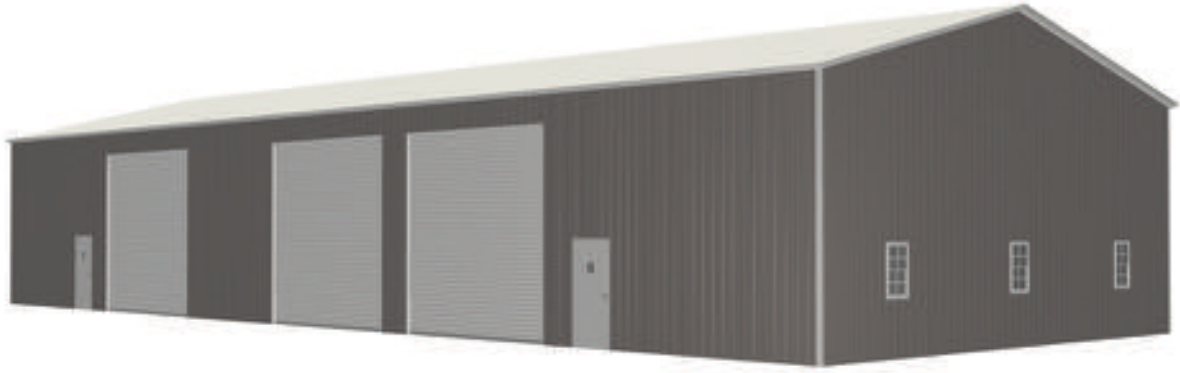
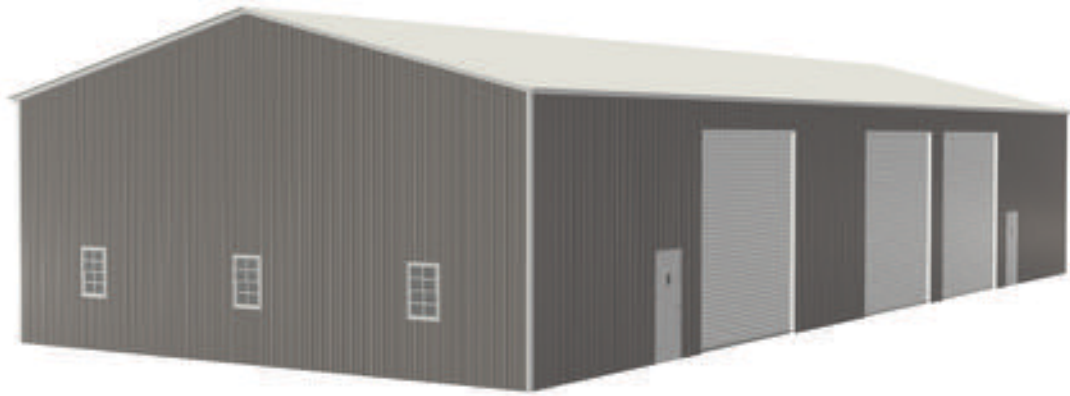
Computer-generated drawing of 110' x 40' x 16' pre-fab steel building

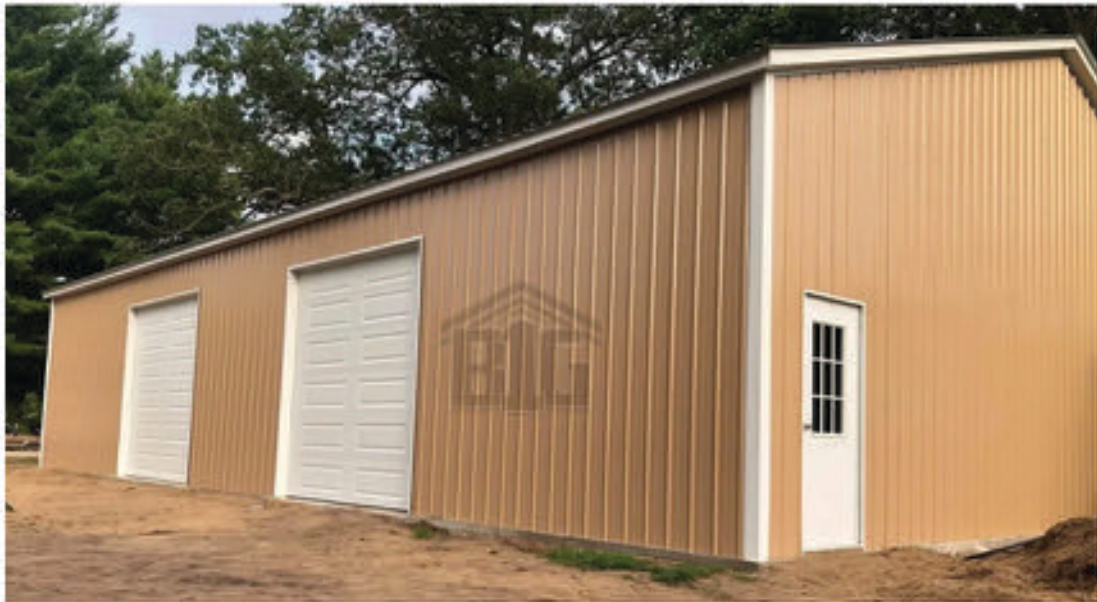
Photograph of actual building similar in size and style

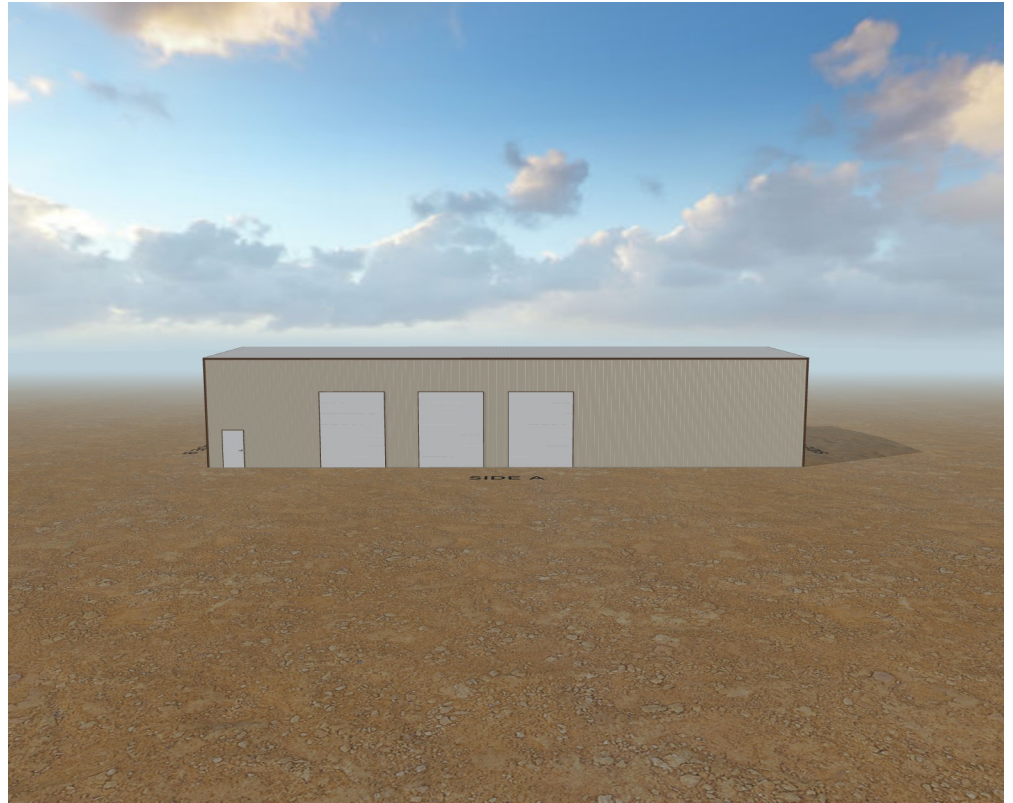
## Front El Mirage RD

Width: 40'  
Length: 110'  
Height: 20'  
Roof Pitch: 1":12"

Roof Color: Polar White  
Wall Color: Desert Sand  
Trim Color: Koko Brown

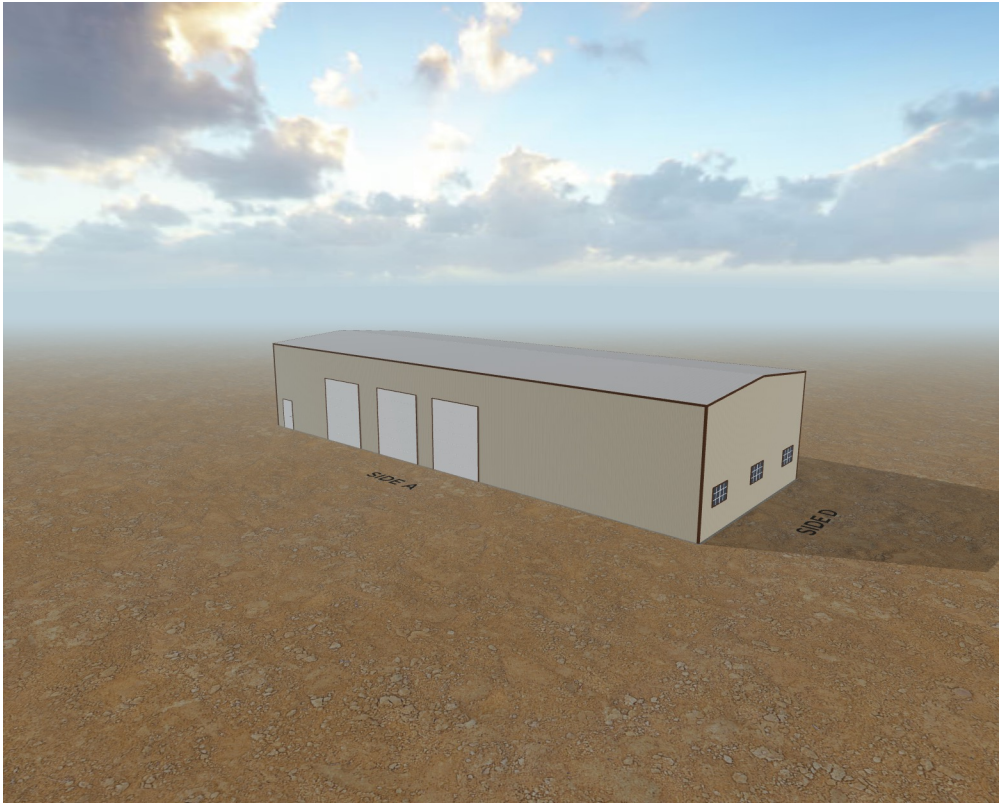
# Front El Mirage / W Butler Dr.

Width: 40'  
Length: 110'  
Height: 20'  
Roof Pitch: 1":12"

Roof Color: Polar White  
Wall Color: Desert Sand  
Trim Color: Koko Brown

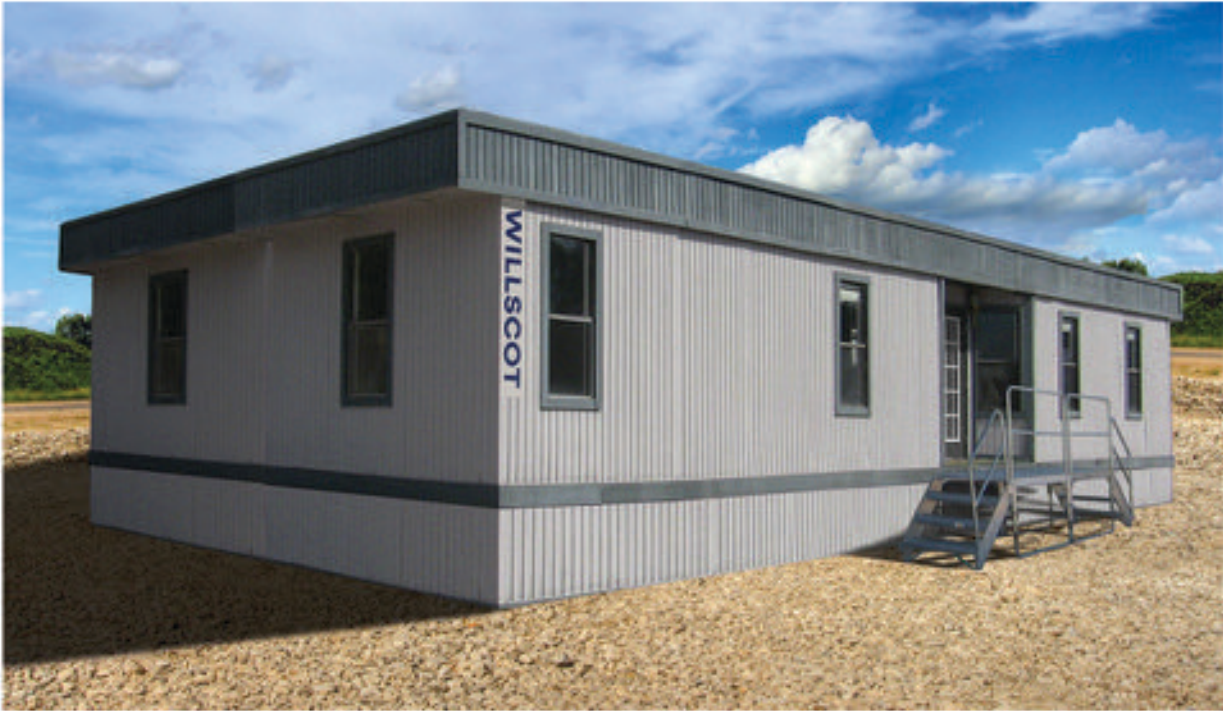
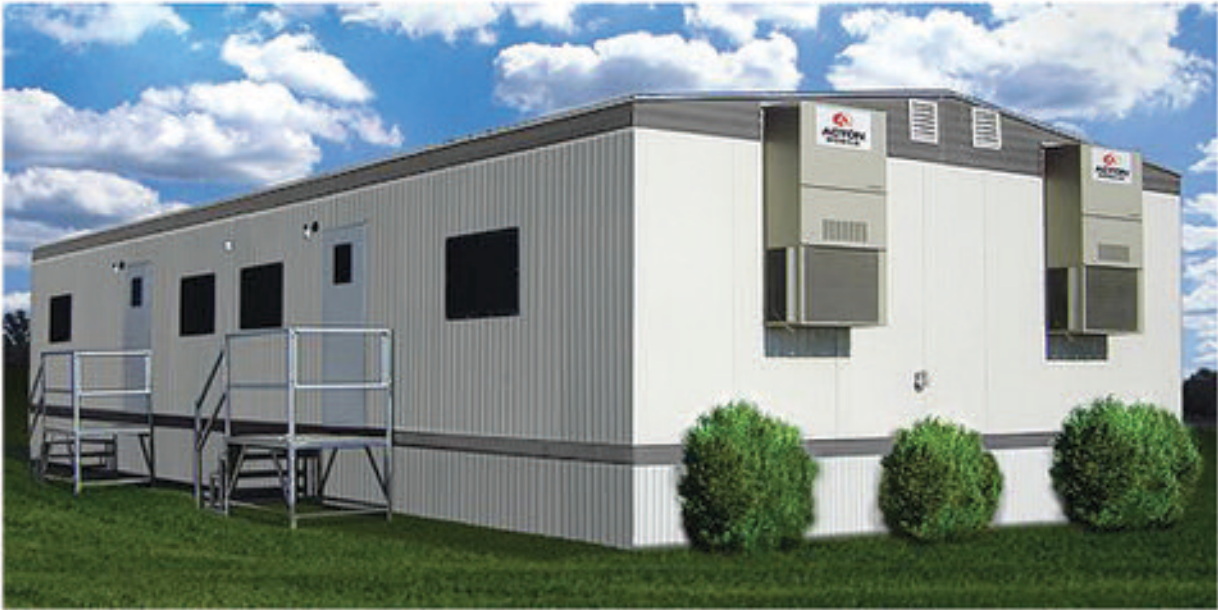
Sample images of double-wide modular pre-fab office buildings

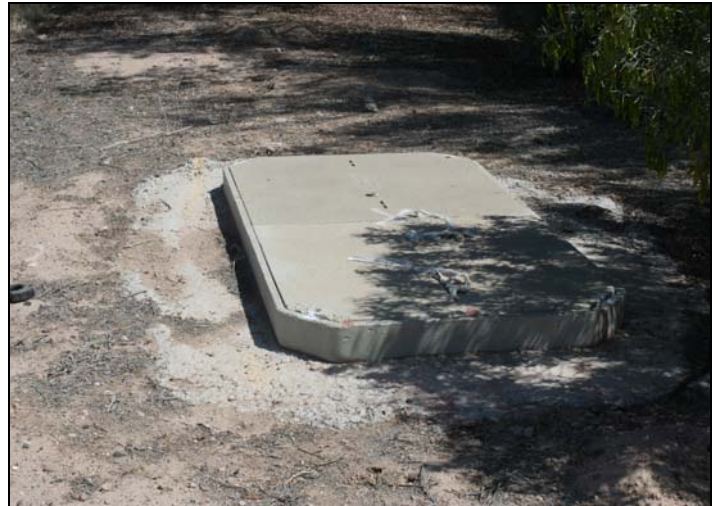
**This view is of a newly installed underground utilities service vault on the site.**

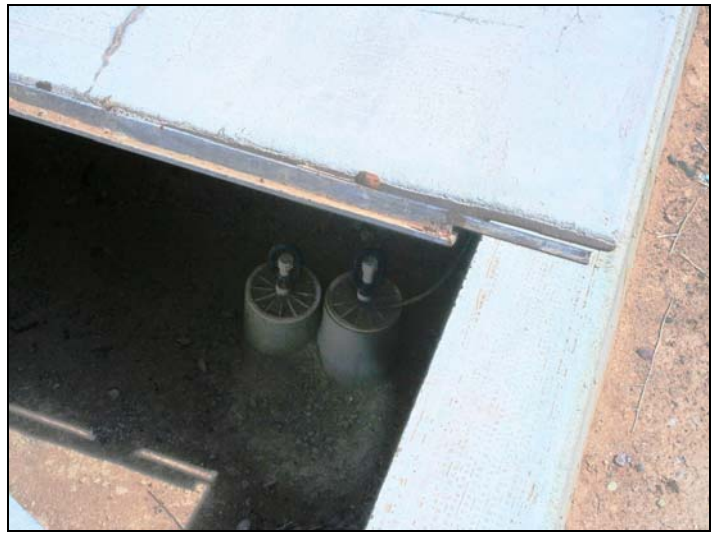
**This is a view of the interior of the underground utility service vault.**

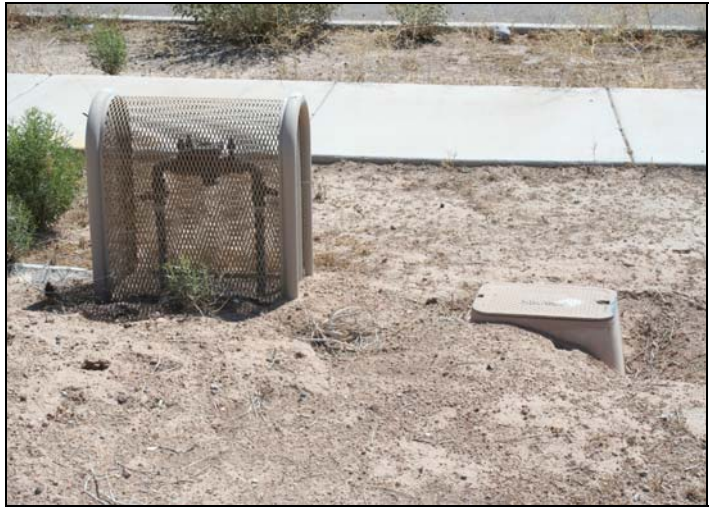
**This is a view of water service available to the site.**

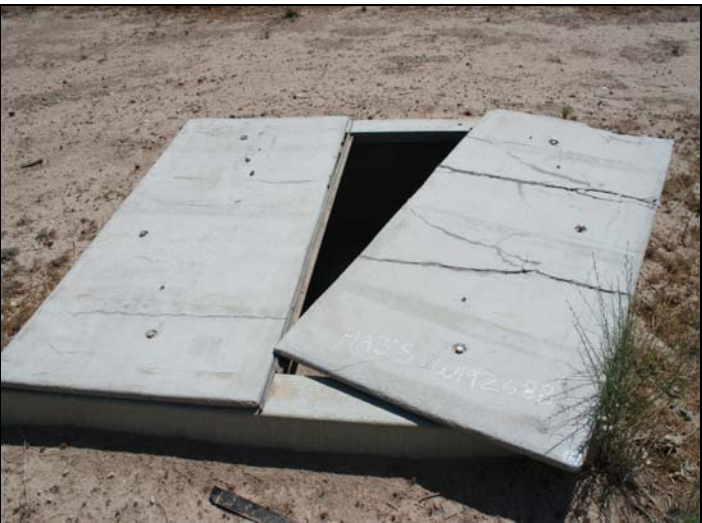
**This is a view of an underground utility service vault.**

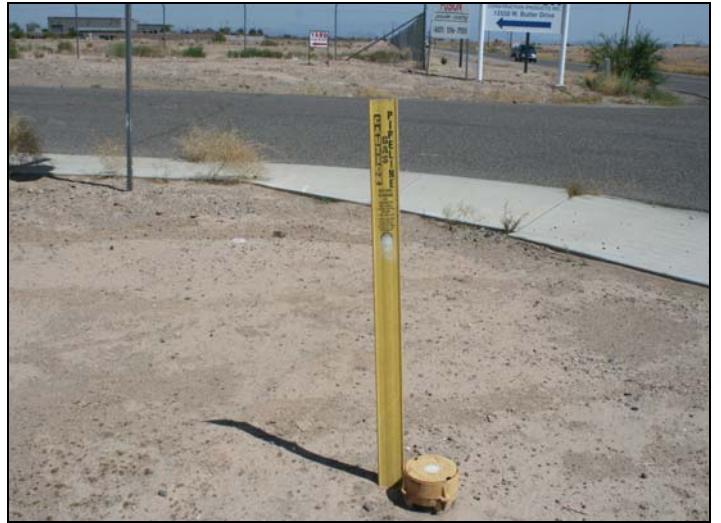
**This view shows the Southwest gas line utility marker on the northeast corner of the site.**
