# Arch Beams: Potential Danger

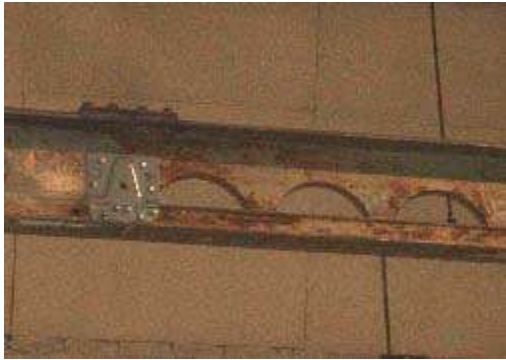
Arch beam (castellated beam) is a type of crane that has cut outs in the web and could look like the one in these images. If the web is not continuously welded to the lower flange it is a castellated beam. Though it hasn't been manufactured since 1962, it is still in use in plants throughout North America.

Companies need to be aware of the possible dangers posed by age and fatigue in the welds of these Arch Beams (castellated beams).

- Cracks in welds and lower T Sections
- Tracks with raised tread worn away
- Most cranes have exceeded their useful life expectancy, but some users see cranes as “timeless”
- Current inadequate crane maintenance regulations may lull owners into a false sense of security about crane safety and/or conditions
- Due to the age of equipment, the exact understanding of a crane's design duty cycle may be difficult to determine without engineering analysis. (i.e. documentation may be missing)

Our primary recommendation is to Replace All Arch Beams with Tarca® Beams - contact Gorbel at 800-821-0086 or email [info@gorbel.com](mailto:info@gorbel.com)

- If this is economically unfeasible, conduct regular safety audits
- Safety Audits: Steps to a safer and more reliable crane - Use only skilled personnel for the audit
- Identify the highest risk cranes in your inventory by age and cycles
- Study and compare the original design versus the current usage
- Fully inspect every weld in the beam. Through inspections, find discontinuity and then use non-destructive testing
- Benchmark critical components using reliability based maintenance practices and software
