MEMORANDUM

Subject: Certificate of No Effect for 720 W Birch in Townsite District

The Heritage Preservation Officer received an application for the review of minor remodel and repair of the residents, and the structural reinforcement and restoration of the rear garage on the property at 720 W Birch. The building is a contributing structure in the Townsite National Register Historic District and was constructed in the 1920s.

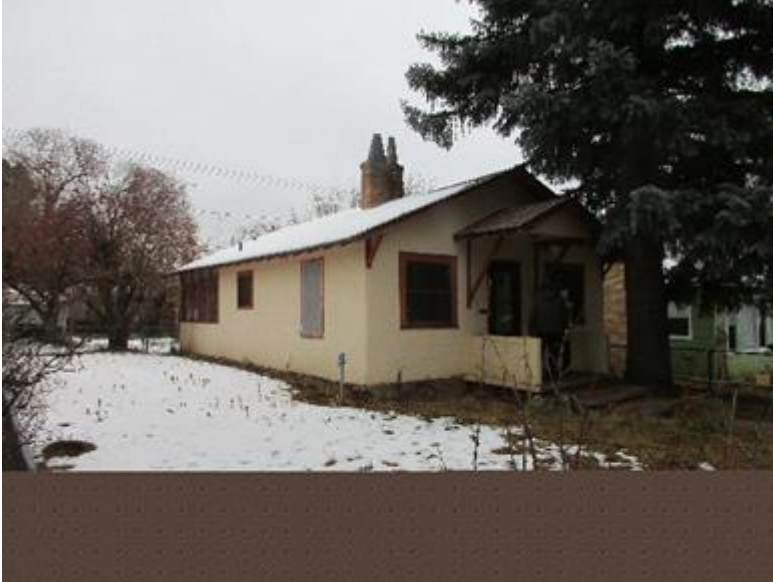
Note Porch and Stair Damage by Tree

Design. The replacement of the front stoop will not alter the design of the entrance and will ensure its future integrity by addressing issues caused by the historic spruce that is
