**ADDENDUM to PHASE 1 HISTORIC RESOURCE STUDY for PARCELS at 43
SOUTH SAN FRANCISCO STREET and 14 SOUTH LEROUX STREET,
FLAGSTAFF, COCONINO COUNTY, ARIZONA —
PROPOSED MITIGATION MEASURES
March 6, 2020 by Lynn A Neal**

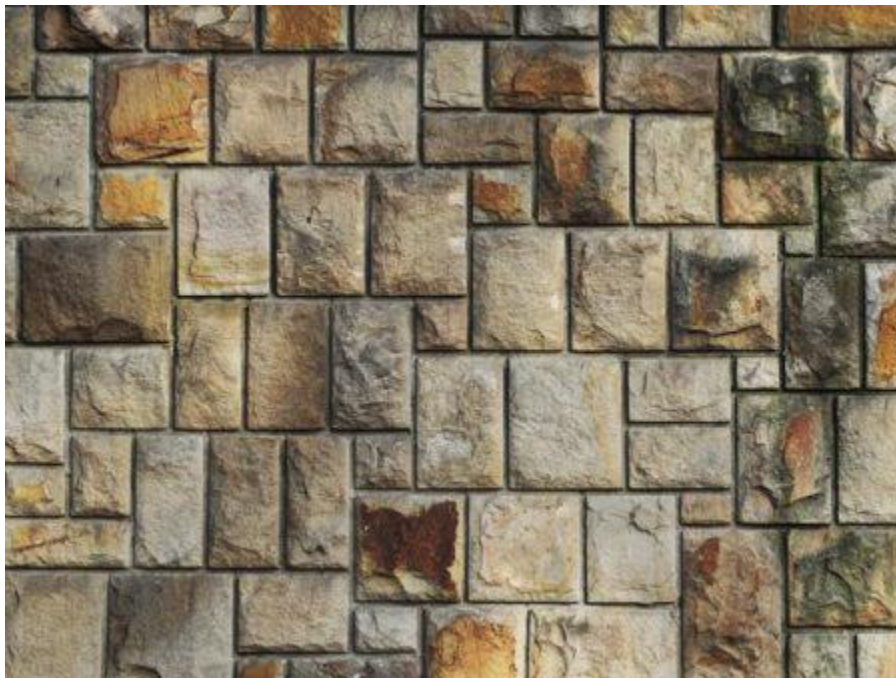
In ashlar masonry all the stones are cut and dressed, or worked, so they have the same shape, size, and surface texture. The stones are then laid together in cement or lime mortar of equal size joints at right angles to each other. The masonry built using ashlar stones is rectangular where cuboid blocks are laid in horizontal courses or layers. The joints between the stones are very thin, regular, and of uniform thickness. In random ashlar masonry, however, the stone block arrangement does not have any specific rule of placement. It has a general course of alignment, but the vertical joints need not be one over the other. Even though it looks very random, it has an in-built harmony. The variations in height and length have to be in proportion to the overall structure for strong bonding, and therefore, the positioning has to be mindfully crafted, requiring skilled and knowledgeable workers. It is often done as a facing, a veneer backed by rubble, uncut stone or brick walls.

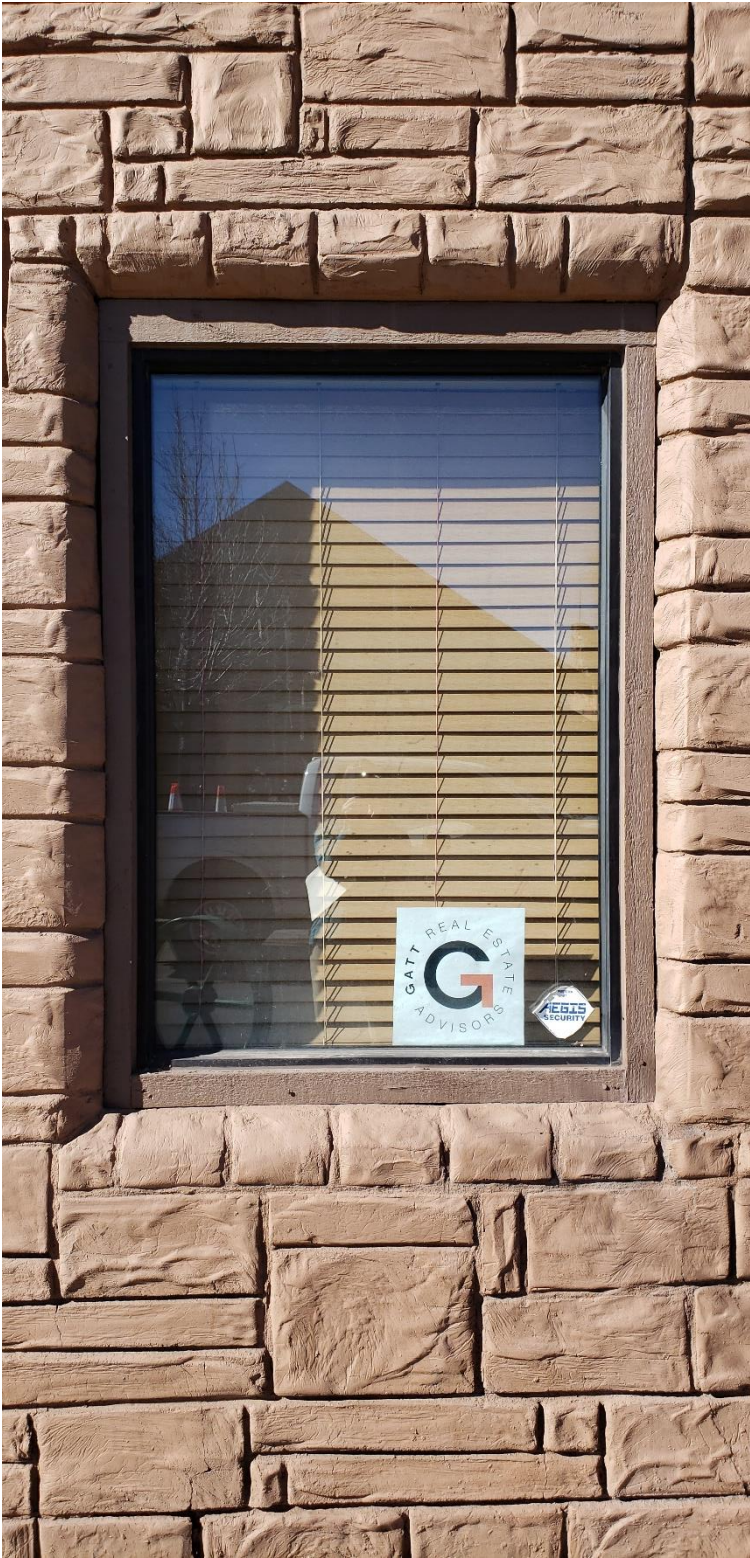
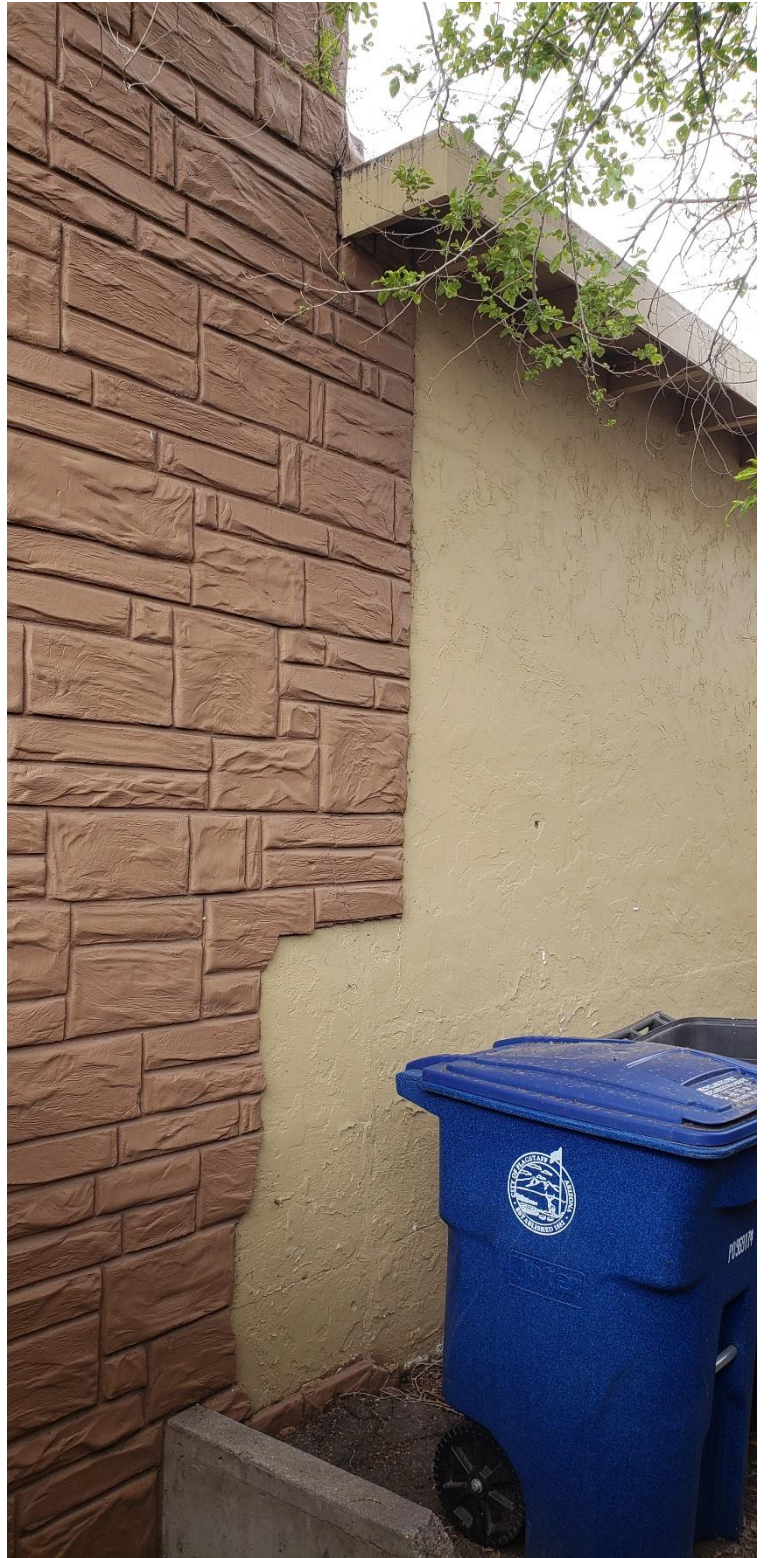
Example of concrete plaster sheathing on 43 S San Francisco's front/E façade (left) & at NE corner (right), December & May 2019.

For 43 S San Francisco this was the concrete plaster sheathing exterior treatment that was installed to simulate random ashlar stone construction (*see photos below*). This method was only used on a handful of buildings in Flagstaff, all of them built in the 1930s to early 1940s. It can still be seen on another Nackard building constructed in 1944 across Cottage Avenue from their S San Francisco Street warehouse (*see photos below*). The same treatment was used on the Hutchinson & Sauer building built in the early 1930s and modified in 1938 at the southwest corner of Beaver Street and Phoenix Avenue (**plan to add photo*). It is an intriguing observation that this sheathing method was ever done here when various construction-compatible stone types were readily available in and around Flagstaff, as well as having access to skilled masons plus the popularity of decorative concrete block at the time. Food for thought—This patterned concrete veneer application may have been a method adopted and used by a local mason or concrete worker for a specific period of time. In addition to masons, Flagstaff also had persons skilled in cement stucco application in the 1930s and 1940s.

As might be assumed, using a concrete plastering technique to mimic this style of masonry construction is equally crafty but ultimately somewhat easier to install. It involves stamping a concrete stucco that has been applied to a wall surface, likely over concrete blocks and/or wood in the case of the 43 S San Francisco Street building. The stucco might be more thickly applied than a non-stamped stucco finish to allow for the depth of the stamp to properly mimic rock coursing. The stucco, likely a mix of Portland cement, was applied directly to the backing wall surface. (**This can be updated after we get a closer*

look at the actual layering and sheathing wall backing prior to full demolition.) The stucco was probably powder tinted with natural pigments to obtain more natural variability in color, again mimicking real stones, as well as painted/color-washed in imitation of marbling. The stucco would be applied in sections, and while wet, stamped with a mold or interlocking molds perhaps made of plaster or metal. (These stamp molds are today made of flexible urethane rubber and foam.) The joints may have also been touched up and further pronounced by retooling. The finished product is strong and looks like stone. The solid-painted color of the plaster sheathing on the 43 S San Francisco Street building, applied sometime after 1992, appeared less like stone than it did originally (*see comparative photos below, and *perhaps pieces of the sheathing, recovered from the demolished building, to be installed in the display*).

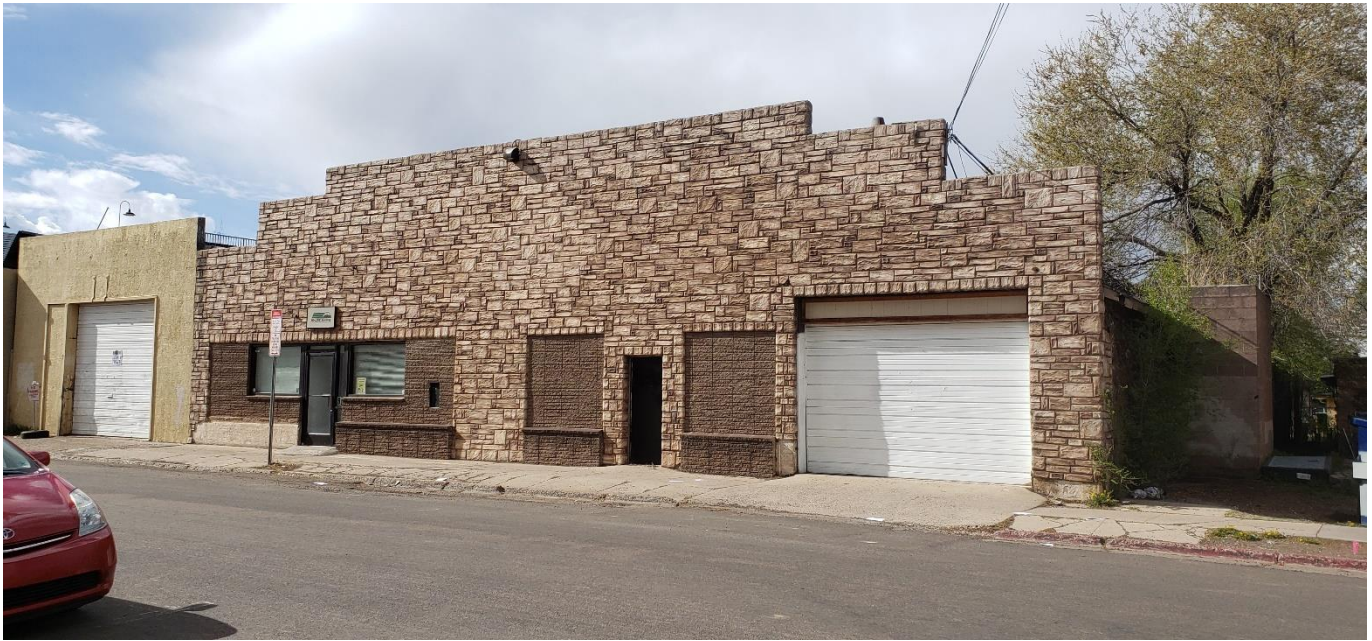
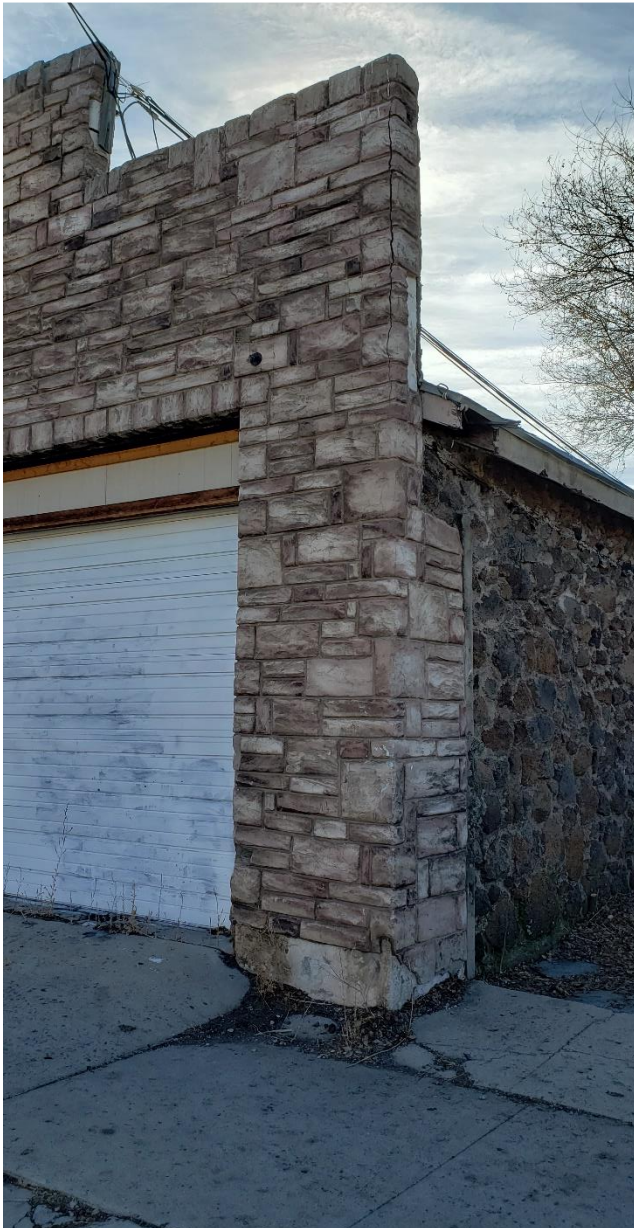
Example of concrete plaster sheathing on adjacent circa 1944 Nackard storage warehouse at 9 E Cottage Avenue, May & December 2019.

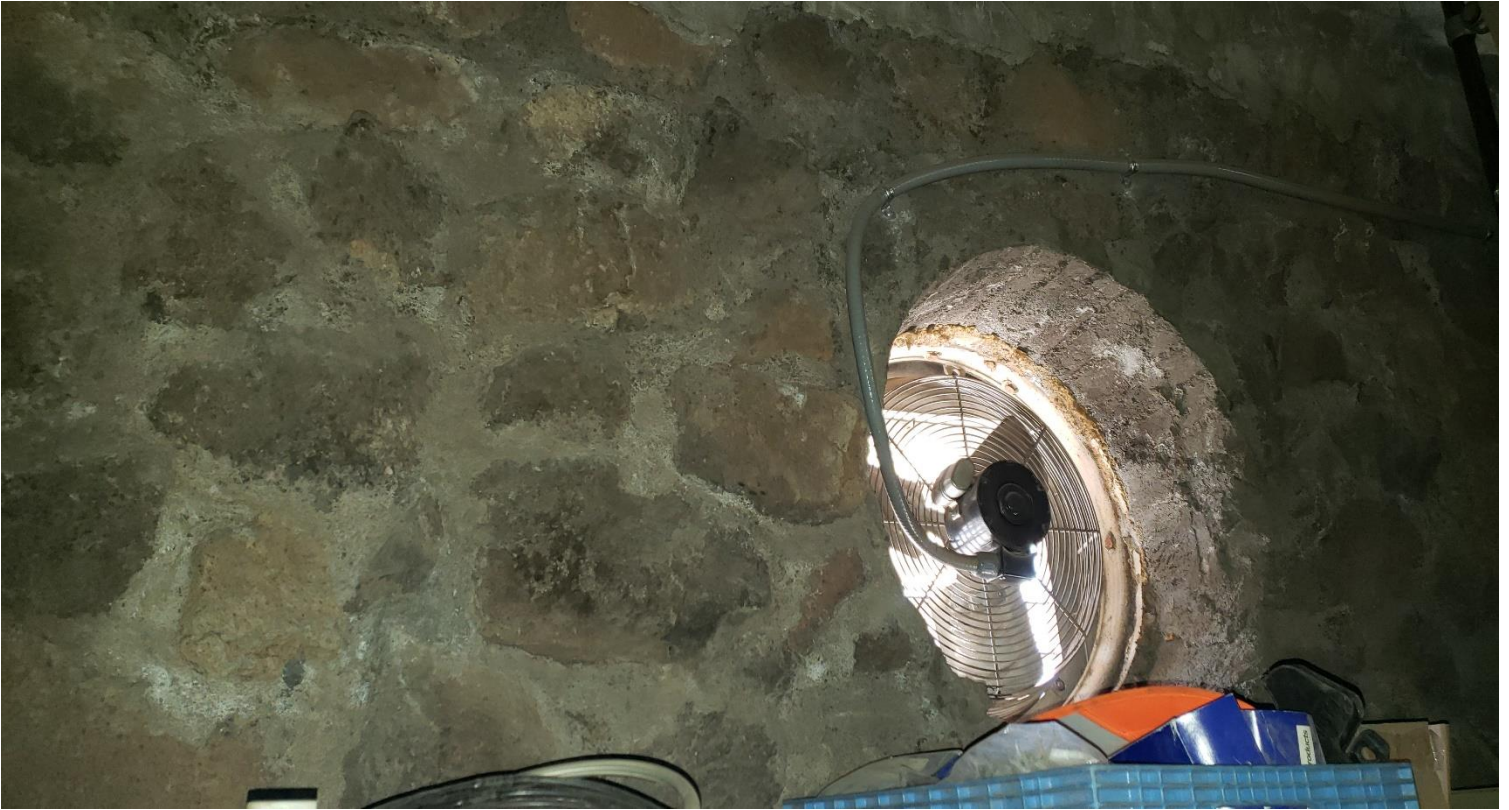
14 S Leroux St interior S façade porthole window, remnant of original garage structure, December 2019.

The most interesting characteristics of the building at 14 S Leroux Street were the remnant porthole windows, cut and set in stone and representing all that remained of the original pre-1948 malpais garage structure (*see photos below*), and the domed roof of a circa 1951 addition/remodel with its intricate curved wood planking and steel trusses that were interiorly visible (*see photo below*). The porthole windows were in the north façade of the garage, the only lighting to the one-time separate building. The domed roof could be seen from the exterior, but the detail of the ceiling was only evident on the interior. Why so much detailing was done to the roofing of this warehouse structure is a mystery.

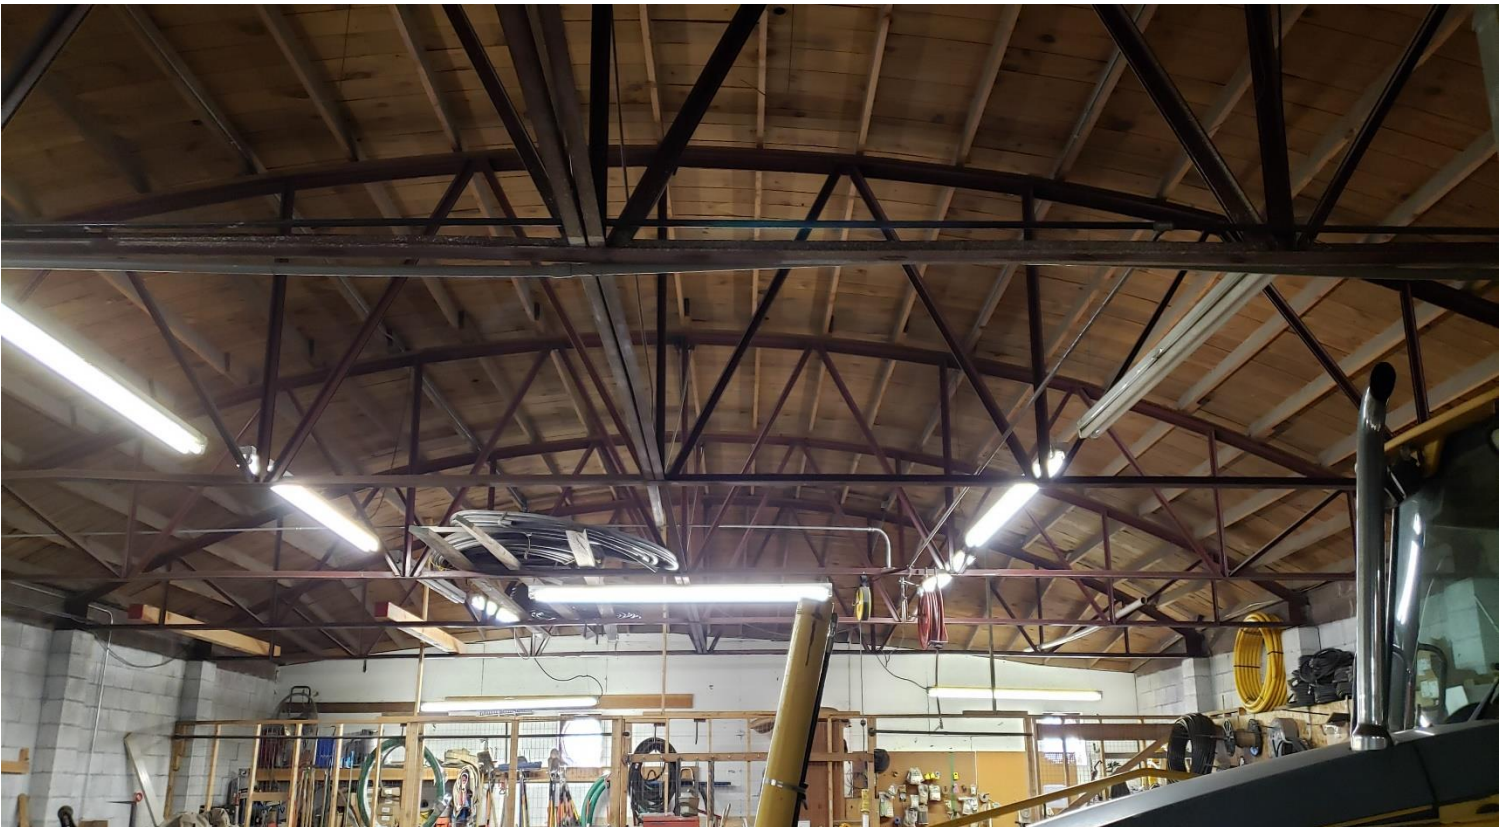
14 S Leroux St interior middle room doomed ceiling/roof, constructed circa 1951, December 2019.
