Class III Cultural Resources Survey of 17.17 Acres along West
University Avenue and South Milton Road, Flagstaff, Coconino
County, Arizona

Submitted to:
Vintage Partners
2502 E. Camelback Road Suite 214
Phoenix, Arizona 85004

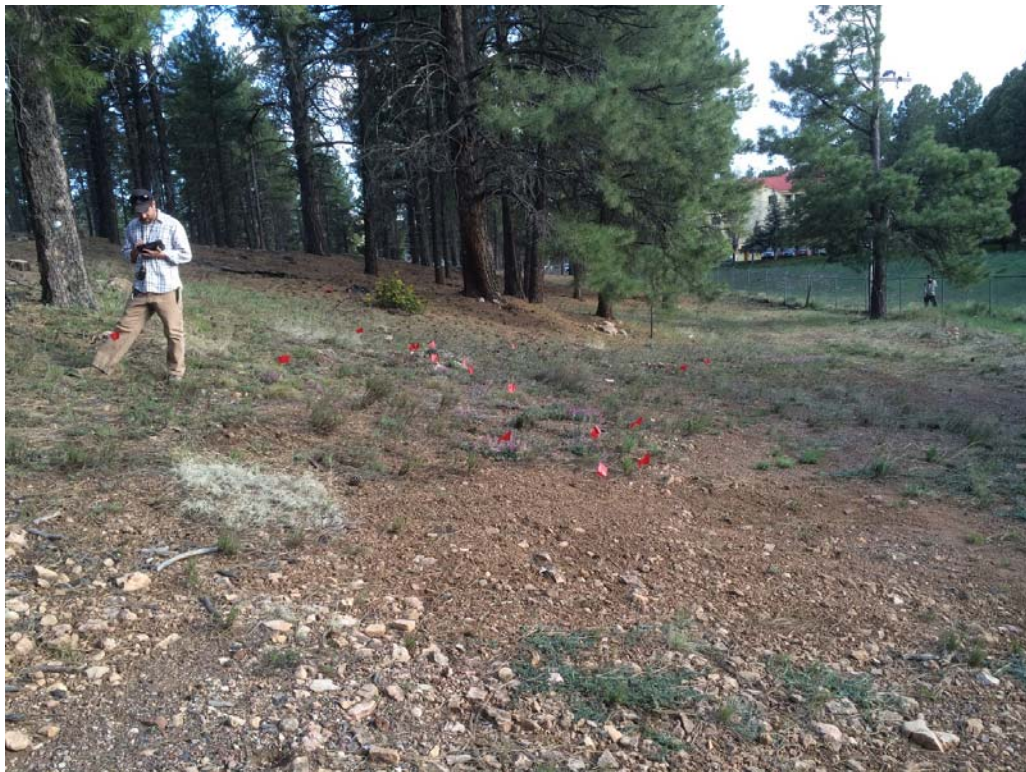
Figure 7. AZ I:14:48(ASM) site overview, facing south.

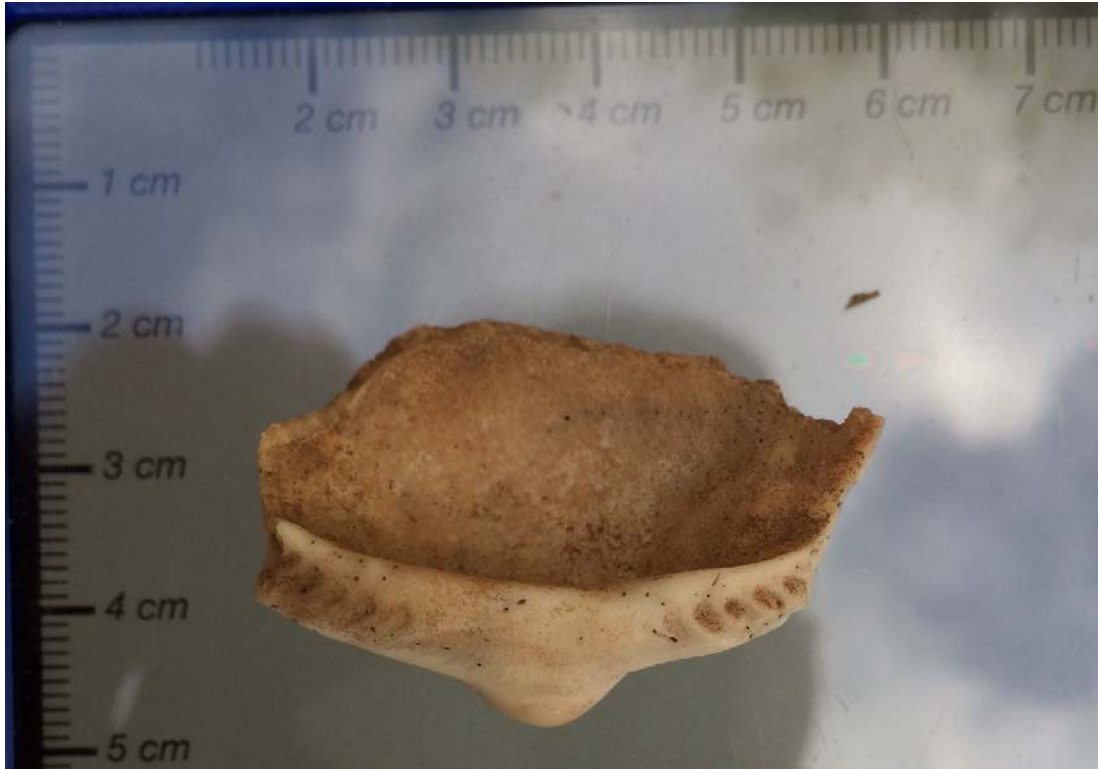
Figure 8. Detail photograph of the glycymeris shell fragment.

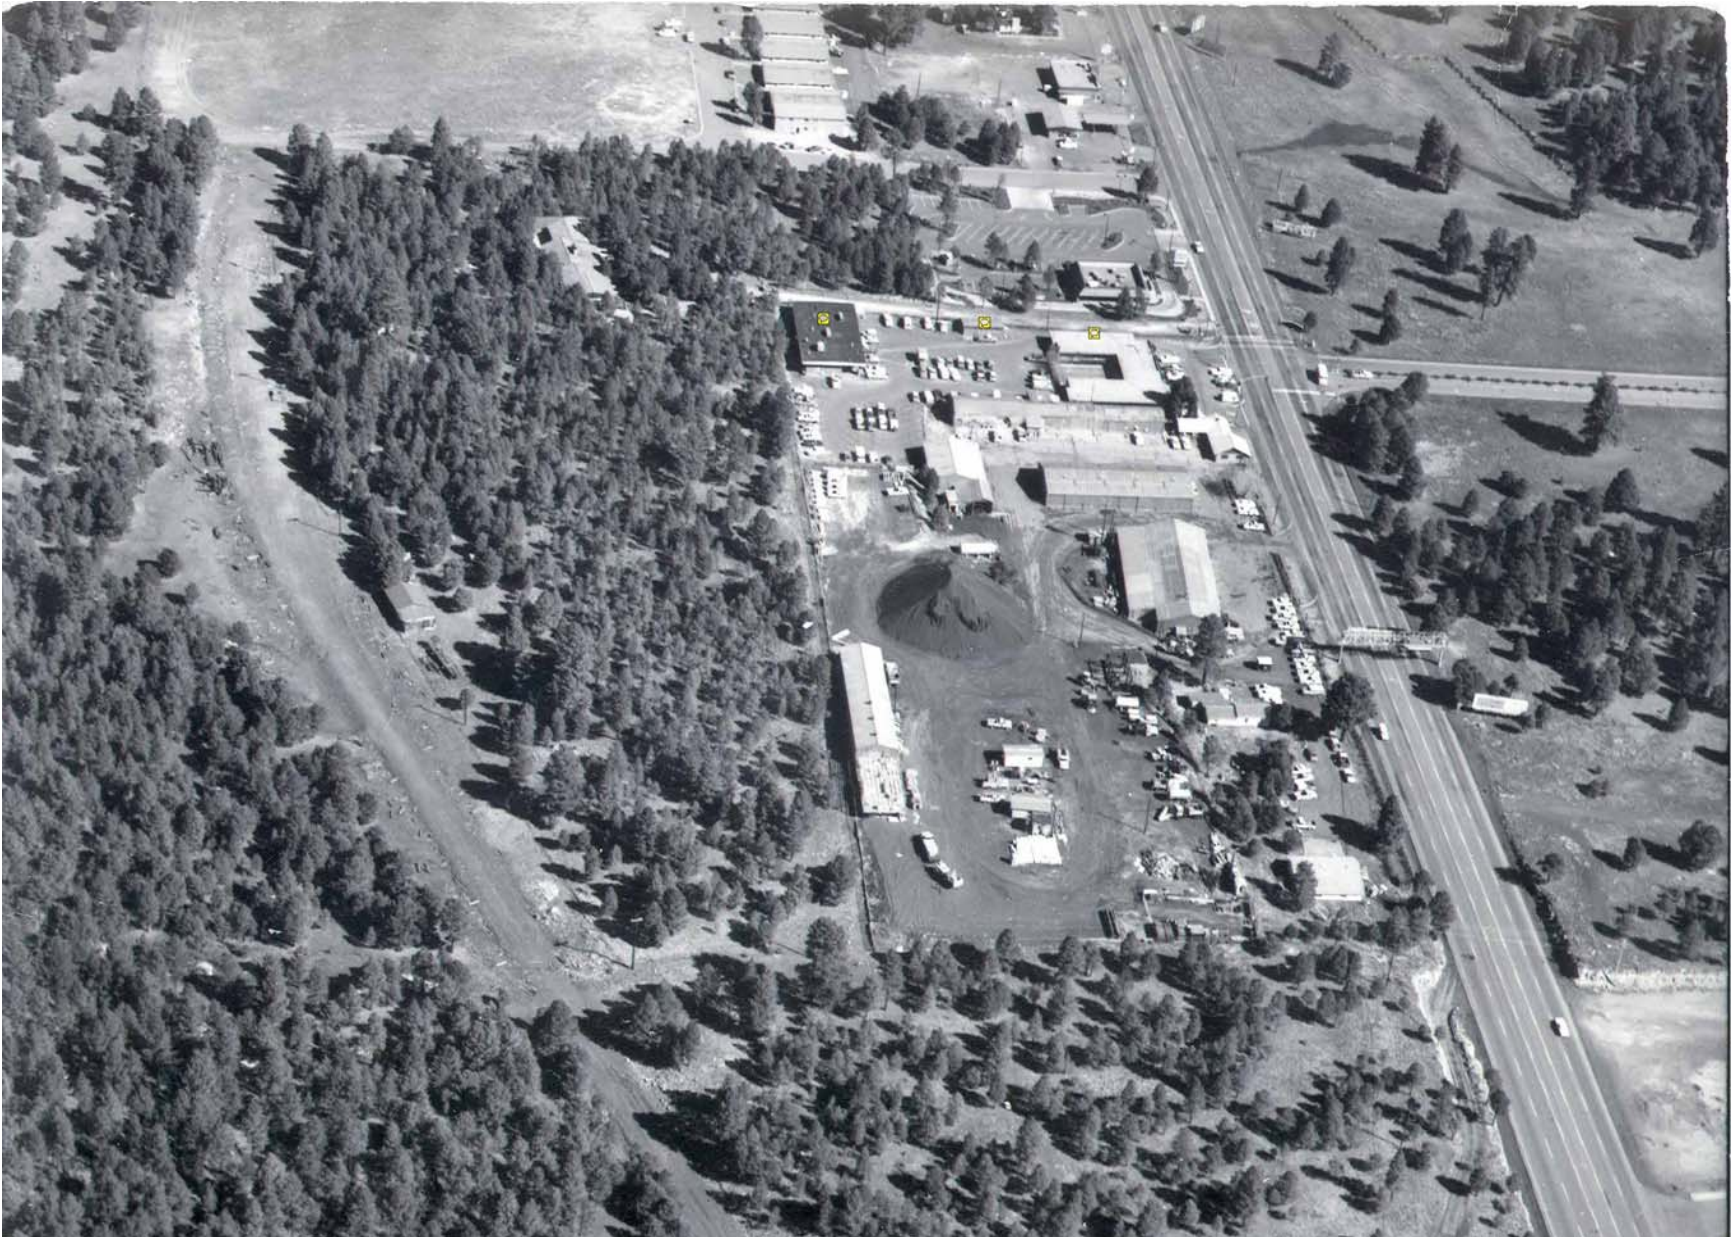
Figure 9. Aerial photo (ca. 1975) showing the project area and ADOT buildings.

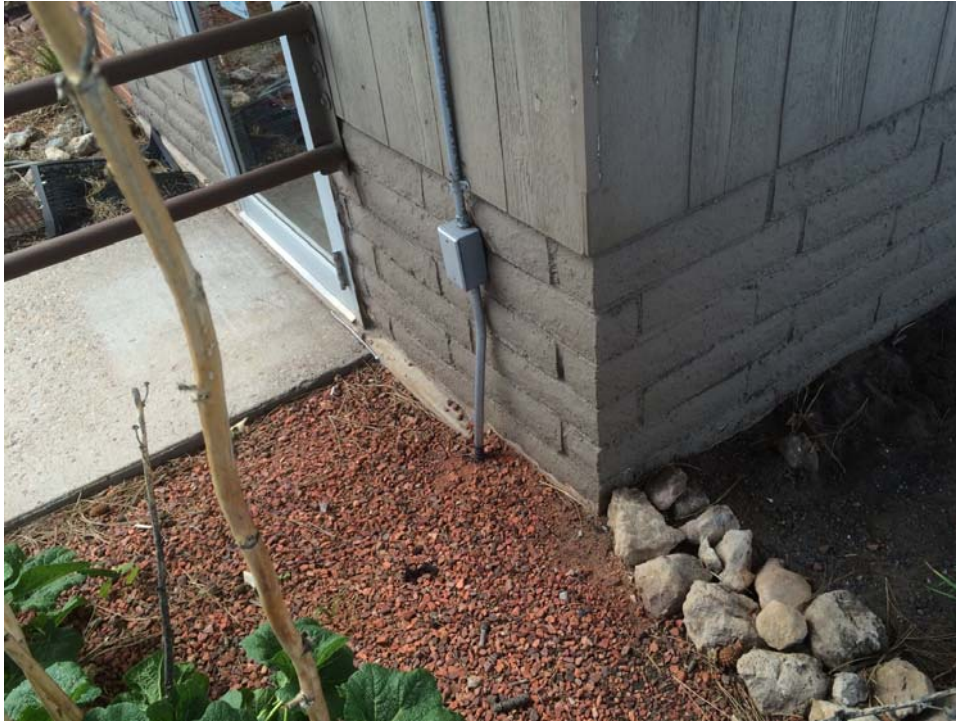
Figure 12. Detail photograph of the southeast corner cinderblock brick dado and concrete continuous spread foundation of the ADOT Flagstaff District Office.

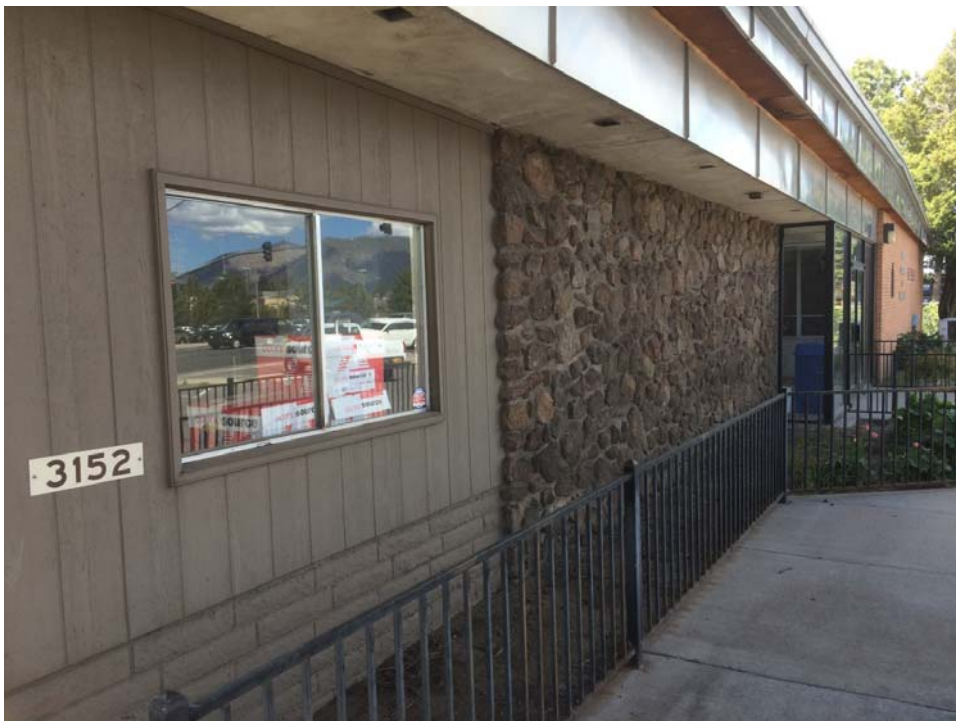
Figure 13. Photograph of the eastern elevation of the structure, facing north-northwest.

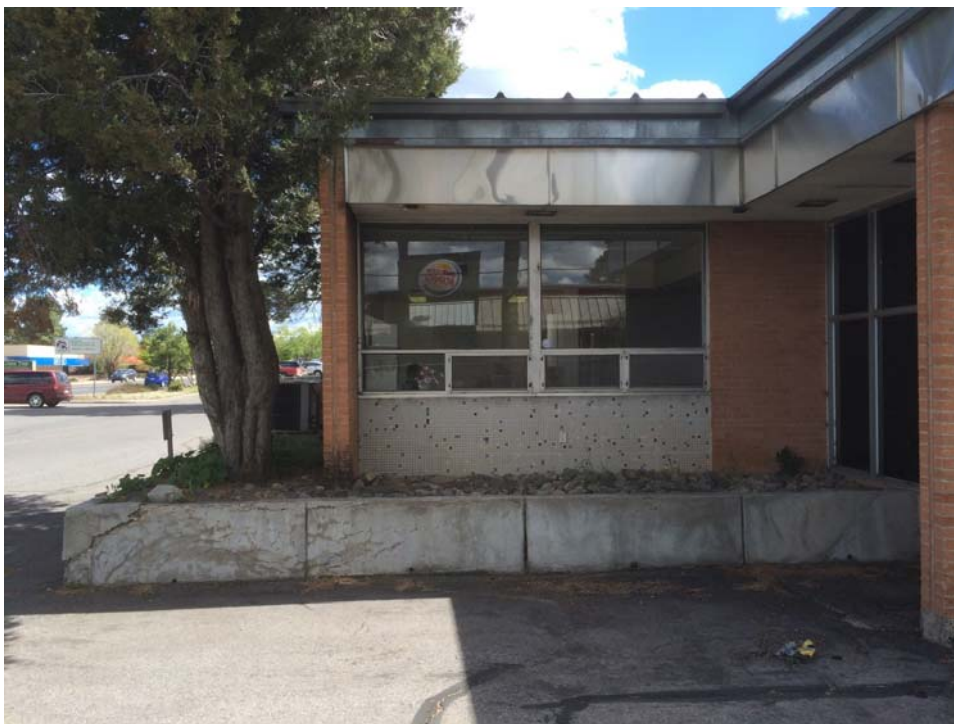
Figure 14. Photograph of the recess on the northeastern corner of the building showing the tile mosaic.

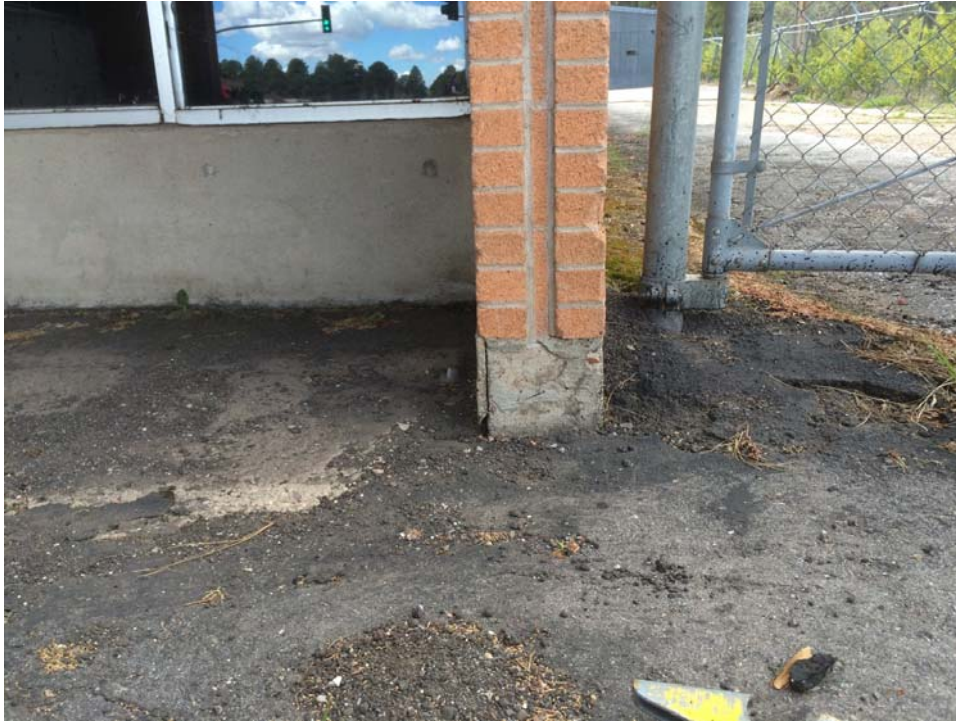
Figure 17. Photograph of concrete foundation and brick wall of the northeast corner of the structure (eastern elevation), facing west.

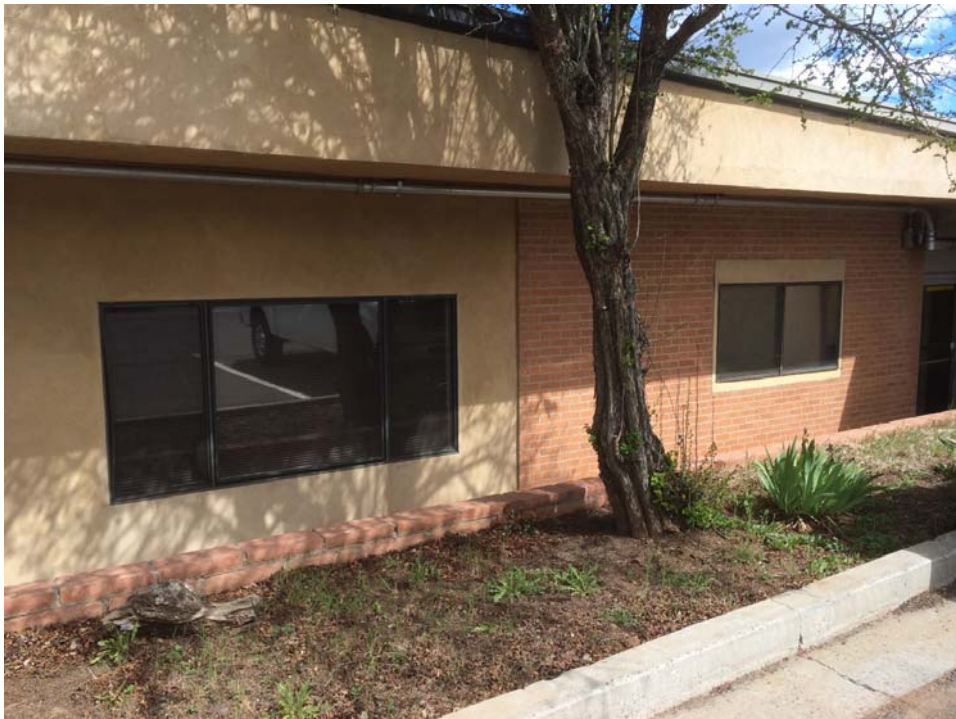
Figure 18. Photograph of the western elevation showing the original brick wall on the right and the later stucco wall on the left.

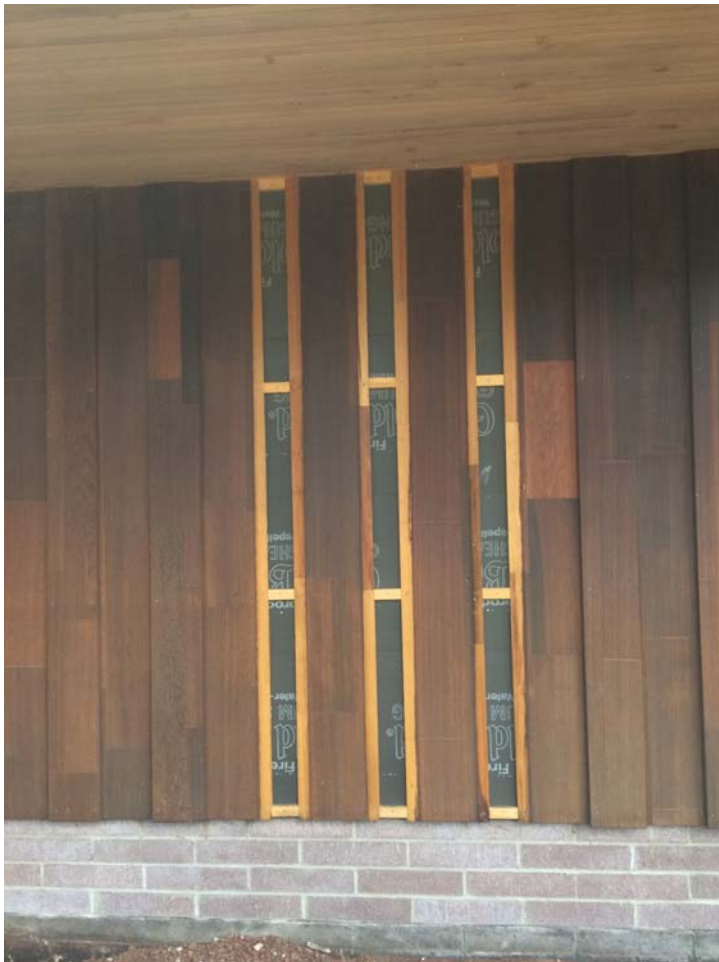
Figure 27. Photograph of a wall section of the primary residence (east elevation), facing west.

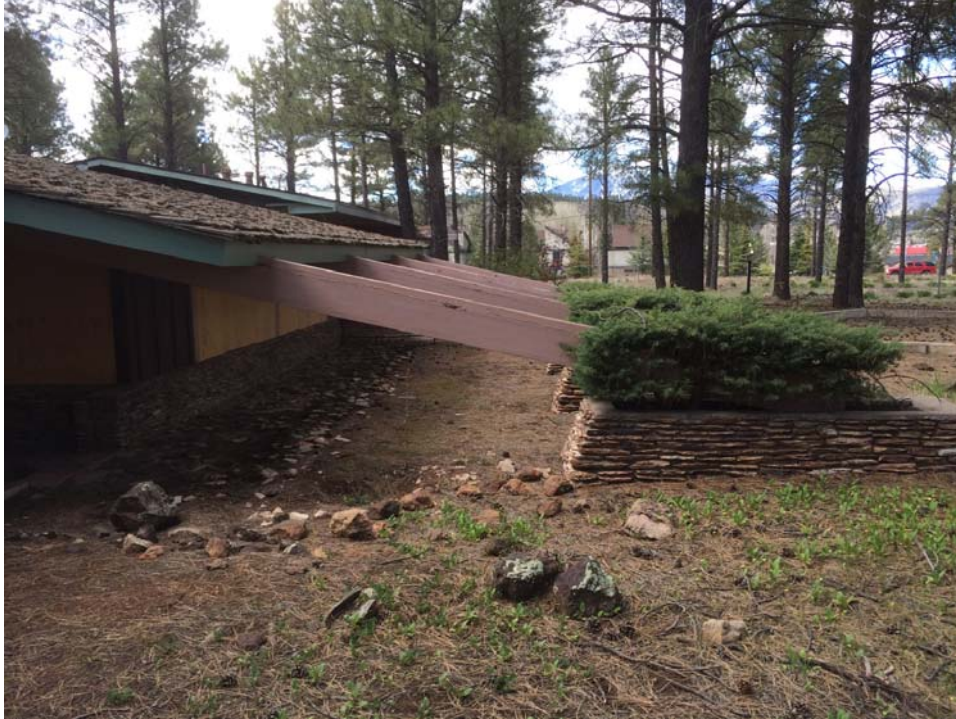
Figure 29. Photograph of the beams and planters on the east side of the residence, facing north.

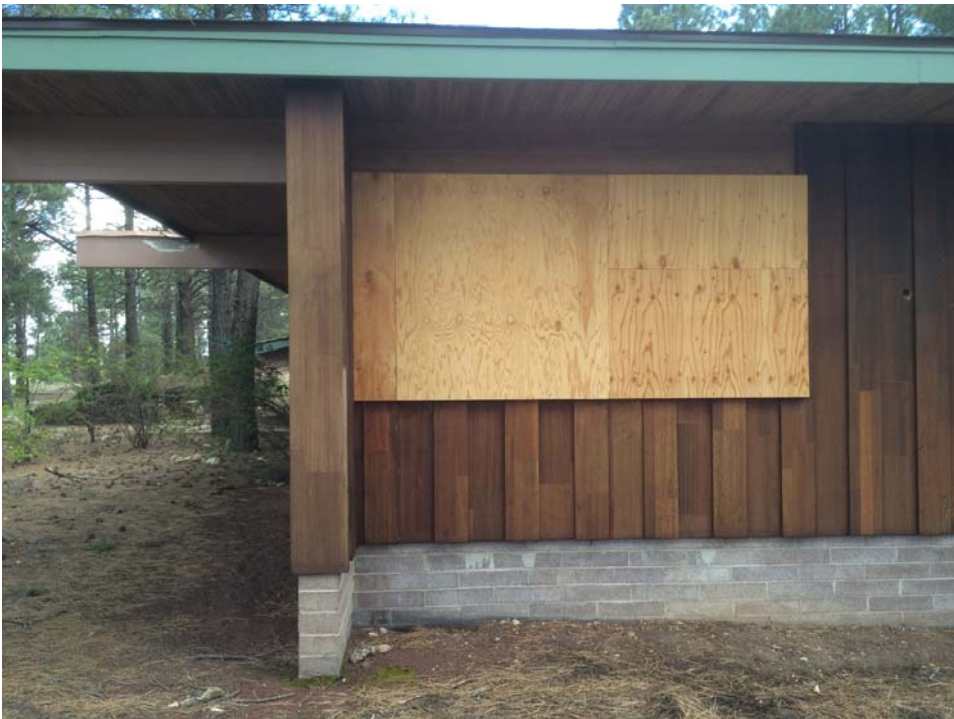
Figure 32. Photograph of the northern elevation of the residence showing the cinderblock brick foundation, facing south.

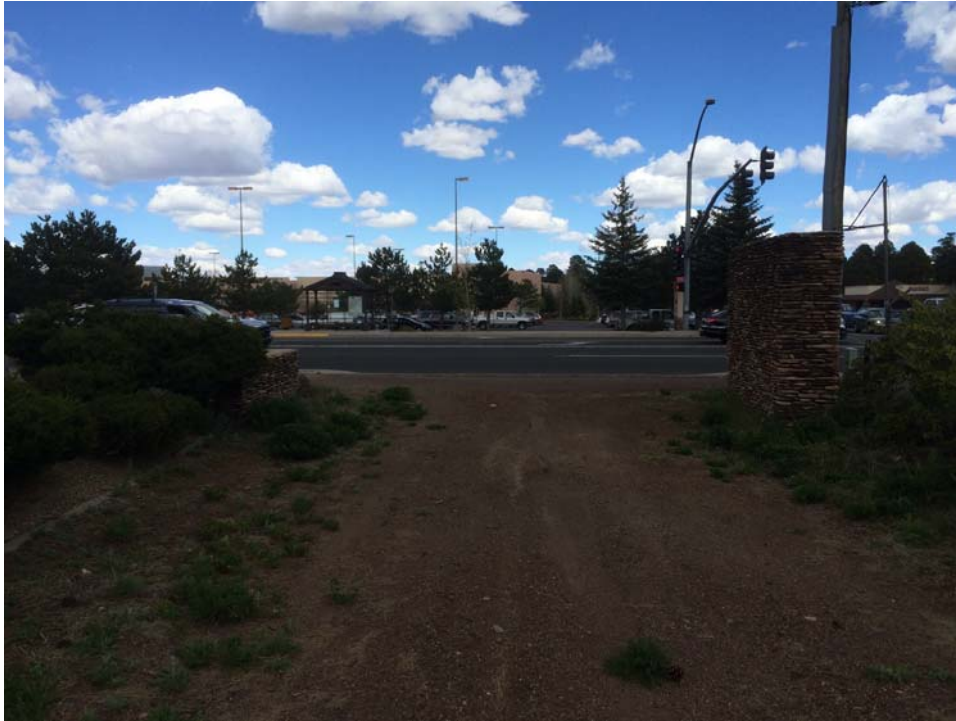
Figure 33. Photograph of the intersection of the driveway and South Milton Road, facing east. Note the rectangular cairns on either side of the driveway.

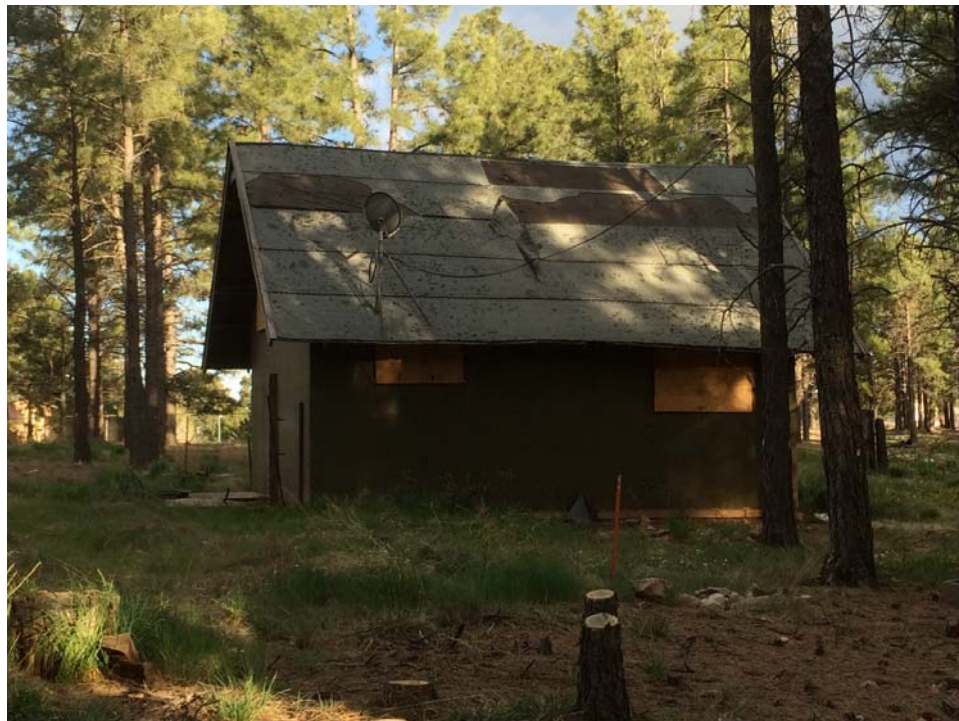
Figure 36. Overview of the barn at 701 West University Avenue, facing southeast.

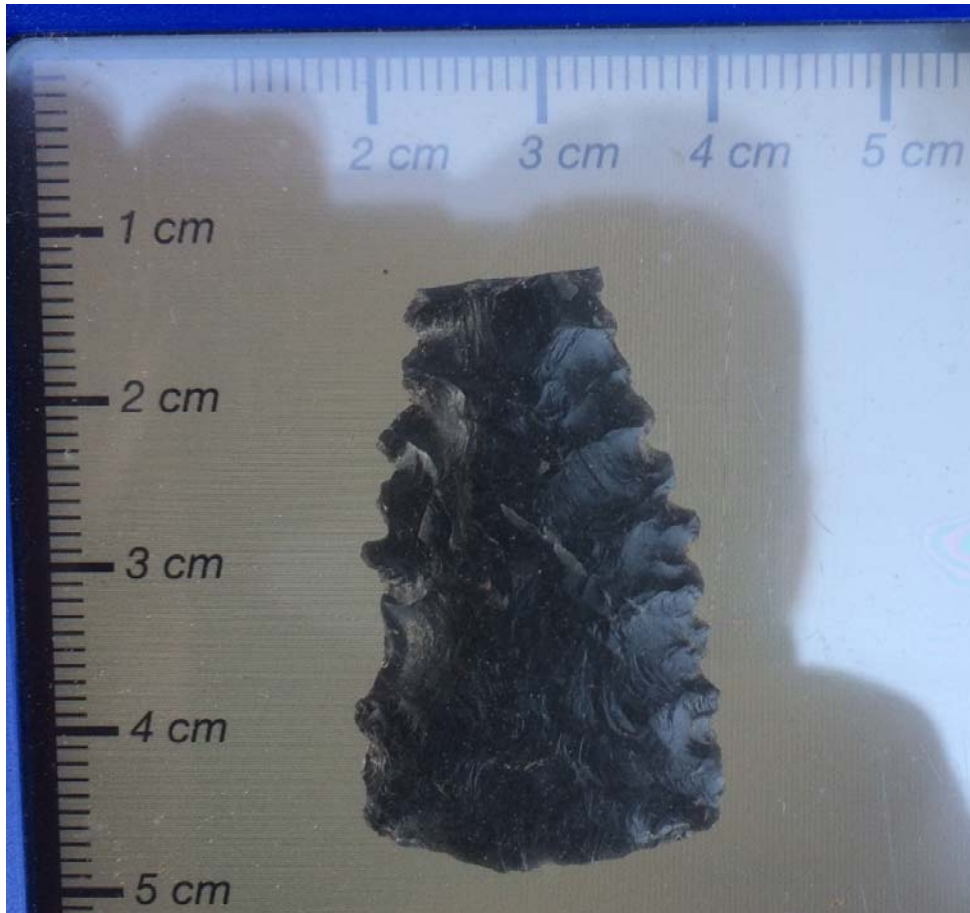
Figure 37. Artifact within IO 1, a projectile point midsection.

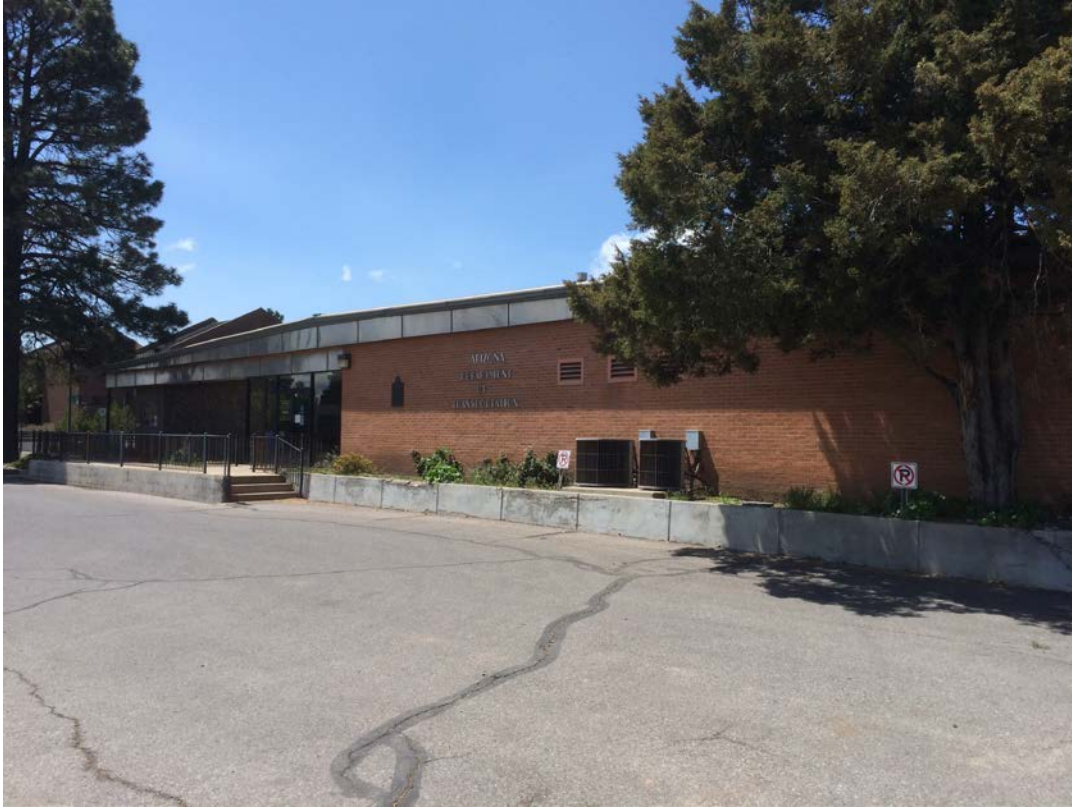
View of eastern elevation of the property at 1801 South Milton Road, photo facing southwest.

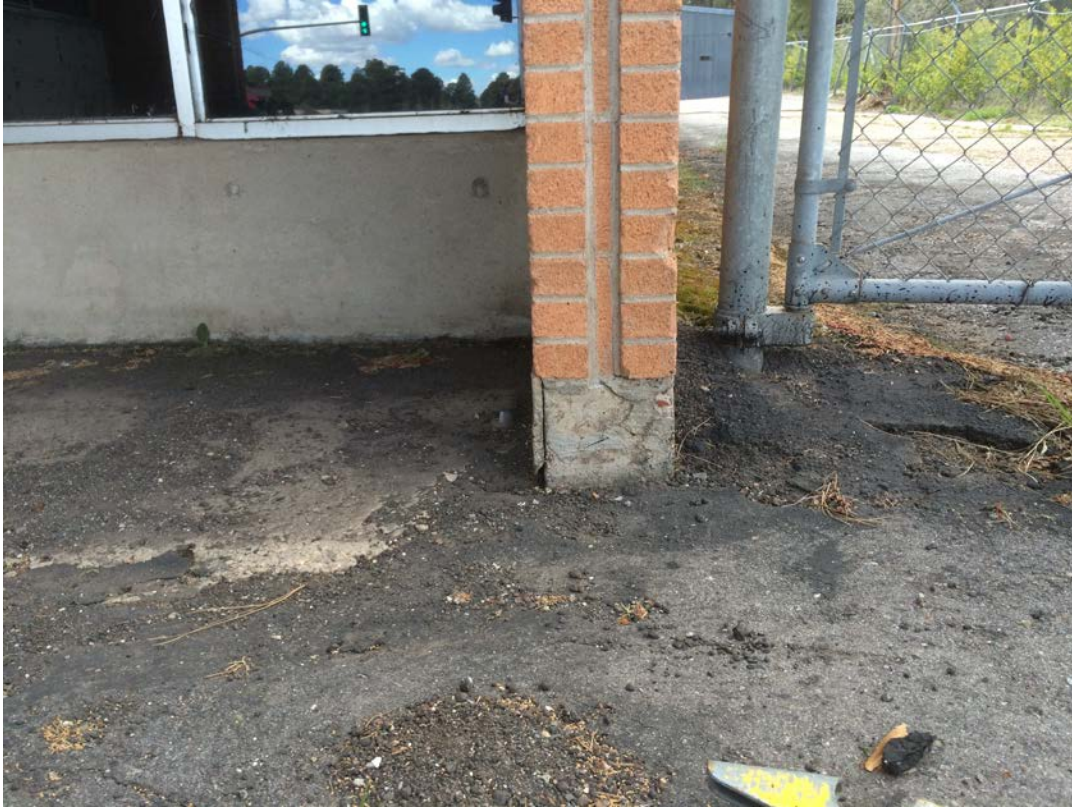
View of continuous spread concrete foundation on north wall, facing west.

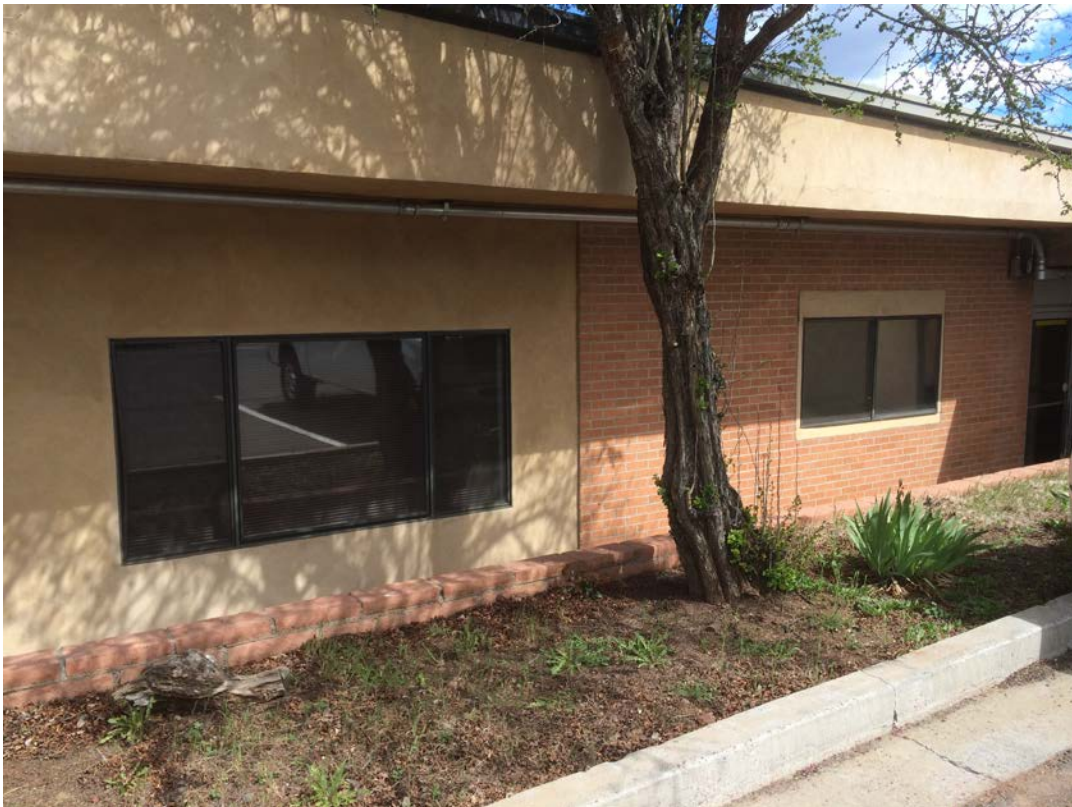
View of southern portion of the western elevation showing differential walls, facing southeast.

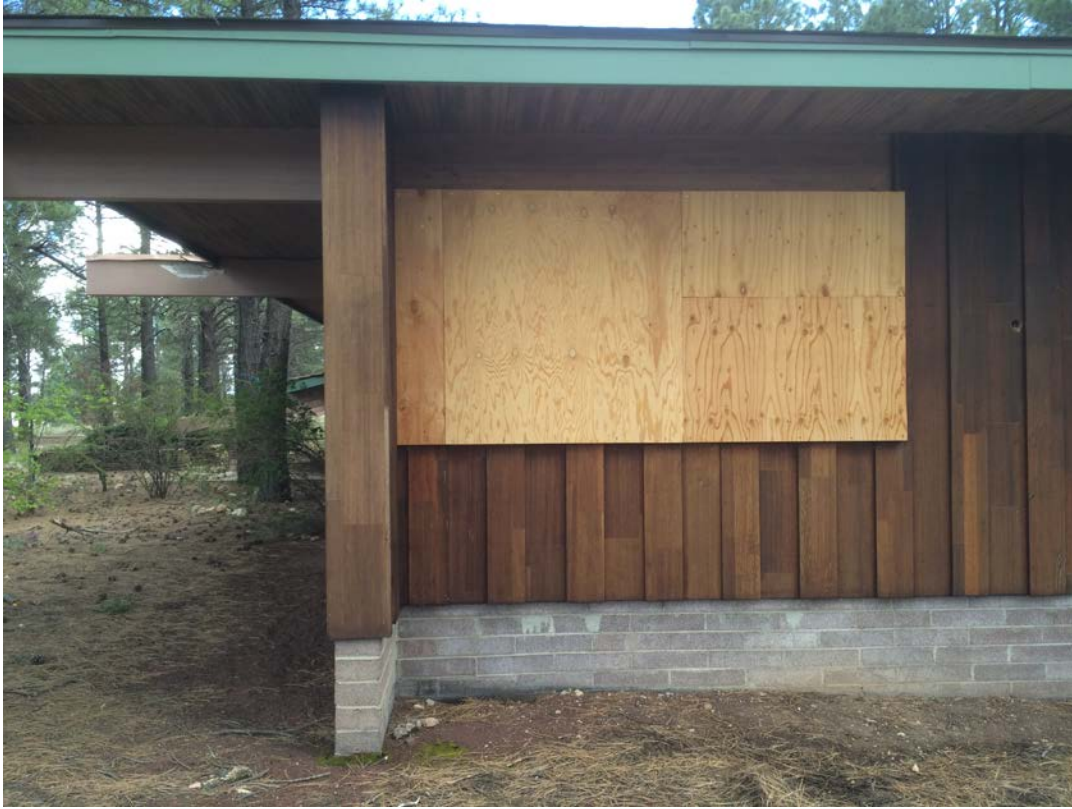
Detail of the foundation, walls, windows, and fascia on east end of north elevation, facing south.

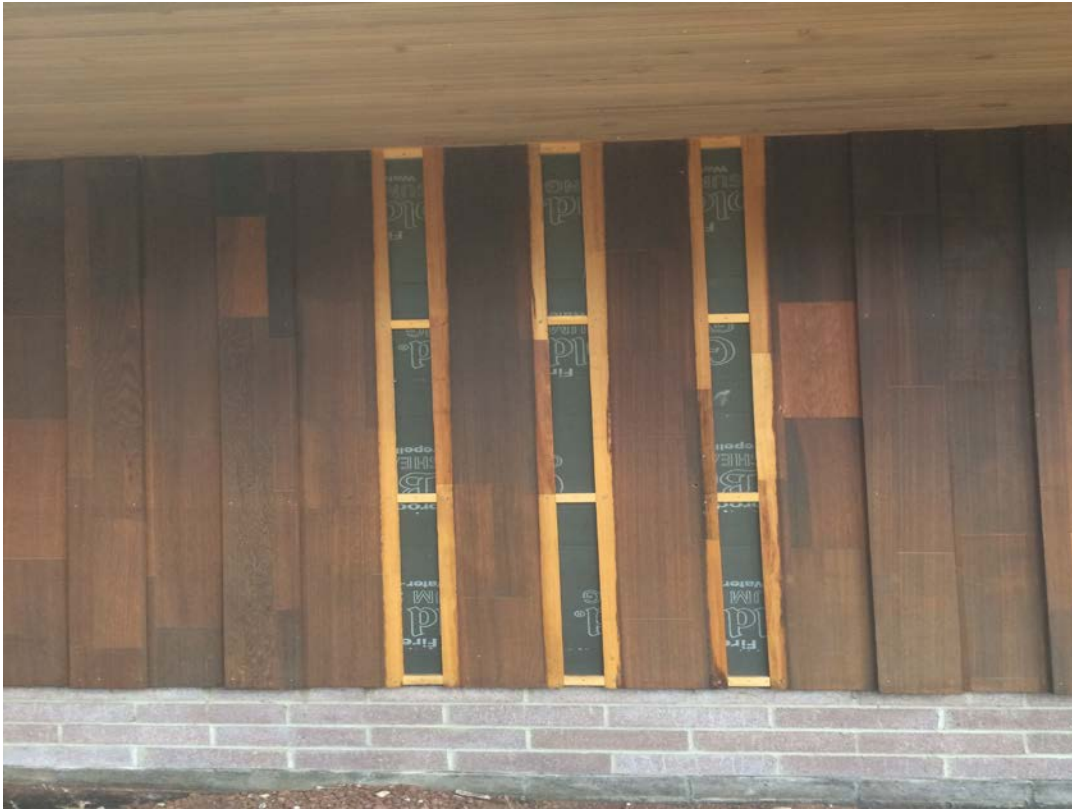
Detail of wall construction along northern end of eastern elevation, photo facing west.
