Phase 1 Historic Resource Study for 1600 E. Butler Avenue in Flagstaff, Coconino County, Arizona

Prepared for

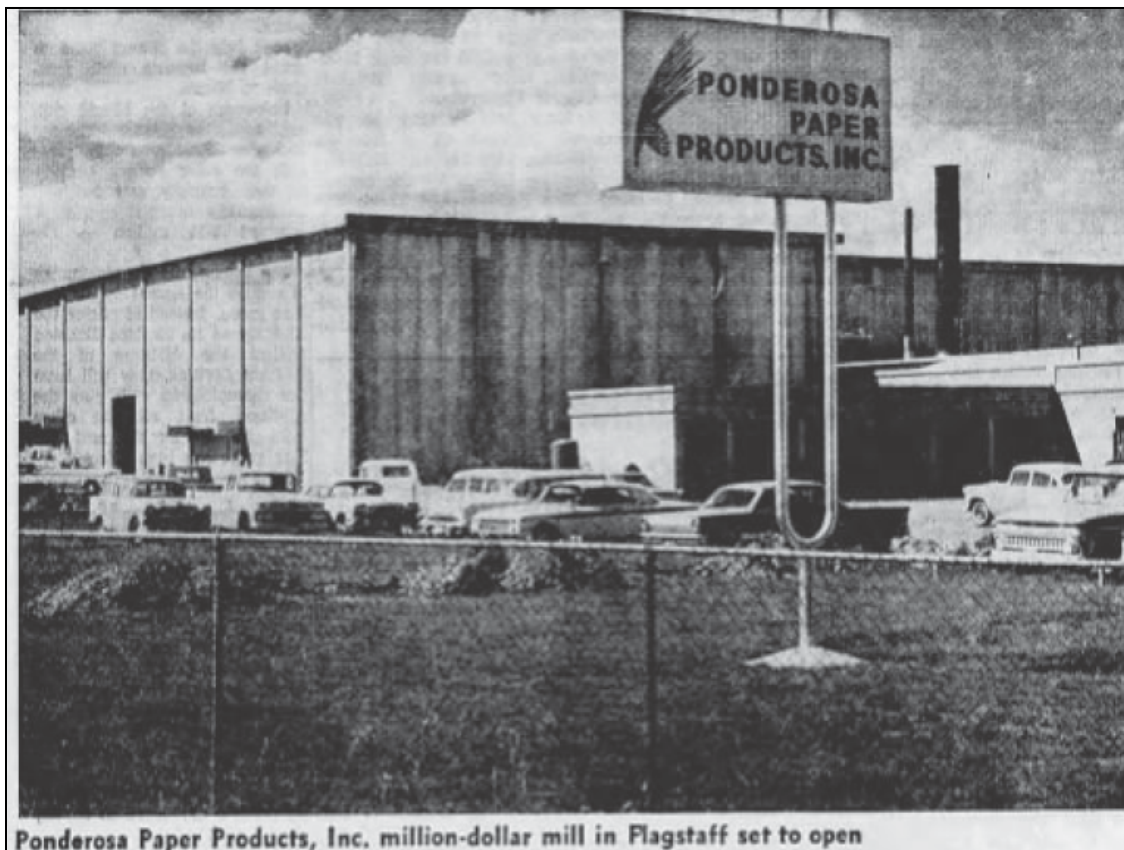
Figure 31. Ponderosa’s new paper mill, Building 3, facing west-northwest (ADS September 14, 1965).

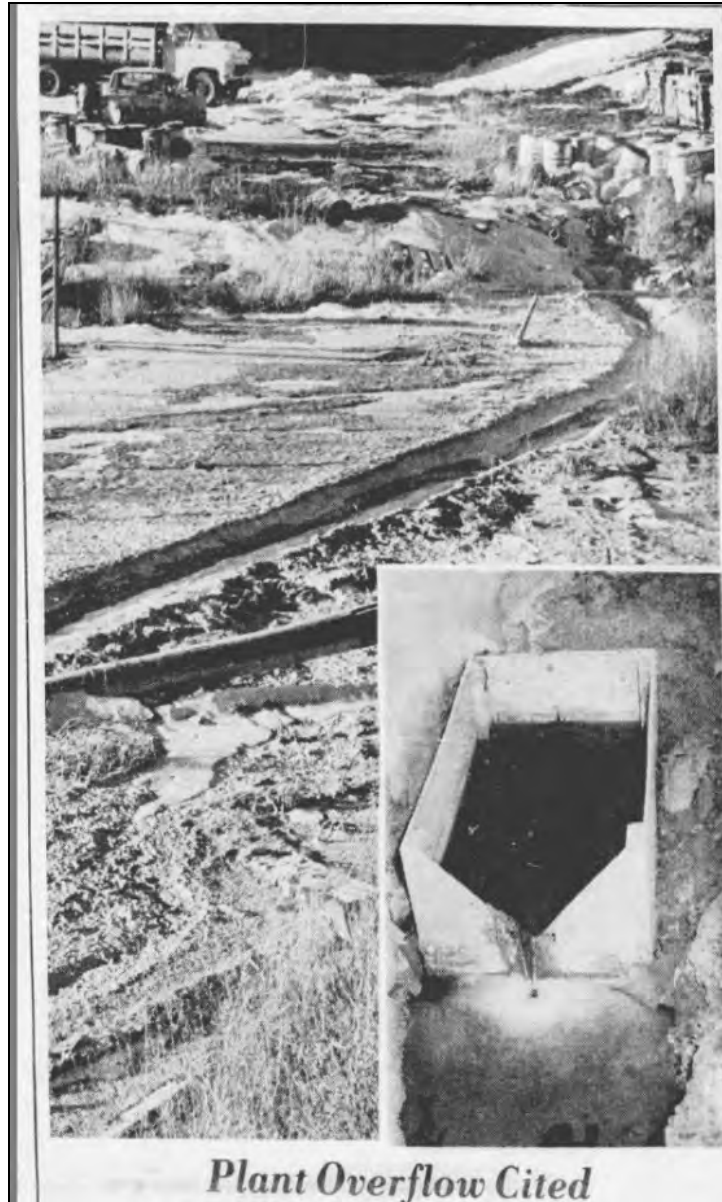
Figure 38. Photo showing effluent overflow into the Rio de Flag (ADS January 14, 1971).

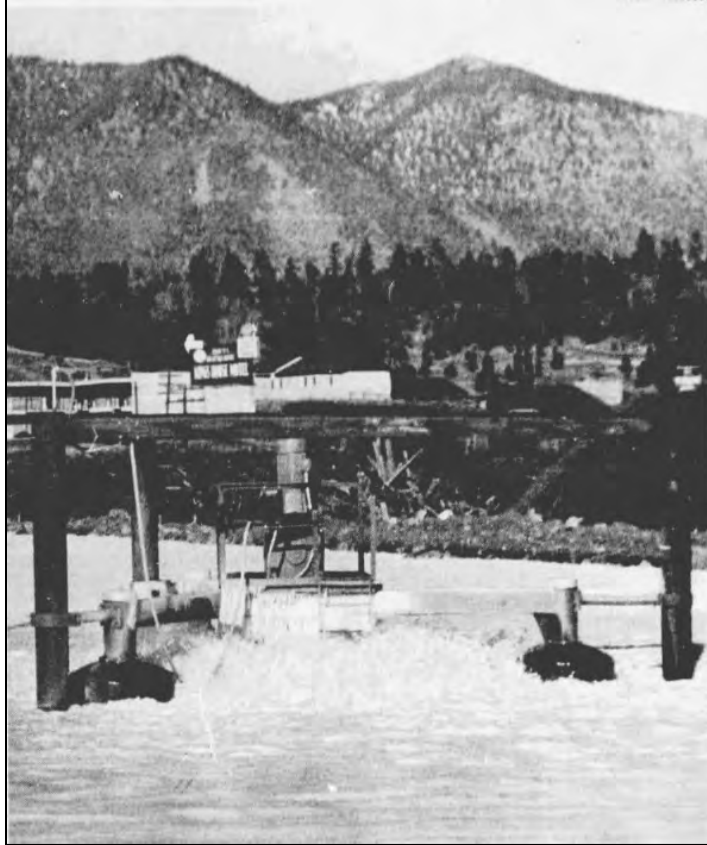
Figure 39. An aerator in the City's new water recycling lagoon (ADS January 5, 1972).

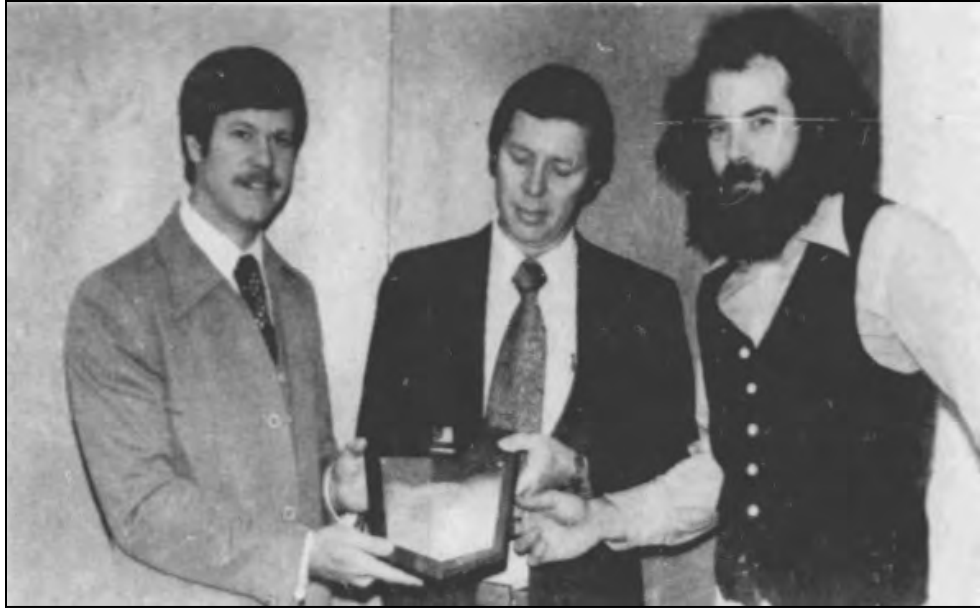
Figure 40. Goodwill thanking Ponderosa for their charitable contributions by giving them an award. Left: Mike Midley, Goodwill; center: Bob Russel, Ponderosa; right: Mel Tucker, Goodwill (ADS April 28, 1978).

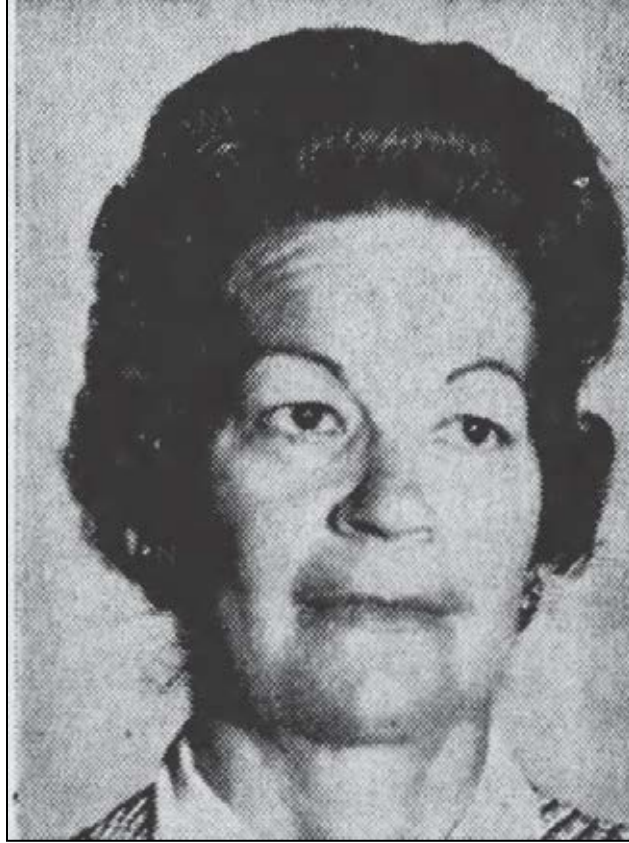
Figure 41. Kay Richey (ADS October 10, 1964).

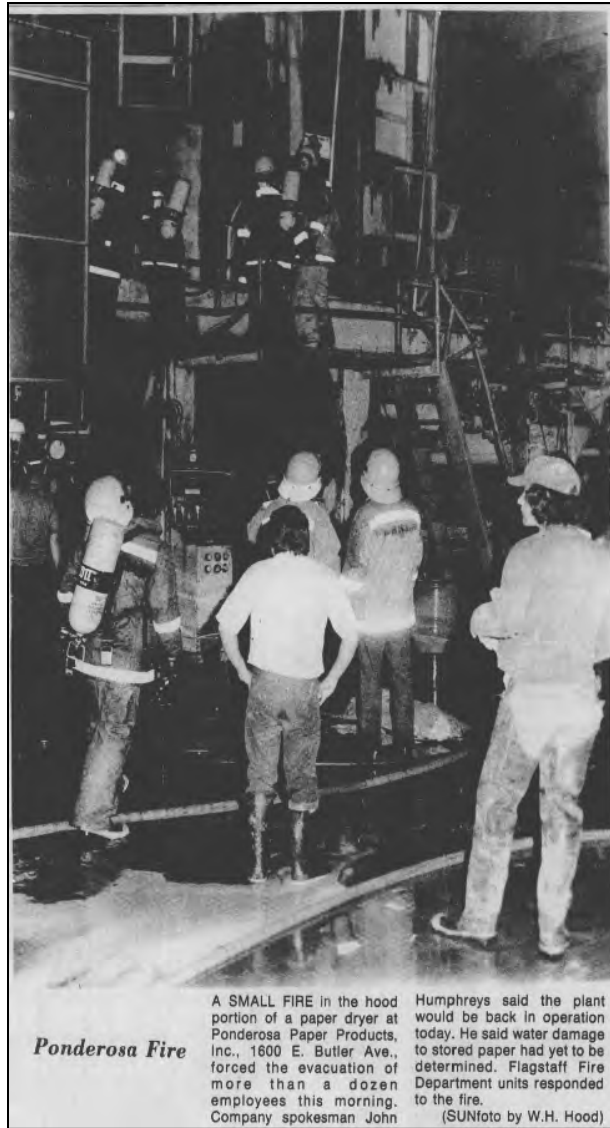
Figure 42. A fire in a paper dryer caused the plant to be evacuated (ADS April 10, 1978).

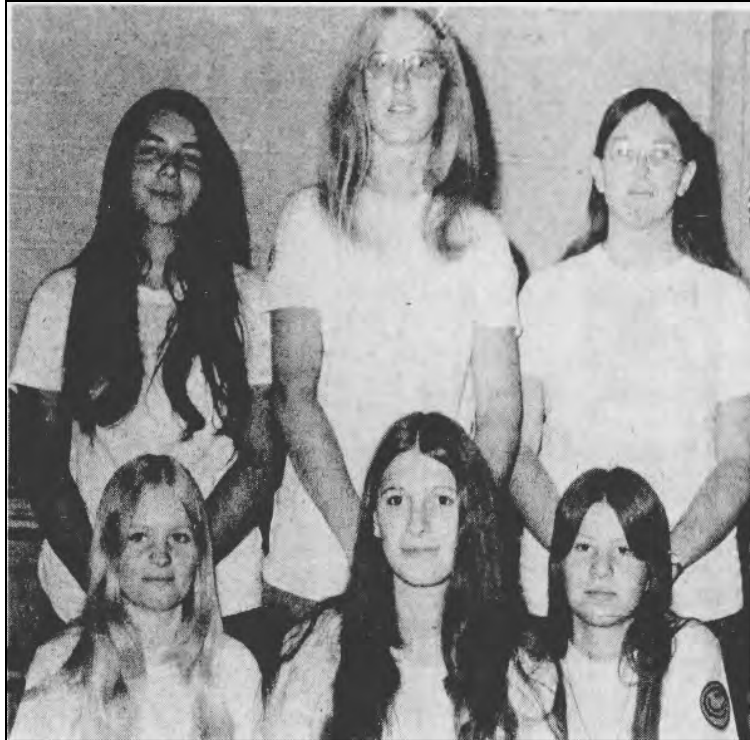
Figure 43. Ponderosa's women's volleyball team (ADS August 9, 1974).

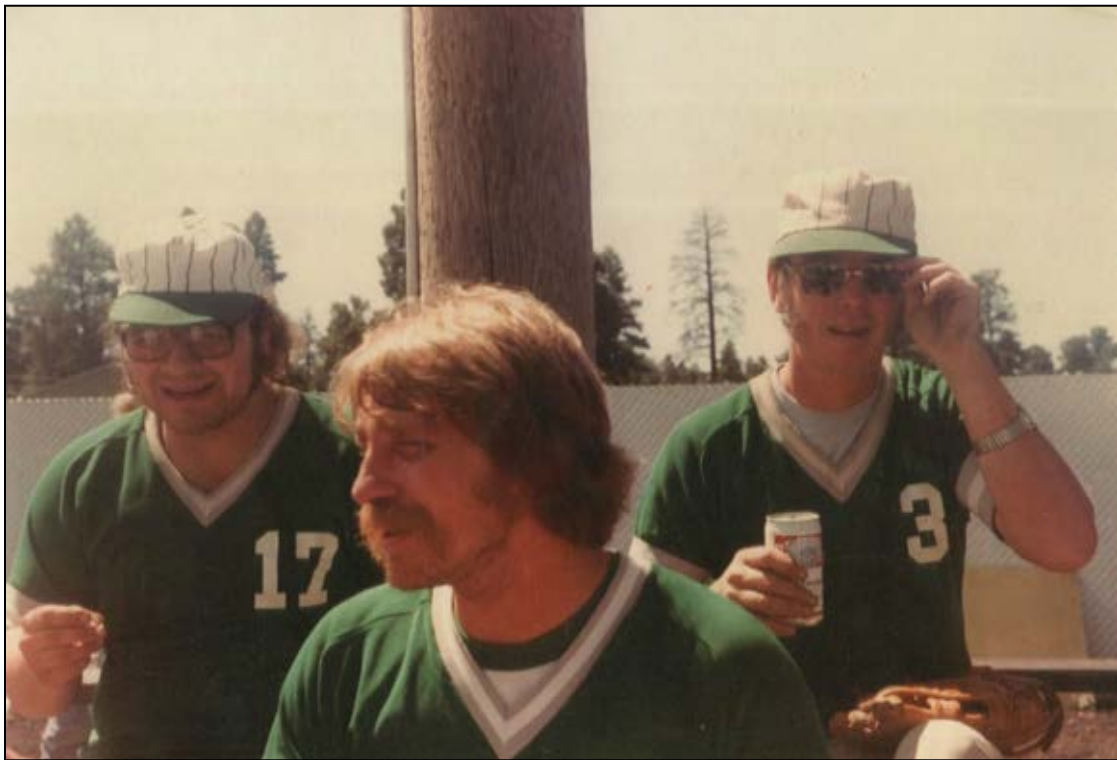
Figure 46. Bruce Jacks (center) and the men's softball team, late 1970s (Bruce Jacks, personal collection).

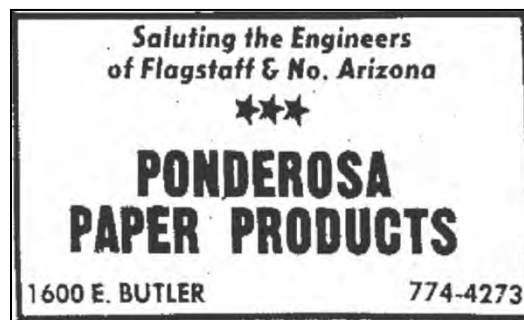
Figure 47. Advertisement for Ponderosa Paper Products (ADS February 20, 1975).

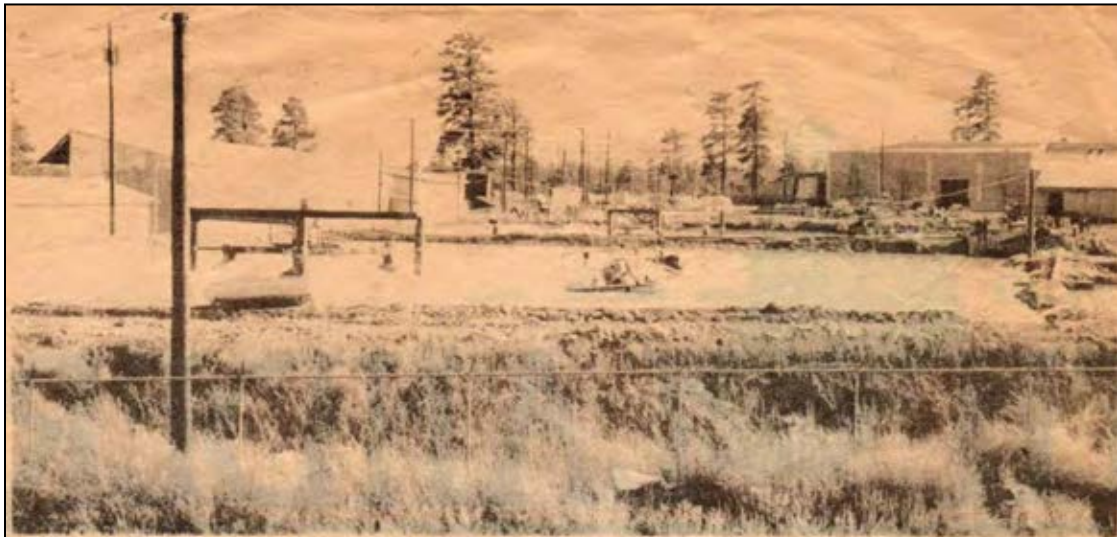
PLANT IMPROVEMENTS— Ponderosa Paper Company officials were in Flagstaff February 24. They met with city and county officials to work out pollution problems associated with the East Flagstaff paper mill. A sewage lagoon, which is the source of a periodic odor problem, is shown above.

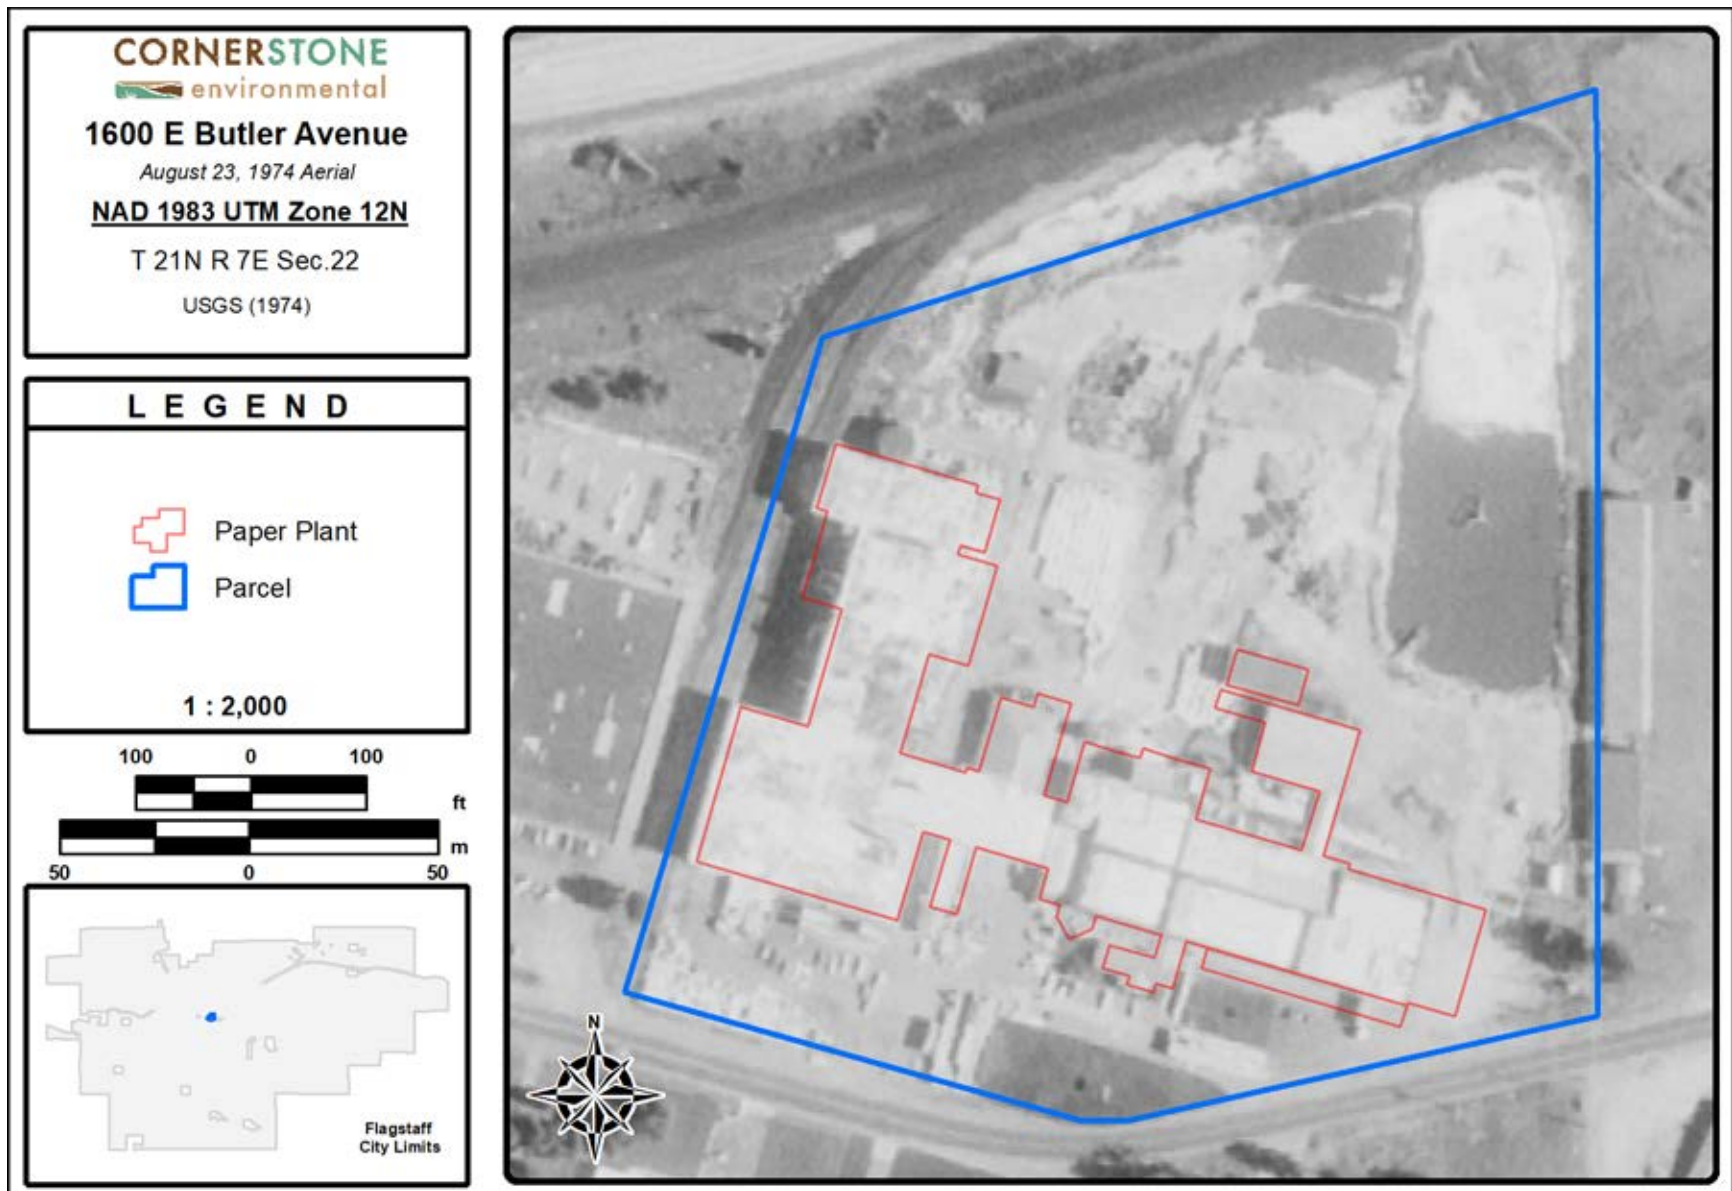
Figure 89. 1974 aerial photo aerial photo with current building outlines.

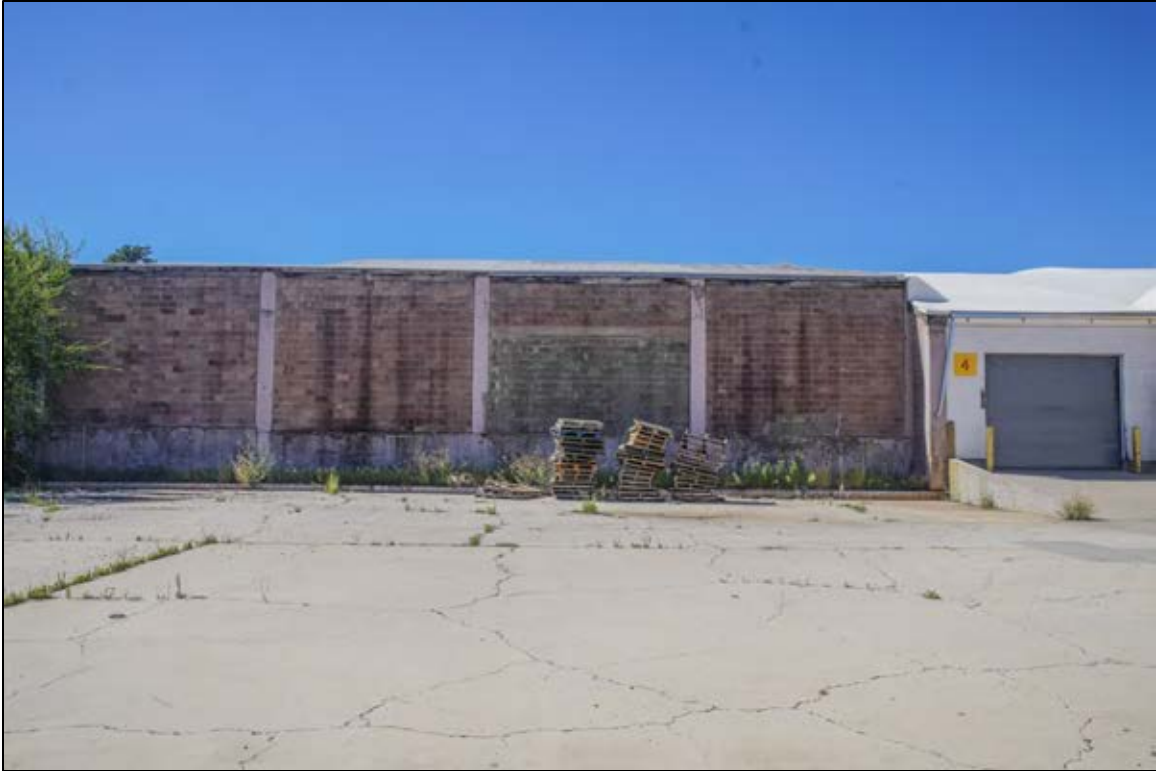
Figure 96. Building 1 exterior, facing south-southeast.

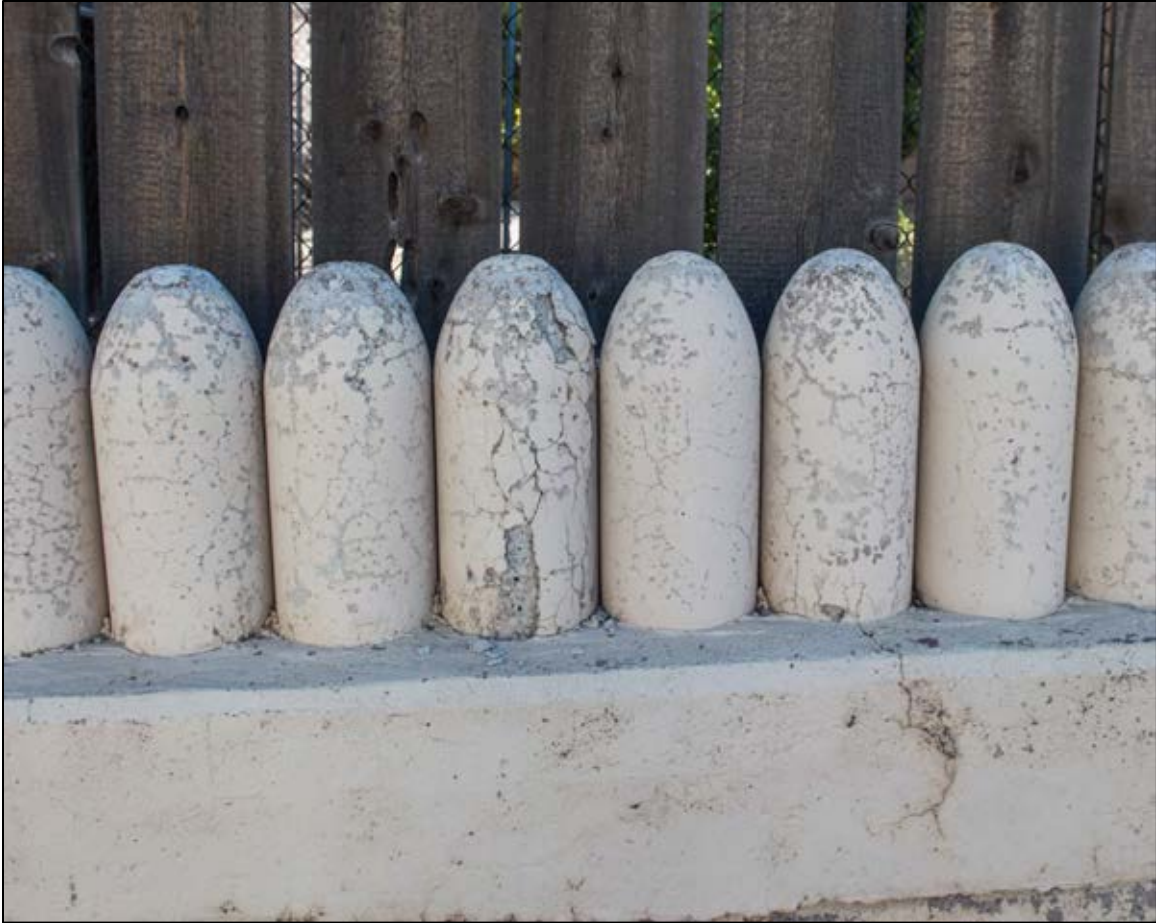
Figure 97. Concrete dummy bombs at a local Flagstaff residence.

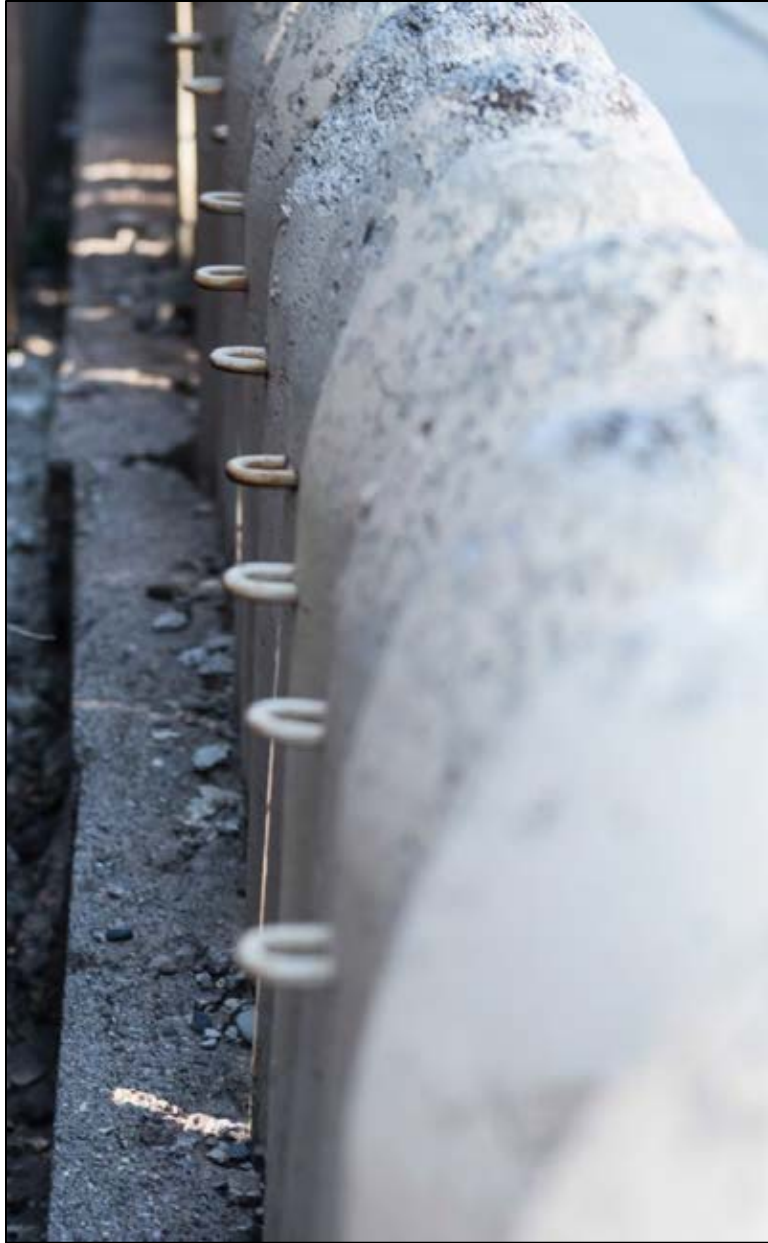
Figure 98. Concrete dummy bombs.

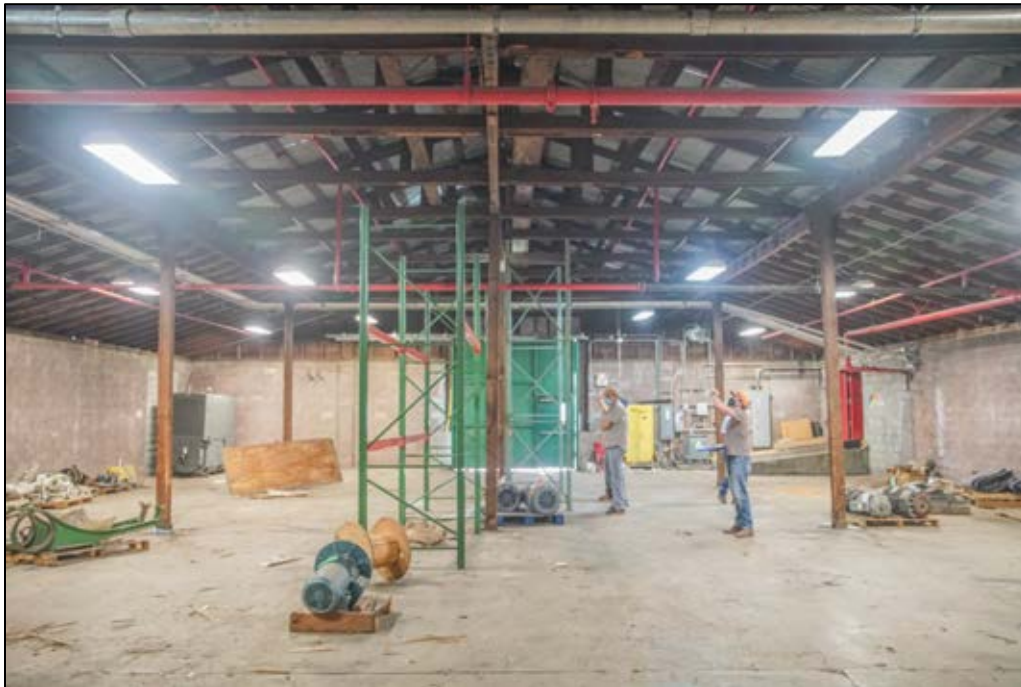
Figure 101. Building 2 interior, facing west-northwest.

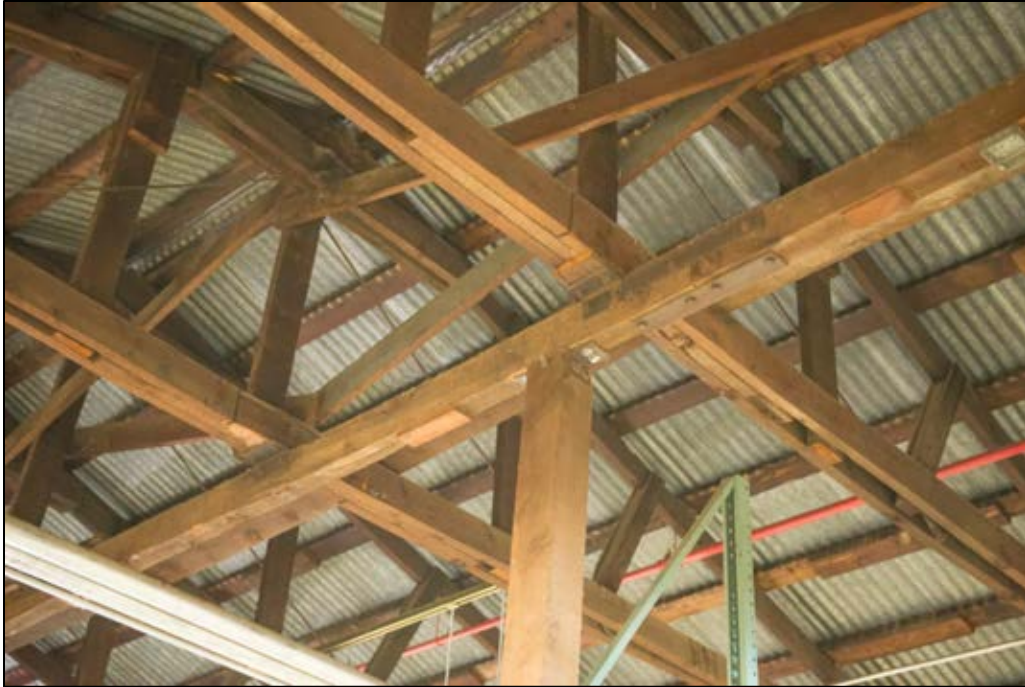
Figure 102. Building 2 roof trusses above post and beam construction.

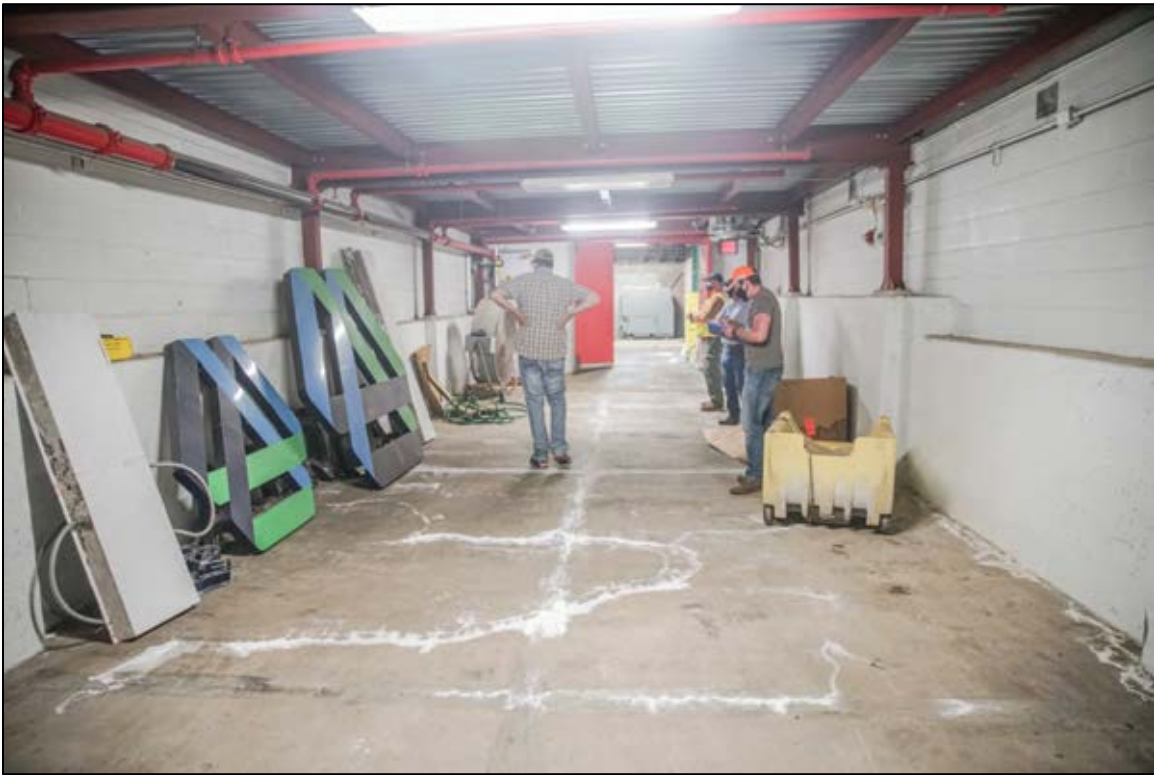
Figure 104. Building 2 connector, facing south-southwest.

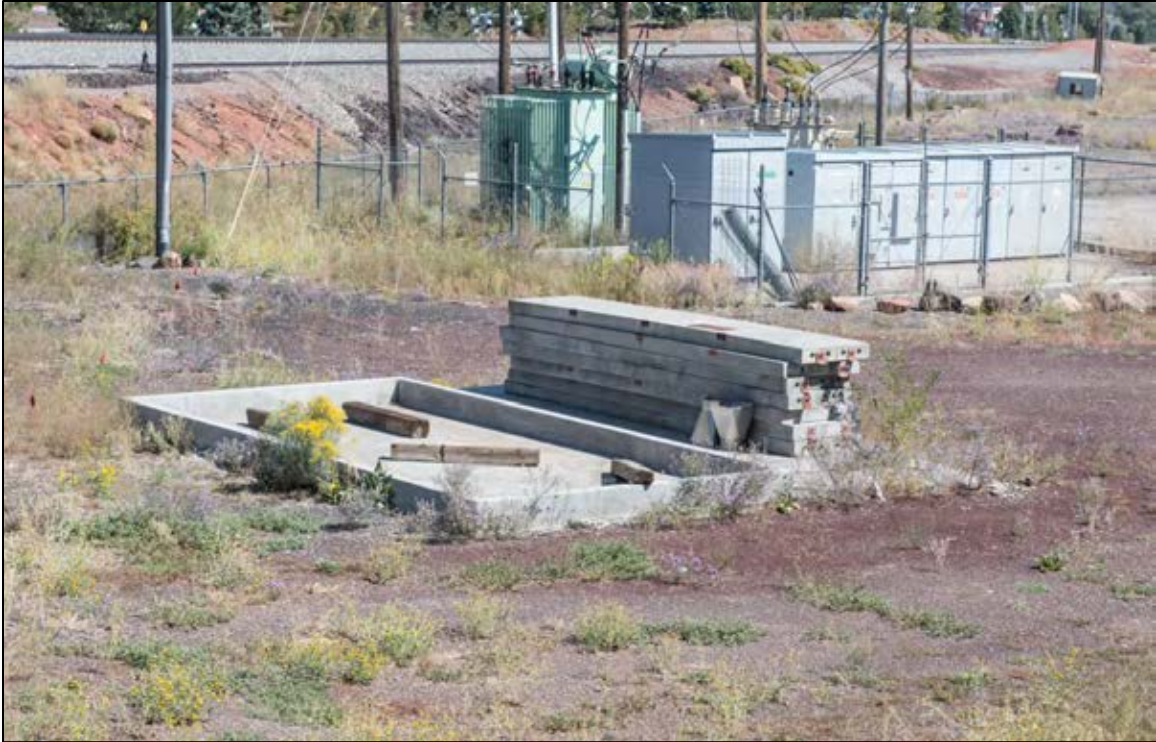
Figure 105. Building 3 pre-stressed roof replacement panels.

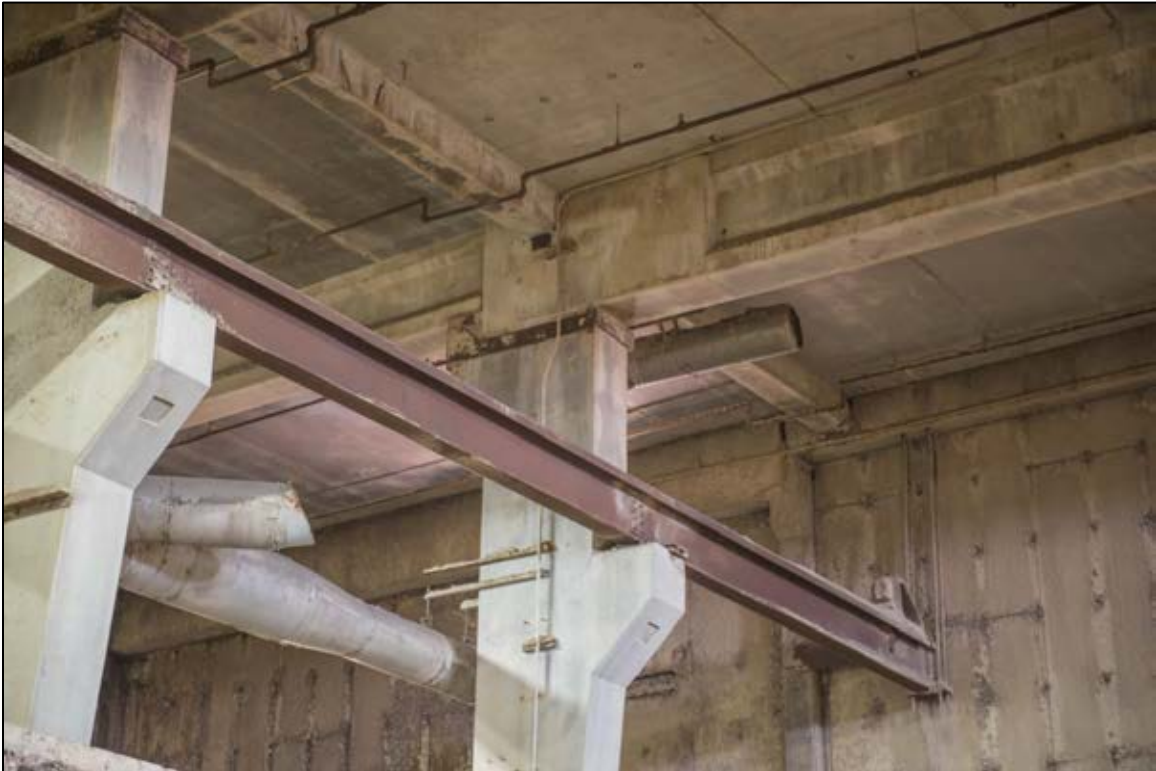
Figure 109. Building 3 column haunch and crane rail.

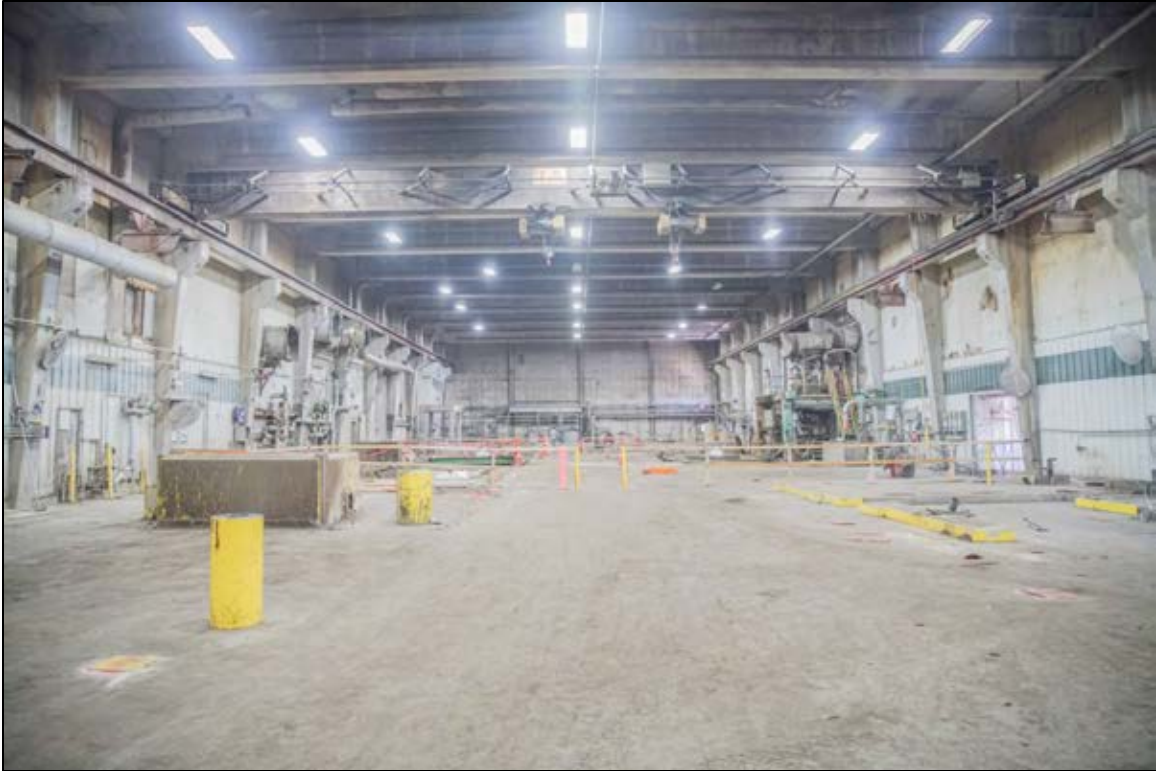
Figure 110. Building 3, north paper production room interior, facing north-northwest.

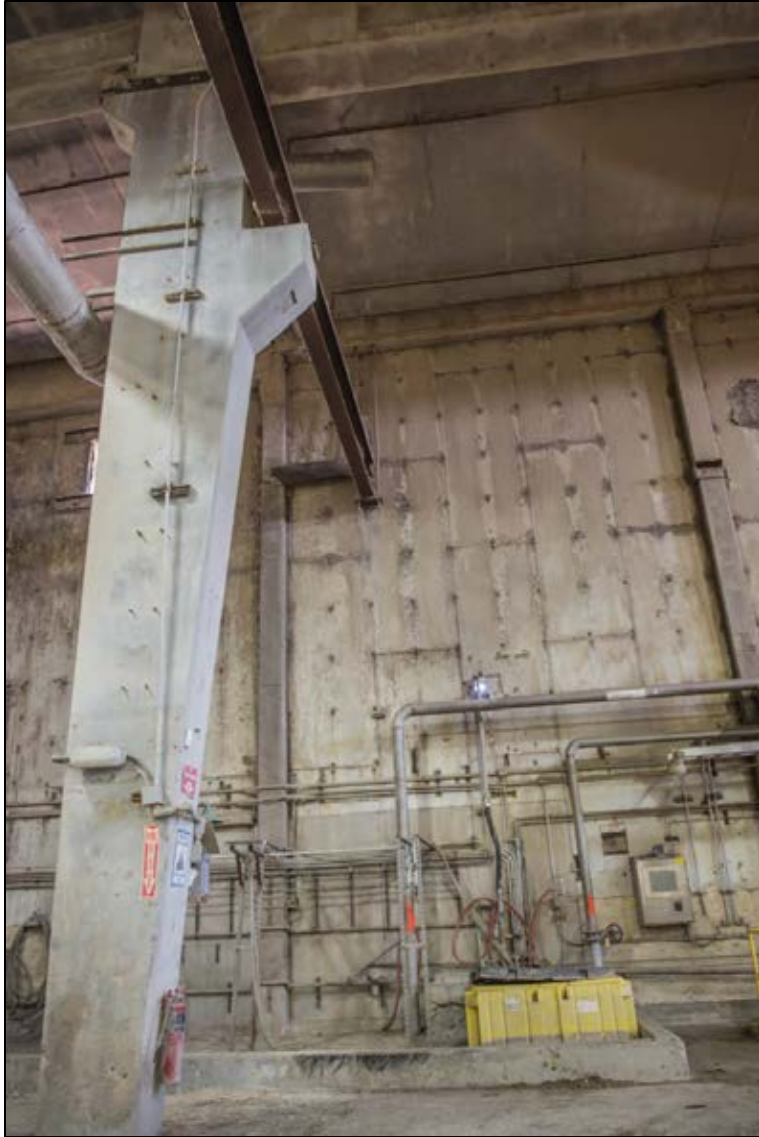
Figure 111. Building 3, tapered column detail.

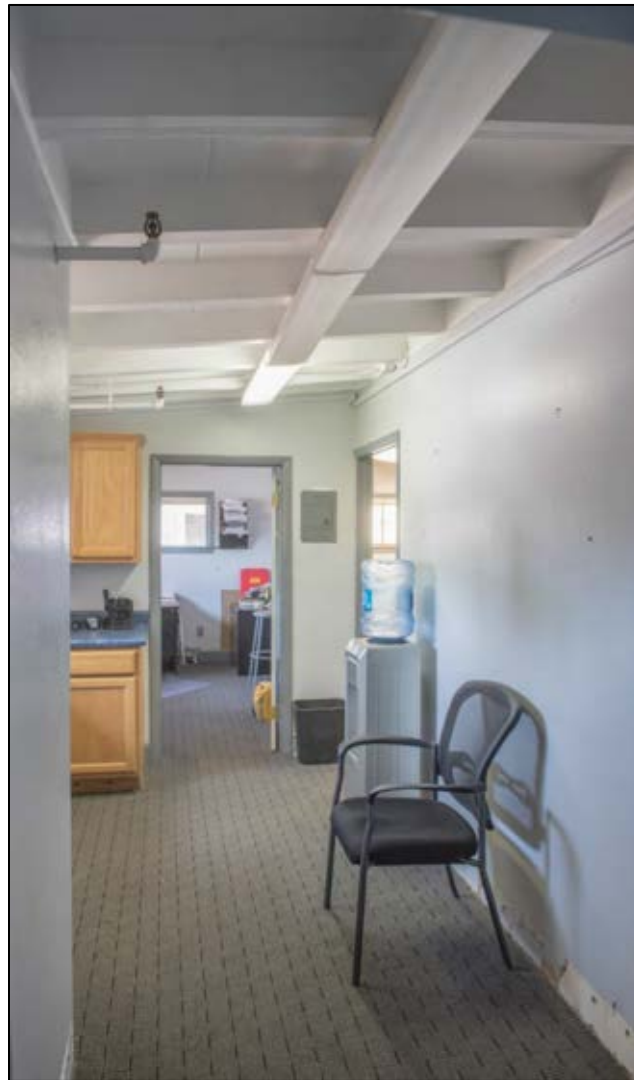
Figure 119. Building 4 interior showing open beam ceiling.

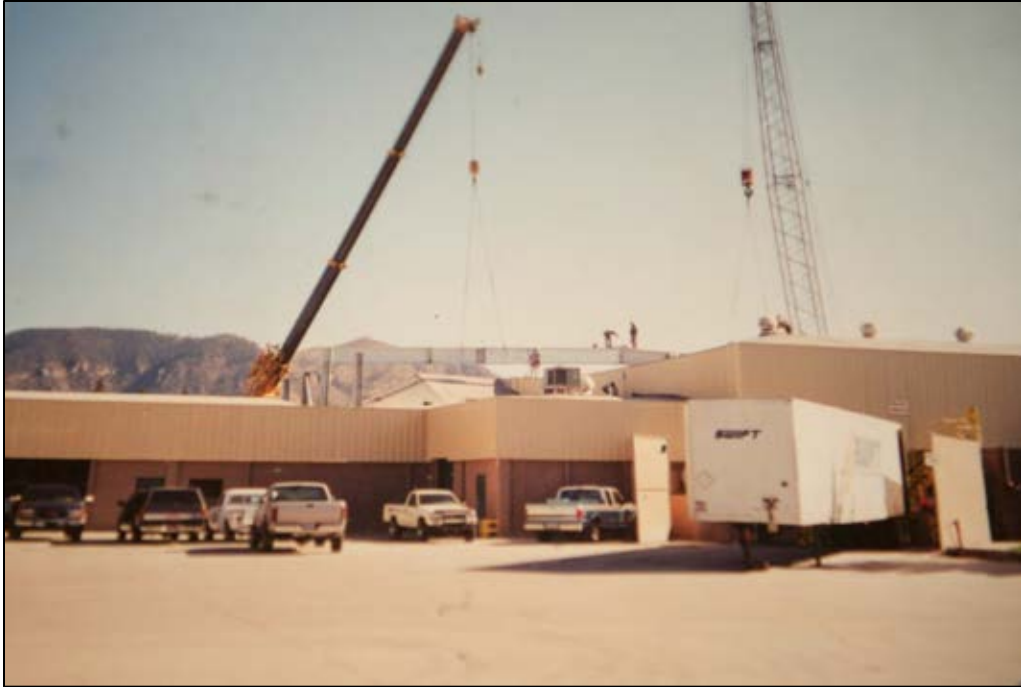
Figure 122. Building 6, roof repair.

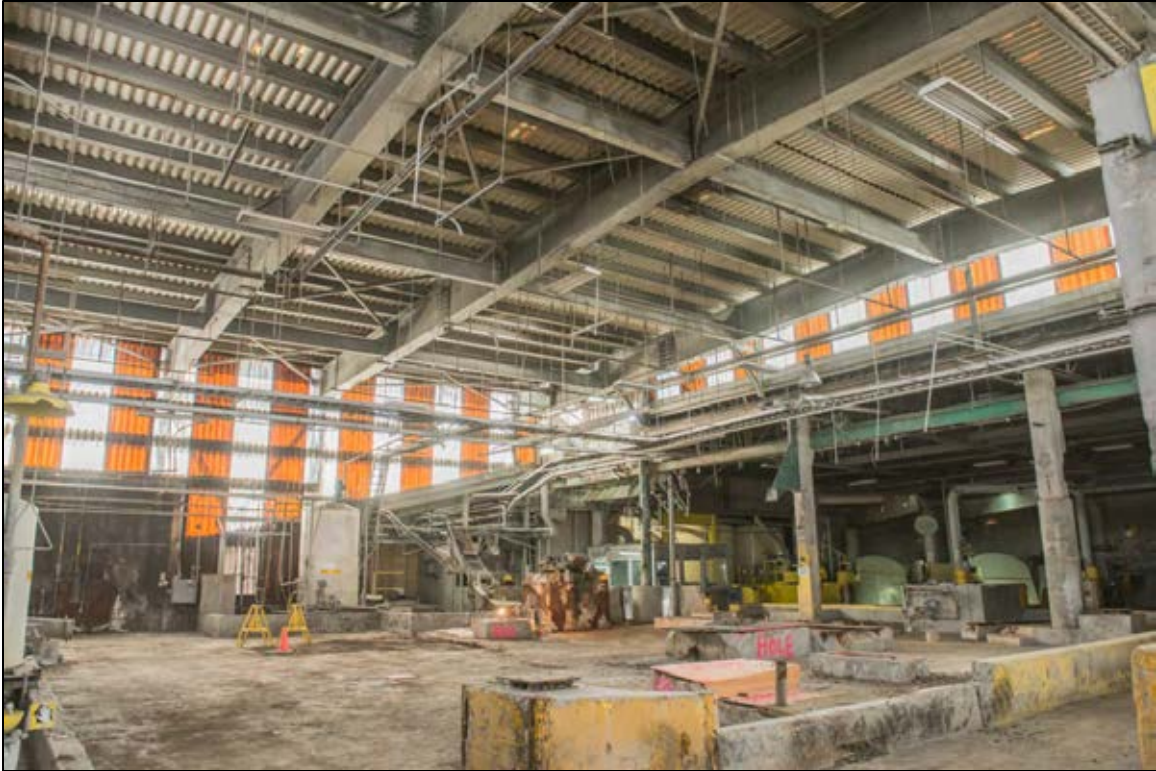
Figure 123. Building 6 interior, facing southeast.
