APPENDIX D

**Interior Photographs of the David Babbitt House
(319 North Beaver Street)**

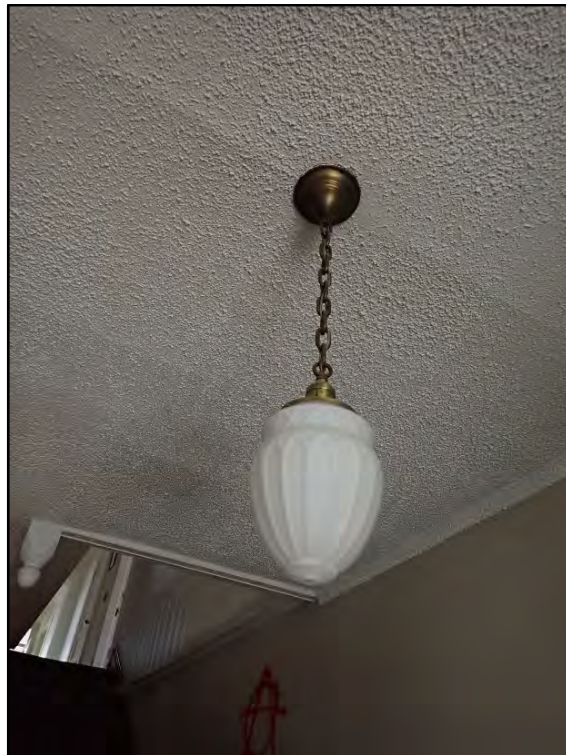
Figure D-50. One solitary drop light hangs from the ceiling, with a decorative frosted finish.

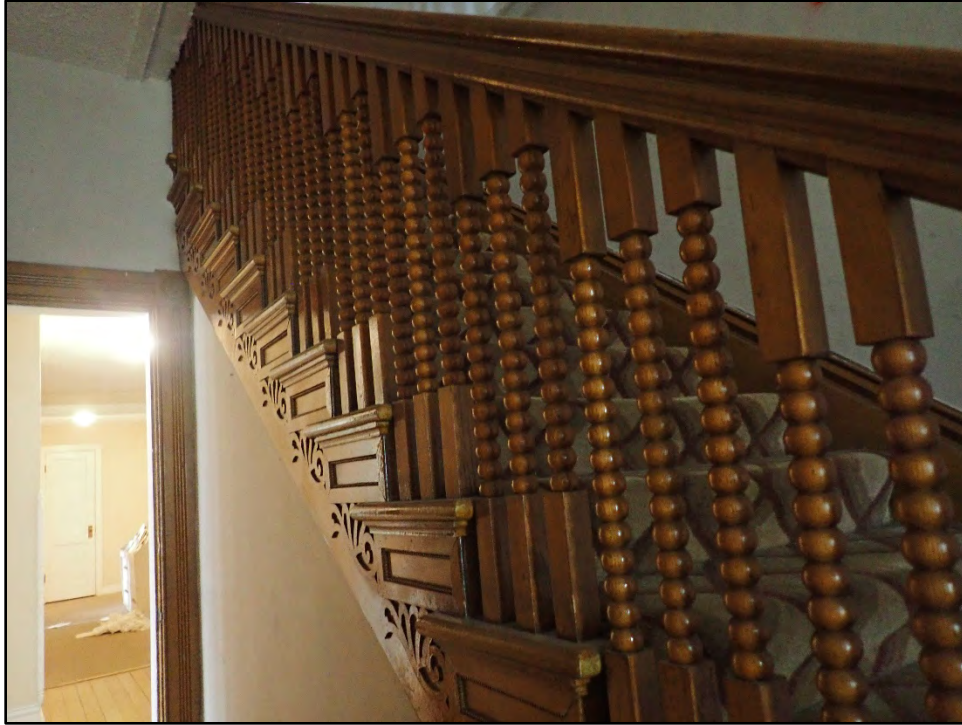
Figure D-51. View of the face stringerboard, turned balusters, and railing of the main staircase.

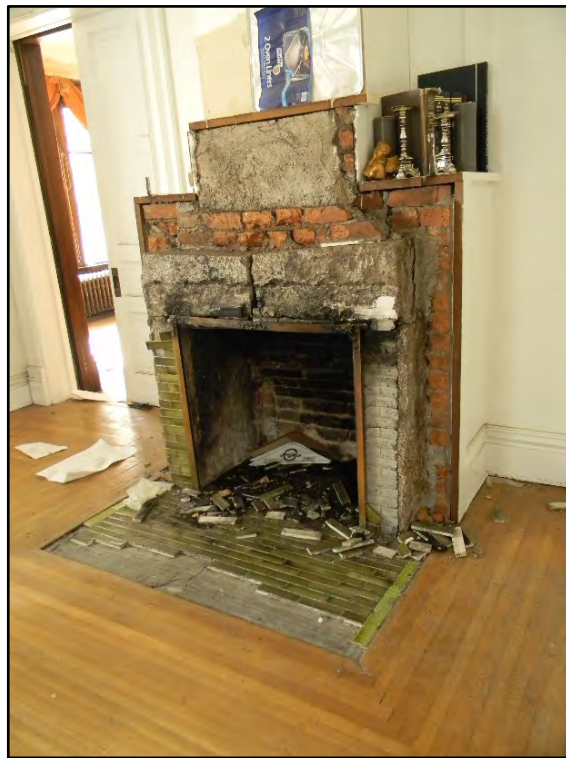
Figure D-72. Overview of the deteriorating fireplace in the sitting room.

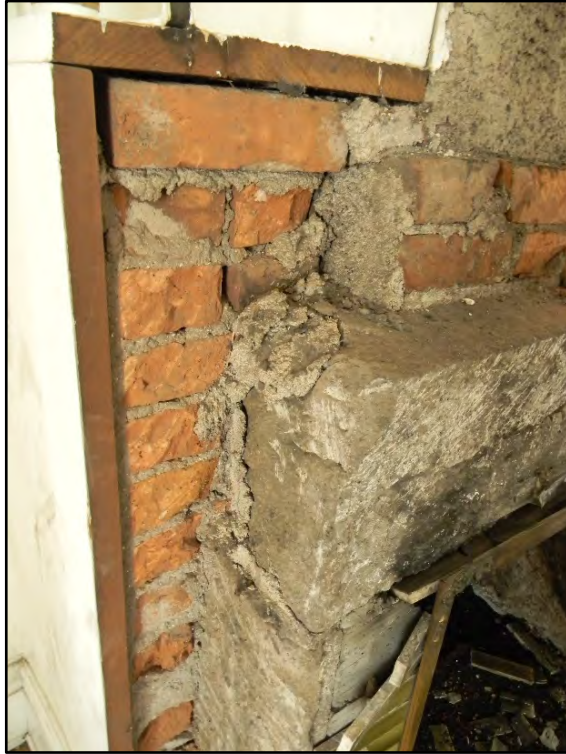
Figure D-73. Detail of the construction and workmanship of the sitting room fireplace.

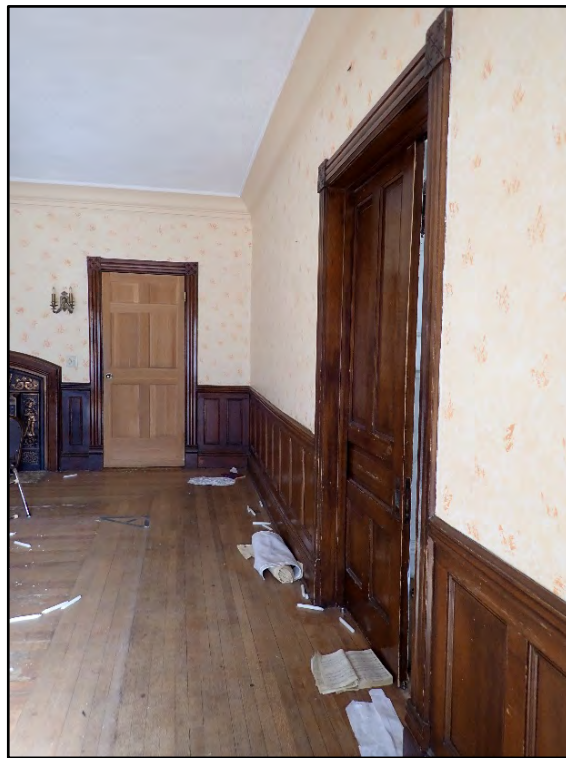
Figure D-82. View of the pocket door to the sitting room and the modern replacement door to the hall.

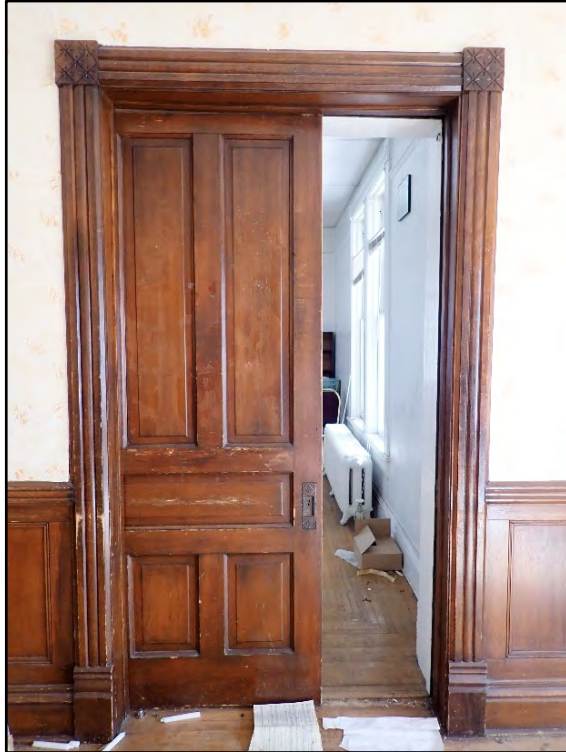
Figure D-83. Pocket door to the sitting room as seen from the formal living room.

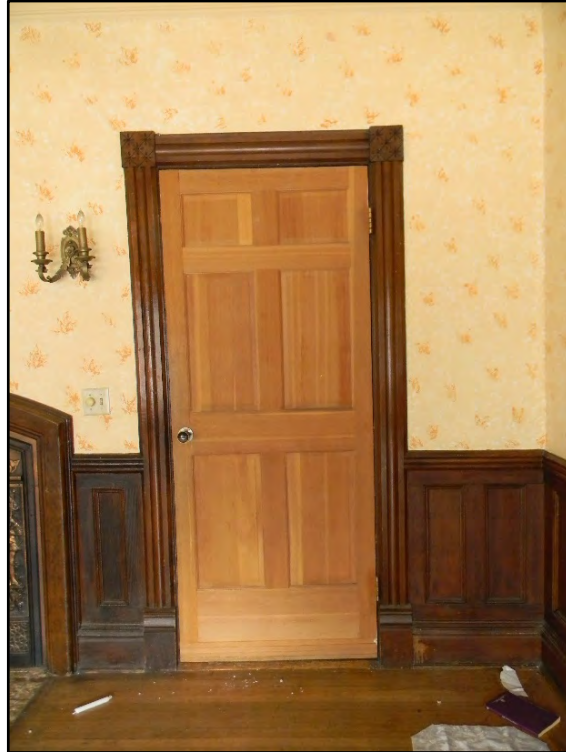
Figure D-87. Modern door that has replaced the original door to the hall.

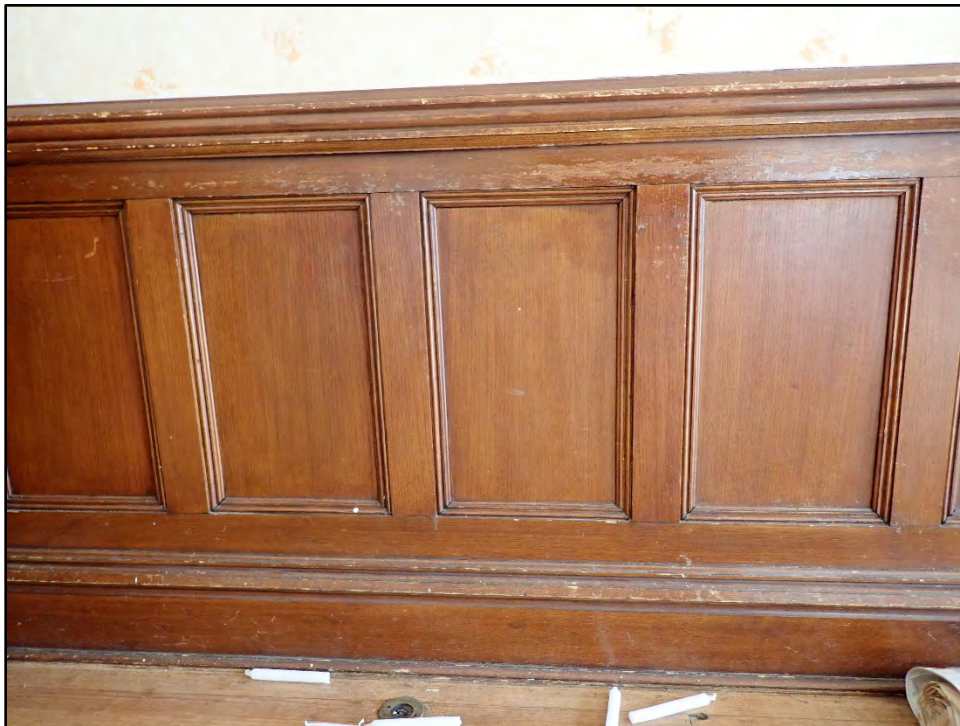
Figure D-88. Detail of the wood wainscoting in the formal living room.
