APPENDIX D

**Interior Photographs of the David Babbitt House
(319 North Beaver Street)**

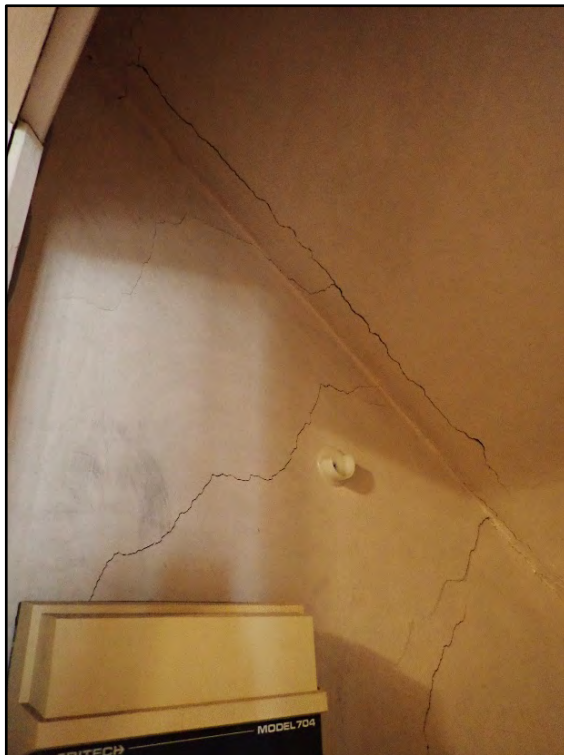
Figure D-226. Detail view of the lath-and-plaster construction of the walls in the under-stair closet, which are cracking.

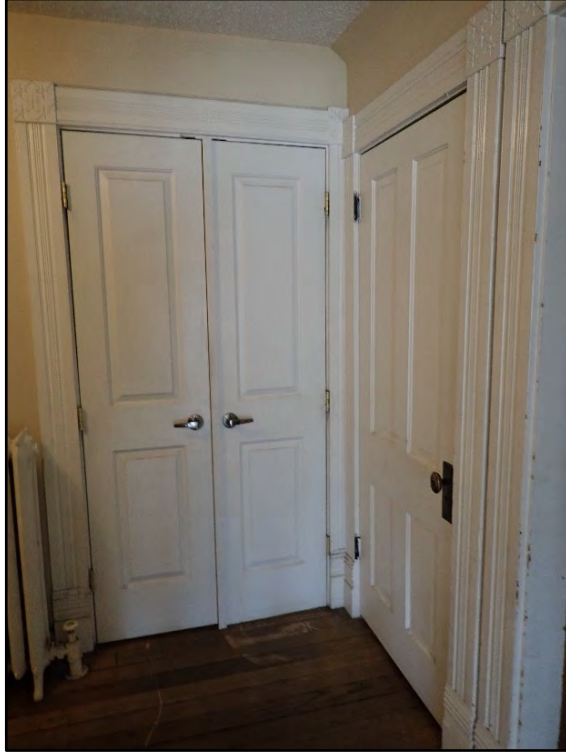
Figure D-227. The modern French doors to the hallway to the bedrooms on the first floor.
