APPENDIX D

**Interior Photographs of the David Babbitt House
(319 North Beaver Street)**

Section 6 of 6

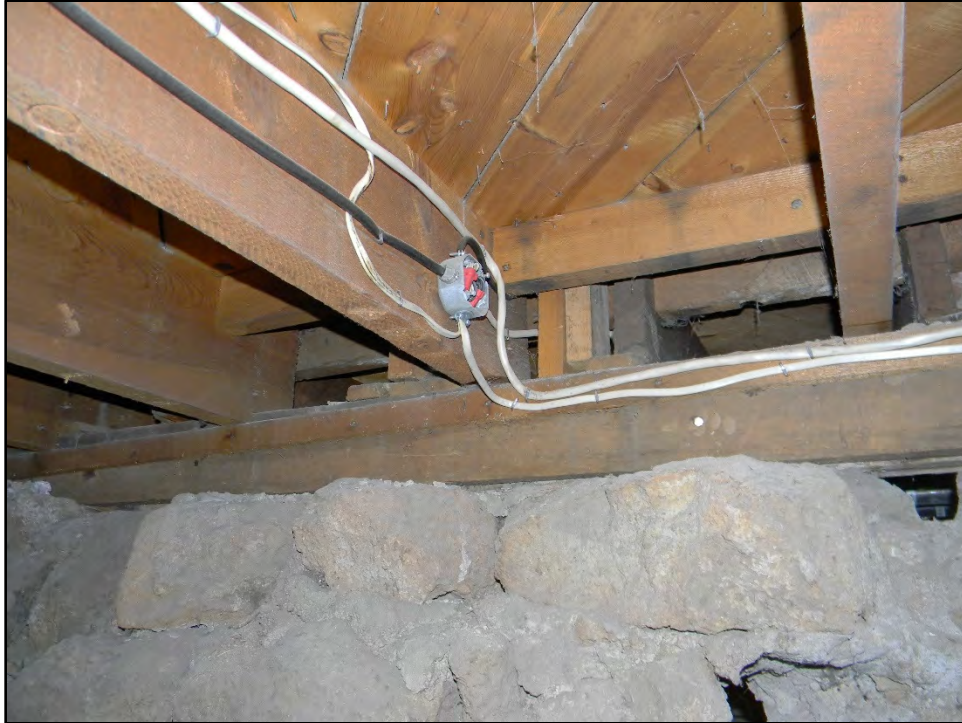
Figure D-657. Detail of the floor system resting atop the basement wall, which is below the main hallway on the first floor.

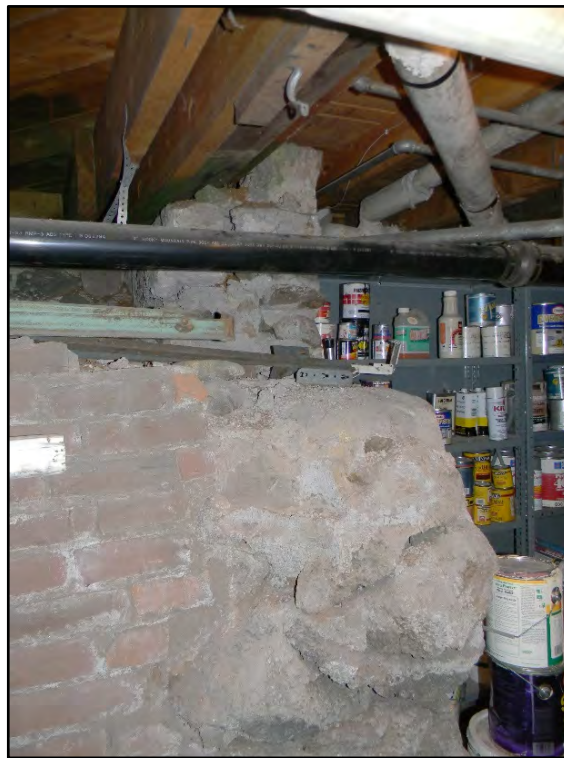
Figure D-658. The north side of the basement has a plethora of brick and rubble masonry retaining walls, the dates and purposes of which remain unknown.

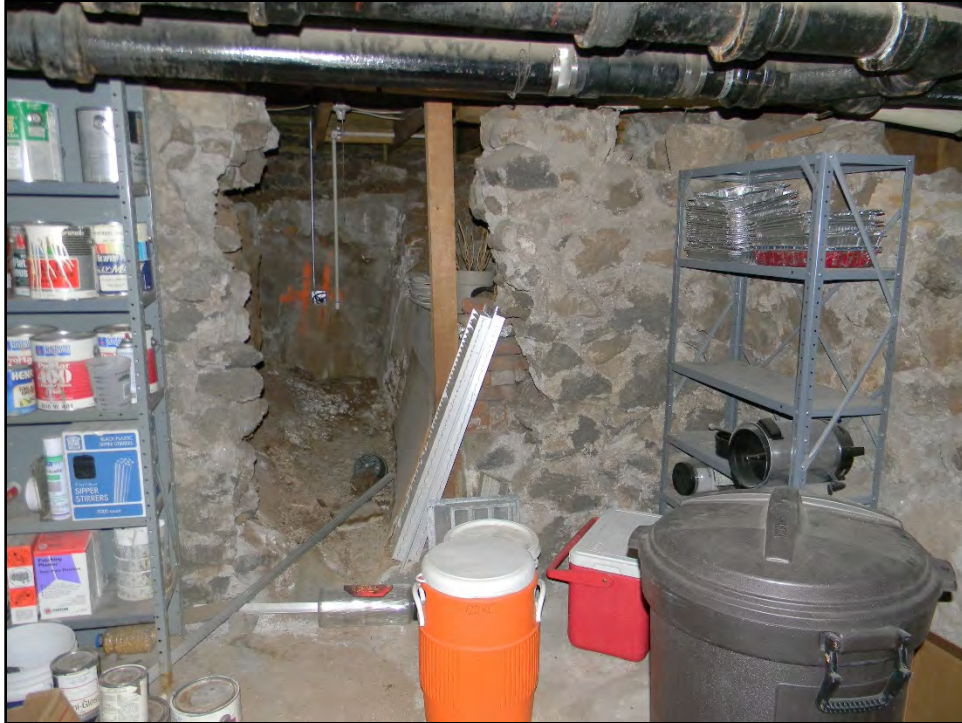
Figure D-659. The northern side of the basement with its original masonry rubble construction (this section likely dates to the earliest period of the residence based on its design and materials).

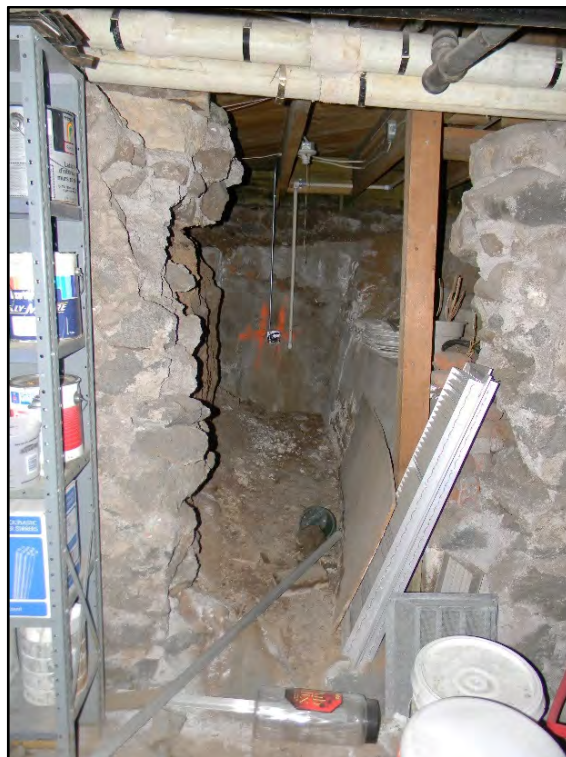
Figure D-660. A detail view of the same crawlspace in the basement.

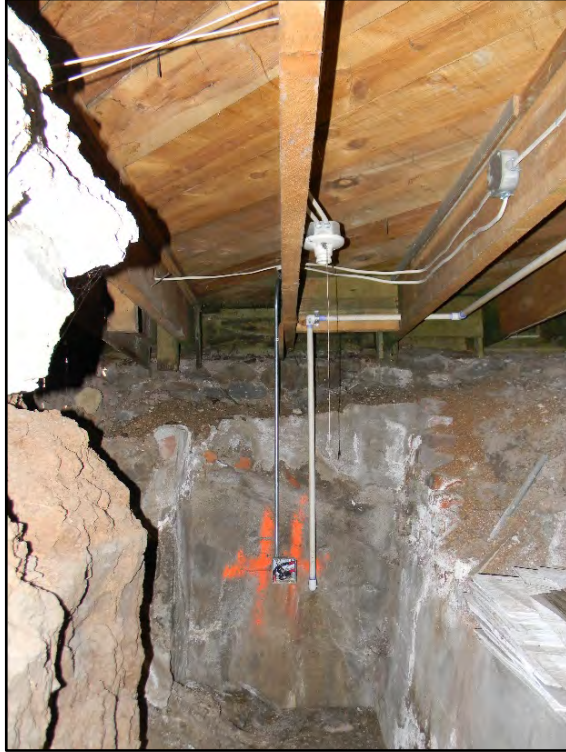
Figure D-661. The floor joists of the first floor atop the stem wall (which is seen at the back).

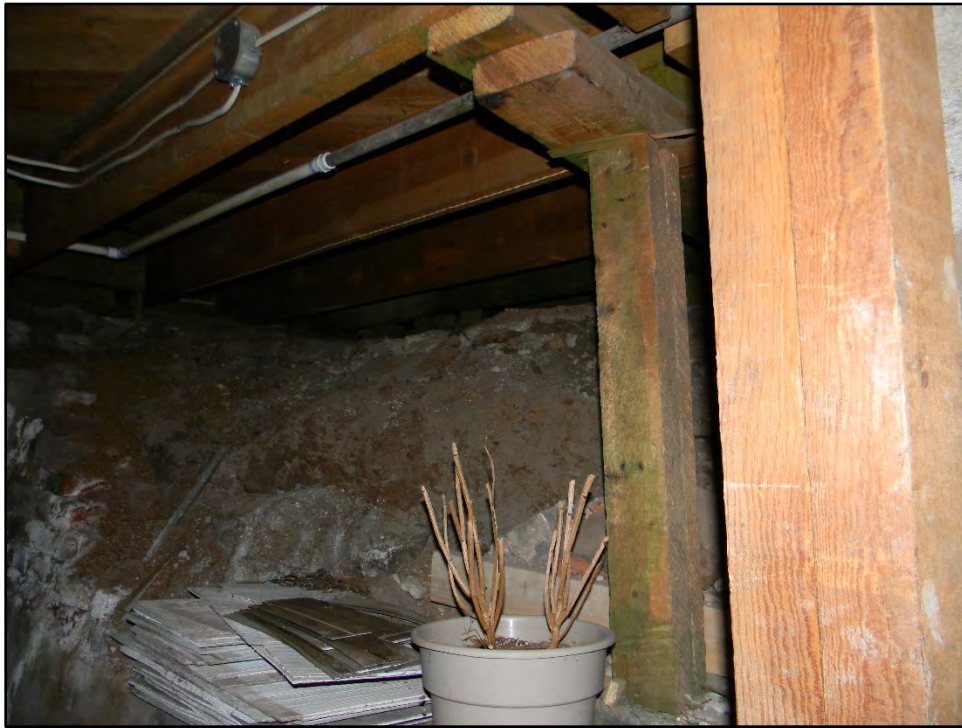
Figure D-662. This image shows the post-and-beam construction of the original extent of the residence (this is below the bedrooms).

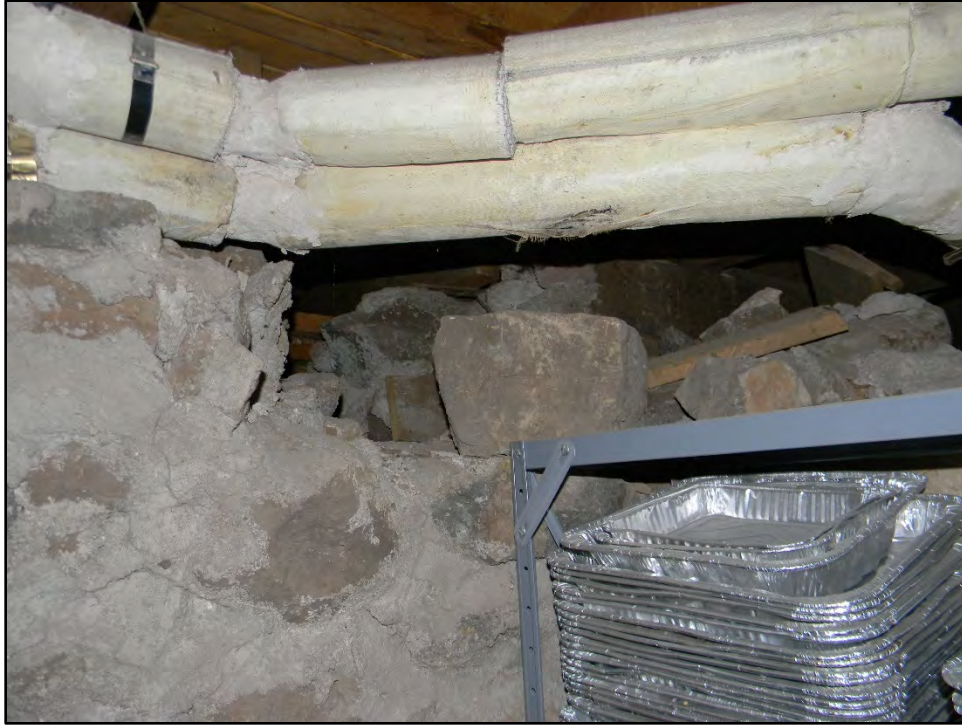
Figure D-663. Portions of the basement walls have collapsed over time.

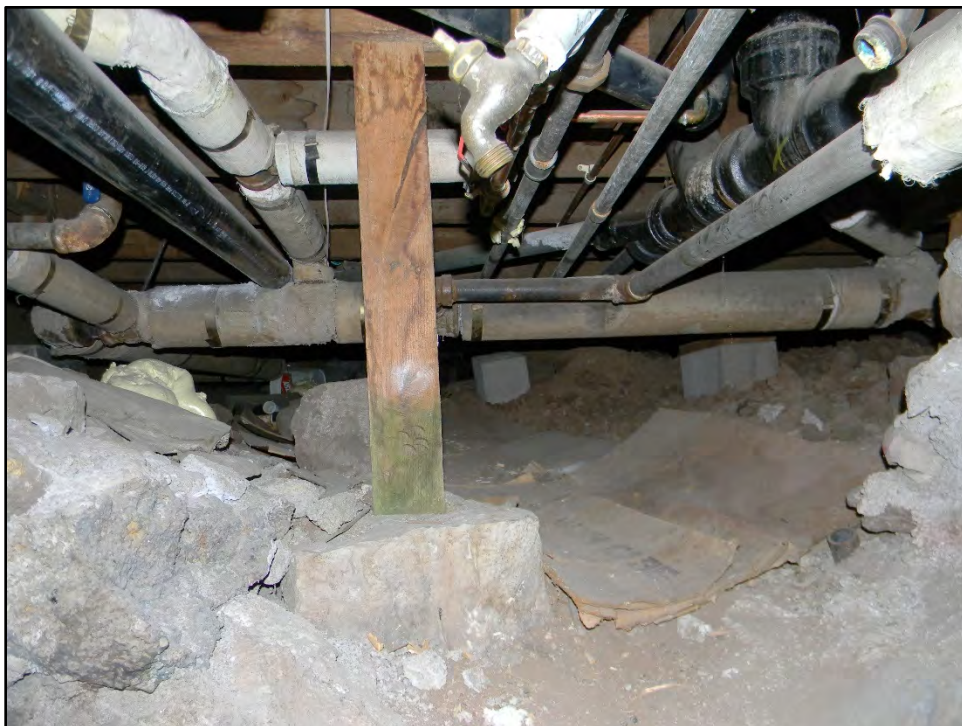
Figure D-664. A detail view of the wood posts and concrete footings that hold up the original extent of the house as built in 1886, which is marked below by this crawlspace which extends back to the stem wall along the North Beaver Street side of the home.

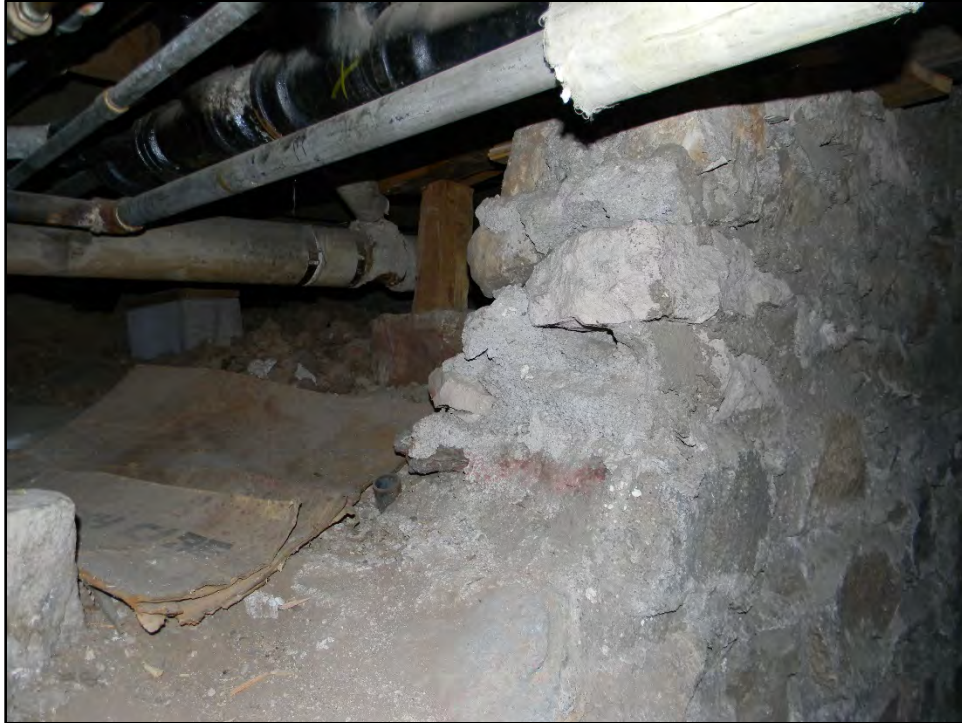
Figure D-665. A detail view of the original masonry construction in the basement dating to the mid-to-late 1880s when the residence was initially built.

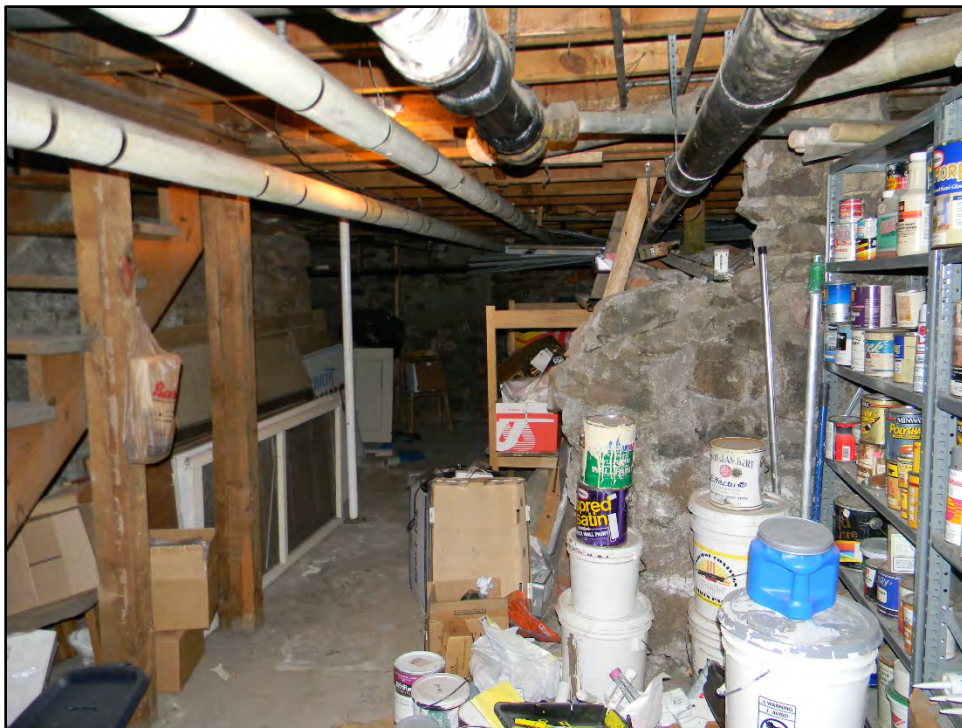
Figure D-666. A glance back toward the well/cistern area of the basement (with the stairs to the first floor at the left).

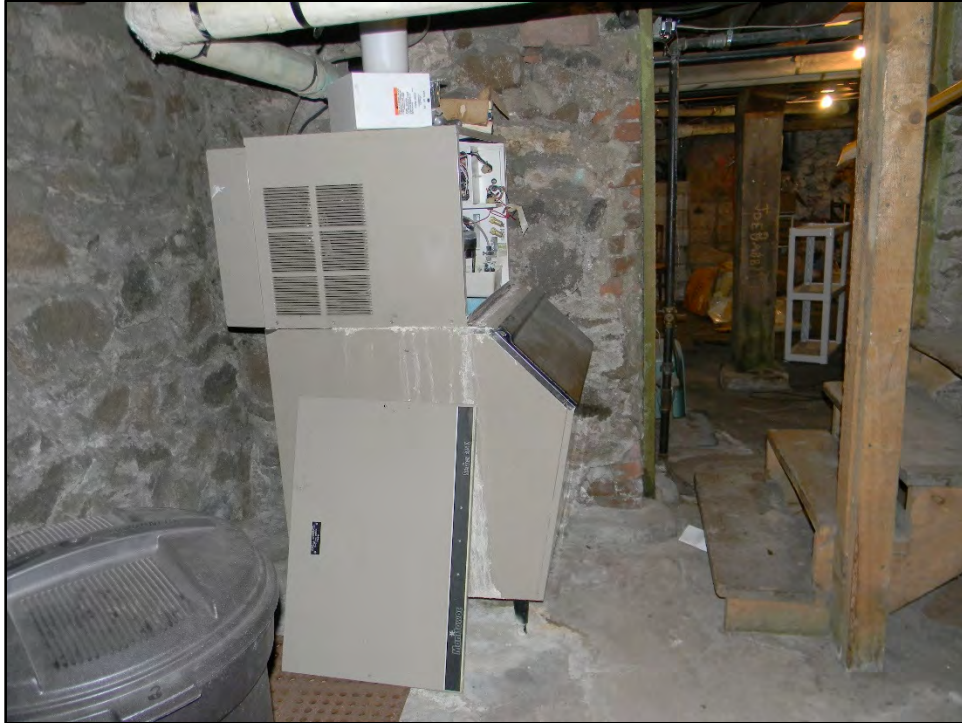
Figure D-667. An ice machine sits at the bottom of the stairs at the corner of the original basement wall dating to 1886.

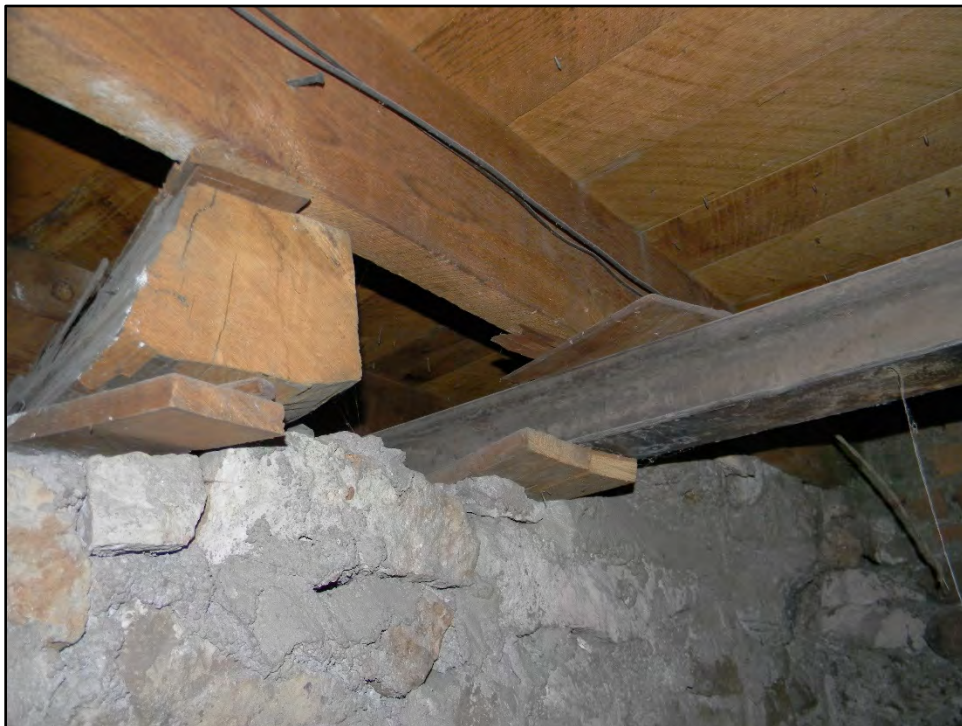
Figure D-668. A close-up view of the steel rail and other materials that still hold up the original 1886 extent of the residence over 130 years later.

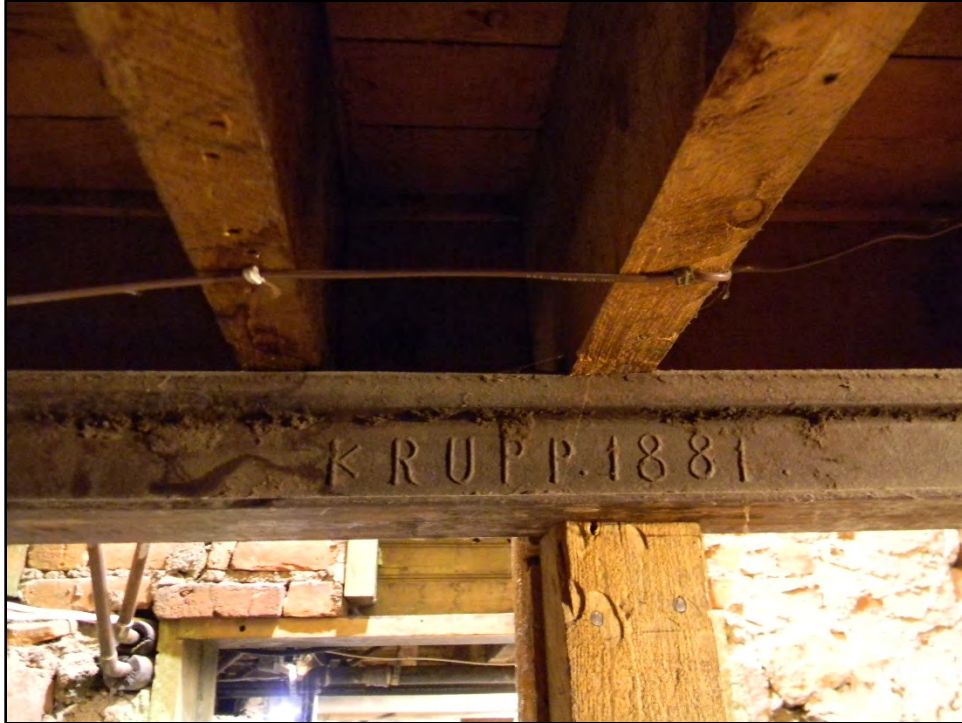
Figure D-669. A segment of steel rail from the Atlantic & Pacific railroad that first came through Flagstaff beginning in August 1882, incorporated into the post-and-beam construction of the 1886 residence.

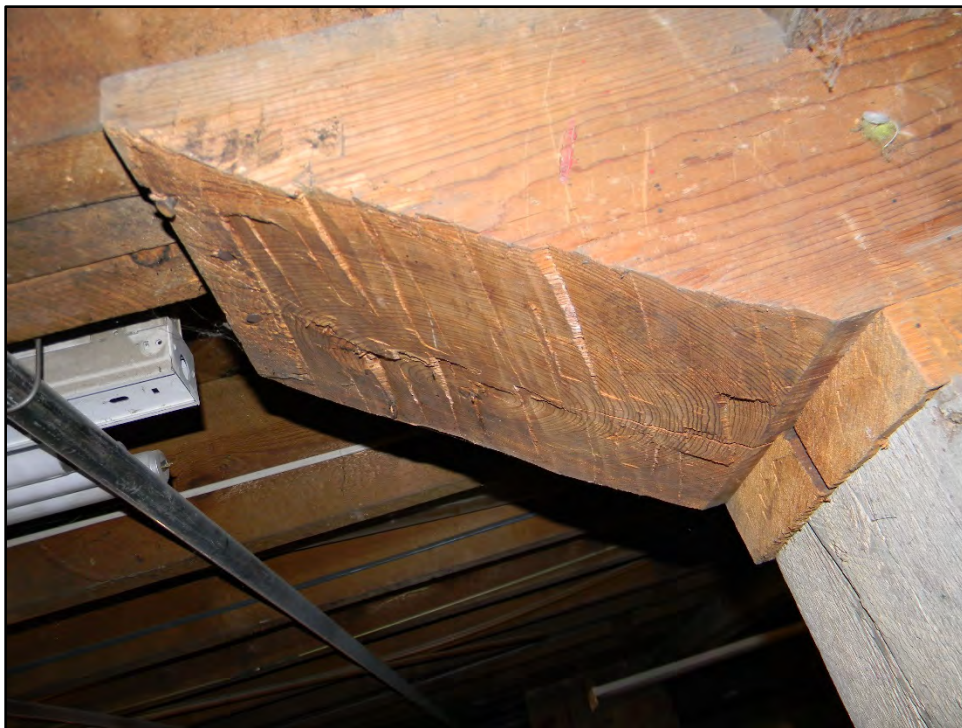
Figure D-670. A close-up view of the main basement support still shows the mark of the ax which shaped it over 130 years ago.

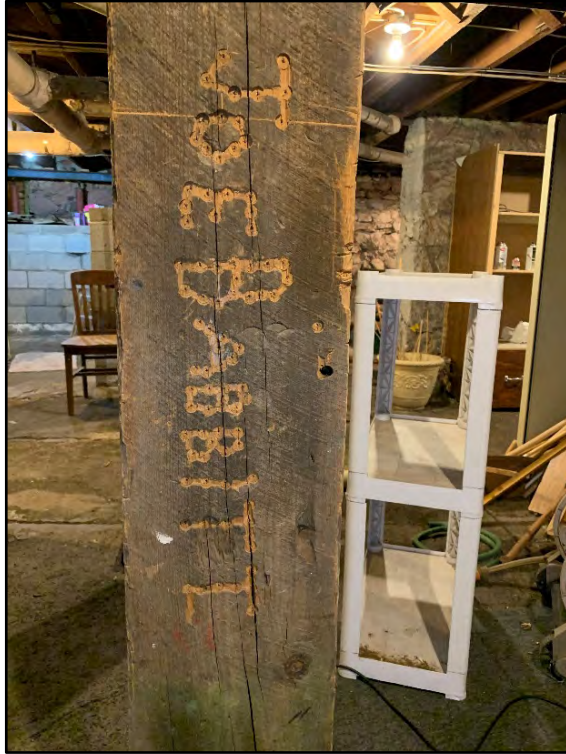
Figure D-671. At one point during his youth, Joe Babbitt took a nail gun and carved his name into the main basement support post (likely in the mid-to-late 1890s or early 1900s), which is clearly visible today.
