September 22, 2022

*RE: Historic Resource Study Letter Report for Parcel 104-02-068 at 609 South Lone Tree Road, City of Flagstaff, Coconino County, Arizona (PZ-22-00148, LA Neal Consulting, LLC Project No. 1081-22)*

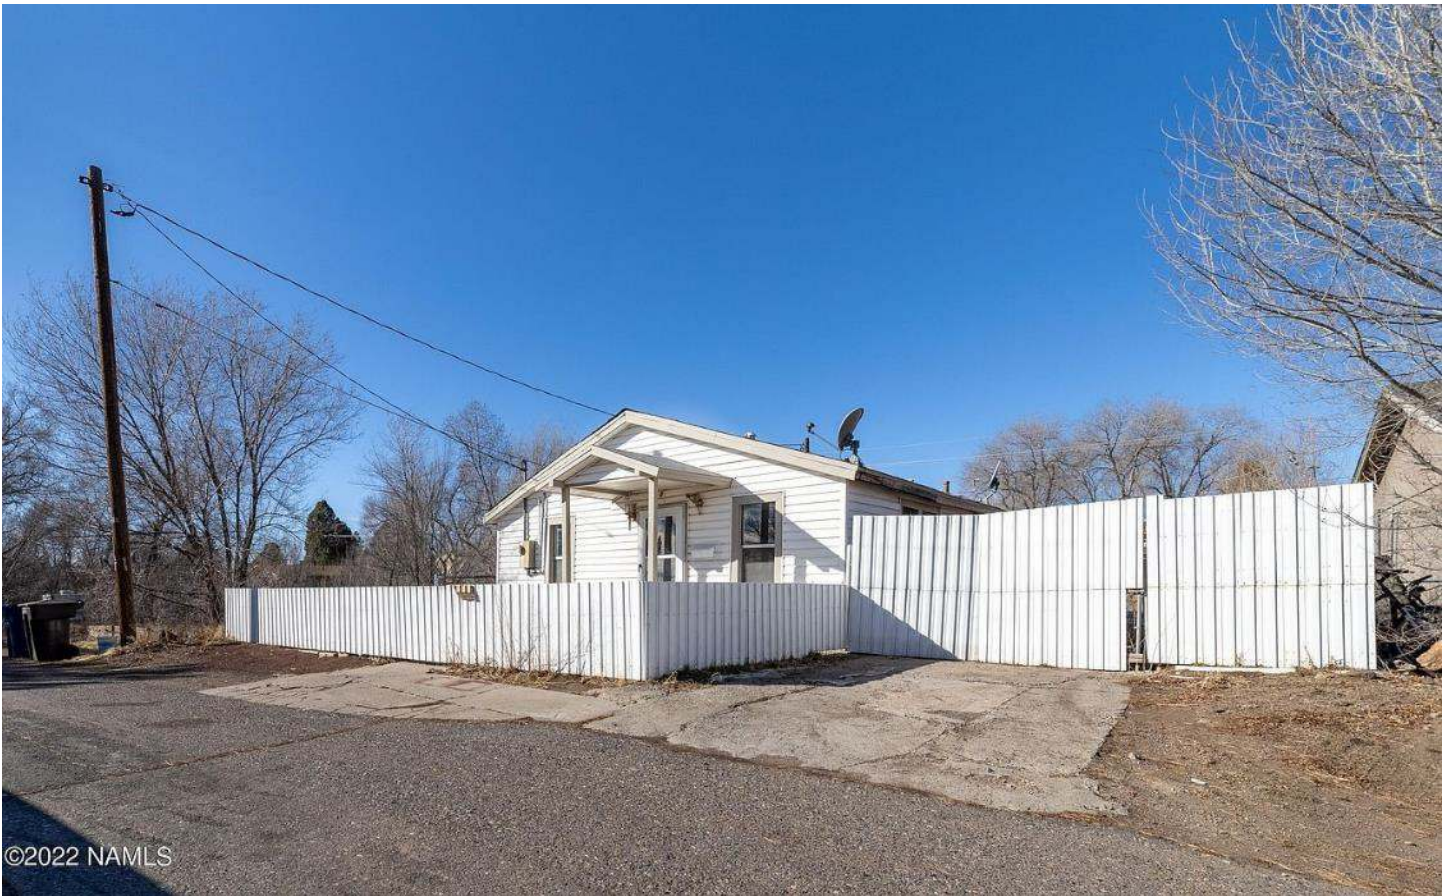
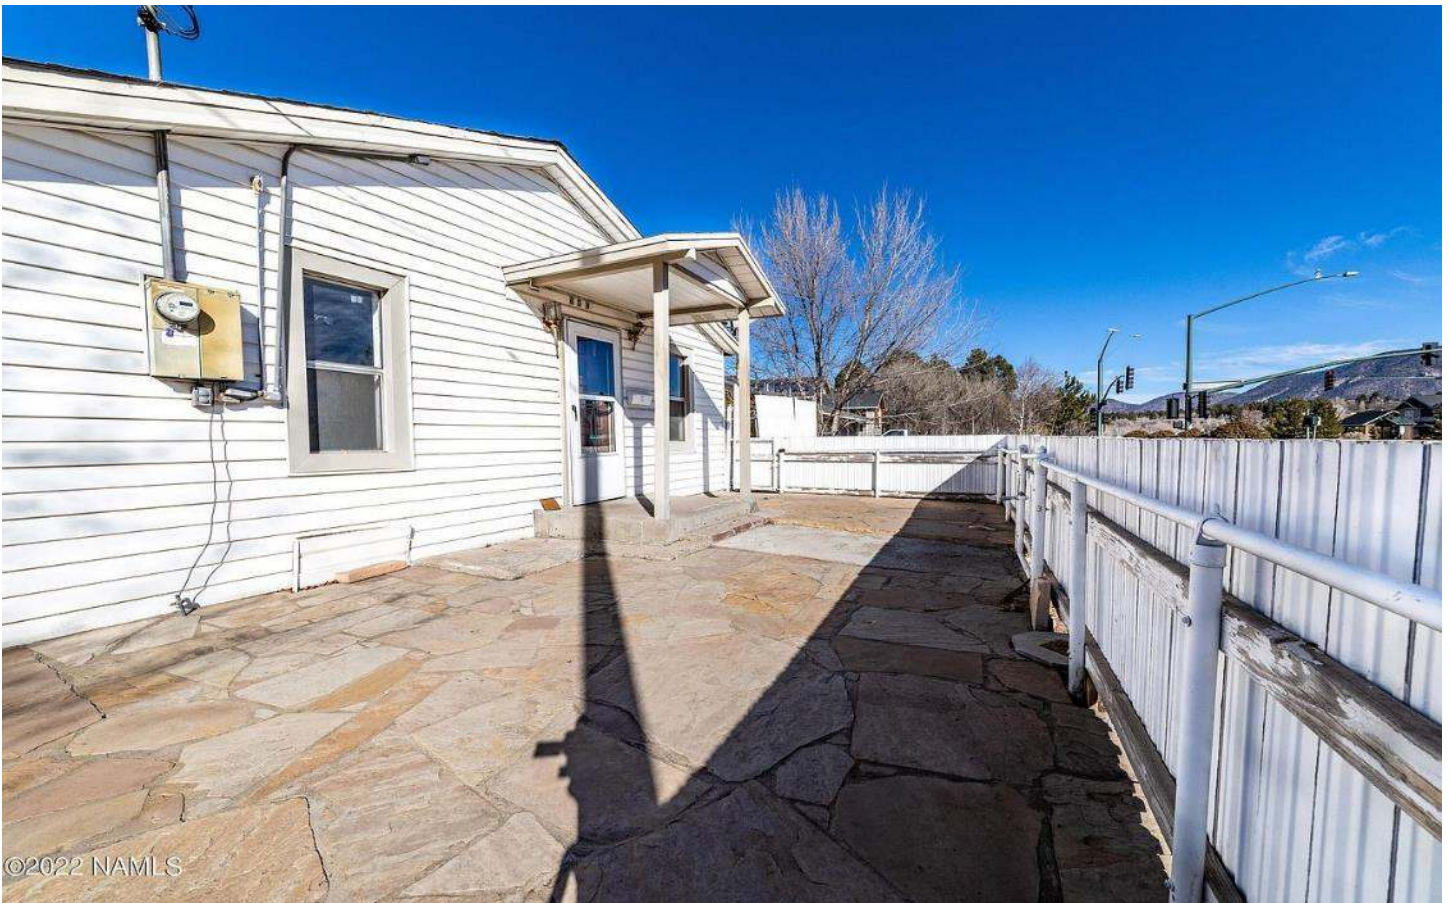
Photos 1–2. 609 S Lone Tree Rd overview from turnout off Lone Tree, view to SW (top) and NNW (bottom).

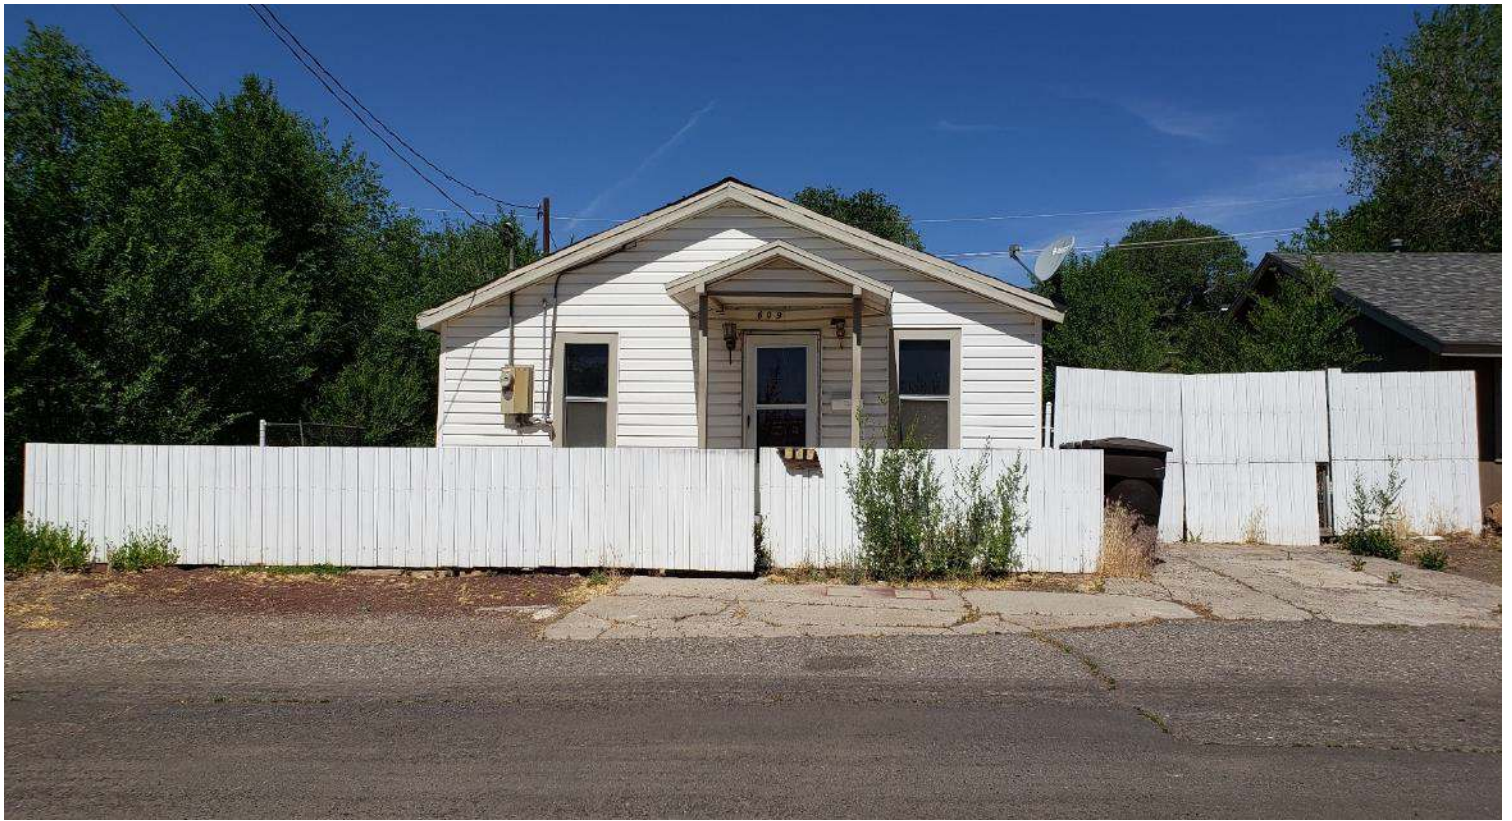
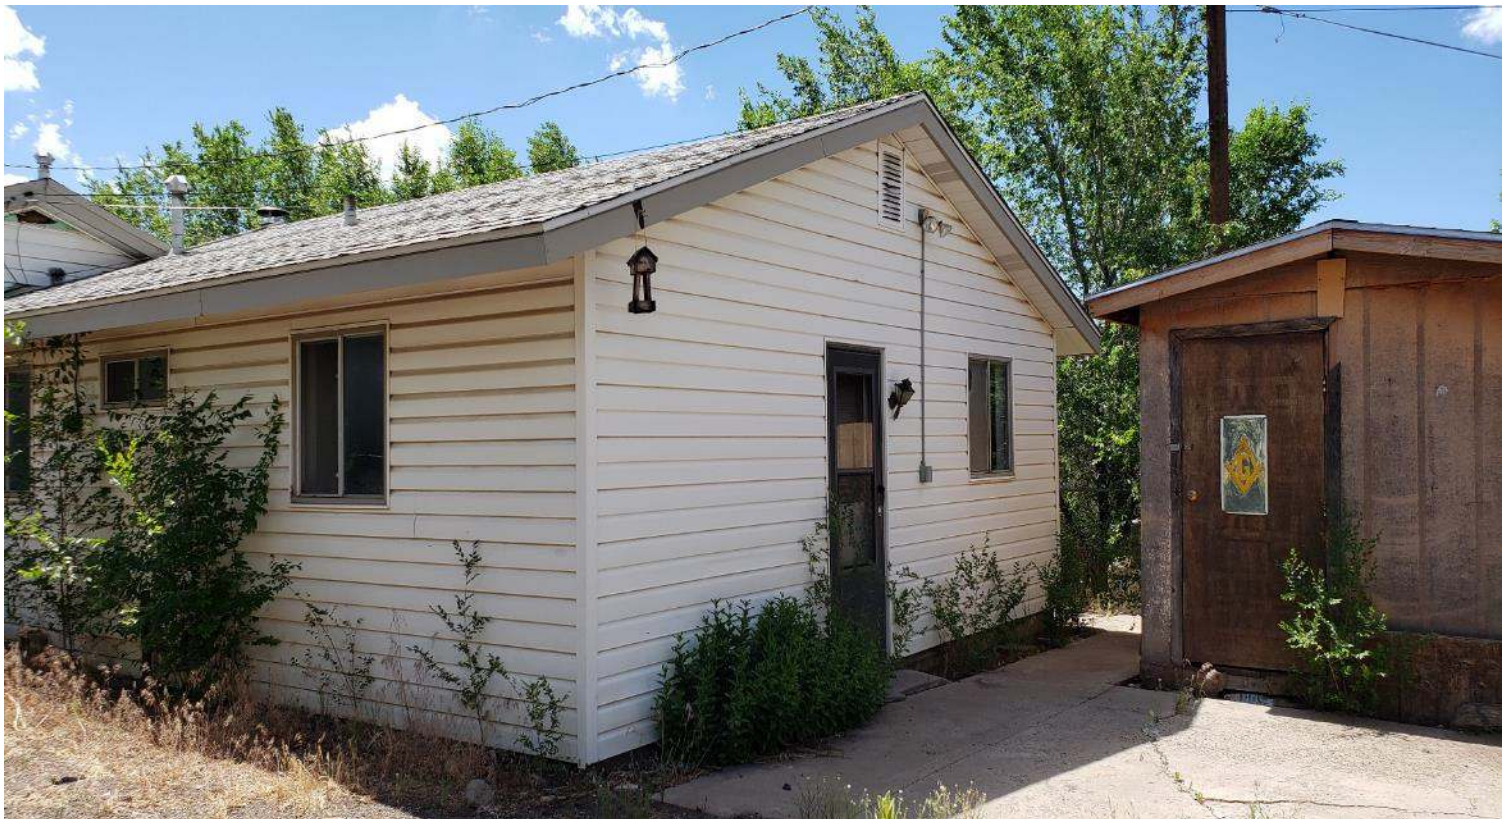
Photos 3–4. 609 S Lone Tree Rd front/E façade (top) and rear/W façade facing SE (bottom).

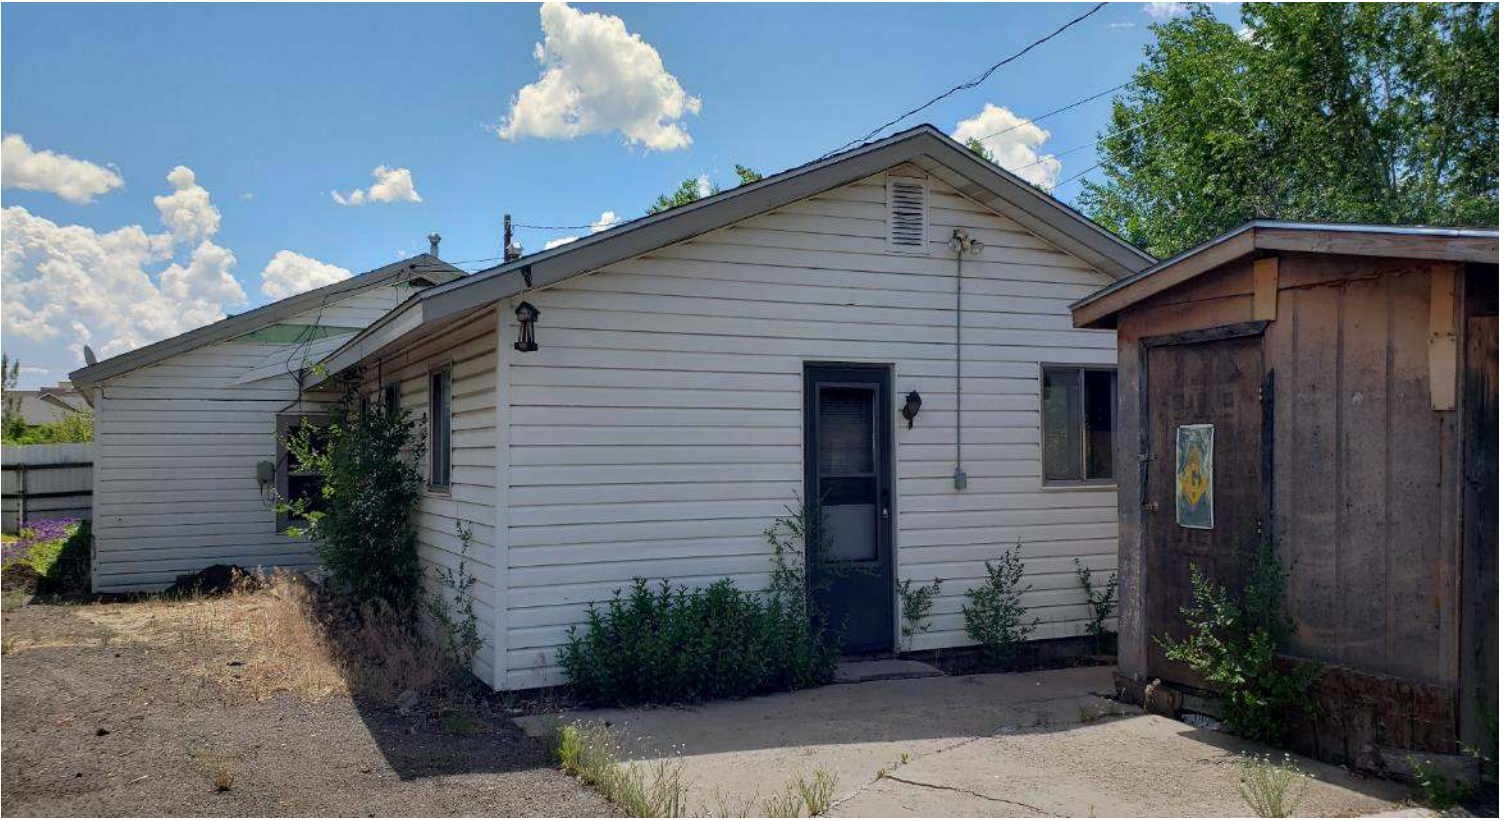
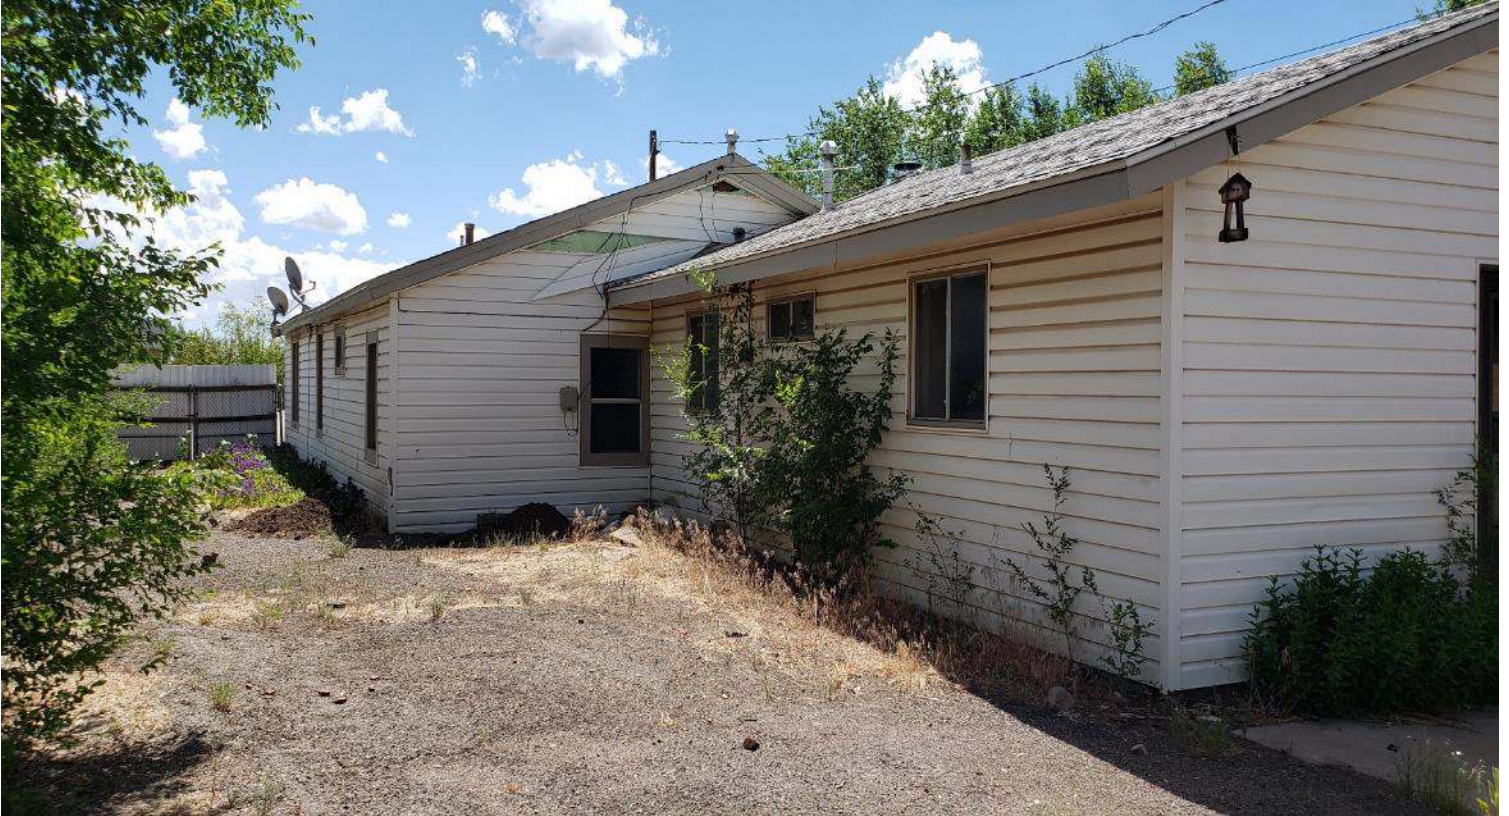
Photos 5–6. 609 S Lone Tree Rd rear/W façades facing ESE (top) and N and W façades facing ESE (bottom).

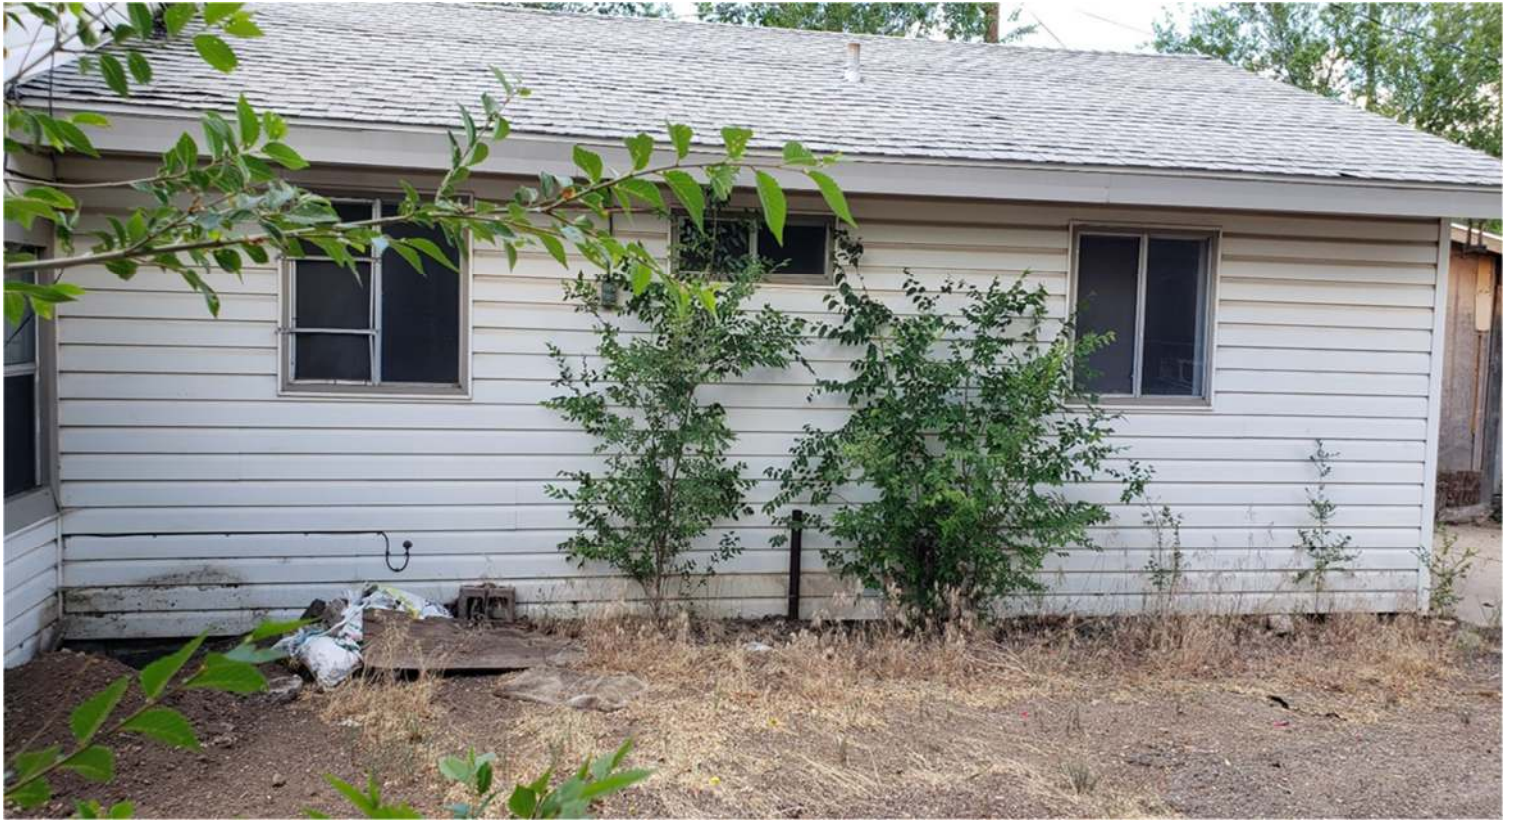
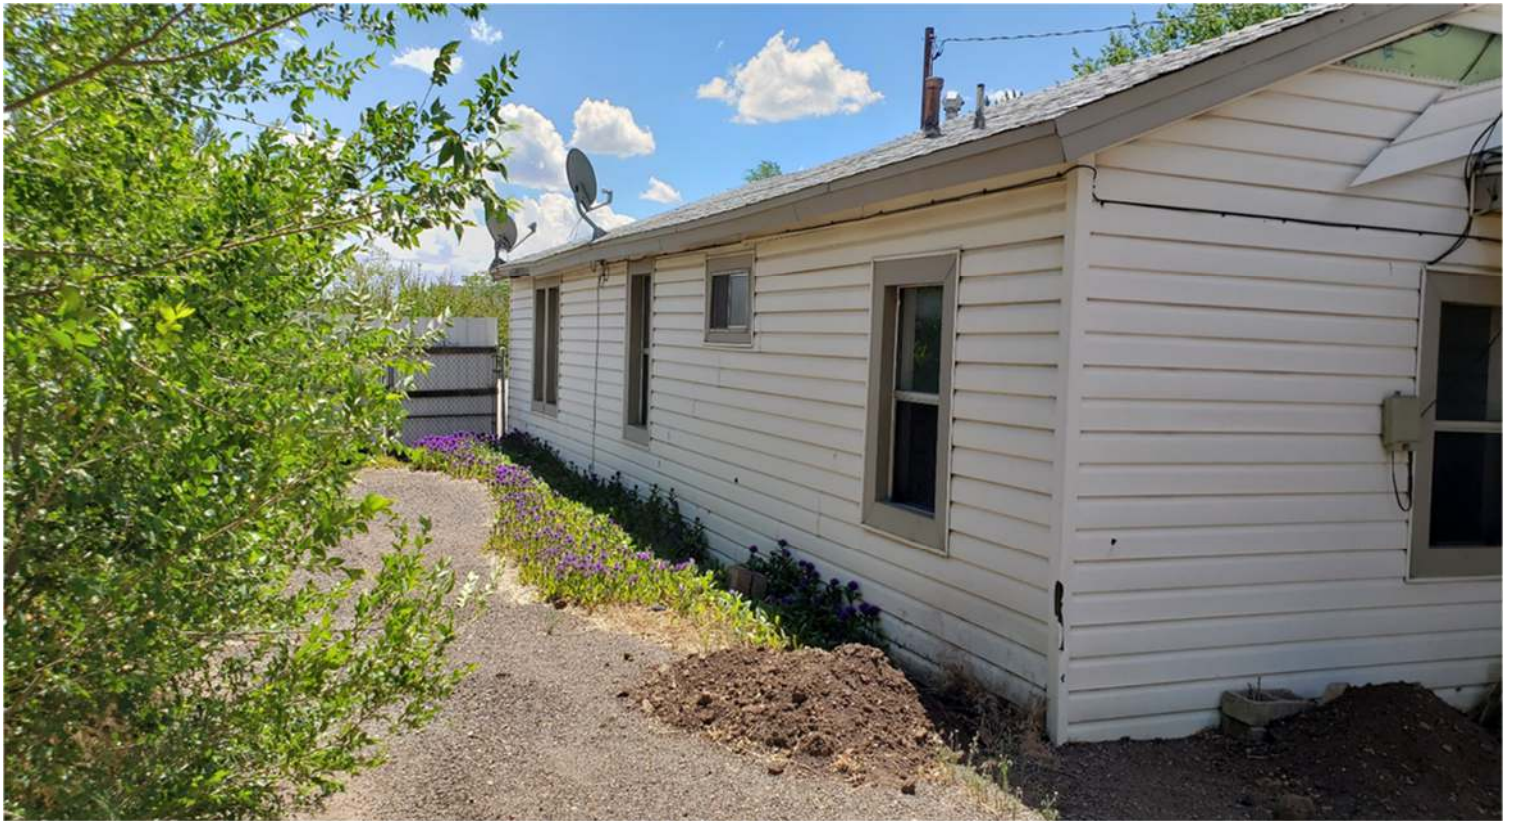
Photos 7–8. 609 S Lone Tree Rd N façade W half (top) and N façade E half/partial W facade facing ESE (bottom).

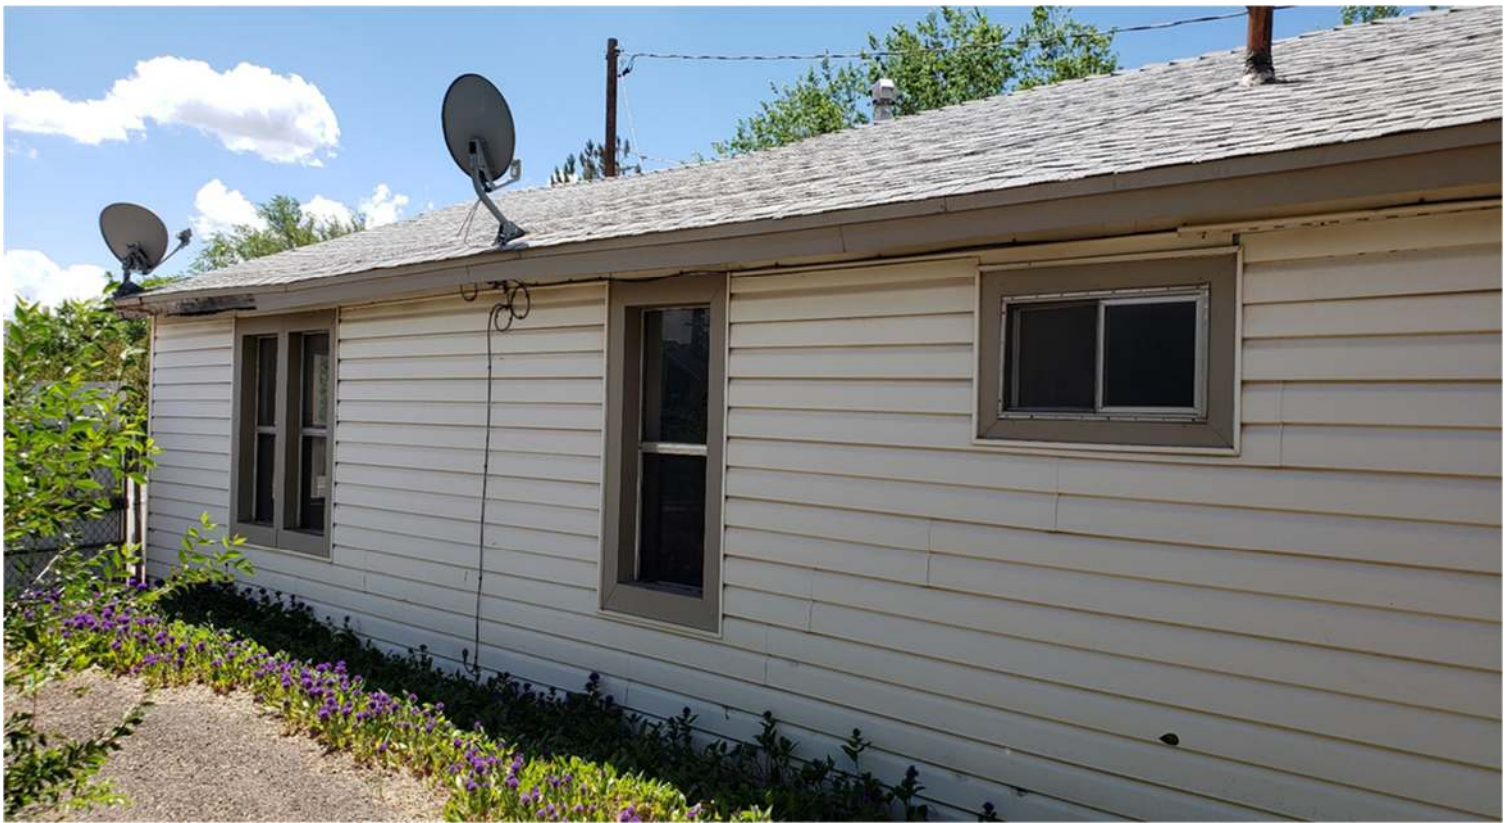
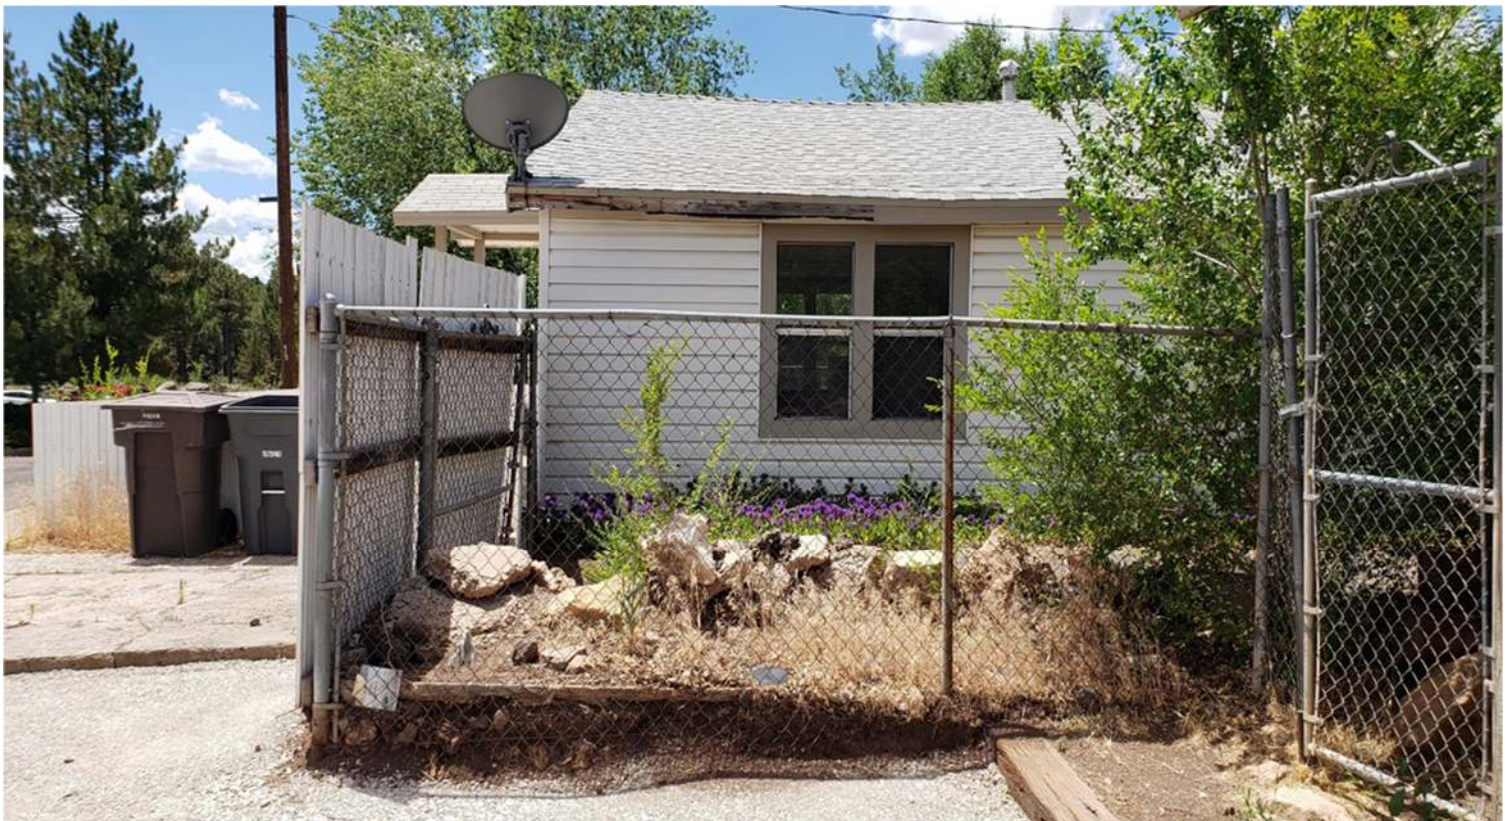
Photos 9–10. 609 S Lone Tree Rd N façade E half facing SE (top) and S from outside the lot (bottom); note rock-lined raised garden bed in foreground inside fence.

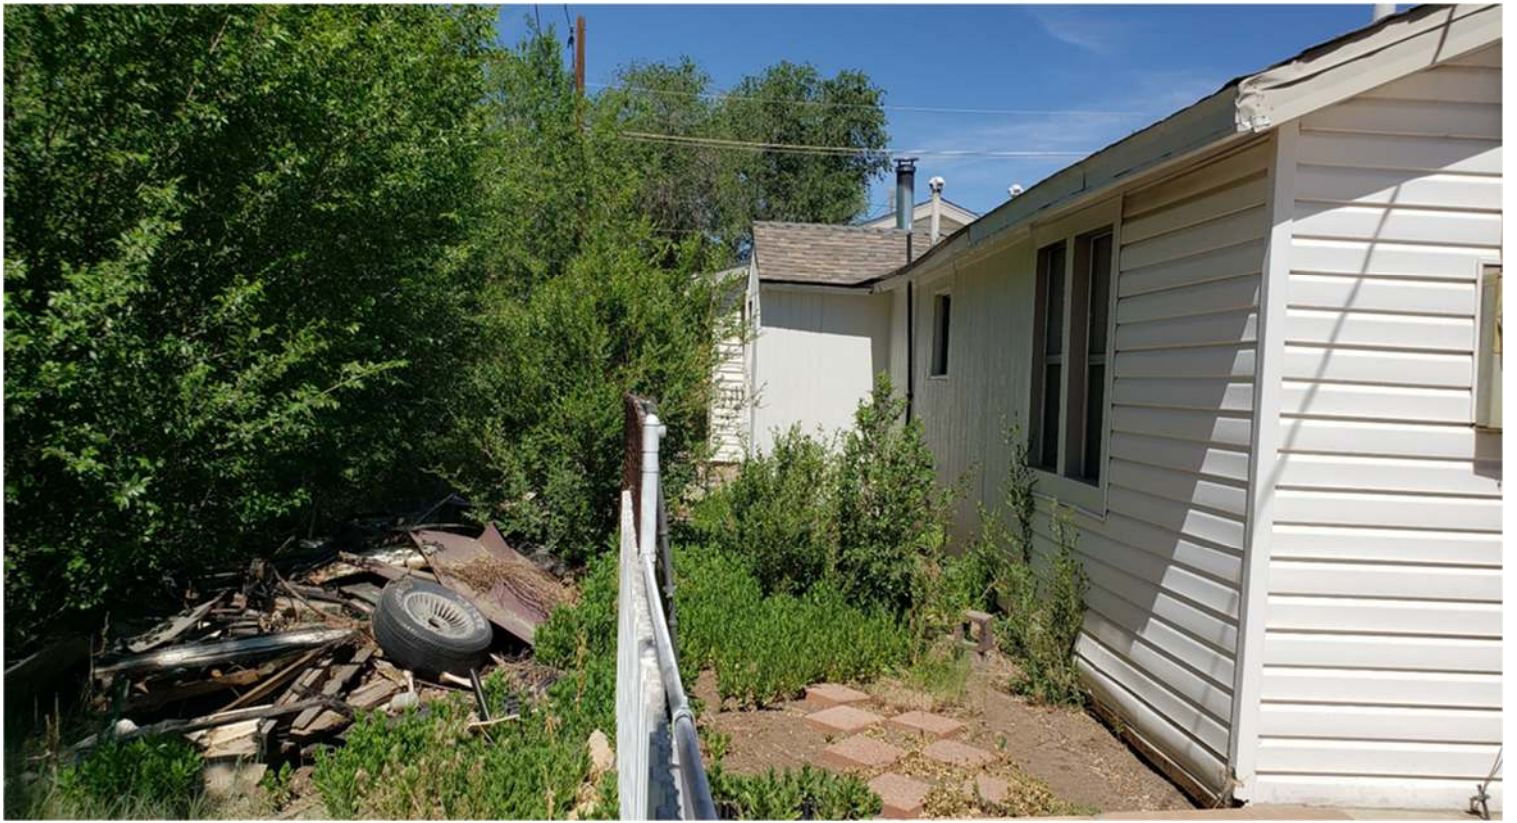
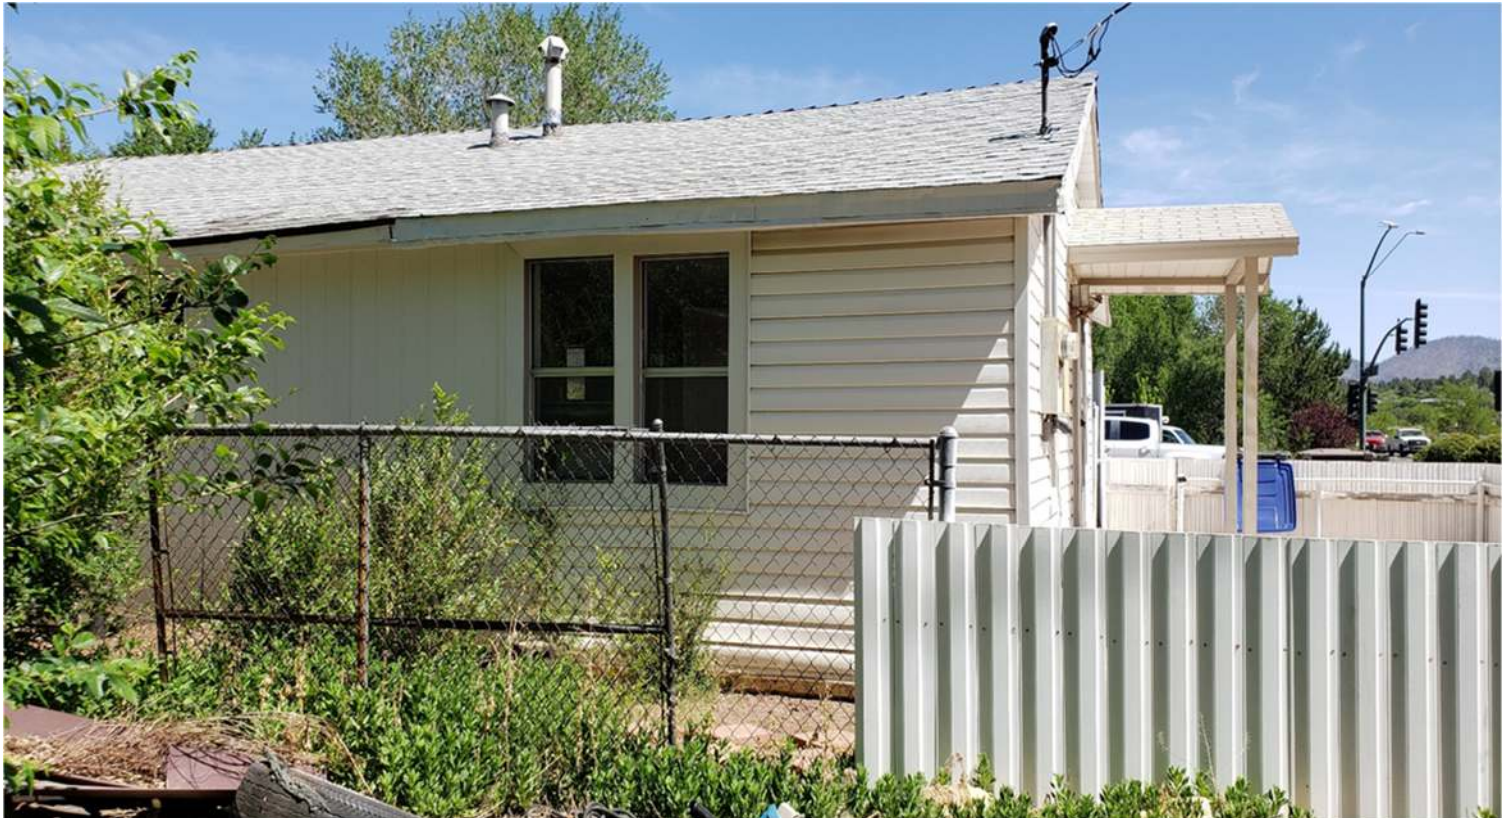
Photos 11–12. 609 S Lone Tree Rd S façade oblique overview facing W (top) and E half facing N (bottom).

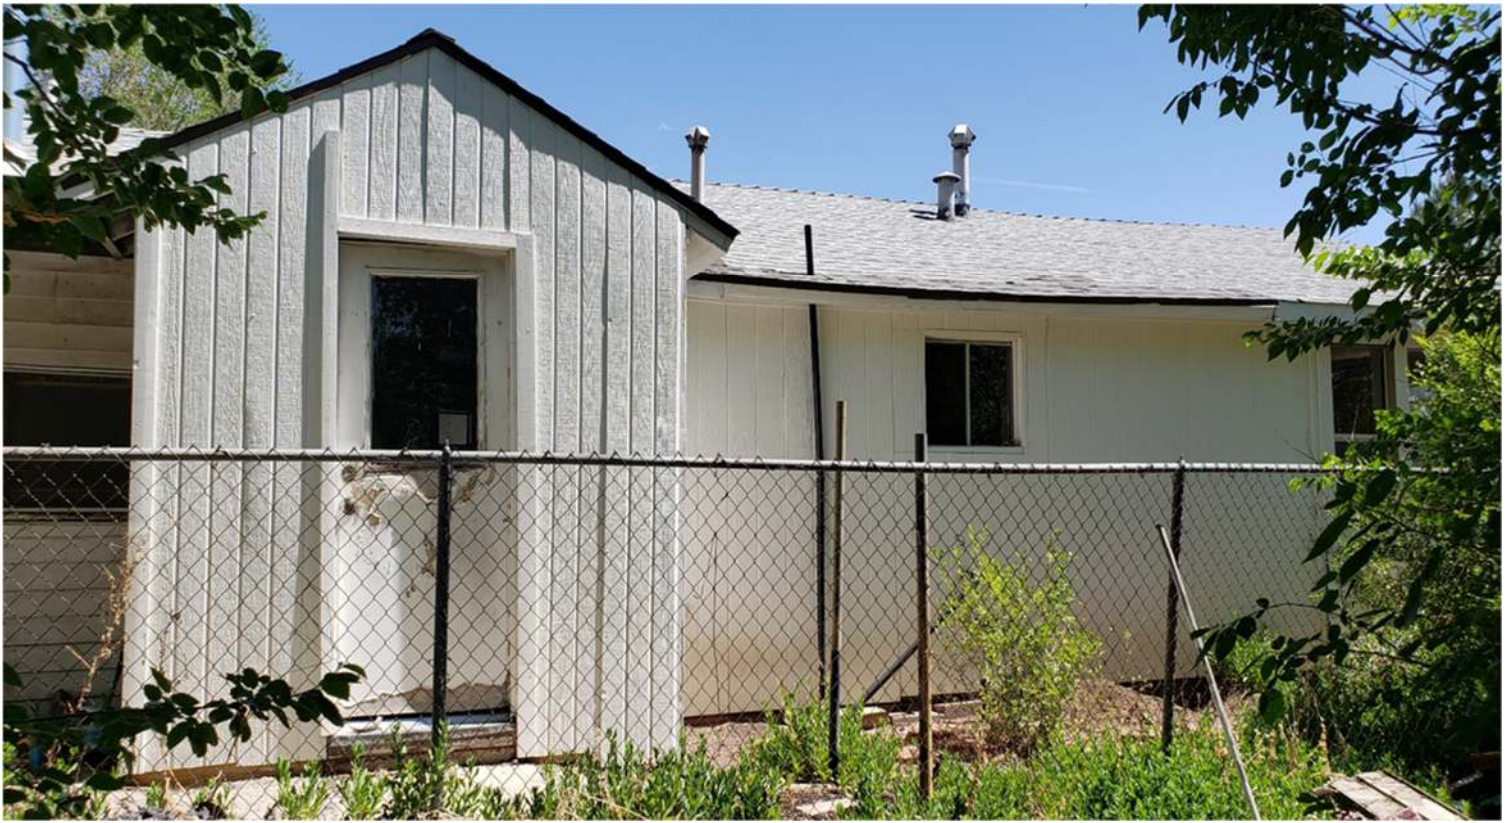
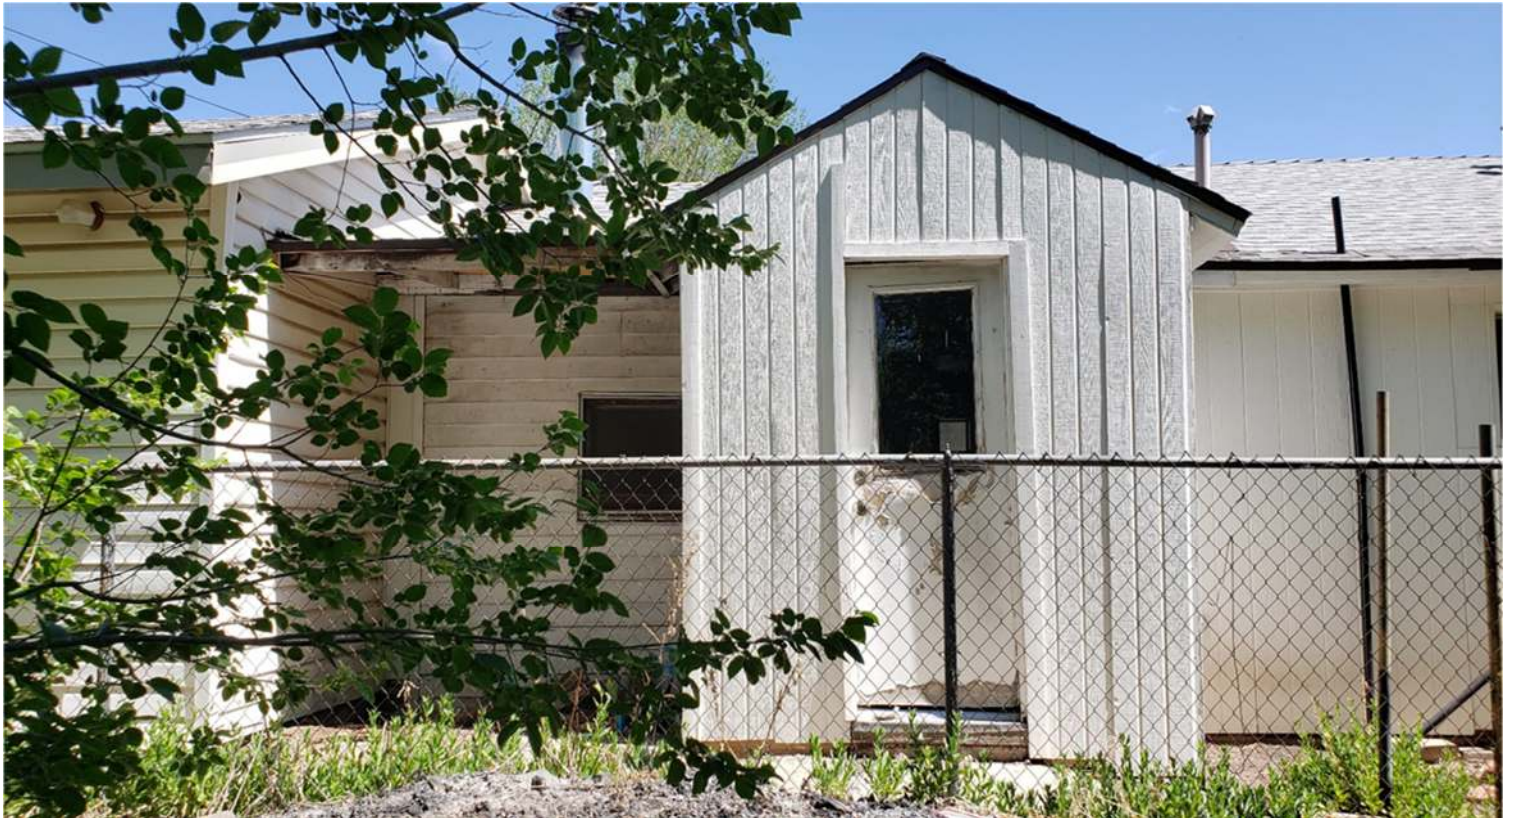
Photos 13–14. 609 S Lone Tree Rd S façade enclosed porch entry and E half (top) and porch entry plus W house addition junction (bottom); photos taken from neighboring property.

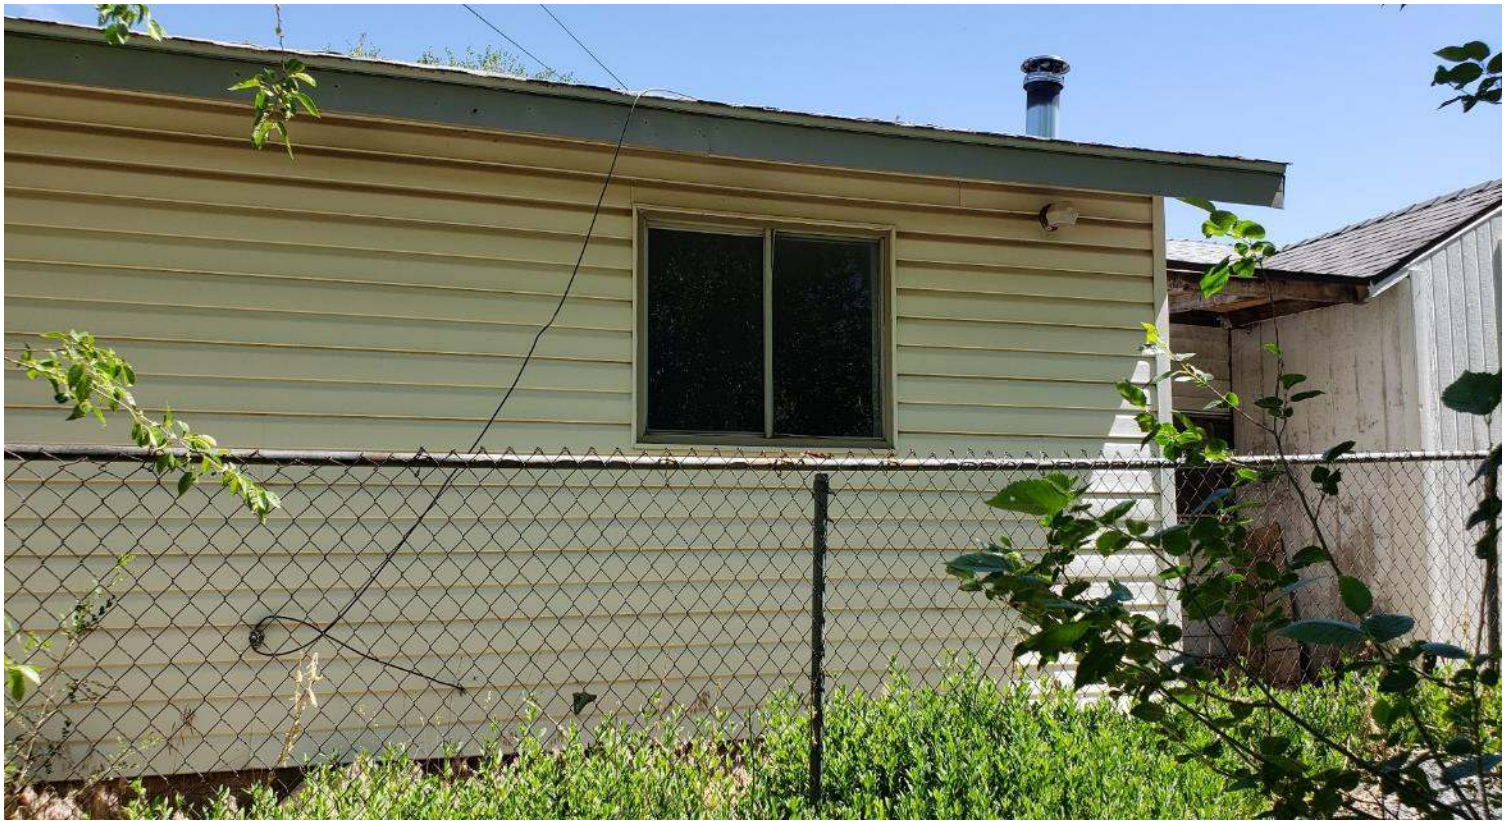
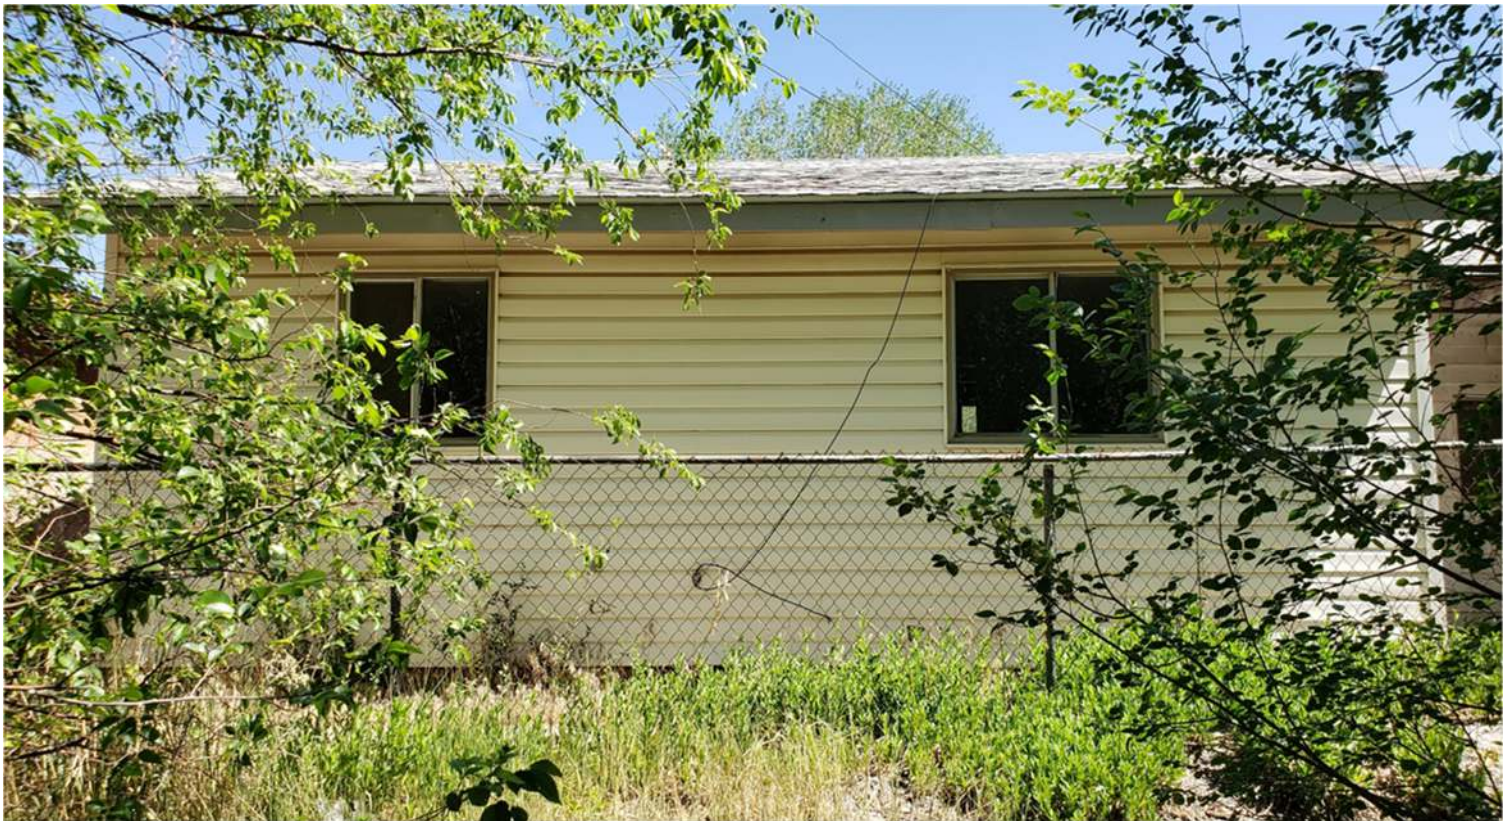
Photos 15–16. 609 S Lone Tree Rd S façade W half, alcove/enclosed porch entry of E half (top) and S façade W half (bottom); photos taken from neighboring property.

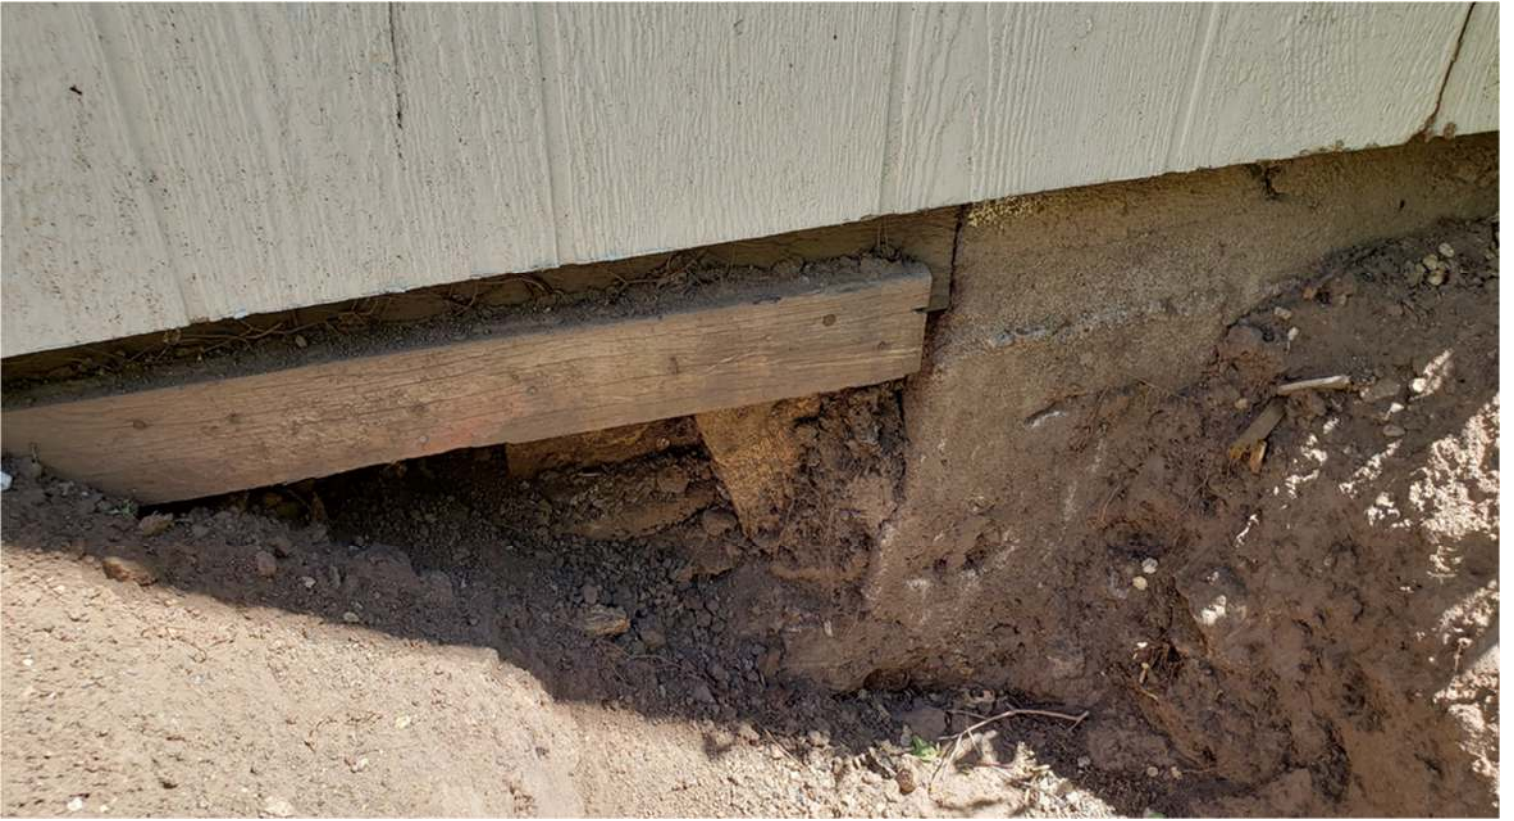
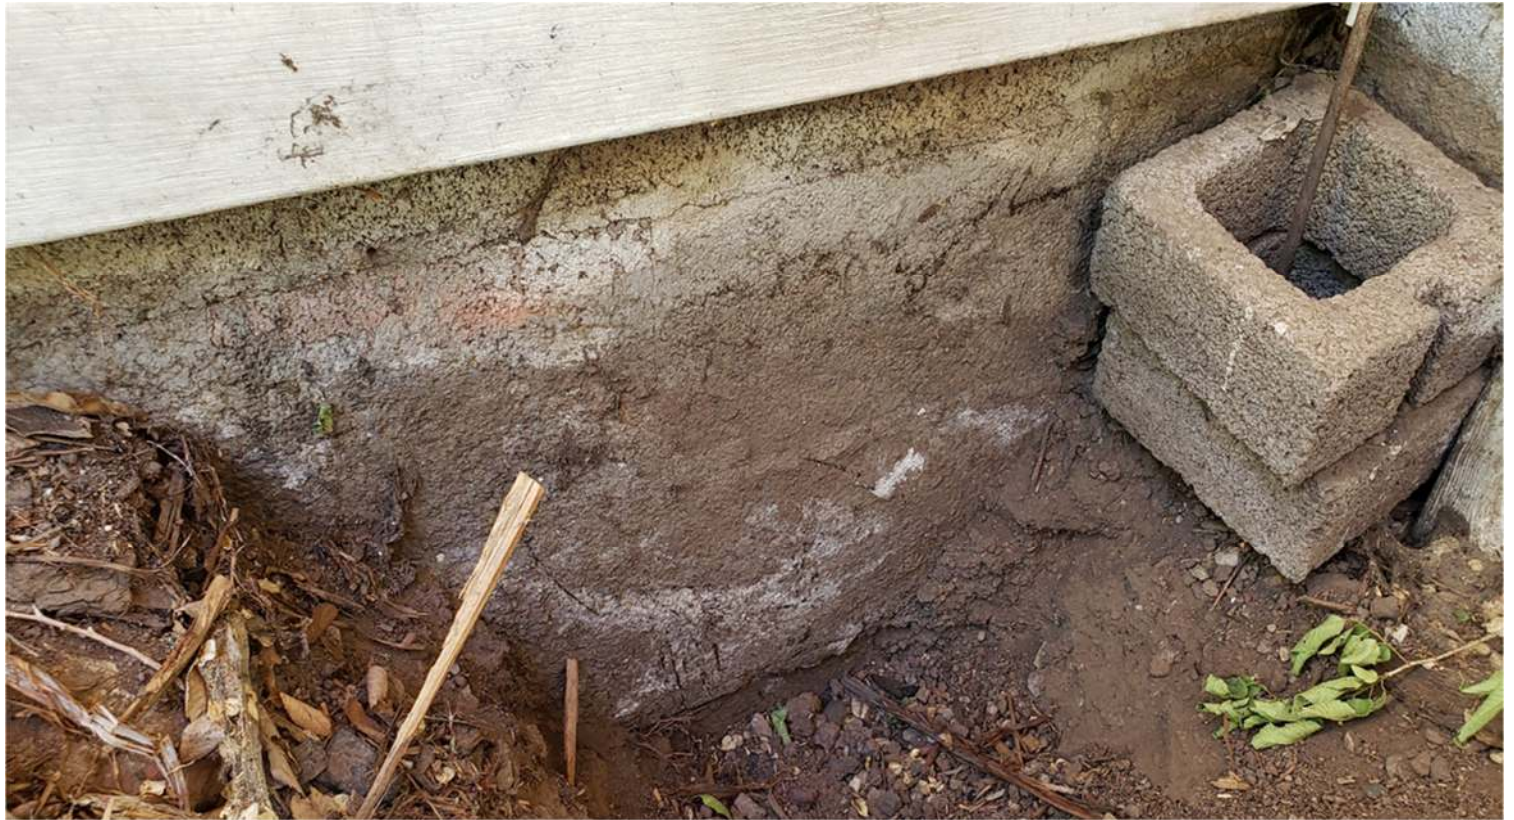
Photos 17–18. 609 S Lone Tree Rd S façade E half footer wall and wood fiberboard siding (top) and E façade W half (within S façade alcove) footer wall and wood-grained vinyl siding (bottom).
