September 22, 2022

*RE: Historic Resource Study Letter Report for Parcel 104-02-068 at 609 South Lone Tree Road, City of Flagstaff, Coconino County, Arizona (PZ-22-00148, LA Neal Consulting, LLC Project No. 1081-22)*

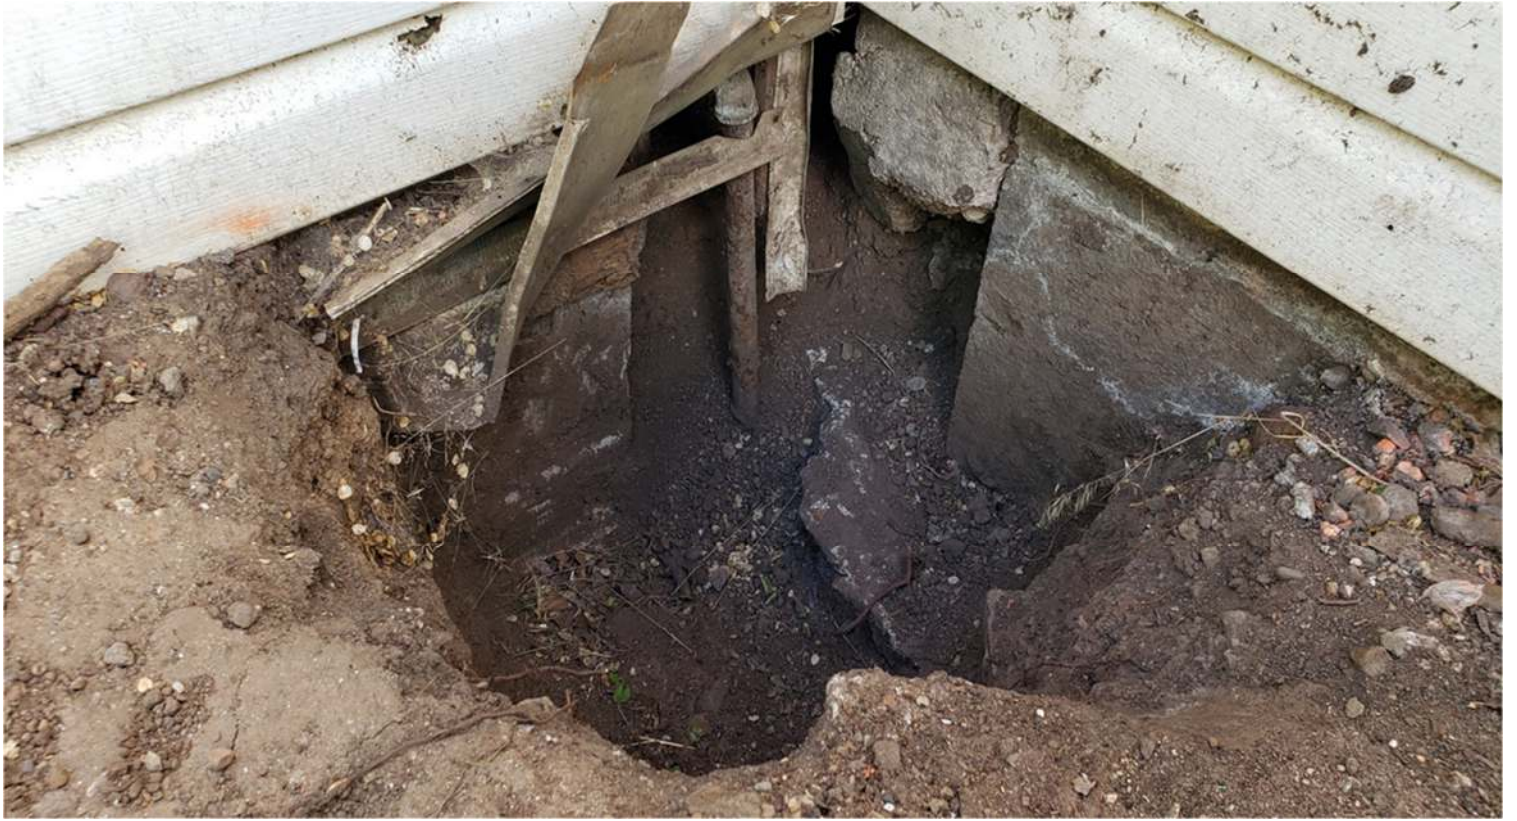
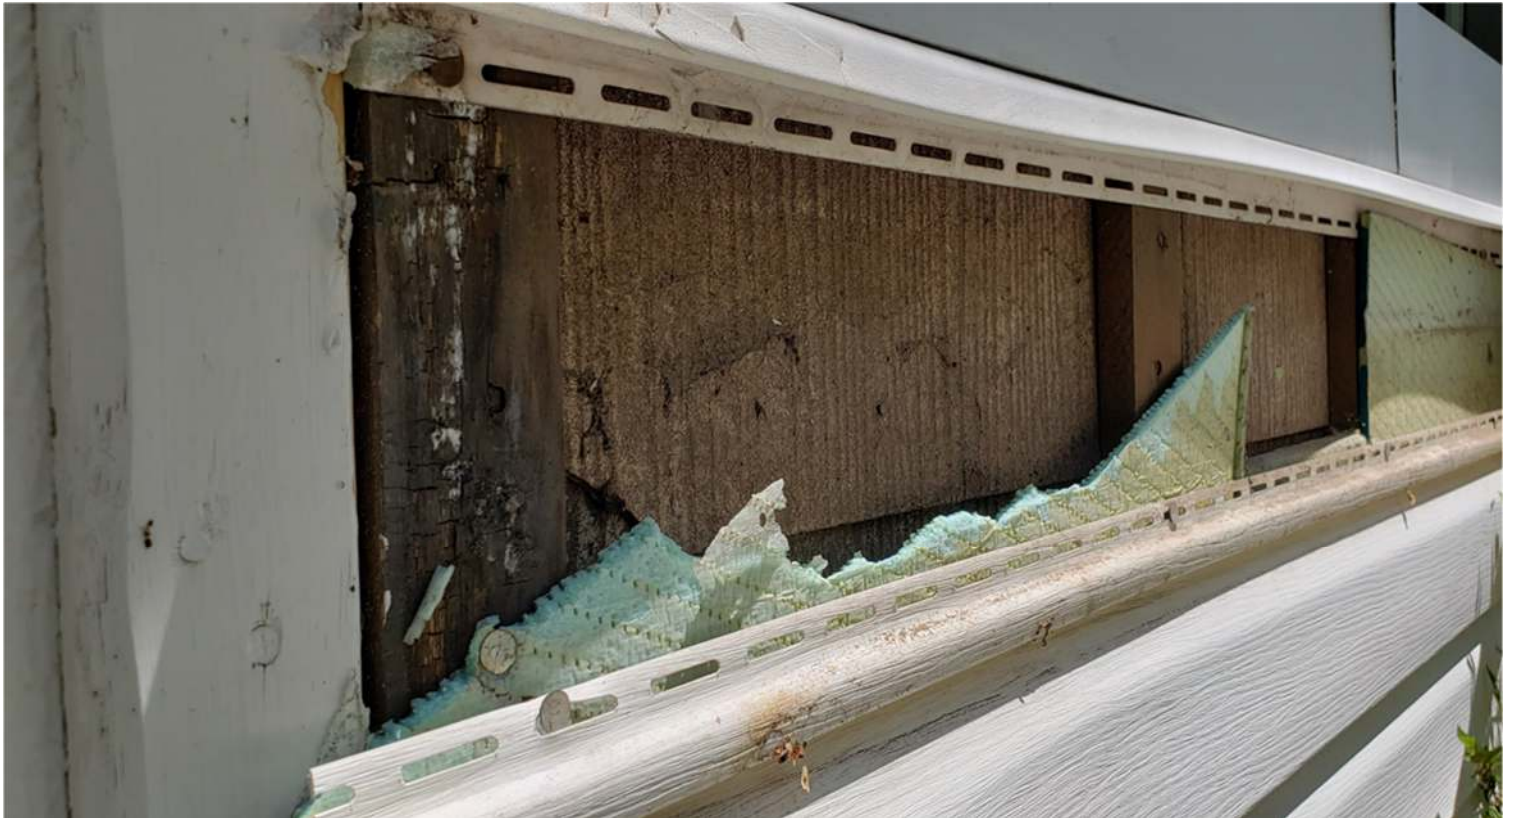
Photos 19–20. 609 S Lone Tree Rd W façade E half / N façade W half footer walls and wood-grained vinyl siding, view to SE (top); example of exterior finish layers on S façade E half, view to NE (bottom).

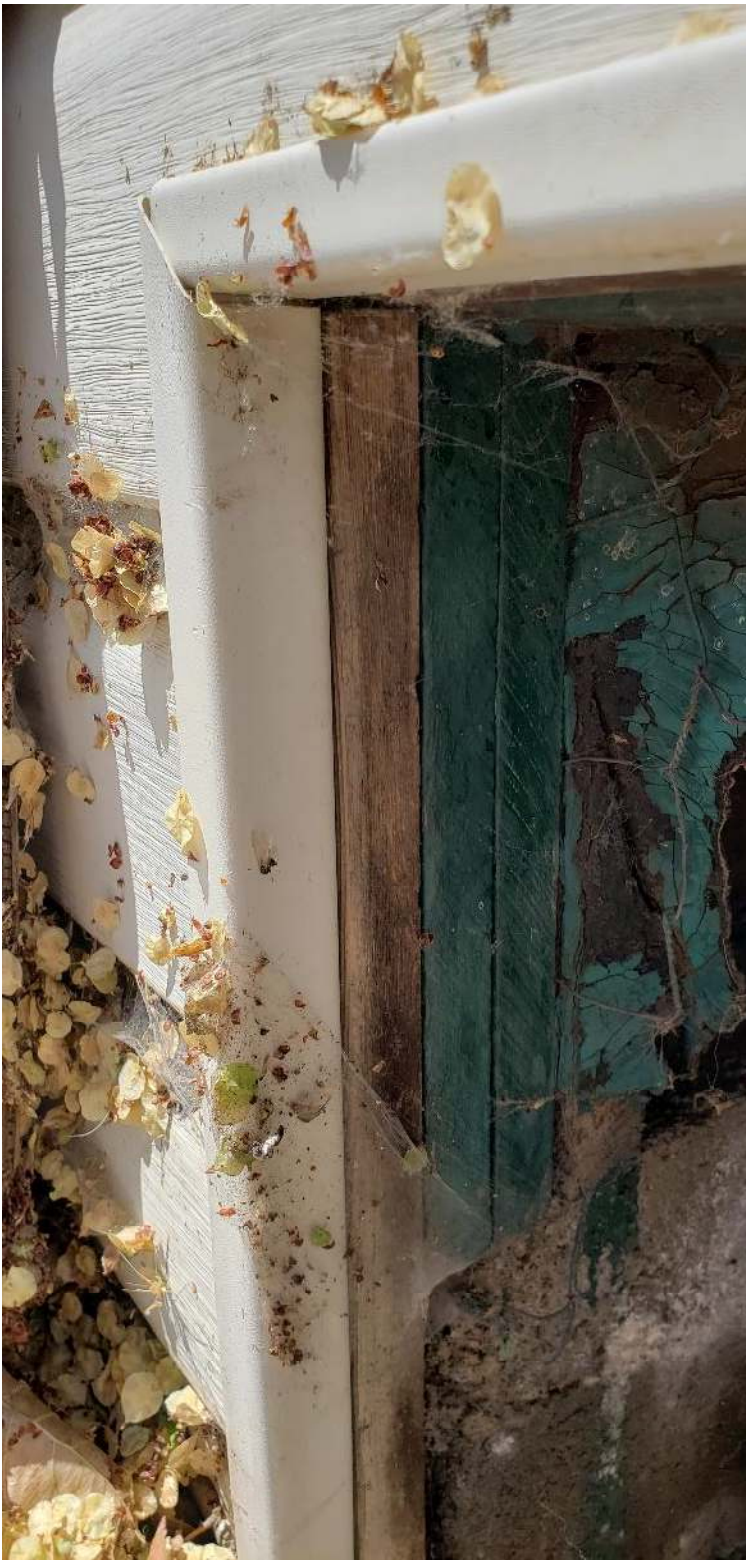
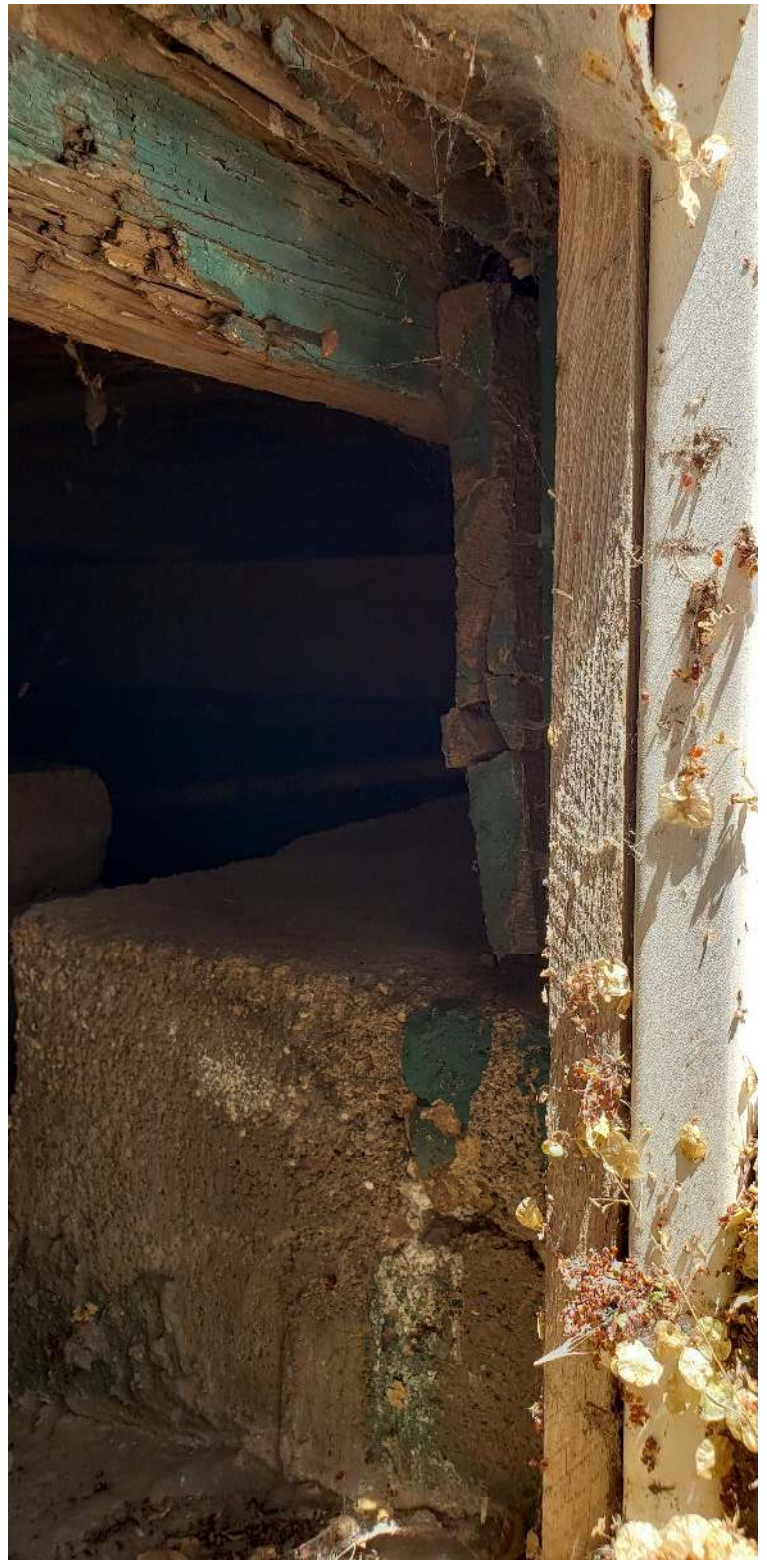
Photos 21–22. 609 S Lone Tree Rd E/front façade crawlspace opening showing footer wall, exterior finish layers, previous paint color; view to SSW (left) and NNW (right).

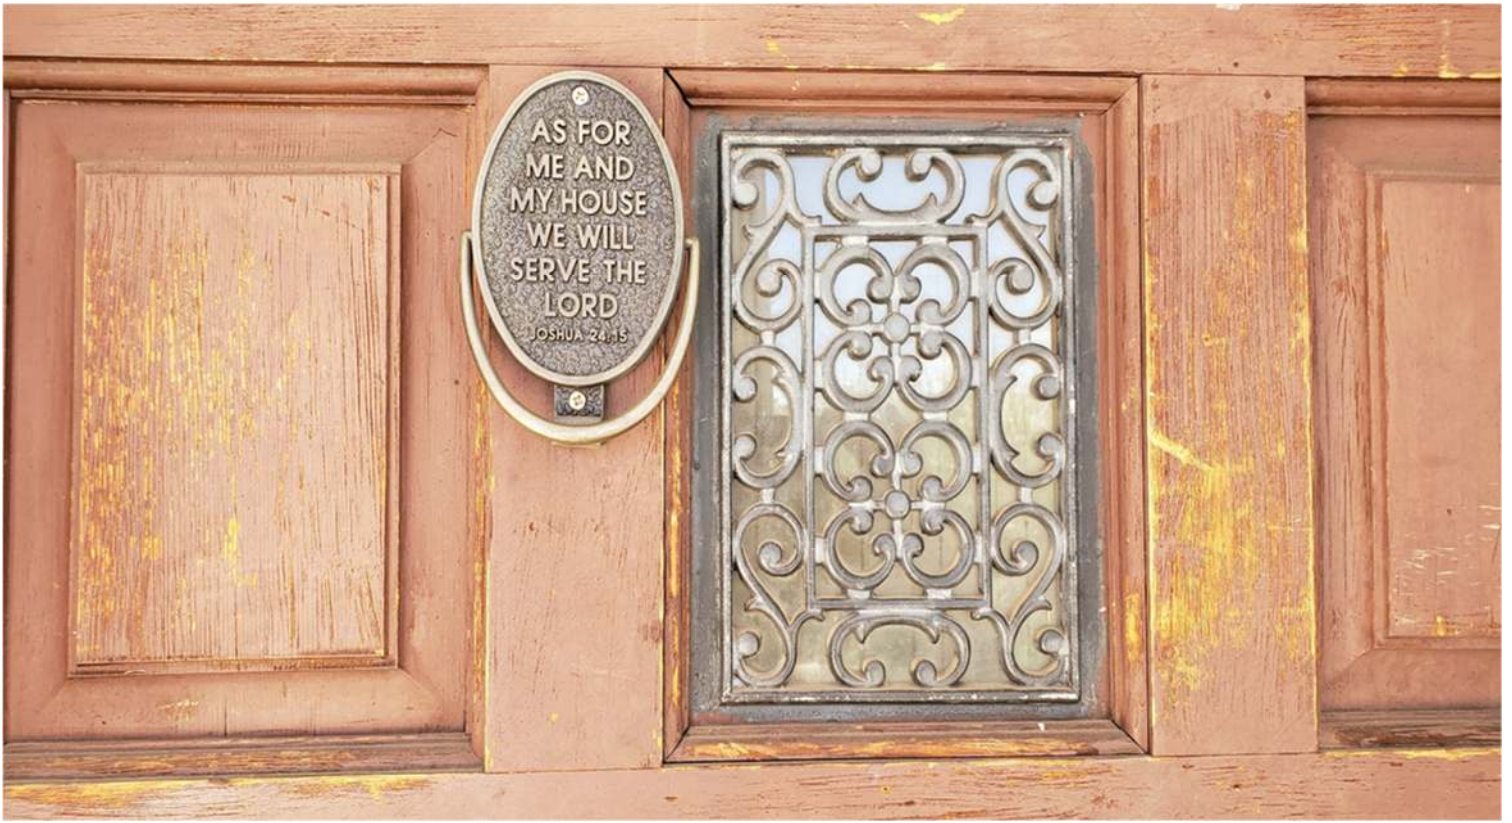
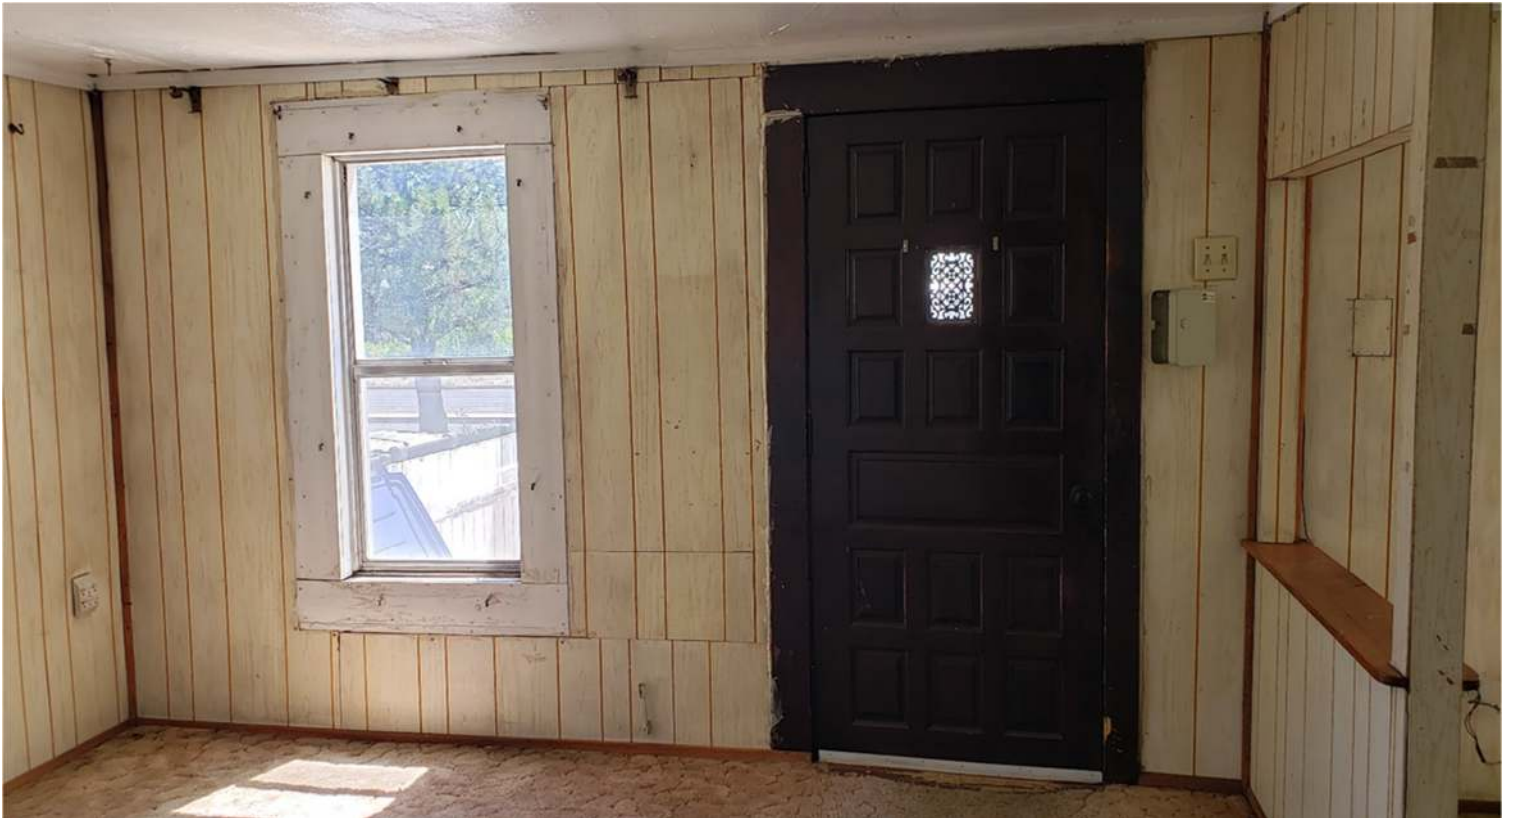
could date to ca. 1950, but the door hardware has been replaced (*Photos 23–24*). A side entrance exists in the form of a wood paneled door with a fixed window (*Photo 42*) and an enclosed porch/mudroom that was added to the south façade of the original house (*Photos 13–14, 39–40*). Windows on the original house are mostly aluminum single-hung ( $n = 9$ ) with one aluminum horizontal slider in the kitchen that also has newer wood framing and trim, one wood horizontal slider with frosted glass in the utility room in the house's southwest corner, and a small aluminum horizontal slider in the bathroom (*Photos 25–36, 41–43*). The aluminum windows are all likely replacements to original wood windows.

Photos 23–24. 609 S Lone Tree Rd E/front door exterior (top) and front door/NE corner room facing E (bottom).

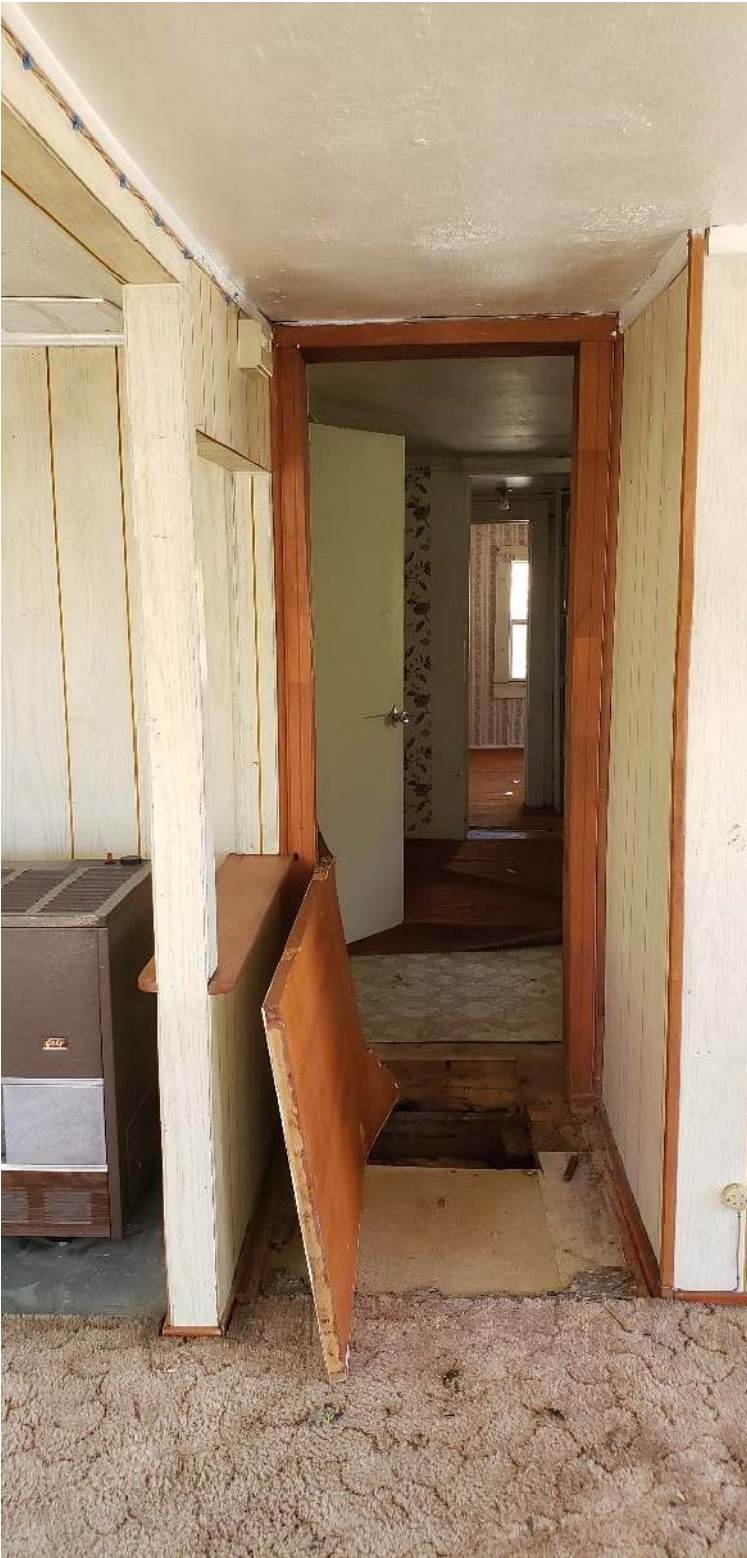
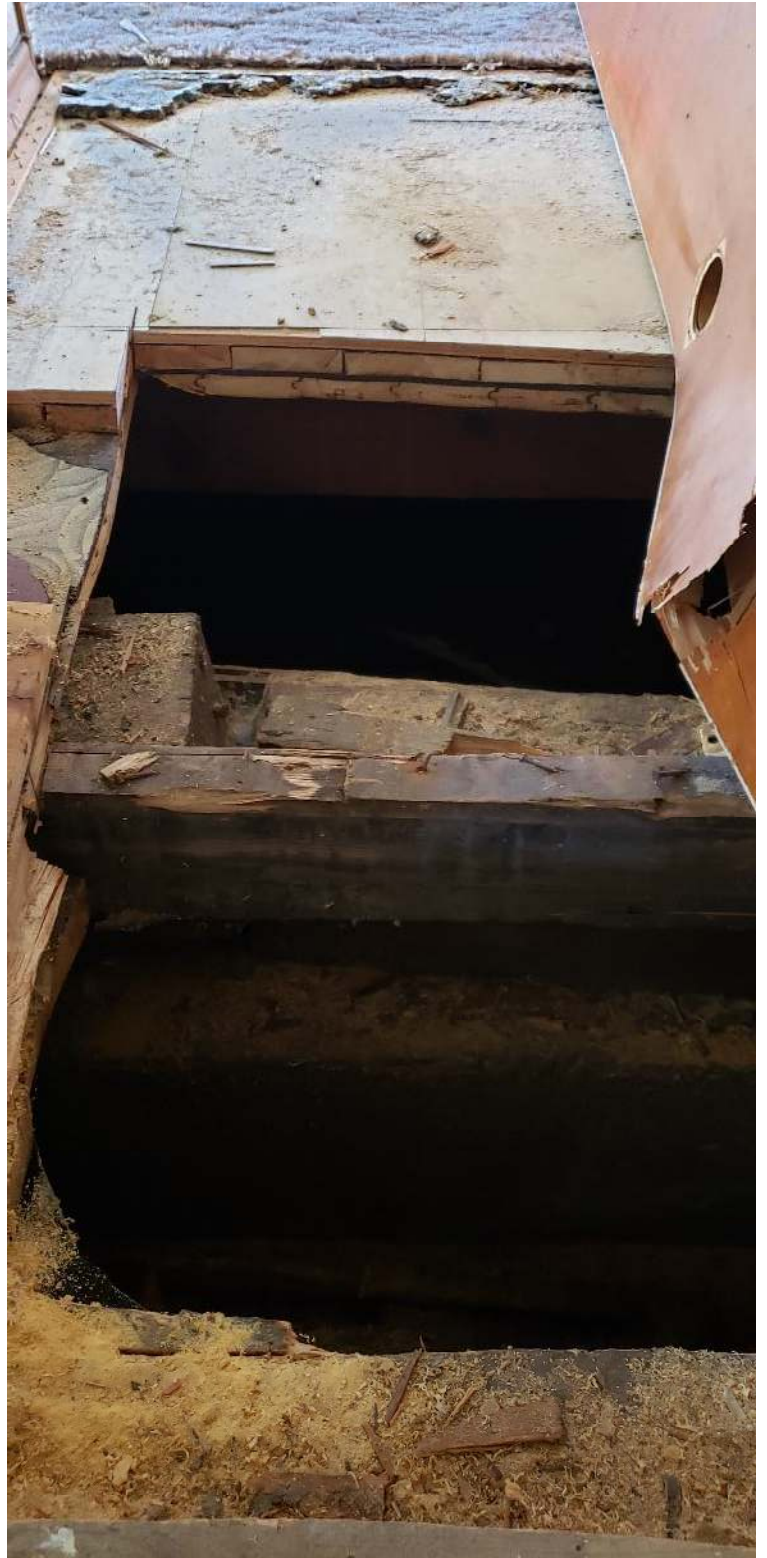
Photos 27–28. 609 S Lone Tree Rd hallway from front room NE corner (top) and view to W of flooring layers in doorway (bottom).

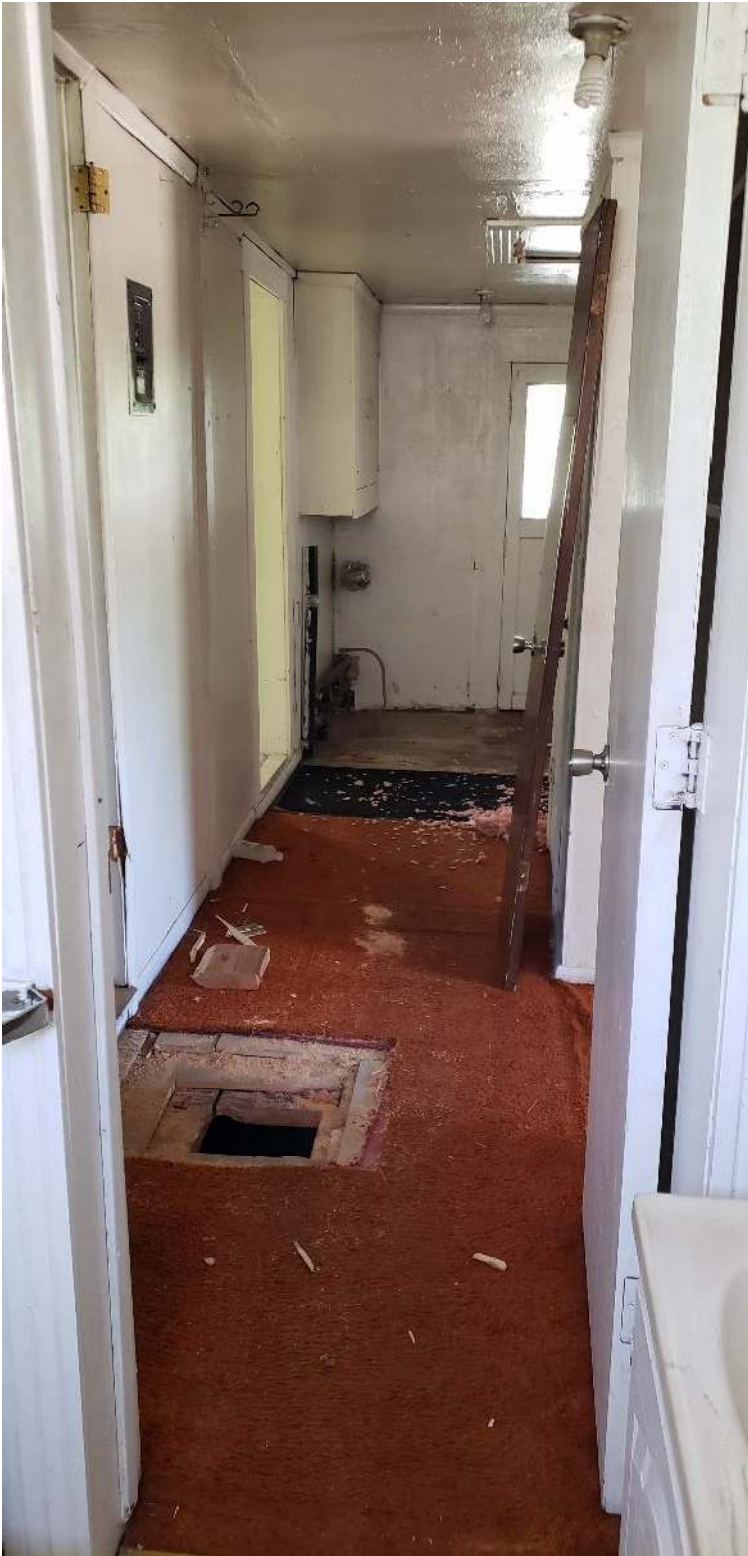
Photos 37–38. 609 S Lone Tree Rd back of main house hallway from bathroom facing S (left) and view of flooring layers in hallway outside middle N bedroom doorway (right).

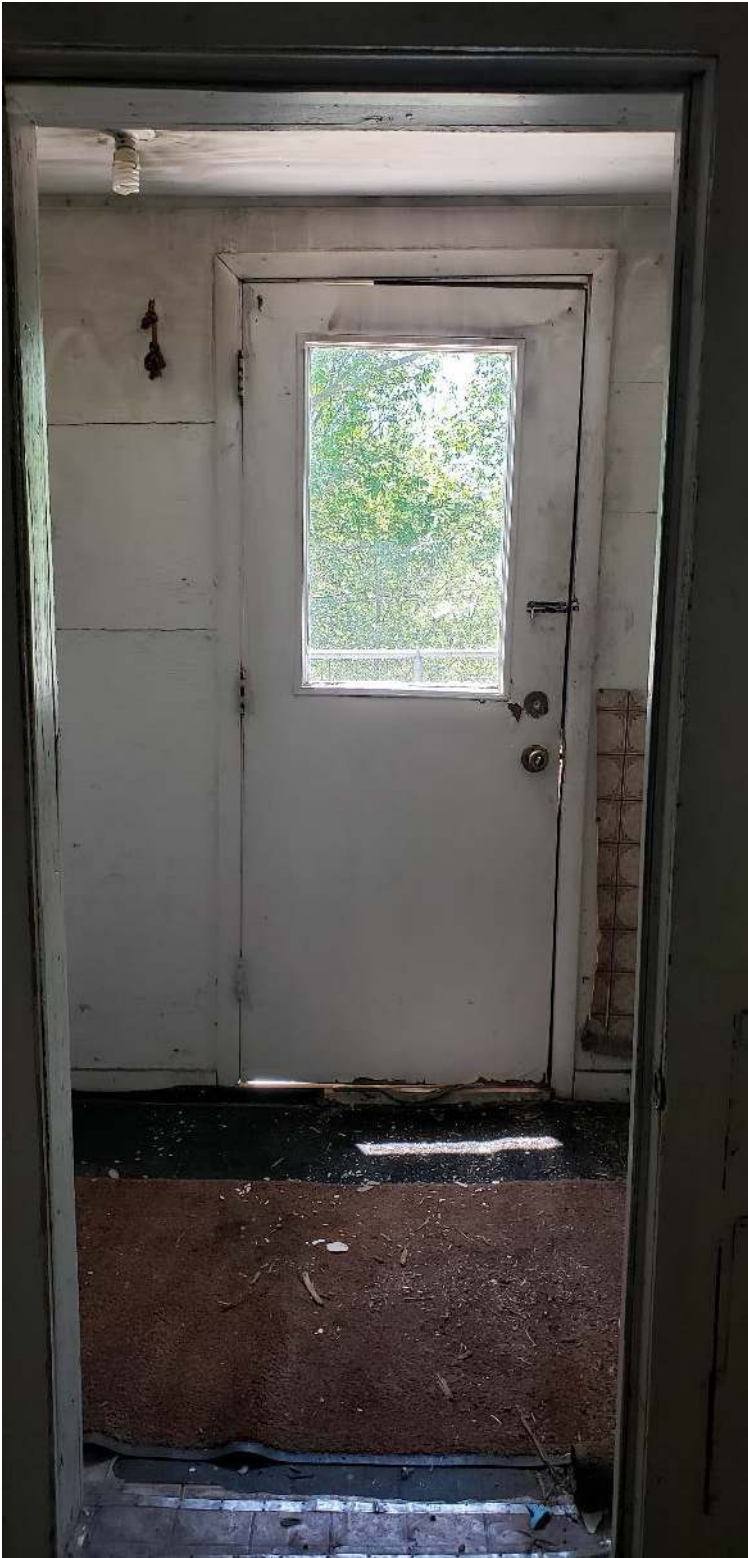
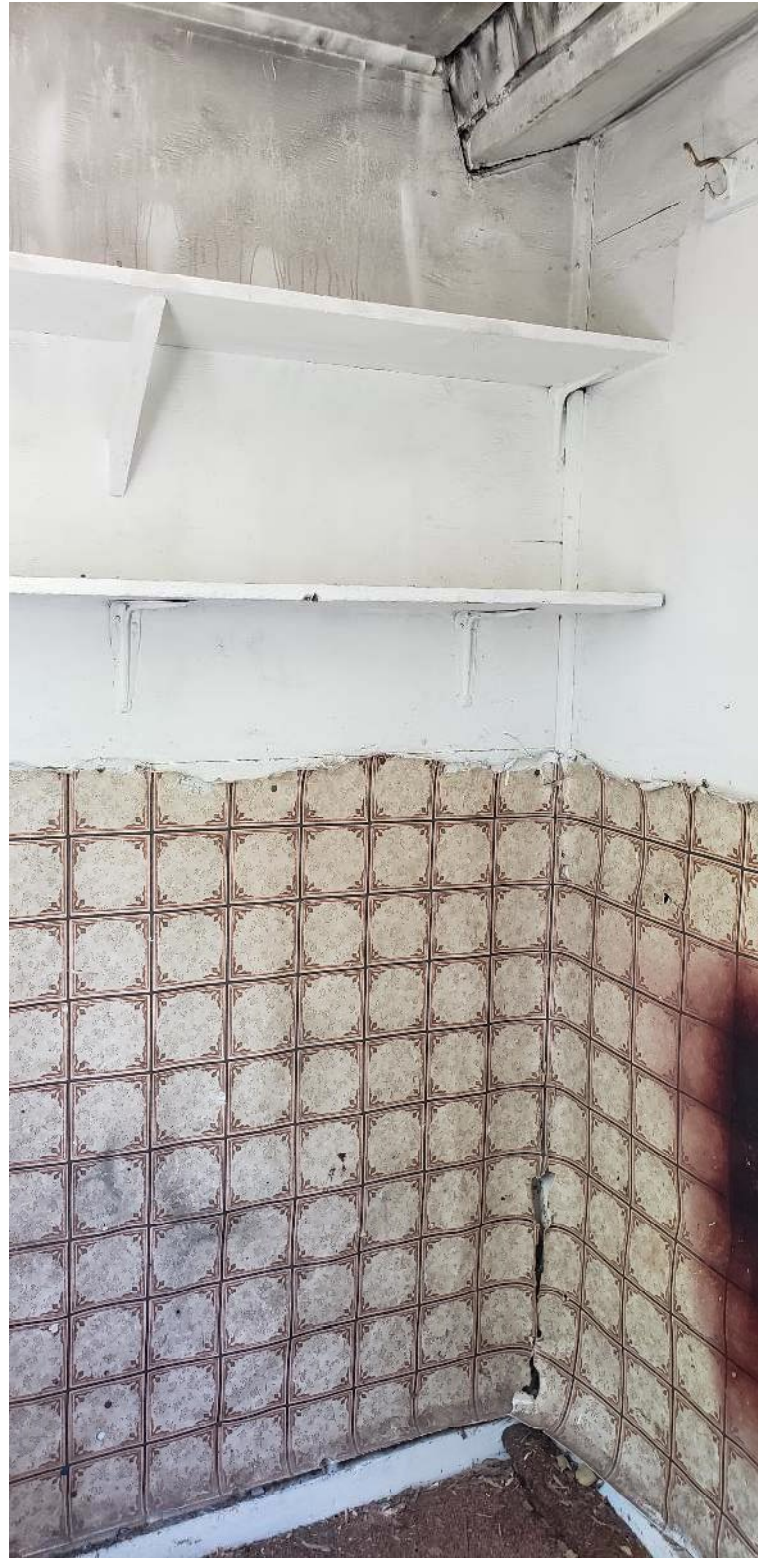
Photos 39–40. 609 S Lone Tree Rd S entry enclosed porch facing S from within utility/stove room (left) and NW corner from SE corner (right).

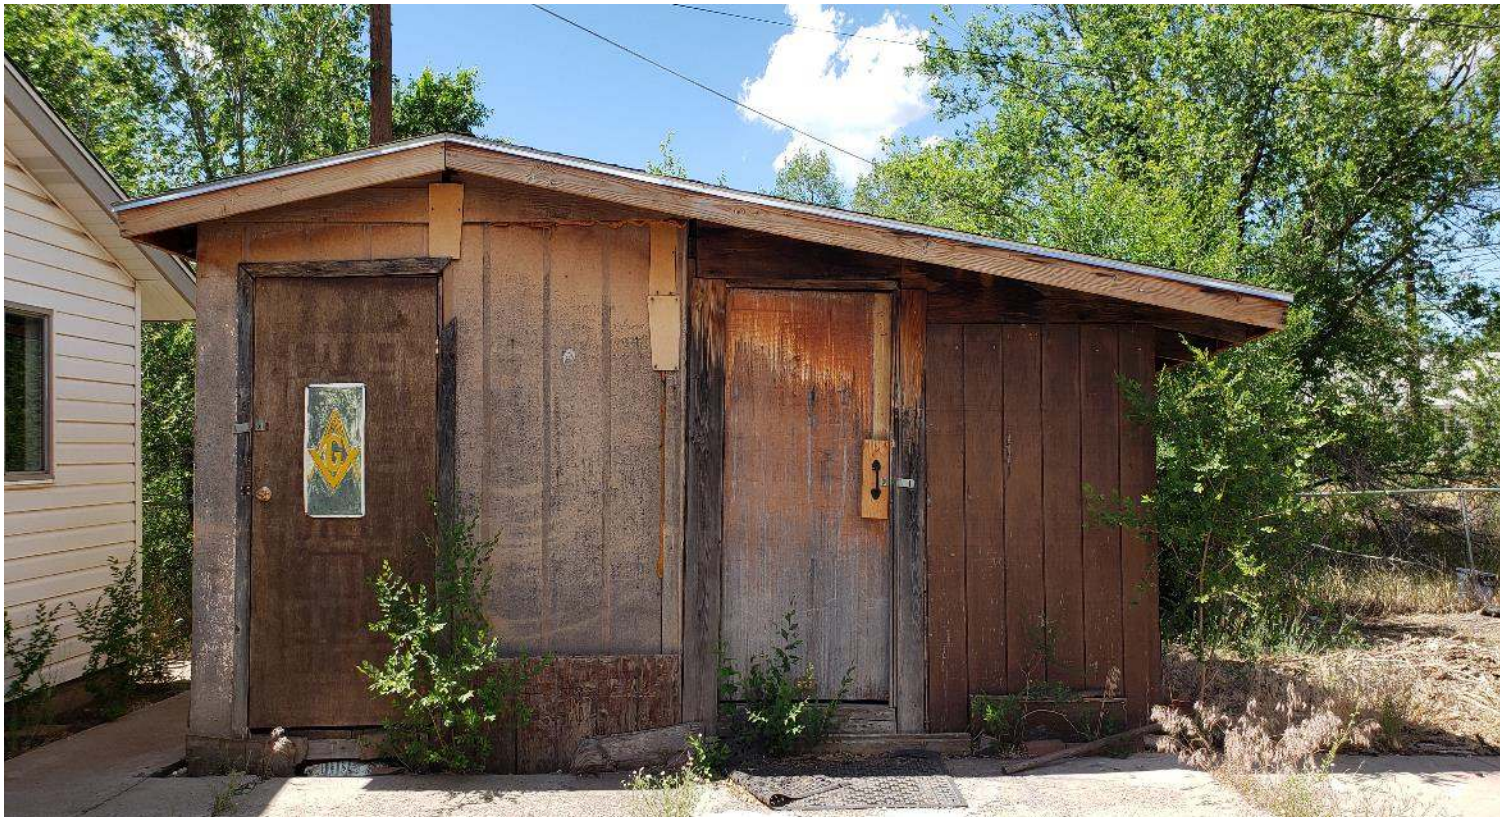
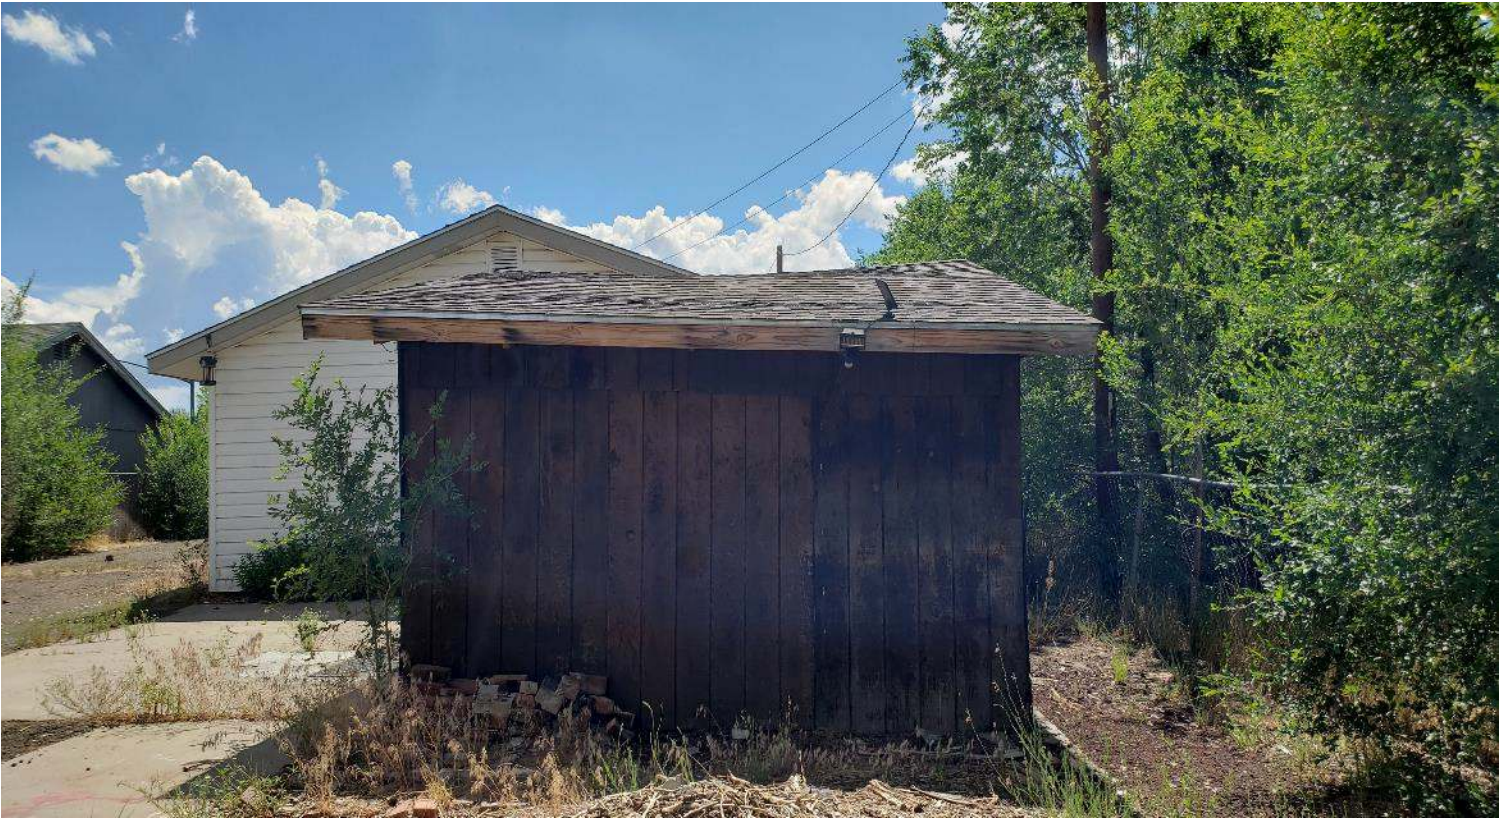
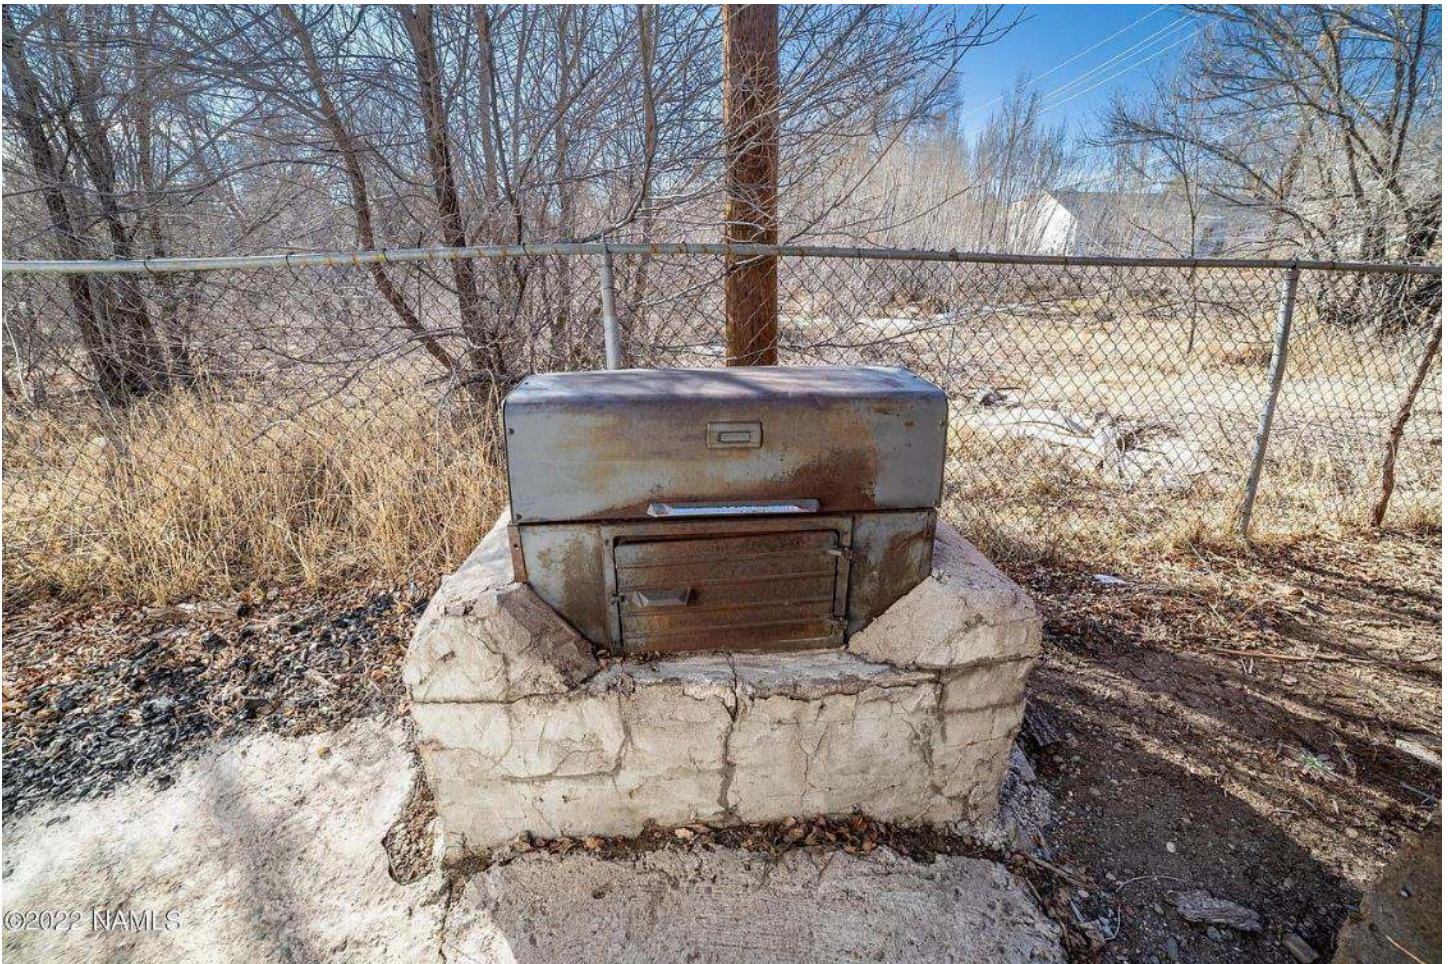
The west half of the 609 S Lone Tree fenced lot is open and contains a wood storage/work shed, concrete pads, and a built-in grill off the house's southwest corner (*Photos 50–56*). The shed and concrete-pedestaled grill may predate the add-on, whereas the concrete pavement laid around these features most likely postdates the addition. There is also a broken concrete parking pad to the front/east of the house, and the tabular rock pavement lining the front yard is likely one of the latest improvements (see *Photos 1–3*).

Photos 53–54. 609 S Lone Tree Rd rear shed W façade (top) and E half interior facing S (bottom).

Photos 55–56. 609 S Lone Tree Rd rear shed E and S façades (top) and nearby built-in grill facing S (bottom).
