*RE: Cultural Resource Study Letter Report for Parcel 100-36-041 at 617 West Tombstone Avenue, City of Flagstaff, Coconino County, Arizona (PZ-23-00173; LA Neal Consulting, LLC Project No. 1091-23)*

### Property Description/Architecture

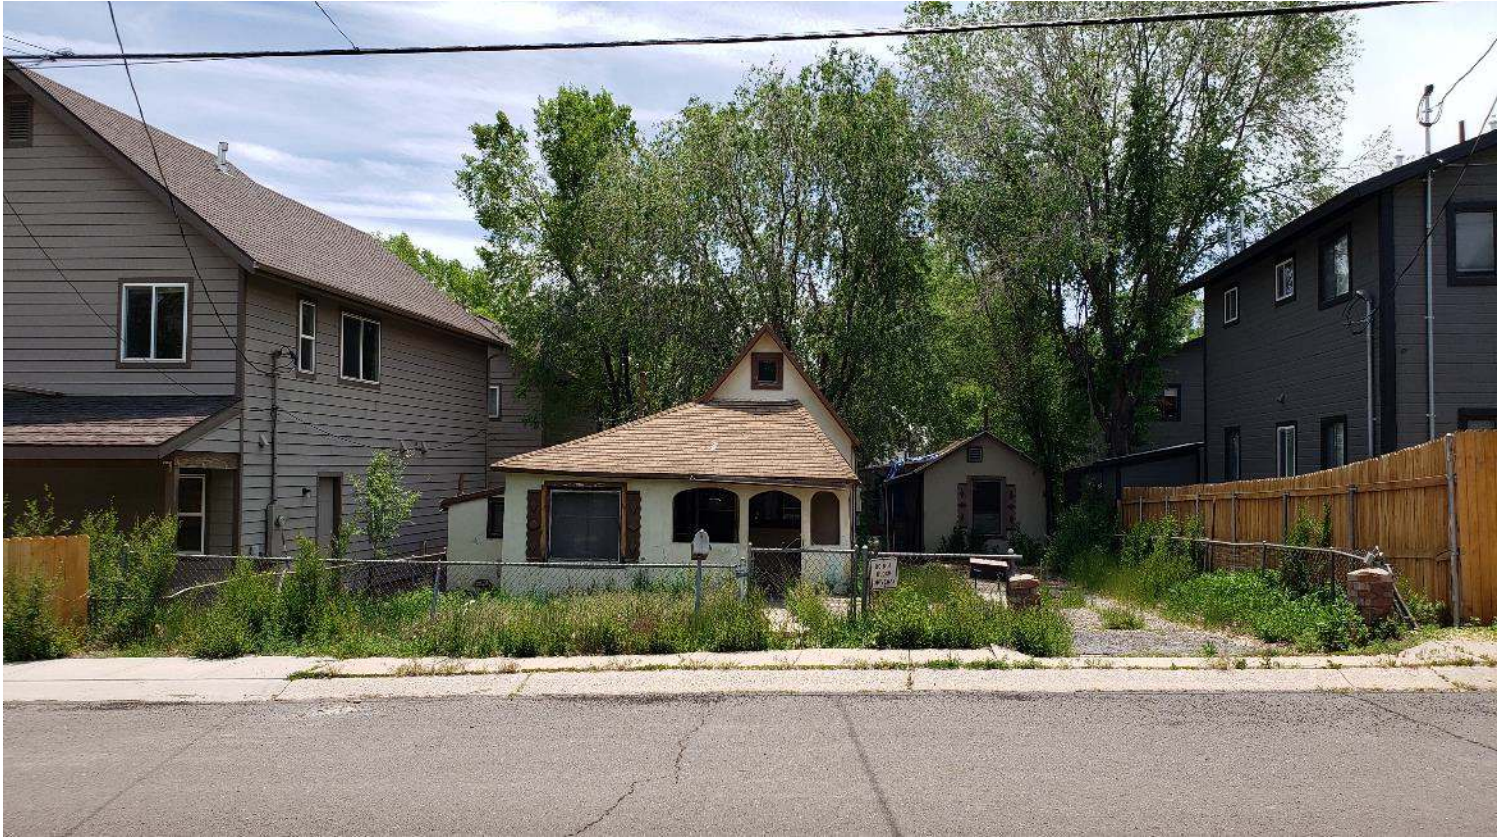
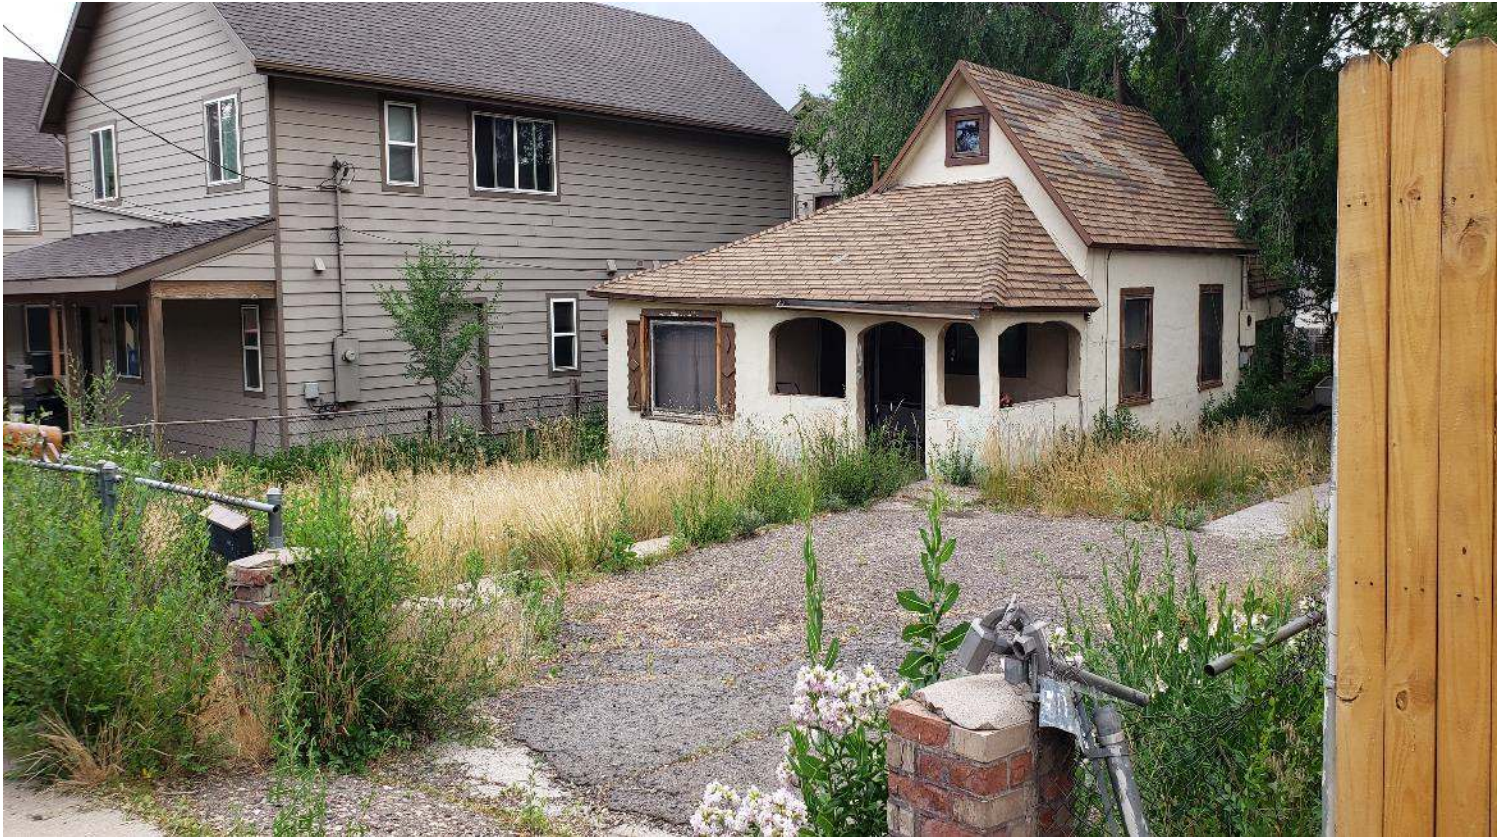
Photos 1–2. 617 W Tombstone Ave overview from N side of Tombstone to SSW (top, surrounded by newer duplexes at 611 W Tombstone & 222 S Globe St) and on front sidewalk to SE (bottom, w/ duplex at 611 W Tombstone).

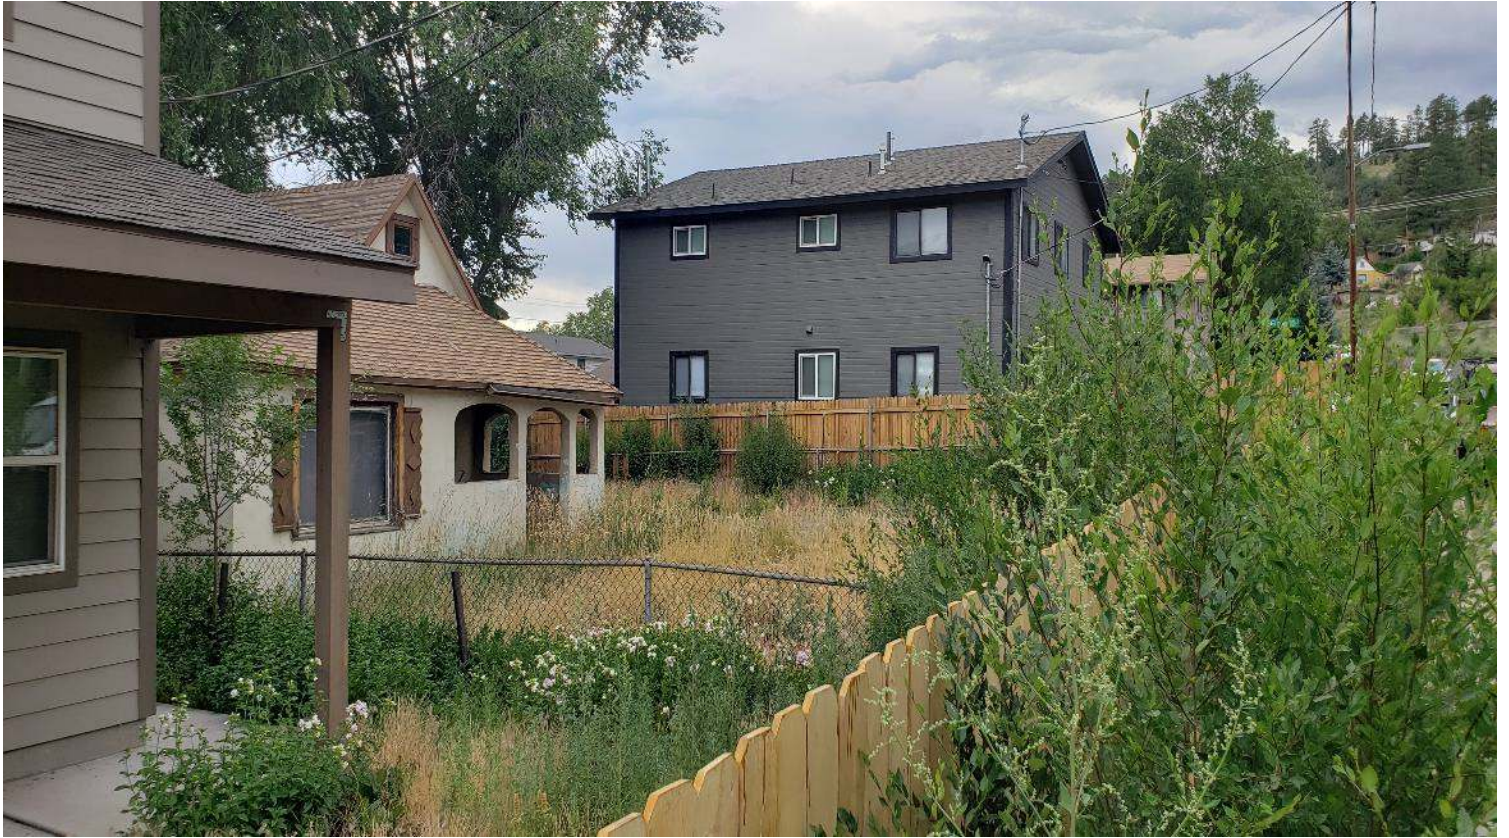
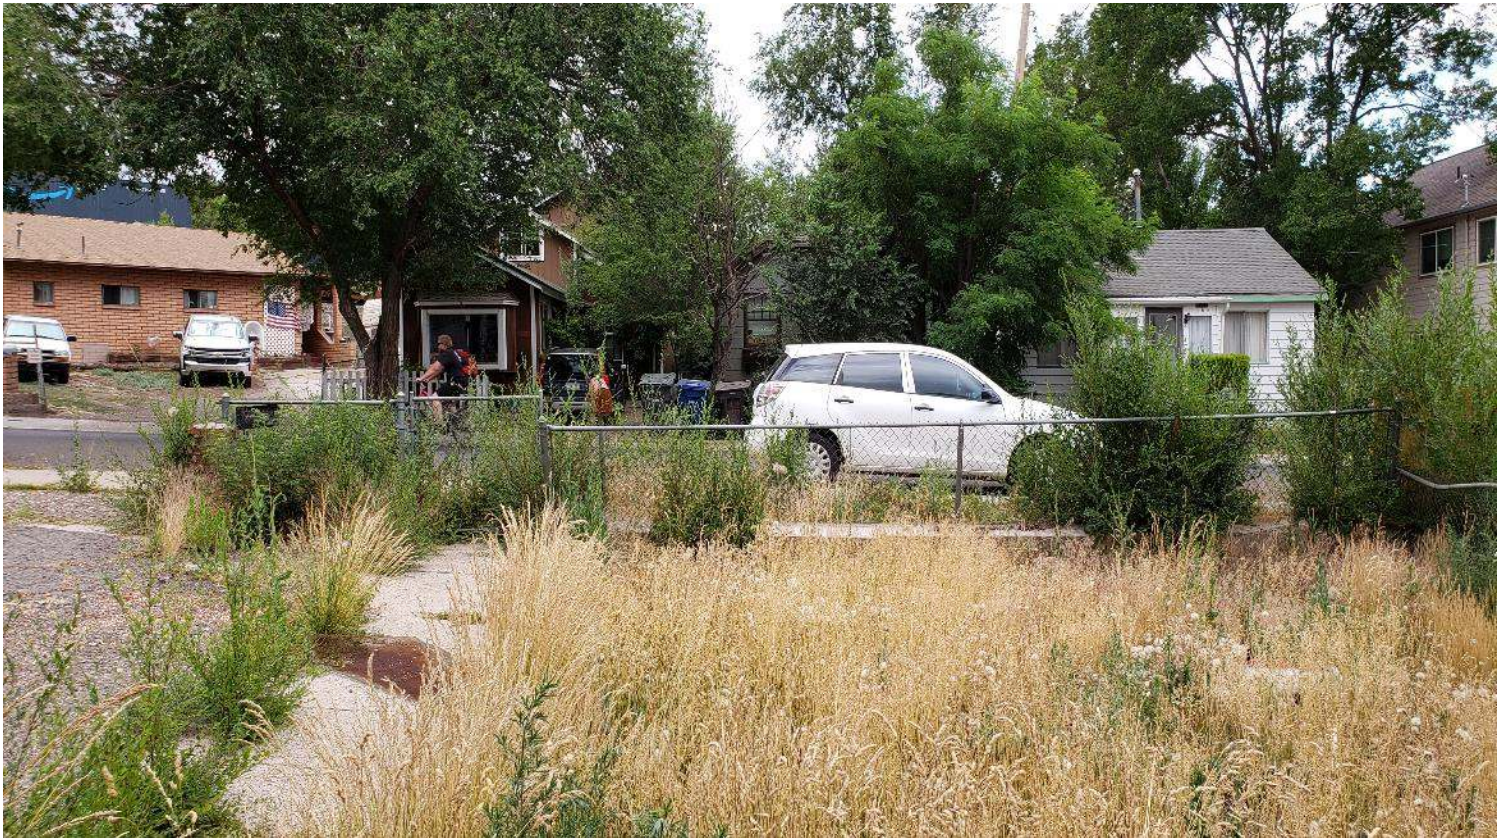
Photos 3–4. 617 W Tombstone overview from sidewalk to SW (top, w/ neighboring duplexes) and view from 617 W Tombstone to N side of Tombstone Ave (bottom, showing L to R 628, 624, 620, 614, 612 W Tombstone).

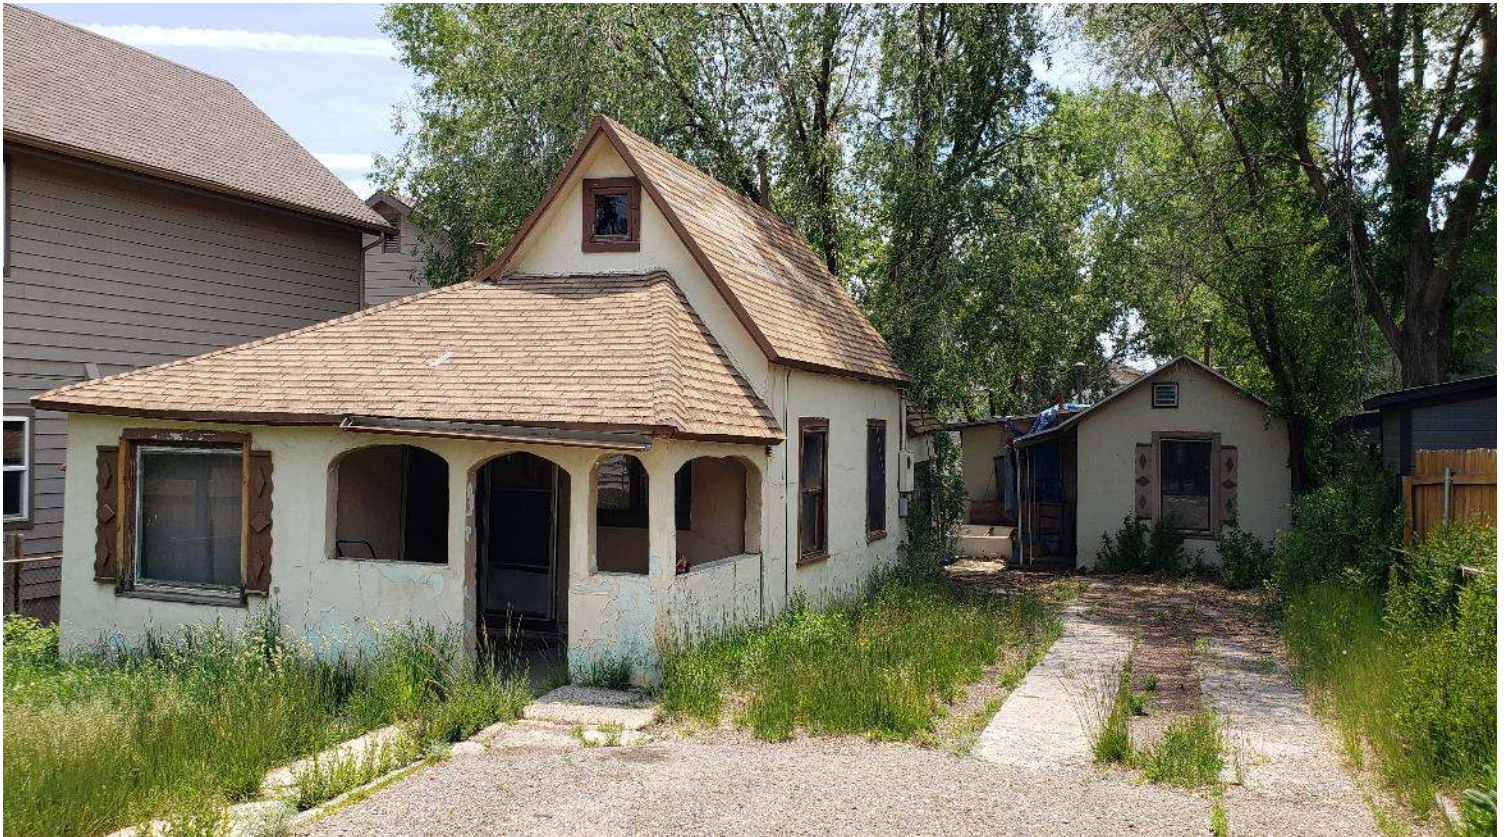
Photos 5–6. View from front sidewalk at 617 W Tombstone to N side of the street (top, showing L to R 628, 624, 620, 614 W Tombstone) and 617 & 617½ W Tombstone overview to SE (bottom).

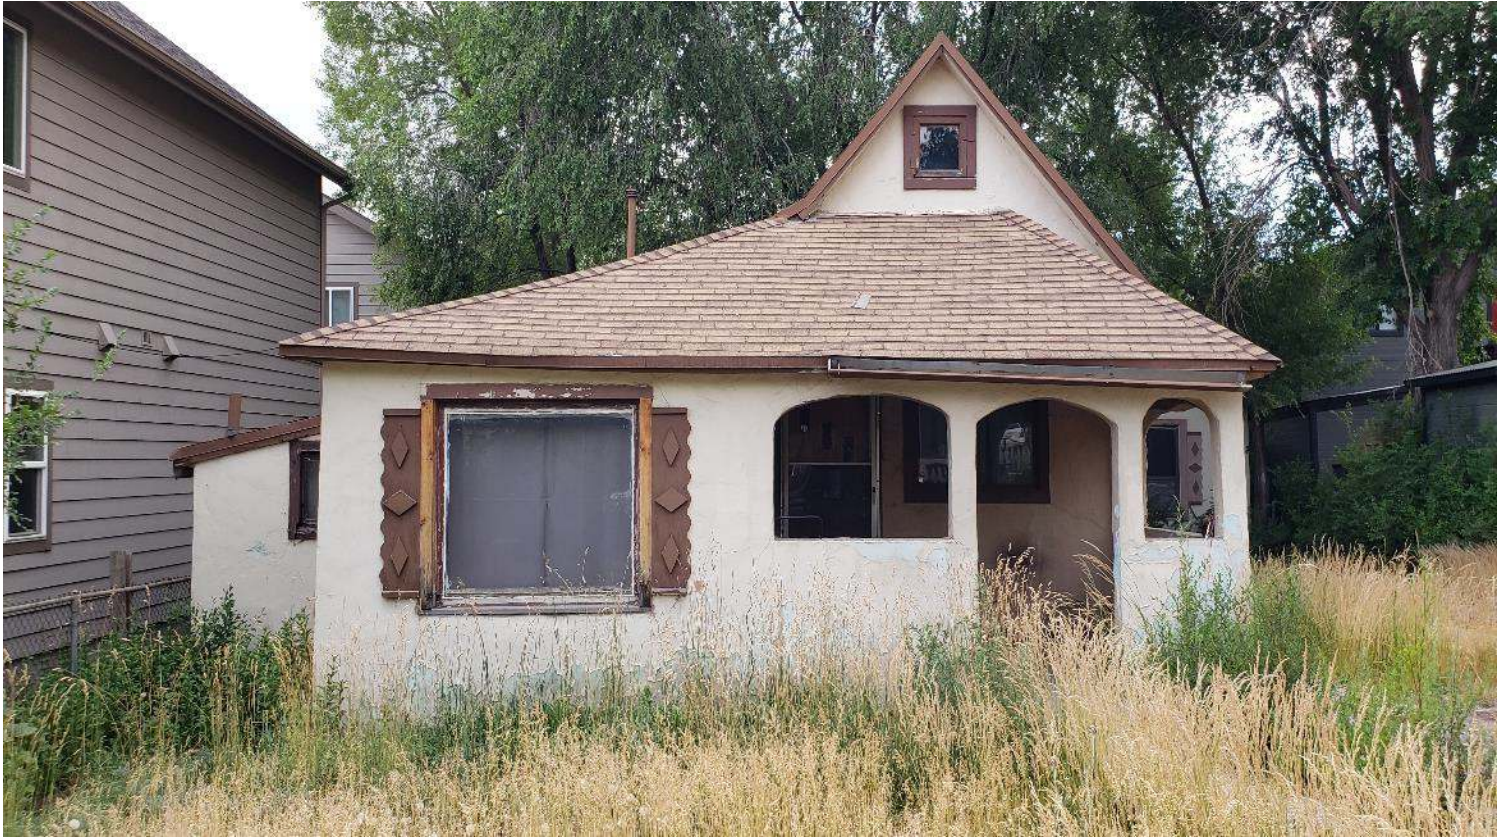
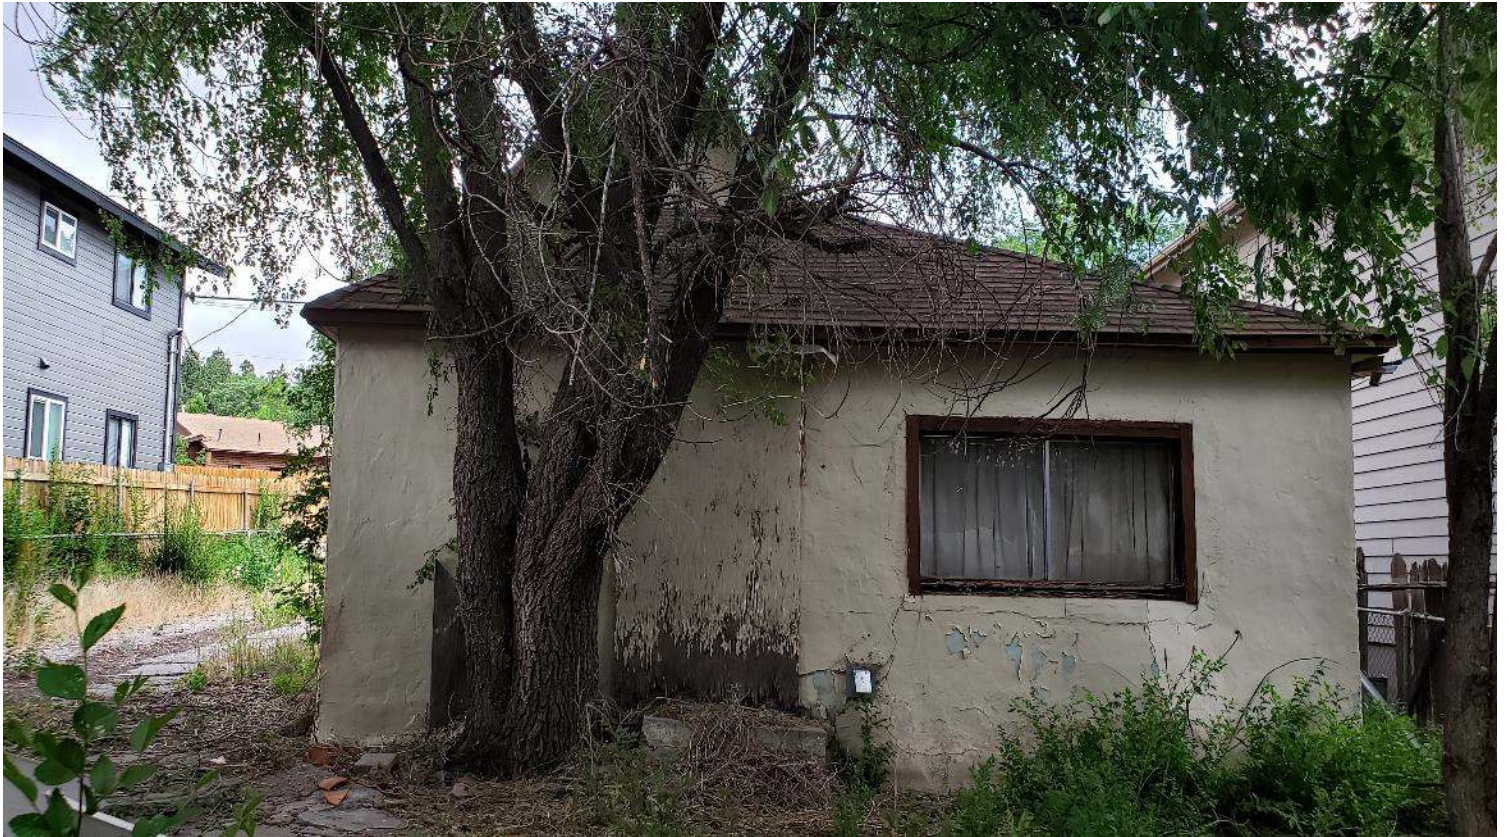
Photos 7–8. 617 W Tombstone Ave front/N façade facing SSW (top) and rear/S façade facing N (bottom).

The property at **617 W Tombstone Avenue** (Block 3Z, Parcel 100-36-041, Lots 10 & 11) is a currently uninhabited one-story, modest vernacular-style, five-room house fronting Tombstone Avenue to the north (*Appendix B, Photos 1–5*). The 824-square foot structure is rectangular in plan with the long axis oriented north-south perpendicular to Tombstone Avenue; it measures overall 37 feet N-S × 23 feet E-W and sits on a 0.16-acre lot (*Appendix A, Figure 5, building plan sketch*). The main house has a high-pitch gable roof and covered front porch/veranda with the east half of the veranda now an enclosed room (*Photos 6–7*). Enclosed eaves are present around the perimeter of the house with gutters on the north and east facades (*Photos 7–11*). Asphalt shingles over wood planking and plywood make up the roof. The house foundation is concrete. The exterior walls are stuccoed and painted light tan over wood siding and framing (*Photo 12*). The front mailbox shows the remnants of what is thought to be G. (Gabriel) Sedillo's name (*Photo 13*). Though vernacular in overall style, the modified front porch confuses the house style, placing Puebloan characteristics on the house (*Photo 14*). The front entrance door is a post-1950 wood replacement with rectangular decorative glass windows (*Photo 15*). A second front entrance was added to access the enclosed room in the house's NE corner (*Photo 16*). There is also an exterior door on the E façade S half at the house's kitchen; the door is a replacement, but the screen door is older (see *Photo 11*). A doorway looks to have been boarded up on the rear façade (see

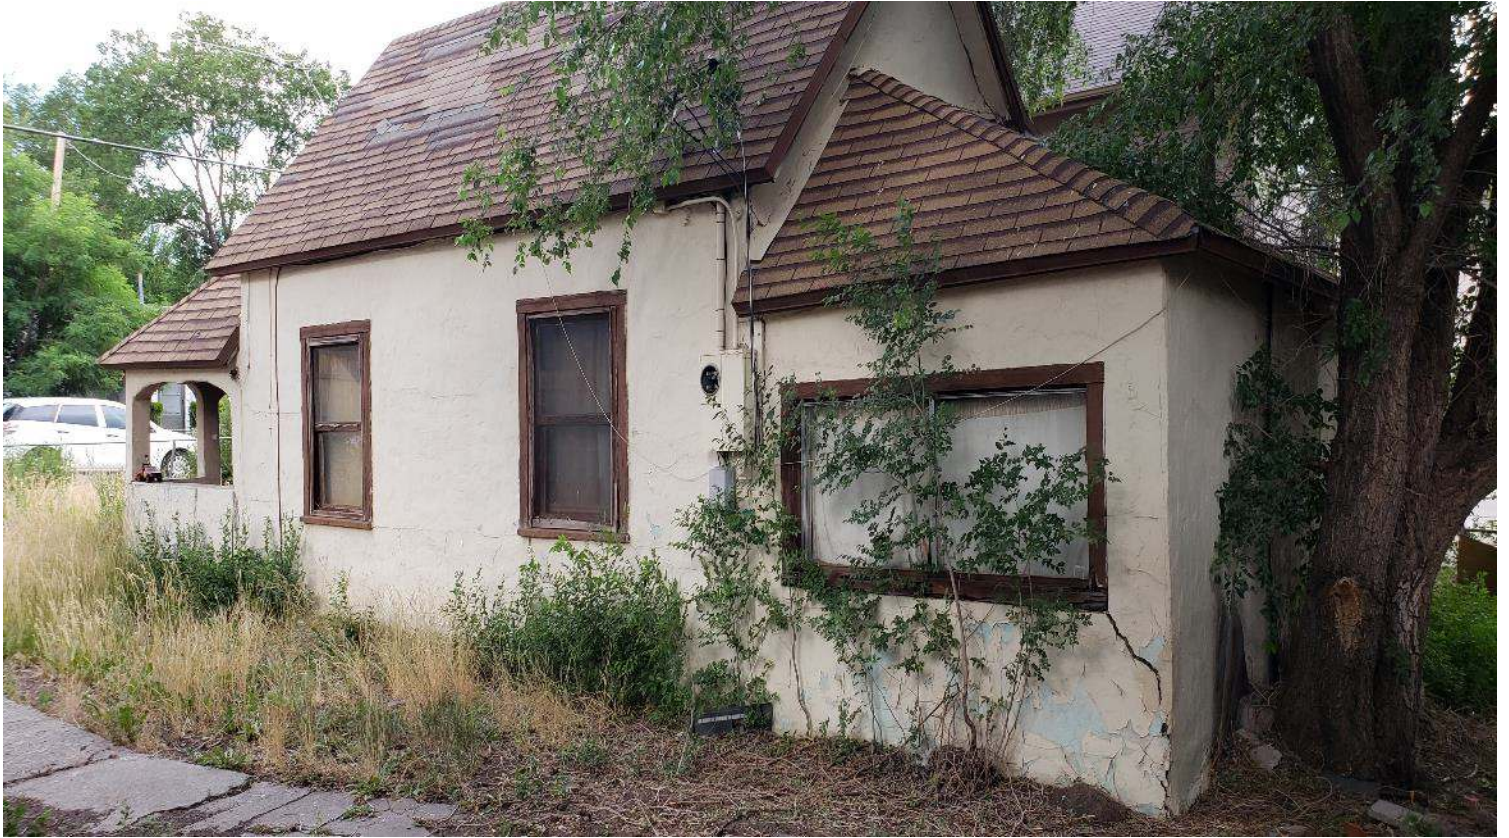
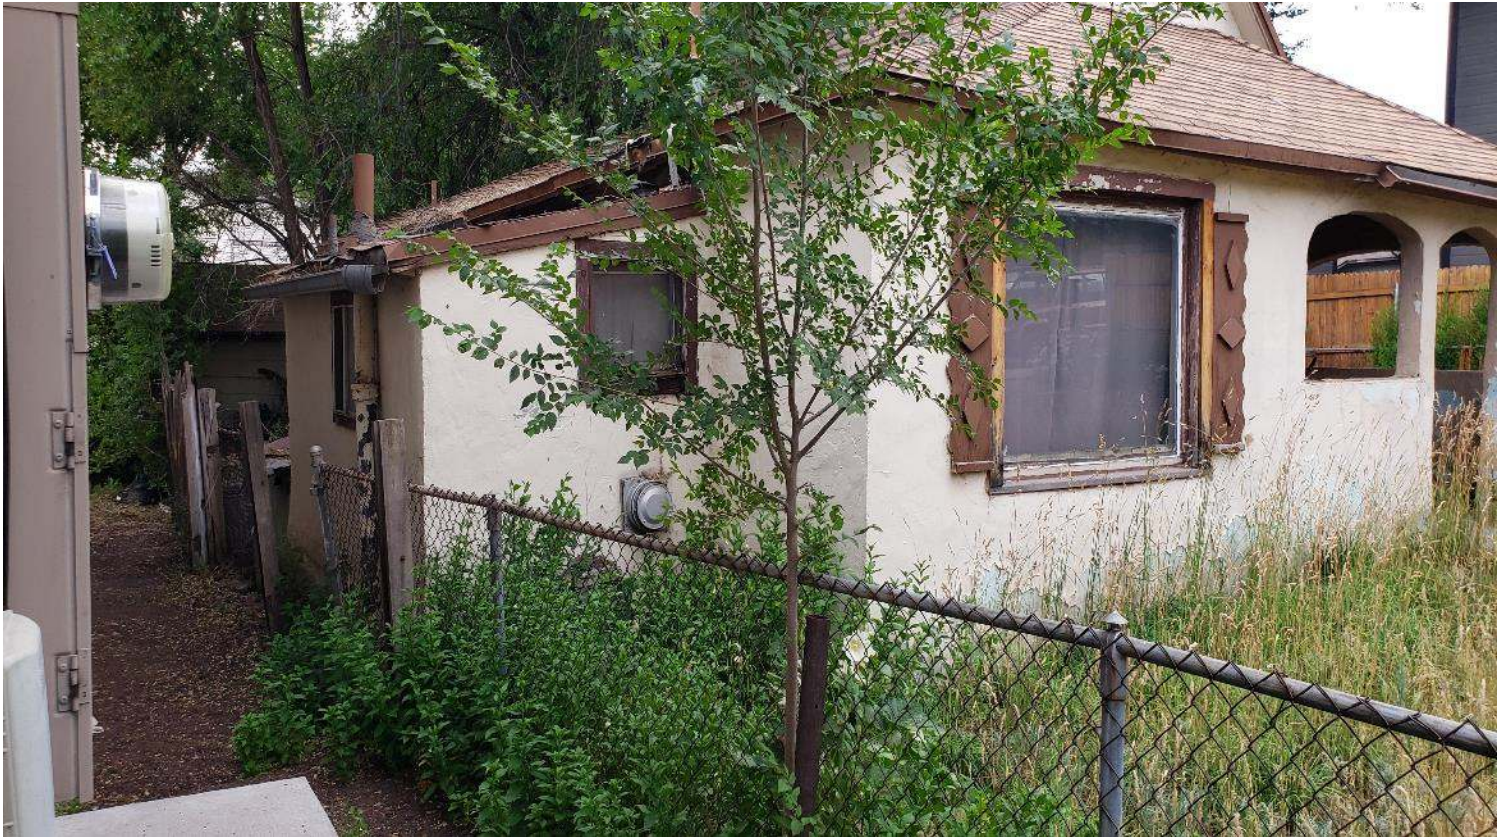
Photos 9–10. 617 W Tombstone Ave W façade to NE (top) and E façade/NE corner to SW (bottom).

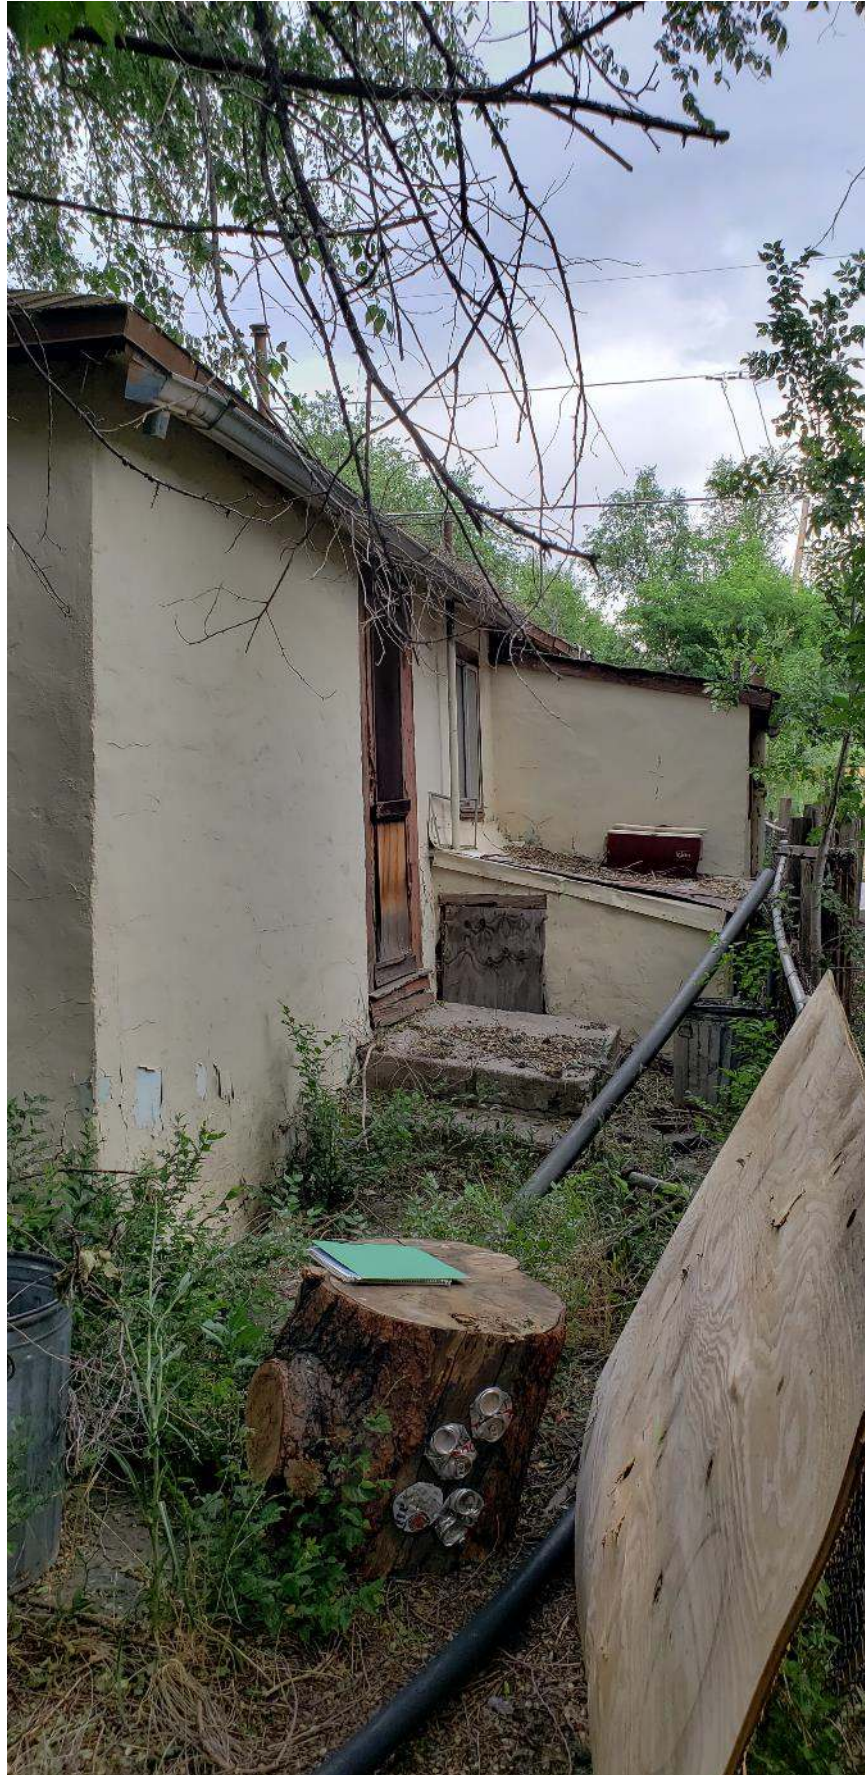
Photo 11. 617 W Tombstone Ave E façade at SE corner to N.

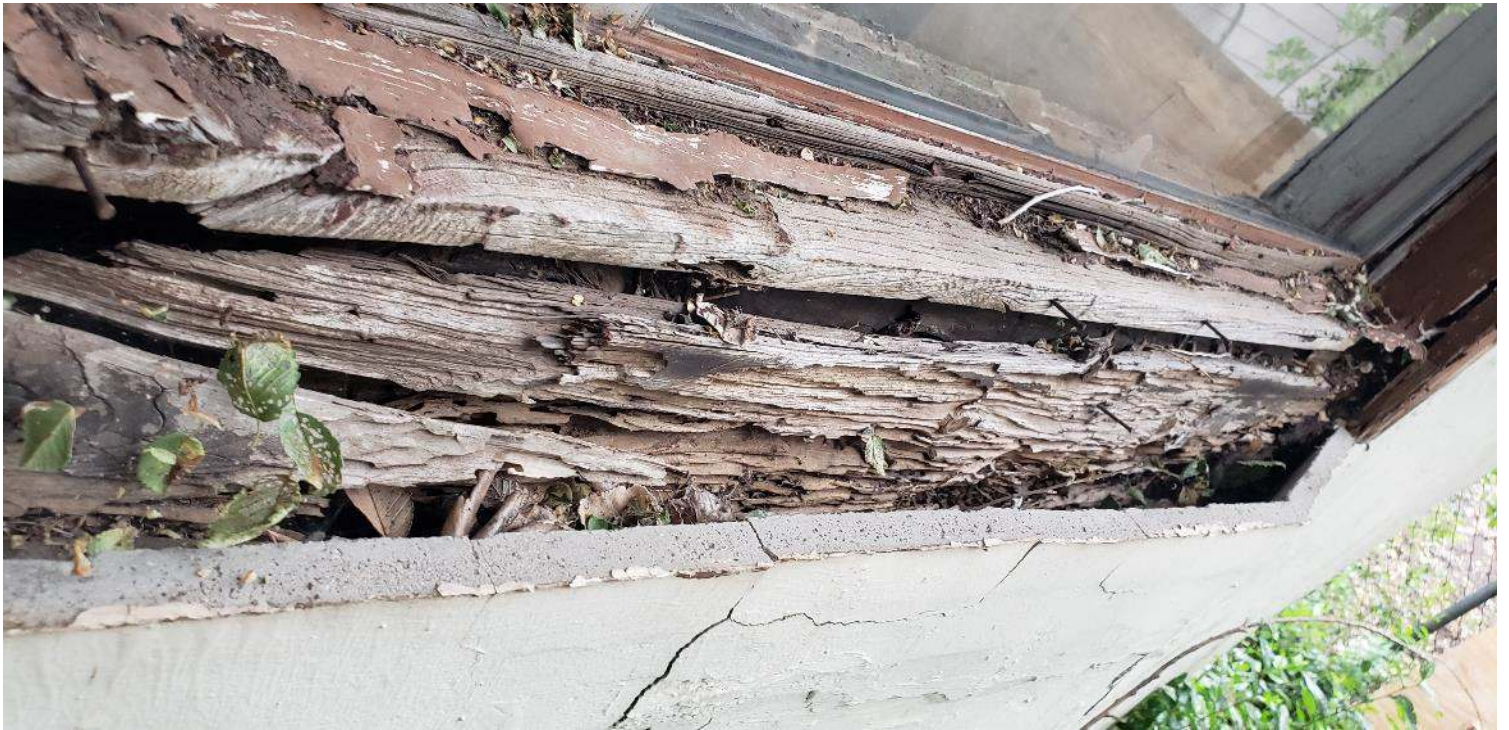
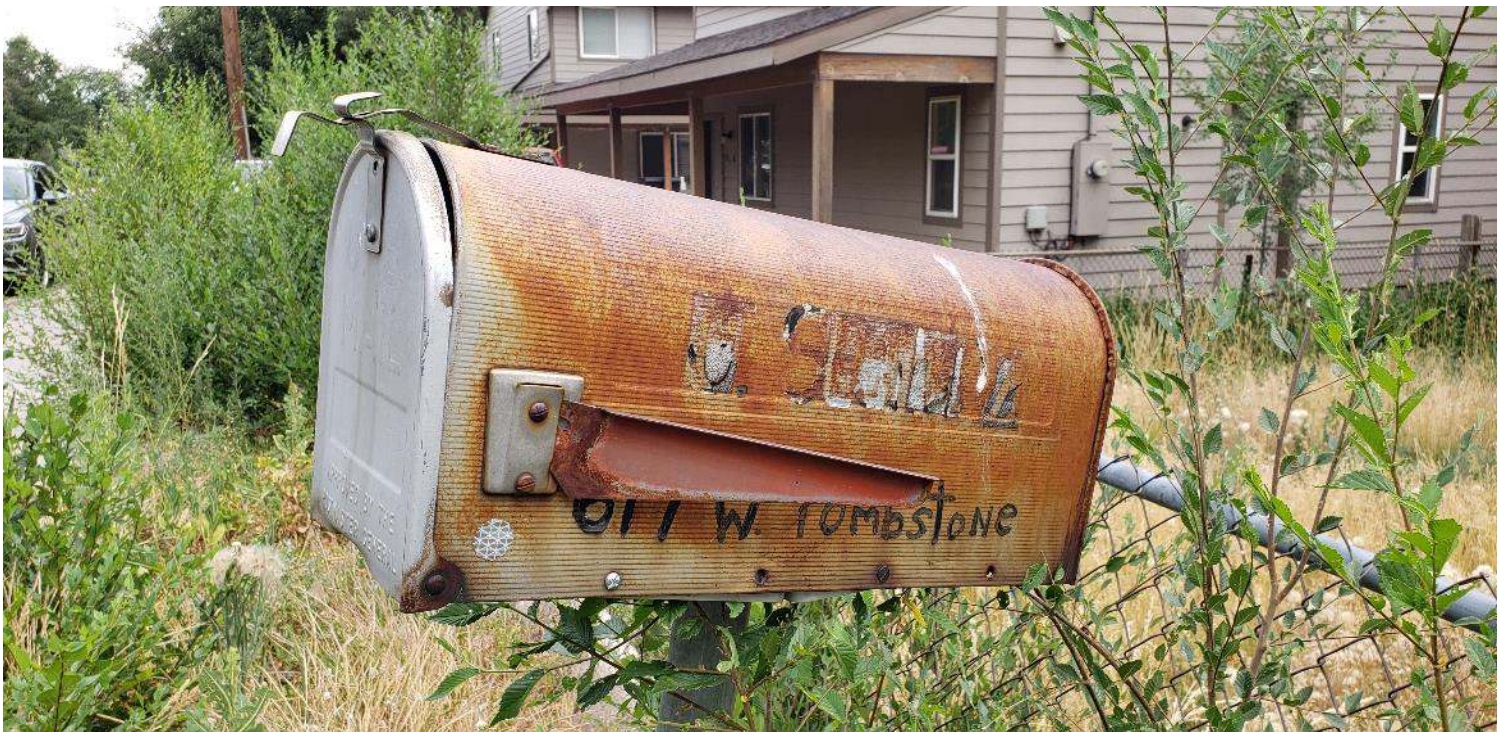
Photos 12–13. 617 W Tombstone exterior siding detail from S façade of house (top) and front mailbox depicting the name of the original Sedillo family owner and occupant (bottom).

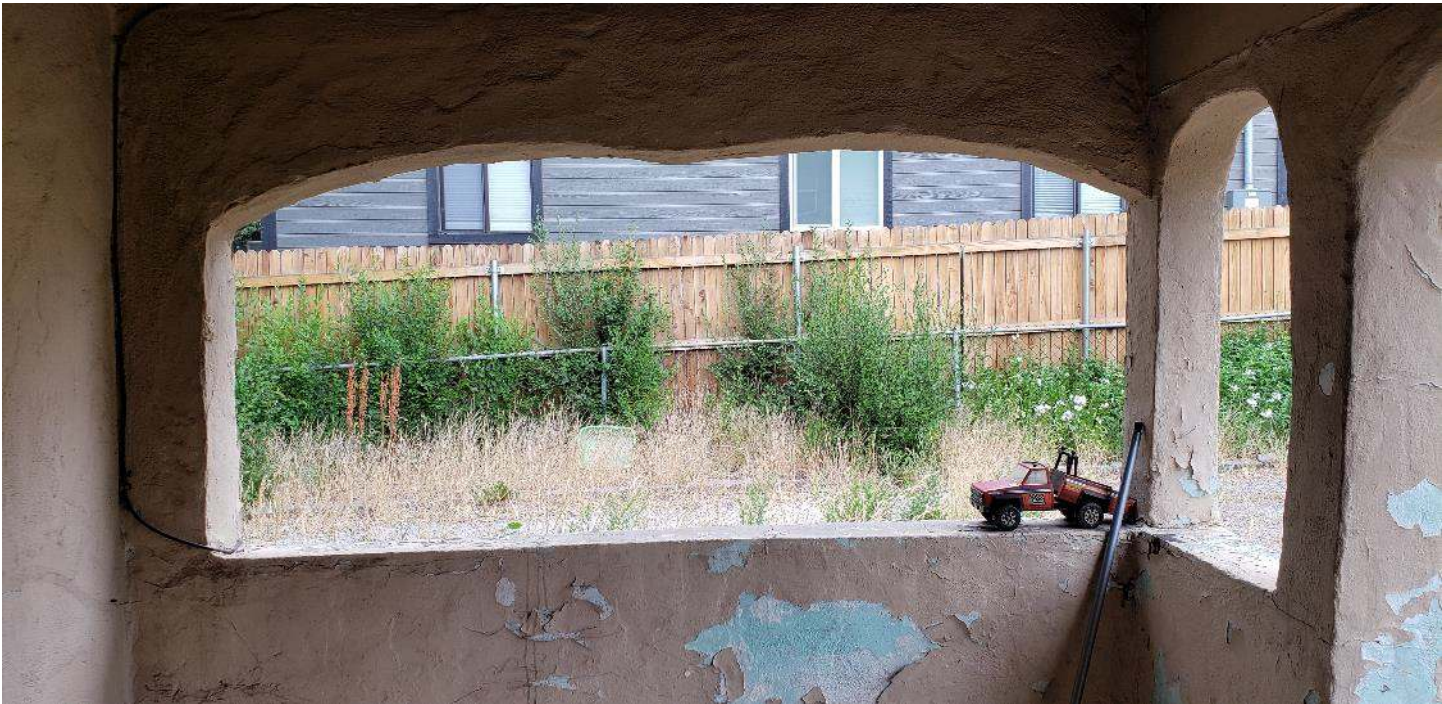
Photos 14–16. 617 W Tombstone front porch to W (top), front door to S (left), and secondary front door to E (right).

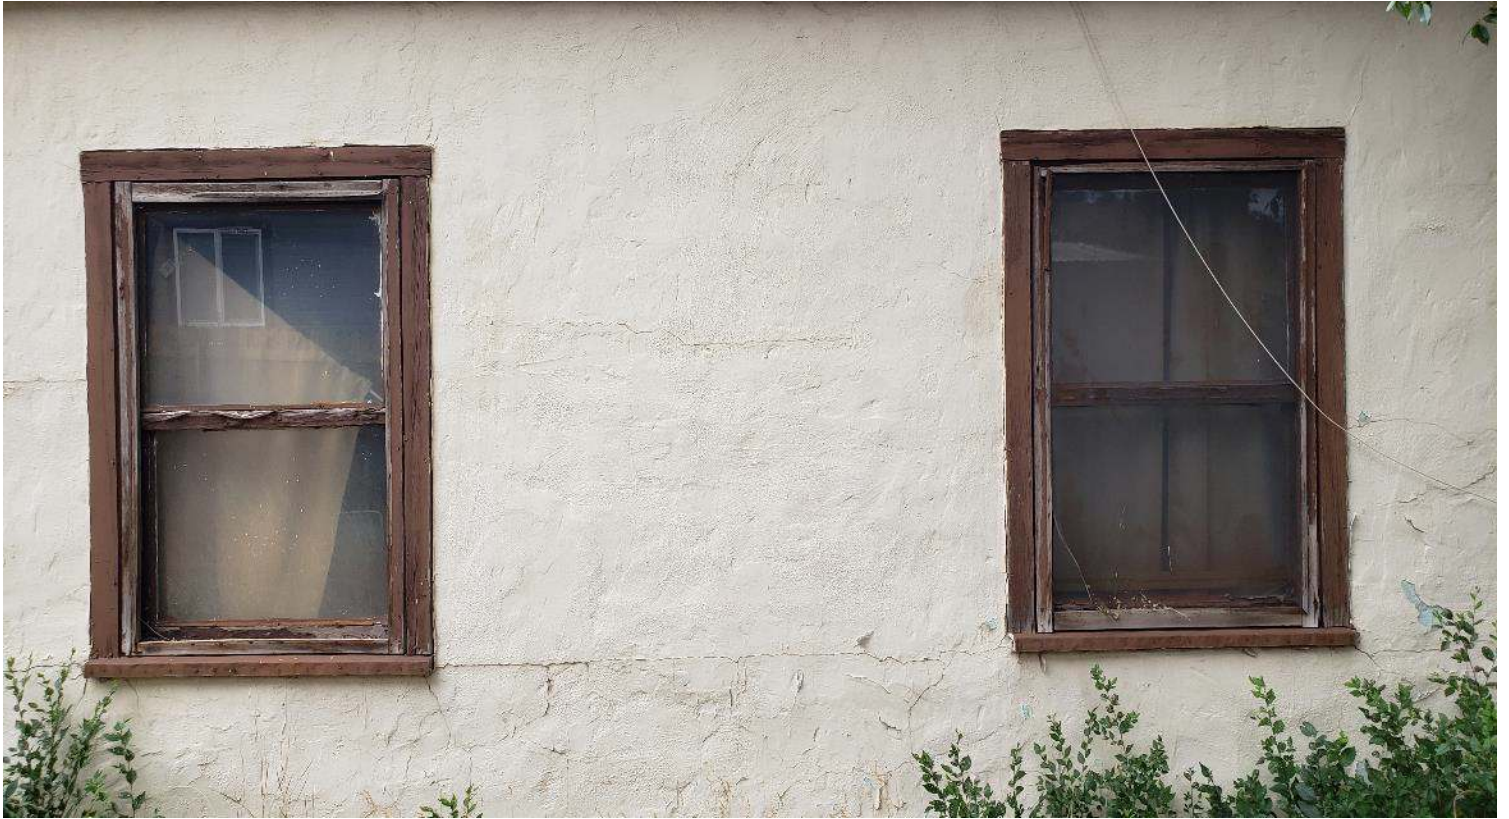
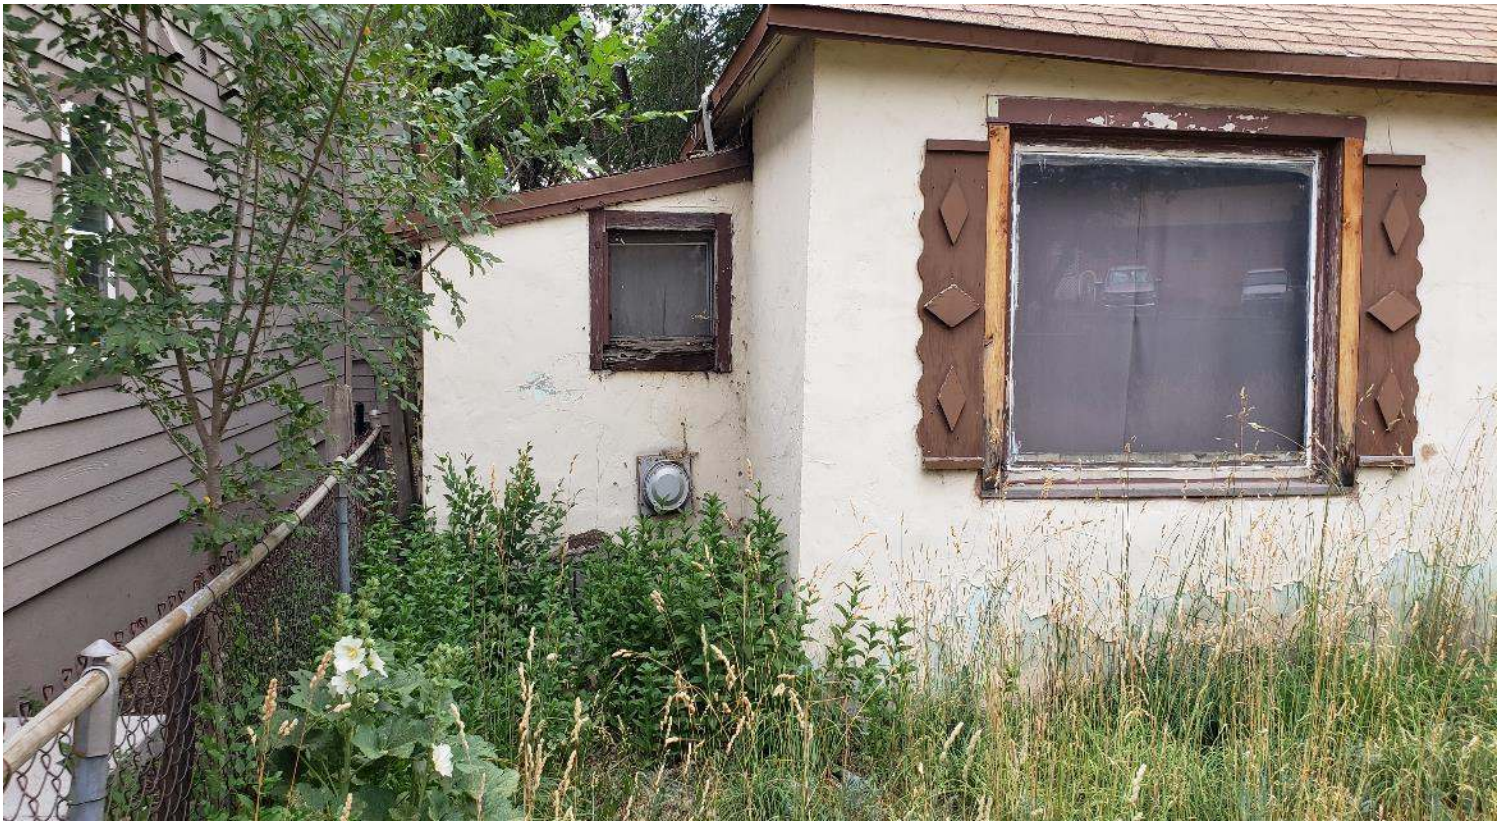
Photos 17–18. 617 W Tombstone Ave W façade N half windows (top) and aluminum and fixed windows on the front/N façade (bottom, bathroom to left and enclosed veranda room to right).

(Photo 8). The oldest windows on the main house are single-hung wood with screens (*Photo 17*), but there are also aluminum replacements on several facades with exterior wood trim and fixed windows as well (*Photo 18*). Significant modifications include enclosure of the veranda's E half, likely adding the current bathroom on the house's E façade, and adding the room across the back/S façade of the house. It is hard to discern whether anything of the original ca. 1926 construction exists; if so, the materials are likely buried under newer yet still dated materials.

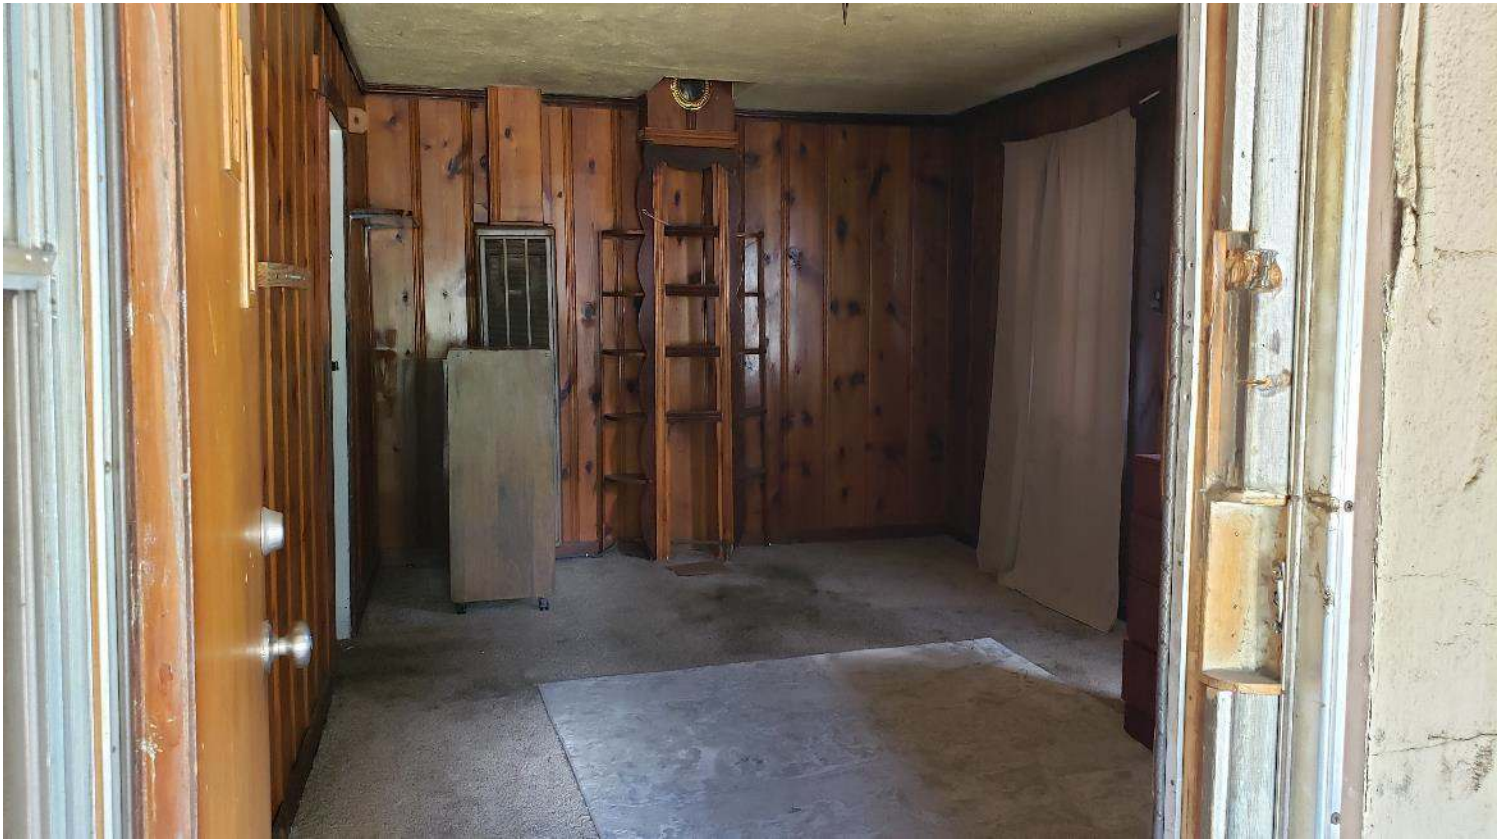
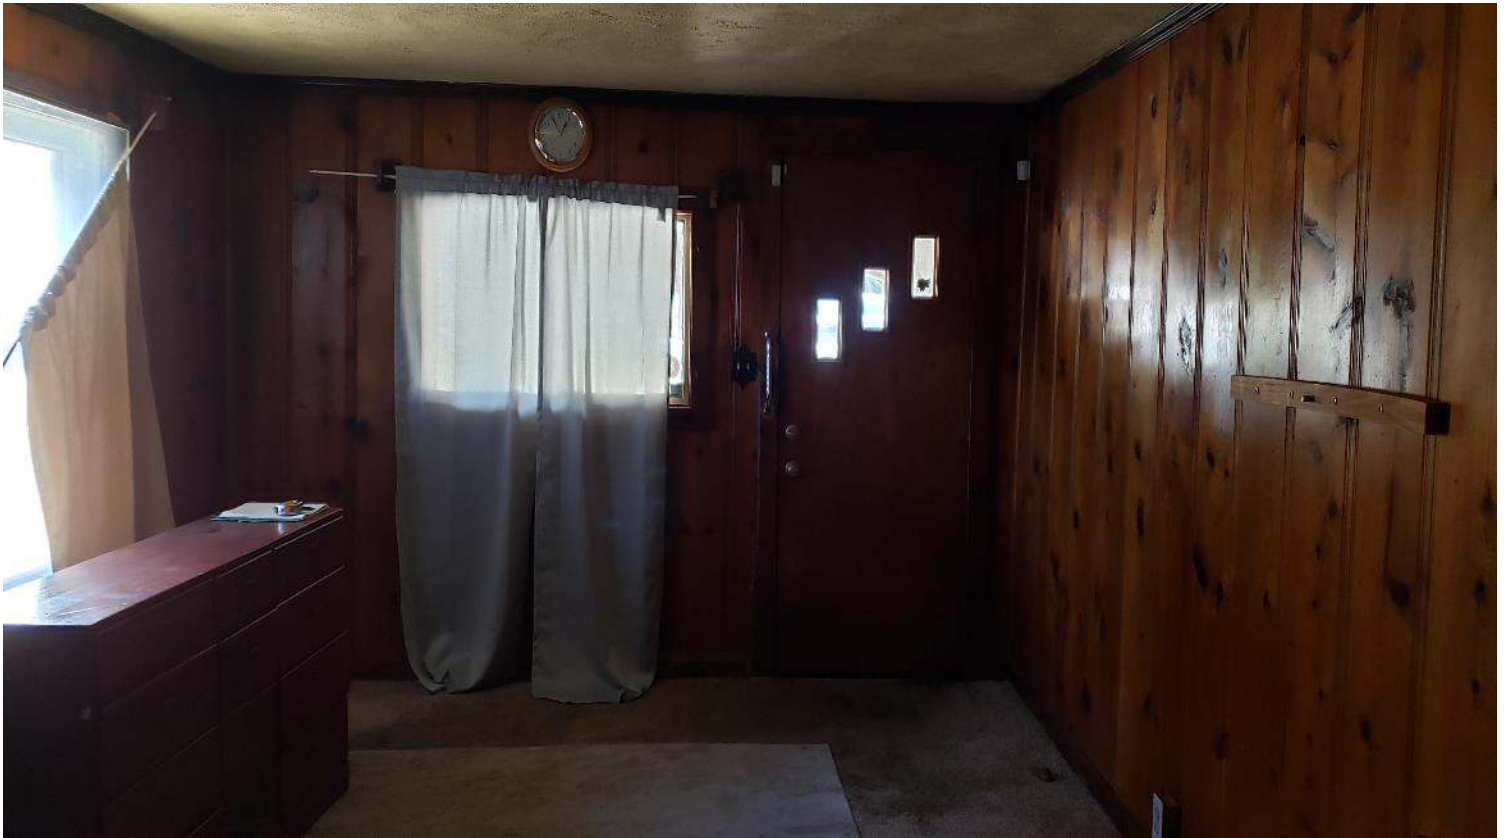
Photos 19–20. 617 W Tombstone wood-paneled front NW corner room facing SSW (top) and N (bottom).

The interior, moving north to south and west to east has a front room/living room (*Photos 19–20*), front bedroom (*Photos 21–22*), bathroom (*Photos 23–26*), kitchen (*Photos 27–30*), and combination rear utility room (likely used as a bedroom at one point) and W bedroom (*Photos 31–33*). There is clear evidence in the front room's S wall and ceiling of a stove having been vented through the ceiling and one-time rear wall of the house (*Photo 34*). The ceilings are drywall and fiberboard, and the floors are likely wood covered with carpet and linoleum. Wall treatments consist of drywall, fabricated wood paneling, and even linoleum in the bathroom. Overall, the treatments and materials are mostly indicative of the house's late 1940s to 1960s remodeling as well as some changes made even later. The house is in poor structural condition and is of moderate architectural interest in general and within the context of Flagstaff's history.
