*RE: Cultural Resource Study Letter Report for Parcel 100-36-041 at 617 West Tombstone Avenue, City of Flagstaff, Coconino County, Arizona (PZ-23-00173; LA Neal Consulting, LLC Project No. 1091-23)*

### Property Description/Architecture

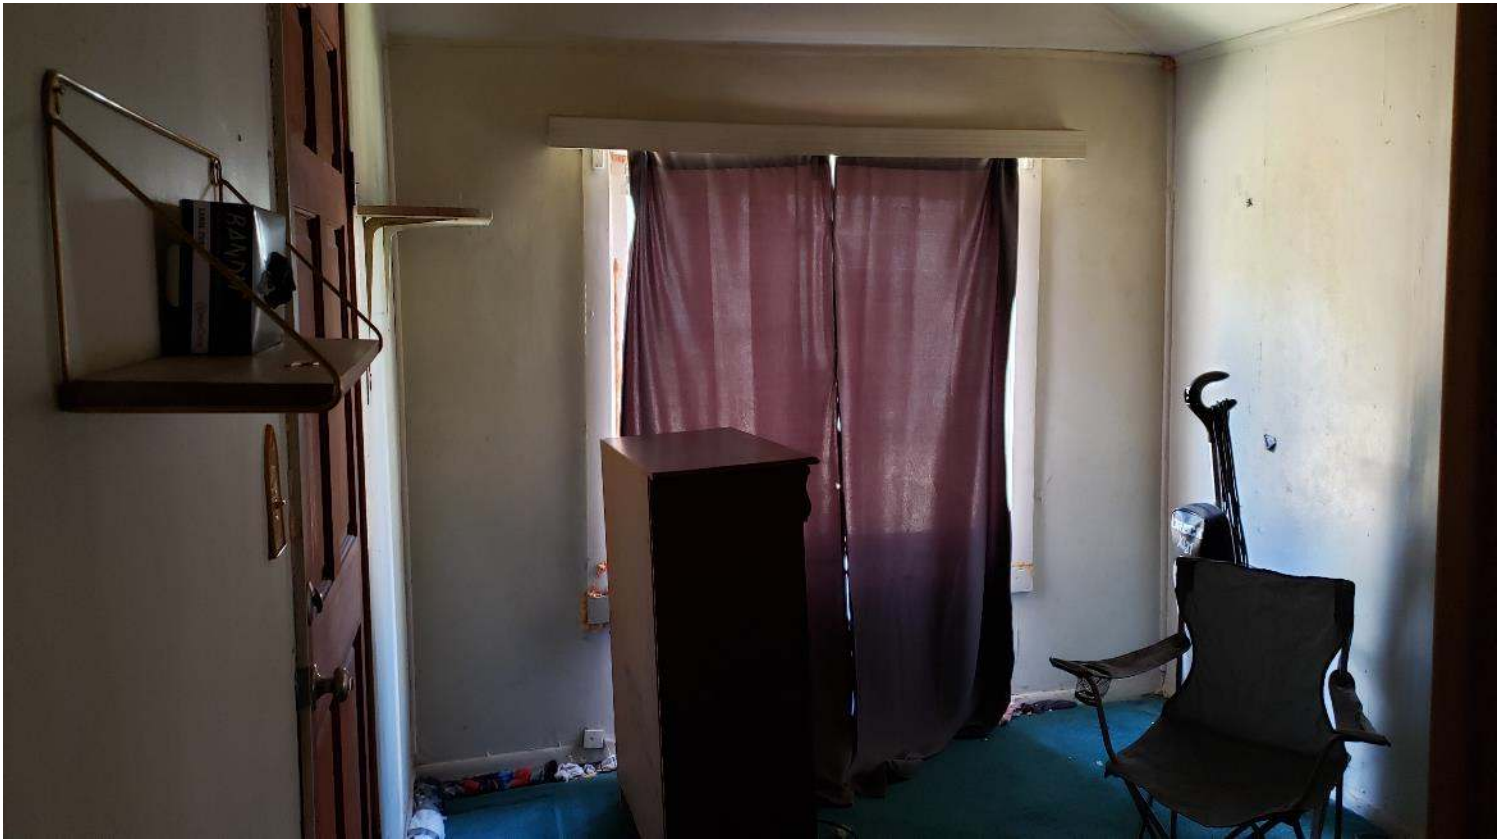
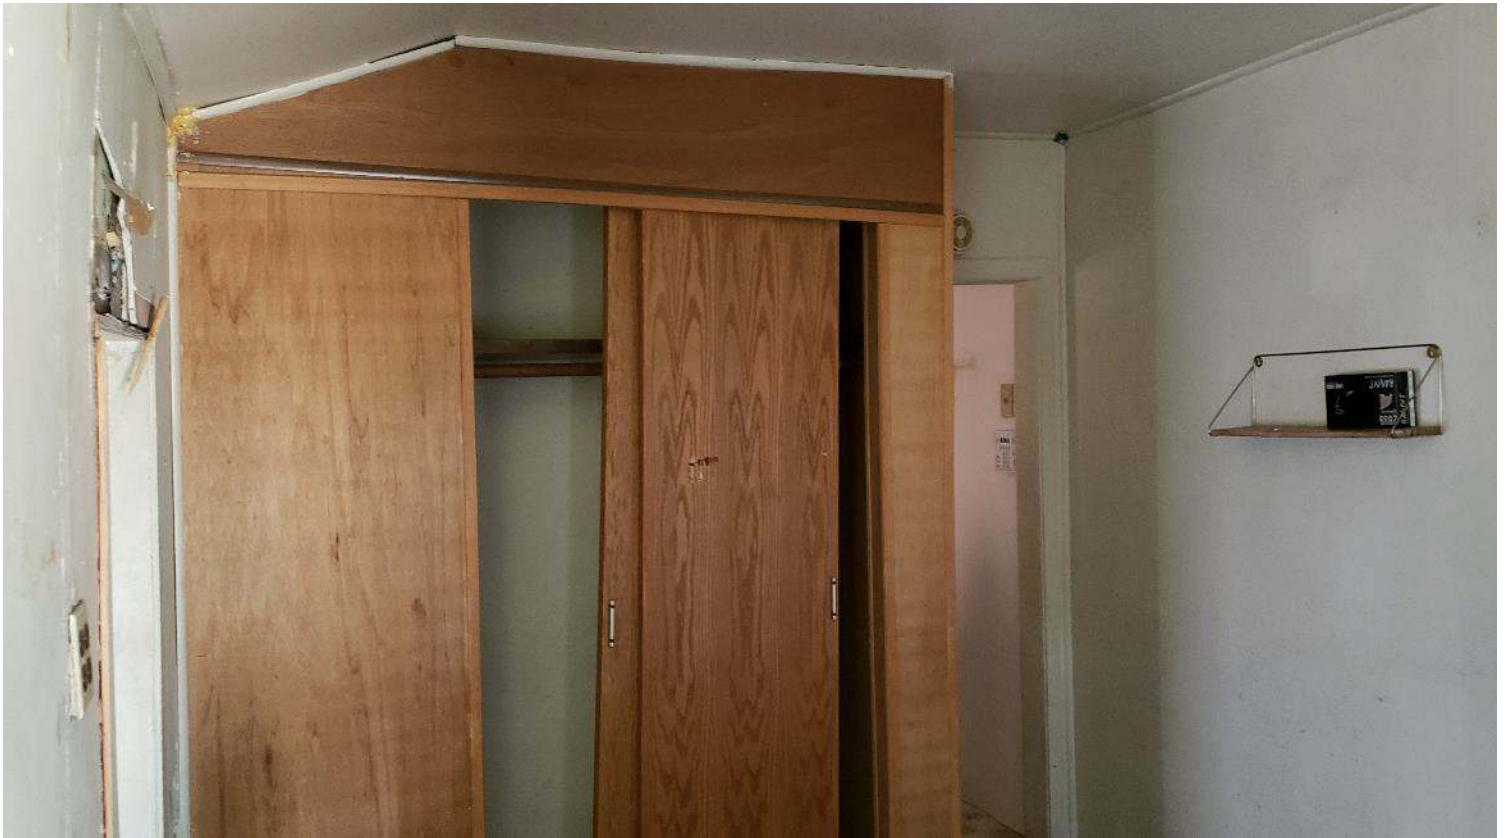
Photos 21–22. 617 W Tombstone front NE corner room facing N (top) and SSW (bottom).

The interior, moving north to south and west to east has a front room/living room (*Photos 19–20*), front bedroom (*Photos 21–22*), bathroom (*Photos 23–26*), kitchen (*Photos 27–30*), and combination rear utility room (likely used as a bedroom at one point) and W bedroom (*Photos 31–33*). There is clear evidence in the front room's S wall and ceiling of a stove having been vented through the ceiling and one-time rear wall of the house (*Photo 34*). The ceilings are drywall and fiberboard, and the floors are likely wood covered with carpet and linoleum. Wall treatments consist of drywall, fabricated wood paneling, and even linoleum in the bathroom. Overall, the treatments and materials are mostly indicative of the house's late 1940s to 1960s remodeling as well as some changes made even later. The house is in poor structural condition and is of moderate architectural interest in general and within the context of Flagstaff's history.

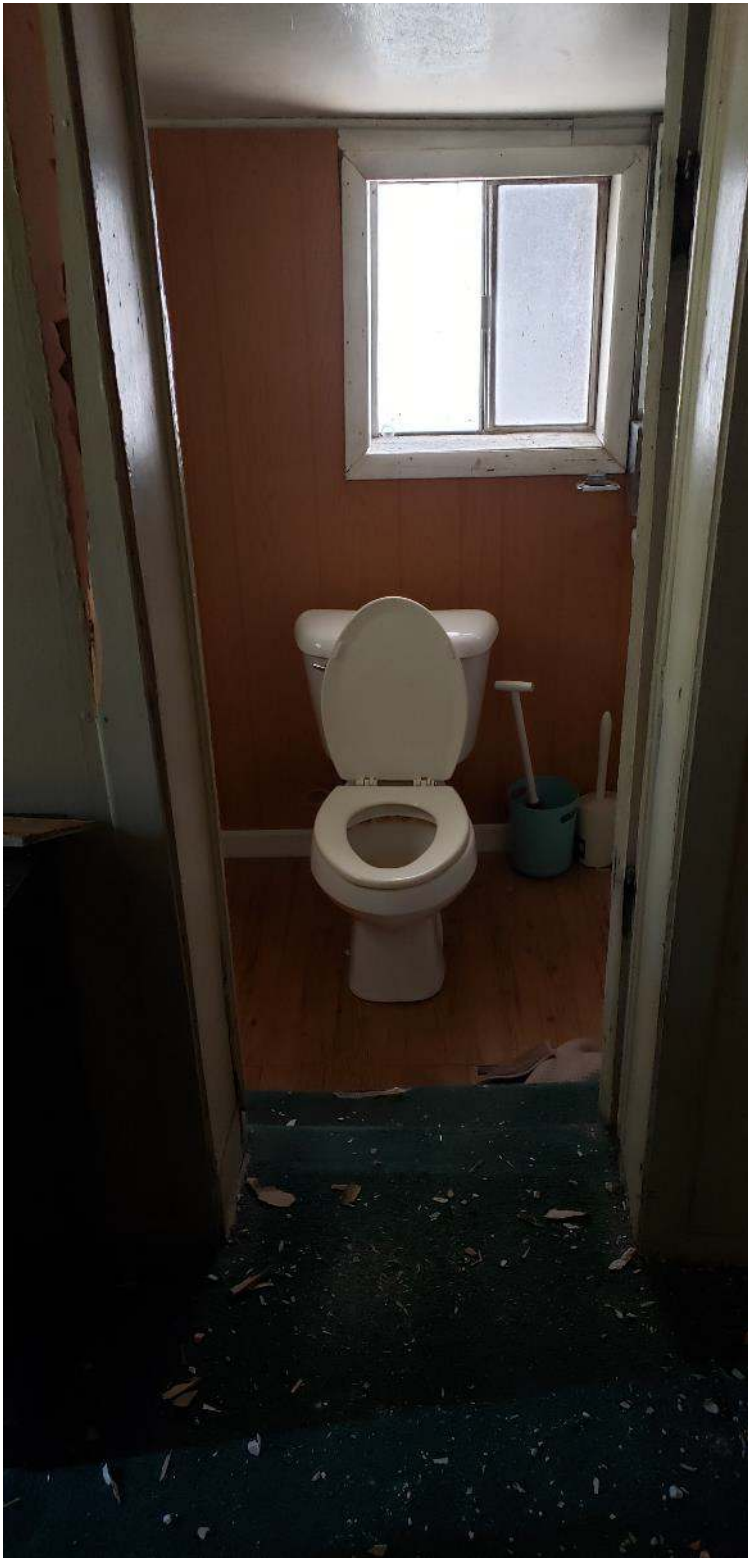
Photos 23–24. 617 W Tombstone bathroom off front NE corner room facing E (left) and within bathroom to N (right).

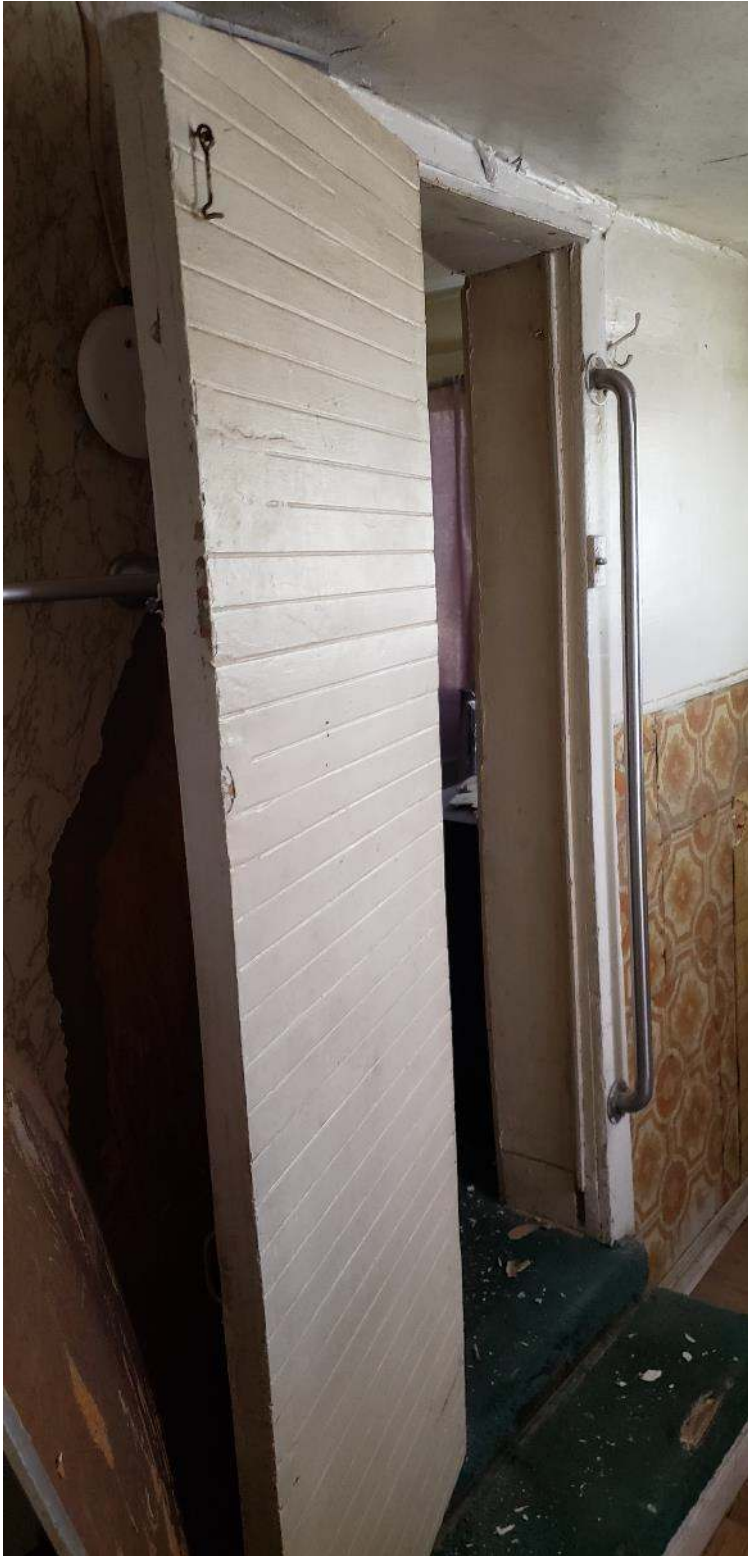
Photos 25–26. 617 W Tombstone bathroom entry and door in W wall facing NW (left) and S end facing SSE (right).

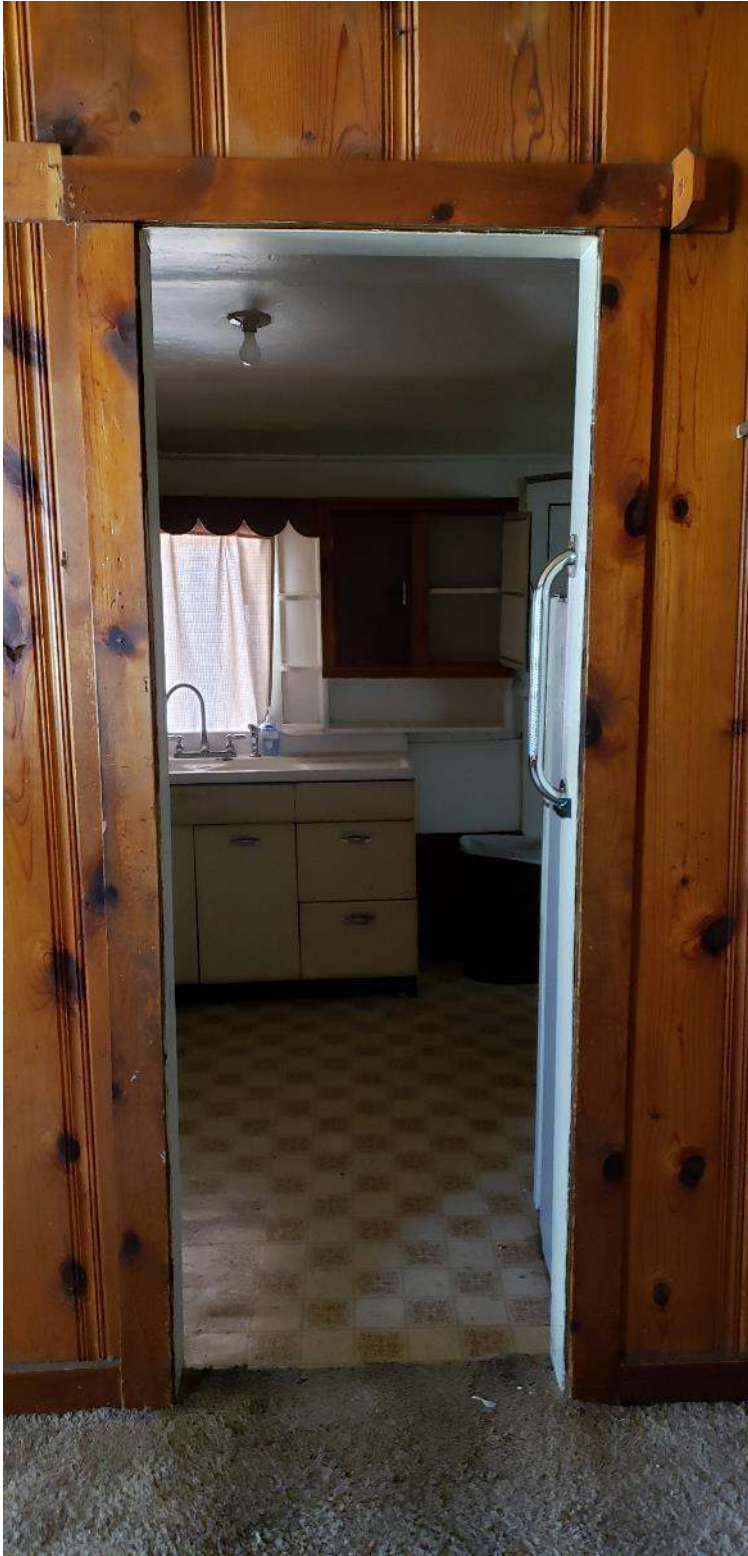
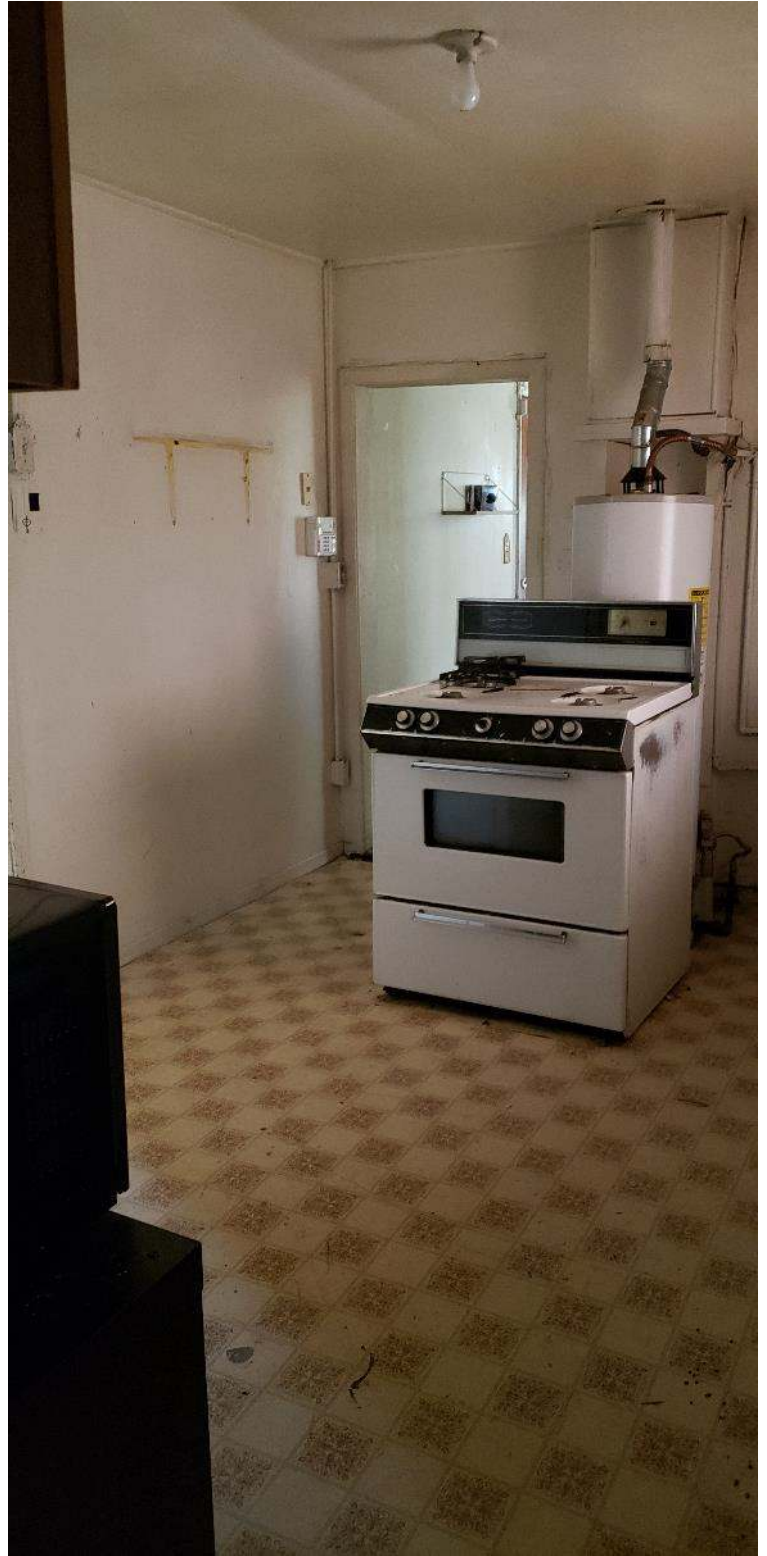
Photos 27–28. 617 W Tombstone kitchen on E side of house from front NW corner room facing E (left) and from SE corner facing NW toward front NE corner room (right).

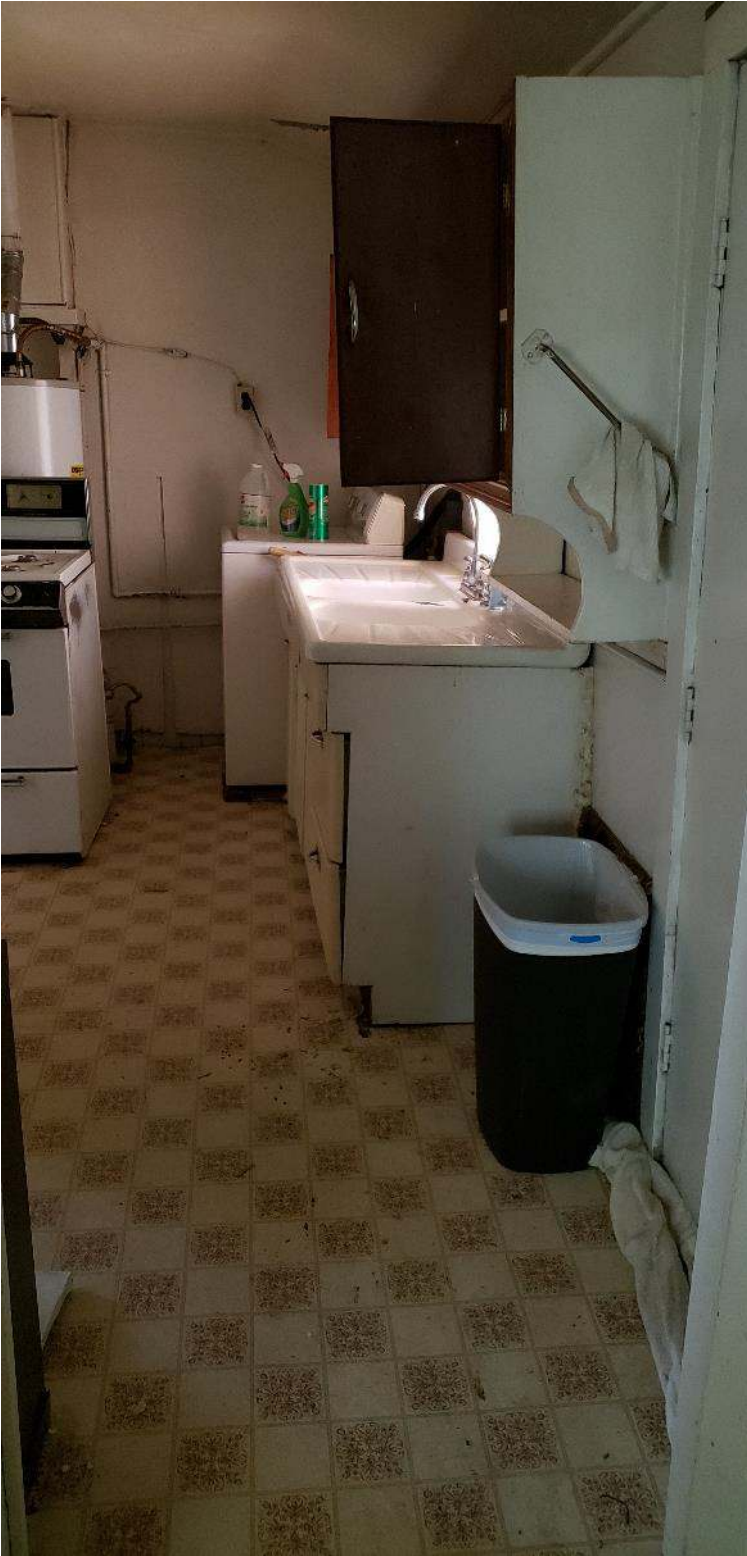
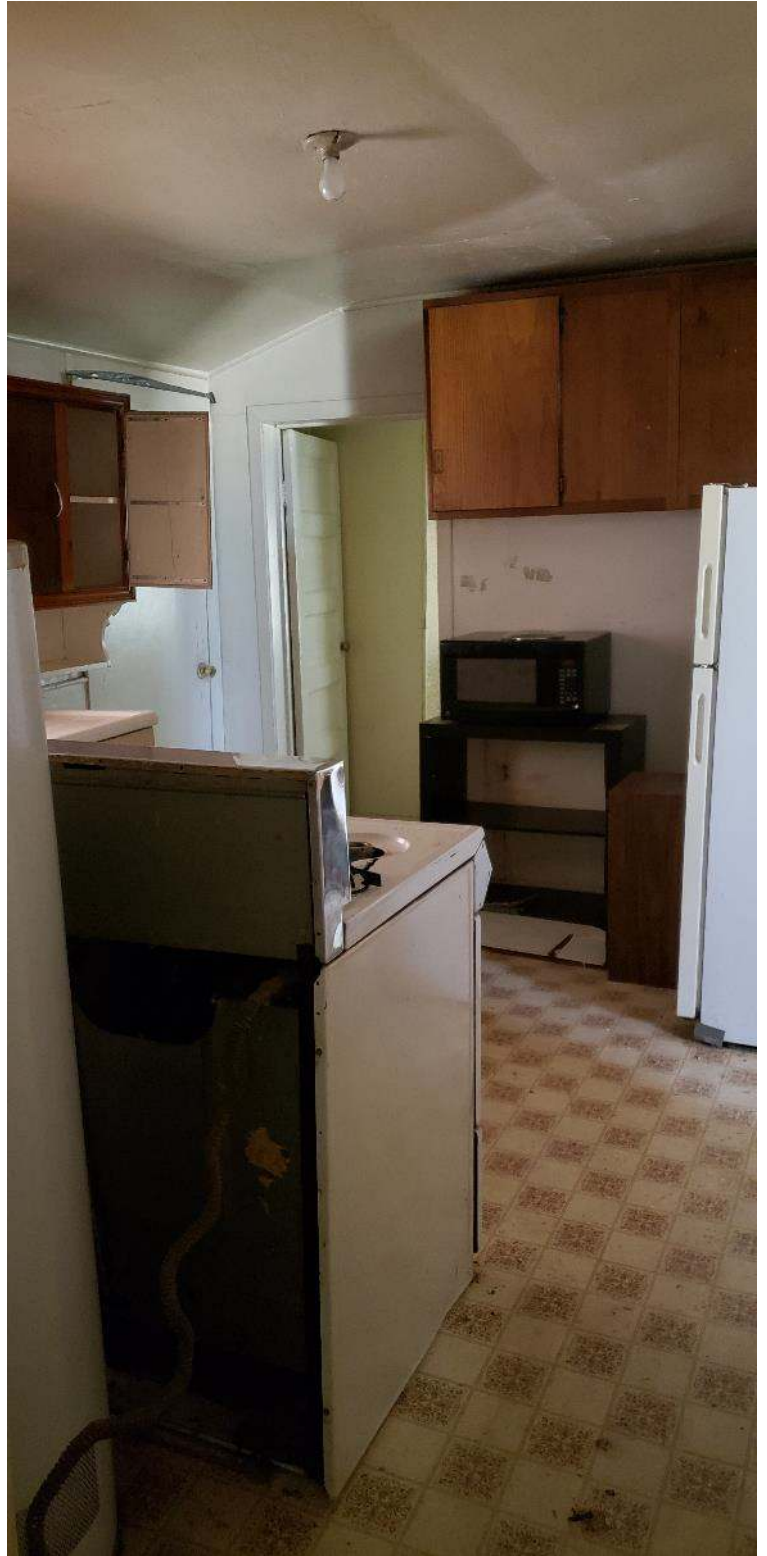
Photos 29–30. 617 W Tombstone kitchen from rear bedroom(s) doorway facing N (left) and from NE corner room doorway facing SSE (right).

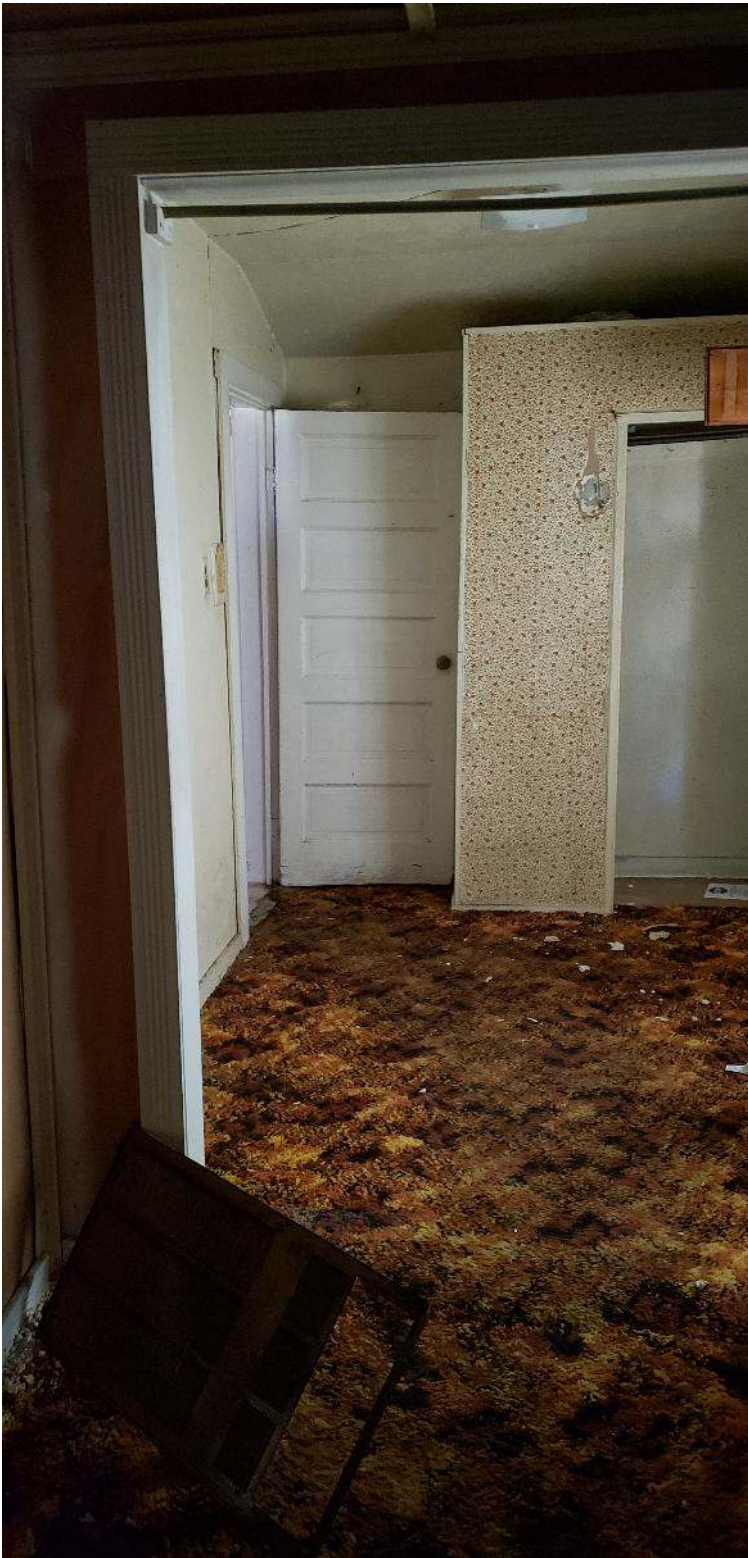
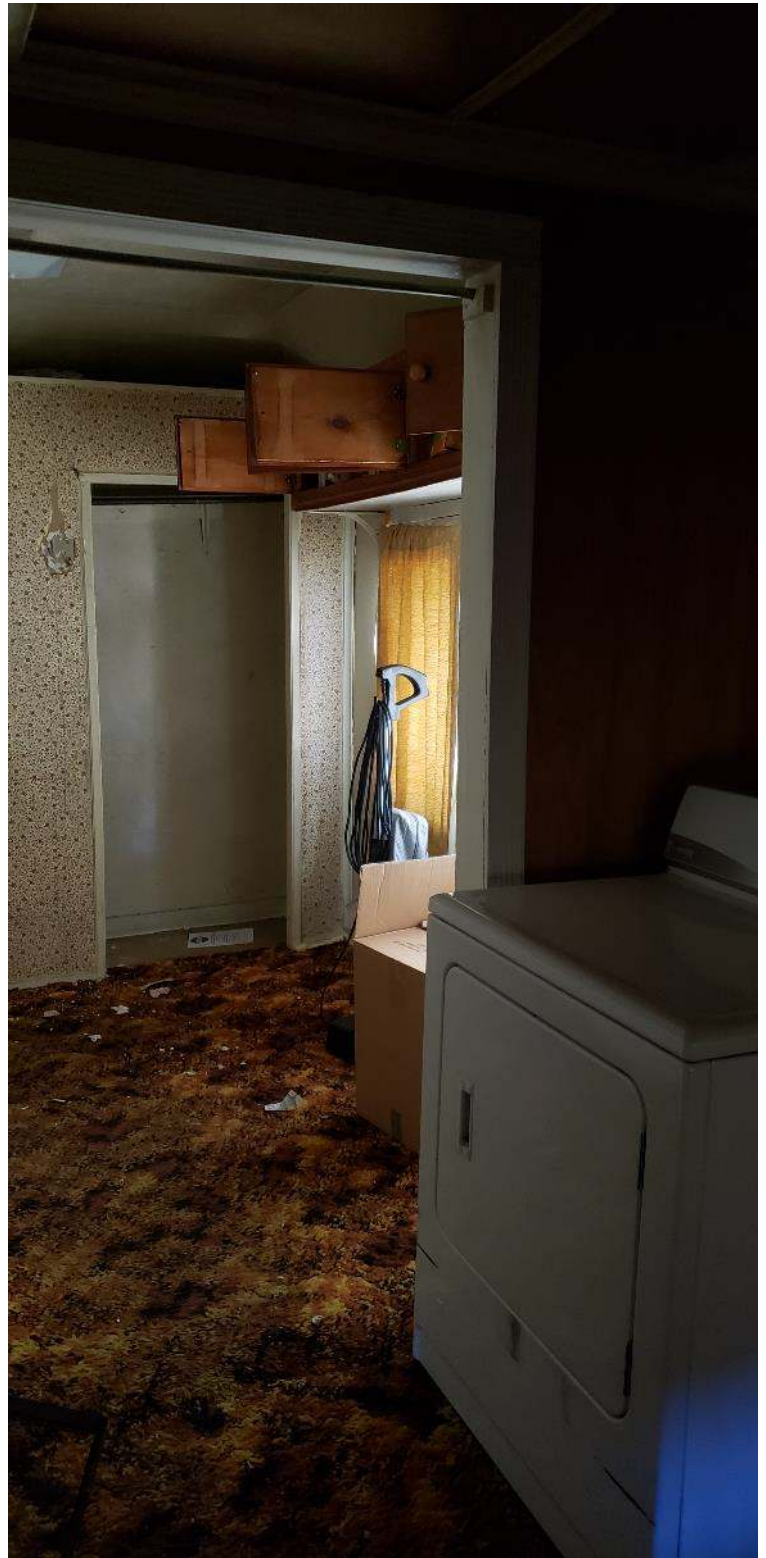
Photos 31–32. 617 W Tombstone back of house SE corner utility room/bedroom facing E (left) and SE (right) from SW corner bedroom.

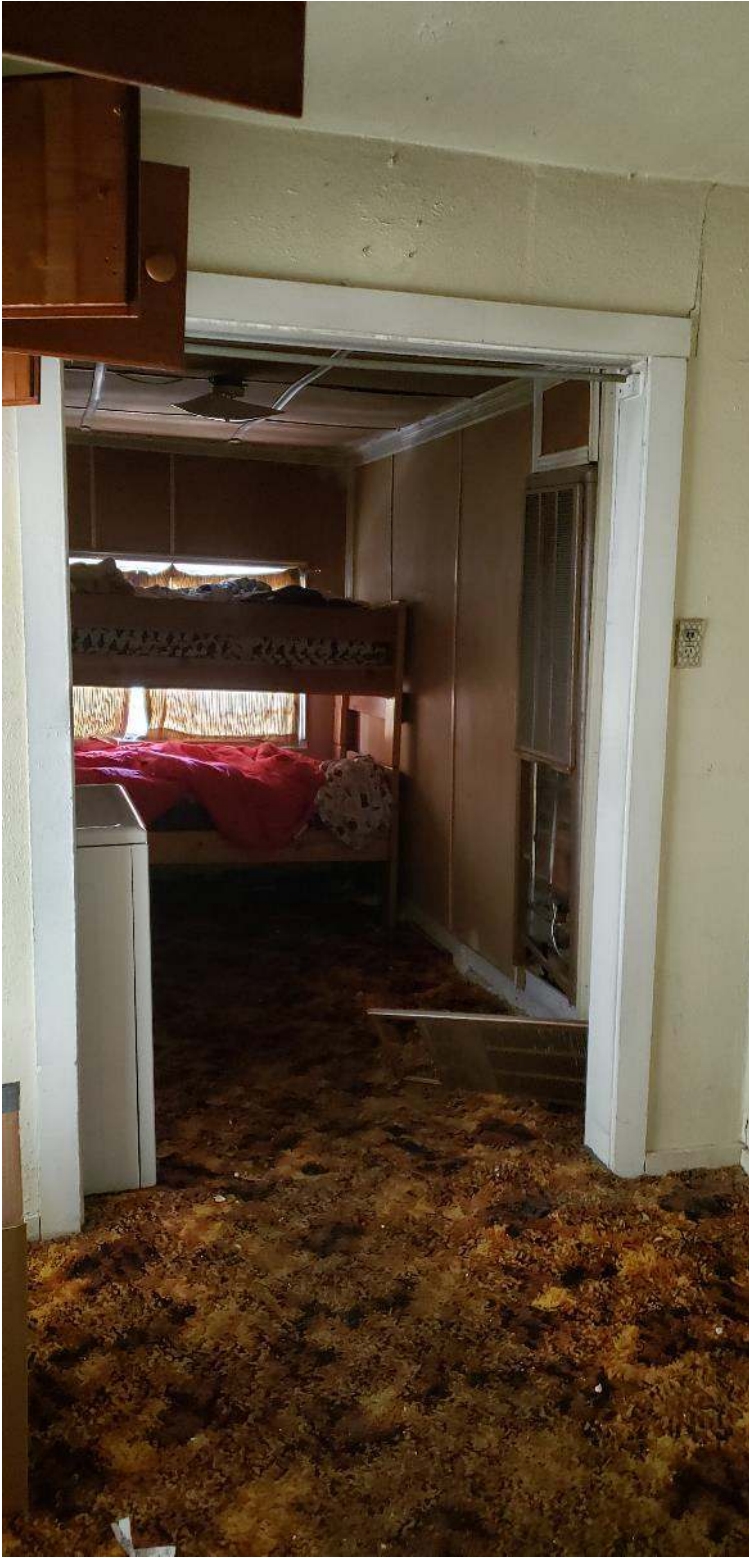
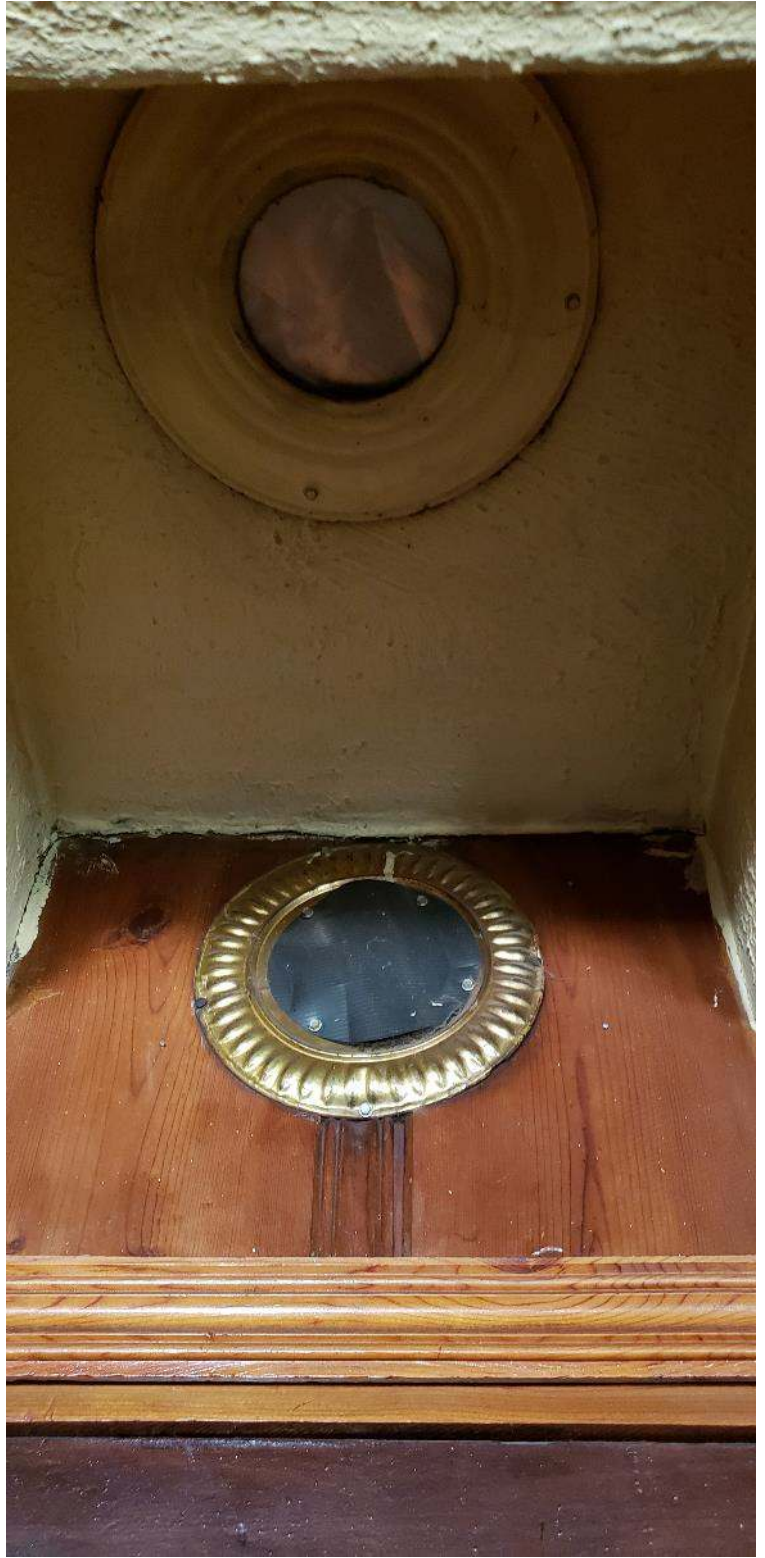
Photos 33–34. 617 W Tombstone back of house SW corner bedroom and laundry room from SE corner room facing W (left) and detail of where a stove pipe once went outside through the house's S façade and the roof, facing S/up (right); the latter photo is evidence of the back room likely being added on at some point.

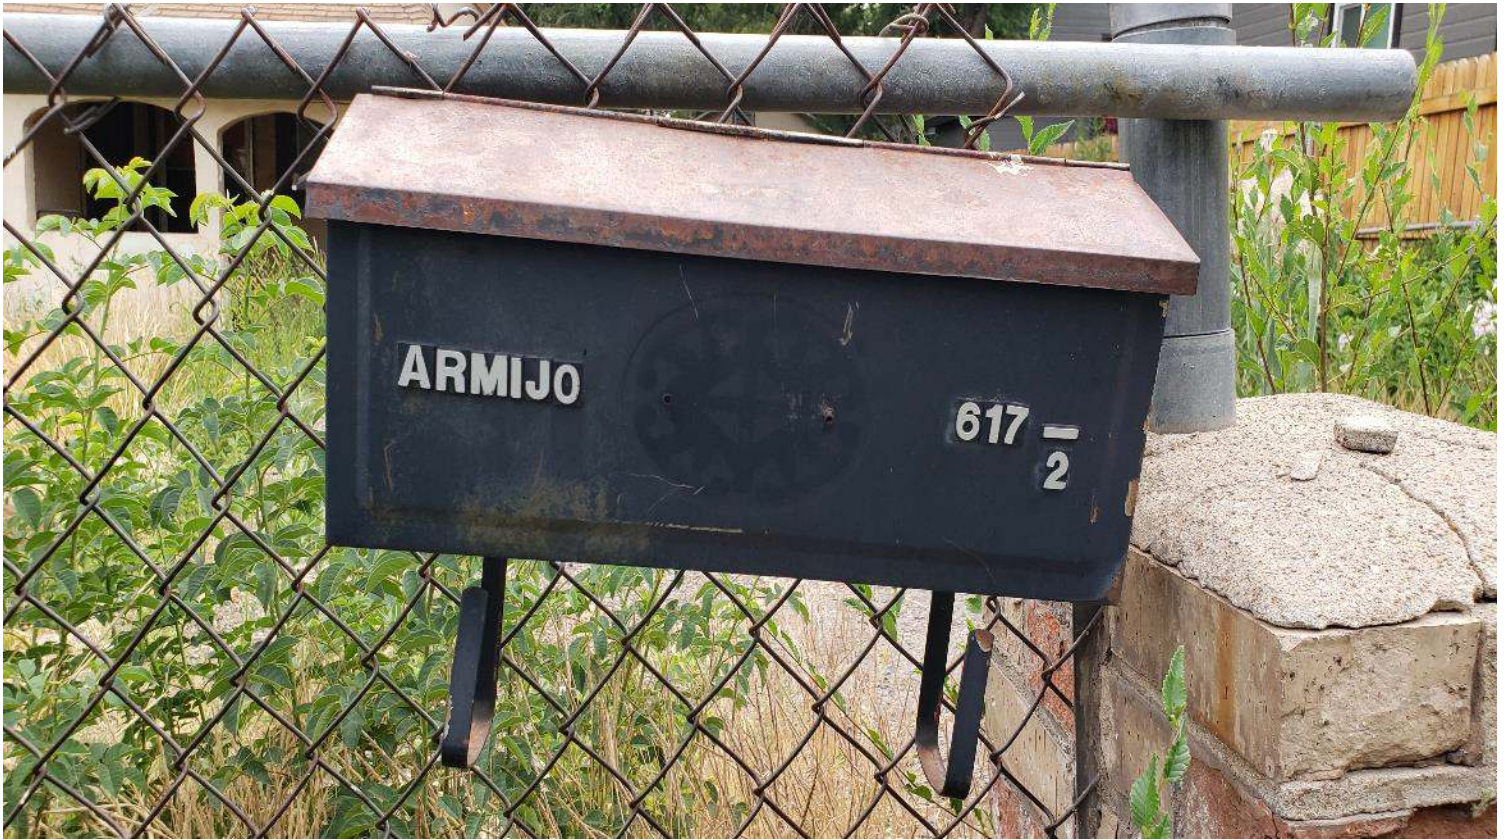
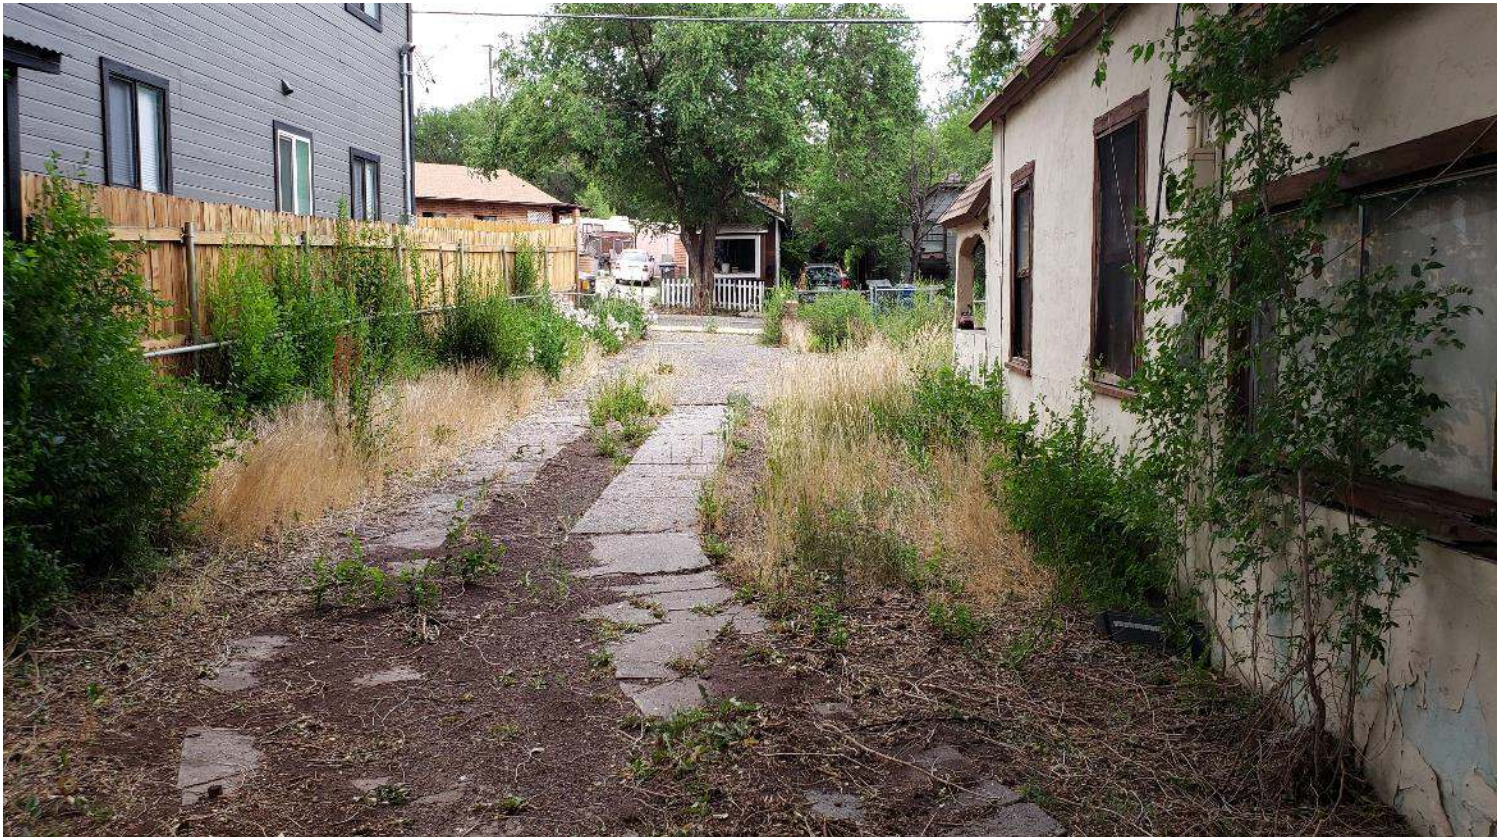
Photos 35–36. 617½ W Tombstone mailbox on front property fence facing S (top) and view from house out to street facing N (bottom).

The second house is reported by the County to have been constructed around 1947 and is thought to be the result of an earlier garage structure conversion. The 617½ W Tombstone Avenue address is understood to have had a tenant with the last name Armijo as its resident for many years (*Photo 35*). As far as 40-year-old descendant Matthew Sedillo can recall, this house has always been rented but is thought to have been constructed by his grandfather Felipe (Philip) Sedillo for family members to live on the property. The house sits back from the road and has concrete tracks leading to it (*Photo 36*), with the tracks extending beyond to a presumably newer garage (now shed). There are four rooms (living room, bedroom, kitchen, bathroom) in the 469-square foot (26.7 × 20.5 feet overall), semi-rectangular vernacular home (see Figure 5, building sketch map). The house construction style, materials, and treatments are like those used for the main house but are even more reflective of the 1960s (e.g., aluminum-frame windows, doors, interior fixtures and appliances) rather than the suspected time of construction/conversion (*Photos 37–50*). Akin to the main house, this house is also in poor structural condition and has not been well maintained in recent years.

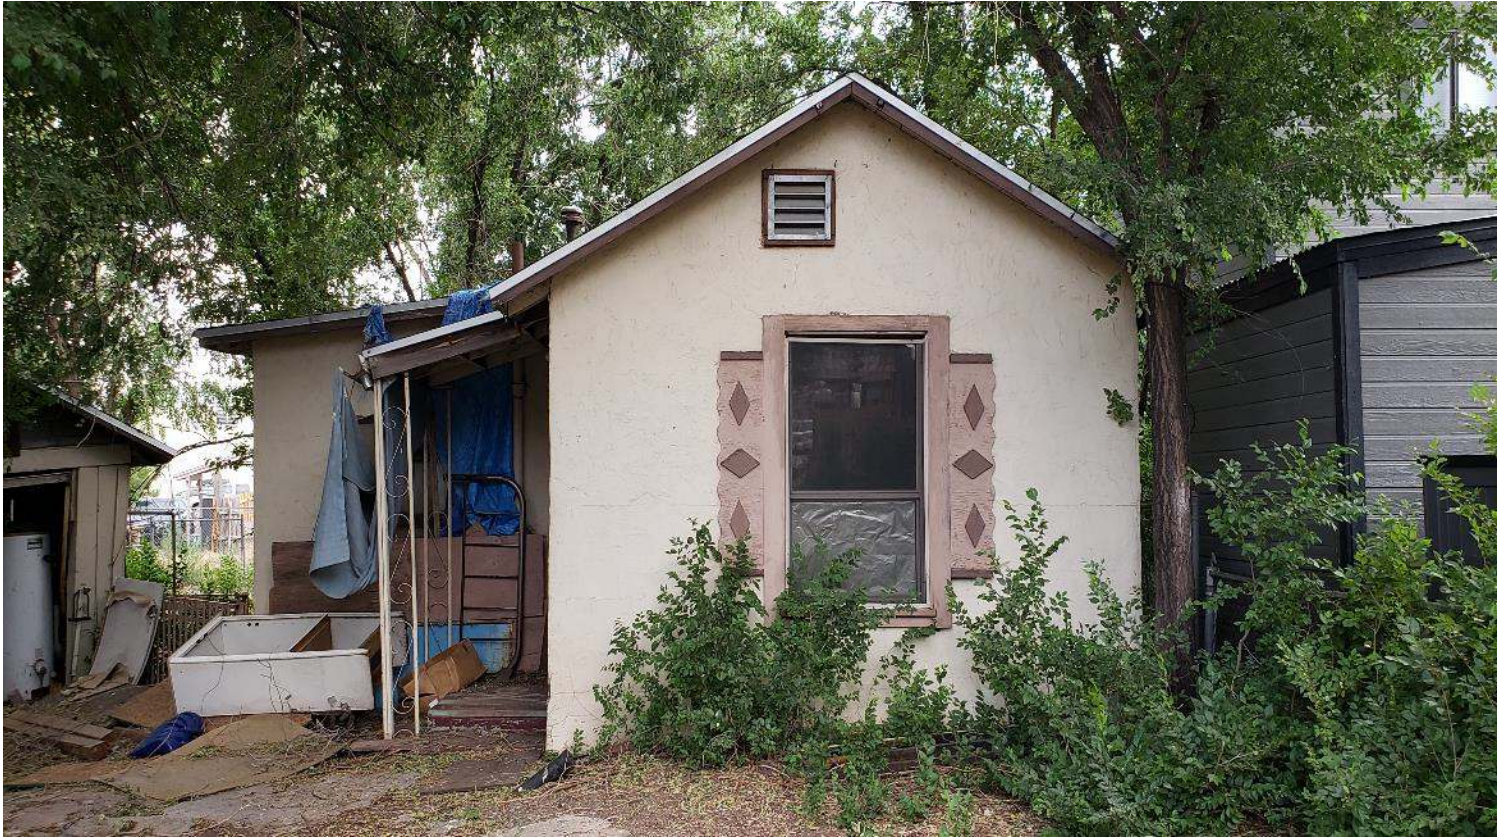
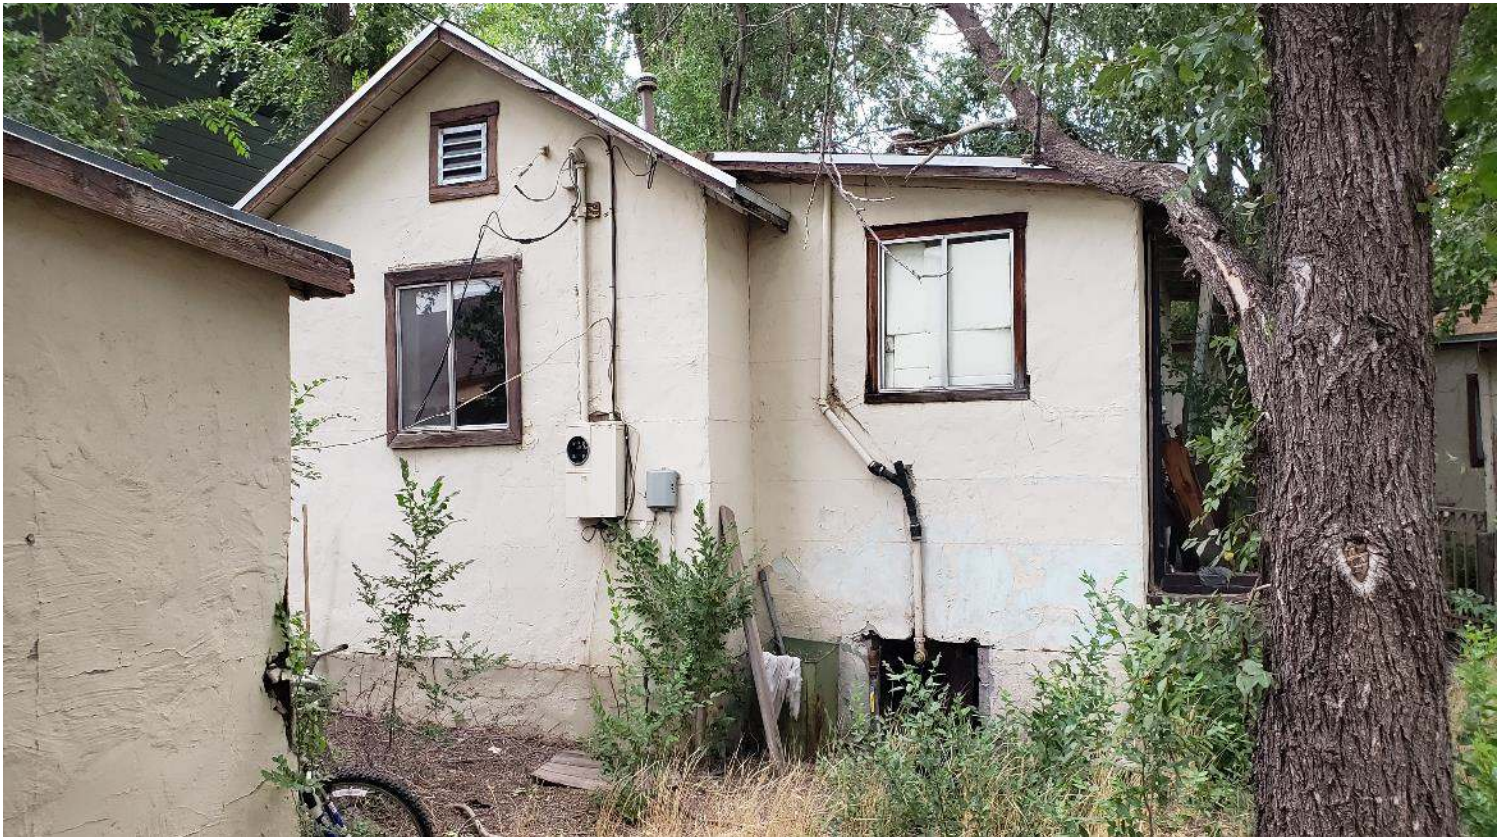
Photos 37–38. 617½ W Tombstone front/N façade (top) and S façade facing NNW (bottom).

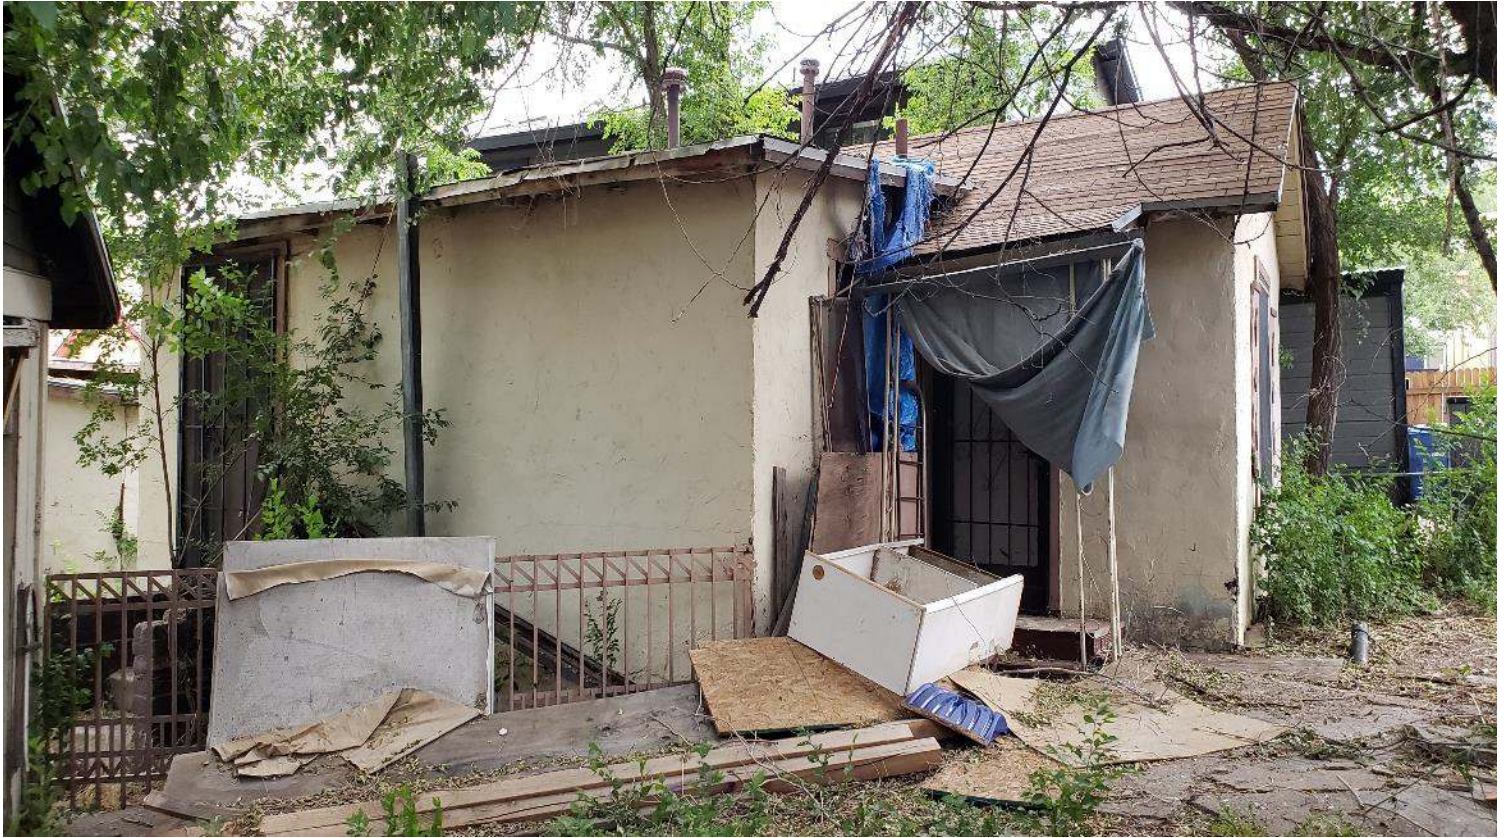
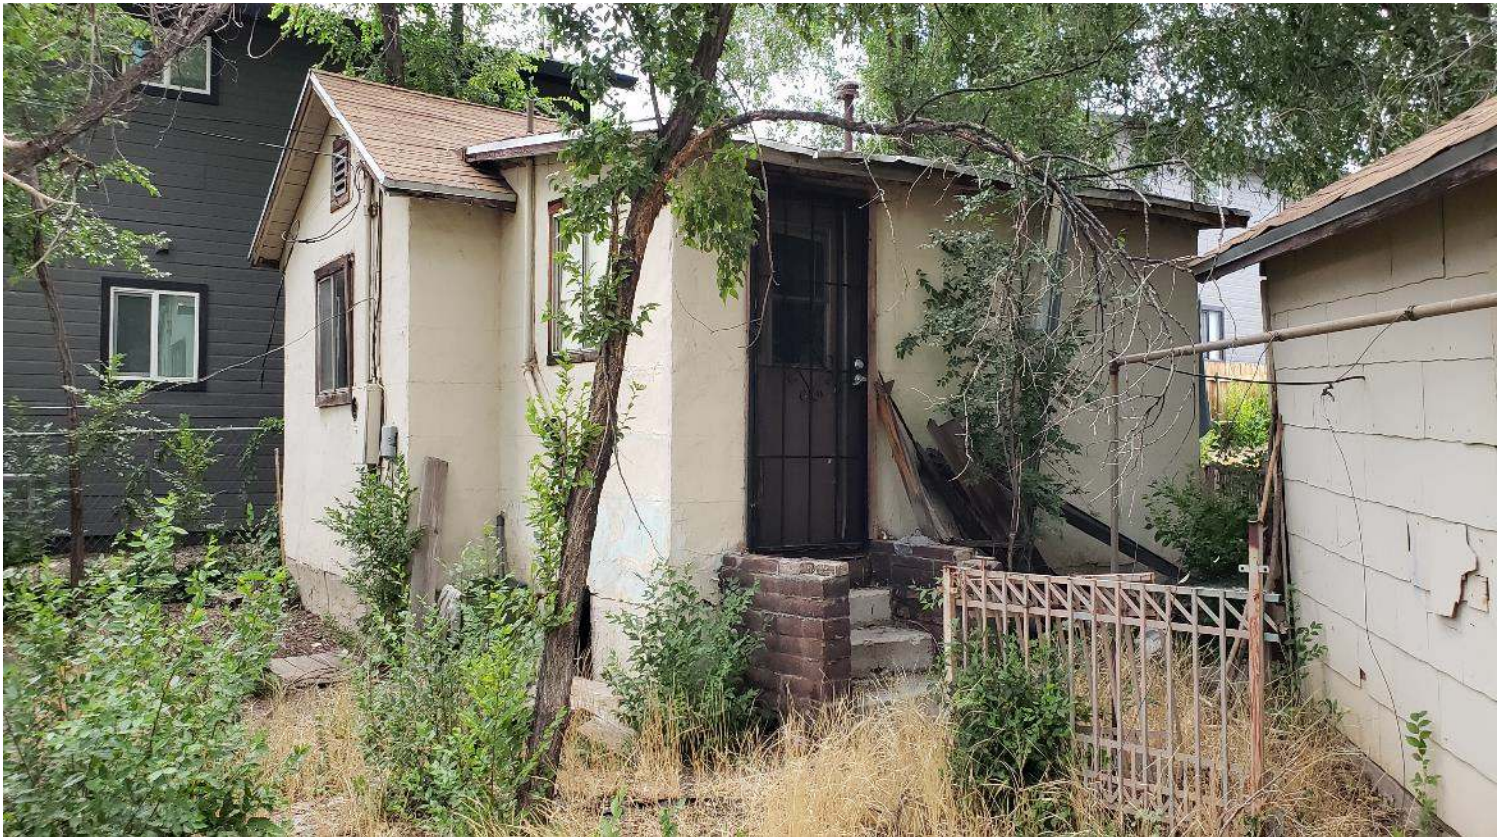
Photos 39–40. 617½ W Tombstone E façade facing W (top) and E & S facades facing WNW (bottom).
