*RE: Cultural Resource Study Letter Report for Parcel 100-36-041 at 617 West Tombstone Avenue, City of Flagstaff, Coconino County, Arizona (PZ-23-00173; LA Neal Consulting, LLC Project No. 1091-23)*

### Property Description/Architecture

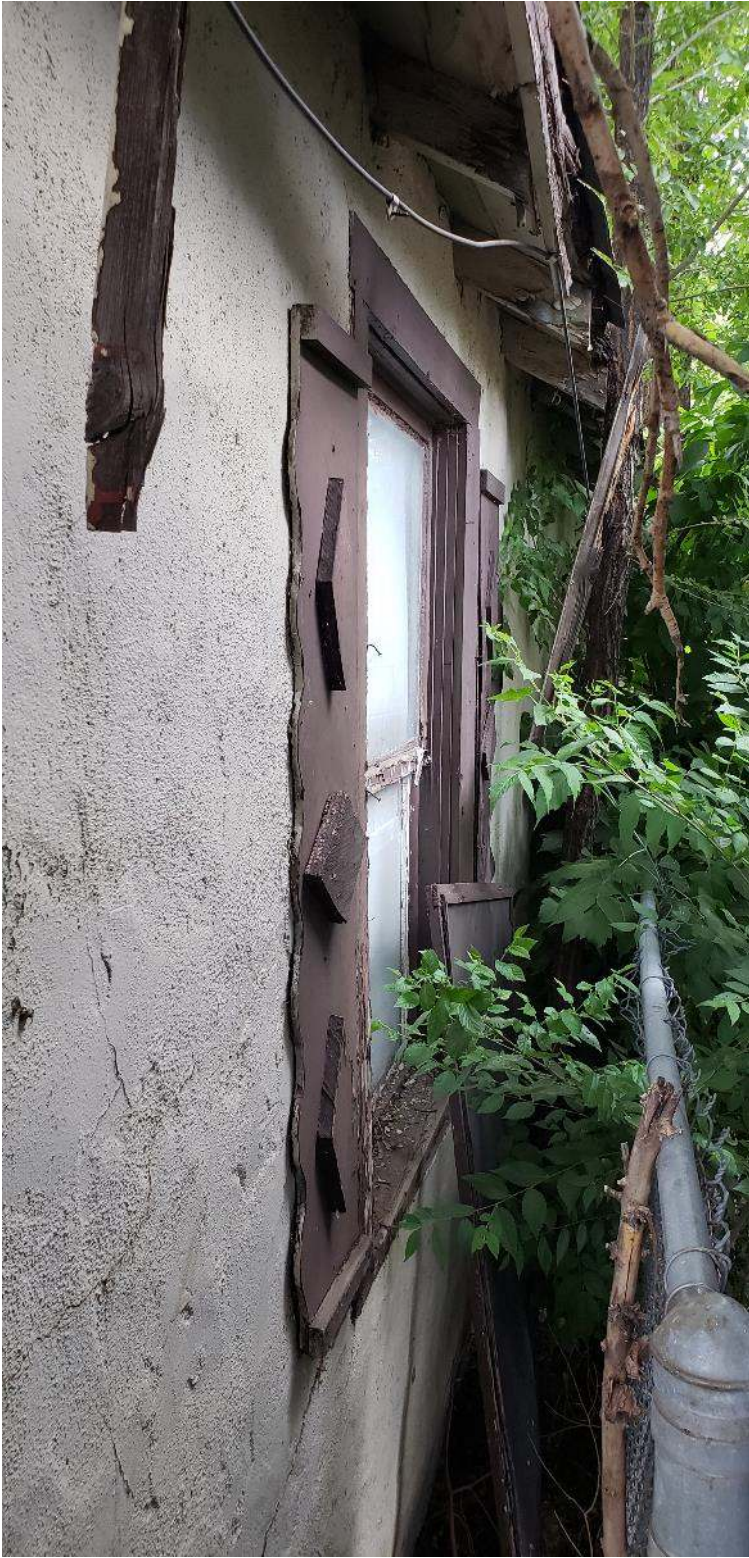
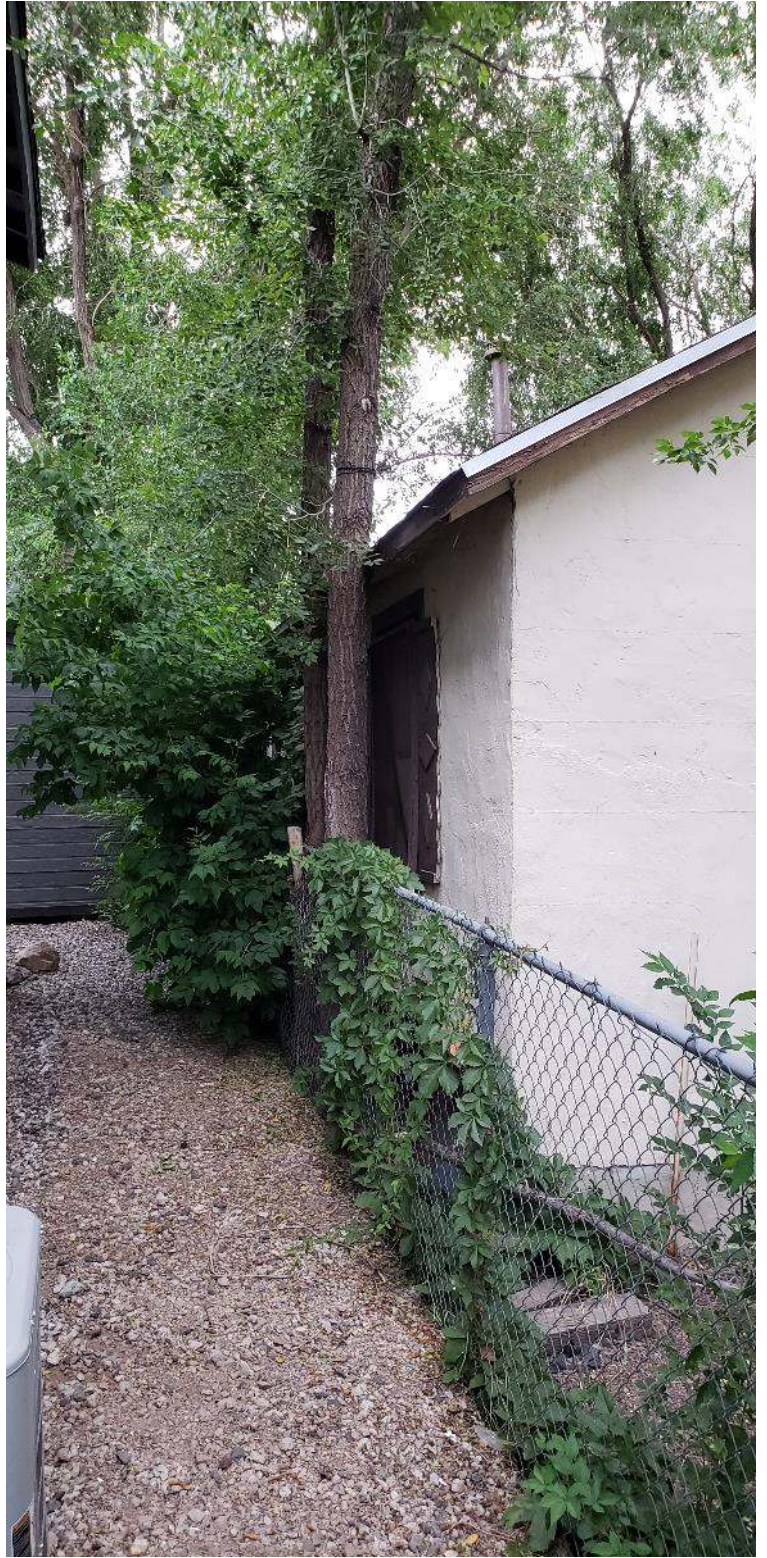
Photos 41–42. 617½ W Tombstone W façade from NW corner and W property line facing S (left) and off SW corner facing N (right).

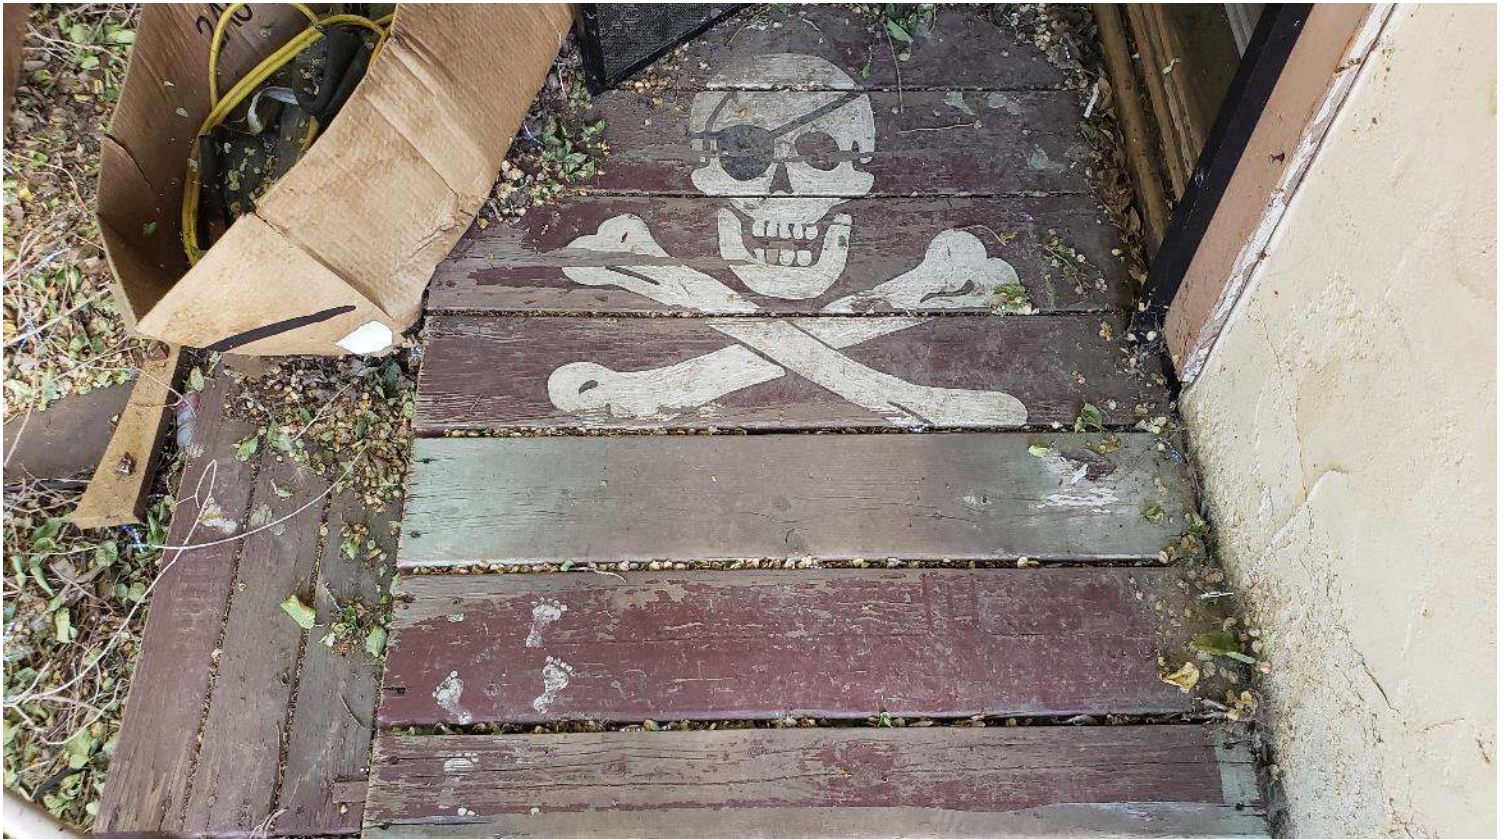
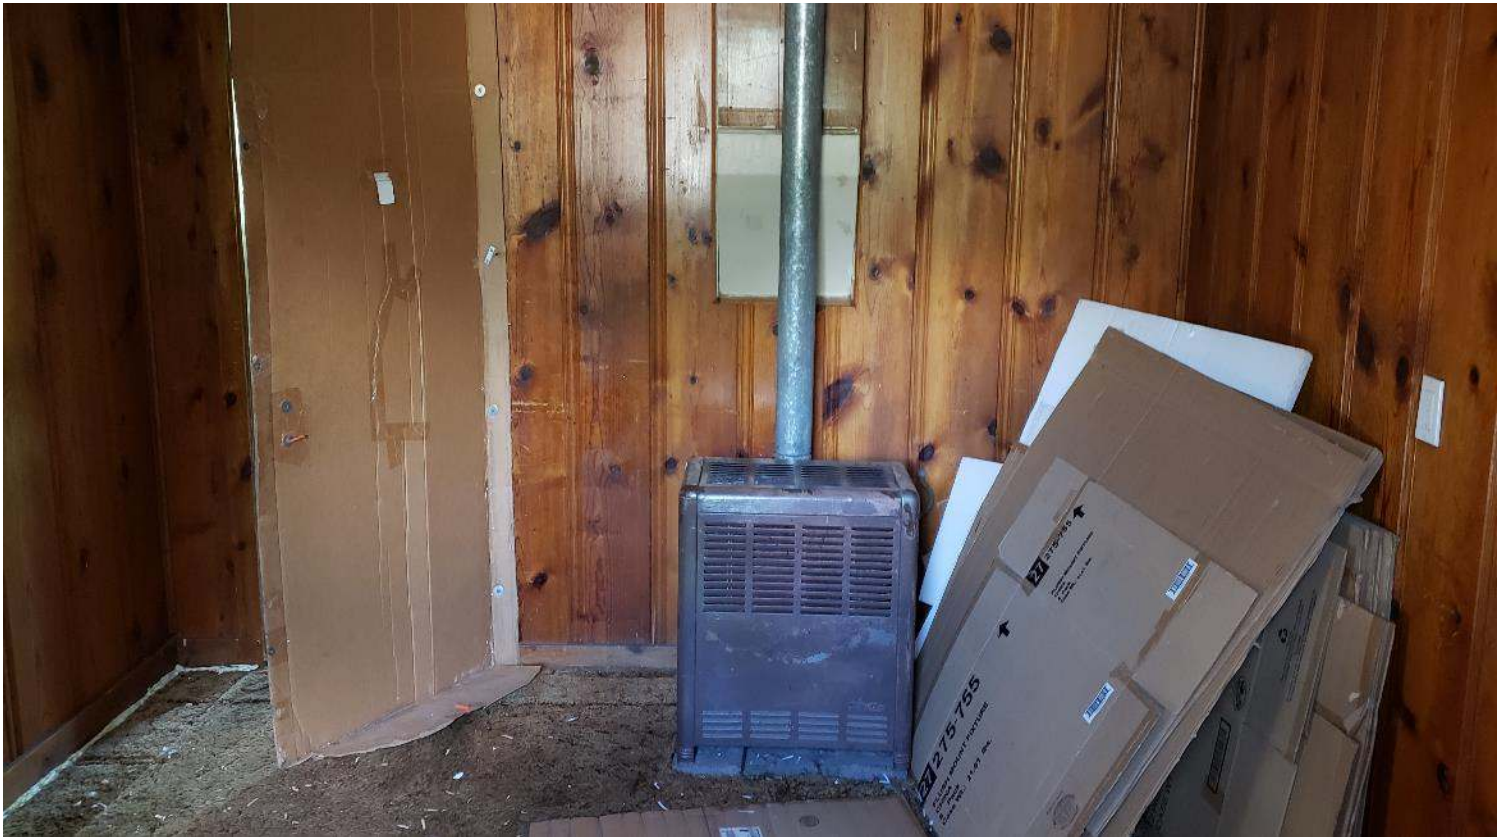
Photos 43–44. 617½ W Tombstone colorful stoop/porch at house NE corner facing down/S (top) and front NW corner room/living room facing S (bottom).

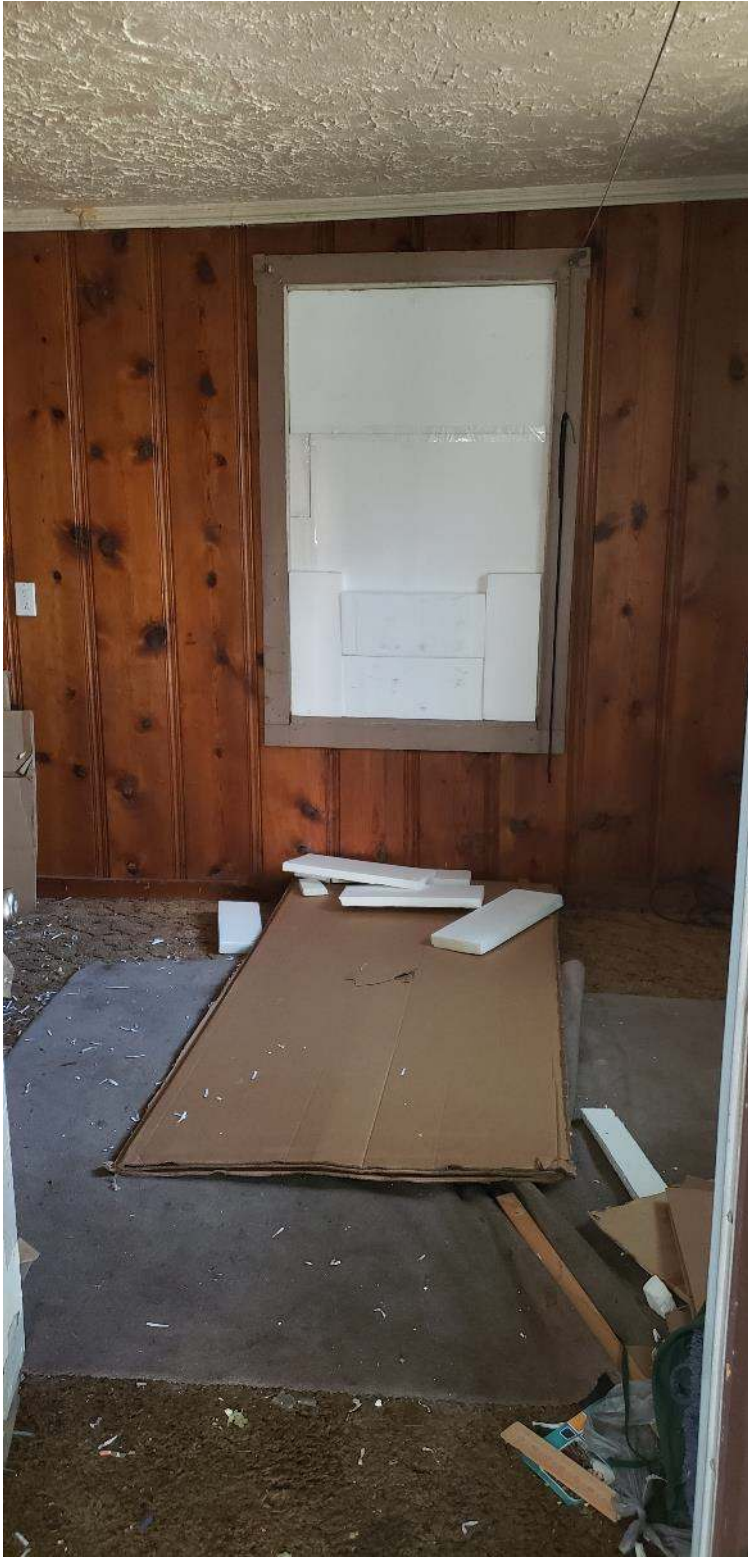
Photos 45–46. 617½ W Tombstone front NW corner room/living room facing W from front doorway (left) and facing N with front door open (right).

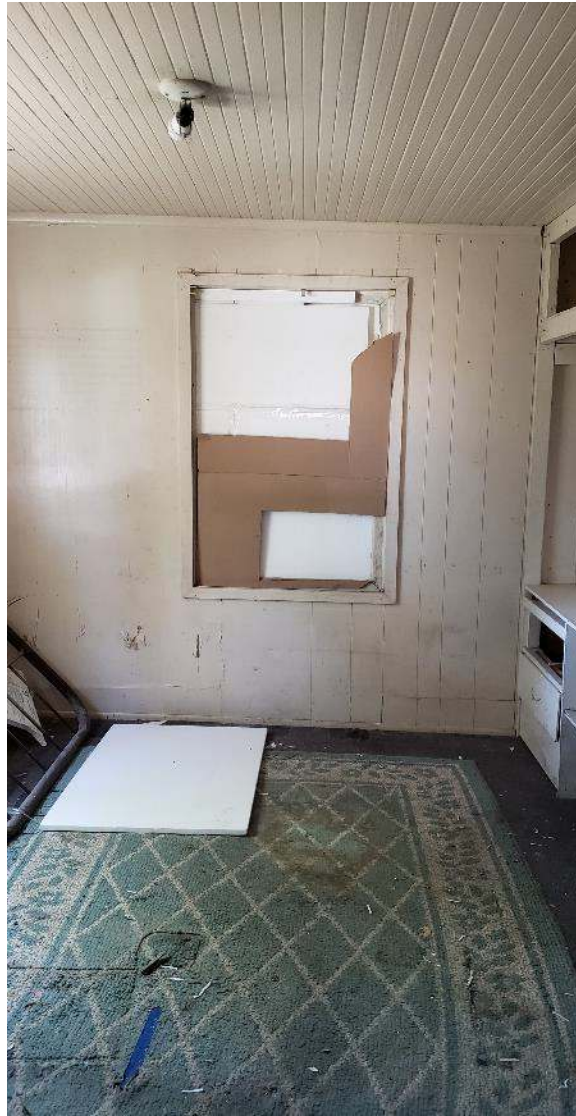
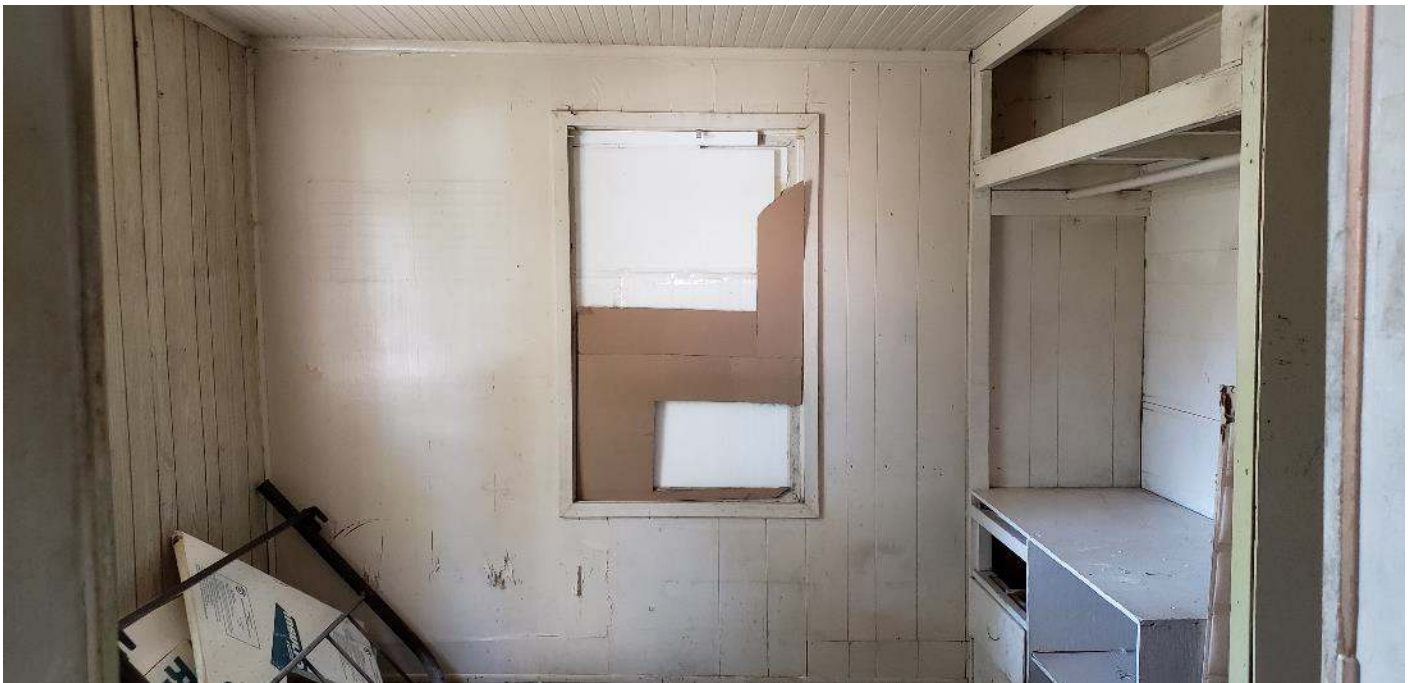
Photos 47–48. 617½ W Tombstone rear/S bedroom facing W (top and bottom).

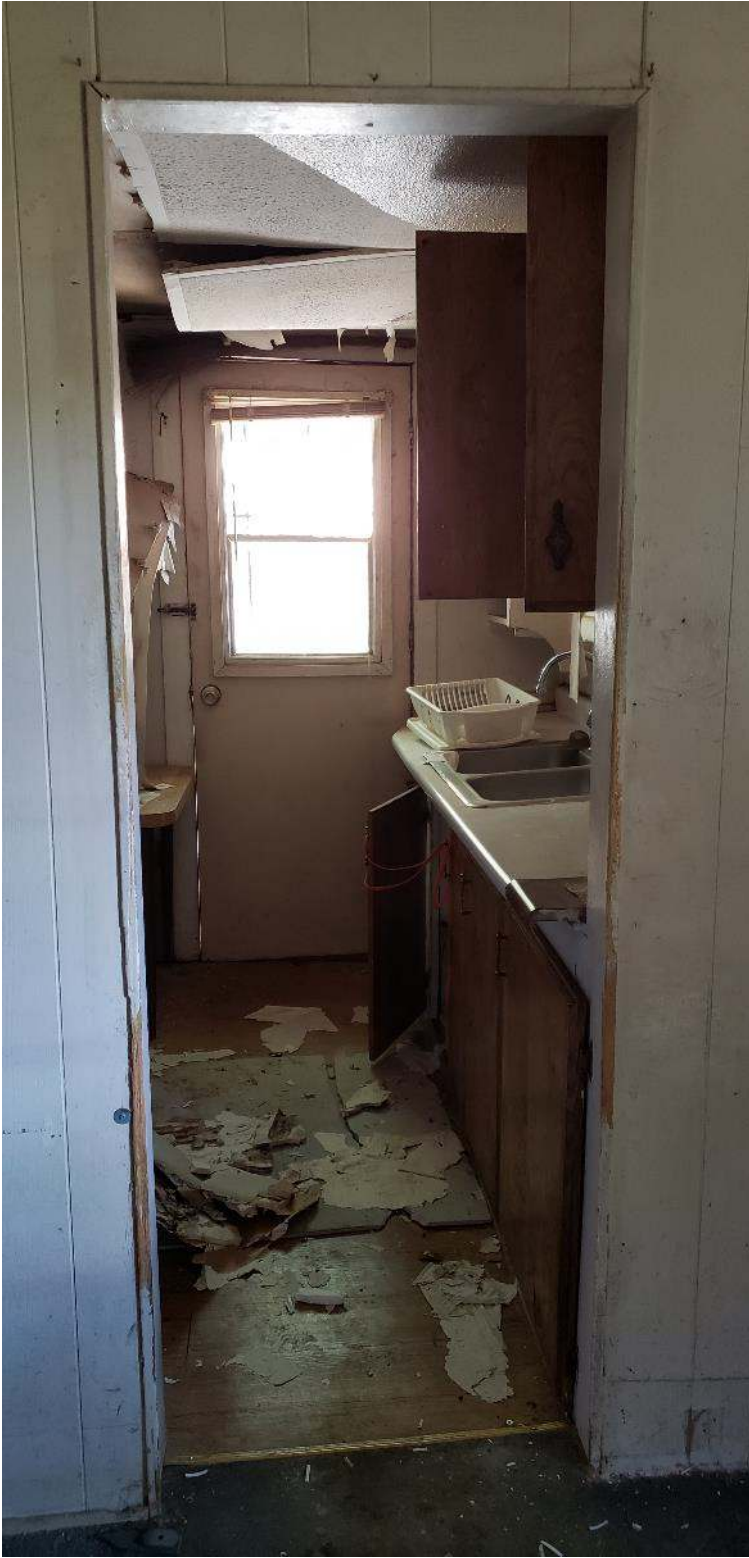
Photos 49–50. 617½ W Tombstone kitchen on E side of house in SE corner facing E from rear bedroom (left) and view from within kitchen looking into bathroom in NE corner of house facing N (right).

When current property owner L & M Prop3 Flagstaff, LLC acquired the property, the two houses had been residential rentals but had fallen into significant disrepair. The main house has evidence of roof leakage and ceiling sag, and the secondary house has a collapsed bathroom and kitchen ceiling. The workshop and garage were being used as storage, but the workshop's roof had partially collapsed at some point making it unsafe to use. The property has been unoccupied for months, largely because it was not livable and could not be safely rented by the current owner. The present-day houses have been cleared and stripped interiorly; masking is recommended to enter any of the buildings because of cats living under and around all the structures. The houses are reflective of late 1940s to 1960s modifications such as enclosed porches, window replacements, add-ons, conversions (secondary house from a garage), doors, and exterior finishes (stucco added likely in 1940s).

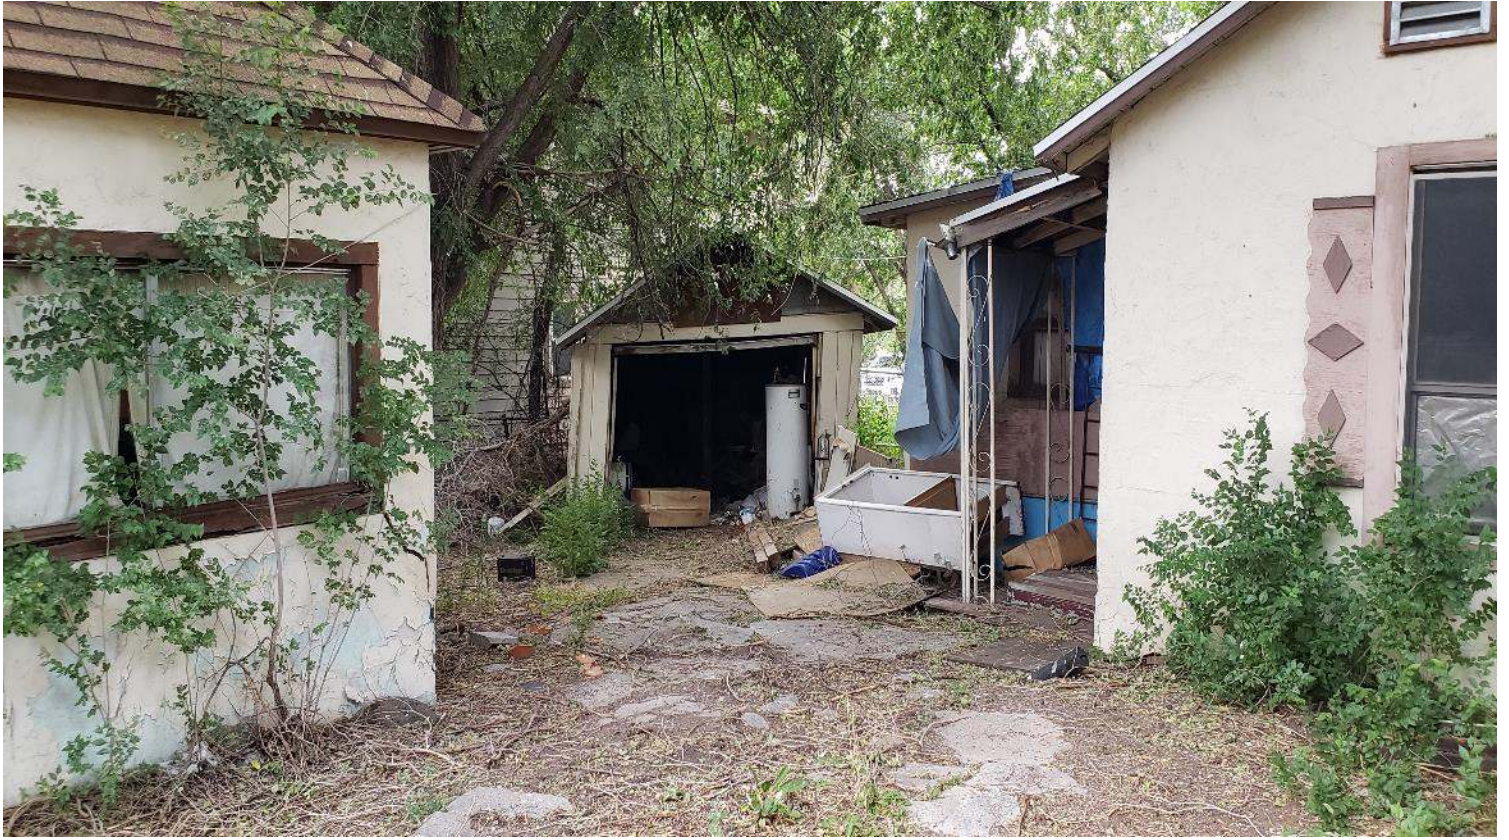
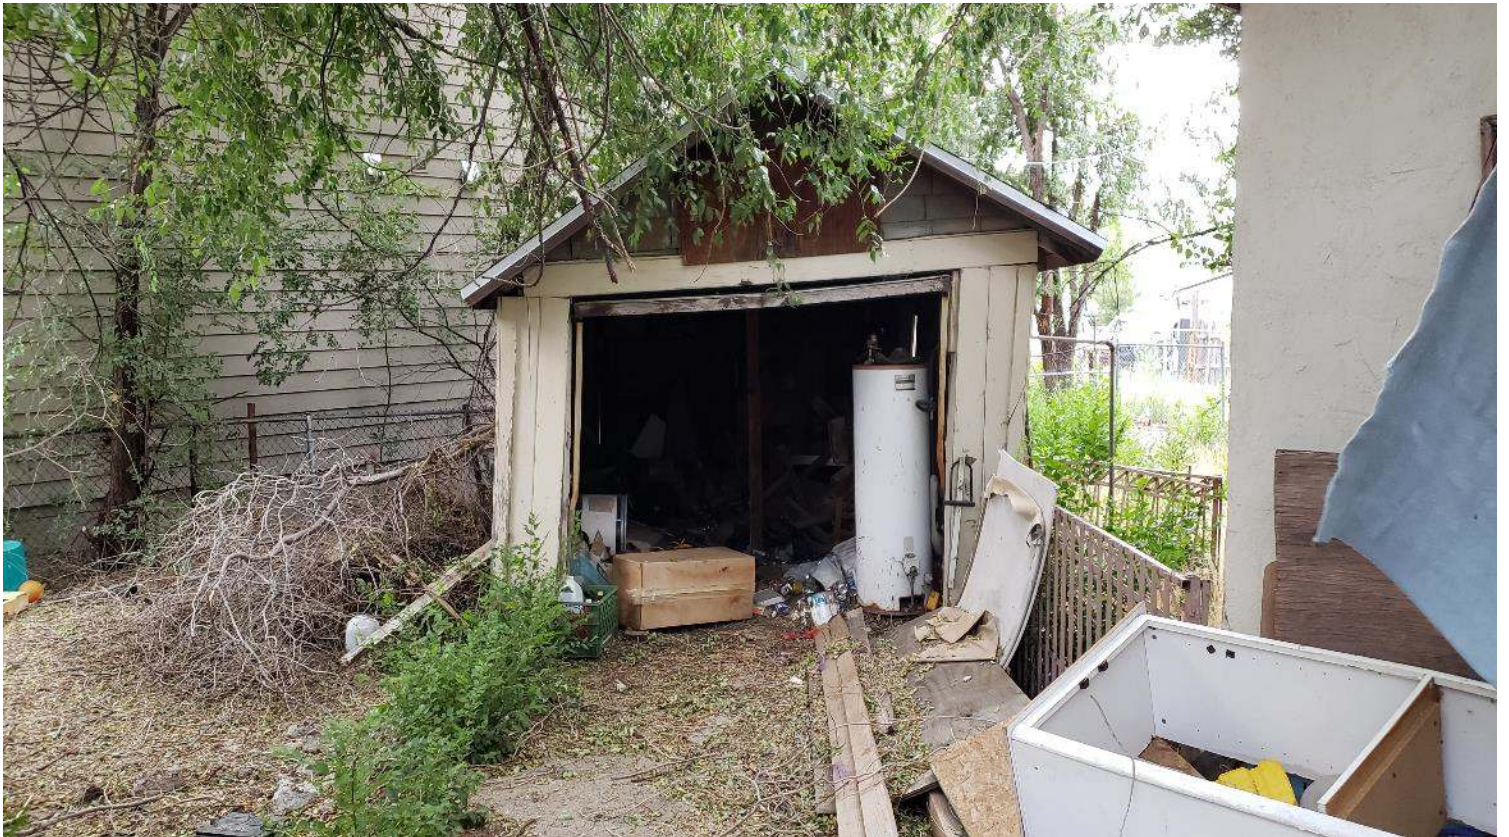
Photos 51–52. 617 W Tombstone garage behind main house and E of secondary house, facing SE (top) and NW façade (bottom).

The garage/shed at the rear of the main house is thought to be a replacement for the original garage likely converted to the secondary house. It consists of 2 × 4-inch wood framing and rafters, 1 × 7-inch horizontal wood wall siding and roofing covered with asphalt shingles, and the garage door in the NW façade. Asbestos tile and asphalt shingles cover the exterior walls, and the spring-hinged garage door is wood framed with corrugated aluminum finish (*Photos 51–56*). Interviewee Matthew Sedillo has only ever known this structure to be used for storage.

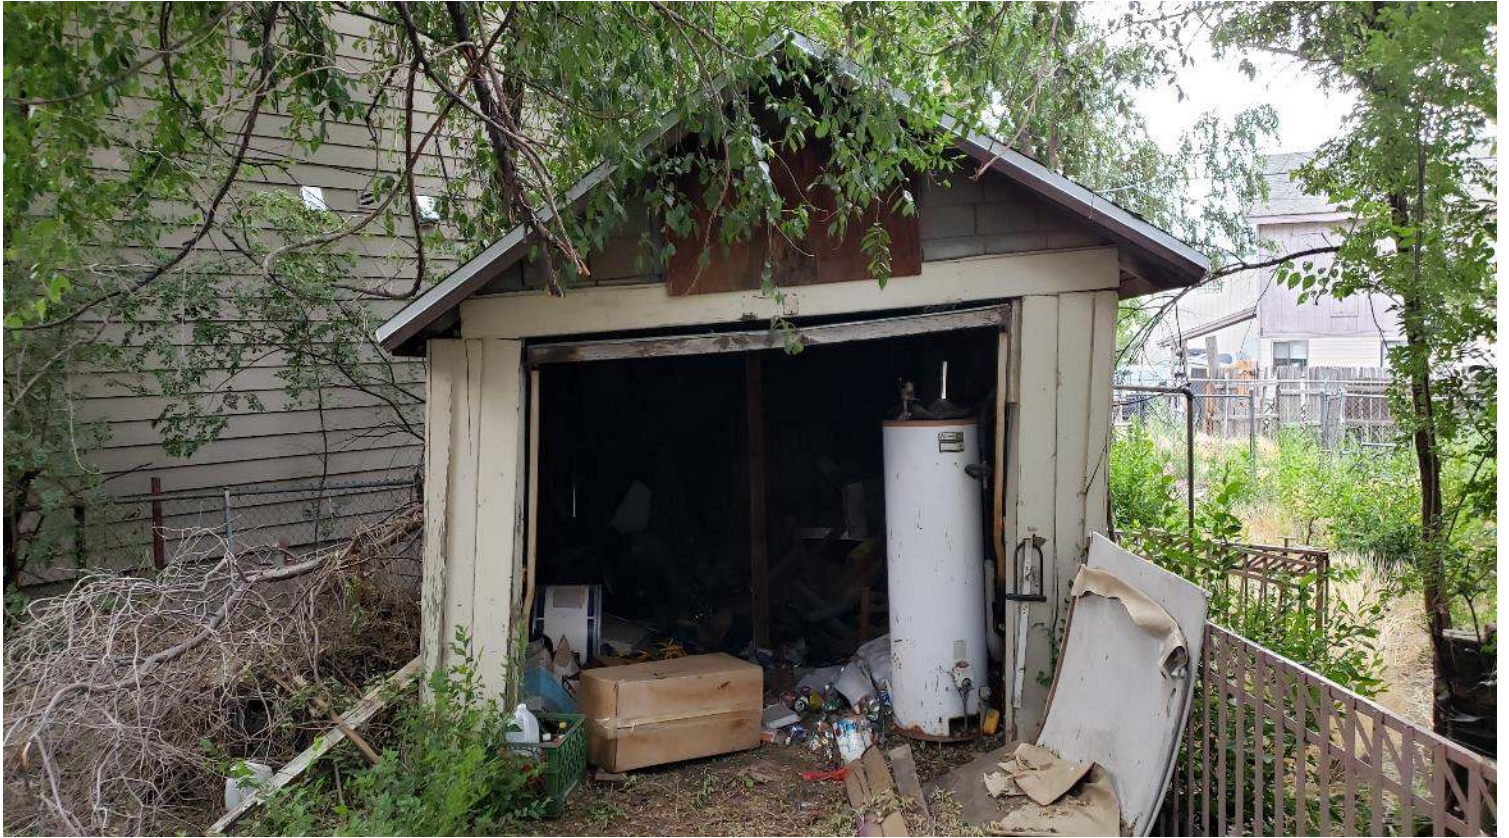
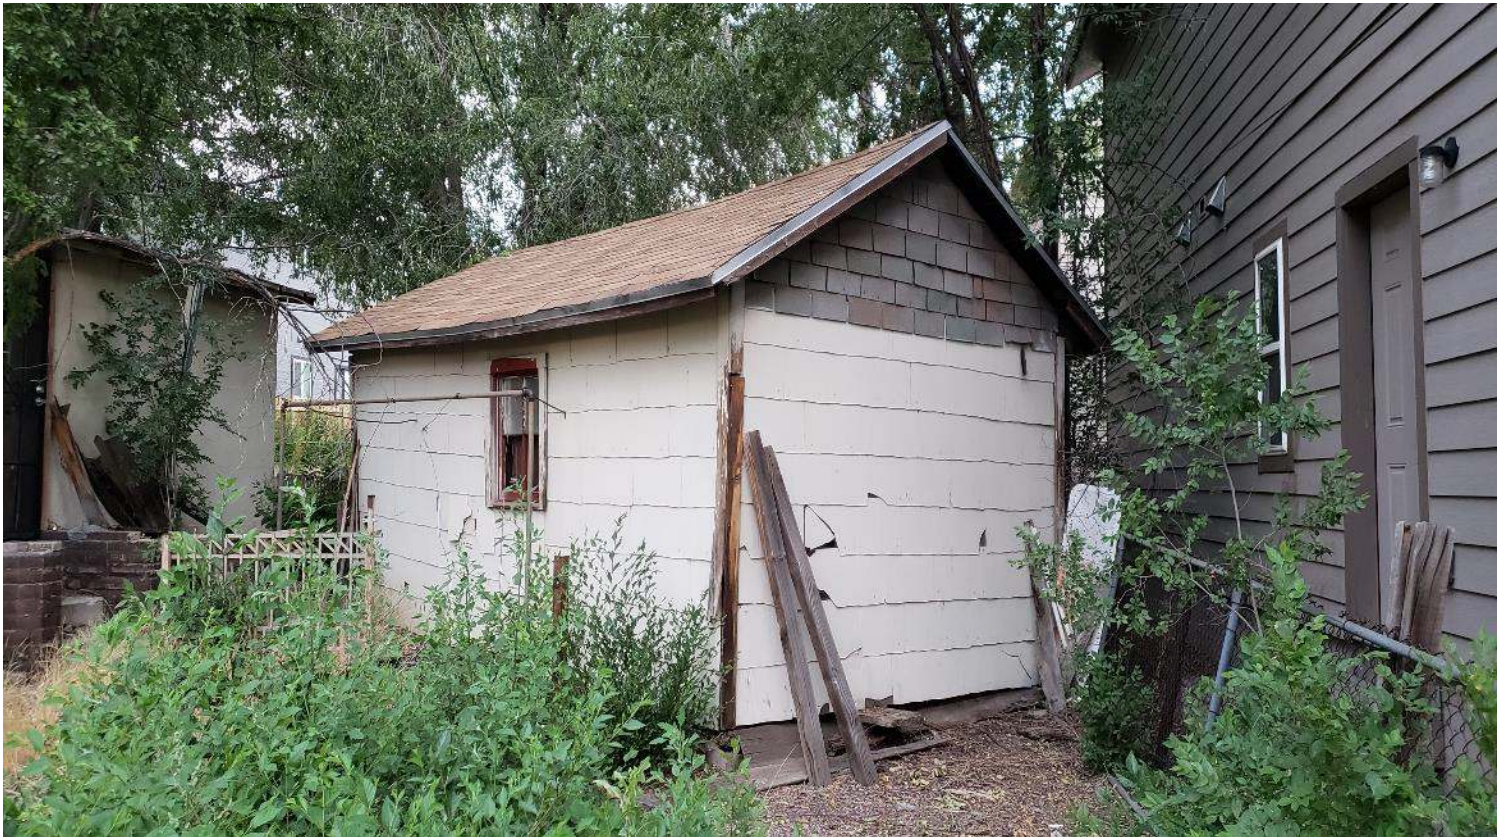
Photos 53–54. 617 W Tombstone garage NW façade close-up (garage door up) facing SE (top) and SW & SE façades facing N (bottom).

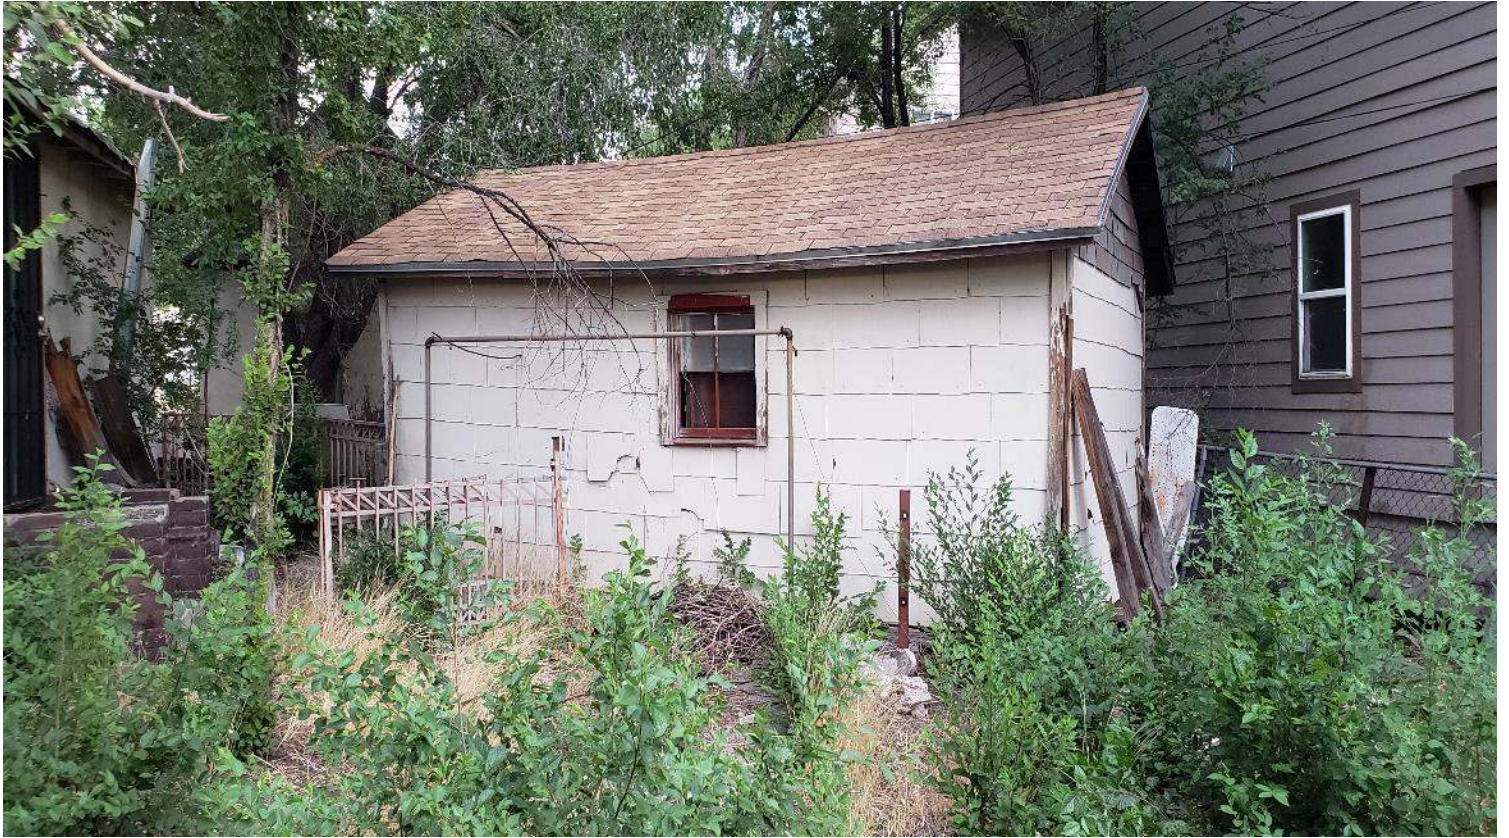
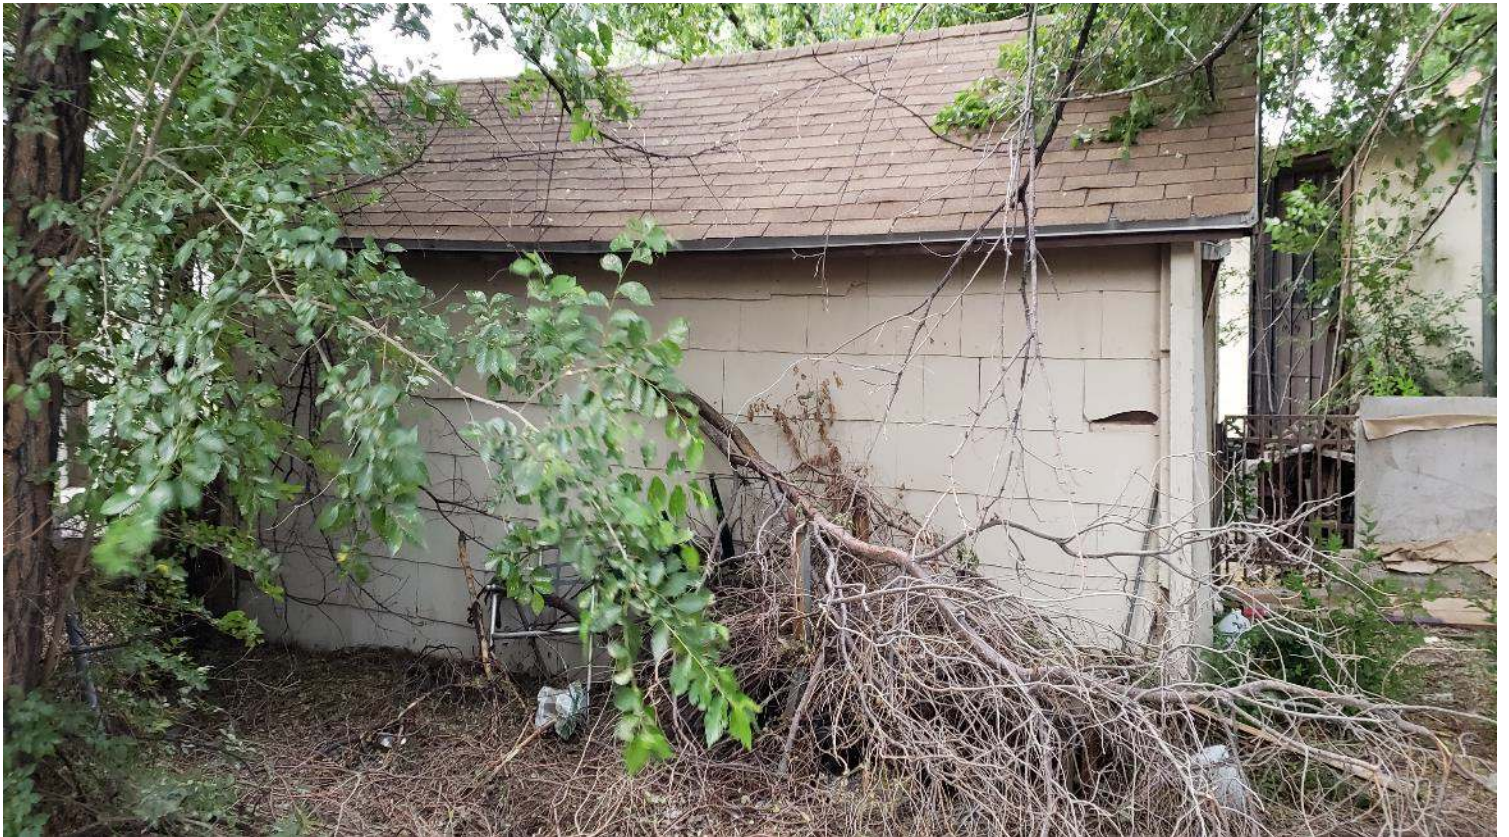
Photos 55–56. 617 W Tombstone garage NW façade close-up (garage door up) facing SE (top) and SW & SE façades facing N (bottom).

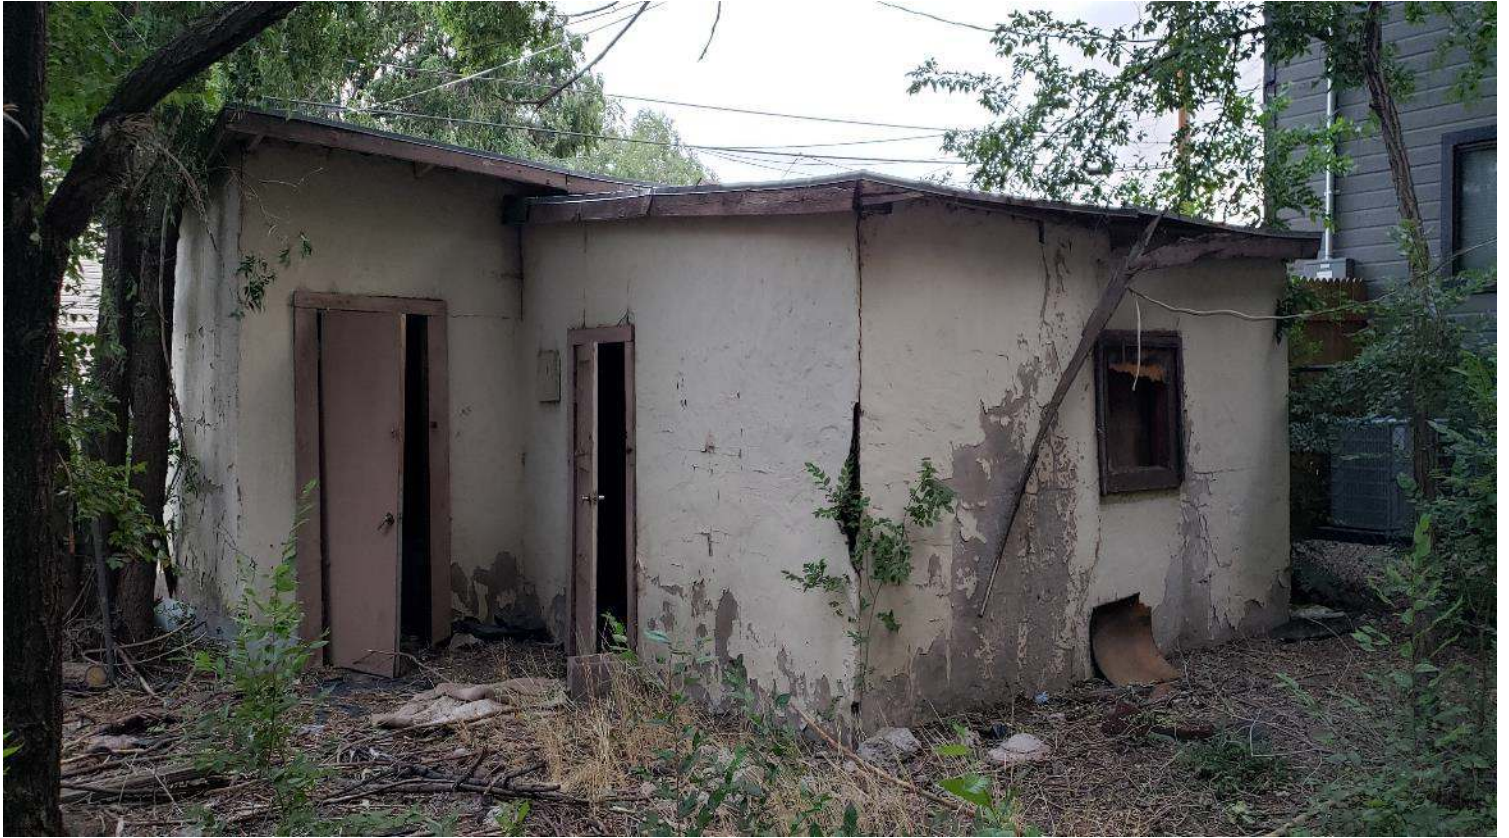
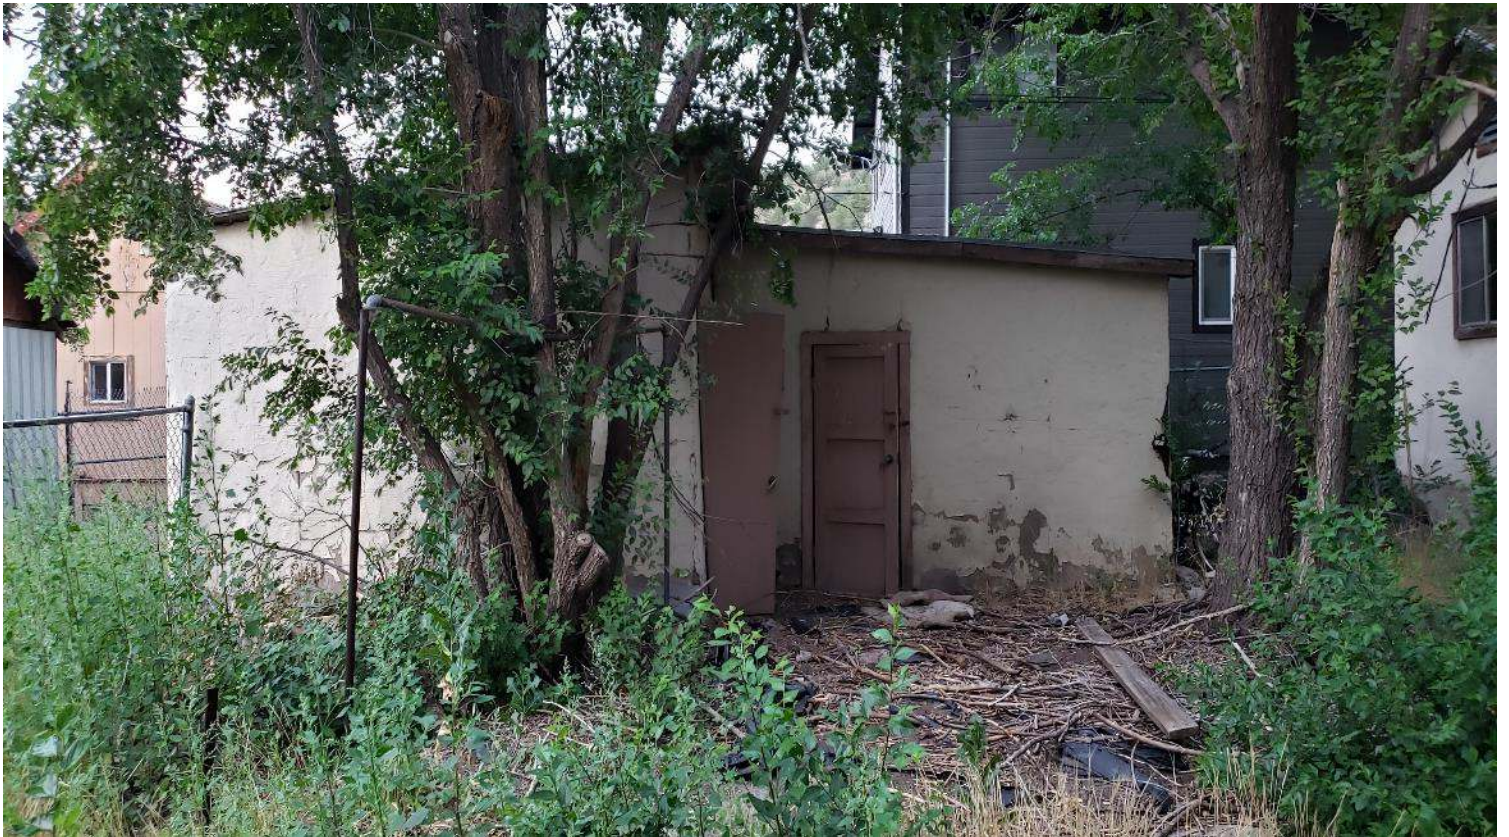
Photos 57–58. 617 W Tombstone workshop N & E façades facing SW (top) and E façade (bottom).

The building most reflective of the late 1920s to 1940s development of the property is the workshop/shed at the back of property on the alley (*Photos 57–63*). This structure was referred to as grandpa's shop by Matthew Sedillo; according to Matthew's father Gabriel, Matthew's grandfather Philip was a woodworker. The shop consists of two rooms, and the S room still contained presumably Philip's workbenches and tools (*Photos 64–68*). The walls are mostly vertical 1 × 12-inch planks, with 1 × 12s and 1 × 7s used for the roofing. The exterior is covered in stucco, likely added at a later date, perhaps in the 1940s to all the buildings. The roofing is rolled asphalt over wood planking. In more recent times, the rooms were used for storage like the garage.

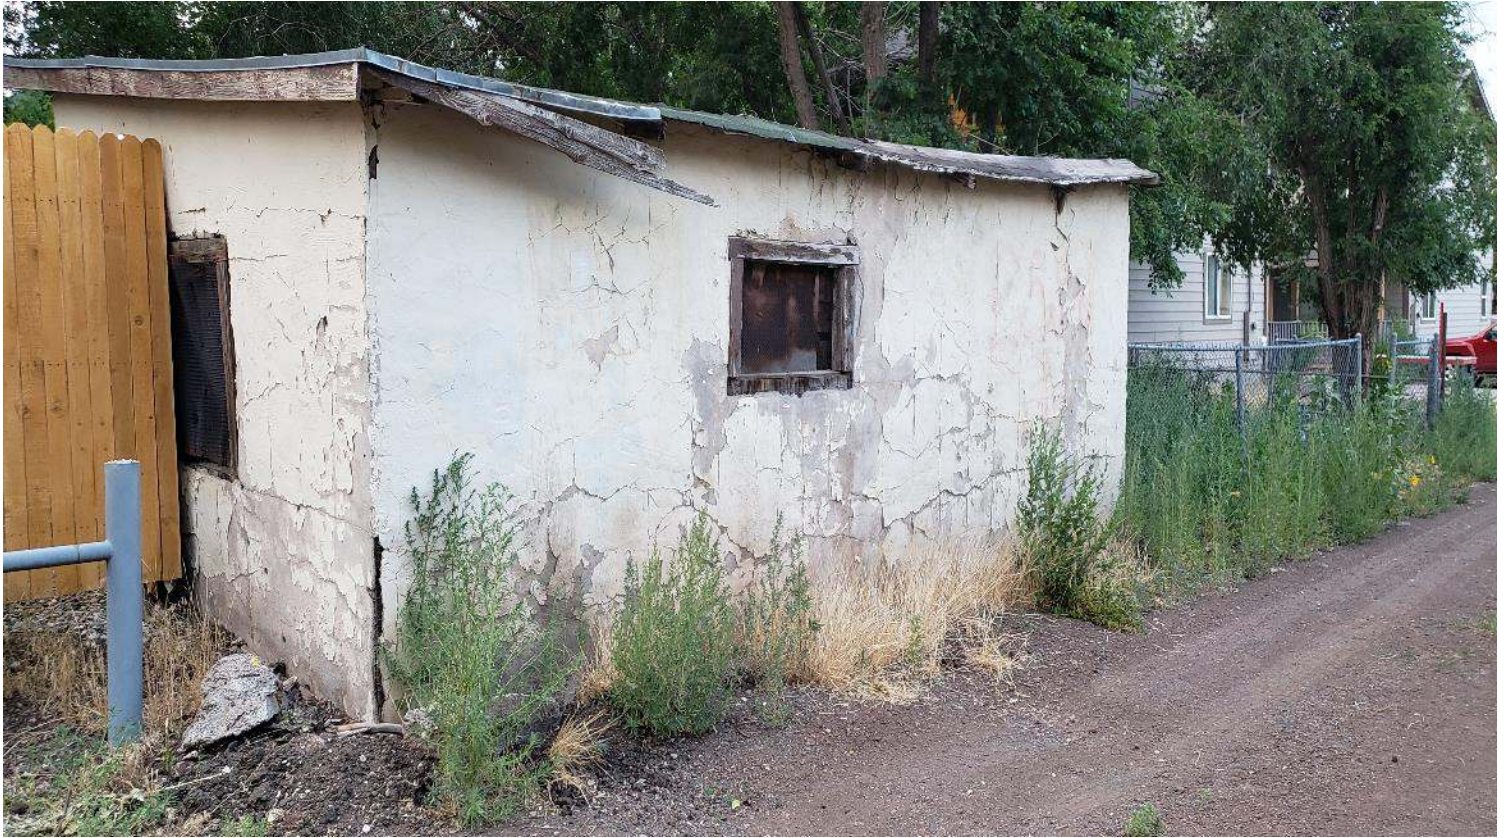
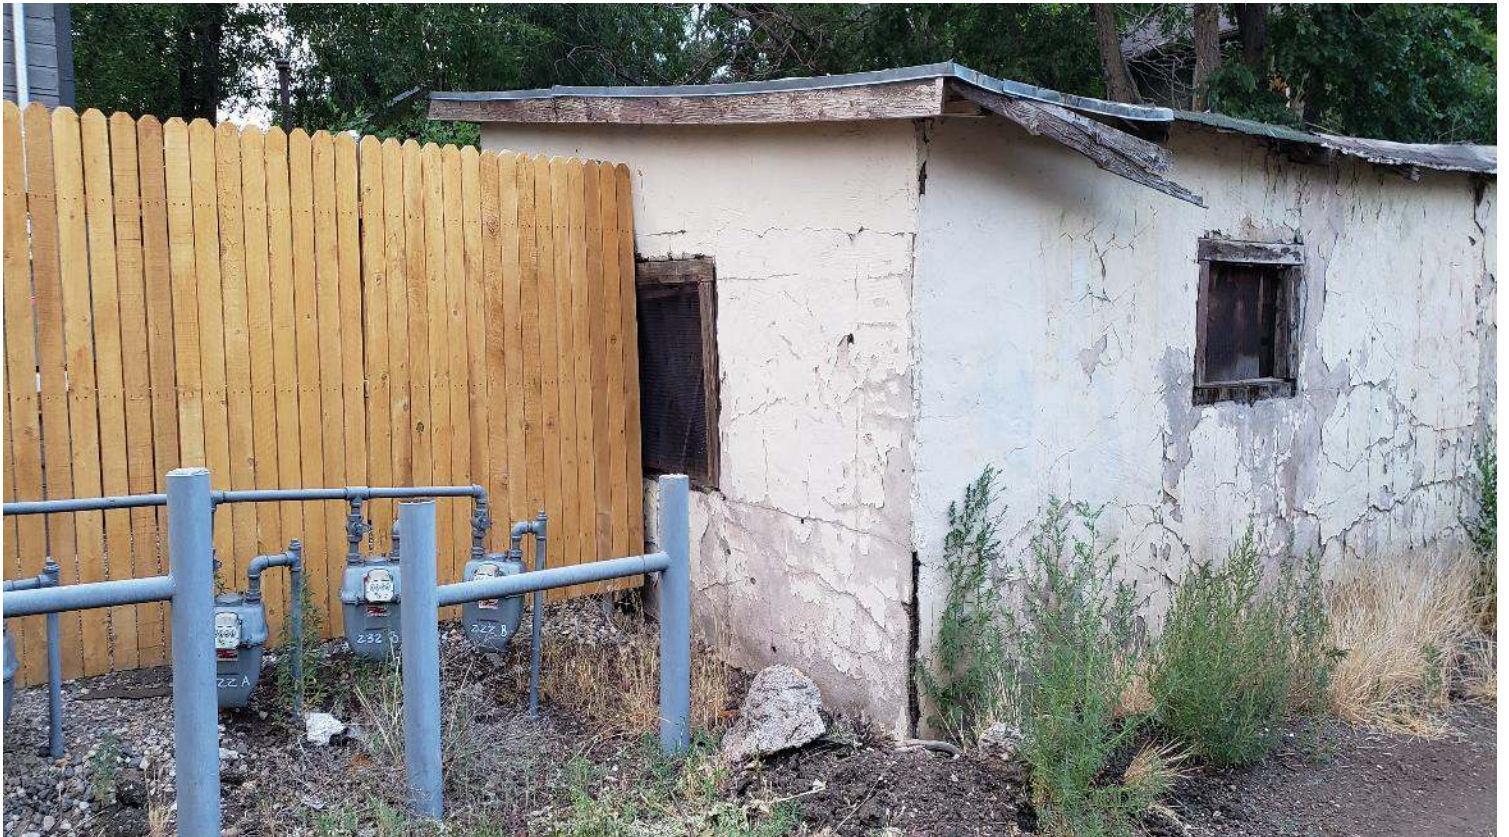
Photos 59–60. 617 W Tombstone workshop S & W façades facing ENE (top) and NE (bottom).
